# Visual Site Inspection Report

<b>Project Name</b>	H-600 Pipeline Spread G	<b>AFE</b>	124300137	<b>Spread</b>	H-600 Pipeline Spread G
<b>Contractor</b>	Precision			<b>Report #</b>	8737
<b>Inspector</b>	Chris Burns			<b>Date/Time</b>	3/2/2020 6:45 AM
<b>Permit #</b>	TBD	<b>Inspection Type</b>	VA SWPP	<b>Station Begin</b>	11254+99
<b>State</b>	VA	<b>Inspection Area</b>	Partial	<b>Station End</b>	11353+67
<b>County</b>	Giles	<b>Ground</b>	Damp	<b>Temperature (°F)</b>	50.00
<b>Municipality</b>	N/A	<b>Weather</b>	Cloudy	<b>Rain Gauge (in)</b>	0.00
				<b>Rain Accumulation Time (days)</b>	1.00

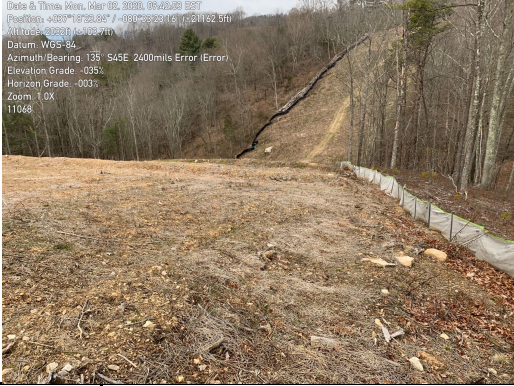
<b>GPS Location</b>	See picture above for GPS coordinates		<b>GPS Location</b>	See picture above for GPS coordinates	
<b>Field Station#</b>	11068+00		<b>Field Station#</b>	11080+00	
<b>Pic 1 Desc.</b>	ECD's and row conditions		<b>Pic 2 Desc.</b>	ECD's and row conditions	
<p>Date &amp; Time Wed, Mar 04, 2020, 10:47:47 EST  Position: +48°15'29.87" N -88°23'25.16" W (±21162.5m)  Altitude: 1830' (±1.20)  Datum: WGS-84  Azimuth/Bearing: 135° S45E 2400mils Error (Error)  Elevation Grade: -03%  Horizon Grade: -00%  Zoom: 1.0X  11120</p>

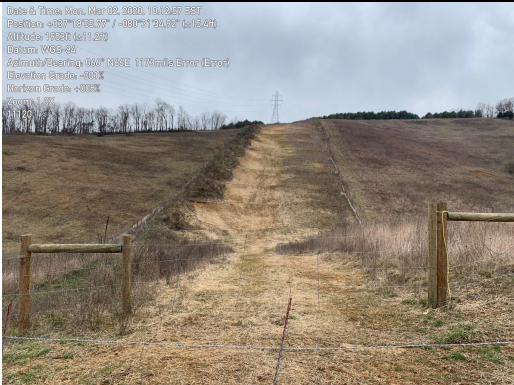
<b>GPS Location</b>	See picture above for GPS coordinates		<b>GPS Location</b>	See picture above for GPS coordinates	
<b>Field Station#</b>	11120+00		<b>Field Station#</b>	11132+00	
<b>Pic 3 Desc.</b>	ECD's and row conditions		<b>Pic 4 Desc.</b>	ECD's and row conditions	
<p>Date &amp; Time Wed, Mar 04, 2020, 10:51:47 EST  Position: +48°15'29.87" N -88°23'25.16" W (±21162.5m)  Altitude: 1830' (±1.20)  Datum: WGS-84  Azimuth/Bearing: 141° S59E 3300mils Error (Error)  Elevation Grade: -03%  Horizon Grade: -00%  Zoom: 1.0X  11140</p>

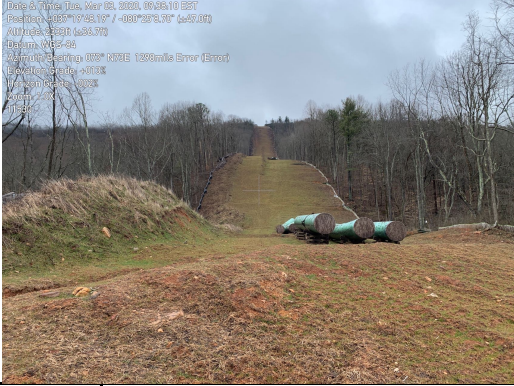
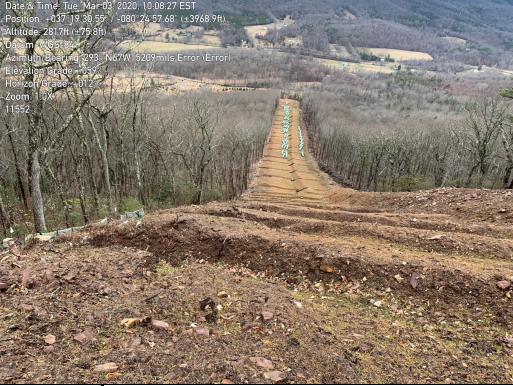
<b>GPS Location</b>	See picture above for GPS coordinates		<b>GPS Location</b>	See picture above for GPS coordinates	
<b>Field Station#</b>	11530+00		<b>Field Station#</b>	11552+00	
<b>Pic 1 Desc.</b>	ECD's and row conditions		<b>Pic 2 Desc.</b>	ECD's and row conditions

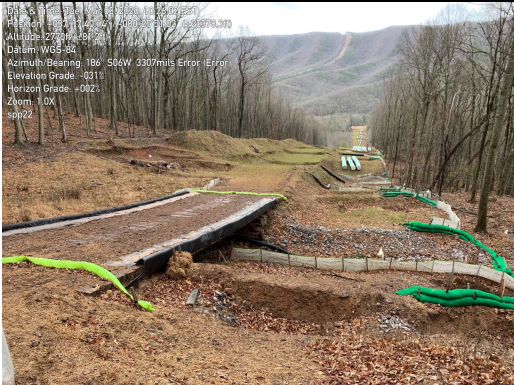
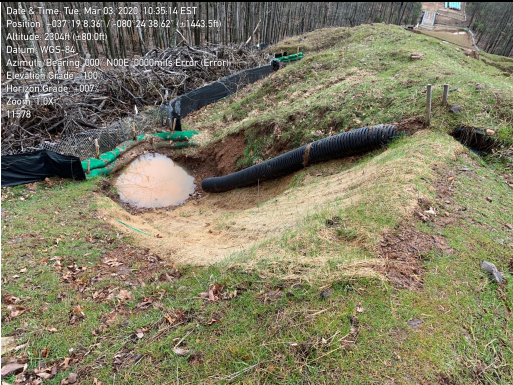
<b>GPS Location</b>	See picture above for GPS coordinates		<b>GPS Location</b>	See picture above for GPS coordinates	
<b>Field Station#</b>	11565+00		<b>Field Station#</b>	11578+00	
<b>Pic 3 Desc.</b>	ECD's and row conditions		<b>Pic 4 Desc.</b>	ECD's and row conditions

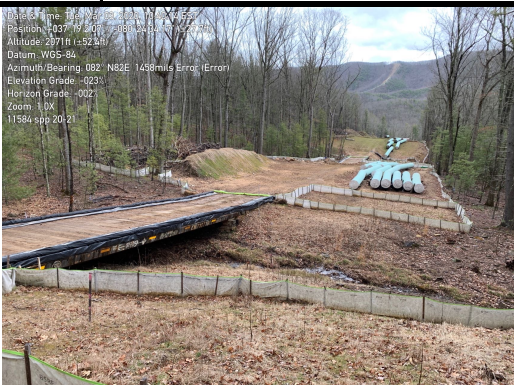
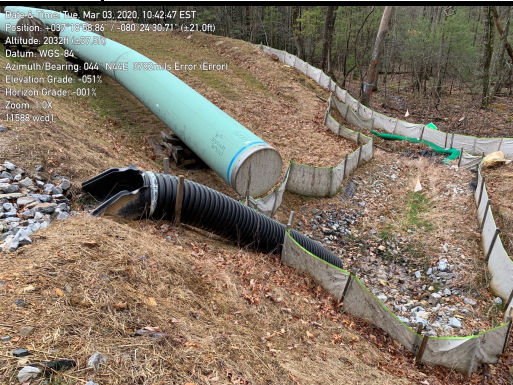
<b>GPS Location</b>	See picture above for GPS coordinates		<b>GPS Location</b>	See picture above for GPS coordinates	
<b>Field Station#</b>	11584+00		<b>Field Station#</b>	11588+00	
<b>Pic 5 Desc.</b>	ECD's and row conditions		<b>Pic 6 Desc.</b>	ECD's and row conditions

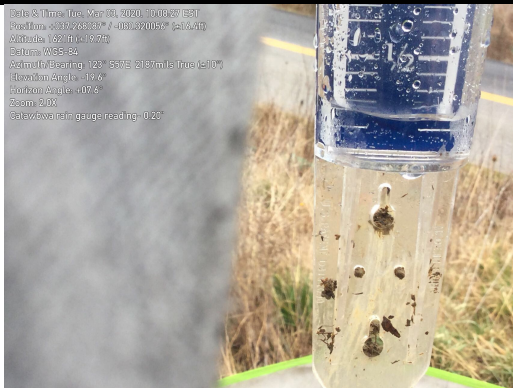
GPS Location		See photo GPS		GPS Location		See photo GPS	
Field Station#		11963+00		Field Station#		11989+00	
Pic 5 Desc.		Perimeter controls have been replaced where damaged.		Pic 6 Desc.		Catawba rain gauge reading- 0.20"

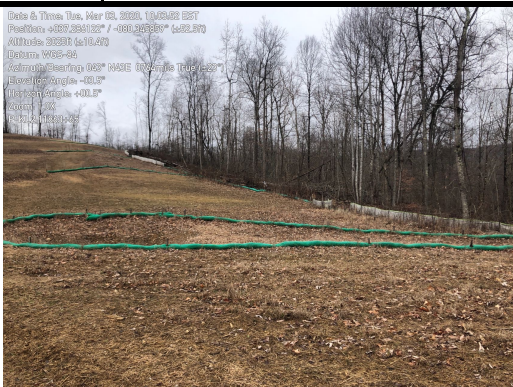
GPS Location	5	GPS Location	6		
Field Station#	11863+65	Field Station#	11897+00		
Pic 5 Desc.	P-KL2.		Pic 6 Desc.	RoW conditions and controls.

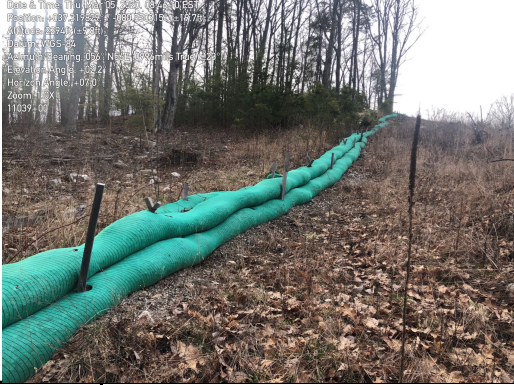
<b>GPS Location</b>	3	<b>GPS Location</b>	4		
<b>Field Station#</b>	11039+00	<b>Field Station#</b>	11050+10		
<b>Pic 3 Desc.</b>	CFS perimeter controls.	<b>Pic 4 Desc.</b>	S-IJ16B and S-IJ17.		
<p>Date &amp; Time: Thu, Mar 05, 2020, 09:00:00 EST  Position: +037.211809° / -080.544488° (-19.3N)  Altitude: 2675ft (-8.0m)  Datum: WGS-84  Azimuth/Bearing: 051° N51E 0907mils True (-22°)  Elevation Angle: -10.4°  Horizon Angle: +00.9°  Zoom: 1.0x  11055+00</p>

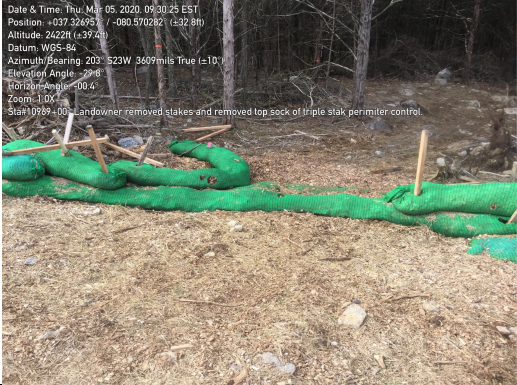
<p><small>Date &amp; Time: Thu, Mar 05, 2020, 09:30:25 EST Position: +037 336951 / -080 570242 (±32.8ft) Altitude: 2422ft (±39.7m) Datum: WGS-84 Azimuth/Bearing: 203° S23W 3609mils True (±10°) Elevation Angle: -29.8° Horizon Angle: +00.4° Zoom: 1.0X Sta#10969+00: Landowner removed stakes and removed top sock of triple stake perimeter control.</small></p>			
<b>GPS Location</b>	See photo GPS	<b>GPS Location</b>	See photo GPS		
<b>Field Station#</b>	10980+00	<b>Field Station#</b>	10969+00

<b>Pic 7 Desc.</b>	Landowner drove on travel lane and rutted row and damaged mulch.	<b>Pic 8 Desc.</b>	Landowner removed top CFS perimeter control and drove onto row.

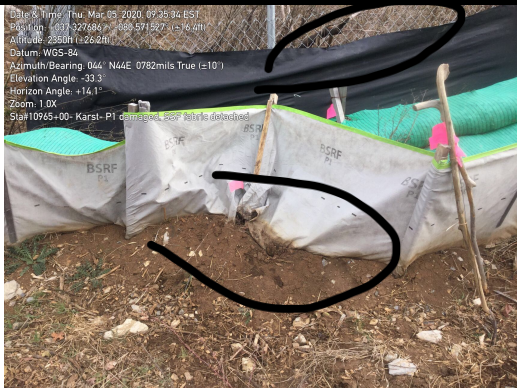
<p><small>Date &amp; Time: Thu, Mar 05, 2020, 09:35:34 EST Position: +037 337886 / -080 571527 (±36.4ft) Altitude: 2580ft (±26.2m) Datum: WGS-84 Azimuth/Bearing: 044° N44E 0782mils True (±10°) Elevation Angle: -33.3° Horizon Angle: +14.1° Zoom: 1.0X Sta#10965+00: Karst-P1 damaged, silt fence destroyed</small></p>		<p style="text-align: center;">Insert image here</p>			
<b>GPS Location</b>	See photo GPS	<b>GPS Location</b>			
<b>Field Station#</b>	10964+00	<b>Field Station#</b>			
<b>Pic 9 Desc.</b>	Animal damage to P1 at Karst.	<b>Pic 10 Desc.</b>			
<p style="text-align: center;">Insert image here</p>		<p style="text-align: center;">Insert image here</p>			
<b>GPS Location</b>		<b>GPS Location</b>			
<b>Field Station#</b>		<b>Field Station#</b>

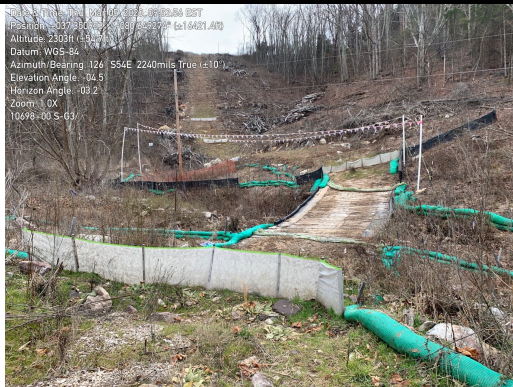
</div></div></div>			<div><div><div>Date &amp; Time: Thu, Mar 05, 2020, 09:54:04 EST Position: +037.351077 / -080.649432 (+274.3m) Altitude: 2303ft (+70.2ft) Datum: WGS-84 Azimuth/Bearing: 126° S54E 2240mils True (+10°) Elevation Angle: -14.5 Horizon Angle: -03.2 Zoom: 1.0x 10698+00 S-G32</div><div>

</div></div></div>			
GPS Location		See photo for GPS location.		GPS Location		See photo for GPS location.
Field Station#		10711+00		Field Station#		10698+00
Pic 3 Desc.		Waterbar with CFS end treatment in place across travel.		Pic 4 Desc.		Sensitive resource buffer in place at stream S-G32.
<div><div><div>Date &amp; Time: Thu, Mar 05, 2020, 09:49:23 EST Position: +037.349223 / -080.632600 (+15.4ft) Altitude: 2265ft (+69.3ft) Datum: WGS-84 Azimuth/Bearing: 140° S40E 2489mils True (+10°) Elevation Angle: -07.6 Horizon Angle: -100.0 Zoom: 1.0x 10696+00</div><div>

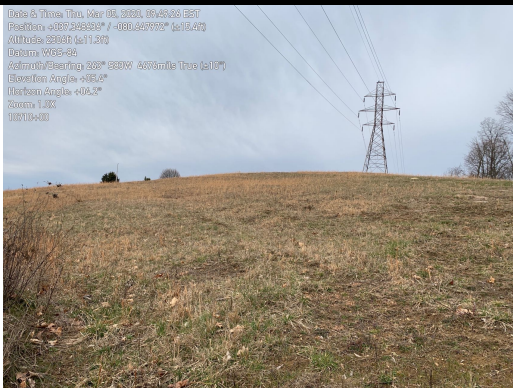
GPS Location		See photo for GPS location.		GPS Location		See photo for GPS location.
Field Station#		10710+00		Field Station#		10696+00
Pic 5 Desc.		ROW stabilized with natural vegetation.		Pic 6 Desc.		RCE in place at Buffalo Anklets Road.

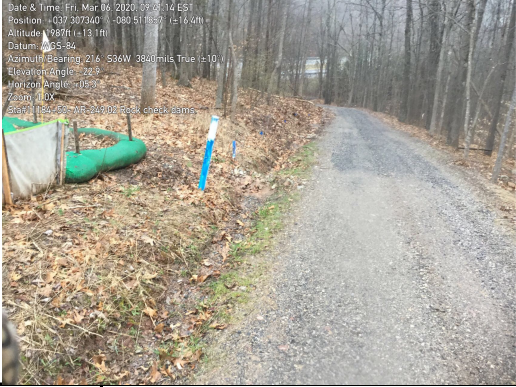
<b>GPS Location</b>	See photo GPS	<b>GPS Location</b>	See photo GPS		
<b>Field Station#</b>	11184+50	<b>Field Station#</b>	11161+00		
<b>Pic 5 Desc.</b>	AR-249.02- Access road and rock check dams are in acceptable condition.	<b>Pic 6 Desc.</b>	Rain, sleet, snow with gusty winds during inspection.
