Visual Site Inspection Report

Project Name	H-600 Pipeline Spread G	AFE	124300137	Spread	H-600 Pipeline Spread G
Contractor	Precision			Report #	9596
Inspector	Len Kruizenga			Date/Time	3/30/2020 2:01 PM
Permit #	TBD	Inspection Type	VA SWPP	Station Begin	11254+88
State	VA	Inspection Area	Full	Station End	11161+00
County	Giles	Ground	Dry	Temperature (°F)	55.00
Municipality	N/A	Weather	Sunny	Rain Gauge (in)	0.00
				Rain Accumulation Time (days)	2.00

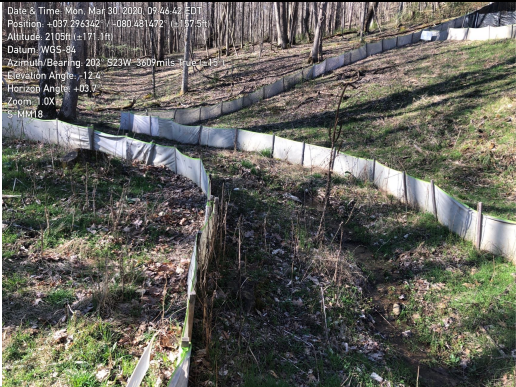
GPS Location	1	GPS Location	2		
Field Station#	11258+00	Field Station#	11265+25		
Pic 1 Desc.	Vegetation or stabilization sufficient.	Pic 2 Desc.	P-1 perimeter controls functional.

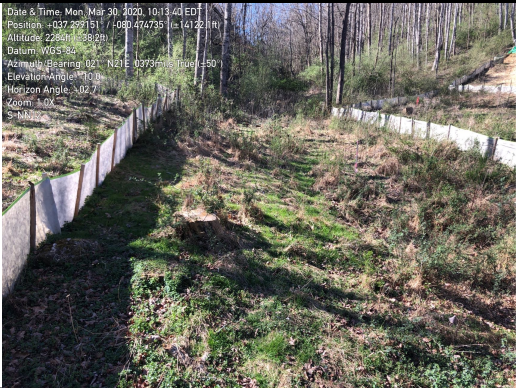
GPS Location	3	GPS Location	4		
Field Station#	11292+80	Field Station#	11310+00		
Pic 3 Desc.	S-MM18.	Pic 4 Desc.	PPL crews replacing P-1 perimeter controls.

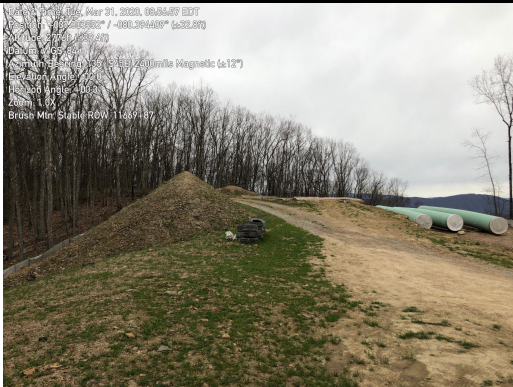
<p>Date & Time: Tue, Mar 31, 2020, 09:56:57 EDT Position: +037.385529° / -080.394601° (+52.270) Altitude: 2922ft (+98.770) Datum: WGS-84 Azimuth/Bearing: 109° S 80° E 341.00m Magnetic (+12°) Elevation Angle: +01.6° Horizon Angle: +04.8° Zoom: 1.0X Brush Min. Stable ROW: 11659+00</p>

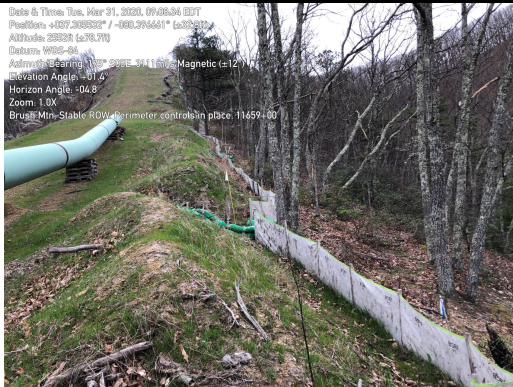
<p>Date & Time: Tue, Mar 31, 2020, 09:56:54 EDT Position: +037.385529° / -080.394601° (+52.270) Altitude: 2922ft (+98.770) Datum: WGS-84 Azimuth/Bearing: 109° S 80° E 341.00m Magnetic (+12°) Elevation Angle: +01.6° Horizon Angle: +04.8° Zoom: 1.0X Brush Min. Stable ROW: Perimeter controls in place 11659+00</p>			
GPS Location		On photo		GPS Location	
Field Station#		11669+87		Field Station#	
Pic 1 Desc.		ROW and topsoil piles are stable		Pic 2 Desc.	
				Perimeter controls are in place

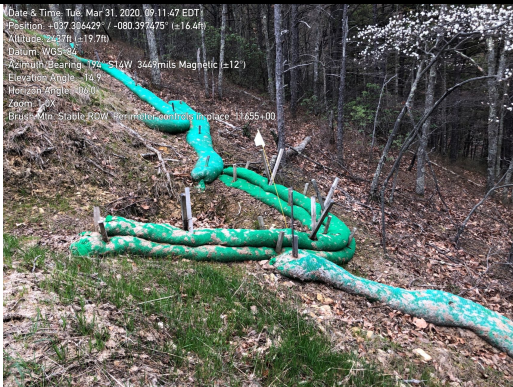
<p>Date & Time: Tue, Mar 31, 2020, 09:11:47 EDT Position: +037.384229° / -080.397475° (+16.4ft) Altitude: 2937ft (+19.7ft) Datum: WGS-84 Azimuth/Bearing: 127° N 81° W 344.00m Magnetic (+12°) Elevation Angle: +1.6° Horizon Angle: +0.0° Zoom: 1.0X Brush Min. Stable ROW: Perimeter controls in place 11655+00</p>

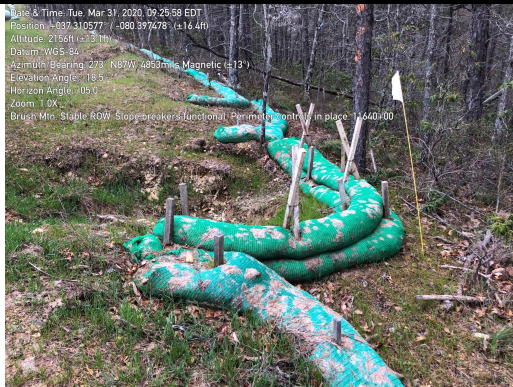
<p>Date & Time: Tue, Mar 31, 2020, 09:25:58 EDT Position: +037.310577° / -080.397475° (+16.4ft) Altitude: 2156ft (+13.1ft) Datum: WGS-84 Azimuth/Bearing: 127° N 81° W 344.00m Magnetic (+13°) Elevation Angle: +1.6° Horizon Angle: +0.0° Zoom: 1.0X Brush Min. Stable ROW: Slope breakers functional. Perimeter controls in place 11640+00</p>

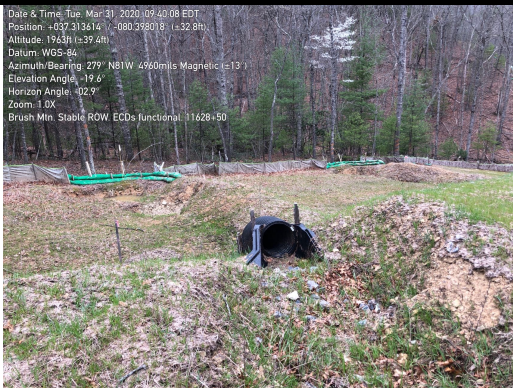
<p>Date & Time: Tue, Mar 31, 2020, 09:40:08 EDT Position: +037.318141° / -080.398018° (+32.8ft) Altitude: 1943ft (+39.4ft) Datum: WGS-84 Azimuth/Bearing: 279° N 81° W 496.00m Magnetic (+13°) Elevation Angle: +19.6° Horizon Angle: +02.9° Zoom: 1.0X Brush Min. Stable ROW: ECDs functional 11628+50</p>

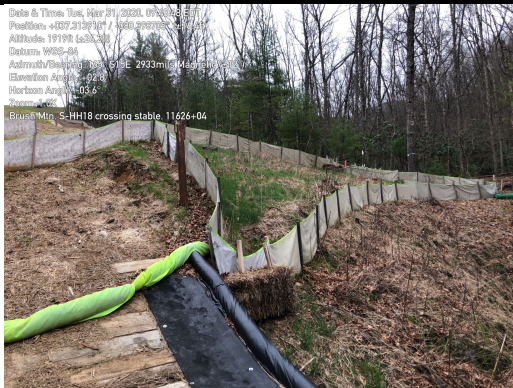
<p>Date & Time: Tue, Mar 31, 2020, 09:40:55 EDT Position: +037.318141° / -080.398018° (+32.8ft) Altitude: 1919ft (+35.3ft) Datum: WGS-84 Azimuth/Bearing: 279° N 81° E 293.00m Magnetic (+13°) Elevation Angle: +22.8° Horizon Angle: +02.6° Zoom: 1.0X Brush Min. Stable ROW: S-HH18 crossing stable 11626+04</p>			
GPS Location		On photo		GPS Location	
Field Station#		11628+50		Field Station#	
Pic 5 Desc.		Diversion pipes are in place		Pic 6 Desc.

S-HH18 crossing is stable. Buffers are vegetated and controls in place.

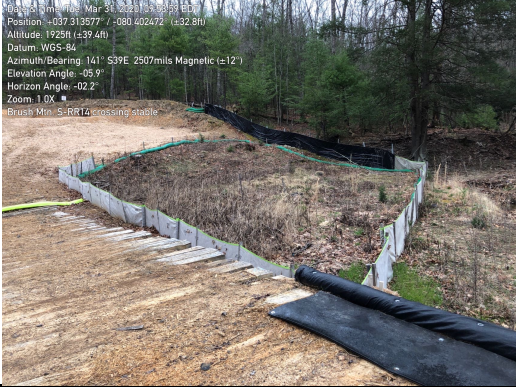
<p>Time & Date: Tue Mar 31 2020 11:56:01 EDT Position: -037.3135777, -080.4024725 (s32.8N) Altitude: 1925ft (s39.4N) Datum: WGS-84 Azimuth/Bearing: 141° S39E 2507mils Magnetic (s12°) Elevation Angle: -05.9° Horizon Angle: -02.2° Zoom: 1.0X Brush Mat: S-RR12 crossing stable</p>

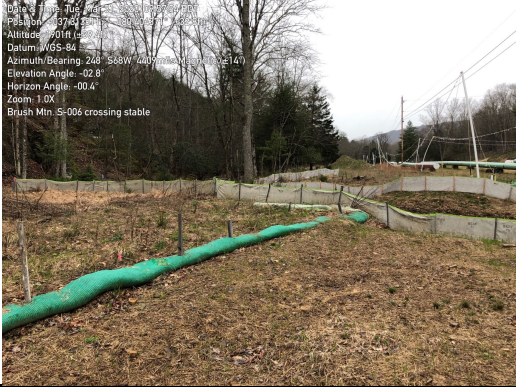
<p>Time & Date: Tue Mar 31 2020 11:56:01 EDT Position: -037.3135777, -080.4024725 (s32.8N) Altitude: 1925ft (s39.4N) Datum: WGS-84 Azimuth/Bearing: 208° S08W 2007mils Magnetic (s14°) Elevation Angle: -02.8° Horizon Angle: -00.4° Zoom: 1.0X Brush Mat: S-006 crossing stable</p>			
GPS Location	On photo	GPS Location	On photo		
Field Station#	11614+20	Field Station#	11608+17		
Pic 7 Desc.	Buffers stable with controls in place at S-RR14 crossing	Pic 8 Desc.	Buffers stable at S006 crossing

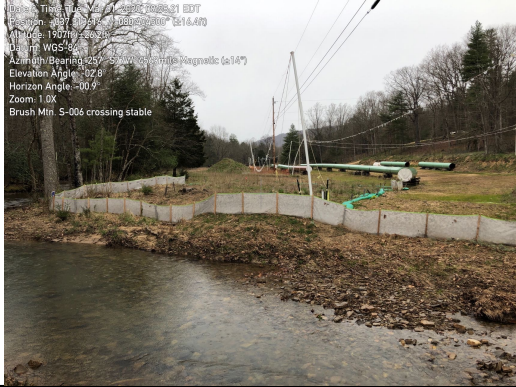
<p>Time & Date: Tue Mar 31 2020 10:02:32 EDT Position: -037.3135777, -080.402725 (s39.4N) Altitude: 1925ft (s39.4N) Datum: WGS-84 Azimuth/Bearing: 208° S08W 2007mils Magnetic (s14°) Elevation Angle: -02.8° Horizon Angle: -00.9° Zoom: 1.0X Brush Mat: S-006 crossing stable</p>

GPS Location	On photo	GPS Location	On photo		
Field Station#	11608+17	Field Station#	11613+69		
Pic 9 Desc.	Environmental controls are in place at the S006 crossing	Pic 10 Desc.	S-RR13 crossing at access road MN-258.04 is stable		
Insert image here		Insert image here			
GPS Location		GPS Location			
Field Station#		Field Station#			
Pic 11 Desc.		Pic 12 Desc.

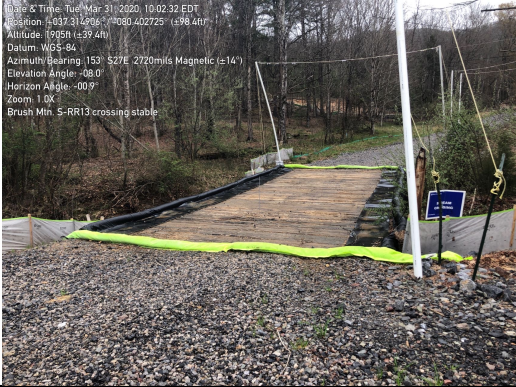
<p>Time & Date: Tue Mar 31 2020 10:02:32 EDT Position: -037.3135777, -080.402725 (s39.4N) Altitude: 1925ft (s39.4N) Datum: WGS-84 Azimuth/Bearing: 153° S27E 2720mils Magnetic (s14°) Elevation Angle: -08.0° Horizon Angle: -00.9° Zoom: 1.0X Brush Mat: S-RR13 crossing stable</p>

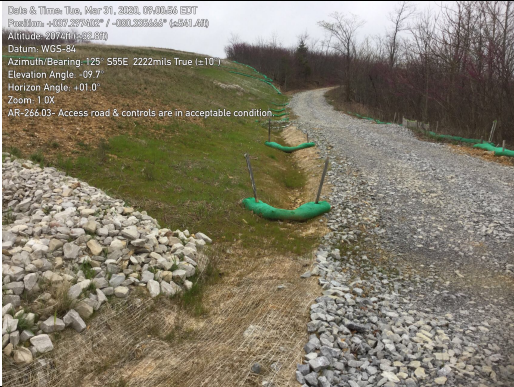
AFE	124300137	Date/Time	3/31/2020 12:57 PM	Report #	
Pictures					
<p>Date & Time: Tue, Mar 31, 2020, 09:46:53 EDT Position: +037.277436° / -080.275329° (±16.40) Altitude: 017.01m (±1.00) Datum: WGS-84 Azimuth/Bearing: 125.55SE 2222mils True (±10°) Elevation Angle: -09.7° Horizon Angle: +01.0° Zoom: 1.0X Start: 11900+00- Access road & controls are in acceptable condition</p>

GPS Location	See photo GPS	GPS Location	See photo GPS		
Field Station#	11900+00	Field Station#	11936+00		
Pic 1 Desc.	AR-266.03- Access rd & ECD's.	Pic 2 Desc.	Row permanent restoration		
<p>Date & Time: Tue, Mar 31, 2020, 09:31:48 EDT Position: +037.277436° / -080.309199° (±8150.0m) Altitude: 017.01m (±1.00) Datum: WGS-84 Azimuth/Bearing: 132.54SE 2364mils True (±10°) Elevation Angle: -12.2° Horizon Angle: +00.0° Zoom: 1.0X Start: 11950+00- Karst ECD's are in acceptable condition</p>

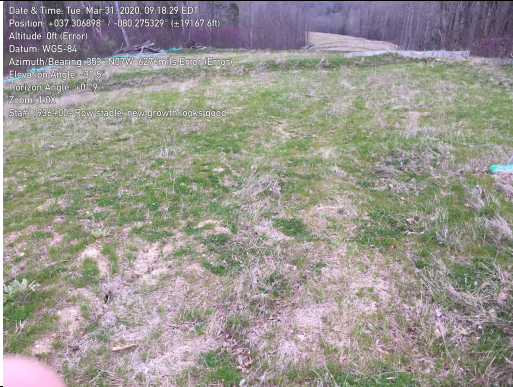
<p>Date & Time: Tue, Mar 31, 2020, 09:18:29 EDT Position: +037.306598° / -080.275329° (±19.67.44) Altitude: 017.01m (±1.00) Datum: WGS-84 Azimuth/Bearing: 055.50NW 6274mils True (±10°) Elevation Angle: -13.5° Horizon Angle: +00.9° Zoom: 1.0X Start: 11936+00- Row stable, new growth looks good</p>

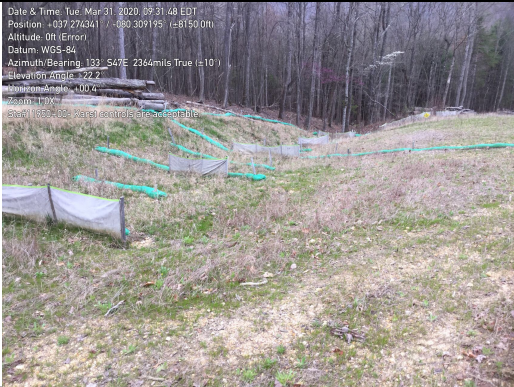
GPS Location	See photo GPS	GPS Location	See photo GPS		
Field Station#	11950+00	Field Station#	11977+00		
Pic 3 Desc.	ECD's protecting Karst	Pic 4 Desc.	Karst and Karst ECD's are in acceptable condition		
<p>Date & Time: Tue, Mar 31, 2020, 10:19:48 EDT Position: +037.262230° / -080.517017° (±16.40) Altitude: 15.57m (±105.0m) Datum: WGS-84 Azimuth/Bearing: 221.54W 3929mils True (±10°) Elevation Angle: -15.4° Horizon Angle: +01.5° Zoom: 1.0X Start: 12000+00 to 12001+00- Wetland ECD's are in acceptable condition</p>

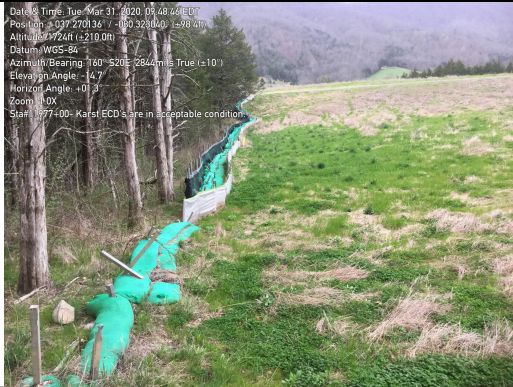
<p>Date & Time: Tue, Mar 31, 2020, 09:40:44 EDT Position: +037.270136° / -080.320000° (±98.4m) Altitude: 017.24m (±210.0m) Datum: WGS-84 Azimuth/Bearing: 160.53SE 2864mils True (±10°) Elevation Angle: -14.7° Horizon Angle: +01.3° Zoom: 1.0X Start: 11977+00- Karst ECD's are in acceptable condition</p>

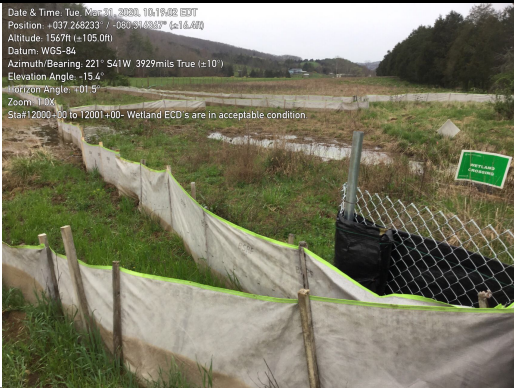
Pic 5 Desc.	Wetland ECD's are in acceptable condition.	Pic 6 Desc.	SSF fabric sagging, Contractor has been notified.

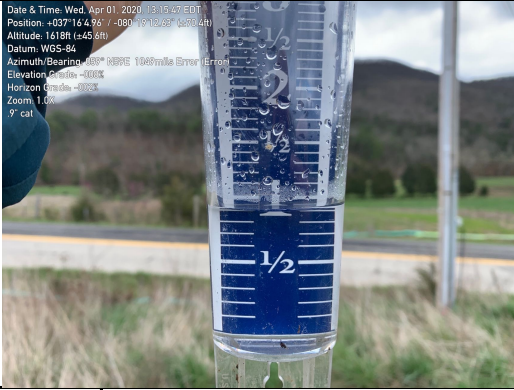
<p>Date & Time: Wed, Apr 01, 2020 13:15:27 EDT Position: +037° 16' 43.1" / -086° 15' 10.37" (Error: 0) Altitude: 1618ft (+45.8ft) Datum: WGS-84 Azimuth/Bearing: 103° N03E 104mils Error (Error) Elevation Grade: +003% Horizon Grade: +003% Zoom: 1.0X 9" cat</p>

<p>Date & Time: Wed, Apr 01, 2020 09:12:24 EDT Position: +037° 16' 43.1" / -086° 15' 10.37" (Error: 0) Altitude: 1618ft (+45.8ft) Datum: WGS-84 Azimuth/Bearing: 103° N03E 104mils Error (Error) Elevation Grade: +003% Horizon Grade: +003% Zoom: 1.0X 9"</p>			
GPS Location	See picture above for GPS coordinates		GPS Location	See picture above for GPS coordinates	
Field Station#	12005+00		Field Station#	12005+00	
Pic 1 Desc.	.9" of rain recorded @ Catawba		Pic 2 Desc.	ECD's and row conditions

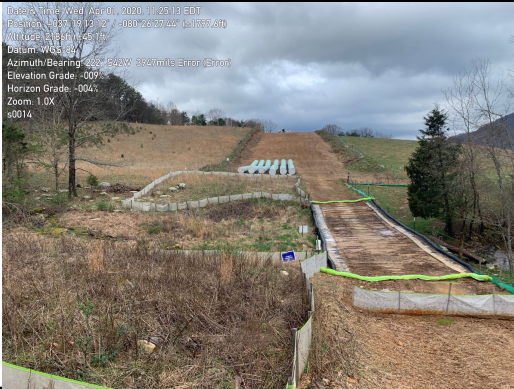
<p>Date & Time: Wed, Apr 01, 2020 11:03:07 EDT Position: +037° 19' 14.41" / -086° 26' 11.07" (Error: 0) Altitude: 2236ft (+63.1ft) Datum: WGS-84 Azimuth/Bearing: 103° N03E 103mils Error (Error) Elevation Grade: +003% Horizon Grade: +004% Zoom: 1.0X 11425</p>

GPS Location	See picture above for GPS coordinates		GPS Location	See picture above for GPS coordinates	
Field Station#	+1		Field Station#	11425+00	
Pic 3 Desc.	ECD's and row conditions		Pic 4 Desc.	New sinkhole discovered

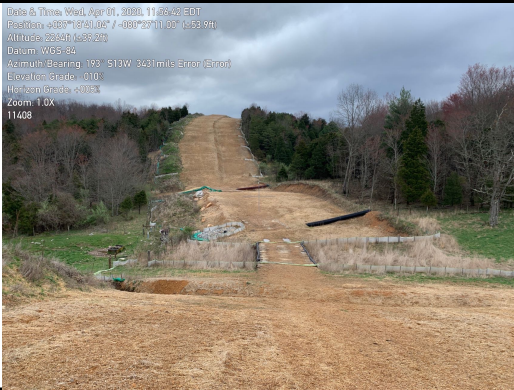
<p>Date & Time: Wed, Apr 01, 2020 11:03:07 EDT Position: +037° 19' 14.41" / -086° 26' 11.07" (Error: 0) Altitude: 2236ft (+63.1ft) Datum: WGS-84 Azimuth/Bearing: 103° N03E 103mils Error (Error) Elevation Grade: +003% Horizon Grade: +004% Zoom: 1.0X 11408</p>

Pic 5 Desc.	ECD's and row conditions		Pic 6 Desc.	ECD's and row conditions

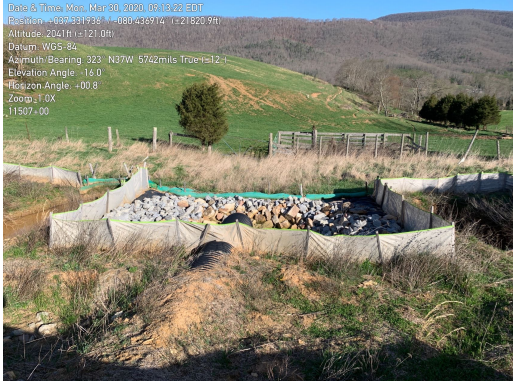
GPS Location				See photo for GPS location.				GPS Location				See photo for GPS location.			
Field Station#				11507+00				Field Station#				11503+00			
Pic 1 Desc.				Plunge pool in place.				Pic 2 Desc.				Conveyance channel with rock checks in place.			
<p>Date & Time: Mon, Mar 30, 2020, 09:19:14 EDT Position: +037.325114 / -080.430988 (+632.2ft) Altitude: 2181ft (+67.7m) Datum: WGS-84 Azimuth/Bearing: 244° S29W 4242mils True (±12°) Elevation Angle: -11.7° Horizon Angle: +03.8° Zoom: 1.0X 11489+00</p>

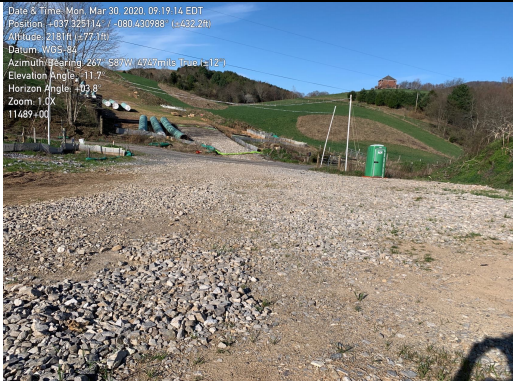
GPS Location				See photo for GPS location.				GPS Location				See photo for GPS location.			
Field Station#				11489+00				Field Station#				11478+00			
Pic 3 Desc.				RCE in place at Stevers Gap Road.				Pic 4 Desc.				Slope drains and ECB in place.			
<p>Date & Time: Mon, Mar 30, 2020, 09:42:10 EDT Position: +037.335467 / -080.444461 (+24528.9ft) Altitude: 2221ft (+67.8m) Datum: WGS-84 Azimuth/Bearing: 224° S44W 3982mils True (±12°) Elevation Angle: -09.3° Horizon Angle: -01.9° Zoom: 1.0X 11451+00 S-0012 & S-0013</p>  				<p>Date & Time: Mon, Mar 30, 2020, 09:43:05 EDT Position: +037.322107 / -080.435547 (+4600.9ft) Altitude: 2275ft (+69.2ft) Datum: WGS-84 Azimuth/Bearing: 218° S38W 3876mils True (±12°) Elevation Angle: -15.0° Horizon Angle: +00.5° Zoom: 1.0X 11472+00</p>  											
GPS Location				See photo for GPS location.				GPS Location				See photo for GPS location.			
Field Station#				11451+00				Field Station#				11472+00

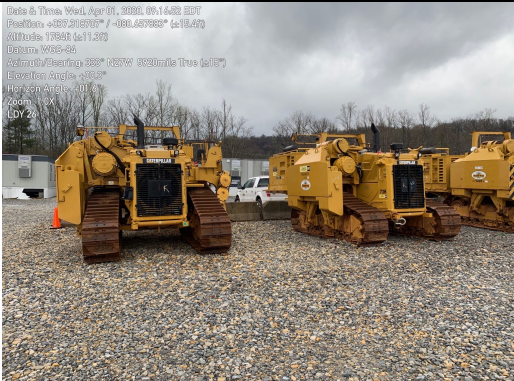
GPS Location	See photo for GPS location.		GPS Location	See photo for GPS location.	
Field Station#	12005+00		Field Station#	12005+00	
Pic 3 Desc.	Checked staged equipment for leaks. No leaks observed.		Pic 4 Desc.	Secondary containment in place under fuel cell.

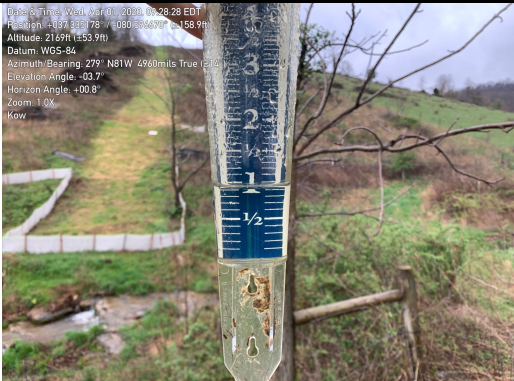
GPS Location	See photo for GPS location.		GPS Location	See photo for GPS location.	
Field Station#	10883+50		Field Station#	11025+00	
Pic 5 Desc.	Rain gauge at Kow Camp Road reads 1 inch.		Pic 6 Desc.	Rain gauge at access road 244 reads 0.9 inches.

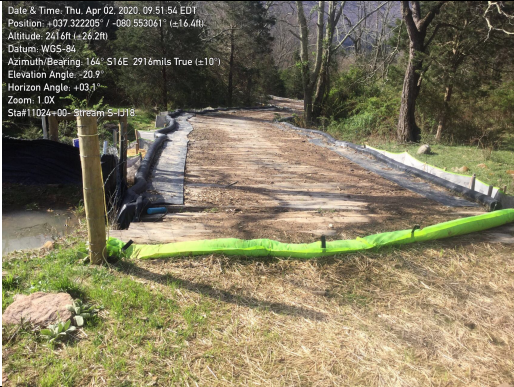
<p>Date & Time: Thu, Apr 02, 2020, 09:51:56 EDT Position: +037.322205 / -080.553061 (+16.4ft) Altitude: 2610ft (+29.2m) Datum: WGS-84 Azimuth/Bearing: 164.516E 2916mils True (+10°) Elevation Angle: -20.9° Horizon Angle: +03.1° Zoom: 1.0X Sta#11024+00-Stream S-IJ18</p>

<p>Date & Time: Thu, Apr 02, 2020, 10:02:31 EDT Position: +037.322691 / -080.555679 (+32.8ft) Altitude: 2606ft (+29.4m) Datum: WGS-84 Azimuth/Bearing: 095° 58'E 1689mils True (+25°) Elevation Angle: -21.6° Horizon Angle: +01.6° Zoom: 1.0X Sta#11017+00-Stream S-RR5</p>			
GPS Location	See photo GPS	GPS Location	See photo GPS		
Field Station#	11024+00	Field Station#	11017+00		
Pic 1 Desc.	Stream S- IJ18.	Pic 2 Desc.	Stream S-RR5

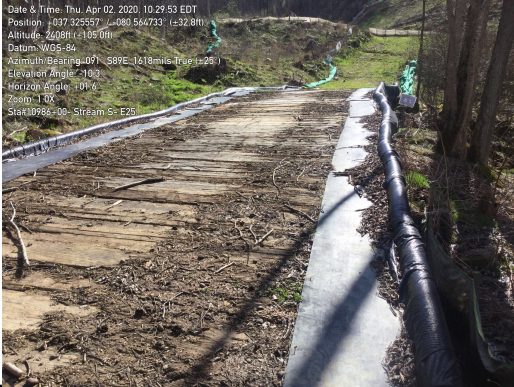
<p>Date & Time: Thu, Apr 02, 2020, 10:29:53 EDT Position: +037.322557 / -080.564733 (+32.0ft) Altitude: 2608ft (+105.0ft) Datum: WGS-84 Azimuth/Bearing: 097° 58'E 1618mils True (+25°) Elevation Angle: -10.3° Horizon Angle: +01.6° Zoom: 1.0X Sta#10986+00-Stream S-E25</p>

GPS Location	See photo GPS	GPS Location	See photo GPS		
Field Station#	10986+00	Field Station#	10985+00		
Pic 3 Desc.	Stream S- E25	Pic 4 Desc.	Stream S- E24

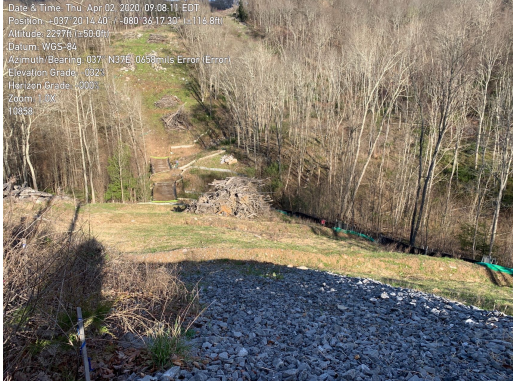
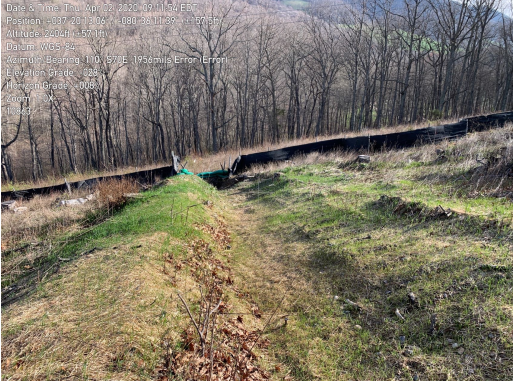
GPS Location				See picture above for GPS coordinates				GPS Location				See picture above for GPS coordinates			
Field Station#				10858+00				Field Station#				10863+00			
Pic 1 Desc.				ECD's and row conditions				Pic 2 Desc.				ECD's and row conditions

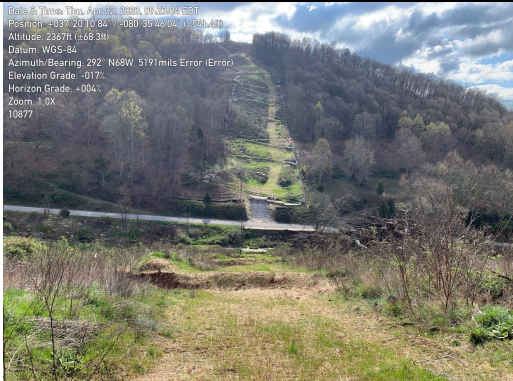
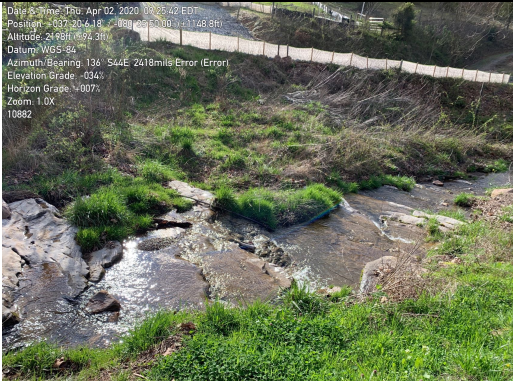
GPS Location				See picture above for GPS coordinates				GPS Location				See picture above for GPS coordinates			
Field Station#				10877+00				Field Station#				10882+00			
Pic 3 Desc.				ECD's and row conditions				Pic 4 Desc.				ECD's and row conditions

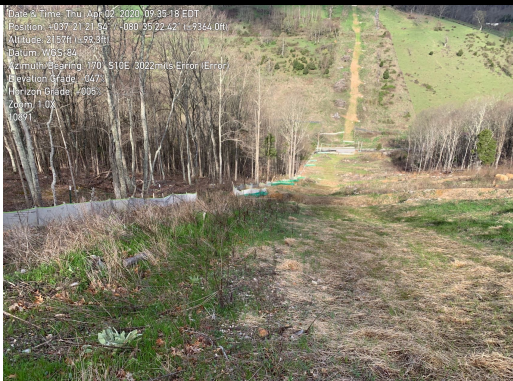
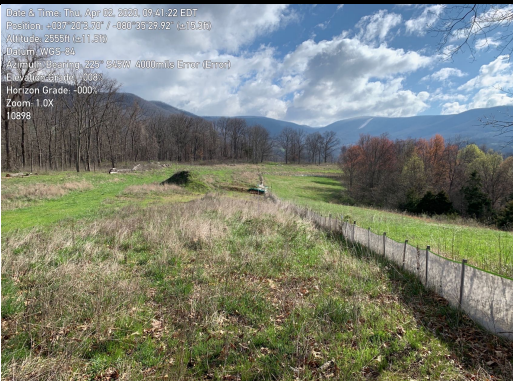
GPS Location				See picture above for GPS coordinates				GPS Location				See picture above for GPS coordinates			
Field Station#				10891+00				Field Station#				10898+00			
Pic 5 Desc.				ECD's and row conditions				Pic 6 Desc.				ECD's and row conditions

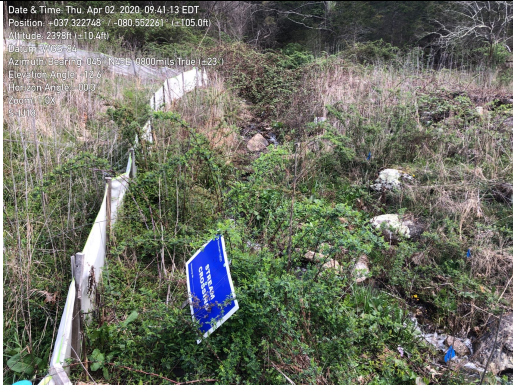
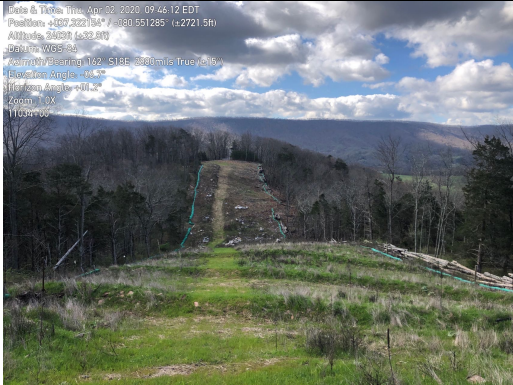
GPS Location	1		GPS Location	2	
Field Station#	11025+50		Field Station#	11034+00	
Pic 1 Desc.	S-IJ18.		Pic 2 Desc.	RoW conditions and controls.

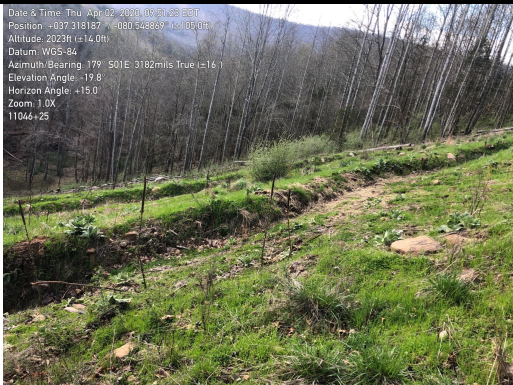
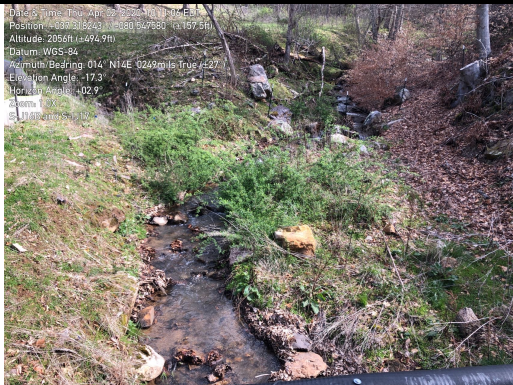
GPS Location	3		GPS Location	4	
Field Station#	11046+25		Field Station#	11050+10	
Pic 3 Desc.	Water bars and vegetation new growth.		Pic 4 Desc.	S-IJ16B and S-IJ17.

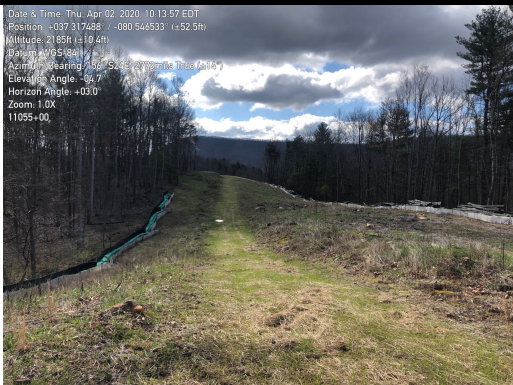
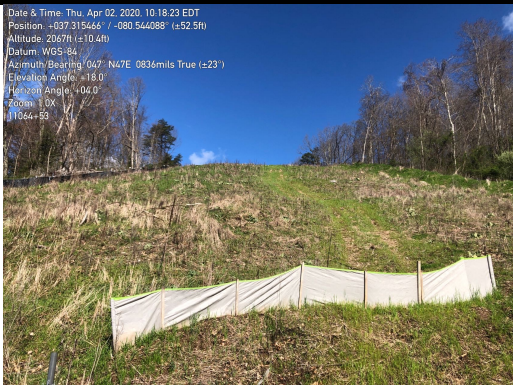
GPS Location	5		GPS Location	6	
Field Station#	11055+00		Field Station#	11064+53	
Pic 5 Desc.	RoW conditions and controls.		Pic 6 Desc.	RoW conditions and controls.

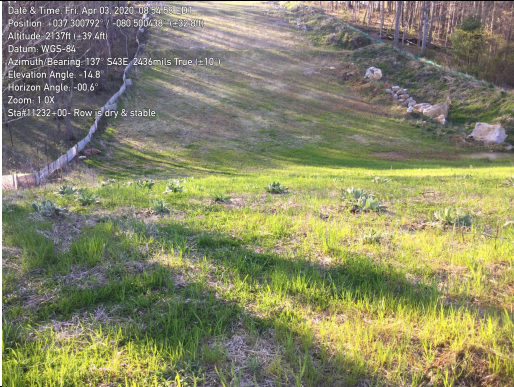
GPS Location	See photo GPS		GPS Location	See photo GPS	
Field Station#	11232+00		Field Station#	11225+00	
Pic 1 Desc.	Row is in stable condition.		Pic 2 Desc.	Slope drain, end treatment and rock channel are in acceptable condition.

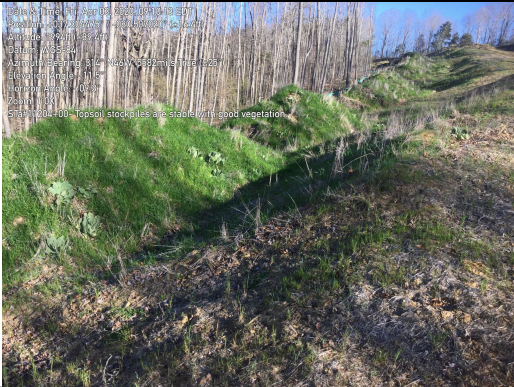
GPS Location	See photo GPS		GPS Location	See photo GPS	
Field Station#	11204+00		Field Station#	11191+00	
Pic 3 Desc.	Topsoil stockpiles are stable & well vegetated.		Pic 4 Desc.	Drainage feature and ECD's are in acceptable condition.

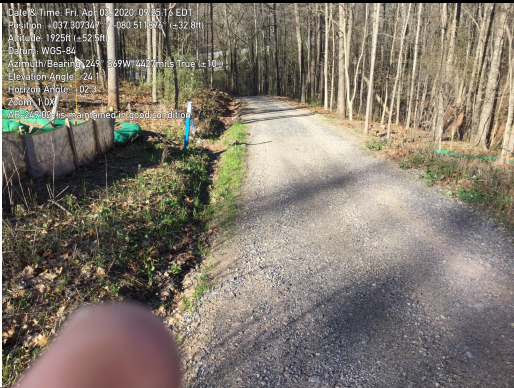
GPS Location	See photo GPS		GPS Location	See photo GPS	
Field Station#	11184+50		Field Station#	11184+00	
Pic 5 Desc.	AR-249.02- Road and environmental controls are in acceptable condition.		Pic 6 Desc.	CWD pipe and plunge pool are in good condition.

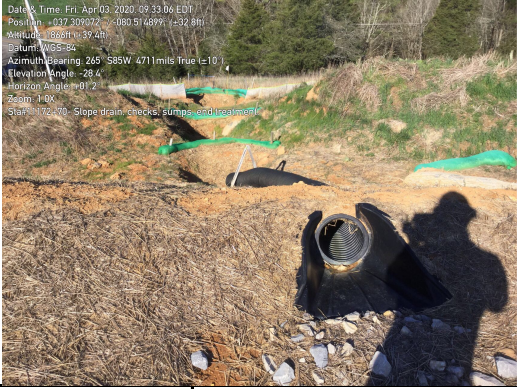
<p>Insert image here</p>			
GPS Location	See photo GPS	GPS Location			
Field Station#	11172+70	Field Station#			
Pic 7 Desc.	Slope drain, CFS checks, sumps & end treatment are in acceptable condition.	Pic 8 Desc.			
<p>Insert image here</p>		<p>Insert image here</p>			
GPS Location		GPS Location			
Field Station#		Field Station#			
Pic 9 Desc.		Pic 10 Desc.			
<p>Insert image here</p>		<p>Insert image here</p>			
GPS Location		GPS Location			
Field Station#		Field Station#			
Pic 11 Desc.		Pic 12 Desc.

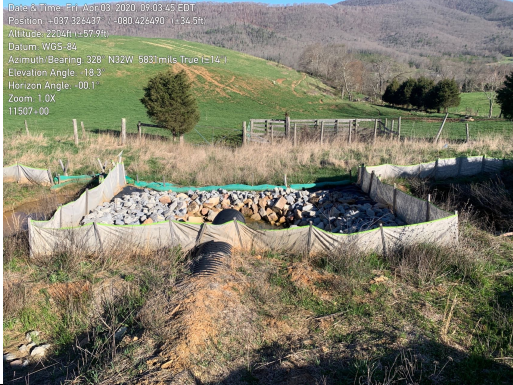
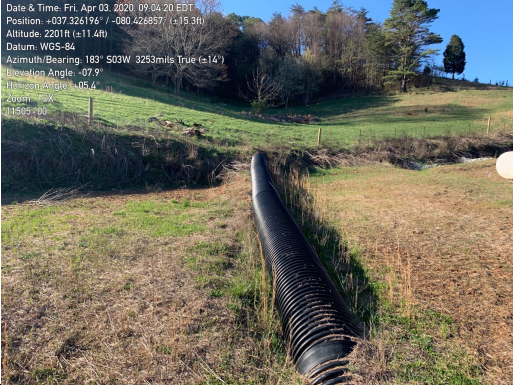
GPS Location		See photo for GPS location.						GPS Location		See photo for GPS location.	
Field Station#		11507+00						Field Station#		11505+00	
Pic 1 Desc.		Clean water diversion pipe and plunge pool in place.						Pic 2 Desc.		Clean water diversion pipe and clean water diversion berm in place.	
<p>Date & Time: Fri, Apr 03, 2020, 09:04:37 EDT Position: +037.326010 / -080.426931 (+15.3h) Altitude: 2208ft (+11.4h) Datum: WGS-84 Azimuth/Bearing: 234° S54W 4160mils True (+14°) Elevation Angle: -00.2° Horizon Angle: -02.9° Zoom: 1.0X 11503+00</p>

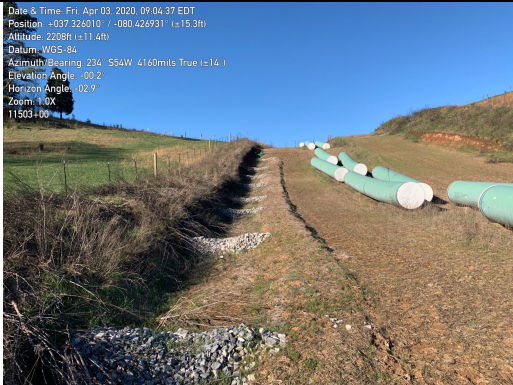
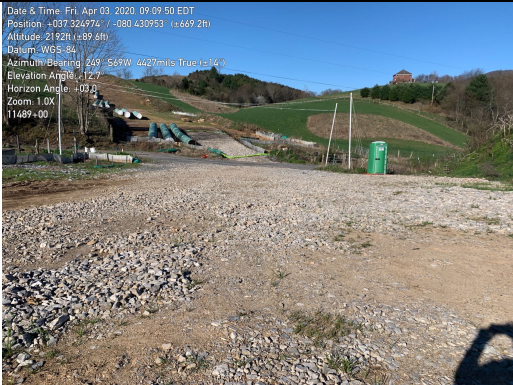
GPS Location		See photo for GPS location.						GPS Location		See photo for GPS location.	
Field Station#		11503+00						Field Station#		11489+00	
Pic 3 Desc.		Conveyance channel with rock checks in place at double cut section of ROW.						Pic 4 Desc.		RCE in place at Stevers Gap Road.	
<p>Date & Time: Fri, Apr 03, 2020, 09:15:16 EDT Position: +037.322684 / -080.434455 (+15.2h) Altitude: 2260ft (+11.5h) Datum: WGS-84 Azimuth/Bearing: 275° N85W 4889mils True (+14°) Elevation Angle: +14.3° Horizon Angle: +16.7° Zoom: 1.0X 11477+00</p>

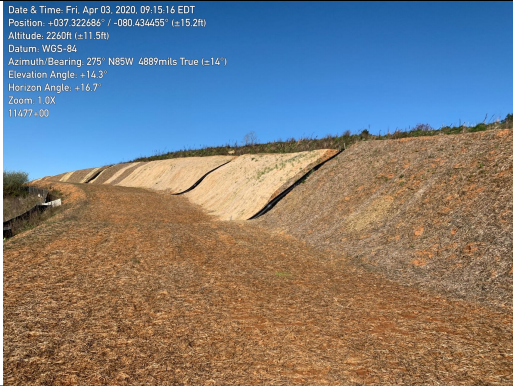
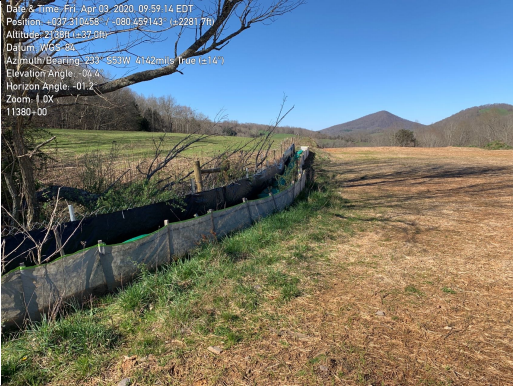
GPS Location		See photo for GPS location.						GPS Location		See photo for GPS location.	
Field Station#		11477+00						Field Station#		11380+00

Pic 5 Desc.		Two-tone stabilized with ECB and slope drain in place to minimize erosion.						Pic 6 Desc.		Triple barrier ECDs in place at off ROW karst feature.
