# Visual Site Inspection Report

<b>Project Name</b>	H-600 Pipeline Spread G	<b>AFE</b>	124300137	<b>Spread</b>	H-600 Pipeline Spread G
<b>Contractor</b>	Precision			<b>Report #</b>	8975
<b>Inspector</b>	Len Kruizenga			<b>Date/Time</b>	3/9/2020 7:18 AM
<b>Permit #</b>	TBD	<b>Inspection Type</b>	VA SWPP	<b>Station Begin</b>	11898+00
<b>State</b>	VA	<b>Inspection Area</b>	Full	<b>Station End</b>	12005+00
<b>County</b>	Montgomery	<b>Ground</b>	Dry	<b>Temperature (°F)</b>	54.00
<b>Municipality</b>	N/A	<b>Weather</b>	Sunny	<b>Rain Gauge (in)</b>	0.00
				<b>Rain Accumulation Time (days)</b>	4.00

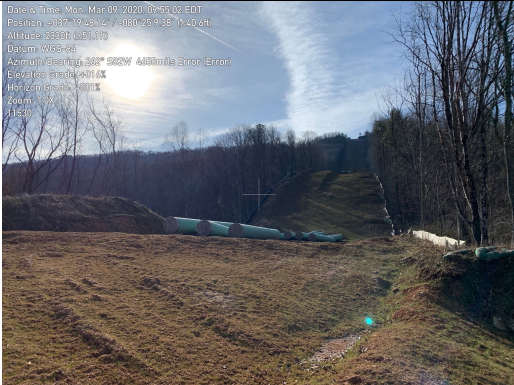
<b>GPS Location</b>	See picture above for GPS coordinates		<b>GPS Location</b>	See picture above for GPS coordinates	
<b>Field Station#</b>	11530+00		<b>Field Station#</b>	11544+00	
<b>Pic 1 Desc.</b>	ECD's and row conditions		<b>Pic 2 Desc.</b>	ECD's and row conditions

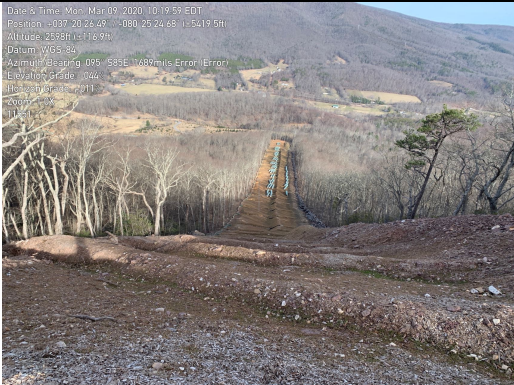
<b>GPS Location</b>	See picture above for GPS coordinates		<b>GPS Location</b>	See picture above for GPS coordinates	
<b>Field Station#</b>	11551+00		<b>Field Station#</b>	11567+00	
<b>Pic 3 Desc.</b>	ECD's and row conditions		<b>Pic 4 Desc.</b>	ECD's and row conditions

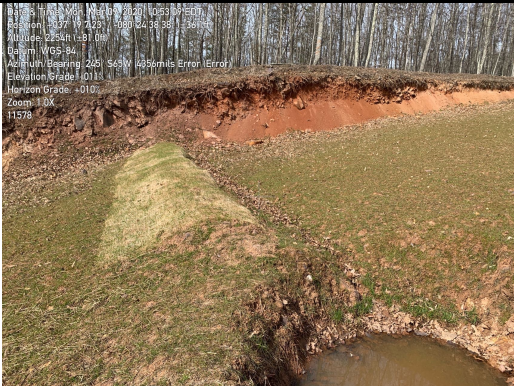
<b>GPS Location</b>	See picture above for GPS coordinates		<b>GPS Location</b>	See picture above for GPS coordinates	
<b>Field Station#</b>	11578+00		<b>Field Station#</b>	11588+00	
<b>Pic 5 Desc.</b>	ECD's and row conditions		<b>Pic 6 Desc.</b>	ECD's and row conditions

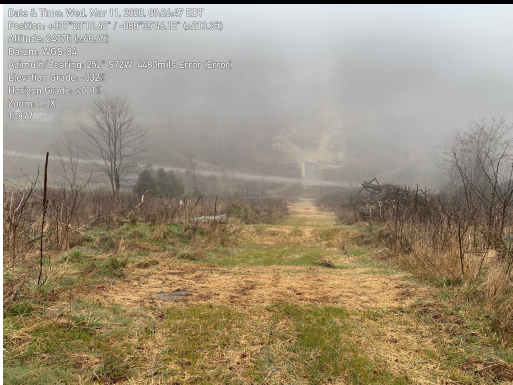
GPS Location	See picture above for GPS coordinates		GPS Location	See picture above for GPS coordinates	
Field Station#	10877+00		Field Station#	10880+00	
Pic 3 Desc.	ECD's and row conditions		Pic 4 Desc.	.3" of rain recorded @ Kow Camp

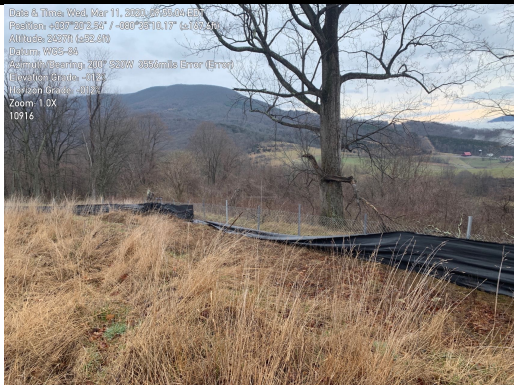
Pic 5 Desc.	ECD's and row conditions		Pic 6 Desc.	SSF detached from wire backing

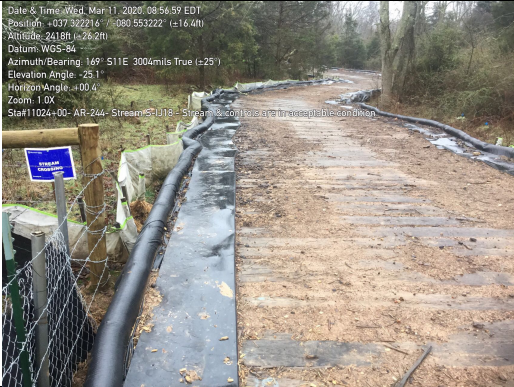
<p>Date &amp; Time: Wed, Mar 11, 2020, 08:56:59 EDT Position: +037.332216 / -080.553222 (±16.4ft) Altitude: 2418ft (±26.2ft) Datum: WGS-84 Azimuth/Bearing: 169° S11E 3004mils True (±25°) Elevation Angle: -25.1° Horizon Angle: +00.4° Zoom: 1.0X Sta#11024+00- AR-244 - Stream S-IJ18 - Stream and controls are in acceptable condition.</p>

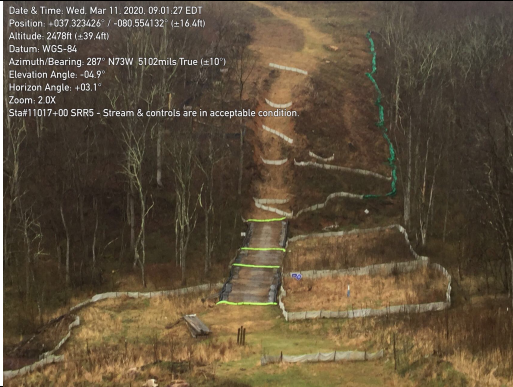
<p>Date &amp; Time: Wed, Mar 11, 2020, 09:01:27 EDT Position: +037.323426 / -080.554132 (±16.4ft) Altitude: 2478ft (±39.4ft) Datum: WGS-84 Azimuth/Bearing: 287° N73W 5102mils True (±10°) Elevation Angle: -04.9° Horizon Angle: +03.1° Zoom: 2.0X Sta#11017+00 SRR5 - Stream and controls are in acceptable condition.</p>			
<b>GPS Location</b>	See photo GPS	<b>GPS Location</b>	See photo GPS		
<b>Field Station#</b>	11024+00	<b>Field Station#</b>	11017+00		
<b>Pic 1 Desc.</b>	AR-244 bridge over stream S-IJ18	<b>Pic 2 Desc.</b>	Stream S-RR5

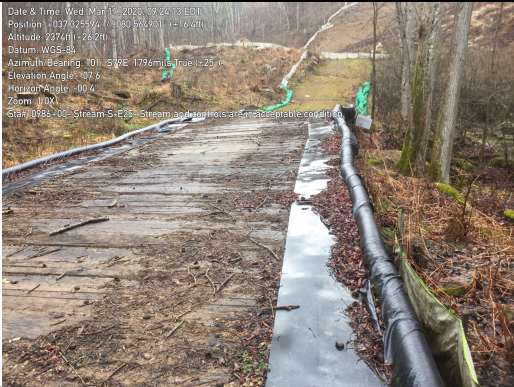
<p>Date &amp; Time: Wed, Mar 11, 2020, 09:05:48 EDT Position: +037.025554 / -080.554132 (±16.4ft) Altitude: 2374ft (±26.2ft) Datum: WGS-84 Azimuth/Bearing: 101° S79E 1736mils True (±25°) Elevation Angle: -07.6° Horizon Angle: -00.4° Zoom: 1.0X Sta#10986+00- Stream S-E25- Stream and controls are in acceptable condition.</p>

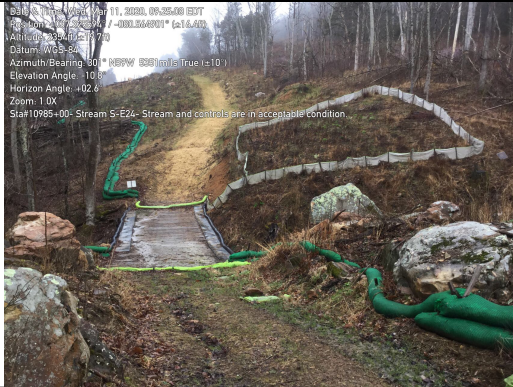
<p>Date &amp; Time: Wed, Mar 11, 2020, 09:05:48 EDT Position: +037.025554 / -080.554132 (±16.4ft) Altitude: 2374ft (±26.2ft) Datum: WGS-84 Azimuth/Bearing: 101° S79E 1736mils True (±25°) Elevation Angle: -07.6° Horizon Angle: -00.4° Zoom: 1.0X Sta#10985+00- Stream S-E24- Stream and controls are in acceptable condition.</p>			
<b>GPS Location</b>	See photo GPS	<b>GPS Location</b>	See photo GPS		
<b>Field Station#</b>	10986+00	<b>Field Station#</b>	10985+00		
<b>Pic 3 Desc.</b>	Stream S-E25	<b>Pic 4 Desc.</b>	S- E24

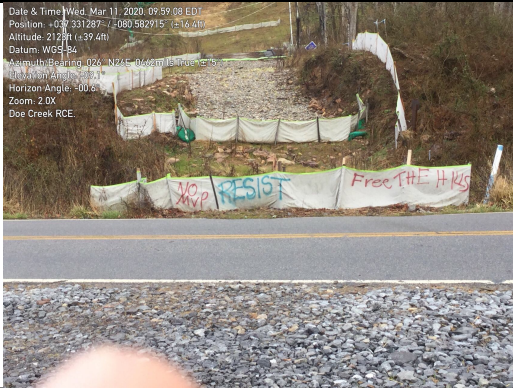
<p>Date &amp; Time: Wed, Mar 11, 2020, 09:59:08 EDT Position: +037.331297 / -080.562915 (±16.4ft) Altitude: 2123ft (±39.4ft) Datum: WGS-84 Azimuth/Bearing: 026° N24E 0646mils True (±10°) Elevation Angle: -10.3° Horizon Angle: +04.9° Zoom: 2.0X Doe Creek RCE.</p>

<b>GPS Location</b>	See photo GPS	<b>GPS Location</b>	See		
<b>Field Station#</b>	10977+00	<b>Field Station#</b>	10930+00		
<b>Pic 5 Desc.</b>	Contractor has stabilized travel lane with straw mulch.	<b>Pic 6 Desc.</b>	Doe Creek RCE- Protesters have sprayed silt fence with graffiti.

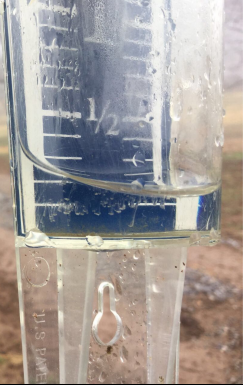
<small>Date &amp; Time: Wed, Mar 11, 2020, 10:42:59 EST  Position: +037.303542° / -080.503442° (-51.640)  Altitude: 1848ft (+13.1ft)  Datum: WGS-84  Azimuth/Bearing: 170° S00E 99.3miles True (-2.1°)  Elevation Angle: +14.2°  Horizon Angle: +08.3°  Zoom: 2.0X  Winding Way rain gauge reading- 0.30"</small>

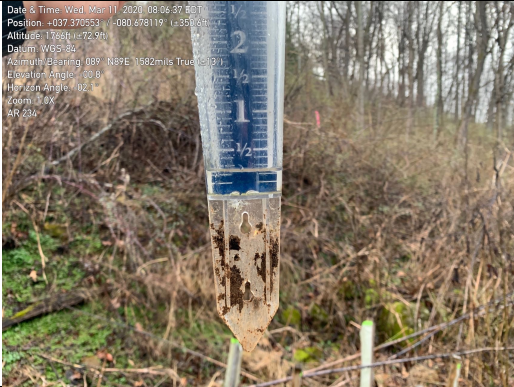
<b>GPS Location</b>	See photo for GPS location.		<b>GPS Location</b>	See photo for GPS location.	
<b>Field Station#</b>	12005+00		<b>Field Station#</b>	10712+50	
<b>Pic 1 Desc.</b>	Rain gauge at access road 234 reads 0.25 inches.		<b>Pic 2 Desc.</b>	Sensitive resource buffer in place at stream S-G33.

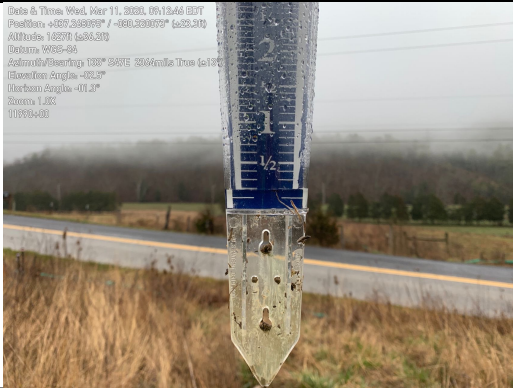
<b>GPS Location</b>	See photo for GPS location.		<b>GPS Location</b>	See photo for GPS location.	
<b>Field Station#</b>	10696+00		<b>Field Station#</b>	10696+00	
<b>Pic 3 Desc.</b>	RCE in place at Buffalo Anklets Road.		<b>Pic 4 Desc.</b>	Rain gauge at Buffalo Anklets Road reads 0.3 inches.

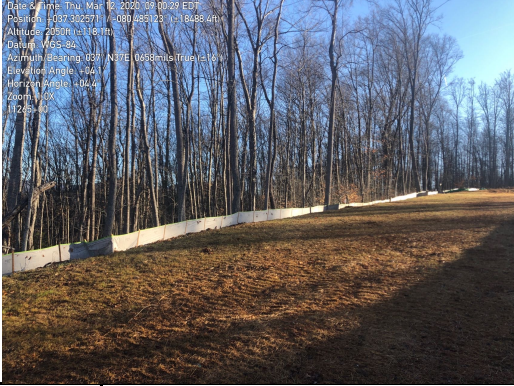
<p>Date &amp; Time: Thu, Mar 12, 2020, 09:11:14 EDT Position: +037 296679° / -080 479036° (±10.4ft) Altitude: 2264ft (±10.4ft) Datum: WGS-84 Azimuth/Bearing: 246° S66W 4373mils True (±16°) Elevation Angle: -07° Horizon Angle: -00.3° Zoom: 1.0X 11288+00</p>			
<b>GPS Location</b>	1	<b>GPS Location</b>	2		
<b>Field Station#</b>	11265+00	<b>Field Station#</b>	11288+00		
<b>Pic 1 Desc.</b>	P-1 perimeter controls are functional.	<b>Pic 2 Desc.</b>	Section of RoW recently stabilized.

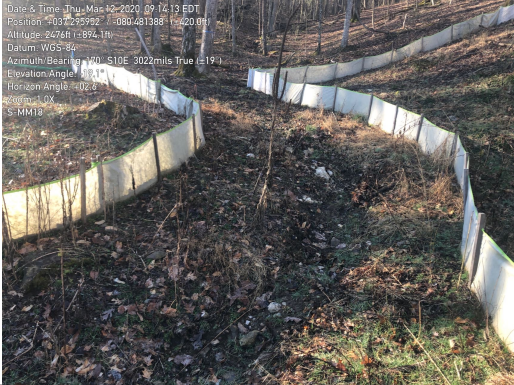
<b>GPS Location</b>	3	<b>GPS Location</b>	4		
<b>Field Station#</b>	11292+80	<b>Field Station#</b>	11300+00		
<b>Pic 3 Desc.</b>	S-MM18.	<b>Pic 4 Desc.</b>	Section of RoW recently stabilized.

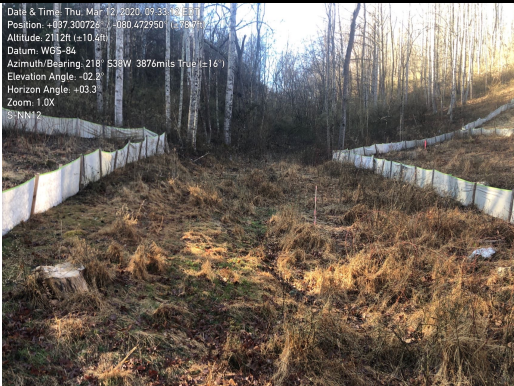
<p>Date &amp; Time: Thu, Mar 12, 2020, 09:44:01 EDT Position: +037 296679° / -080 479036° (±10.4ft) Altitude: 2010ft (±10.4ft) Datum: WGS-84 Azimuth/Bearing: 137° S01E 2636mils True (±16°) Elevation Angle: -19.1° Horizon Angle: -00.1° Zoom: 1.0X S-NN11</p>			
<b>GPS Location</b>	5	<b>GPS Location</b>	6		
<b>Field Station#</b>	11327+85	<b>Field Station#</b>	11352+97		
<b>Pic 5 Desc.</b>	S-NN12.	<b>Pic 6 Desc.</b>	S-NN11.

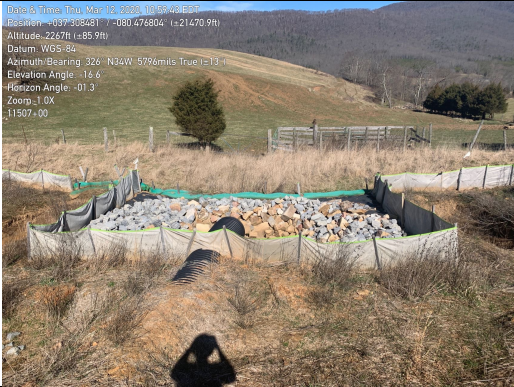
<b>GPS Location</b>	See photo for GPS location.		<b>GPS Location</b>	See photo for GPS location.	
<b>Field Station#</b>	11507+00		<b>Field Station#</b>	11505+00	
<b>Pic 1 Desc.</b>	Clean water diversion pipe and plunge pool in place.		<b>Pic 2 Desc.</b>	Clean water diversion pipe and clean water diversion berm in place.

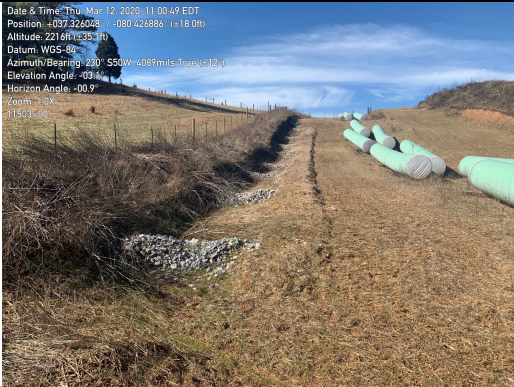
<b>GPS Location</b>	See photo for GPS location.		<b>GPS Location</b>	See photo for GPS location.	
<b>Field Station#</b>	11503+00		<b>Field Station#</b>	11489+00	
<b>Pic 3 Desc.</b>	Conveyance channel with rock checks in place at double cut section of ROW.		<b>Pic 4 Desc.</b>	RCE in place at Stevers Gap Road.	
<p>Date &amp; Time: Thu, Mar 12, 2020, 11:15:45 EDT  Position: +037.3227017 / -080.434408 / (+21.3ft)  Altitude: 2247ft (+69.0ft)  Datum: WGS-84  Azimuth/Bearing: 270° S90W 4800mils True (+12°)  Elevation Angle: -25.1°  Horizon Angle: -00.8°  Zoom: 1.0X  11477+00</p>

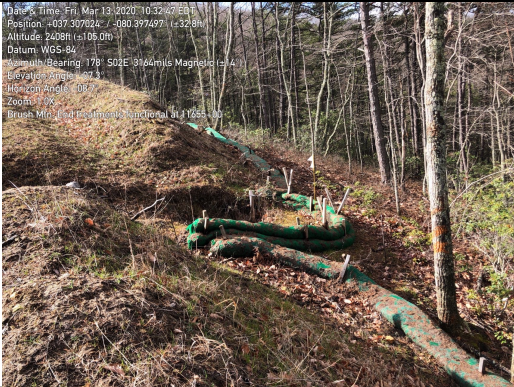
<b>GPS Location</b>	On photo	<b>GPS Location</b>	On photo		
<b>Field Station#</b>	11655+00	<b>Field Station#</b>	11654+00		
<b>Pic 3 Desc.</b>	Perimeter controls effective.	<b>Pic 4 Desc.</b>	ROW stable. ECDs in place. Slope breakers effective.

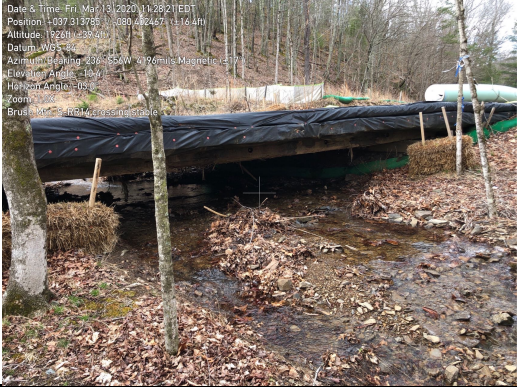
<p><small>Date &amp; Time: Fri Mar 13 2020 11:28:21 EDT Position: +037.313755 / -080.402471 / +16.4m Altitude: 1920ft (+25.0m) Datum: WGS-84 Azimuth/Bearing: 236° S44W 1926mils Magnetic (+17.1) Elevation Angle: -14.5 Horizon Angle: -00.3 Zoom: 1.0X Brush Mtn. SRR14 crossing stable</small></p>			
<b>GPS Location</b>	On photo	<b>GPS Location</b>	On photo		
<b>Field Station#</b>	11626+04	<b>Field Station#</b>	11614+20		
<b>Pic 7 Desc.</b>	S-HH18 crossing stable	<b>Pic 8 Desc.</b>	SRR14 crossing stable

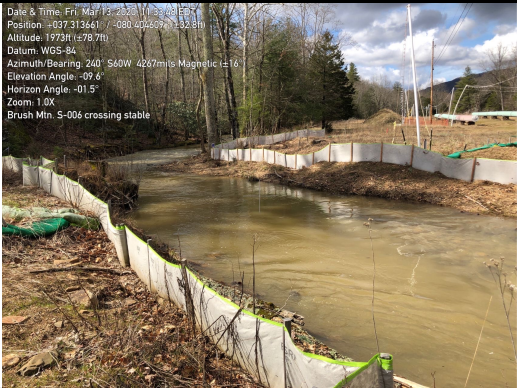
<p><small>Date &amp; Time: Fri Mar 13 2020 11:43:00 EDT Position: +037.313451 / -080.402471 / +32.81 Altitude: 1920ft (+27.7m) Datum: WGS-84 Azimuth/Bearing: 240° S40W 4267mils Magnetic (+16) Elevation Angle: -09.6 Horizon Angle: -01.5 Zoom: 1.0X Brush Mtn. S-006 crossing stable</small></p>			
<b>GPS Location</b>	On photo	<b>GPS Location</b>	On photo		
<b>Field Station#</b>	11613+69	<b>Field Station#</b>	11608+17		
<b>Pic 9 Desc.</b>	S-RR13 crossing stable	<b>Pic 10 Desc.</b>	S-006 crossing stable		
Insert image here		Insert image here			
<b>GPS Location</b>		<b>GPS Location</b>			
<b>Field Station#</b>		<b>Field Station#</b>

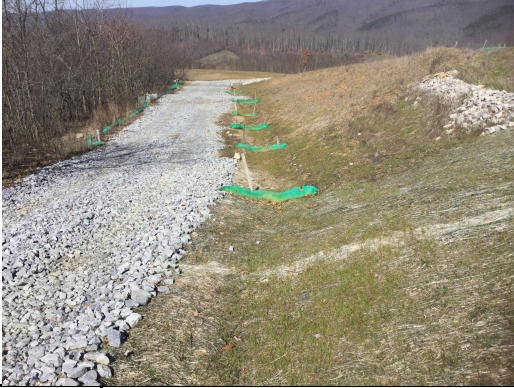
<b>GPS Location</b>	See photo GPS		<b>GPS Location</b>	See photo GPS	
<b>Field Station#</b>	11900+00		<b>Field Station#</b>	11942+00	
<b>Pic 1 Desc.</b>	AR-266.03		<b>Pic 2 Desc.</b>	Karst and Karst ECD's

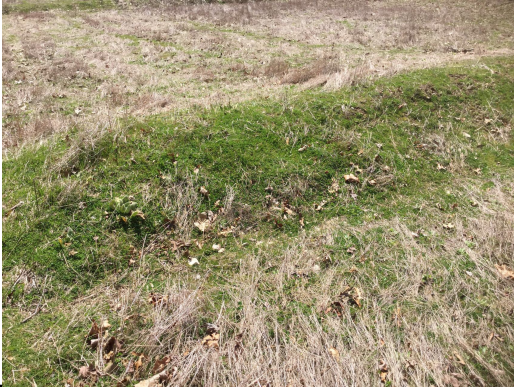
<b>GPS Location</b>	See photo GPS		<b>GPS Location</b>	See photo GPS	
<b>Field Station#</b>	11976+00		<b>Field Station#</b>	11979+00	
<b>Pic 3 Desc.</b>	Perennial vegetation looks good on permanent restoration.		<b>Pic 4 Desc.</b>	Karst and Karst ECD's

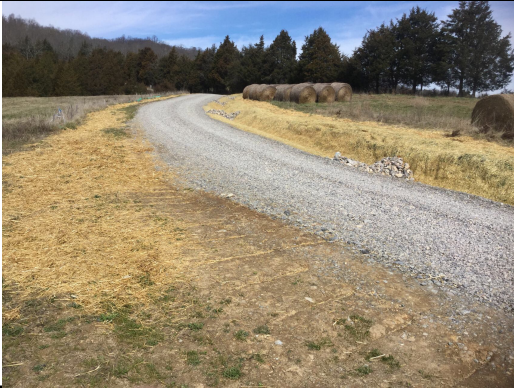
<b>GPS Location</b>	See photo GPS		<b>GPS Location</b>	See photo GPS	
<b>Field Station#</b>	11987+00		<b>Field Station#</b>	12000+00	
<b>Pic 5 Desc.</b>	AR-266- Newly installed rock checks and stabilized ditch banks.		<b>Pic 6 Desc.</b>	Wetland ECD's

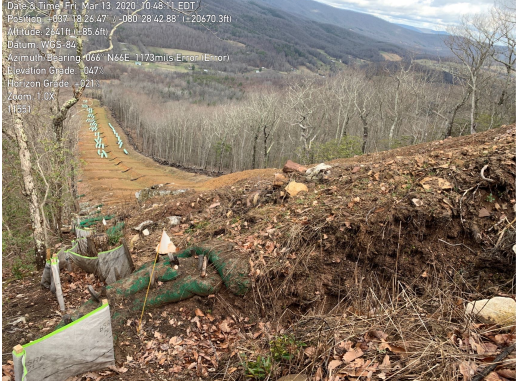
<b>GPS Location</b>	See picture above for GPS coordinates		<b>GPS Location</b>	See picture above for GPS coordinates	
<b>Field Station#</b>	11551+00		<b>Field Station#</b>	11554+00	
<b>Pic 1 Desc.</b>	ECD's and row conditions		<b>Pic 2 Desc.</b>	ECD's and row conditions

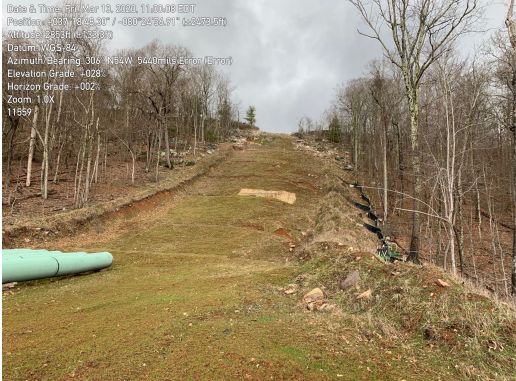
<b>GPS Location</b>	See picture above for GPS coordinates		<b>GPS Location</b>	See picture above for GPS coordinates	
<b>Field Station#</b>	11559+00		<b>Field Station#</b>	11569+00	
<b>Pic 3 Desc.</b>	ECD's and row conditions		<b>Pic 4 Desc.</b>	ECD's and row conditions

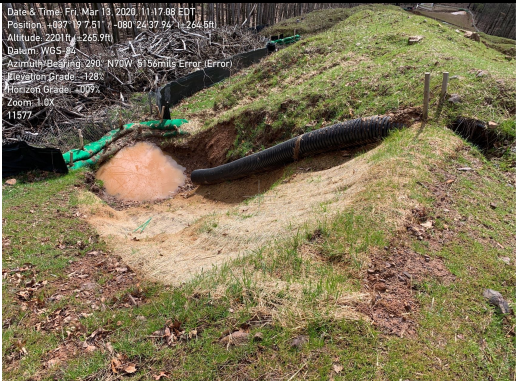
<b>GPS Location</b>	See picture above for GPS coordinates		<b>GPS Location</b>	See picture above for GPS coordinates	
<b>Field Station#</b>	11577+00		<b>Field Station#</b>	11596+00	
<b>Pic 5 Desc.</b>	ECD's and row conditions		<b>Pic 6 Desc.</b>	ECD's and row conditions

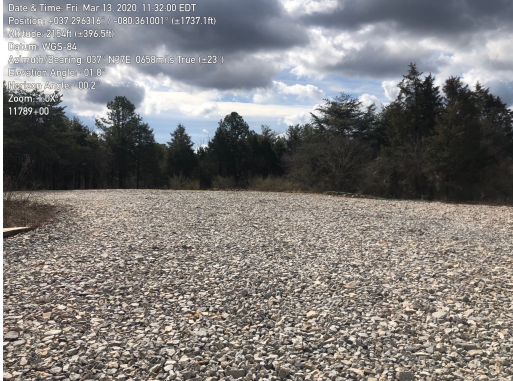
<p>Date &amp; Time: Fri, Mar 13, 2020 11:32:00 EDT Position: +037 234316° / -080 341001° (-1737.1ft) Altitude: 2107ft (-10.4ft) Datum: WGS-84 Azimuth Bearing: 037° N37E 048mils True (-23.1°) Elevation Angle: -01.8° Horizon Angle: -00.2° Zoom: 1.0x 11789+00</p>

<p>Date &amp; Time: Fri, Mar 13, 2020 11:33:00 EDT Position: +037 234330° / -080 340137° (-157.5ft) Altitude: 2033ft (-12.0ft) Datum: WGS-84 Azimuth Bearing: 039° N39E 1300mils True (-10.4°) Elevation Angle: -01.5° Horizon Angle: -00.4° Zoom: 1.0x 11792+00</p>							
GPS Location				1				GPS Location				2			
Field Station#				11789+00				Field Station#				11792+00			
Pic 1 Desc.				RCE on the South side of Mt Tabor rd.				Pic 2 Desc.				Section of restored RoW and controls.

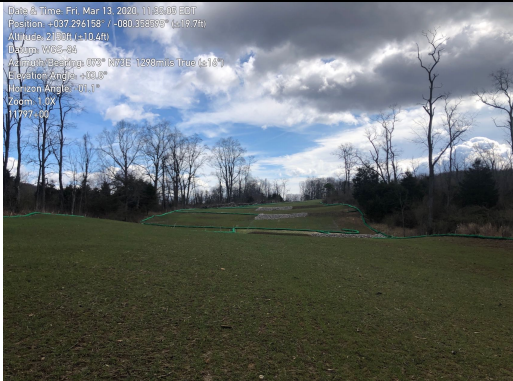
<p>Date &amp; Time: Fri, Mar 13, 2020 11:34:00 EDT Position: +037 234158° / -080 343800° (-149.7ft) Altitude: 2100ft (-10.4ft) Datum: WGS-84 Azimuth Bearing: 039° N39E 1298mils True (-10.4°) Elevation Angle: -01.8° Horizon Angle: -00.5° Zoom: 1.0x 11797+00</p>

GPS Location				3				GPS Location				4			
Field Station#				11797+00				Field Station#				11842+00			
Pic 3 Desc.				Section of restored RoW and controls.				Pic 4 Desc.				Section of restored RoW and controls.

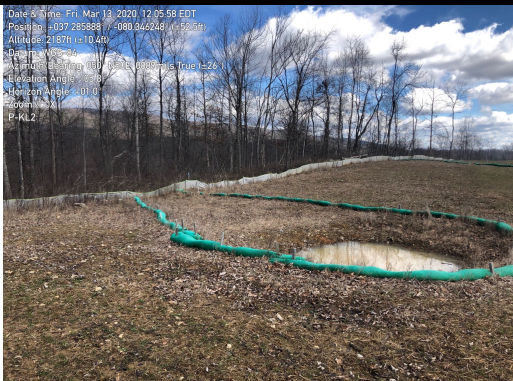
<p>Date &amp; Time: Fri, Mar 13, 2020 12:05:58 EDT Position: +037 235361° / -080 042240° (-132.1ft) Altitude: 2187ft (-10.4ft) Datum: WGS-84 Azimuth Bearing: 037° N37E 048mils True (-23.1°) Elevation Angle: -01.8° Horizon Angle: -00.2° Zoom: 1.0x P-KL2</p>

<p>Date &amp; Time: Fri, Mar 13, 2020 12:24:50 EDT Position: +037 245841° / -080 429133° (-184.2ft) Altitude: 2107ft (-12.6ft) Datum: WGS-84 Azimuth Bearing: 202° S22W 2302mils True (-15.1°) Elevation Angle: -01.1° Horizon Angle: -01.2° Zoom: 1.0x 11899+00</p>							
GPS Location				5				GPS Location				6			
Field Station#				11863+65				Field Station#				11899+00			
Pic 5 Desc.				P-KL2.				Pic 6 Desc.				Section of restored RoW and controls.
