Visual Site Inspection Report

Project Name	H-600 Pipeline Spread G	AFE	124300137	Spread	H-600 Pipeline Spread G
Contractor	Precision			Report #	9995
Inspector	Len Kruizenga			Date/Time	4/13/2020 8:27 AM
Permit #	TBD	Inspection Type	VA SWPP	Station Begin	12005+00
State	VA	Inspection Area	Full	Station End	12005+00
County	Giles	Ground	Muddy	Temperature (°F)	62.00
Municipality	N/A	Weather	Cloudy	Rain Gauge (in)	2.90
				Rain Accumulation Time (days)	1.00

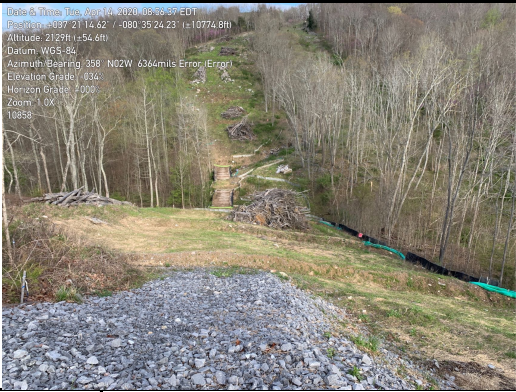
GPS Location	See picture above for GPS coordinates		GPS Location	See picture above for GPS coordinates	
Field Station#	10858+00		Field Station#	10867+00	
Pic 1 Desc.	ECD's and row conditions		Pic 2 Desc.	ECD's and row conditions	
<p>Date & Time: Tue, Apr 14, 2020 09:11:32 EDT Position: -037° 20' 8.95" / -080 35 54.53" (-156.3ft) Altitude: 2300ft (-40.2ft) Datum: WGS-84 Azimuth/Bearing: 057 N57E 1013mils Error (Error) Elevation Grade: -040 Horizon Grade: -003 Zoom: 1.0x 10875</p>

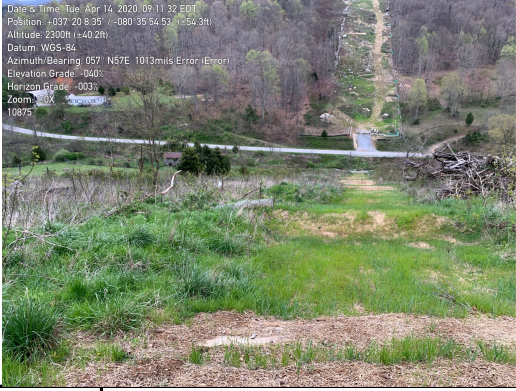
GPS Location	See picture above for GPS coordinates		GPS Location	See picture above for GPS coordinates	
Field Station#	10875+00		Field Station#	10899+00	
Pic 3 Desc.	ECD's and row conditions		Pic 4 Desc.	ECD's and row conditions	
<p>Date & Time: Tue, Apr 14, 2020 07:15:04 EDT Position: -027° 22' 12.1" / -080 38 48.67" (-120.2ft) Altitude: 2150ft (-23.6ft) Datum: WGS-84 Azimuth/Bearing: 324 N34W 5796mils Error (Error) Elevation Grade: -055 Horizon Grade: -001 Zoom: 1.0x 10880</p>

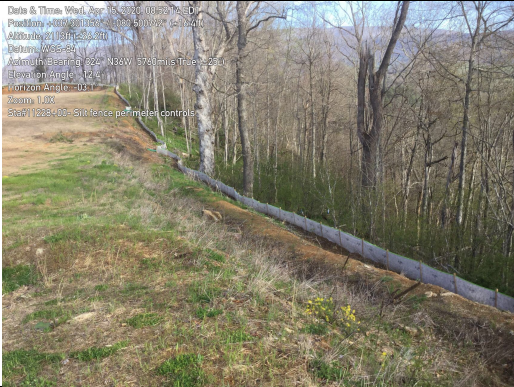
<p>Date & Time: Wed, Apr 15, 2020, 08:55:56 EDT Position: +337.3014667, -80.5026497 (+16.4m) Altitude: 2078ft (+59.4m) Datum: WGS-84 Azimuth/Bearing: 189° 50'W, 3340mils True (±10°) Elevation Angle: -30.7° Horizon Angle: +00.7° Zoom: 1.0x Sta#11228+00- Silt fence perimeter controls</p>

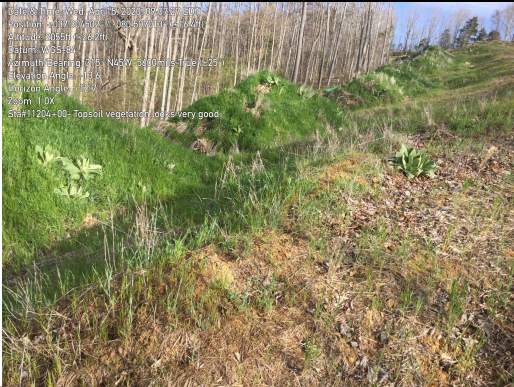
<p>Date & Time: Wed, Apr 15, 2020, 09:20:45 EDT Position: +337.3022367, -80.5009198 (+20.2m) Altitude: 2001ft (+61.4m) Datum: WGS-84 Azimuth/Bearing: 099° 58'E, 1100mils True (±25°) Elevation Angle: -06.0° Horizon Angle: +03.1° Zoom: 1.0x Sta#11204+00- Topsoil vegetation is very good</p>

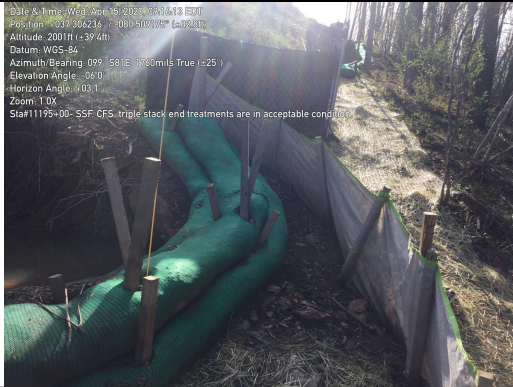
<p>Date & Time: Wed, Apr 15, 2020, 09:15:15 EDT Position: +337.3022367, -80.5009198 (+20.2m) Altitude: 2001ft (+61.4m) Datum: WGS-84 Azimuth/Bearing: 099° 58'E, 1100mils True (±25°) Elevation Angle: -06.0° Horizon Angle: +03.1° Zoom: 1.0x Sta#11195+00- SSF, CFS, triple stack end treatments are in acceptable condition</p>			
GPS Location	See photo GPS		GPS Location	See photo GPS	
Field Station#	11204+00		Field Station#	11195+00	
Pic 3 Desc.	Topsoil stockpiles vegetation is good.		Pic 4 Desc.	Water bar end treatments & SSF perimeter controls are in acceptable condition.

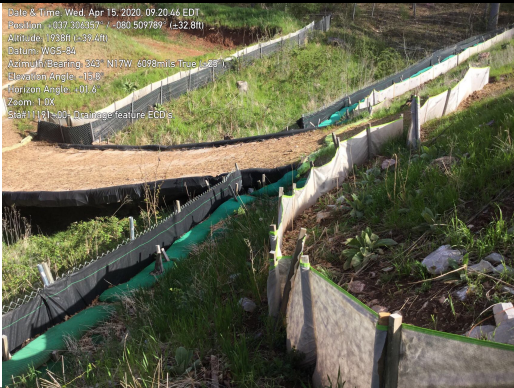
<p>Date & Time: Wed, Apr 15, 2020, 09:20:45 EDT Position: +337.3022367, -80.5009198 (+20.2m) Altitude: 2001ft (+61.4m) Datum: WGS-84 Azimuth/Bearing: 342° N, 7W, 6098mils True (±48°) Elevation Angle: -13.5° Horizon Angle: +01.6° Zoom: 1.0x Sta#11191+00- drainage feature ECD's</p>

GPS Location	See photo GPS		GPS Location	See photo GPS	
Field Station#	11191+00		Field Station#	11184+00	
Pic 5 Desc.	Drainage feature and ECD's are in acceptable condition.		Pic 6 Desc.	CWD pipe and plunge pool are in good condition.

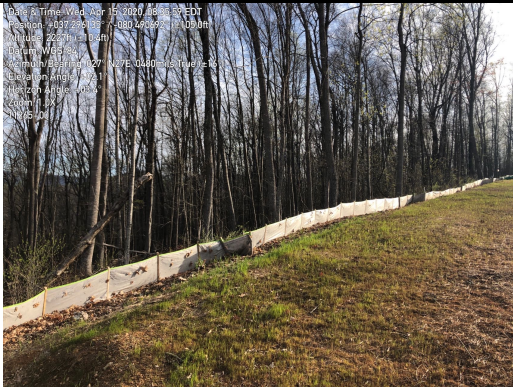
GPS Location	1	GPS Location	2		
Field Station#	11265+00	Field Station#	11292+80		
Pic 1 Desc.	Perimeter controls functional.	Pic 2 Desc.	S-MM18 and controls.

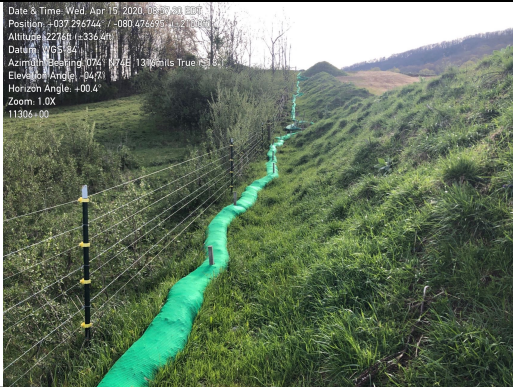
GPS Location	3	GPS Location	4		
Field Station#	11306+00	Field Station#	11327+85		
Pic 3 Desc.	Perimeter controls functional.	Pic 4 Desc.	S-NN12 and controls.

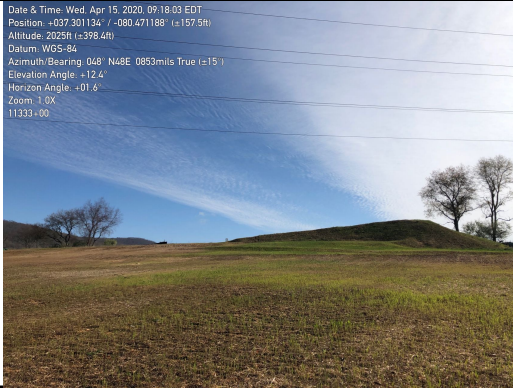
GPS Location	5	GPS Location	6		
Field Station#	11333+00	Field Station#	11352+97		
Pic 5 Desc.	RoW conditions and controls.	Pic 6 Desc.	S-NN11 and controls.

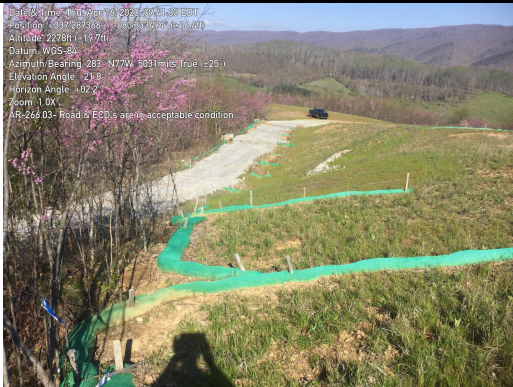
GPS Location		See photo GPS		GPS Location		See photo GPS	
Field Station#		1190300-		Field Station#		11922+00	
Pic 1 Desc.		AR-266.03- Access road and controls are in acceptable condition.		Pic 2 Desc.		P1 fabric detached from stakes. Contractor notified.

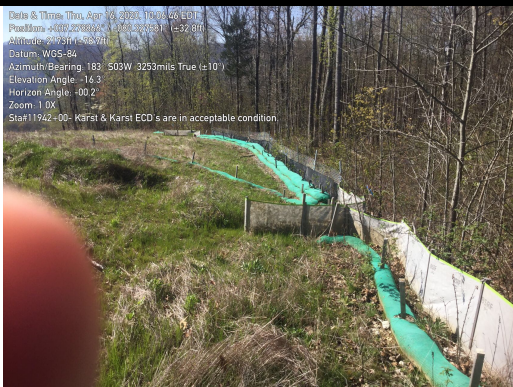
GPS Location		See photo GPS		GPS Location		See photo GPS	
Field Station#		11942+00		Field Station#		11950+00	
Pic 3 Desc.		Karst and Karst ECD's are in acceptable condition.		Pic 4 Desc.		Karst controls are in acceptable condition.

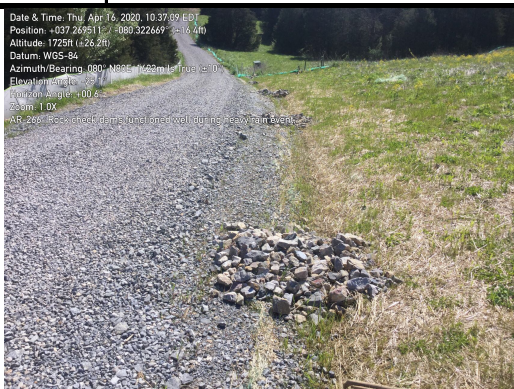
GPS Location		See photo GPS		GPS Location		See photo GPS	
Field Station#		11962+00		Field Station#		11979+00	
Pic 5 Desc.		Tree up rooted in Karst, lasting across P1 perimeter control and level spreader.		Pic 6 Desc.		AR- 266.00- Rock check dams are in acceptable condition.

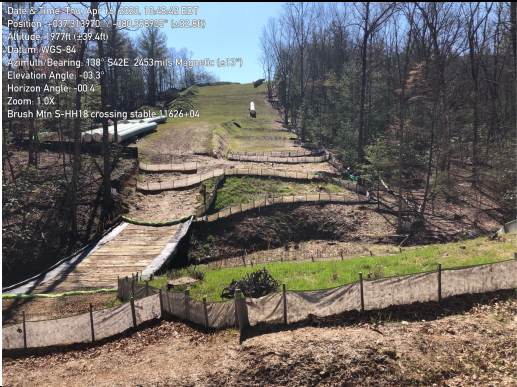
<p>Date & Time: Thu Apr 16, 2020 11:04:57 EDT Position: +037.313970, -080.202625 (±32.8M) Altitude: 1777ft (±39.4ft) Datum: WGS-84 Azimuth/Bearing: 188° S42E 2453mils Magnetic (±13°) Elevation Angle: -00.3° Horizon Angle: -00.4° Zoom: 1.0X Brush Min S-HH18 crossing stable 11626+04</p>

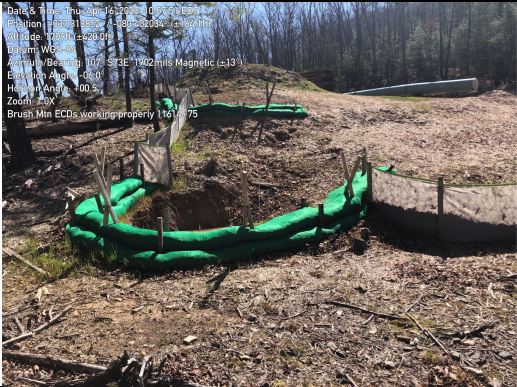
<p>Date & Time: Thu Apr 16, 2020 11:04:57 EDT Position: +037.313970, -080.202625 (±32.8M) Altitude: 1777ft (±39.4ft) Datum: WGS-84 Azimuth/Bearing: 188° S42E 2453mils Magnetic (±13°) Elevation Angle: -00.3° Horizon Angle: -00.4° Zoom: 1.0X Brush Min S-HH18 crossing stable 11626+04</p>			
GPS Location	On photo	GPS Location	On photo		
Field Station#	11626+04	Field Station#	11614+75		
Pic 7 Desc.	S-HH18 crossing is stable.	Pic 8 Desc.	Perimeter controls effective.

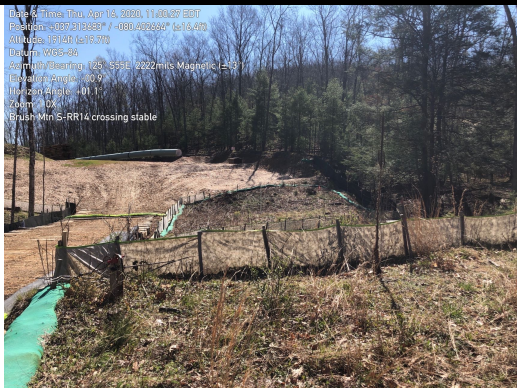
<p>Date & Time: Thu Apr 16, 2020 11:04:57 EDT Position: +037.313970, -080.202625 (±32.8M) Altitude: 1777ft (±39.4ft) Datum: WGS-84 Azimuth/Bearing: 188° S42E 2453mils Magnetic (±13°) Elevation Angle: -00.3° Horizon Angle: -00.4° Zoom: 1.0X Brush Min S-RR14 crossing stable</p>

GPS Location	On photo	GPS Location	On photo		
Field Station#	11614+20	Field Station#	11613+69		
Pic 9 Desc.	S-RR14 crossing is stable.	Pic 10 Desc.	S-RR13 crossing stable on access road 258.04.

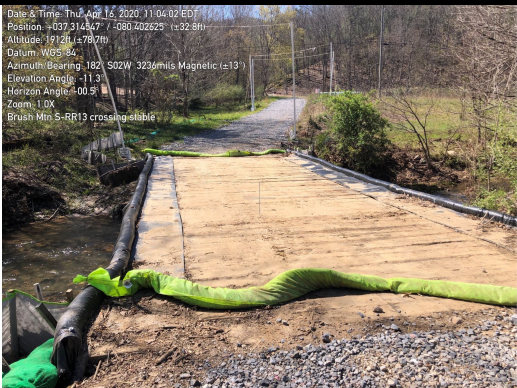
<p>Date & Time: Thu Apr 16, 2020 11:04:57 EDT Position: +037.313970, -080.202625 (±32.8M) Altitude: 1777ft (±39.4ft) Datum: WGS-84 Azimuth/Bearing: 188° S42E 2453mils Magnetic (±13°) Elevation Angle: -00.3° Horizon Angle: -00.4° Zoom: 1.0X Brush Min S-RR13 crossing stable</p>

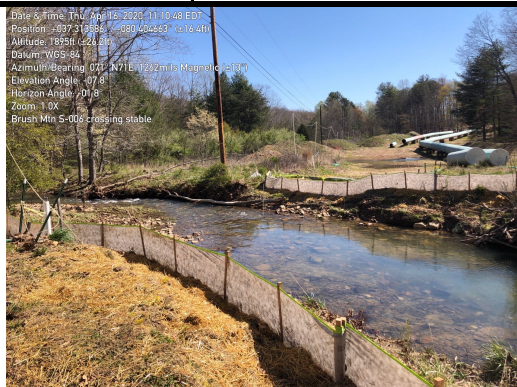
<p>Date & Time: Thu Apr 16, 2020 11:04:57 EDT Position: +037.313970, -080.202625 (±32.8M) Altitude: 1777ft (±39.4ft) Datum: WGS-84 Azimuth/Bearing: 188° S42E 2453mils Magnetic (±13°) Elevation Angle: -00.3° Horizon Angle: -00.4° Zoom: 1.0X Brush Min S-006 crossing stable</p>		<p style="text-align: center;">Insert image here</p>			
GPS Location	On photo	GPS Location			
Field Station#	11607+81	Field Station#			
Pic 11 Desc.	S-006 crossing is stable.	Pic 12 Desc.

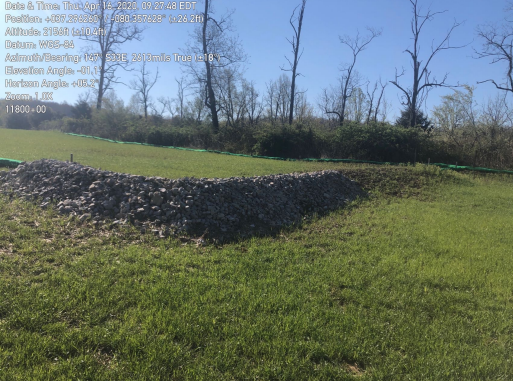
GPS Location	1	GPS Location	2		
Field Station#	11792+00	Field Station#	11800+00		
Pic 1 Desc.	Section of restored RoW conditions and controls.	Pic 2 Desc.	Water bar and level spreader.

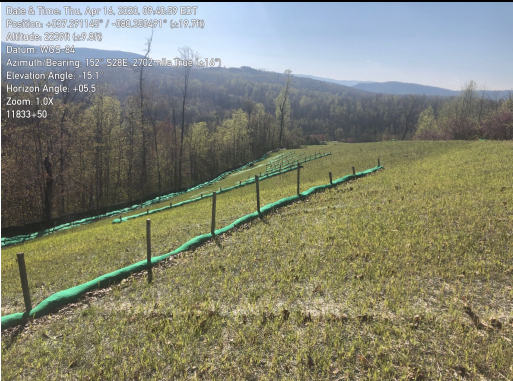
GPS Location	3	GPS Location	4		
Field Station#	11819+00	Field Station#	11833+50		
Pic 3 Desc.	Section of restored RoW conditions and controls.	Pic 4 Desc.	Section of restored RoW conditions and controls.

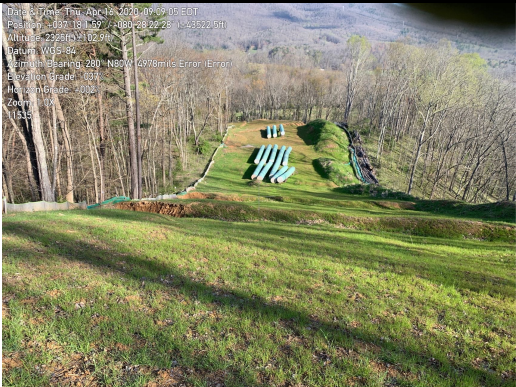
<p>Date & Time: Thu Apr 16 2020 09:25:31 EDT Position: +037 19 53.827 / -080 25 59.84 / 124300137 Altitude: 2250ft (+102.9ft) Datum: WGS 84 Azimuth/Bearing: 107 S21E 2613mils Error (Error) Elevation Grade: +03% Horizon Grade: +00% Zoom: 1.0X 11551</p>			
GPS Location	See picture above for GPS coordinates		GPS Location	See picture above for GPS coordinates	
Field Station#	11535+00		Field Station#	11551+00	
Pic 1 Desc.		ECD's and row conditions		Pic 2 Desc.

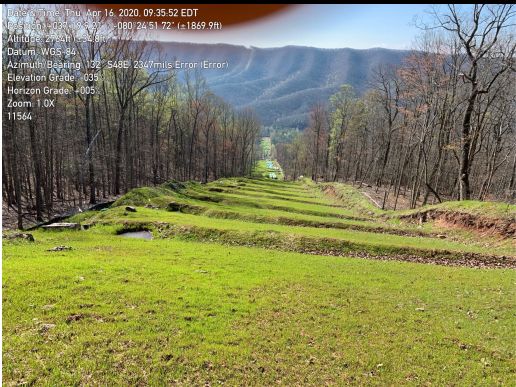
GPS Location	See picture above for GPS coordinates		GPS Location	See picture above for GPS coordinates	
Field Station#	11564+00		Field Station#	11577+00	
Pic 3 Desc.		ECD's and row conditions		Pic 4 Desc.

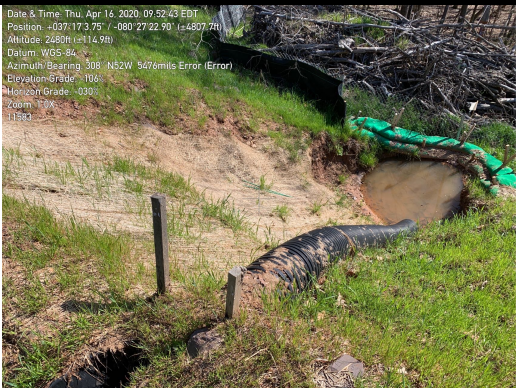
<p>Date & Time: Thu Apr 16 2020 09:53:38 EDT Position: +037 19 53.827 / -080 24 07.96 / 11583 Altitude: 2420ft (+114.9ft) Datum: WGS 84 Azimuth/Bearing: 070 N20E 1244mils Error (Error) Elevation Grade: +10% Horizon Grade: +00% Zoom: 1.0X 11583</p>			
GPS Location	See picture above for GPS coordinates		GPS Location	See picture above for GPS coordinates	
Field Station#	11583+00		Field Station#	11583+00	
Pic 5 Desc.		ECD's and row conditions		Pic 6 Desc.

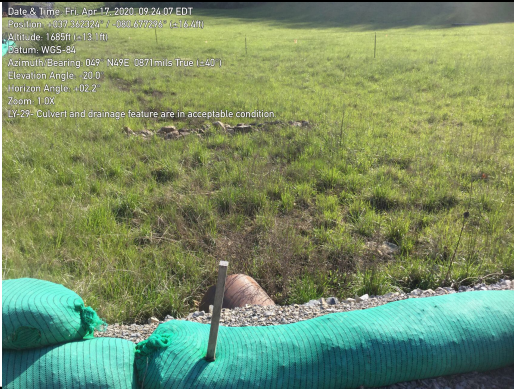
<p>Date & Time: Fri, Apr 17, 2020, 09:24:07 EDT Position: +037.363322N, -080.670324W (+16.4ft) Altitude: 1695ft (+13.1ft) Datum: WGS-84 Azimuth/Bearing: 045.149E, 087.1mils True (+42°) Elevation Angle: +20.0° Horizon Angle: +02.2° Zoom: 1.0x LY-29- Culvert and drainage feature are in acceptable condition.</p>		  <p>Date & Time: Fri, Apr 17, 2020, 09:22:11 EDT Position: +037.363532N, -080.676310W (+16.4ft) Altitude: 1705ft (+19.7ft) Datum: WGS-84 Azimuth/Bearing: 226.546W, 401.9mils True (+26°) Elevation Angle: -14.8° Horizon Angle: +01.3° Zoom: 1.0x LY-29- CFS triple stack perimeter controls are in acceptable condition.</p>			
GPS Location	LY-29- Culvert and drainage feature are in acceptable condition.		GPS Location	See photo GPS	
Field Station#	12005+00		Field Station#	12005+00	
Pic 3 Desc.	Culvert and drainage feature are in acceptable condition.		Pic 4 Desc.	CFS triple stack perimeter controls are in acceptable condition.

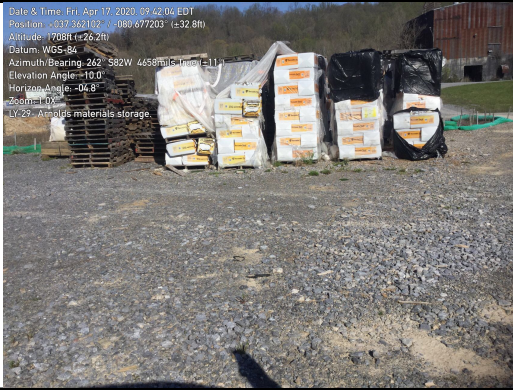
<p>Date & Time: Fri, Apr 17, 2020, 09:22:04 EDT Position: +037.363102N, -080.677203W (+16.4ft) Altitude: 1708ft (+26.2ft) Datum: WGS-84 Azimuth/Bearing: 262.582W, 465.6mils True (+11°) Elevation Angle: -10.0° Horizon Angle: -05.8° Zoom: 1.0x LY-29- Arnold's materials storage.</p>			
GPS Location	See photo GPS		GPS Location	See photo GPS	
Field Station#	12005+00		Field Station#	12005+00	
Pic 5 Desc.	LY-29- Rock surface of the yard is maintained in acceptable condition.		Pic 6 Desc.	LY-29- Arnold's materials storage.
