Visual Site Inspection Report

Project Name	H-600 Pipeline Spread G	AFE	124300137	Spread	H-600 Pipeline Spread G
Contractor	Precision			Report #	10439
Inspector	Chris Burns			Date/Time	4/27/2020 8:02 AM
Permit #	TBD	Inspection Type	VA SWPP	Station Begin	11254+99
State	VA	Inspection Area	Partial	Station End	11353+67
County	Giles	Ground	Wet	Temperature (°F)	58.00
Municipality	N/A	Weather	Cloudy	Rain Gauge (in)	0.40
				Rain Accumulation Time (days)	1.00

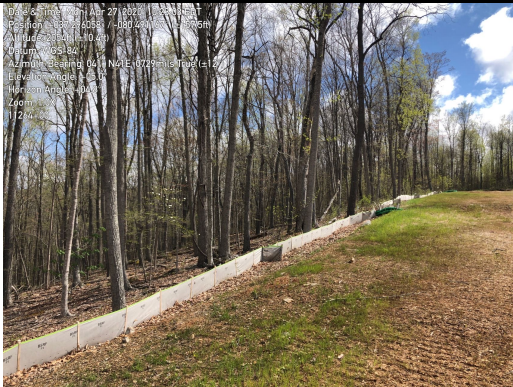
GPS Location	1	GPS Location	2		
Field Station#	11264+00	Field Station#	11286+00		
Pic 1 Desc.	Perimeter controls functional.	Pic 2 Desc.	Perimeter controls functional.

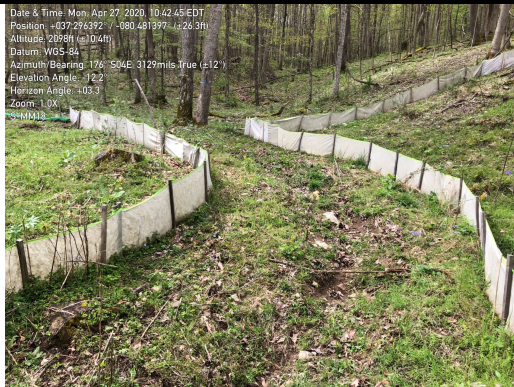
GPS Location	3	GPS Location	4		
Field Station#	11292+80	Field Station#	11292+80		
Pic 3 Desc.	Disturbance by others within S-MM18 downstream and outside of the MVP LoD.	Pic 4 Desc.	S-MM18 and controls.

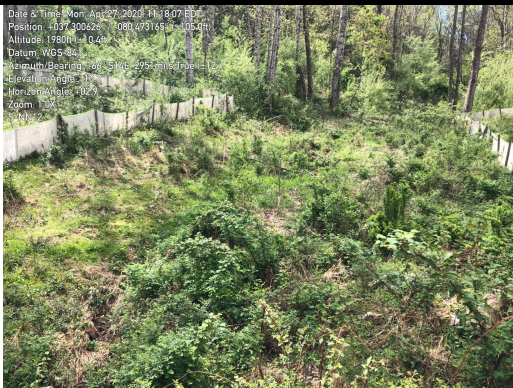
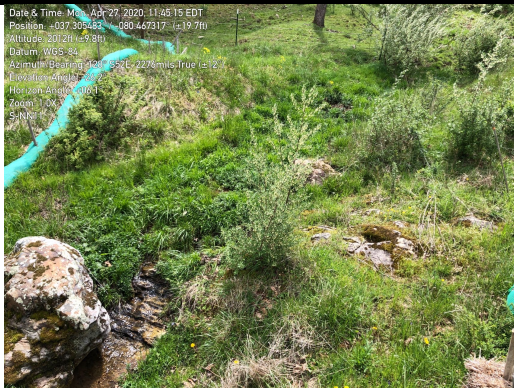
GPS Location	5	GPS Location	6		
Field Station#	11327+85	Field Station#	11352+97		
Pic 5 Desc.	S-NN11.	Pic 6 Desc.	S-NN11.

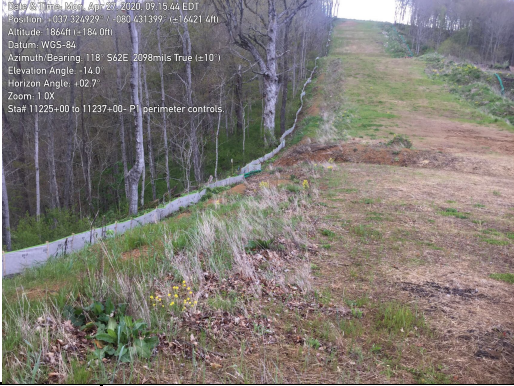
<p>Date & Time: Mon Apr 27, 2020 09:15:44 EDT Position: +037 334929.1 (-000 502636) (-17621.6ft) Altitude: 1864ft (+184.0m) Datum: WGS-84 Azimuth/Bearing: 118.542E 2098mils True (±10°) Elevation Angle: -14.0° Horizon Angle: +02.7° Zoom: 1.0x Sta# 11225+00- P1 perimeter controls.</p>

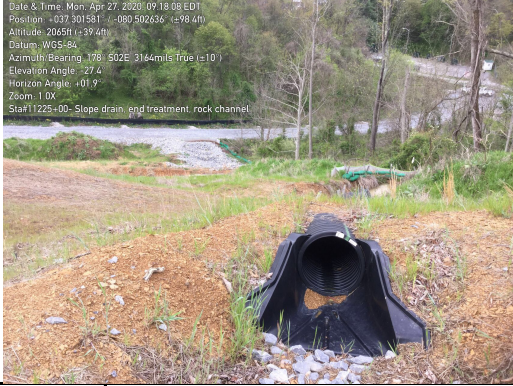
<p>Date & Time: Mon Apr 27, 2020 09:18:08 EDT Position: +037 301581.1 (-000 502636) (-17614m) Altitude: 2065ft (+194.0m) Datum: WGS-84 Azimuth/Bearing: 178.502E 3164mils True (±10°) Elevation Angle: -27.4° Horizon Angle: +01.9° Zoom: 1.0x Sta#11225+00- Slope drain, end treatment, rock channel.</p>			
GPS Location	See photo GPS		GPS Location	See photo GPS	
Field Station#	11225+00		Field Station#	11225+00	
Pic 1 Desc.	P1 silt fence perimeter controls are in acceptable condition.		Pic 2 Desc.	Slope drain, end treatment and rock channel are in acceptable condition.

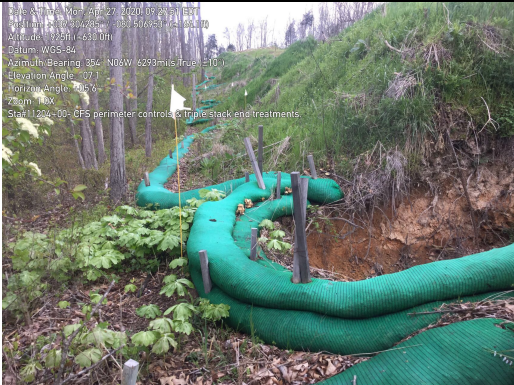
<p>Date & Time: Mon Apr 27, 2020 09:36:55 EDT Position: +037 334929.1 (-000 502636) (-17621.6ft) Altitude: 1725ft (+163.0m) Datum: WGS-84 Azimuth/Bearing: 354.983W 6293mils True (±10°) Elevation Angle: -07.1° Horizon Angle: +05.5° Zoom: 1.0x Sta# 11204+00- CFS perimeter controls & triple stack end treatments.</p>

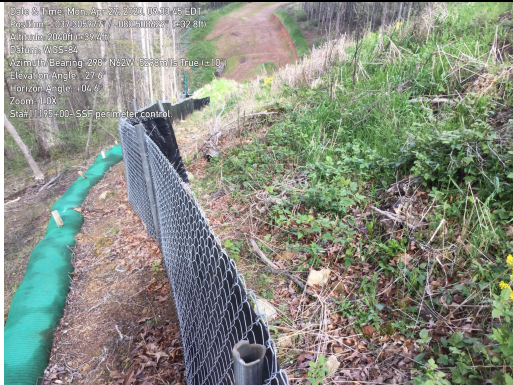
<p>Date & Time: Mon Apr 27, 2020 09:41:45 EDT Position: +037 334929.1 (-000 502636) (-17621.6ft) Altitude: 1725ft (+163.0m) Datum: WGS-84 Azimuth/Bearing: 289.923W 518mils True (±10°) Elevation Angle: -27.6° Horizon Angle: +06.7° Zoom: 1.0x Sta# 11195+00- SSF perimeter control.</p>			
GPS Location	See photo GPS		GPS Location	See photo GPS	
Field Station#	11204+00		Field Station#	11195+00	
Pic 3 Desc.	CFS perimeter controls and triple stack end treatments are in acceptable condition.		Pic 4 Desc.	Sta#11195+00- SSF perimeter controls are in acceptable condition.

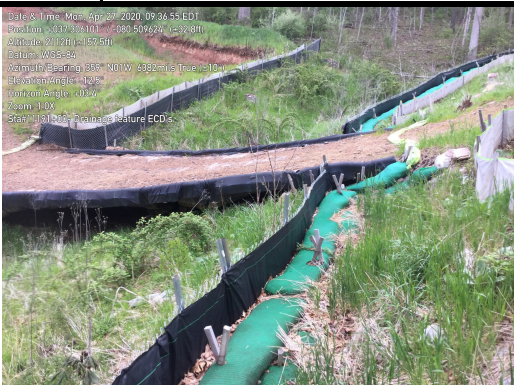
<p>Date & Time: Mon Apr 27, 2020 09:36:55 EDT Position: +037 334929.1 (-000 502636) (-17621.6ft) Altitude: 2112ft (+197.5m) Datum: WGS-84 Azimuth/Bearing: 355.901W 6392mils True (±10°) Elevation Angle: -12.4° Horizon Angle: +01.9° Zoom: 1.0x Sta# 11191+00- drainage feature ECD's.</p>

GPS Location	See photo GPS		GPS Location	See photo GPS	
Field Station#	11191+00		Field Station#	11184+00	
Pic 5 Desc.	Drainage feature and ECD's are in acceptable condition.		Pic 6 Desc.	CWD pipe and plunge pool are in good condition.

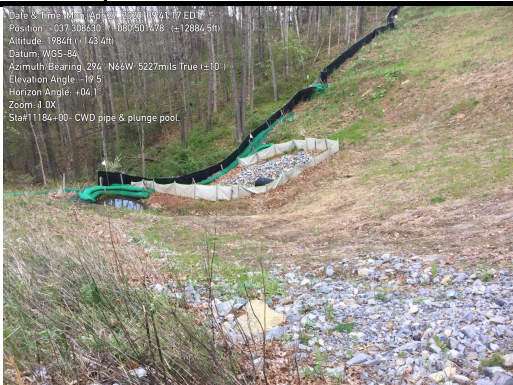
<p>Date & Time: Mon Apr 27, 2020 11:47:17 EDT Position: +037 33825.1 (-000 501478) (-17286.5ft) Altitude: 1984ft (+183.4m) Datum: WGS-84 Azimuth/Bearing: 296.944W 5227mils True (±10°) Elevation Angle: -19.5° Horizon Angle: +04.1° Zoom: 1.0x Sta#11184+00- CWD pipe & plunge pool.</p>

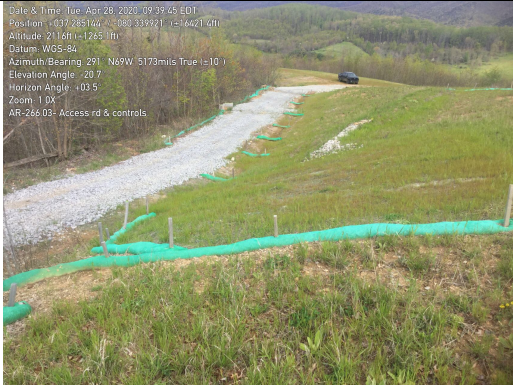
<p>Date & Time: Tue Apr 28, 2020 09:39:45 EDT Position: 431° 281.0m E 4369.333271 N 46621.0m Altitude: 2110ft (643.1m) Datum: WGS-84 Azimuth/Bearing: 291° N49W 5173mils True (±10°) Elevation Angle: -20.7° Horizon Angle: +03.5° Zoom: 1.0X AR-266.03- Access rd & controls</p>

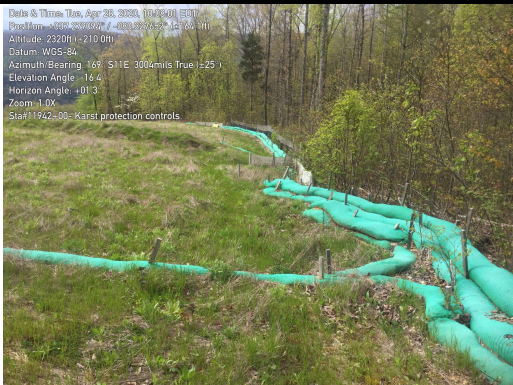
<p>Date & Time: Tue Apr 28, 2020 10:00:00 EDT Position: 433° 281.0m E 4369.333271 N 46621.0m Altitude: 2320ft (707.0m) Datum: WGS-84 Azimuth/Bearing: 168° S11E 3094mils True (±25°) Elevation Angle: -16.4° Horizon Angle: +01.3° Zoom: 1.0X Stat 11942.00- Karst protection controls</p>

GPS Location		See photo GPS		GPS Location		See photo GPS	
Field Station#		11942+00		Field Station#		11964+00	
Pic 3 Desc.		Karst ECD's		Pic 4 Desc.		Karst protection controls.

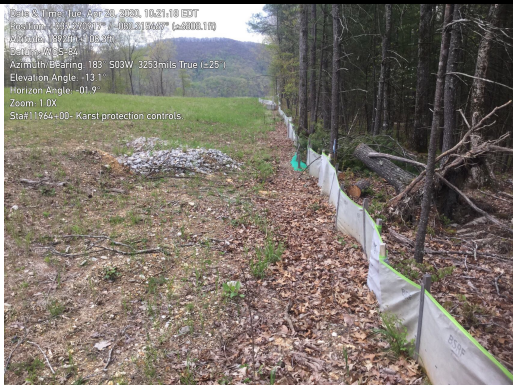
<p>Date & Time: Tue Apr 28, 2020 10:51:18 EDT Position: 433° 281.0m E 4369.333271 N 46621.0m Altitude: 2320ft (707.0m) Datum: WGS-84 Azimuth/Bearing: 182° S03W 3253mils True (±25°) Elevation Angle: -13.1° Horizon Angle: -01.9° Zoom: 1.0X Stat 11964.00- Karst protection controls</p>

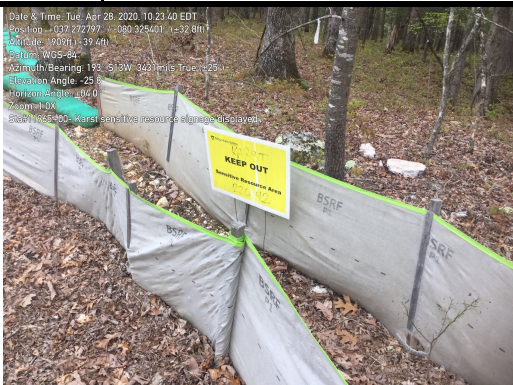
<p>Date & Time: Tue Apr 28, 2020 10:23:40 EDT Position: 433° 281.0m E 4369.333271 N 46621.0m Altitude: 1901ft (579.4m) Datum: WGS-84 Azimuth/Bearing: 193° S15W 3421mils True (±25°) Elevation Angle: -25° Horizon Angle: +05.0° Zoom: 1.0X SR-11965.00- Karst protection resources signage displayed</p>

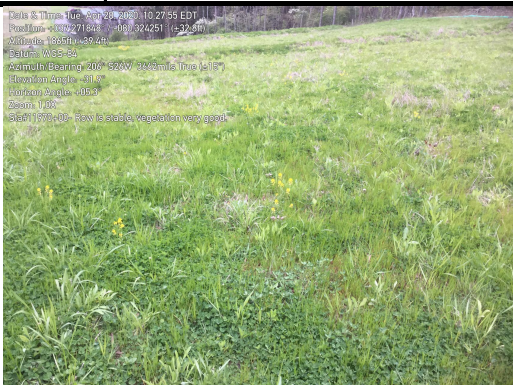
<p>Date & Time: Tue Apr 28, 2020 10:27:55 EDT Position: 433° 281.0m E 4369.333271 N 46621.0m Altitude: 1905ft (580.4m) Datum: WGS-84 Azimuth/Bearing: 200° S20W 3242mils True (±15°) Elevation Angle: -31.1° Horizon Angle: +05.7° Zoom: 1.0X SR-11970.00- Row to double vegetation rows appear</p>					
GPS Location		See photo GPS		GPS Location		See photo GPS	
Field Station#		11965+00		Field Station#		11970+00	
Pic 5 Desc.		Karst ECD's and signage		Pic 6 Desc.		Row vegetation

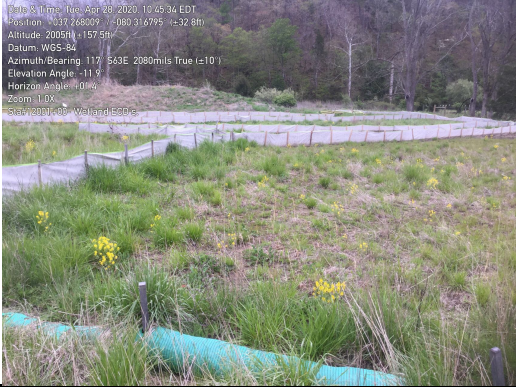
<p> <small> GPS Time: Tue Apr 28 2020 12:45:34 EDT Location: 43.1726809, -70.980316795, -32.8ft Altitude: 2005ft, 157.5ft Datum: WGS-84 Azimuth/Bearing: 117.563E, 2080mils True (±10.1) Elevation Angle: -11.9 Horizon Angle: 0.0% Zoom: 1.0X Pic: 12001+00 Wetland ECD's </small> </p>					
GPS Location	See photo GPS	GPS Location			
Field Station#	12001+00	Field Station#			
Pic 7 Desc.	Wetland ECD's	Pic 8 Desc.			
Insert image here		Insert image here			
GPS Location		GPS Location			
Field Station#		Field Station#			
Pic 9 Desc.		Pic 10 Desc.			
Insert image here		Insert image here			
GPS Location		GPS Location			
Field Station#		Field Station#			
Pic 11 Desc.		Pic 12 Desc.

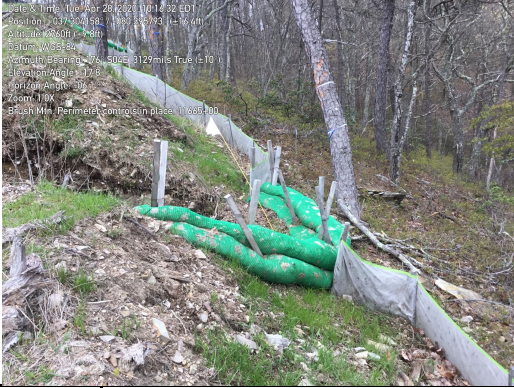
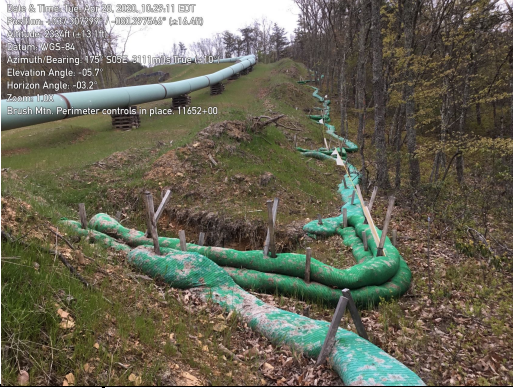
GPS Location	On photo	GPS Location	On photo		
Field Station#	11665+00	Field Station#	11652+00		
Pic 1 Desc.	Perimeter controls in place and functional.	Pic 2 Desc.	Perimeter controls in place and functional.

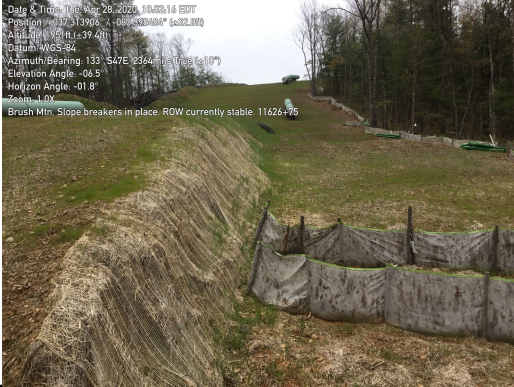
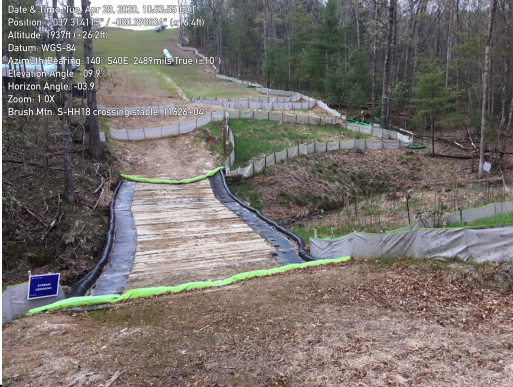
GPS Location	On photo	GPS Location	On photo		
Field Station#	11626+75	Field Station#	11626+04		
Pic 3 Desc.	ROW stable. ECDs in place.	Pic 4 Desc.	S-HH18 crossing stable.

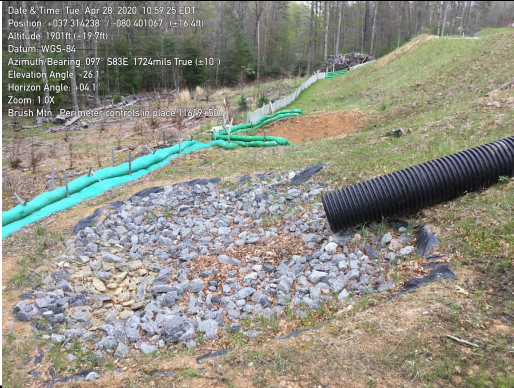
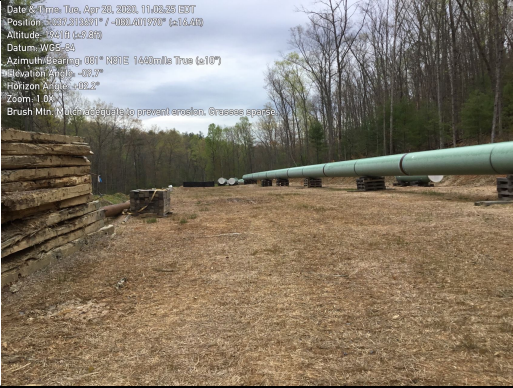
GPS Location	On photo	GPS Location	On the		
Field Station#	11619+00	Field Station#	11616+00		
Pic 5 Desc.	Perimeter controls and plunge pools in acceptable condition.	Pic 6 Desc.	ROW stable.

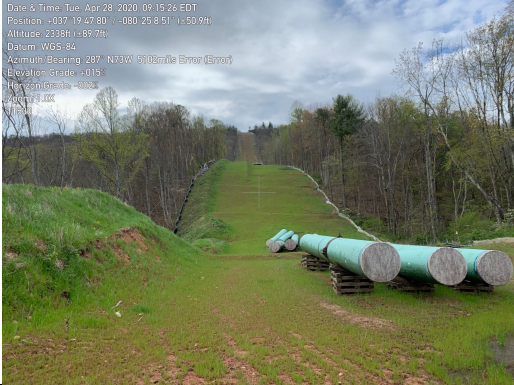
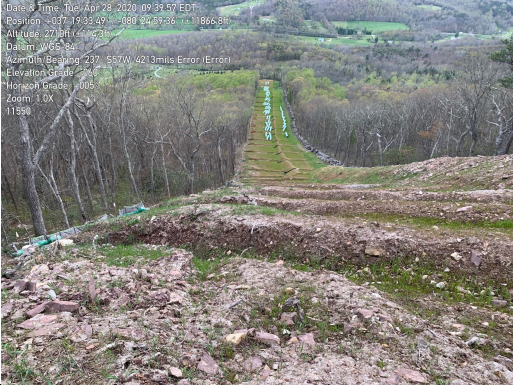
GPS Location	See picture above for GPS coordinates		GPS Location	See picture above for GPS coordinates	
Field Station#	11530+00		Field Station#	11550+00	
Pic 1 Desc.	ECD's and row conditions		Pic 2 Desc.	ECD's and row conditions

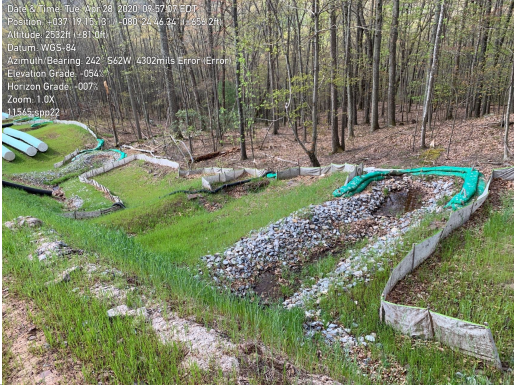
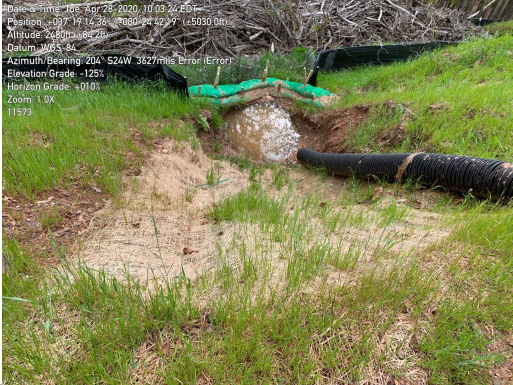
GPS Location	See picture above for GPS coordinates		GPS Location	See picture above for GPS coordinates	
Field Station#	11565+00		Field Station#	11573+00	
Pic 3 Desc.	ECD's and row conditions		Pic 4 Desc.	ECD's and row conditions

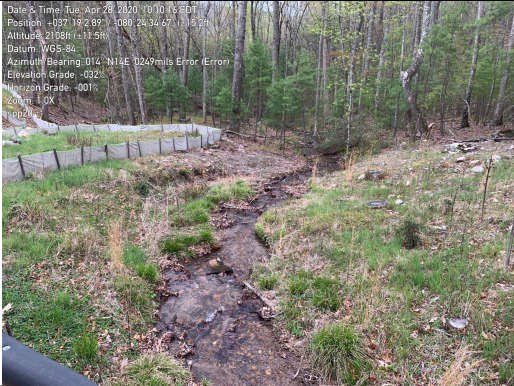
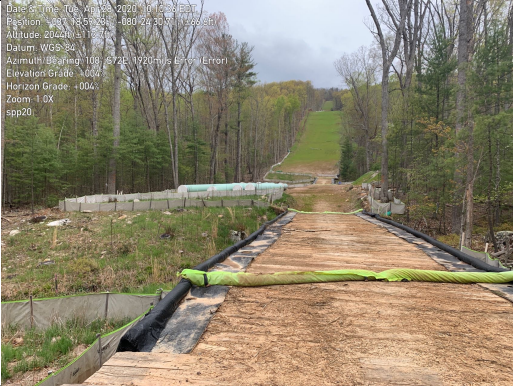
GPS Location	See picture above for GPS coordinates		GPS Location	See picture above for GPS coordinates	
Field Station#	11585+00		Field Station#	11585+00	
Pic 5 Desc.	ECD's and row conditions		Pic 6 Desc.	ECD's and row conditions

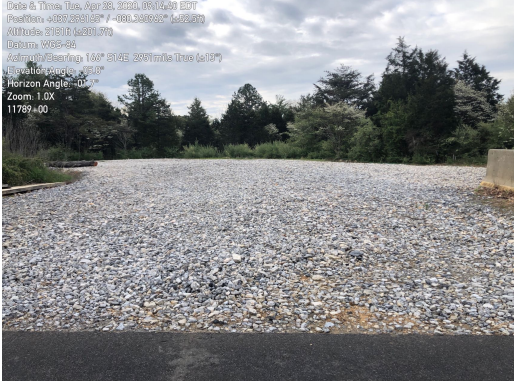
GPS Location	1	GPS Location	2		
Field Station#	11789+00	Field Station#	11792+00		
Pic 1 Desc.	RCE on the South side of Mt Tabor road.		Pic 2 Desc.	Restored section of RoW showing conditions and controls.

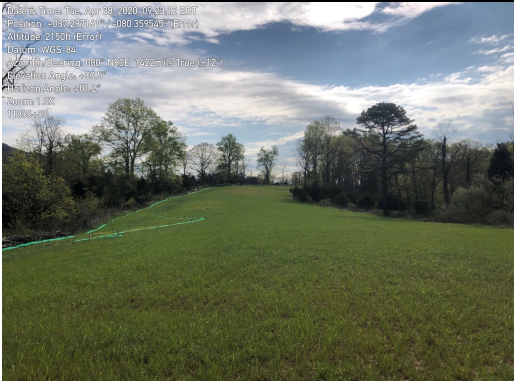
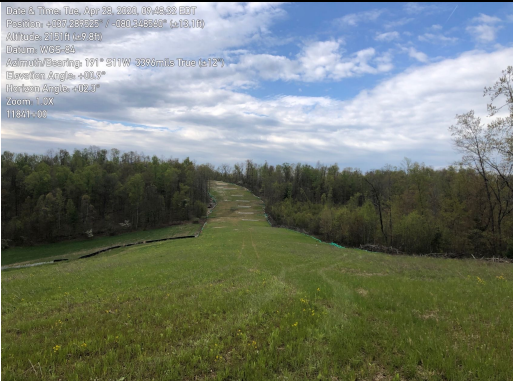
GPS Location	3	GPS Location	4		
Field Station#	11806+00	Field Station#	11841+00		
Pic 3 Desc.	Restored section of RoW showing conditions and controls.		Pic 4 Desc.	Restored section of RoW showing conditions and controls.

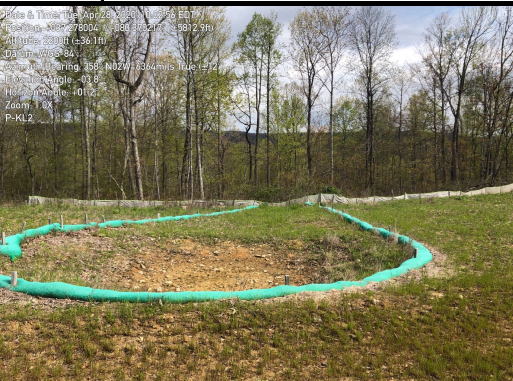
GPS Location	5	GPS Location	6		
Field Station#	11859+00	Field Station#	11863+65		
Pic 5 Desc.	Small sinkhole and current conditions.		Pic 6 Desc.	P-KL2 and controls.

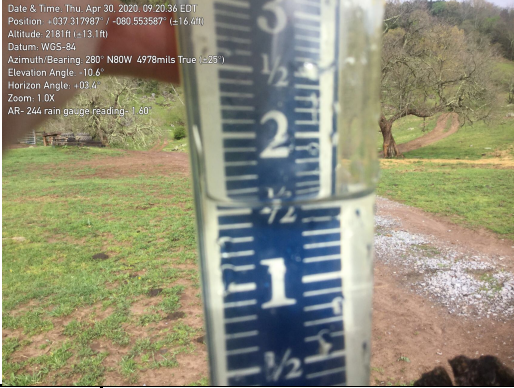
<p>Date & Time: Thu, Apr 30, 2020, 09:20:36 EDT Position: +037.317997, -080.553587 (±16.4ft) Altitude: 2181ft (±13.1ft) Datum: WGS-84 Azimuth/Bearing: 280° N80W 4978mils True (±25°) Elevation Angle: -10.6° Horizon Angle: +03.6° Zoom: 1.0X AR-244 rain gauge reading: 1.60"</p>

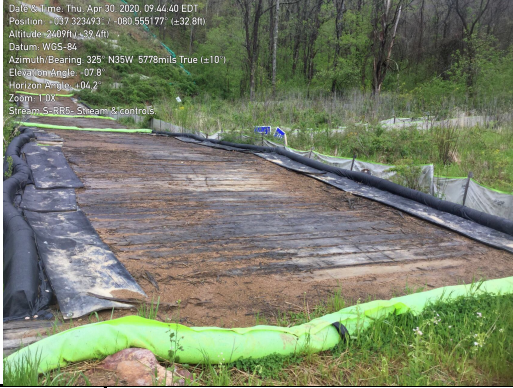
<p>Date & Time: Thu, Apr 30, 2020, 09:44:40 EDT Position: +037.323493, -080.555177 (±32.8ft) Altitude: 2469ft (±30.4ft) Datum: WGS-84 Azimuth/Bearing: 325° N35W 5778mils True (±10°) Elevation Angle: -07.8° Horizon Angle: +04.2° Zoom: 1.0X Stream: S-RR5-Stream & controls</p>			
GPS Location	See photo GPS		GPS Location	See photo GPS	
Field Station#	11024+00		Field Station#	11017+00	
Pic 1 Desc.	AR-244.00 rain gauge reading- 1.60"		Pic 2 Desc.	Stream S-RR5

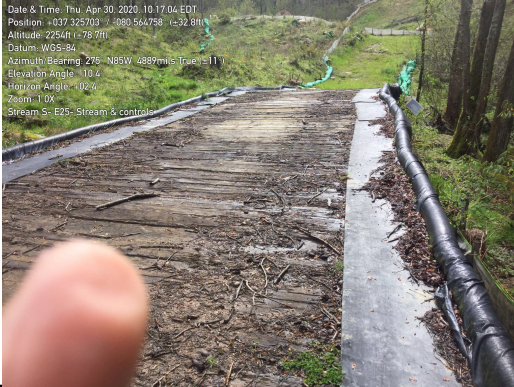
<p>Date & Time: Thu, Apr 30, 2020, 10:17:04 EDT Position: +037.325703, -080.564758 (±32.8ft) Altitude: 2254ft (±78.7ft) Datum: WGS-84 Azimuth/Bearing: 275° N85W 4887mils True (±11°) Elevation Angle: -10.4° Horizon Angle: +02.6° Zoom: 1.0X Stream: S-E25-Stream & controls</p>

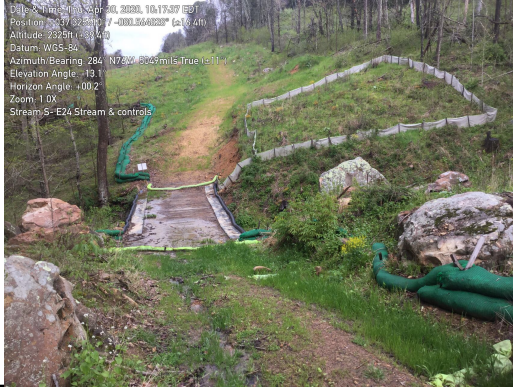
<p>Date & Time: Thu, Apr 30, 2020, 10:15:59 EDT Position: +037.325807, -080.564828* (±32.8ft) Altitude: 2255ft (±78.7ft) Datum: WGS-84 Azimuth/Bearing: 284° N72W 5045mils True (±11°) Elevation Angle: -13.1° Horizon Angle: +00.2° Zoom: 1.0X Stream: S-E24-Stream & controls</p>

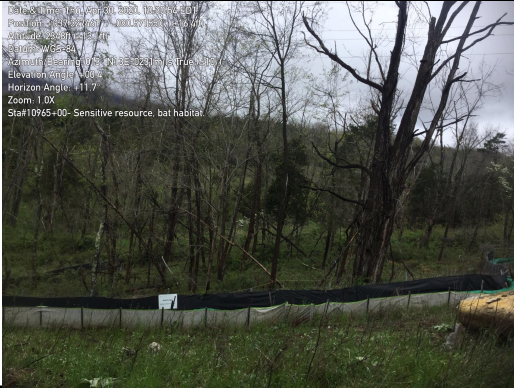
<p>Date & Time: Thu, Apr 30, 2020, 10:50:10 EDT Position: +037.326667, -080.576667 (±32.8ft) Altitude: 2422ft (±30.4ft) Datum: WGS-84 Azimuth/Bearing: 170° S85W 4533mils True (±15°) Elevation Angle: -04.5° Horizon Angle: +11.7° Zoom: 1.0X Sta#10965+00- Sensitive resource, bat habitat</p>

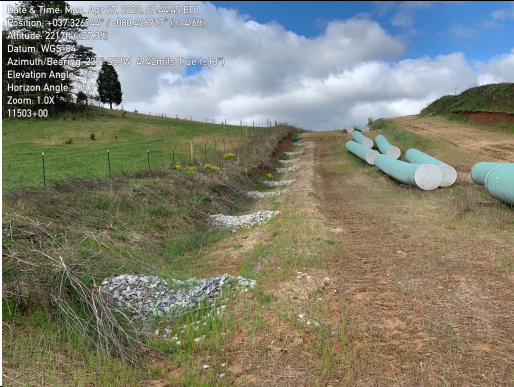
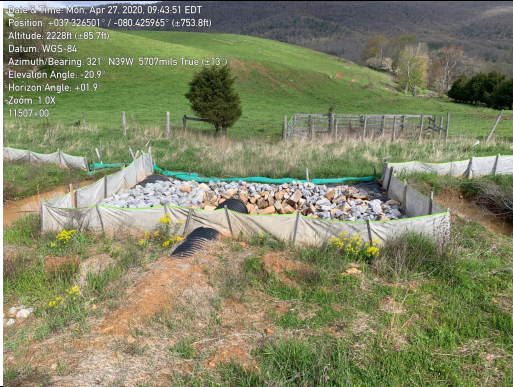
GPS Location	See photo for GPS location.		GPS Location	See photo for GPS location.	
Field Station#	11503+00		Field Station#	11507+00	
Pic 1 Desc.	Conveyance channel with rock checks in place at double cut section of ROW.		Pic 2 Desc.	Clean water diversion pipe and plunge pool in place.

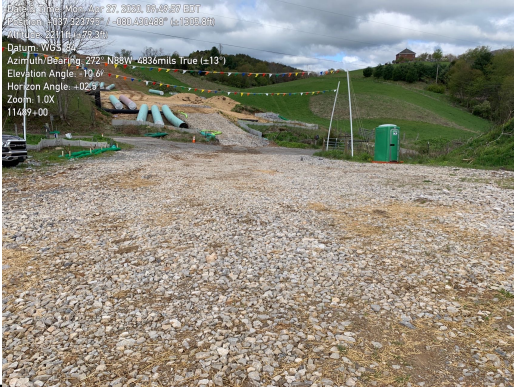
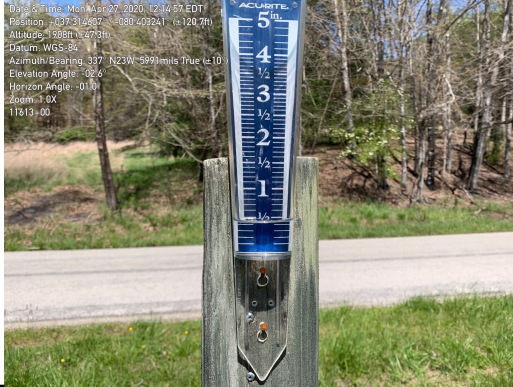
GPS Location	See photo for GPS location.		GPS Location	See photo for GPS location.	
Field Station#	11489+00		Field Station#	11613+00	
Pic 3 Desc.	RCE in place at Stevers Gap Road.		Pic 4 Desc.	Rain gauge at Craig Creek Road reads 0.5 inches.

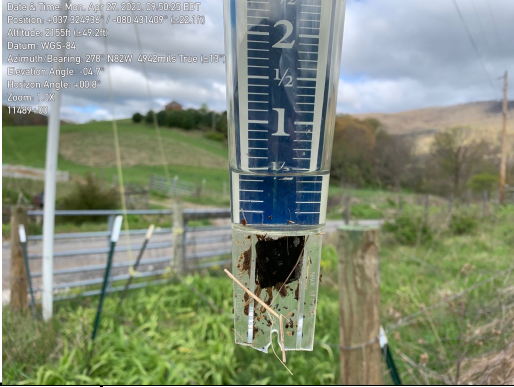
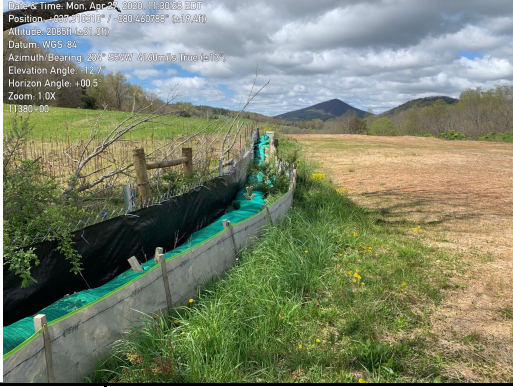
GPS Location	See photo for GPS location.		GPS Location	See photo for GPS location.	
Field Station#	11489+00		Field Station#	11380+00	
Pic 5 Desc.	Rain gauge at Stevers Gap Road reads 0.5 inches.		Pic 6 Desc.	Triple barrier ECDs in place at off ROW karst feature.

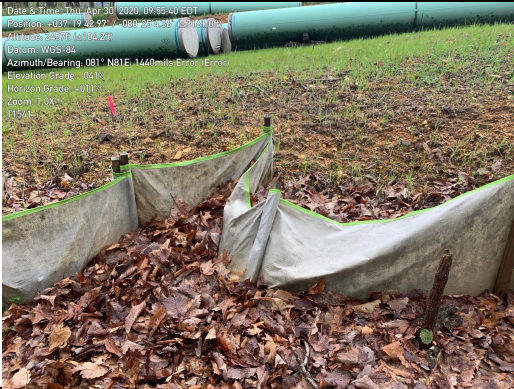
<p>Date & Time: Thu Apr 30, 2020 09:55:40 EDT Position: +037 19.02.27 / -080 25.55.53 (+3.89m) Altitude: 2030ft (+62.2m) Datum: WGS-84 Azimuth/Bearing: 081° N81E 1440mils Error (Error) Elevation Grade: -041° Horizon Grade: -011° Zoom: 1.0x 11541</p>

Field Station#	11541+00	Field Station#	11555+00	GPS Location	See picture above for GPS coordinates
Pic 3 Desc.	Damaged P1	Pic 4 Desc.	ECD's and row conditions	GPS Location	See picture above for GPS coordinates

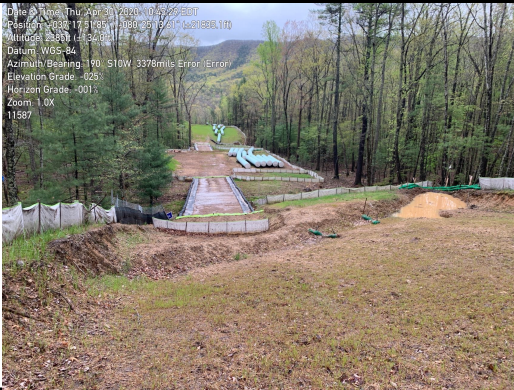
<p>Date & Time: Thu Apr 30, 2020 10:50:29 EDT Position: +037 19.02.04 / -080 30.06.27 (+3.89m) Altitude: 2125ft (+64.7m) Datum: WGS-84 Azimuth/Bearing: 190° S10W 3376mils Error (Error) Elevation Grade: -023° Horizon Grade: -001° Zoom: 1.0x 11587</p>

<p>Date & Time: Thu Apr 30, 2020 10:50:29 EDT Position: +037 19.02.04 / -080 30.06.27 (+3.89m) Altitude: 2125ft (+64.7m) Datum: WGS-84 Azimuth/Bearing: 177° S77W 3358mils Error (Error) Elevation Grade: -038° Horizon Grade: -005° Zoom: 1.0x 10889</p>		GPS Location	See picture above for GPS coordinates
Field Station#	11587+00	Field Station#	10889+00	GPS Location	See picture above for GPS coordinates
Pic 5 Desc.	ECD's and row conditions	Pic 6 Desc.	ECD's and row conditions	GPS Location	See picture above for GPS coordinates

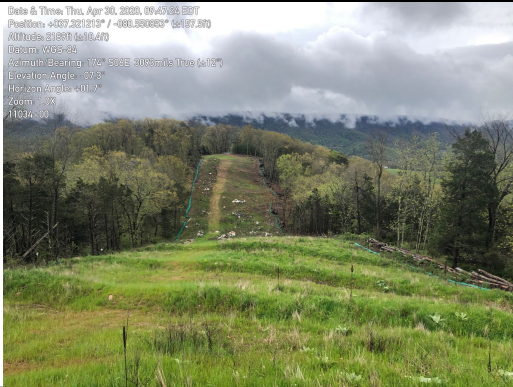
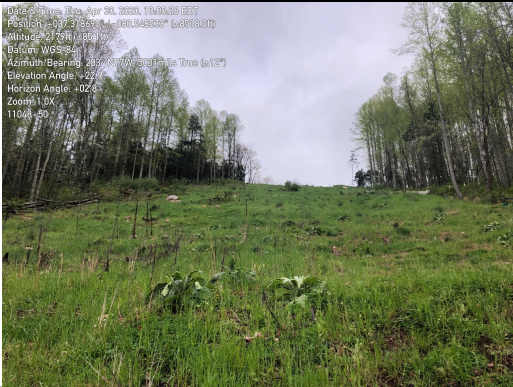
GPS Location	3	GPS Location	4		
Field Station#	11034+00	Field Station#	11048+50		
Pic 3 Desc.	RoW conditions and controls.	Pic 4 Desc.	RoW conditions and controls.

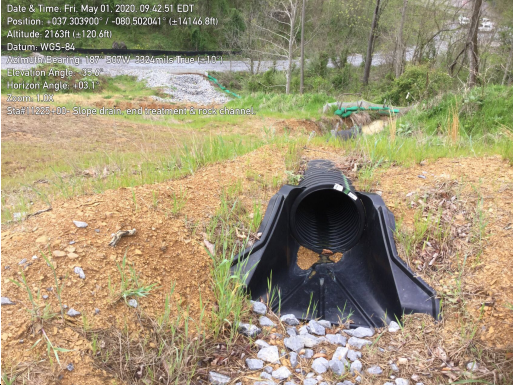
<p>Date & Time: Fri, May 01, 2020 09:42:51 EDT Position: +337.303908° / -080.502041° (+14146.8ft) Altitude: 2163ft (+120.6ft) Datum: WGS-84 Azimuth/Bearing: 185° S60° W23.2mils True (±10°) Elevation Angle: -3.4° Horizon Angle: +103.1° Zoom: 1.0x Sta# 11225+00 - Slope drain, end treatment & rock channel</p>			
GPS Location	See photo GPS	GPS Location	See photo GPS		
Field Station#	11233+00	Field Station#	11225+00		
Pic 1 Desc.	P1 silt fence damaged, contractor notified and repairs have been made.	Pic 2 Desc.	Slope drain pipe, end treatment, & rock channel are in acceptable condition.

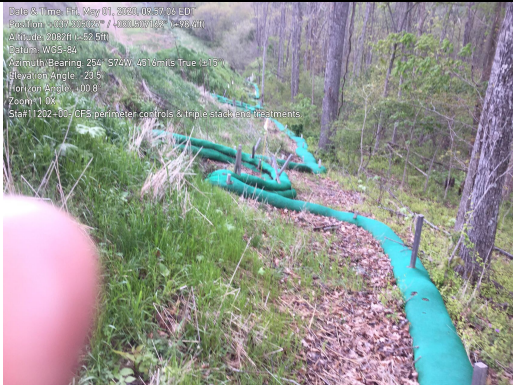
<p>Date & Time: Fri, May 01, 2020 10:07:39 EDT Position: +337.304991° / -080.502676° (+26443.5ft) Altitude: 1835ft (+165.6ft) Datum: WGS-84 Azimuth/Bearing: 25° S74° W45.0mils True (±10°) Elevation Angle: -23.6° Horizon Angle: +100.8° Zoom: 1.0x Sta# 11202+00 - CFS perimeter controls & triple stack end treatments</p>

<p>Date & Time: Fri, May 01, 2020 10:14:33 EDT Position: +337.307597° / -080.511363° (+1614.4ft) Altitude: 1926ft (+152.5ft) Datum: WGS-84 Azimuth/Bearing: 281° N79° W49.6mils True (±10°) Elevation Angle: -16.9° Horizon Angle: +04.7° Zoom: 2.0x Sta# 11184+00 - CWD drainage feature</p>			
GPS Location	See photo GPS	GPS Location	See photo GPS		
Field Station#	11202+00	Field Station#	11191+00		
Pic 3 Desc.	CFS perimeter controls and triple stack end treatments are in acceptable condition.	Pic 4 Desc.	Drainage feature and ECD's.

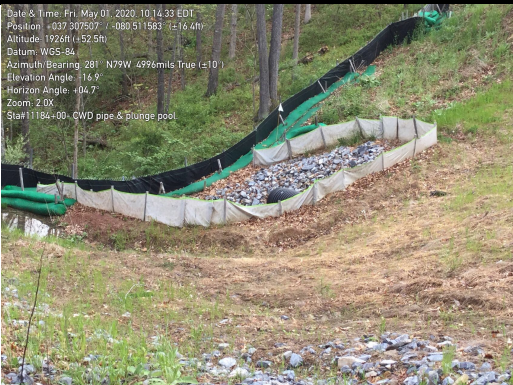
<p>Date & Time: Fri, May 01, 2020 10:14:33 EDT Position: +337.307597° / -080.511363° (+1614.4ft) Altitude: 1926ft (+152.5ft) Datum: WGS-84 Azimuth/Bearing: 281° N79° W49.6mils True (±10°) Elevation Angle: -16.9° Horizon Angle: +04.7° Zoom: 2.0x Sta# 11184+00 - CWD pipe & plunge pool</p>

GPS Location	See photo GPS	GPS Location	See photo GPS		
Field Station#	11191+00	Field Station#	11184+00		
Pic 5 Desc.	P1 stake broken off, contractor notified and repairs have been made.	Pic 6 Desc.	CWD pipe and plunge pool are in good condition.

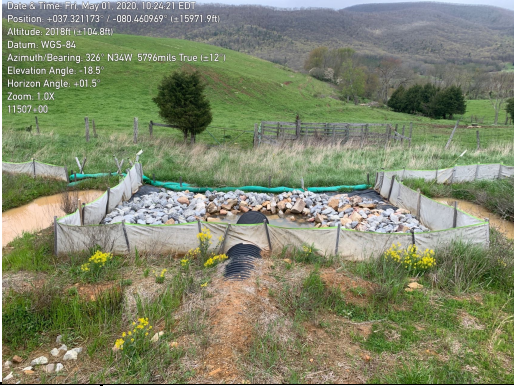
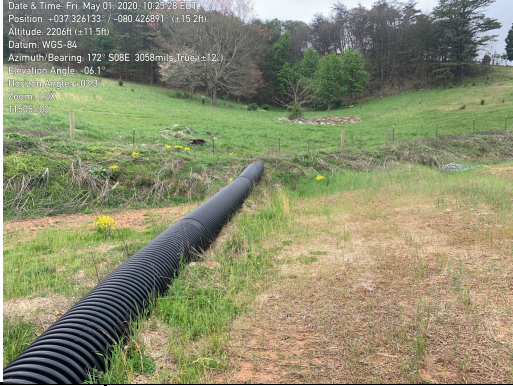
GPS Location	See photo for GPS location.		GPS Location	See photo for GPS location.	
Field Station#	11507+00		Field Station#	11505+00	
Pic 1 Desc.	Clean water diversion pipe and plunge pool in place.		Pic 2 Desc.	Clean water diversion pipe and clean water diversion berm in place.

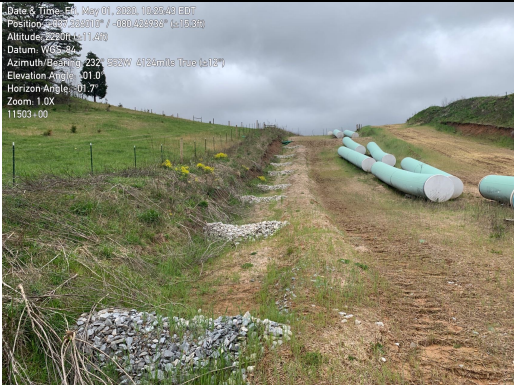
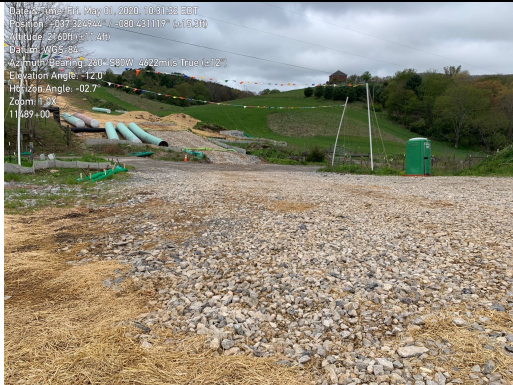
GPS Location	See photo for GPS location.		GPS Location	See photo for GPS location.	
Field Station#	11503+00		Field Station#	11489+00	
Pic 3 Desc.	Conveyance channel with rock checks in place at double cut section of ROW.		Pic 4 Desc.	RCE in place Stevers Gap Road.

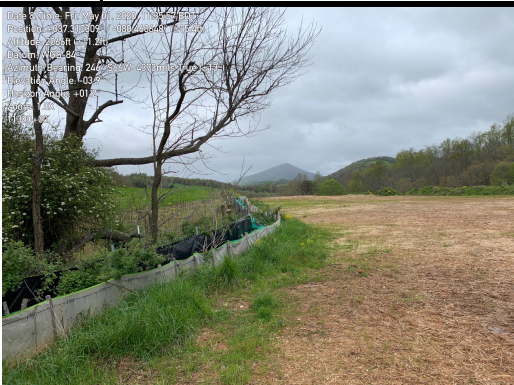
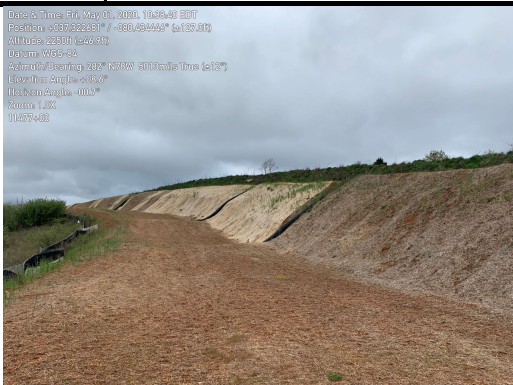
GPS Location	See photo for GPS location.		GPS Location	See photo for GPS location.	
Field Station#	11380+00		Field Station#	11477+00	
Pic 5 Desc.	Triple barrier ECDs in place at off ROW karst feature.		Pic 6 Desc.	ECB in place on two-tone to minimize erosion.

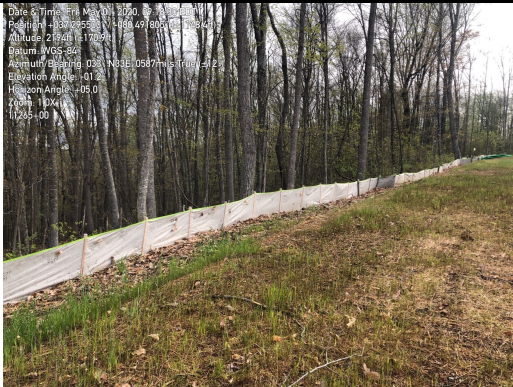
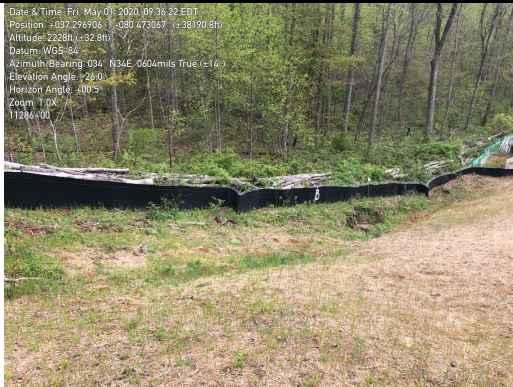
GPS Location	1		GPS Location	2	
Field Station#	11265+00		Field Station#	11286+00	
Pic 1 Desc.	Perimeter controls functional.		Pic 2 Desc.	Perimeter controls functional.

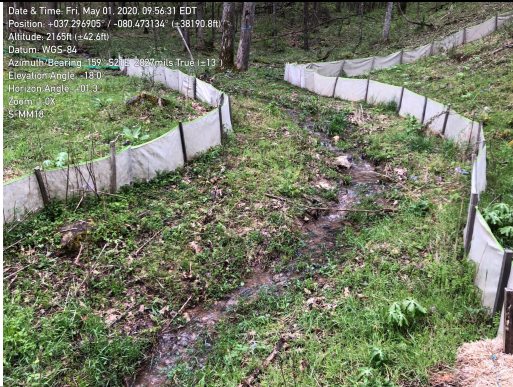
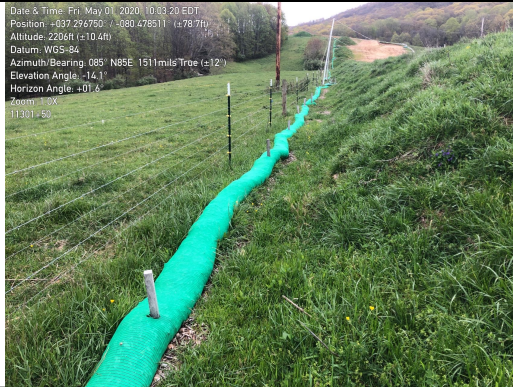
GPS Location	3		GPS Location	4	
Field Station#	11292+80		Field Station#	11301+50	
Pic 3 Desc.	S-MM18.		Pic 4 Desc.	Perimeter controls functional.
