Visual Site Inspection Report

Project Name	H-600 Pipeline Spread G	AFE	124300137	Spread	H-600 Pipeline Spread G
Contractor	Precision			Report #	9796
Inspector	Len Kruizenga			Date/Time	4/6/2020 2:43 PM
Permit #	TBD	Inspection Type	VA SWPP	Station Begin	11899+00
State	VA	Inspection Area	Full	Station End	12005+00
County	Montgomery	Ground	Dry	Temperature (°F)	55.00
Municipality	N/A	Weather	Light Rain	Rain Gauge (in)	0.00
				Rain Accumulation Time (days)	1.00

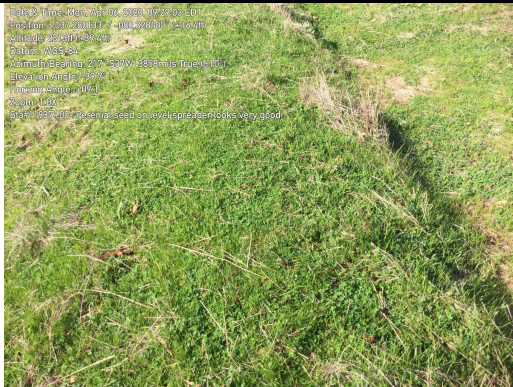
</div>			
GPS Location		See photo GPS		GPS Location	
Field Station#		11900+00		Field Station#	
Pic 1 Desc.		AR-266.03- Access road and environmental controls are in acceptable condition.		Pic 2 Desc.	
<div><p>Date & Time: Mon, Apr 06, 2020, 09:35:54 EDT Position: +037 275640 / -089 326286 (+16.4m) Altitude: 1966ft (+39.4m) Datum: WGS-84 Azimuth/Bearing: 238.592W 1853mils True (+10°) Elevation Angle: -11.9° Horizon Angle: +00.8° Zoom: 1.0X See 11943+00- Karst & Karst ECD's are in acceptable condition.</p>

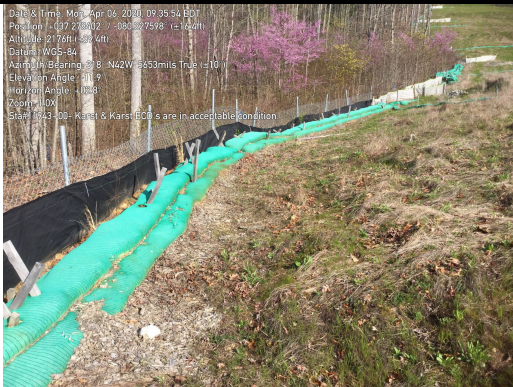
GPS Location		See photo GPS		GPS Location	
Field Station#		11943+00		Field Station#	
Pic 3 Desc.		Karst and Karst ECD's are in acceptable condition.		Pic 4 Desc.	
<div><p>Date & Time: Mon, Apr 06, 2020, 10:00:19 EDT Position: +037 2260111 / -089 326286 (+16.4m) Altitude: 1966ft (+39.4m) Datum: WGS-84 Azimuth/Bearing: 019° N19E 0338mils True (+10°) Elevation Angle: -10.1° Horizon Angle: -01.8° Zoom: 1.0X AR-266.00- Roadside ditch stabilization.</p> </div>		<div><p>Date & Time: Mon, Apr 06, 2020, 10:04:59 EDT Position: +037 2260111 / -089 326286 (+16.4m) Altitude: 2112ft (+420.0m) Datum: WGS-84 Azimuth/Bearing: 218° S38W 3878mils True (+10°) Elevation Angle: -10.0° Horizon Angle: +02.2° Zoom: 1.0X See 12001+00 to 12000+00- Wetland ECD's are in acceptable condition.</p> </div>			
GPS Location		See photo GPS		GPS Location	
Field Station#		11989+00		Field Station#	
Pic 5 Desc.		AR- 266.00 is maintained in acceptable condition.		Pic 6 Desc.

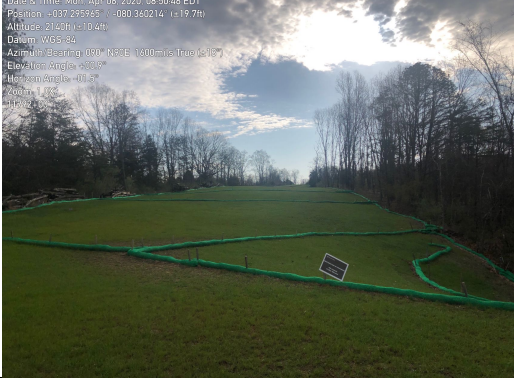
GPS Location	1	GPS Location	2		
Field Station#	11792+00	Field Station#	11804+00		
Pic 1 Desc.	Section of restored RoW and controls.	Pic 2 Desc.	Section of restored RoW and controls.		
<p>Date & Time: Mon, Apr 06, 2020, 09:14:00 EDT Position: +037.290901° / -080.380040° (+28.3ft) Altitude: 2237ft (+184.0ft) Datum: WGS 84 Azimuth/Bearing: 214° S34W 380mils True (+24.1°) Elevation Angle: +16.6° Horizon Angle: +06.0° Zoom: 1.0X 11834+00</p>

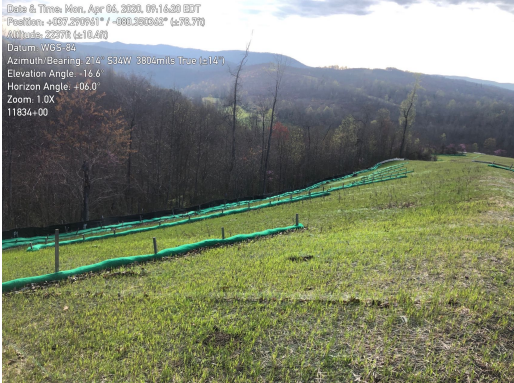
GPS Location	3	GPS Location	4		
Field Station#	11834+00	Field Station#	11863+65		
Pic 3 Desc.	Section of restored RoW and controls.	Pic 4 Desc.	P-KL2.		
<p>Date & Time: Mon, Apr 06, 2020, 09:51:10 EDT Position: +037.237292° / -080.342993° (+428.7ft) Altitude: 2110ft (+162.8ft) Datum: WGS 84 Azimuth/Bearing: 093° S87E 1653mils True (+16.1°) Elevation Angle: +02.3° Horizon Angle: +01.1° Zoom: 1.0X 11880+00</p>

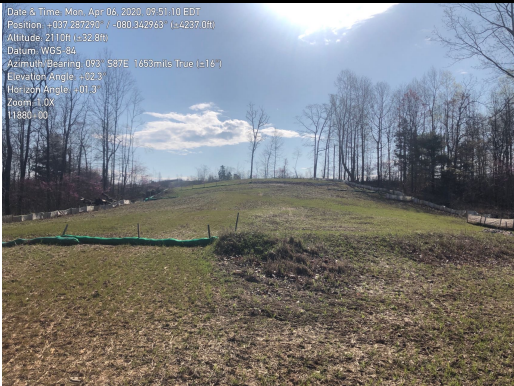
GPS Location	5	GPS Location	6		
Field Station#	11880+00	Field Station#	11887+00		
Pic 5 Desc.	Section of restored RoW and controls.	Pic 6 Desc.	Section of restored RoW and controls.

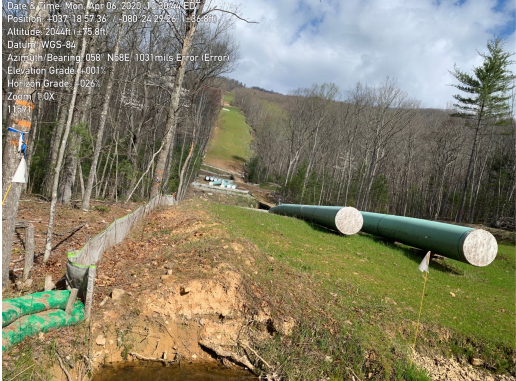
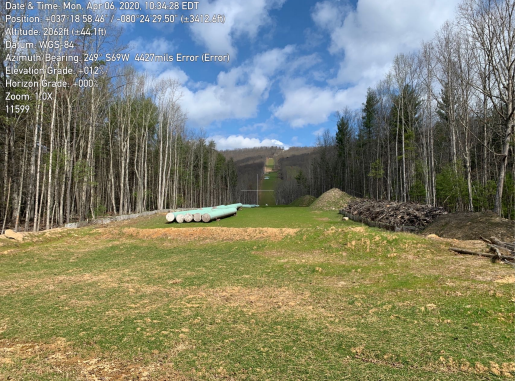
GPS Location	See picture above for GPS coordinates		GPS Location	See picture above for GPS coordinates	
Field Station#	11591+00		Field Station#	11599+00	
Pic 1 Desc.	ECD's and row conditions		Pic 2 Desc.	ECD's and row conditions

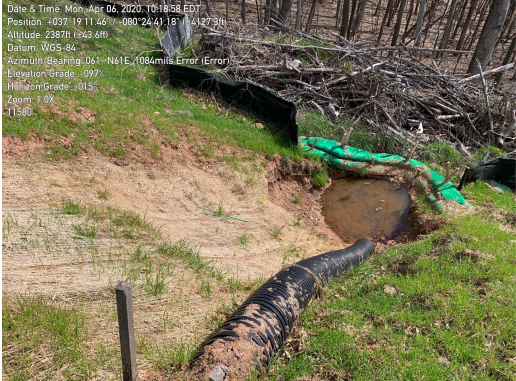
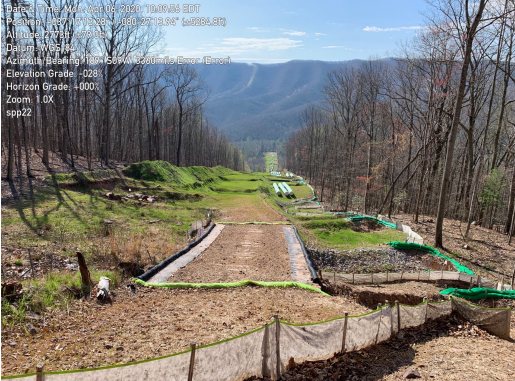
GPS Location	See picture above for GPS coordinates		GPS Location	See picture above for GPS coordinates	
Field Station#	11580+00		Field Station#	11569+00	
Pic 3 Desc.	ECD's and row conditions		Pic 4 Desc.	ECD's and row conditions

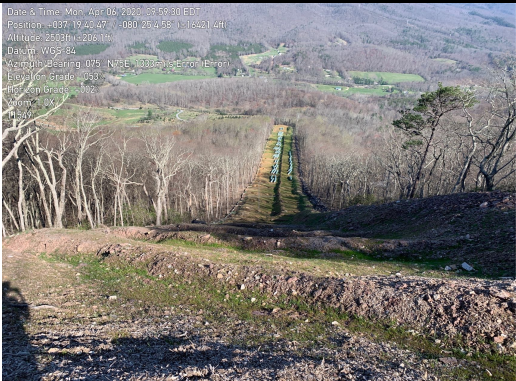
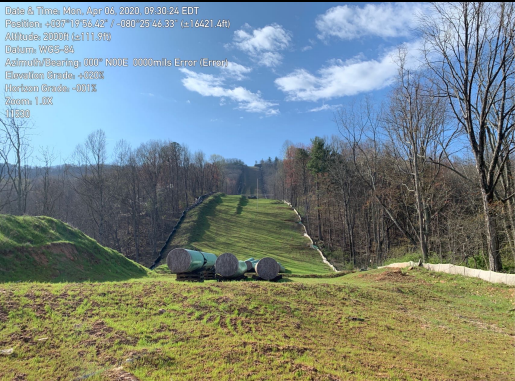
GPS Location	See picture above for GPS coordinates		GPS Location	See picture above for GPS coordinates	
Field Station#	11549+00		Field Station#	11530+00	
Pic 5 Desc.	ECD's and row conditions		Pic 6 Desc.	ECD's and row conditions

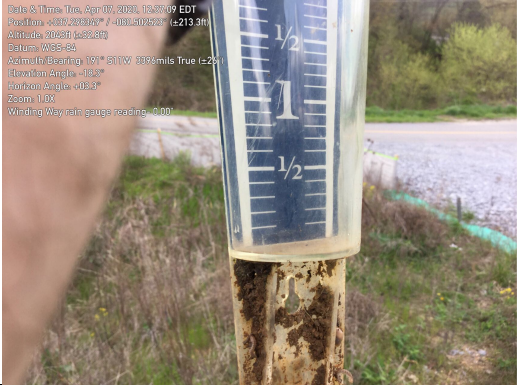
GPS Location	See photo GPS	GPS Location			
Field Station#	11227+00	Field Station#			
Pic 7 Desc.	Winding Way rain gauge reading-0.00"	Pic 8 Desc.			
Insert image here		Insert image here			
GPS Location		GPS Location			
Field Station#		Field Station#			
Pic 9 Desc.		Pic 10 Desc.			
Insert image here		Insert image here			
GPS Location		GPS Location			
Field Station#		Field Station#			
Pic 11 Desc.		Pic 12 Desc.

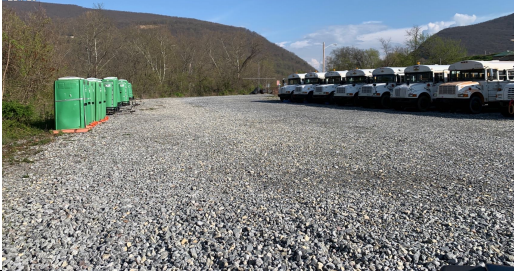
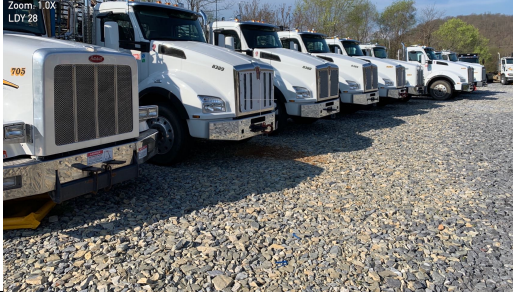
GPS Location	See picture above for GPS coordinates		GPS Location	See picture above for GPS coordinates	
Field Station#	12005+00		Field Station#	12005+00	
Pic 1 Desc.	ECD's and row conditions		Pic 2 Desc.	ECD's and row conditions	
<p>Date & Time: Tue Apr 07 2020 09:40:00 EDT Position: +037 20 31.50 / -080 48 11.57 (+168.1ft) Altitude: 1637ft (+51.2ft) Datum: WGS-84 Azimuth/Bearing: 057 N57E 135mils Error (Error) Elevation Grade: +083 Horizon Grade: +002 Zoom: 1.0X LDY 28</p>

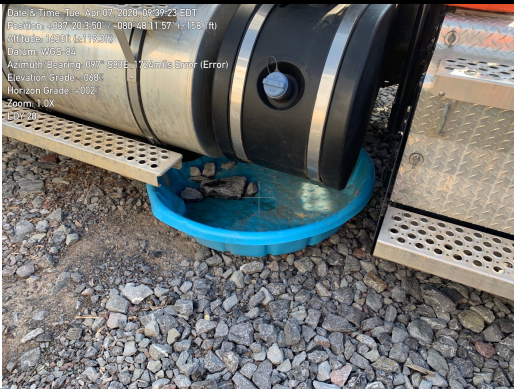
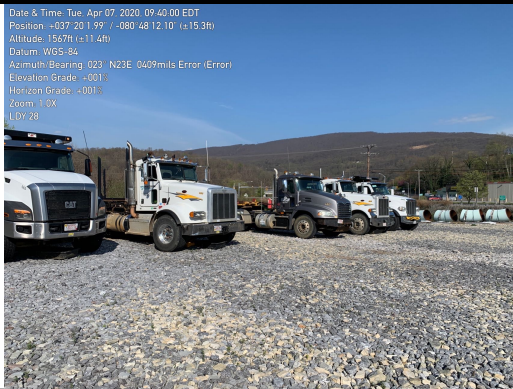
GPS Location	See picture above for GPS coordinates		GPS Location	See picture above for GPS coordinates	
Field Station#	12005+00		Field Station#	12005+00	
Pic 3 Desc.	Secondary containment		Pic 4 Desc.	ECD's and row conditions	
<p>Date & Time: Tue Apr 07 2020 09:41:28 EDT Position: +037 20 31.17 / -080 48 12.37 (+115.9ft) Altitude: 1562ft (+28.3ft) Datum: WGS-84 Azimuth/Bearing: 032 N32E 0569mils Error (Error) Elevation Grade: +004 Horizon Grade: +001 Zoom: 1.0X LDY 28</p>

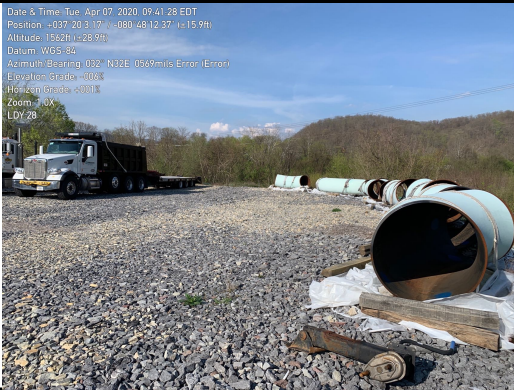
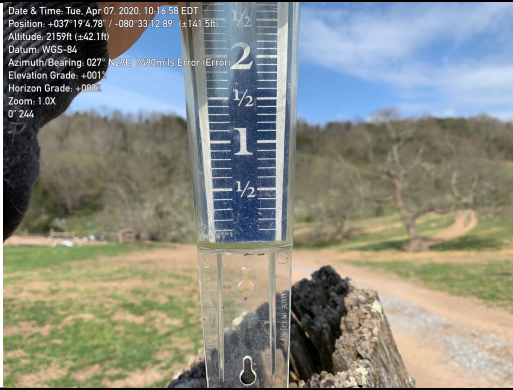
GPS Location	See picture above for GPS coordinates		GPS Location	See picture above for GPS coordinates	
Field Station#	12005+00		Field Station#	+1	
Pic 5 Desc.	ECD's and row conditions		Pic 6 Desc.	No rain recorded

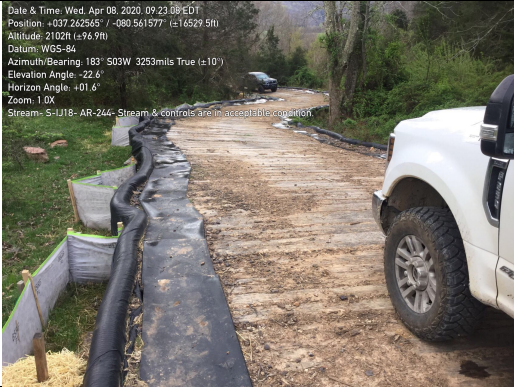
A/E	124300137	Date/Time	4/8/2020 8:15 AM	Report #	
Pictures					
<p>Date & Time: Wed, Apr 08, 2020, 09:23:09 EDT Position: +037.323654° / -080.561577° (±16529.5ft) Altitude: 2102ft (±93.9ft) Datum: WGS-84 Azimuth/Bearing: 183° S03W 3253mils True (±10°) Elevation Angle: -22.6° Horizon Angle: +01.6° Zoom: 1.0X Stream: S-IJ18-AR-244-Stream & controls are in acceptable condition.</p>

GPS Location	See photo GPS		GPS Location	See photo GPS	
Field Station#	11024+00		Field Station#	11016+00	
Pic 1 Desc.	Stream S- IJ18 and stream ECD's.		Pic 2 Desc.	Stream S- RR5 and stream ECD's	
<p>Date & Time: Wed, Apr 08, 2020, 09:41:15 EDT Position: +037.314199° / -080.531954° (±20111.0ft) Altitude: 2717ft (±127.8ft) Datum: WGS-84 Azimuth/Bearing: 295° N65W 5244mils True (±10°) Elevation Angle: -27.9° Horizon Angle: +02.1° Zoom: 1.0X Stream: S-IJ18-AR-244-Contractor has reseeded & mulched row & water bars with sparse vegetation.</p>

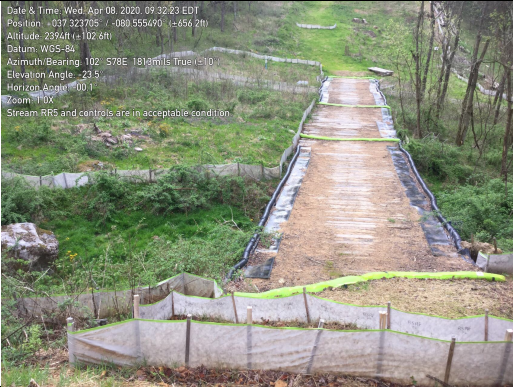
<p>Date & Time: Wed, Apr 08, 2020, 09:32:23 EDT Position: +037.323705° / -080.555470° (±456.2ft) Altitude: 2294ft (±102.6ft) Datum: WGS-84 Azimuth/Bearing: 102° S78E 181mils True (±10°) Elevation Angle: -21.5° Horizon Angle: +00.1° Zoom: 1.0X Stream: RR5 and controls are in acceptable condition.</p>

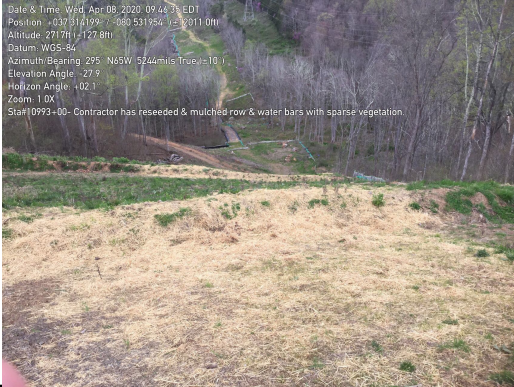
GPS Location	See photo GPS		GPS Location	See photo GPS	
Field Station#	10993+00		Field Station#	10986+00	
Pic 3 Desc.	Contractor has reseeded and mulched water bars and areas with sparse vegetation.		Pic 4 Desc.	Stream S- E25 and ECD's.	
<p>Date & Time: Wed, Apr 08, 2020, 09:44:32 EDT Position: +037.323654° / -080.561577° (±16529.5ft) Altitude: 2102ft (±93.9ft) Datum: WGS-84 Azimuth/Bearing: 301° N59W 5333mils True (±10°) Elevation Angle: -19.3° Horizon Angle: +00.9° Zoom: 1.0X Stream: S-E24-Stream and controls are in acceptable condition.</p>

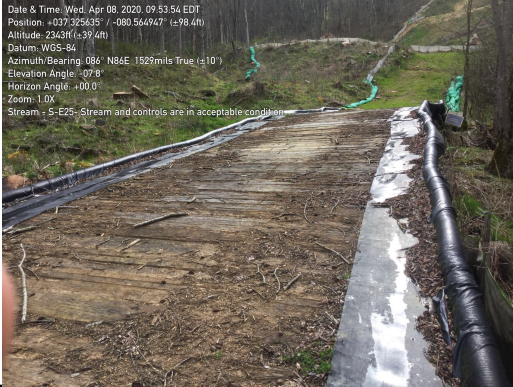
<p>Date & Time: Wed, Apr 08, 2020, 09:53:54 EDT Position: +037.325635° / -080.564947° (±98.4ft) Altitude: 2343ft (±39.4ft) Datum: WGS-84 Azimuth/Bearing: 096° N84E 1529mils True (±10°) Elevation Angle: -07.8° Horizon Angle: +00.0° Zoom: 1.0X Stream: S-E25-Stream and controls are in acceptable condition.</p>

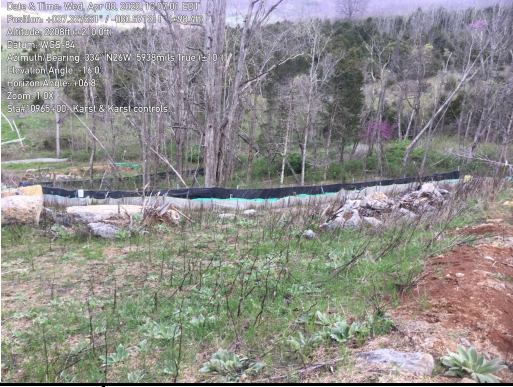
<p>Date & Time: Wed, Apr 08, 2020, 09:46:15 EDT Position: +037.323654° / -080.561577° (±16529.5ft) Altitude: 2102ft (±93.9ft) Datum: WGS-84 Azimuth/Bearing: 324° N26W 5538mils True (±10°) Elevation Angle: -16.0° Horizon Angle: +00.0° Zoom: 1.0X Stream: S-IJ18-AR-244-Karst & Karst controls.</p>

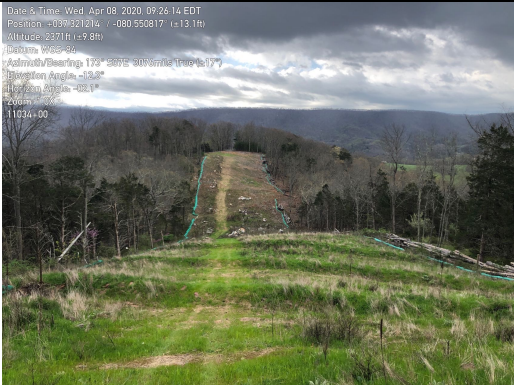
GPS Location	3	GPS Location	4		
Field Station#	11034+00	Field Station#	11050+10		
Pic 3 Desc.	RoW conditions and controls.	Pic 4 Desc.	S-IJ16B and S-IJ17 and controls.

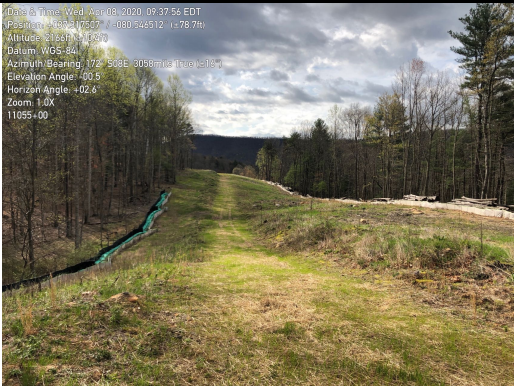
GPS Location	5	GPS Location	6		
Field Station#	11055+00	Field Station#	11064+53		
Pic 5 Desc.	RoW conditions and controls.	Pic 6 Desc.	RoW conditions and controls.

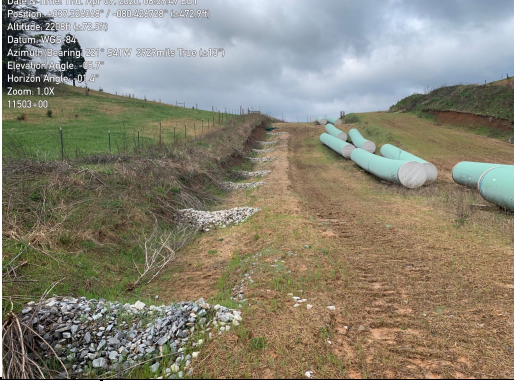
GPS Location		See photo for GPS location.		GPS Location	
Field Station#		11503+00		Field Station#	
Pic 1 Desc.		Conveyance channel with rock checks in place at double cut section of ROW.		Pic 2 Desc.	
				Sump pit sloughed off resulting in priority one silt fence flap being exposed. Contractor informed.	
<p>Date & Time: Thu, Apr 09, 2020, 09:12:46 EDT Position: +33°33'14.74"N, -80°43'50.2" W Altitude: 2162ft (659.6m) Datum: WGS-84 Azimuth: Bearing: 141° S2E 349mils True (E15) Elevation Angle: -19.2° Horizon Angle: +00.1° Zoom: 1.0X 11478+00</p>

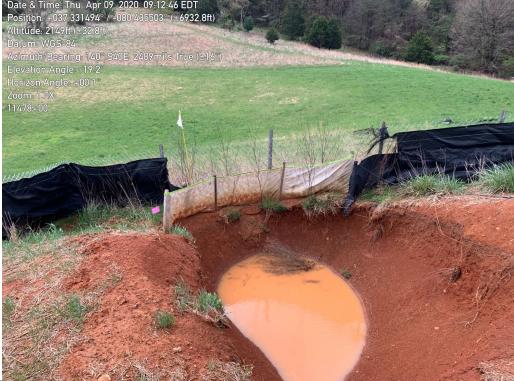
GPS Location		See photo for GPS location.		GPS Location	
Field Station#		11478+00		Field Station#	
Pic 3 Desc.		Sump pit sloughed off resulting in priority one silt fence flap being exposed. Contractor informed.		Pic 4 Desc.	
				Rain gauge at Stevers Gap Road reads 0.7 inches.	
<p>Date & Time: Thu, Apr 09, 2020, 10:43:10 EDT Position: +33°23'41.02"N, -80°36'50.9" W Altitude: 2014ft (613.9m) Datum: WGS-84 Azimuth: Bearing: 344° N16W 611mils True (E15) Elevation Angle: +02.6° Horizon Angle: +02.1° Zoom: 1.0X 11767+00</p>

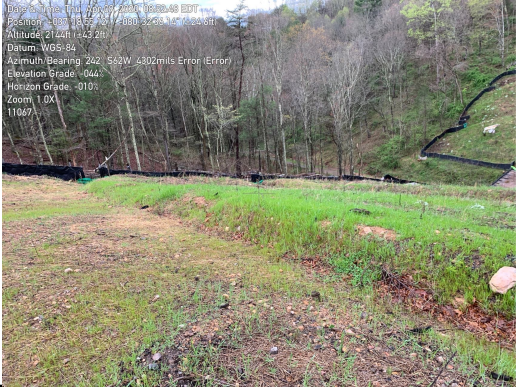
GPS Location	See picture above for GPS coordinates		GPS Location	See picture above for GPS coordinates	
Field Station#	11067+00		Field Station#	11101+00	
Pic 3 Desc.	ECD's and row conditions		Pic 4 Desc.	ECD's and row conditions

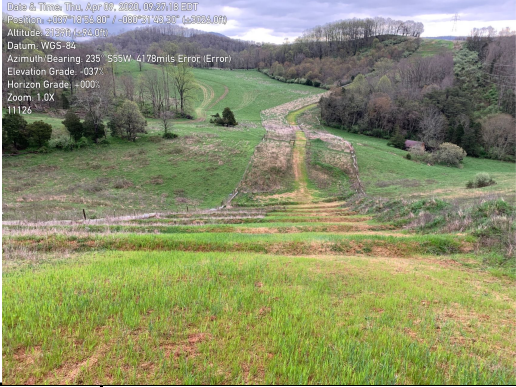
GPS Location	See picture above for GPS coordinates		GPS Location	See picture above for GPS coordinates	
Field Station#	11126+00		Field Station#	11138+00	
Pic 5 Desc.	ECD's and row conditions		Pic 6 Desc.	ECD's and row conditions

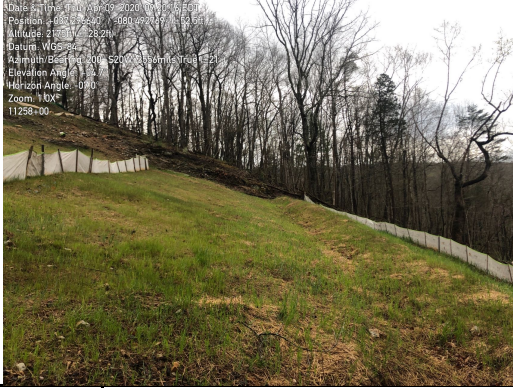
<p>Date & Time: Thu Apr 09, 2020 09:26:58 EDT Position: +037.296338° / -080.481579° (-52.5ft) Altitude: 2080ft (-115.7m) Datum: WGS-84 Azimuth/Bearing: 288° N72W 5120mils True (-16°) Elevation Angle: -11.5° Horizon Angle: +02.0° Zoom: 1.0X 11266+00</p>		
GPS Location	1	GPS Location	2		
Field Station#	11258+00	Field Station#	11266+00		
Pic 1 Desc.	RoW conditions and controls.		Pic 2 Desc.	Perimeter controls functional.

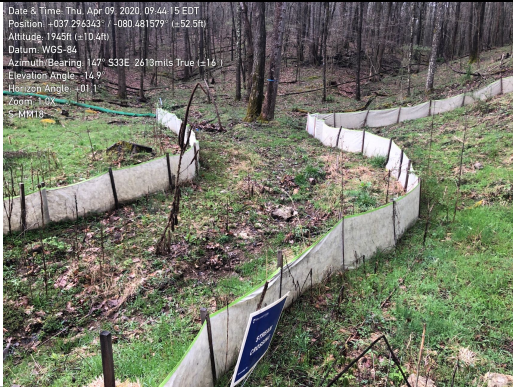
GPS Location	3	GPS Location	4		
Field Station#	11292+80	Field Station#	11298+00		
Pic 3 Desc.	S-MM18.		Pic 4 Desc.	Vegetation and perimeter controls.

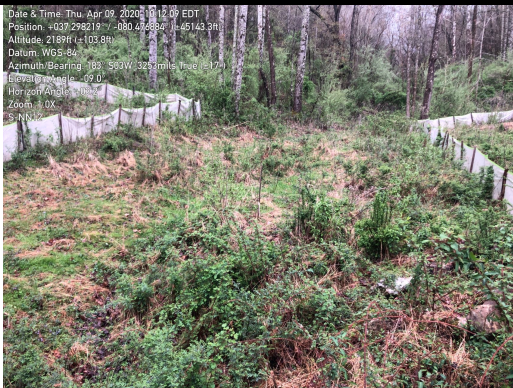
<p>Date & Time: Thu Apr 09, 2020 10:12:09 EDT Position: +037.292218° / -080.472832° (-51.43.9ft) Altitude: 1839ft (-108.0m) Datum: WGS-84 Azimuth/Bearing: 173° N87E 3009mils True (-5°) Elevation Angle: -01.8° Horizon Angle: +00.7° Zoom: 1.0X S-NN11</p>		
GPS Location	5	GPS Location	6		
Field Station#	11327+85	Field Station#	11352+97		
Pic 5 Desc.	S-NN12.		Pic 6 Desc.	S-NN11.

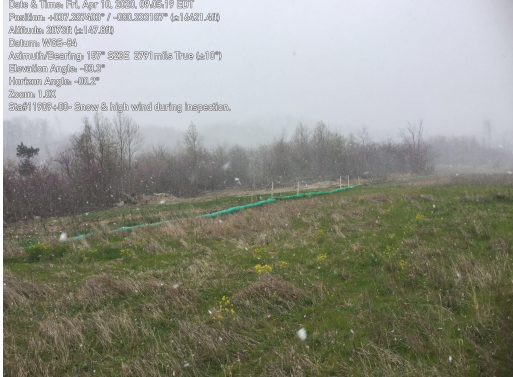
AFE 124300137		Date/Time 4/10/2020 7:57 AM		Report #	
Pictures					
<p>Date & Time: Fri, Apr 10, 2020, 06:45:19 EDT Position: +037.2094007 / -080.327598 (±16420.4ft) Altitude: 3275ft (±167.2ft) Datum: WGS-84 Azimuth/Bearing: 182° S88E 329ft/mils True (±10°) Elevation Angle: -48.3° Horizon Angle: -00.2° Zoom: 1.0X Sta#11909+00- Snow & high wind during inspection.</p>

GPS Location		See photo GPS		GPS Location	
Field Station#		11909+00		Field Station#	
Pic 1 Desc.		Snow and high winds during inspection.		Pic 2 Desc.	
<p>Date & Time: Fri, Apr 10, 2020, 09:28:23 EDT Position: +037.278811 / -080.327598 (±16421.0ft) Altitude: 2191ft (±73.7ft) Datum: WGS-84 Azimuth/Bearing: 168° S12E 298ft/mils True (±10°) Elevation Angle: -00.3° Horizon Angle: -00.3° Zoom: 1.0X Sta#11953+00- Karst controls</p>

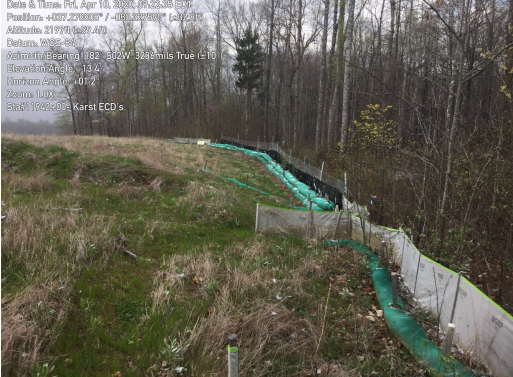
<p>Date & Time: Fri, Apr 10, 2020, 06:23:38 EDT Position: +037.276168 / -080.325636 (±15984ft) Altitude: 3197ft (±162.4ft) Datum: WGS-84 Azimuth/Bearing: 182° S88W 328ft/mils True (±10°) Elevation Angle: -13.4° Horizon Angle: -00.7° Zoom: 1.0X Sta#11942+00- Karst ECD's.</p>

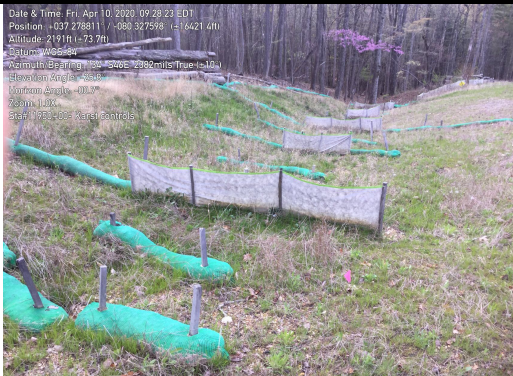
GPS Location		See photo GPS		GPS Location	
Field Station#		11950+00		Field Station#	
Pic 3 Desc.		Karst controls are in acceptable condition.		Pic 4 Desc.	
<p>Date & Time: Fri, Apr 10, 2020, 09:41:36 EDT Position: +037.271016 / -080.323358 (±16810.6ft) Altitude: 1762ft (±84.3ft) Datum: WGS-84 Azimuth/Bearing: 140° S40E 248ft/mils True (±25°) Elevation Angle: -23.5° Horizon Angle: -02.0° Zoom: 1.0X Sta#11973+00- Water bars are stable & well vegetated.</p>

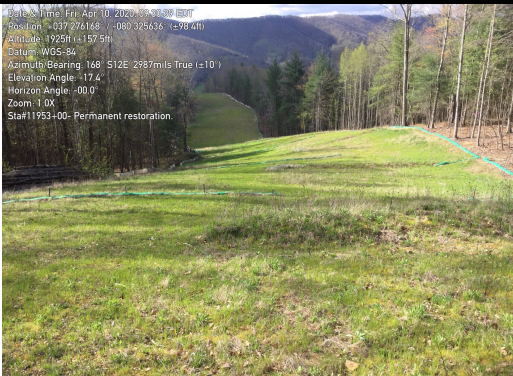
<p>Date & Time: Fri, Apr 10, 2020, 09:10:50 EDT Position: +037.276168 / -080.325636 (±15984ft) Altitude: 1925ft (±157.5ft) Datum: WGS-84 Azimuth/Bearing: 168° S12E 298ft/mils True (±10°) Elevation Angle: -17.4° Horizon Angle: -00.0° Zoom: 1.0X Sta#11953+00- Permanent restoration.</p>

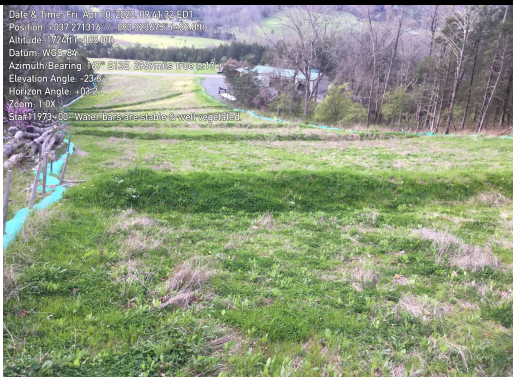
GPS Location		See photo GPS		GPS Location	
Field Station#		11973+00		Field Station#	
Pic 5 Desc.		Water bars are stable and well vegetated.		Pic 6 Desc.

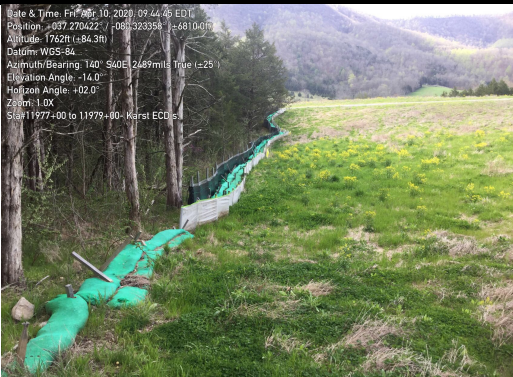
<p>Date & Time: Fri, Apr 10, 2020, 09:24:46 EDT Position: +037.276222 / -080.323358 (±16810.6ft) Altitude: 1762ft (±84.3ft) Datum: WGS-84 Azimuth/Bearing: 140° S40E 248ft/mils True (±25°) Elevation Angle: -14.0° Horizon Angle: -02.0° Zoom: 1.0X Sta#11977+00 to 11979+00- Karst ECD's.</p>

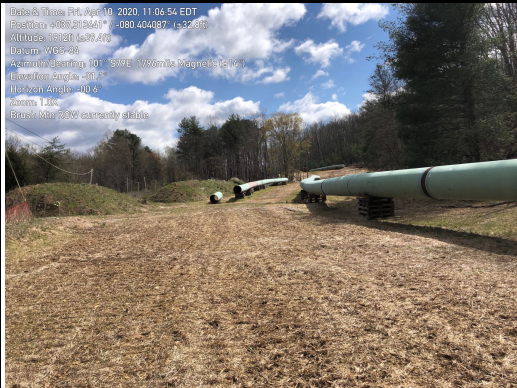
GPS Location	On photo	GPS Location	On photo		
Field Station#	11607+25	Field Station#	11606+50		
Pic 9 Desc.	ROW stable.	Pic 10 Desc.	Topsoil piles are stable.		
 		<p>Insert image here</p>			
GPS Location	On photo	GPS Location			
Field Station#	11613+69	Field Station#			
Pic 11 Desc.	S-RR13 crossing is stable. ECDs in place.	Pic 12 Desc.

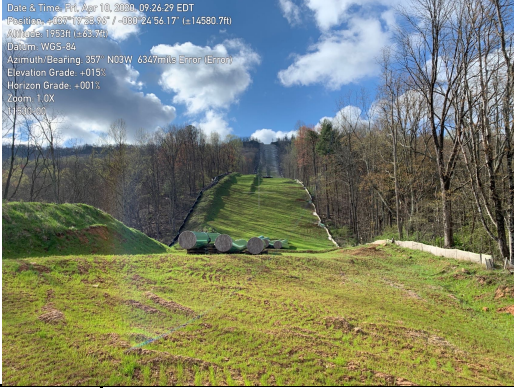
<p>Date & Time: Fri Apr 10, 2020, 09:26:29 EDT Position: 357° 19' 23.94" N -080° 24' 56.17" W (4580 7ft) Altitude: 11530 (1.0534) Datum: WGS 84 Azimuth/Bearing: 357° N03W 6347mils Error: Error Elevation Grade: +015° Horizon Grade: +001° Zoom: 1.0X 11530</p>

<p>Date & Time: Fri Apr 10, 2020, 09:44:55 EDT Position: 357° 19' 23.94" N -080° 24' 56.17" W (4580 7ft) Altitude: 11540 (1.0534) Datum: WGS 84 Azimuth/Bearing: 357° N03W 6347mils Error: Error Elevation Grade: +015° Horizon Grade: +001° Zoom: 1.0X 11540</p>			
GPS Location	See picture above for GPS coordinates		GPS Location	See picture above for GPS coordinates	
Field Station#	11530+00		Field Station#	11540+00	
Pic 1 Desc.	ECD's and row conditions are		Pic 2 Desc.	ECD's and row conditions

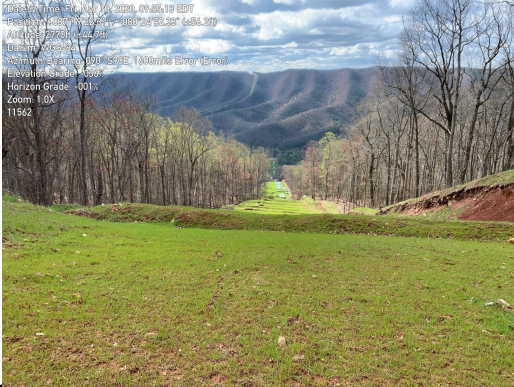
<p>Date & Time: Fri Apr 10, 2020, 09:46:19 EDT Position: 357° 19' 23.94" N -080° 24' 56.17" W (4580 7ft) Altitude: 11562 (1.0534) Datum: WGS 84 Azimuth/Bearing: 357° N03W 6347mils Error: Error Elevation Grade: +015° Horizon Grade: +001° Zoom: 1.0X 11562</p>

GPS Location	See picture above for GPS coordinates		GPS Location	See picture above for GPS coordinates	
Field Station#	11562+00		Field Station#	11569+00	
Pic 3 Desc.	ECD's and row conditions		Pic 4 Desc.	ECD's and row conditions

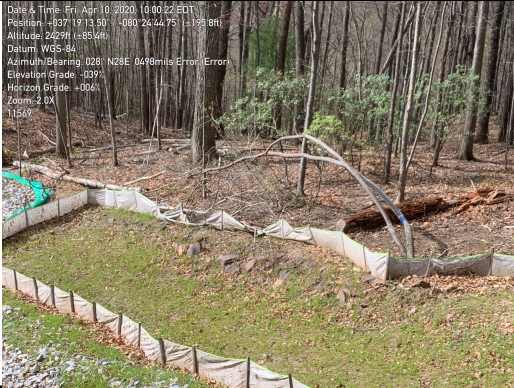
<p>Date & Time: Fri Apr 10, 2020, 10:00:22 EDT Position: 357° 19' 13.53" N -080° 24' 44.75" W (4580 7ft) Altitude: 11569 (1.0534) Datum: WGS 84 Azimuth/Bearing: 028° N28E 0498mils Error: Error Elevation Grade: +039° Horizon Grade: +006° Zoom: 2.0X 11569</p>

Pic 5 Desc.	ECD's and row conditions		Pic 6 Desc.	ECD's and row conditions

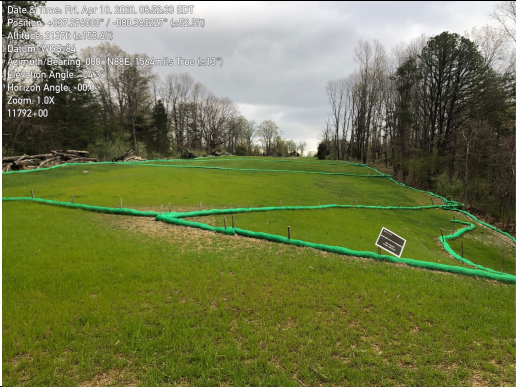
<p> <small> Date & Time Fri, Apr 10, 2020, 05:50:38 EDT Position: +487.259101° / +486.348337° (482.80) Altitude: 21370 (432.80) Datum: WGS-84 Azimuth/Heading: 000° (000° 3056mils True (s18°)) Elevation Angle: +00.0° Horizon Angle: +00.0° Zoom: 1.0X 11818+00 </small> </p>

GPS Location	1	GPS Location	2		
Field Station#	11792+00	Field Station#	11818+00		
Pic 1 Desc.	Section of restored RoW and controls.		Pic 2 Desc.	Section of restored RoW and controls.	
<p> <small> Date & Time Fri, Apr 10, 2020, 06:15:44 EDT Position: +487.258904° / +486.348337° (482.80) Altitude: 22210 (462.80) Datum: WGS-84 Azimuth/Heading: 290° (042° 3056mils True (s18°)) Elevation Angle: +00.0° Horizon Angle: +00.0° Zoom: 1.0X 11842+00 </small> </p>

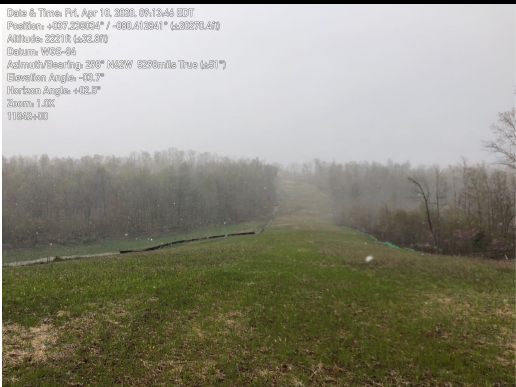
<p> <small> Date & Time Fri, Apr 10, 2020, 06:15:44 EDT Position: +487.258904° / +486.348337° (482.80) Altitude: 22210 (462.80) Datum: WGS-84 Azimuth/Heading: 290° (042° 3056mils True (s18°)) Elevation Angle: +00.0° Horizon Angle: +00.0° Zoom: 1.0X P-KL2 </small> </p>

GPS Location	3	GPS Location	4		
Field Station#	11842+00	Field Station#	11863+65		
Pic 3 Desc.	Section of restored RoW and controls.		Pic 4 Desc.	P-KL2.	
<p> <small> Date & Time Fri, Apr 10, 2020, 06:24:26 EDT Position: +487.258904° / +486.348337° (482.80) Altitude: 21726 (432.80) Datum: WGS-84 Azimuth/Heading: 000° (000° 3056mils True (s18°)) Elevation Angle: +00.0° Horizon Angle: +00.0° Zoom: 1.0X 11870+00 </small> </p>

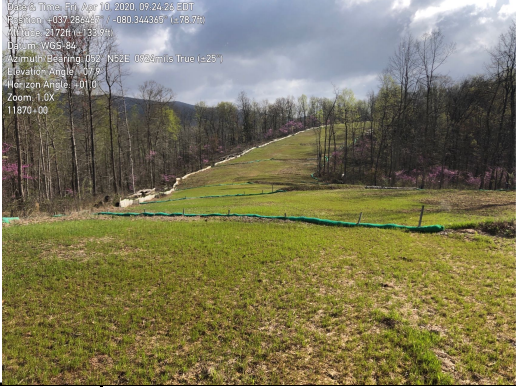
<p> <small> Date & Time Fri, Apr 10, 2020, 06:31:10 EDT Position: +487.258904° / +486.348337° (482.80) Altitude: 21620 (432.80) Datum: WGS-84 Azimuth/Heading: 100° (000° 3056mils True (s18°)) Elevation Angle: +00.0° Horizon Angle: +00.0° Zoom: 1.0X 11885+00 </small> </p>

GPS Location	5	GPS Location	6		
Field Station#	11870+00	Field Station#	11885+00		
Pic 5 Desc.	Section of restored RoW and controls.		Pic 6 Desc.	Section of restored RoW and controls.
