Visual Site Inspection Report

Project Name	H-600 Pipeline Spread G	AFE	124300137	Spread	H-600 Pipeline Spread G
Contractor	Precision			Report #	11274
Inspector	Chris Burns			Date/Time	5/26/2020 7:54 AM
Permit #	TBD	Inspection Type	VA SWPP	Station Begin	11254+99
State	VA	Inspection Area	Partial	Station End	11353+67
County	Giles	Ground	Damp	Temperature (°F)	73.00
Municipality	N/A	Weather	Cloudy	Rain Gauge (in)	0.00
				Rain Accumulation Time (days)	1.00

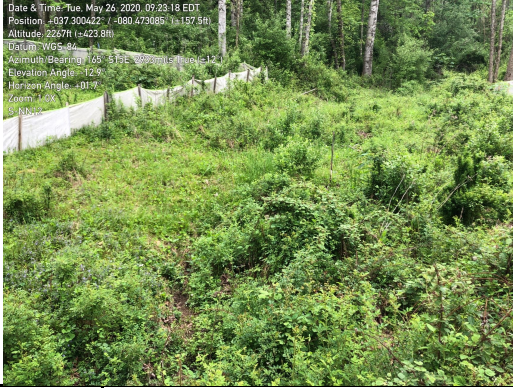
<p>Date & Time: Tue, May 26, 2020, 08:53:01 EDT Position: +037.295966 / -080.463683 (+152.9ft) Altitude: 2242ft (+104ft) Datum: WGS-84 Azimuth/Bearing: 035.1395E 3622mils True (+12) Elevation Angle: -23.8 Horizon Angle: +00.8 Zoom: 1.0X 11286+00</p>			
GPS Location	1	GPS Location	2		
Field Station#	11327+85	Field Station#	11286+00		
Pic 1 Desc.	S-NN12 and controls.	Pic 2 Desc.	Perimeter controls functional.

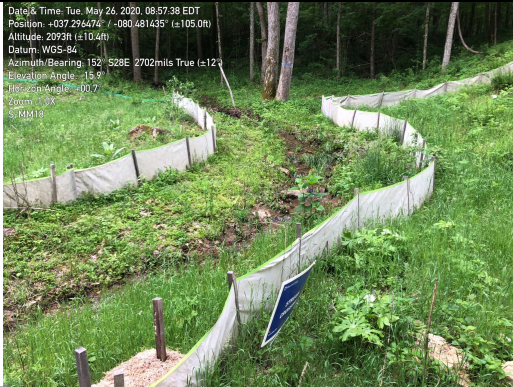
GPS Location	3	GPS Location	4		
Field Station#	11292+80	Field Station#	11303+00		
Pic 3 Desc.	S-MM18 and controls.	Pic 4 Desc.	Perimeter controls functional.

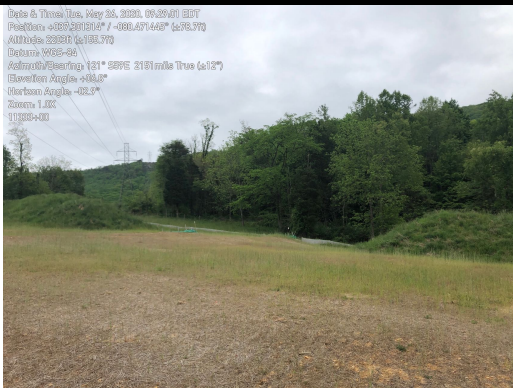
<p>Date & Time: Tue, May 26, 2020, 09:40:28 EDT Position: +037.309527 / -080.471449 (+169.3ft) Altitude: 1853ft (+104ft) Datum: WGS-84 Azimuth/Bearing: 102.588E 1636mils True (+12) Elevation Angle: -21.5 Horizon Angle: +00.8 Zoom: 1.0X S-NN11</p>			
GPS Location	5	GPS Location	6		
Field Station#	11333+00	Field Station#	11352+97		
Pic 5 Desc.	RoW conditions or controls.	Pic 6 Desc.	S-NN11 and controls.

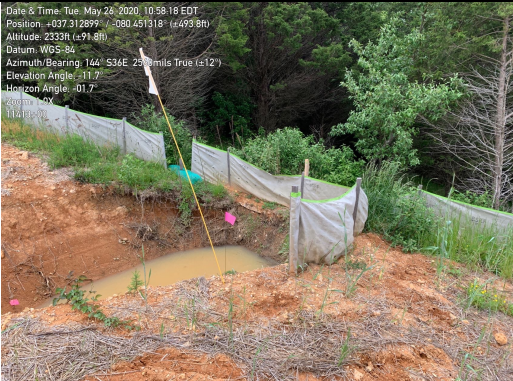
GPS Location	See photo for GPS location.		GPS Location	See photo for GPS location.	
Field Station#	11489+00		Field Station#	11413+00	
Pic 3 Desc.	RCE in place Stevers Gap Road.		Pic 4 Desc.	Priority one silt fence needs retrenched.

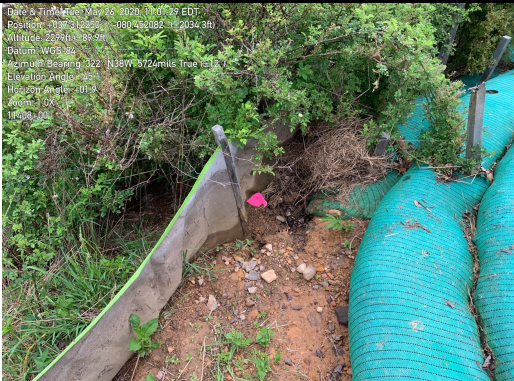
GPS Location	See photo for GPS location.		GPS Location	See photo for GPS location.	
Field Station#	11408+00		Field Station#	11767+00	
Pic 5 Desc.	Priority one silt fence undermined.		Pic 6 Desc.	Rain gauge at Mount Tabor Road reads 0.05 inches.

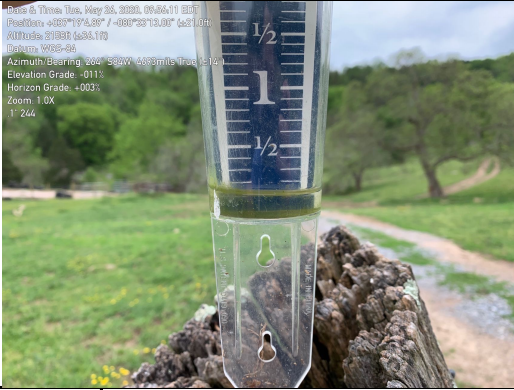
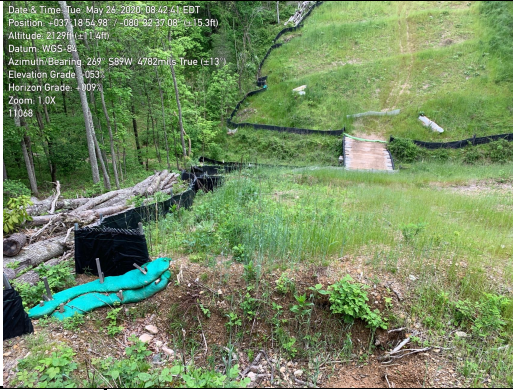
<p>Date & Time: Tue, May 26, 2020, 08:42:41 EDT Position: +43°19'54.28" / -86°23'37.08" (+13.30) Altitude: 3129 (+11.00) Datum: WGS-84 Azimuth/Bearing: 269 S89W 47.62mils True (+13) Elevation Grade: +053 Horizon Grade: +007 Zoom: 1.0X 11068</p>		GPS Location	See picture above for GPS coordinates
Field Station#	+1	Field Station#	11068+00	GPS Location	See picture above for GPS coordinates
Pic 1 Desc.	.1" of rain recorded @ AR 244	Pic 2 Desc.	ECD's and row conditions	GPS Location	See picture above for GPS coordinates

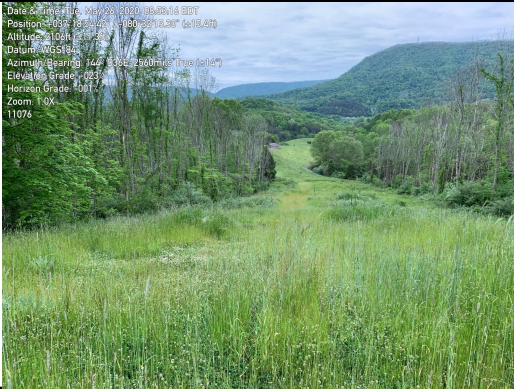
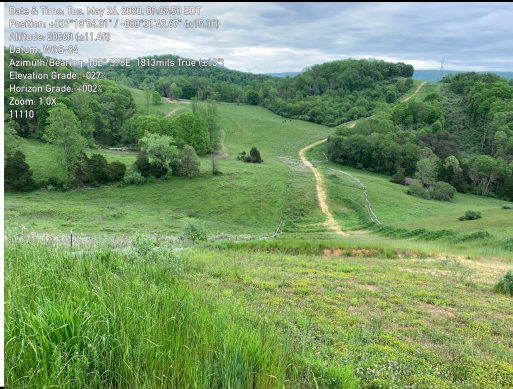
Field Station#	11076+00	Field Station#	11110+00	GPS Location	See picture above for GPS coordinates
Pic 3 Desc.	ECD's and row conditions	Pic 4 Desc.	ECD's and row conditions	GPS Location	See picture above for GPS coordinates

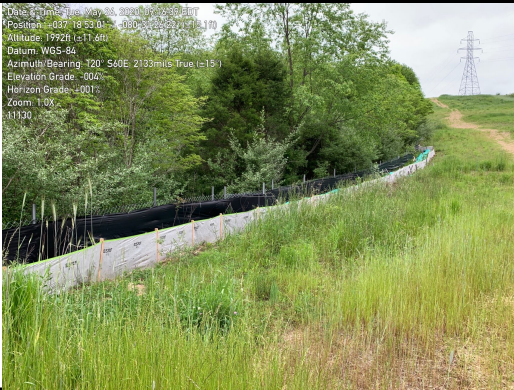
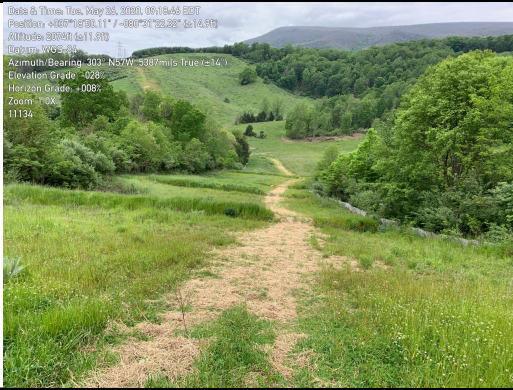
<p>Date & Time: Tue, May 26, 2020, 09:46:11 EDT Position: +43°19'54.28" / -86°23'37.08" (+13.30) Altitude: 3333 (+11.00) Datum: WGS-84 Azimuth/Bearing: 269 S89W 47.62mils True (+13) Elevation Grade: +053 Horizon Grade: +007 Zoom: 1.0X 11134</p>		GPS Location	See picture above for GPS coordinates
Field Station#	11130+00	Field Station#	11134+00	GPS Location	See picture above for GPS coordinates
Pic 5 Desc.	ECD's and row conditions	Pic 6 Desc.	ECD's and row conditions	GPS Location	See picture above for GPS coordinates

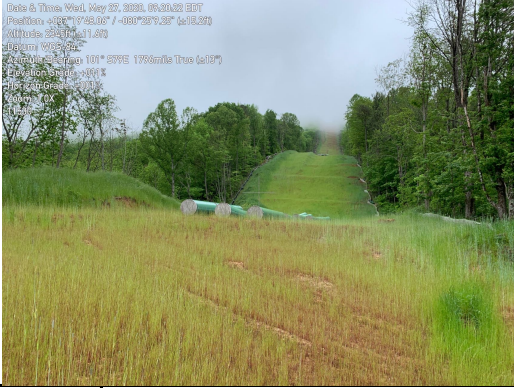
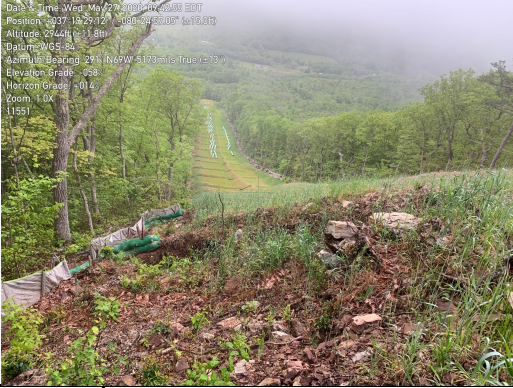
<p> Date & Time: Wed, May 27, 2020, 05:00:00 EDT Position: +037° 19' 58.92" N -080° 24' 38.79" W (+15.8m) Altitude: 2544ft (+11.4ft) Datum: WGS-84 Azimuth/Bearing: 291° NW 512mils True (+13°) Elevation/Grade: +058% Horizon/Grade: +014% Zoom: 1.0X 11551 </p>			
GPS Location	See picture above for GPS coordinates		GPS Location	See picture above for GPS coordinates	
Field Station#	11530+00		Field Station#	11551+00	
Pic 1 Desc.	ECD's and row conditions		Pic 2 Desc.	ECD's and row conditions

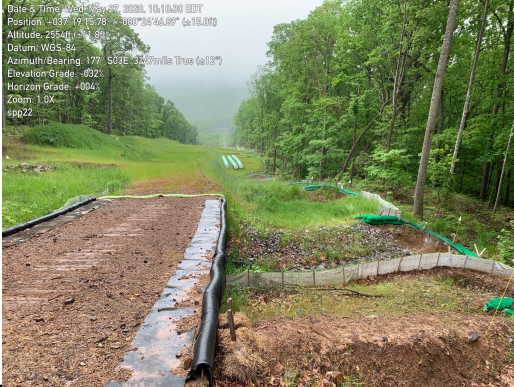
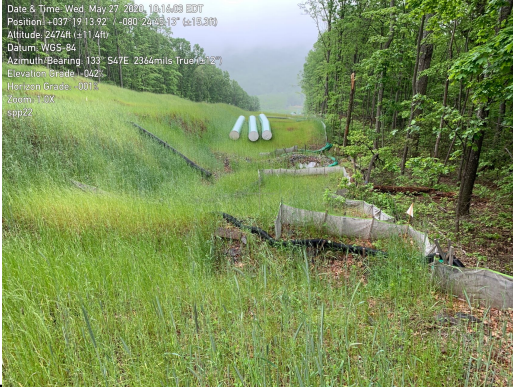
GPS Location	See picture above for GPS coordinates		GPS Location	See picture above for GPS coordinates	
Field Station#	11568+22		Field Station#	11568+30	
Pic 3 Desc.	ECD's and row conditions		Pic 4 Desc.	ECD's and row conditions

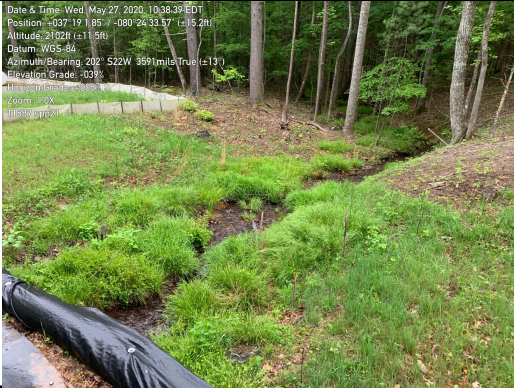
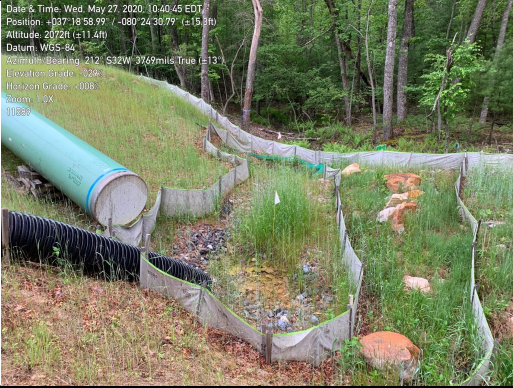
Pic 5 Desc.	ECD's and row conditions		Pic 6 Desc.	ECD's and row conditions

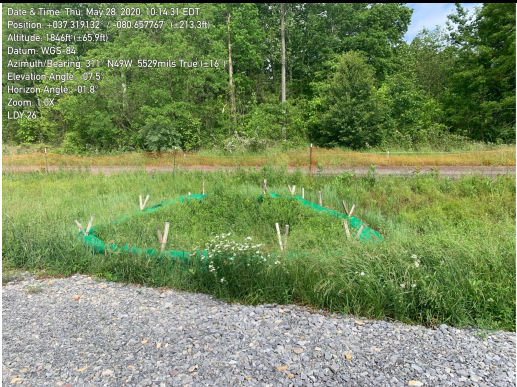
<p>Date & Time: Thu, May 28, 2020, 10:14:30 EDT Position: +37° 21'13.5" / -80° 55'76.7" (+213.3ft) Altitude: 1846ft (+63.7ft) Datum: WGS-84 Azimuth/Bearing: 311° N45W 5529mils True (+16°) Elevation Angle: -67.5° Horizon Angle: -06.7° Zoom: 1.0x LDY 26</p>			
GPS Location	See photo for GPS location.		GPS Location	See photo for GPS location.	
Field Station#	12005+00		Field Station#	12005+00	
Pic 1 Desc.	Triple stack compost filter sock in place around drainage.		Pic 2 Desc.	RCE in place and lay down yard 26 entrance.

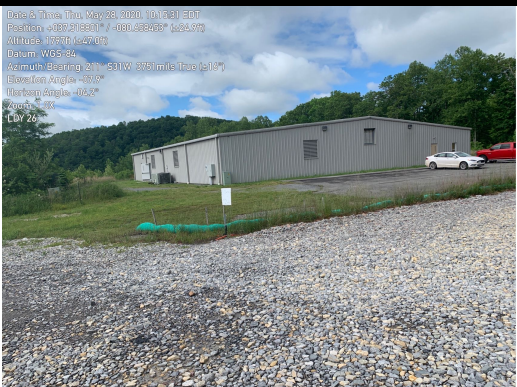
<p>Date & Time: Thu, May 28, 2020, 10:14:30 EDT Position: +37° 21'13.5" / -80° 55'76.7" (+213.3ft) Altitude: 1846ft (+63.7ft) Datum: WGS-84 Azimuth/Bearing: 311° N45W 5529mils True (+16°) Elevation Angle: -67.5° Horizon Angle: -02.5° Zoom: 1.0x LDY 26</p>			
GPS Location	See photo for GPS location.		GPS Location	See photo for GPS location.	
Field Station#	12005+00		Field Station#	12005+00	
Pic 3 Desc.	18 inch compost filter sock in place along LOD.		Pic 4 Desc.	Secondary containment in place under fuel cell.

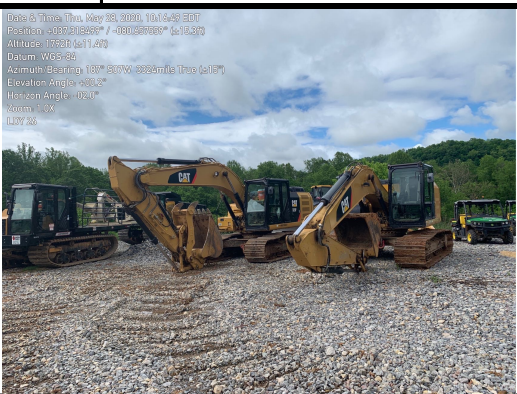
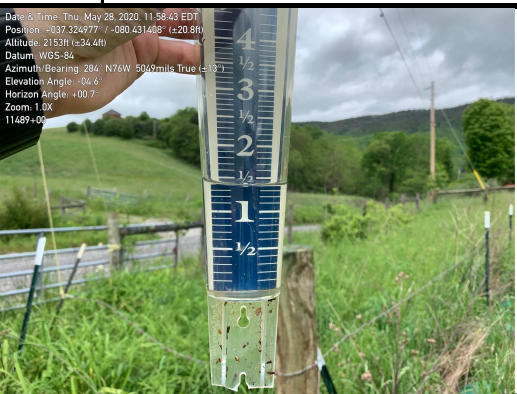
GPS Location	See photo for GPS location.		GPS Location	See photo for GPS location.	
Field Station#	12005+00		Field Station#	11489+00	
Pic 5 Desc.	Checked staged equipment for leaks.		Pic 6 Desc.	Rain gauge at Stevers Gap Road reads 1.5 inches.

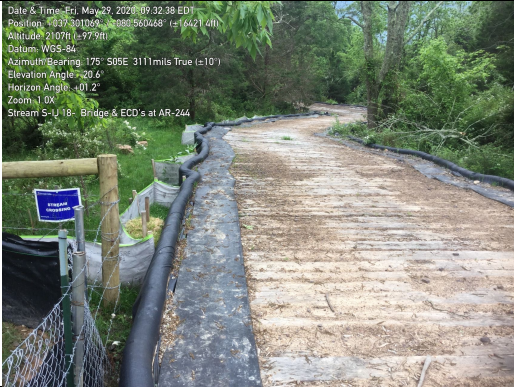
<p>Date & Time: Fri, May 29, 2020 09:41:35 EDT Position: +037269031 / +000650728 (+20463.4ft) Altitude: 2107ft (+77.9ft) Datum: WGS-84 Azimuth/Bearing: 10x 526E 1849mils True (+10°) Elevation Angle: +26.6° Horizon Angle: +07.1° Zoom: 1.0x Stream S-RR5 - Bridge and stream ECD's</p>

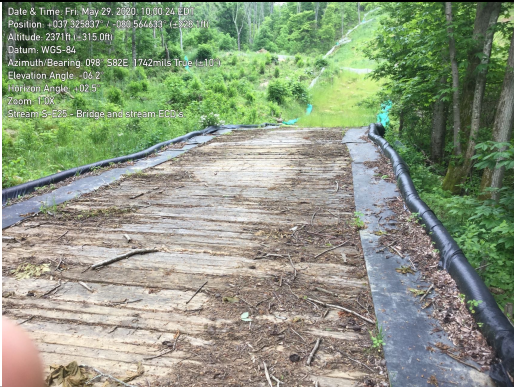
GPS Location	See photo GPS	GPS Location	See photo GPS		
Field Station#	11024+00	Field Station#	11016+00		
Pic 1 Desc.	AR-244- Stream S-IJ18, bridge & controls.	Pic 2 Desc.	Stream S-RR5.		
<p>Date & Time: Fri, May 29, 2020 10:02:24 EDT Position: +037325837 / +000544433 (+2326.0ft) Altitude: 2326ft (+39.4ft) Datum: WGS-84 Azimuth/Bearing: 09x 53SE 1742mils True (+10°) Elevation Angle: +04.2° Horizon Angle: +00.5° Zoom: 1.0x Stream S-E25 - Bridge and stream ECD's</p>

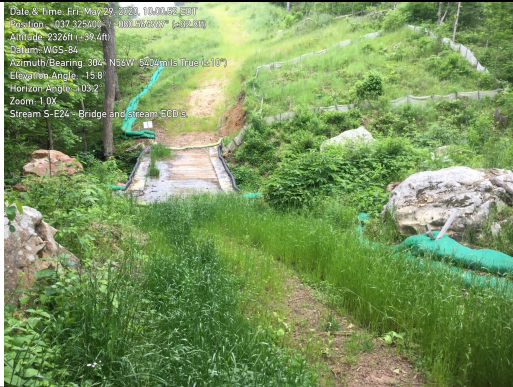
<p>Date & Time: Fri, May 29, 2020 10:04:02 EDT Position: +037325005 / +000544022 (+2326.0ft) Altitude: 2326ft (+39.4ft) Datum: WGS-84 Azimuth/Bearing: 30x N38W 5429mils True (+10°) Elevation Angle: +15.8° Horizon Angle: +00.2° Zoom: 1.0x Stream S-E24 - Bridge and stream ECD's</p>

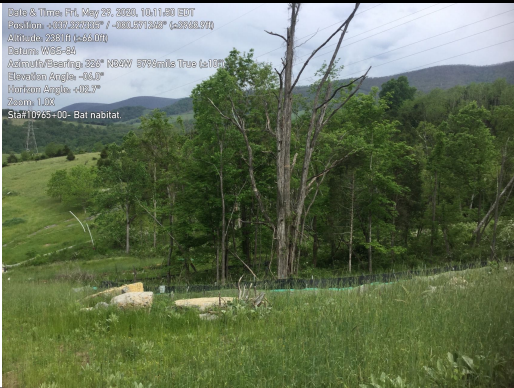
GPS Location	See photo GPS	GPS Location	See photo GPS		
Field Station#	10986+00	Field Station#	10985+00		
Pic 3 Desc.	Stream S - E25	Pic 4 Desc.	Stream S - E24		
<p>Date & Time: Fri, May 29, 2020 10:11:40 EDT Position: +037300000* / +000571000* (20000.0ft) Altitude: 2221ft (683.0m) Datum: WGS-84 Azimuth/Bearing: 25x N54W 5776mils True (+10°) Elevation Angle: +14.0° Horizon Angle: +04.3° Zoom: 1.0x Sta#10965+00- Bat habitat.</p>

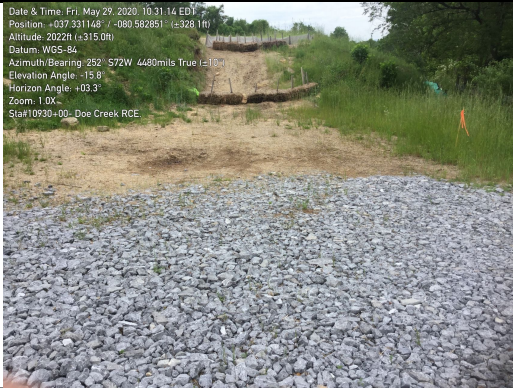
<p>Date & Time: Fri, May 29, 2020 10:31:14 EDT Position: +037331148 / +000562851 (+328.1ft) Altitude: 2022ft (+315.0ft) Datum: WGS-84 Azimuth/Bearing: 25x 572W 4480mils True (+10°) Elevation Angle: +15.8° Horizon Angle: +03.3° Zoom: 1.0x Sta#10930+00- Doe Creek RCE</p>

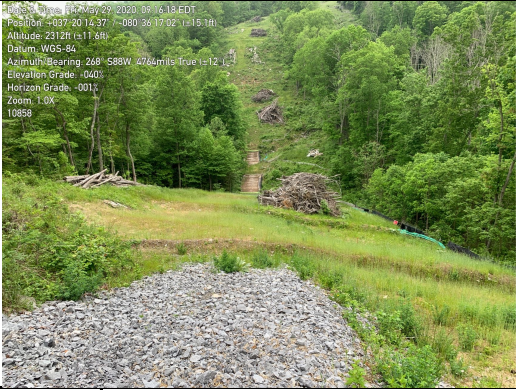
<p>Date & Time: Fri, May 29, 2020 09:16:18 EDT Position: +037°20'14.37" / -080°06'13.02" (+15.1m) Altitude: 2312ft (+11.6m) Datum: WGS-84 Azimuth/Bearing: 268° S88W 4760mils True (+12.1) Elevation Grade: +0401 Horizon Grade: +0011 Zoom: 1.0X 10858</p>

<p>Date & Time: Fri, May 29, 2020 09:20:06 EDT Position: +037°20'13.22" / -080°06'12.44" (+15.3m) Altitude: 2395ft (+11.6m) Datum: WGS-84 Azimuth/Bearing: 032° N32E 0569mils True (+13.1) Elevation Grade: +0311 Horizon Grade: +0181 Zoom: 1.0X 10864</p>			
GPS Location	See picture above for GPS coordinates		GPS Location	See picture above for GPS coordinates	
Field Station#	10858+00		Field Station#	10864+00	
Pic 1 Desc.	ECD's and row conditions		Pic 2 Desc.	ECD's and row conditions

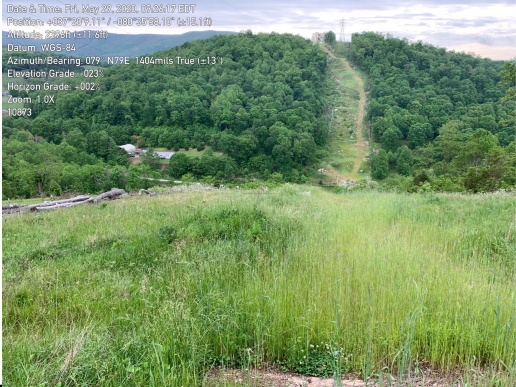
<p>Date & Time: Fri, May 29, 2020 09:35:07 EDT Position: +037°20'19.11" / -080°06'08.10" (+16.1m) Altitude: 2343ft (+11.7m) Datum: WGS-84 Azimuth/Bearing: 072° N72E 1404mils True (+13.1) Elevation Grade: +0211 Horizon Grade: +0021 Zoom: 1.0X 10893</p>

GPS Location	See picture above for GPS coordinates		GPS Location	See picture above for GPS coordinates	
Field Station#	10873+00		Field Station#	10884+00	
Pic 3 Desc.	ECD's and row conditions		Pic 4 Desc.	ECD's and row conditions

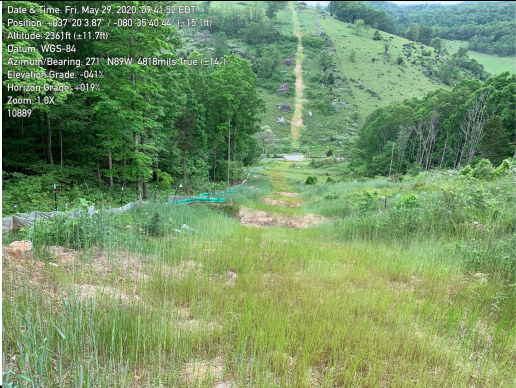
<p>Date & Time: Fri, May 29, 2020 09:41:59 EDT Position: +037°20'23.87" / -080°06'04.64" (+15.1m) Altitude: 2361ft (+11.7m) Datum: WGS-84 Azimuth/Bearing: 271° N97W 4818mils True (+14.1) Elevation Grade: +0411 Horizon Grade: +0191 Zoom: 1.0X 10889</p>

<p>Date & Time: Fri, May 29, 2020 09:42:01 EDT Position: +037°20'23.87" / -080°06'04.64" (+15.1m) Altitude: 2361ft (+11.7m) Datum: WGS-84 Azimuth/Bearing: 024° N24E 1700mils True (+14.1) Elevation Grade: +0391 Horizon Grade: +0131 Zoom: 1.0X 1</p>			
GPS Location	See picture above for GPS coordinates		GPS Location	See picture above for GPS coordinates	
Field Station#	10889+00		Field Station#	10910+00	
Pic 5 Desc.	ECD's and row conditions		Pic 6 Desc.	ECD's and row conditions
