Visual Site Inspection Report

Project Name	H-600 Pipeline Spread G	AFE	124300137	Spread	H-600 Pipeline Spread G
Contractor	Precision			Report #	10655
Inspector	Len Kruizenga			Date/Time	5/4/2020 12:40 PM
Permit #	TBD	Inspection Type	VA SWPP	Station Begin	11899+00
State	VA	Inspection Area	Full	Station End	12005+00
County	Montgomery	Ground	Dry	Temperature (°F)	66.00
Municipality	N/A	Weather	Sunny	Rain Gauge (in)	0.10
				Rain Accumulation Time (days)	1.00

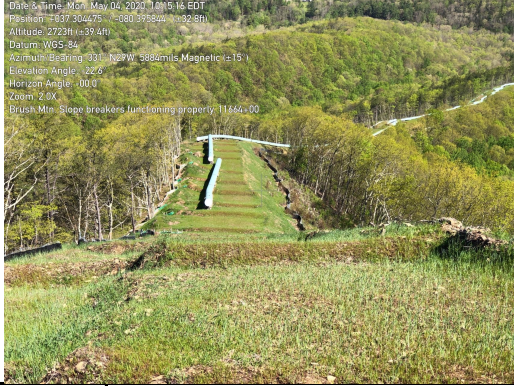
<p>Date & Time: Mon May 04, 2020 10:15:16 EDT Position: -037.302631, -080.394669, 11664.00 Altitude: 2723ft (11664.00) Datum: WGS-84 Azimuth/Bearing: 031.19°E, 2.19mils Magnetic (±15.1) Elevation Angle: -02.6 Horizon Angle: -00.0 Zoom: 2.0x Brush Mtn. Slope breakers functioning properly. 11664+00</p>			
GPS Location	On photo	GPS Location	On photo		
Field Station#	11669+50	Field Station#	11664+00		
Pic 1 Desc.	Topsoil pile stable. No environmental issues at the FS 188 crossing.	Pic 2 Desc.	Slope breakers in place, effective. ROW stable.

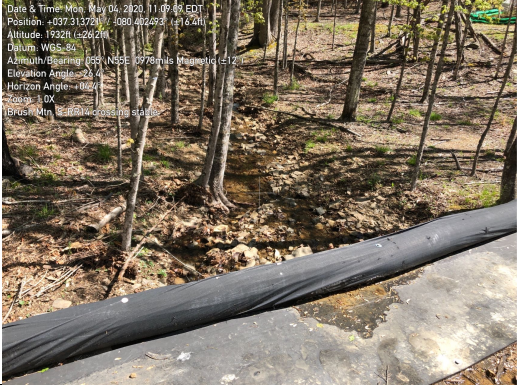
<p><small>Date & Time: Mon May 04 2020 11:09:48 EDT Position: +037.3137201, -080.402693, +16.411 Altitude: 1932ft (+242ft) Datum: WGS-84 Azimuth/Bearing: 034° N34E 0778mits Magnetic (+12°) Elevation Angle: -23.1° Horizon Angle: +06.9° Zoom: 1.0X Brush Min: S-RR14 crossing is stable</small></p>			
GPS Location	On photo	GPS Location	On photo		
Field Station#	11619+54	Field Station#	11614+20		
Pic 7 Desc.	Clean water pipe intake in good condition.	Pic 8 Desc.	S-RR14 crossing is stable.

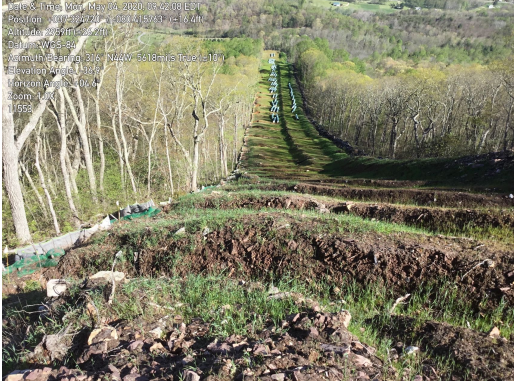
GPS Location	See picture above for GPS coordinates		GPS Location	See picture above for GPS coordinates	
Field Station#	11553+00		Field Station#	11569+00	
Pic 1 Desc.	ECD's and row conditions		Pic 2 Desc.	ECD's and row conditions

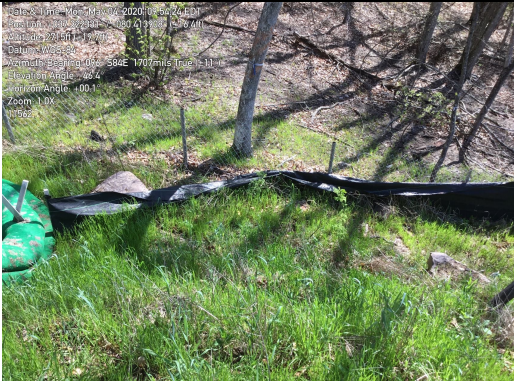
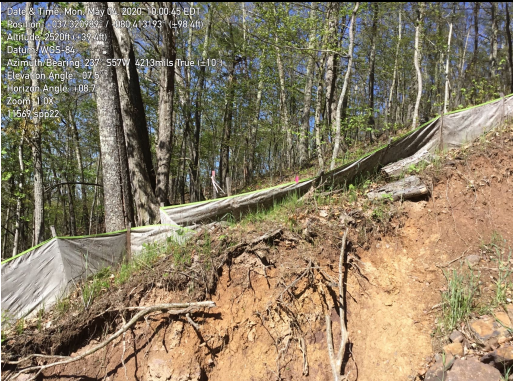
GPS Location	See picture above for GPS coordinates		GPS Location	See picture above for GPS coordinates	
Field Station#	11562+00		Field Station#	11569+00	
Pic 3 Desc.	ECD's and row conditions		Pic 4 Desc.	ECD's and row conditions

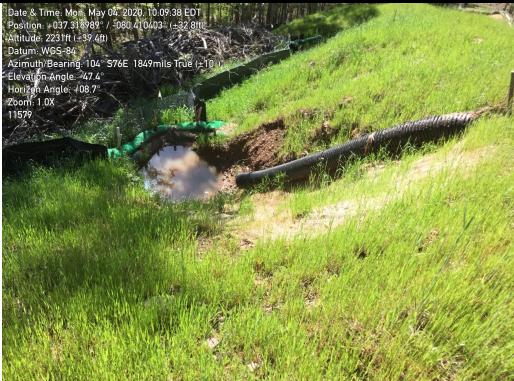
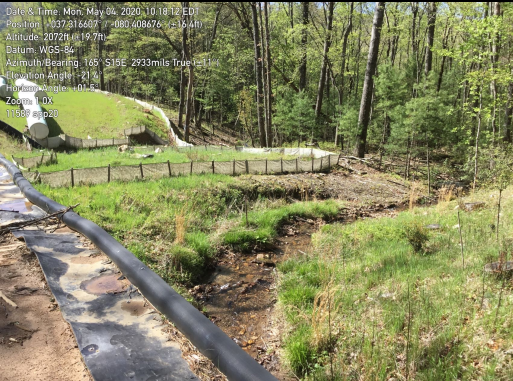
GPS Location	See picture above for GPS coordinates		GPS Location	See picture above for GPS coordinates	
Field Station#	11579+00		Field Station#	11589+00	
Pic 5 Desc.	ECD's and row conditions		Pic 6 Desc.	ECD's and row conditions

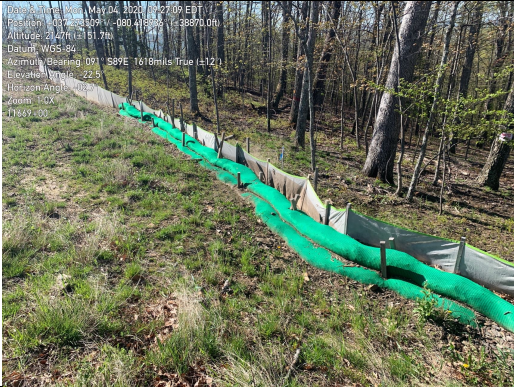
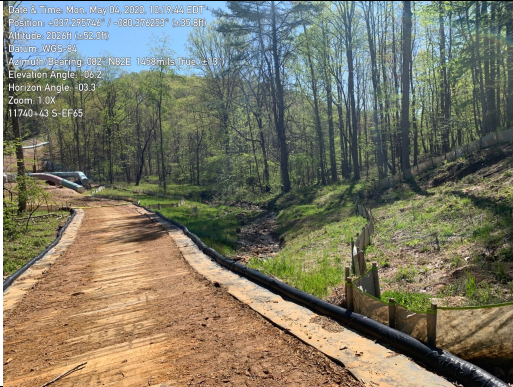
GPS Location	See photo for GPS location.		GPS Location	See photo for GPS location.	
Field Station#	11669+00		Field Station#	11740+43	
Pic 1 Desc.	Triple stack compost filter sock and priority one silt fence in place along LOD.		Pic 2 Desc.	Sensitive resource buffer in place at stream S-EP65.

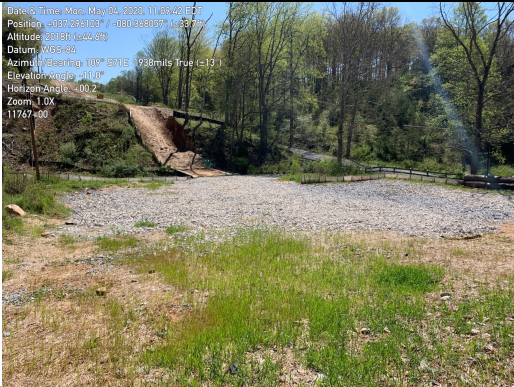
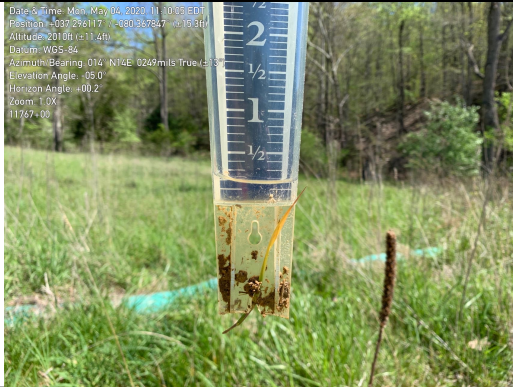
GPS Location	See photo for GPS location.		GPS Location	See photo for GPS location.	
Field Station#	11767+00		Field Station#	11767+00	
Pic 3 Desc.	RCE in place at Main Line Valve 26.		Pic 4 Desc.	Rain gauge at Mount Tabor Road reads 0.2 inches.

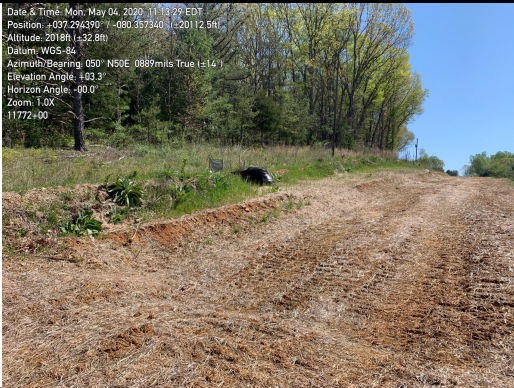
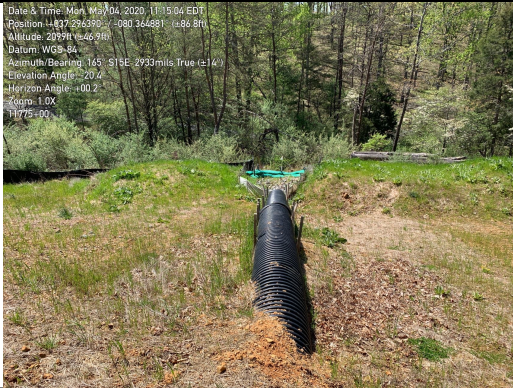
GPS Location	See photo for GPS location.		GPS Location	See photo for GPS location.	
Field Station#	11772+00		Field Station#	11775+00	
Pic 5 Desc.	Clean water diversion pipe inlet and clean water diversion berm in place.		Pic 6 Desc.	Clean water diversion pipe and plunge pool in place.

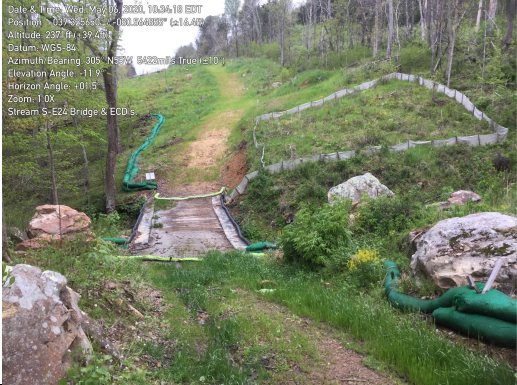
<p>Insert image here</p>			
GPS Location	See photo GPS	GPS Location			
Field Station#	10985+00	Field Station#			
Pic 7 Desc.	Stream S-E24	Pic 8 Desc.			
<p>Insert image here</p>		<p>Insert image here</p>			
GPS Location		GPS Location			
Field Station#		Field Station#			
Pic 9 Desc.		Pic 10 Desc.			
<p>Insert image here</p>		<p>Insert image here</p>			
GPS Location		GPS Location			
Field Station#		Field Station#			
Pic 11 Desc.		Pic 12 Desc.

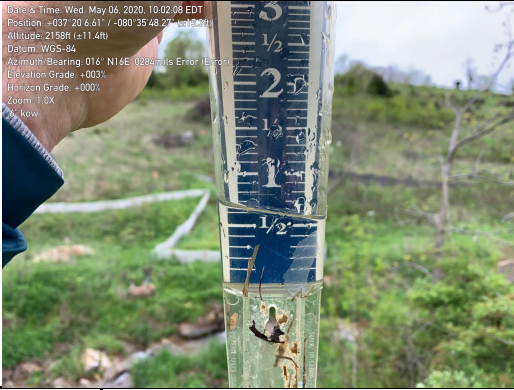
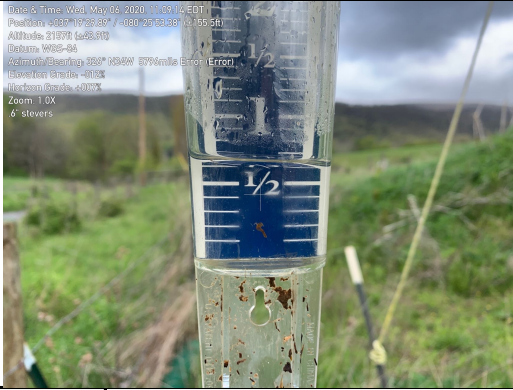
GPS Location	See picture above for GPS coordinates		GPS Location	See picture above for GPS coordinates	
Field Station#	+1		Field Station#	+1	
Pic 1 Desc.	.6" of rain recorded @ Kow Camp		Pic 2 Desc.	.6" of rain recorded @ Stevens Gap

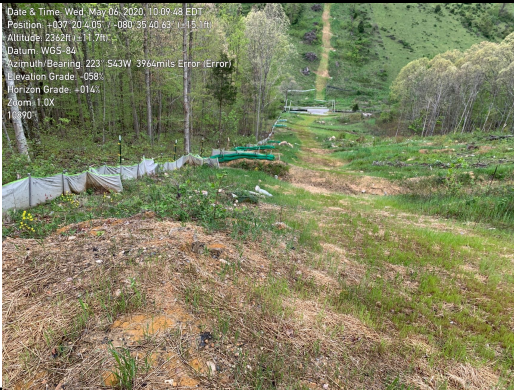
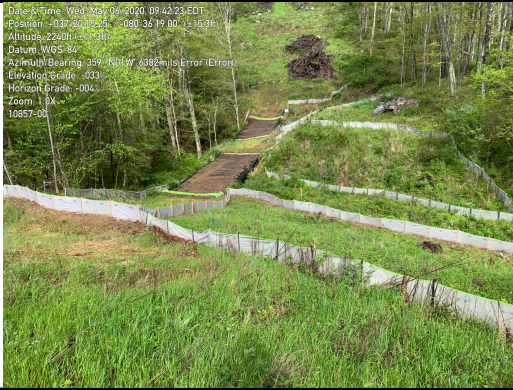
GPS Location	See picture above for GPS coordinates		GPS Location	See picture above for GPS coordinates	
Field Station#	10890+00		Field Station#	10857+00	
Pic 5 Desc.	ECD's and row conditions		Pic 6 Desc.	ECD's and row conditions

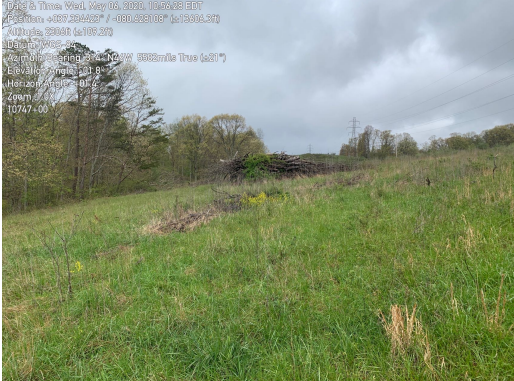
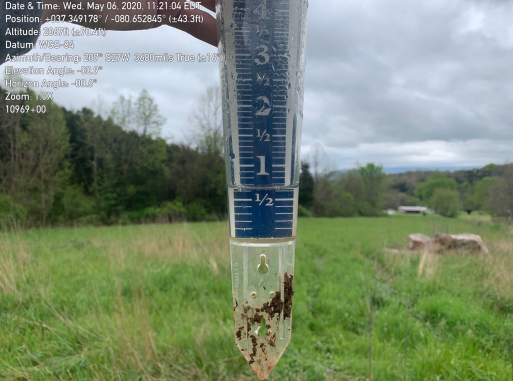
GPS Location	See photo for GPS location.		GPS Location	See photo for GPS location.	
Field Station#	10747+00		Field Station#	10696+00	
Pic 1 Desc.	ROW stabilized with natural vegetation growth.		Pic 2 Desc.	Rain gauge at Buffalo Anklets Road reads 0.7 inches.

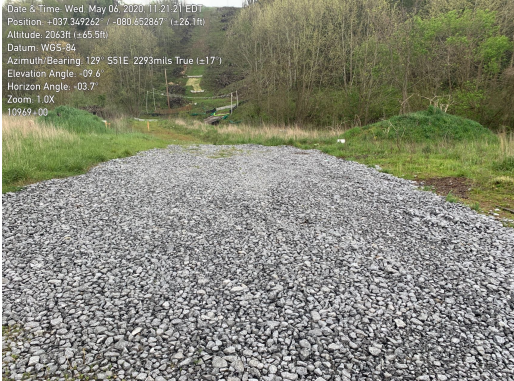
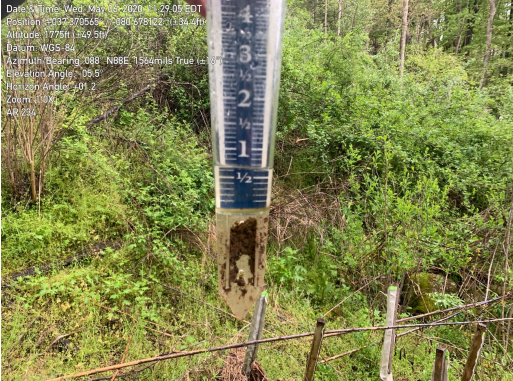
GPS Location	See photo for GPS location.		GPS Location	See photo for GPS location.	
Field Station#	10696+00		Field Station#	12005+00	
Pic 3 Desc.	RCE in place at Buffalo Anklets Road.		Pic 4 Desc.	Rain gauge at Access Road 234 reads 0.7 inches.

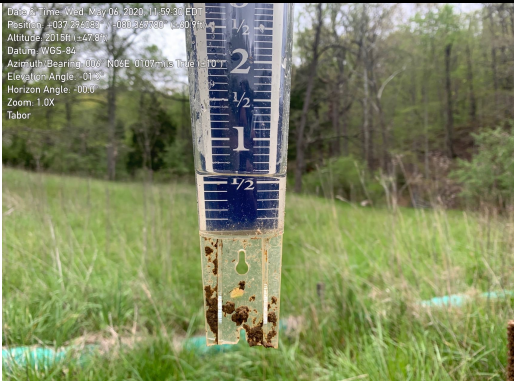
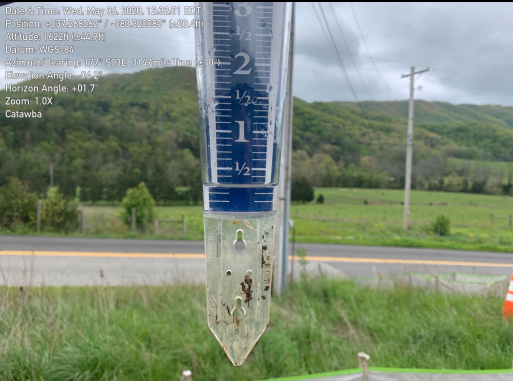
GPS Location	See photo for GPS location.		GPS Location	See photo for GPS location.	
Field Station#	11767+00		Field Station#	11990+00	
Pic 5 Desc.	Rain gauge at Mount Tabor Road reads 0.6 inches.		Pic 6 Desc.	Rain gauge at Catawba Road reads 0.3 inches.

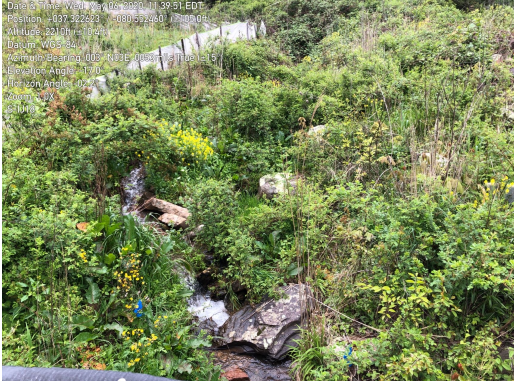
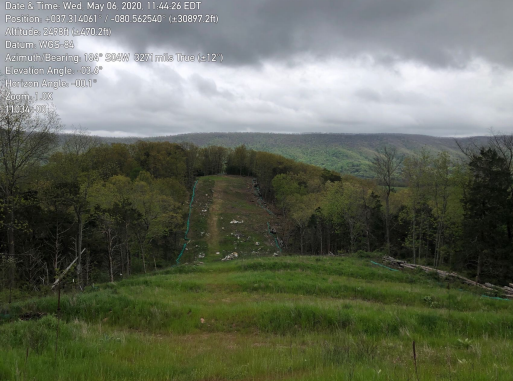
GPS Location	1	GPS Location	2		
Field Station#	11025+50	Field Station#	11034+00		
Pic 1 Desc.	S-IJ18.	Pic 2 Desc.	RoW conditions and controls.

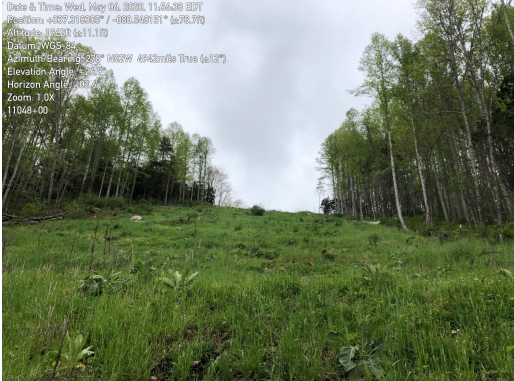
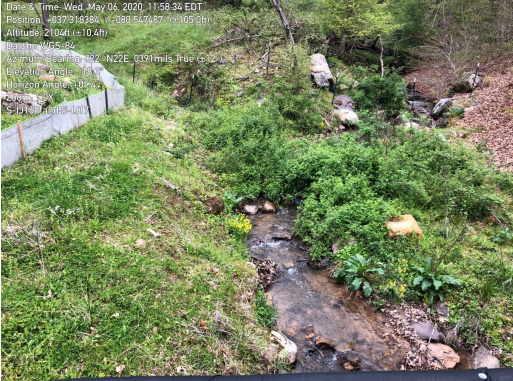
GPS Location	3	GPS Location	4		
Field Station#	11048+00	Field Station#	11050+10		
Pic 3 Desc.	RoW conditions and controls.	Pic 4 Desc.	S-IJ16B and S-IJ17.

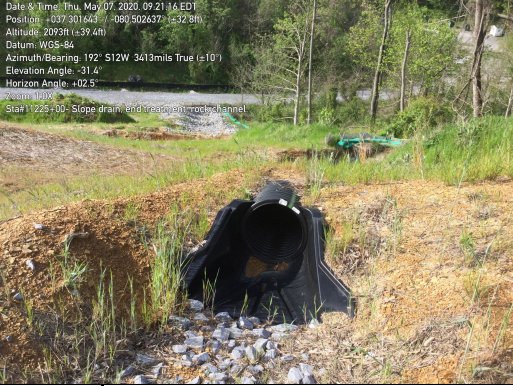
<p>Date & Time: Thu, May 07, 2020, 09:21 EDT Position: +037.301644 / -089.502637 (+32.8m) Altitude: 2093ft (+39.4m) Datum: WGS-84 Azimuth/Bearing: 192° S12W 34/3mils True (±10°) Elevation Angle: -31.4° Horizon Angle: +02.5° Zoom: 1.0X Star#11225+00- Slope drain, end treatment, rock channel</p>			
GPS Location	See photo GPS	GPS Location	See photo GPS		
Field Station#	11228+00	Field Station#	11225+00		
Pic 1 Desc.	P1 perimeter controls.	Pic 2 Desc.	Slope drain, end treatment, rock channel.

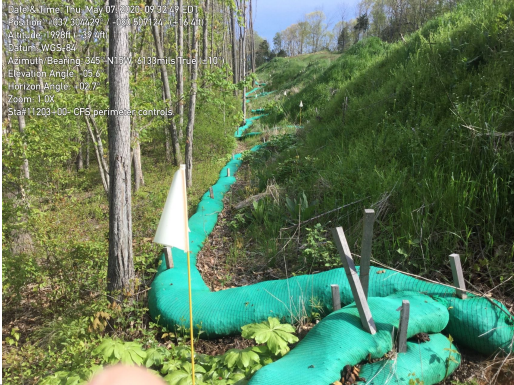
<p>Date & Time: Thu, May 07, 2020, 09:40 EDT Position: +037.306458 / -089.510068 (+32.8m) Altitude: 1972ft (+52.8m) Datum: WGS-84 Azimuth/Bearing: 100° S78E 186mils True (±10°) Elevation Angle: -69.5° Horizon Angle: -00.4° Zoom: 1.0X Star#11203+00- CFS perimeter controls</p>

GPS Location	See photo GPS	GPS Location	See photo GPS		
Field Station#	11203+00	Field Station#	11190+00		
Pic 3 Desc.	CFS perimeter controls and triple stack end treatments.	Pic 4 Desc.	Drainage feature

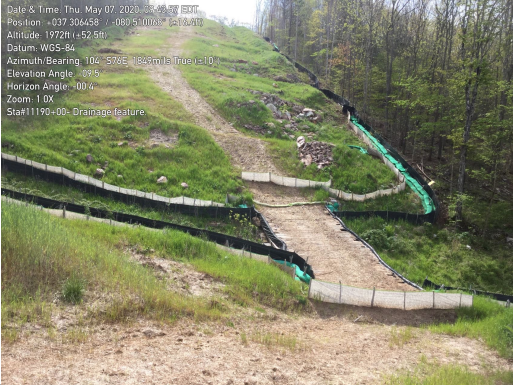
<p>Date & Time: Thu, May 07, 2020, 09:46 EDT Position: +037.306458 / -089.510068 (+32.8m) Altitude: 1972ft (+52.8m) Datum: WGS-84 Azimuth/Bearing: 100° S78E 186mils True (±10°) Elevation Angle: -69.5° Horizon Angle: -00.4° Zoom: 1.0X Star#11190+00- Drainage feature</p>

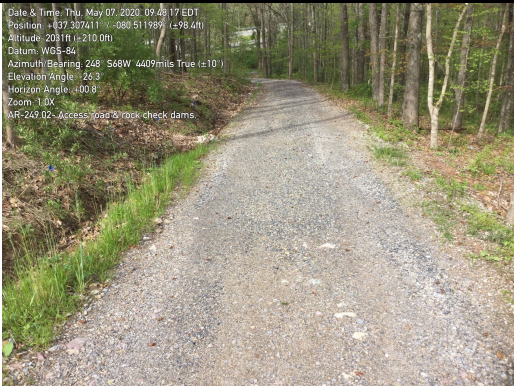
<p>Date & Time: Thu, May 07, 2020, 09:49 EDT Position: +037.307411 / -089.511989 (+32.8m) Altitude: 2031ft (+32.0m) Datum: WGS-84 Azimuth/Bearing: 248° S68W 4409mils True (±10°) Elevation Angle: -26.3° Horizon Angle: +00.8° Zoom: 1.0X AR-249.02- Access road to rock check dam</p>

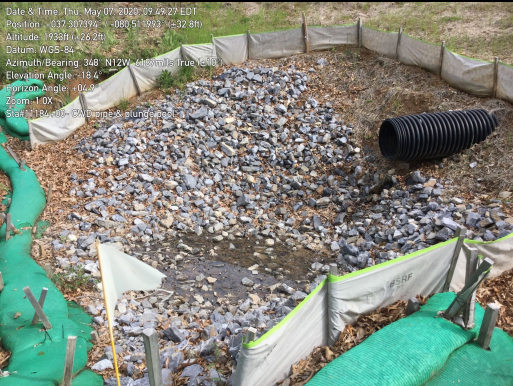
<p>Date & Time: Thu, May 07, 2020, 09:54 EDT Position: +037.307395 / -089.511993 (+32.8m) Altitude: 1923ft (+26.2m) Datum: WGS-84 Azimuth/Bearing: 348° N12W 46mils True (±10°) Elevation Angle: -18.4° Horizon Angle: +00.8° Zoom: 1.0X Star#11184+00- CWD pipe & plunge pool</p>			
GPS Location	See photo GPS	GPS Location	See photo GPS		
Field Station#	11184+50	Field Station#	11184+00		
Pic 5 Desc.	AR-249.02	Pic 6 Desc.	CWD pipe and plunge pool

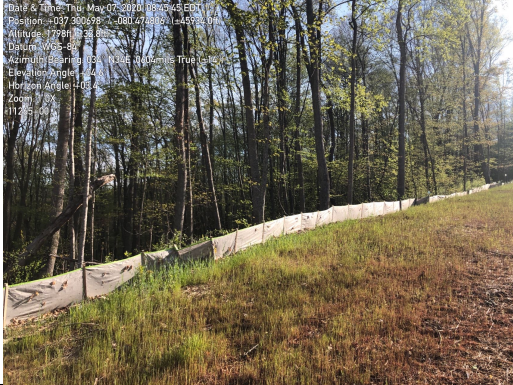
GPS Location	1	GPS Location	2		
Field Station#	11265+00	Field Station#	11286+00		
Pic 1 Desc.	Perimeter controls functional.	Pic 2 Desc.	Perimeter controls functional.

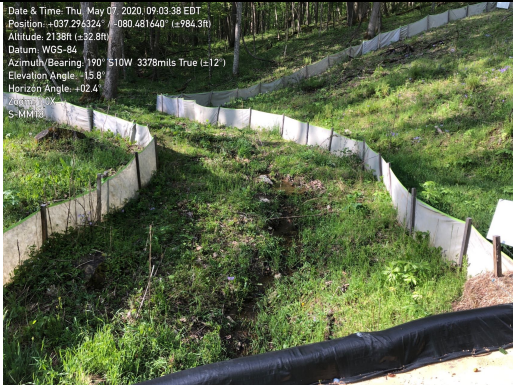
GPS Location	3	GPS Location	4		
Field Station#	11292+80	Field Station#	11297+00		
Pic 3 Desc.	S-MM18 and controls.	Pic 4 Desc.	RoW conditions and controls.

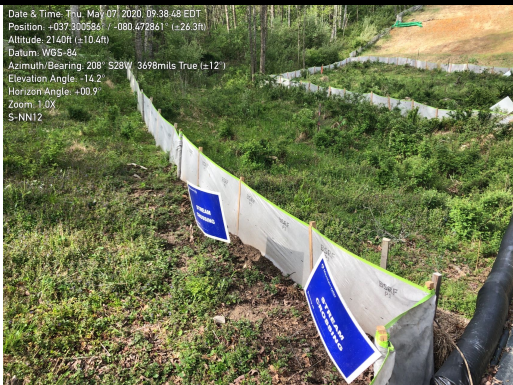
GPS Location	5	GPS Location	6		
Field Station#	11327+85	Field Station#	11352+97		
Pic 5 Desc.	S-NN12 and controls.	Pic 6 Desc.	S-NN11.

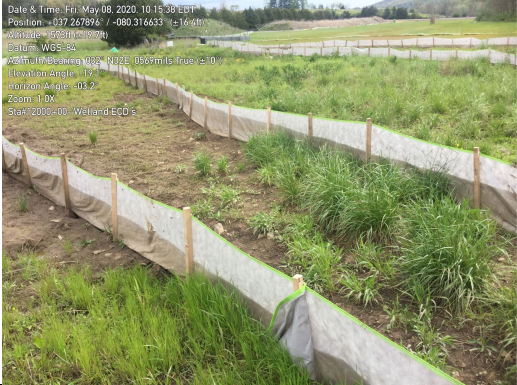
GPS Location	See photo GPS	GPS Location			
Field Station#	12000+00	Field Station#			
Pic 7 Desc.	Wetland ECD's	Pic 8 Desc.			
Insert image here		Insert image here			
GPS Location		GPS Location			
Field Station#		Field Station#			
Pic 9 Desc.		Pic 10 Desc.			
Insert image here		Insert image here			
GPS Location		GPS Location			
Field Station#		Field Station#			
Pic 11 Desc.		Pic 12 Desc.

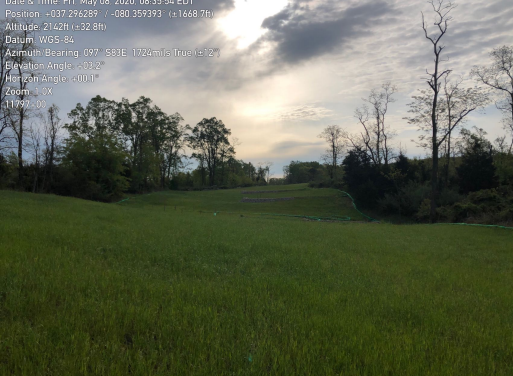
GPS Location	1	GPS Location	2		
Field Station#	11789+00	Field Station#	11797+00		
Pic 1 Desc.	RCE on the South side of Mt Tabor rd.	Pic 2 Desc.	Section of restored RoW showing conditions and controls.		
<p>Date & Time Fri, May 08, 2020, 08:41:13 EDT Position: +037.294179° / -080.357151° (+7774.5m) Altitude: 2142ft (+22.8m) Datum: WGS-84 Azimuth/Bearing: 172° S01E 2016mils True (+12°) Elevation Angle: +03.2° Horizon Angle: +01.1° Zoom: 1.0X 11812+00</p>  		<p>Date & Time Fri, May 08, 2020, 08:42:11 EDT Position: +037.294179° / -080.357151° (+7774.5m) Altitude: 2142ft (+22.8m) Datum: WGS-84 Azimuth/Bearing: 172° S01E 2016mils True (+12°) Elevation Angle: +03.2° Horizon Angle: +01.1° Zoom: 1.0X 11812+00</p>

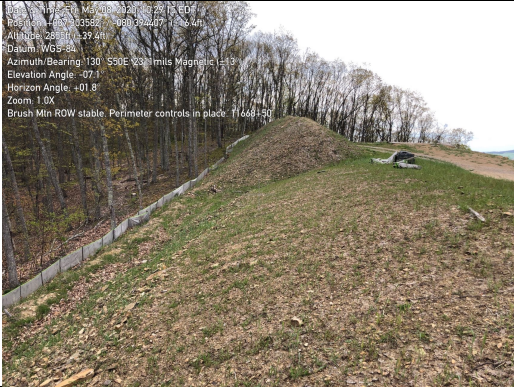
GPS Location	On photo	GPS Location	On photo		
Field Station#	11668+50	Field Station#	11648+00		
Pic 1 Desc.	Soil piles and cuts are stable. Perimeter controls in place and functional.	Pic 2 Desc.	End treatments are functioning as designed. Perimeter controls in place.

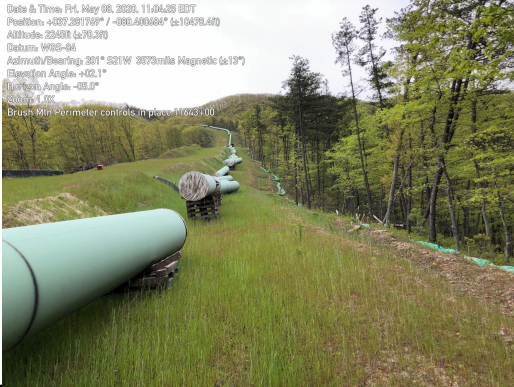
GPS Location	On photo	GPS Location	On photo		
Field Station#	11643+00	Field Station#	11630+00		
Pic 3 Desc.	Grasses adequate. Surface stable. Slope breakers effective.	Pic 4 Desc.	ROW stable. Slope breakers effective. Perimeter controls in place.

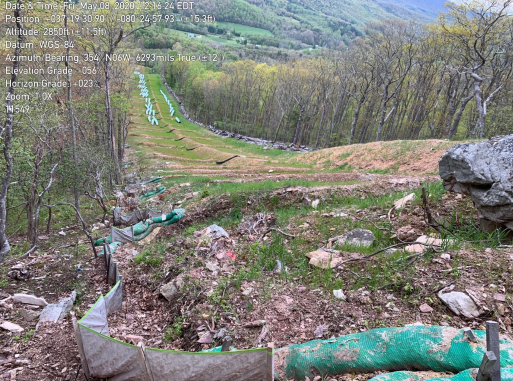
GPS Location	See picture above for GPS coordinates		GPS Location	See picture above for GPS coordinates	
Field Station#	11534+00		Field Station#	11549+00	
Pic 1 Desc.	Confirmed repairs to end treatments		Pic 2 Desc.	ECD's and row conditions

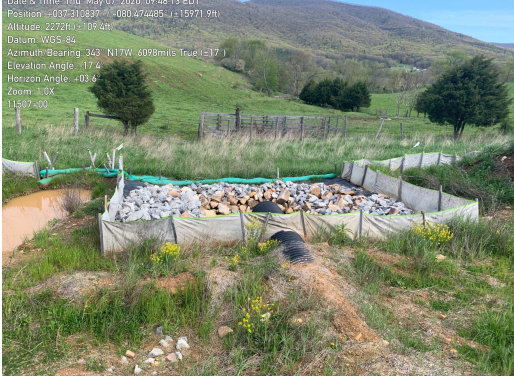
GPS Location	See photo for GPS location.	GPS Location	See photo for GPS location.		
Field Station#	11507+00	Field Station#	11505+00		
Pic 1 Desc.	Clean water diversion pipe and plunge pool in place.	Pic 2 Desc.	Clean water diversion pipe and clean water diversion berm in place.		
<p>Date & Time: Thu May 07 2020 09:49:01 EDT Position: +37°21'22.21" / -80°47'48.91" (+15971.9M) Altitude: 2209ft (+676m) Datum: WGS-84 Azimuth/Bearing: 209° S29W 3710mils True (+17°) Elevation Angle: -07.3 Horizon Angle: -00.9 Zoom: 1.0X 11487+00</p>

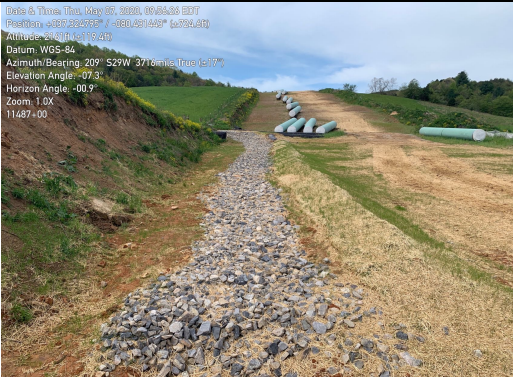
<p>Date & Time: Thu May 07 2020 09:49:01 EDT Position: +37°21'22.21" / -80°47'48.91" (+15971.9M) Altitude: 2209ft (+676m) Datum: WGS-84 Azimuth/Bearing: 209° S29W 3710mils True (+17°) Elevation Angle: -07.3 Horizon Angle: -00.9 Zoom: 1.0X 11487+00</p>

GPS Location	See photo for GPS location.	GPS Location	See photo for GPS location.		
Field Station#	11498+00	Field Station#	11487+00		
Pic 3 Desc.	RCE in place at Stevers Gap Road.	Pic 4 Desc.	Rock lined channel in place.		
<p>Date & Time: Thu May 07 2020 10:08:34 EDT Position: +37°21'51.11" / -80°47'48.91" (+15971.9M) Altitude: 2151ft (+655m) Datum: WGS-84 Azimuth/Bearing: 230° S50W 4089mils True (+22°) Elevation Angle: -07.4 Horizon Angle: -01.5 Zoom: 1.0X 11451+00 S-0012 & S-0013</p>

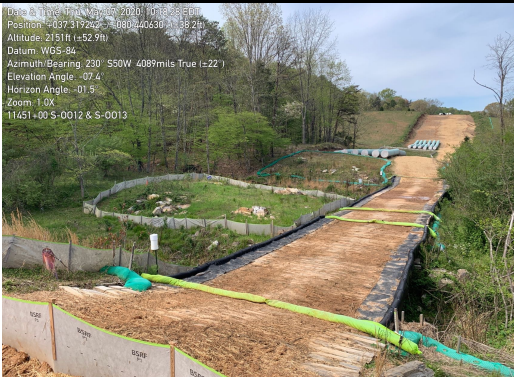
GPS Location	See photo for GPS location.	GPS Location	See photo for GPS location.		
Field Station#	11451+00	Field Station#	11426+00		
Pic 5 Desc.	Sensitive resource buffer in place at stream S-0012 and S-0013.	Pic 6 Desc.	Rock lined channel, sump pit, waterbar and waterbar end treatment in place.
