# Visual Site Inspection Report

<b>Project Name</b>	H-600 Pipeline Spread H	<b>AFE</b>	124300138	<b>Spread</b>	H-600 Pipeline Spread H
<b>Contractor</b>	Precision			<b>Report #</b>	7300
<b>Inspector</b>	Logan Box			<b>Date/Time</b>	1/13/2020 4:50 PM
<b>Permit #</b>	TBD	<b>Inspection Type</b>	VA SWPP	<b>Station Begin</b>	13415+51
<b>State</b>	VA	<b>Inspection Area</b>	Partial	<b>Station End</b>	13670+00
<b>County</b>	Franklin	<b>Ground</b>	Wet	<b>Temperature (°F)</b>	61.00
<b>Municipality</b>	N/A	<b>Weather</b>	Cloudy	<b>Rain Gauge (in)</b>	0.00
				<b>Rain Accumulation Time (days)</b>	0.00

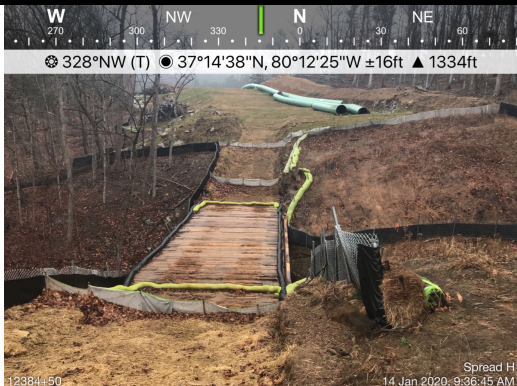
<p>328°NW (T) ● 37°14'38"N, 80°12'25"W ±16ft ▲ 1334ft</p> <p>12384+50 Spread H 14 Jan 2020, 9:36:45 AM</p>

<p>322°NW (T) ● 37°14'37"N, 80°12'22"W ±16ft ▲ 1395ft</p> <p>12385+00 Spread H 14 Jan 2020, 9:34:41 AM</p>		<b>GPS Location</b>	See photo
<b>Field Station#</b>	12441+33	<b>Field Station#</b>	12385+00	<b>Pic 7 Desc.</b>	Roanoke River near the future bore crossing remains unimpacted by PL construction
<b>Pic 8 Desc.</b>	Bridge controls in good condition.

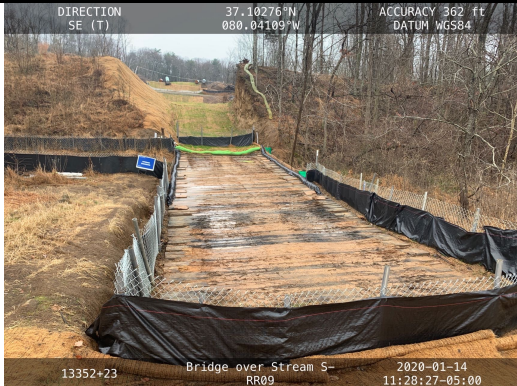
<p>DIRECTION SE (T) 37.10276°N 080.04109°W ACCURACY 362 ft DATUM WGS84</p> <p>13352+23 Bridge over Stream S-RR09 2020-01-14 11:28:27-05:00</p>

<b>GPS Location</b>	See photo for gps data.		<b>GPS Location</b>	See photo for gps data.	
<b>Field Station#</b>	13352+23		<b>Field Station#</b>	13359+00	
<b>Pic 9 Desc.</b>	Photo shows the bridge over stream S-RR09.		<b>Pic 10 Desc.</b>	Photo shows the ROW condition from about 13359+00 to 13363+00.
