Visual Site Inspection Report

Project Name	H-600 Pipeline Spread H	AFE	124300138	Spread	H-600 Pipeline Spread H
Contractor	Precision			Report #	7169
Inspector	Logan Box			Date/Time	1/7/2020 4:49 PM
Permit #	TBD	Inspection Type	VA SWPP	Station Begin	13415+51
State	VA	Inspection Area	Partial	Station End	13670+00
County	Franklin	Ground	Wet	Temperature (°F)	33.00
Municipality	N/A	Weather	Snow/Sleet	Rain Gauge (in)	0.00
				Rain Accumulation Time (days)	0.00

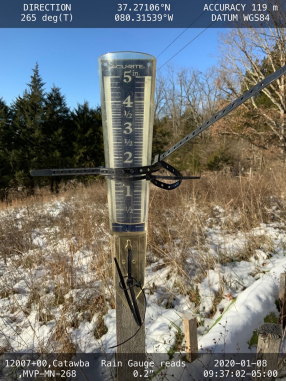
GPS Location	See photo GPS for location		GPS Location	See photo GPS for location	
Field Station#	12007+00		Field Station#	12008+62	
Pic 1 Desc.	Rain gauge read 0.2". This volume came from snow.		Pic 2 Desc.	Stream banks and permanent restoration area are stable.

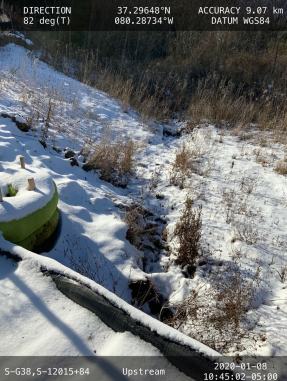
GPS Location	See photo GPS for location		GPS Location	See photo GPS for location	
Field Station#	12001+00		Field Station#	12015+84	
Pic 3 Desc.	Four damaged P1 areas were repaired by the Spread G Precision environmental crew.		Pic 4 Desc.	Water not flowing on S-G38.

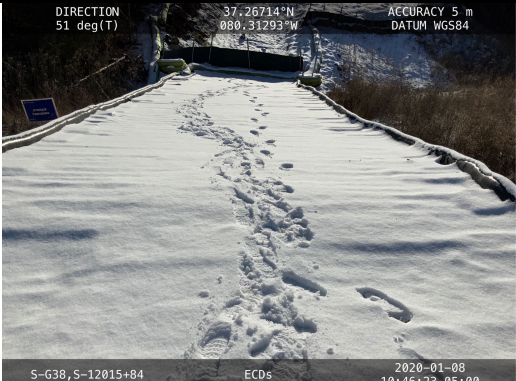
GPS Location	See photo GPS for location		GPS Location	See photo GPS for location	
Field Station#	12015+84		Field Station#	12031+51	
Pic 5 Desc.	All ECDs surrounding this stream are in acceptable condition at this time and functioning properly.		Pic 6 Desc.	All ECDs surrounding this stream are in acceptable condition at this time and functioning properly.

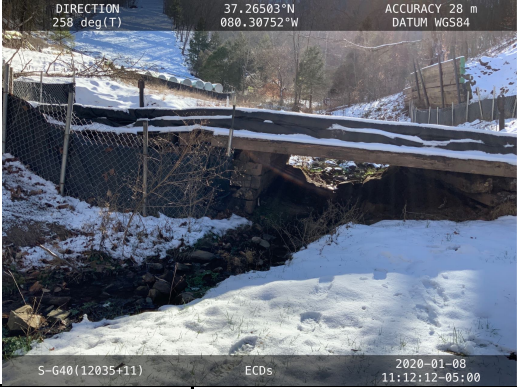
GPS Location	See photo GPS for location		GPS Location	See photo GPS for location	
Field Station#	12035+11		Field Station#	12101+57	
Pic 7 Desc.	All ECDs surrounding this stream are in acceptable condition at this time and functioning properly.		Pic 8 Desc.	All ECDs surrounding this stream are in acceptable condition at this time and functioning properly.

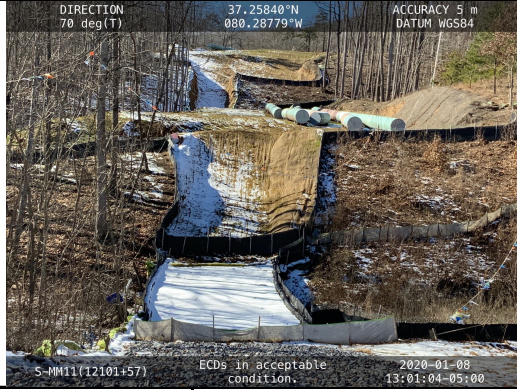
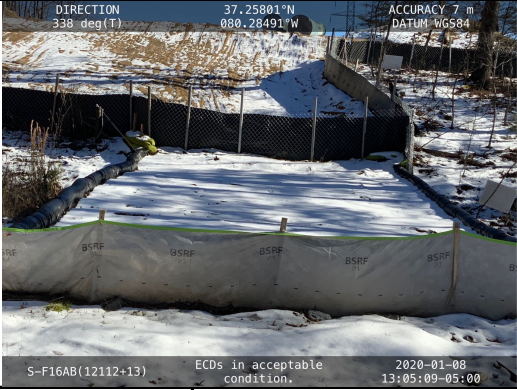
GPS Location	See photo GPS for location		GPS Location	See photo GPS for location	
Field Station#	12101+57		Field Station#	12112+13	
Pic 11 Desc.	All ECDs surrounding this stream are in acceptable condition at this time and functioning properly.		Pic 12 Desc.	All ECDs surrounding this stream are in acceptable condition at this time and functioning properly.

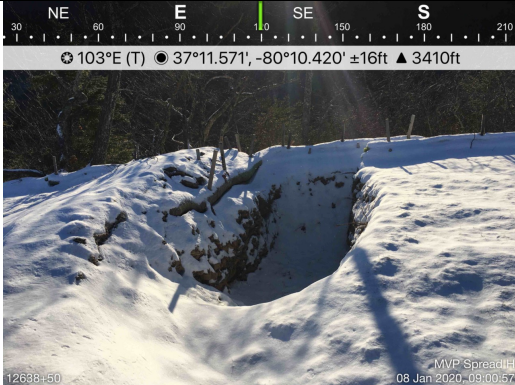
GPS Location	See Picture Watermark		GPS Location	See Picture Watermark	
Field Station#	12638+00		Field Station#	12638+50	
Pic 1 Desc.	ROW covered in snow and ground frozen. Controls in good condition.		Pic 2 Desc.	Waterbar sump pit/end treatment free of runoff and sediment. In good condition.

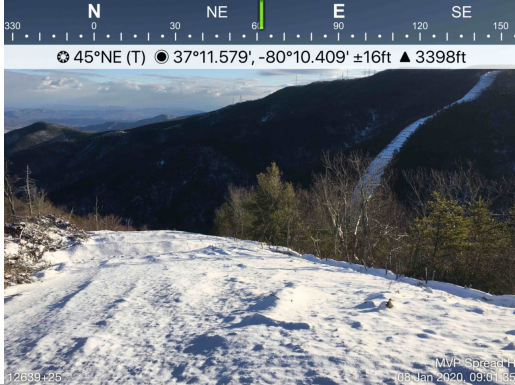
GPS Location	See Picture Watermark		GPS Location	See Picture Watermark	
Field Station#	12638+75		Field Station#	12639+25	
Pic 3 Desc.	Woody debris stockpiled on ROW.		Pic 4 Desc.	ROW frozen and covered in snow. In stable condition.

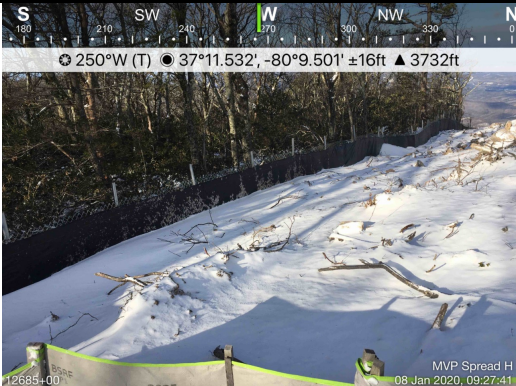
GPS Location	See Picture Watermark		GPS Location	See Picture Watermark	
Field Station#	12685+00		Field Station#	12682+00	
Pic 5 Desc.	Perimeter SSF in good condition.		Pic 6 Desc.	ROW waterbar frozen and in good condition.

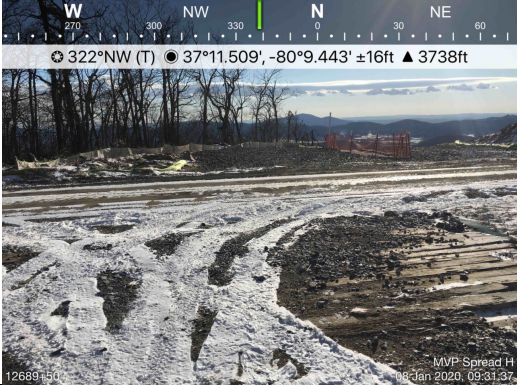
GPS Location	See Picture Watermark		GPS Location	See Picture Watermark	
Field Station#	12689+50		Field Station#	12689+75	
Pic 7 Desc.	Rock construction entrance at Honeysuckle Road in good condition.		Pic 8 Desc.	Soil stockpile remains protected and in good condition.

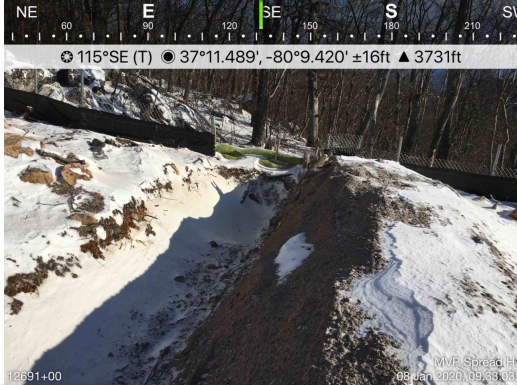
GPS Location	See Picture Watermark		GPS Location	See Picture Watermark	
Field Station#	12691+00		Field Station#	12692+00	
Pic 9 Desc.	Waterbar and end treatment in good condition.		Pic 10 Desc.	ROW on going away side Honeysuckle Road. ROW remains frozen and stable.

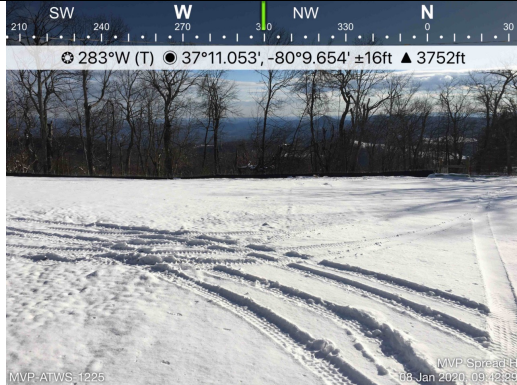
GPS Location	See Picture Watermark		GPS Location	See Picture Watermark	
Field Station#	12689+00		Field Station#	12692+00	
Pic 11 Desc.	MVP-ATWS-1225 covered in snow and frozen. No activity on-site.		Pic 12 Desc.	Stockpiled rock within ROW.

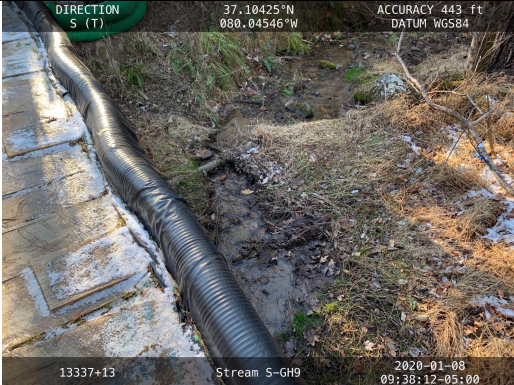
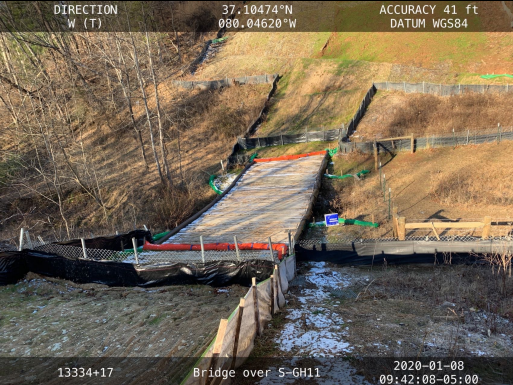
GPS Location	See photo for gps data.		GPS Location	See photo for gps data.	
Field Station#	13337+00		Field Station#	13334+17	
Pic 1 Desc.	Photo shows stream S-GH9 downstream from the ROW.		Pic 2 Desc.	Photo shows the bridge over stream S-GH11.

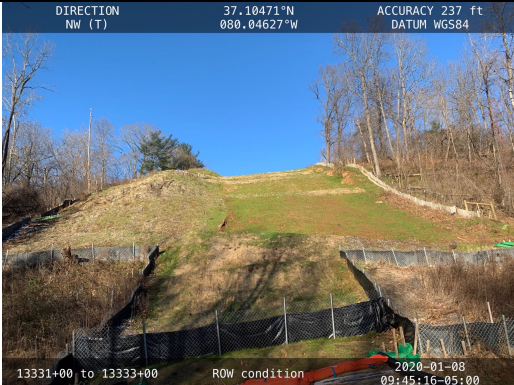
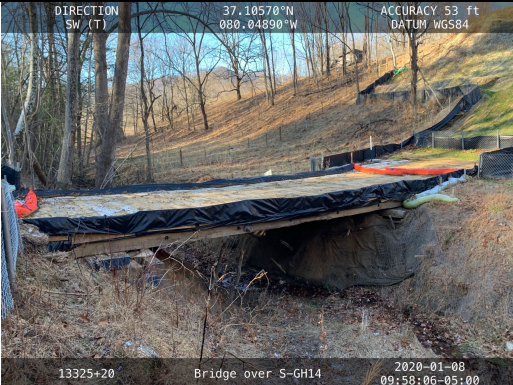
GPS Location	See photo for gps data.		GPS Location	See photo for gps data.	
Field Station#	13333+00		Field Station#	13325+20	
Pic 3 Desc.	Photo shows the ROW condition from about 13331+00 to 13333+00.		Pic 4 Desc.	Photo shows the bridge over stream S-GH14.

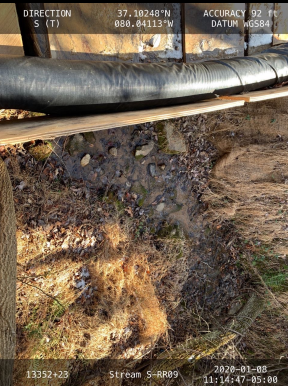
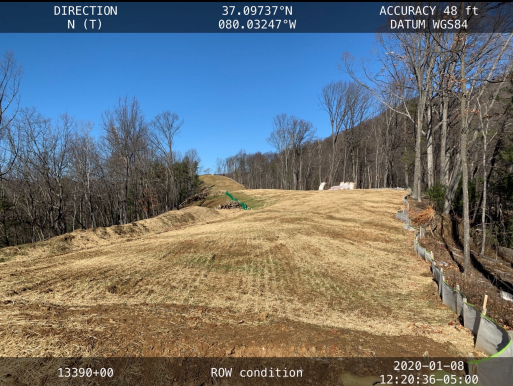
GPS Location	See photo for gps data.		GPS Location	See photo for gps data.	
Field Station#	13352+23		Field Station#	13390+00	
Pic 5 Desc.	Photo shows stream S-RR09 downstream from the ROW.		Pic 6 Desc.	Photo shows the ROW condition from about 13385+00 to 13390+00.

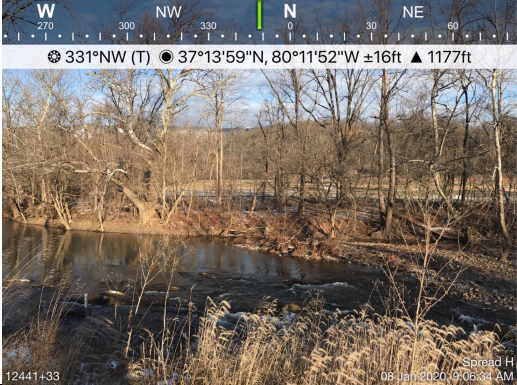
GPS Location	See photo		GPS Location	See photo	
Field Station#	12233+87		Field Station#	12441+33	
Pic 7 Desc.	Windy conditions causing the porta lets to tilt. They are tied to rope restraints and within secondary containment. Monitor as conditions permit.		Pic 8 Desc.	Roanoke River remains unimpacted and in good condition.

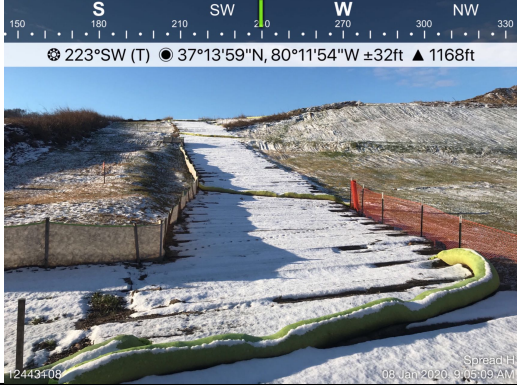
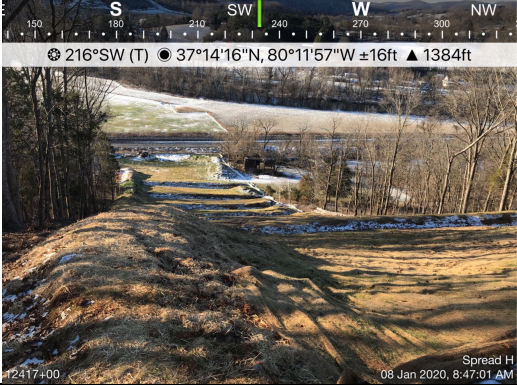
GPS Location	See photo		GPS Location	See photo	
Field Station#	12443+08		Field Station#	12417+00	
Pic 9 Desc.	CFS controls and wood panels in good condition near Rte 11		Pic 10 Desc.	Waterbars and end treatments in good condition and stabilized on this slope.

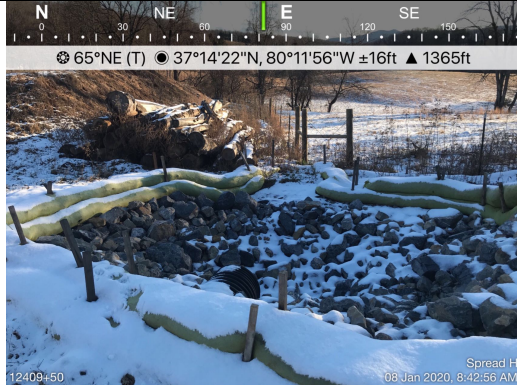
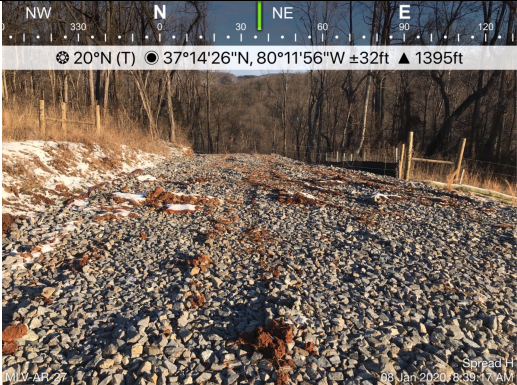
GPS Location	See photo		GPS Location	See photo	
Field Station#	12409+50		Field Station#	+27	
Pic 11 Desc.	Stone outlet protection in good condition.		Pic 12 Desc.	Rock CE in good condition at MLV-AR-27

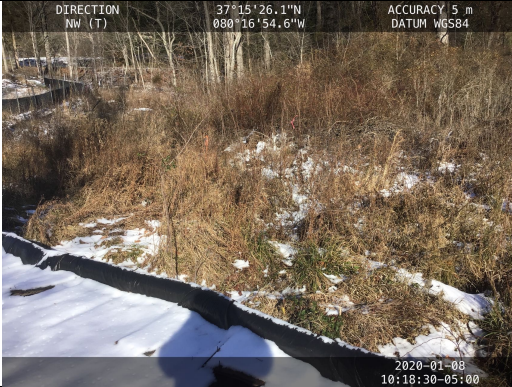
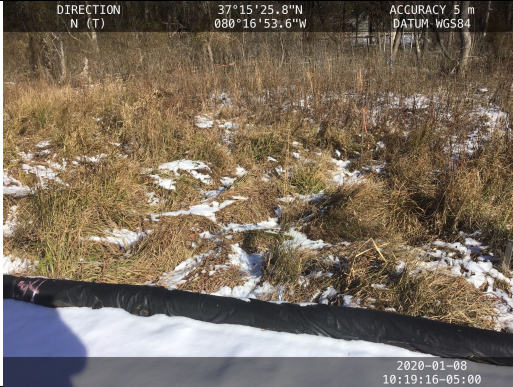
GPS Location	See photo		GPS Location	See photo	
Field Station#	12121+33		Field Station#	12121+83	
Pic 1 Desc.	Stream S-C33, facing northwest, upstream		Pic 2 Desc.	Stream S-C36, facing north, upstream

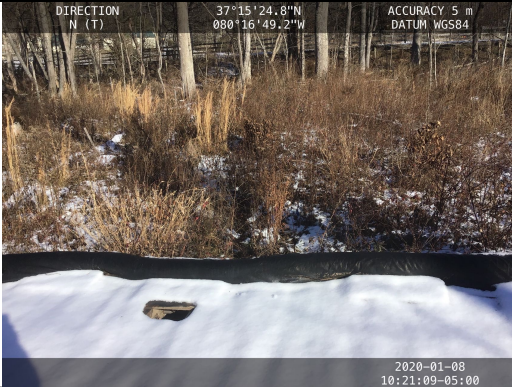
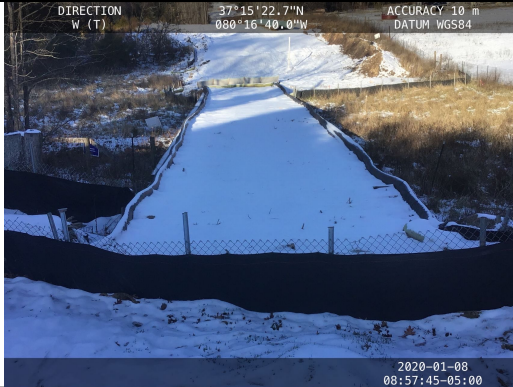
GPS Location	See photo		GPS Location	See photo	
Field Station#	12125+65		Field Station#	12132+73	
Pic 3 Desc.	Stream S-MM31, facing north, upstream		Pic 4 Desc.	Stream S-C29, facing west

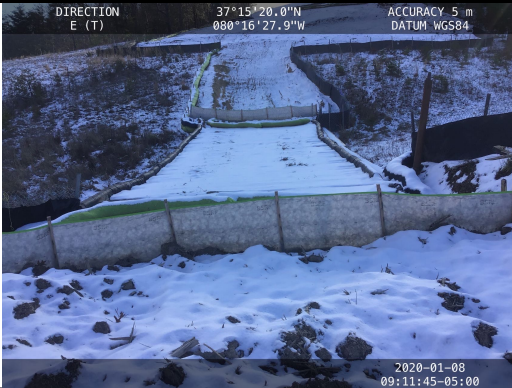
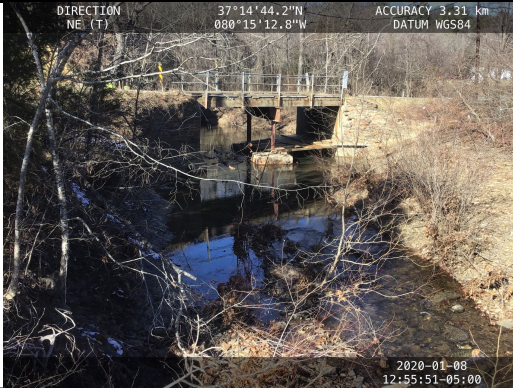
GPS Location	See photo		GPS Location	See photo	
Field Station#	12143+50		Field Station#	12192+50	
Pic 5 Desc.	Wetland W-C5, facing east		Pic 6 Desc.	Stream S-C21, Bradshaw Creek, facing northeast, upstream

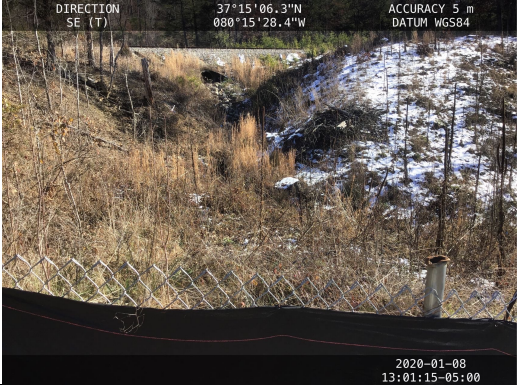
GPS Location	See photo	GPS Location	See photo		
Field Station#	12106+25	Field Station#	12213+00		
Pic 7 Desc.	Stream S-0011, facing southeast, upstream	Pic 8 Desc.	The permanent restoration between Bradshaw Road and the switchback on Reese Mountain is intact and stable.		
Insert image here		Insert image here			
GPS Location		GPS Location			
Field Station#		Field Station#			
Pic 9 Desc.		Pic 10 Desc.			
Insert image here		Insert image here			
GPS Location		GPS Location			
Field Station#		Field Station#			
Pic 11 Desc.		Pic 12 Desc.

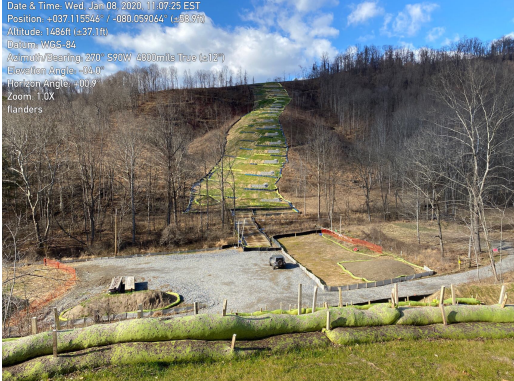
GPS Location	See photo for coordinates.		GPS Location	See photo for coordinates.	
Field Station#	13264+00		Field Station#	13265+00	
Pic 1 Desc.	MVP-FR-293.02, Flanders Road crossing, ECDs functioning acceptably on ROW and along ATWS perimeters.		Pic 2 Desc.	ROW, permanent vegetation establishing moderately to well across the ROW, permanent waterbars functioning acceptably.

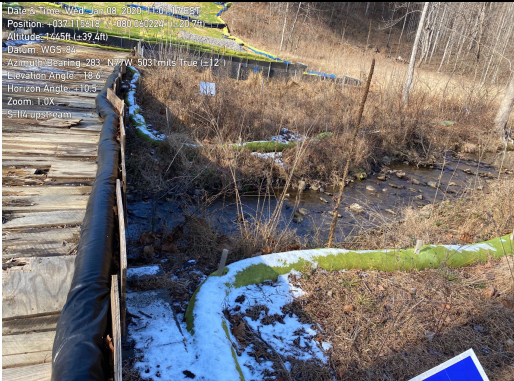
GPS Location	See photo for coordinates.		GPS Location	See photo for coordinates.	
Field Station#	13260+60		Field Station#	13306+00	
Pic 3 Desc.	S-II4, looking upstream of equipment bridge, stream clear, bed and banks stable, ECDs functioning acceptably.		Pic 4 Desc.	ROW, permanent vegetation establishing across ROW, no signs of landowner use of hard crossings.

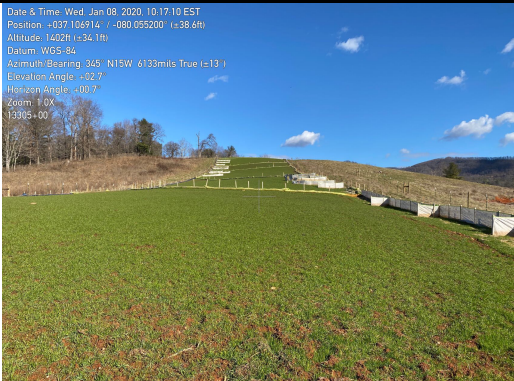
Field Station#	13305+00		Field Station#	1330+09	
Pic 5 Desc.	ROW, ECDs functioning acceptably, permanent vegetation establishing in agricultural field.		Pic 6 Desc.	S-GH7, downstream side of equipment bridge, bridge in good condition, stream bed and banks stable with no changes observed.

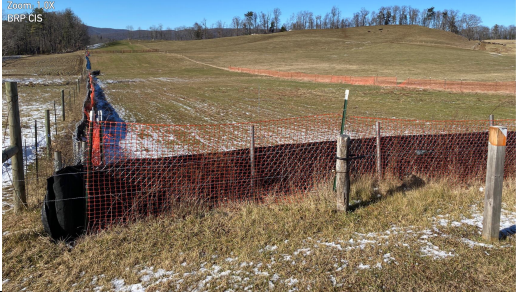
GPS Location	See photo for coordinates.		GPS Location	See photo for coordinates.	
Field Station#	13012+53		Field Station#	12996+00	
Pic 1 Desc.	Blue Ridge Parkways crossing, CIS, vegetation noted across ROW, perimeter ECDs functioning acceptably.		Pic 2 Desc.	ROW stable, ECDs functioning acceptably.	
<p>Date & Time: Wed Jan 08 2020 13:35:54 EST Position: -037.124900 / -080.111014 (-15.2ft) Altitude: 2620ft (-11.3ft) Datum: WGS-84 Azimuth/Bearing: 200. W00W 5156mils True (-12.1) Elevation Angle: -01.3 Horizon Angle: -00.9 Zoom: 1.09 S-G26upstream</p>

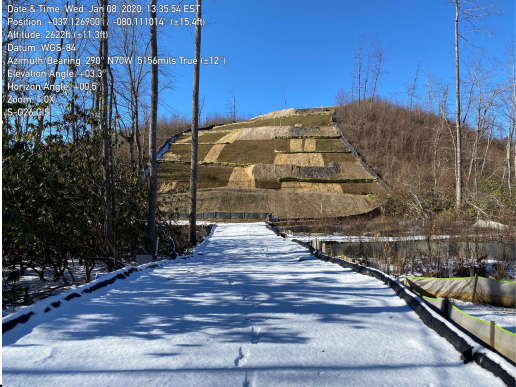
GPS Location	See photo for coordinates.		GPS Location	See photo for coordinates.	
Field Station#	13061+00		Field Station#	13062+96	
Pic 3 Desc.	Equipment bridges over S-GH26 and S-GH27, bridges in acceptable condition, ROW stable with ECDs functioning acceptably.		Pic 4 Desc.	S-G26, looking upstream of equipment bridge, stream flowing clear, stream bed and banks stable.	
<p>Date & Time: Wed Jan 08 2020 13:34:39 EST Position: -037.127027 / -080.111444 (-15.2ft) Altitude: 2620ft (-11.3ft) Datum: WGS-84 Azimuth/Bearing: 123. S57E 2622mils True (-12.1) Elevation Angle: -13.7 Horizon Angle: -01.2 Zoom: 1.09 S-G26upstream</p>

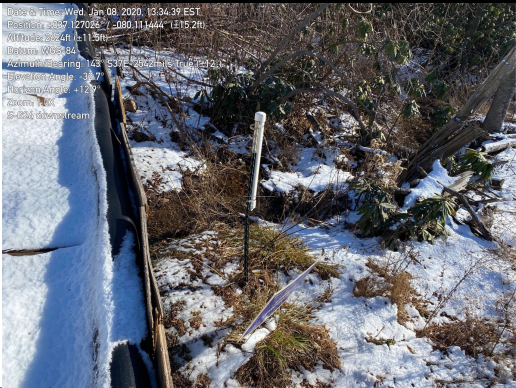
Field Station#	13062+96		Field Station#	13061+89	
Pic 5 Desc.	S-G26, downstream of equipment bridge, no environmental issues observed.		Pic 6 Desc.	S-G27, looking upstream of equipment bridge, geotech and sideboards in good condition, stream bed and banks stable.

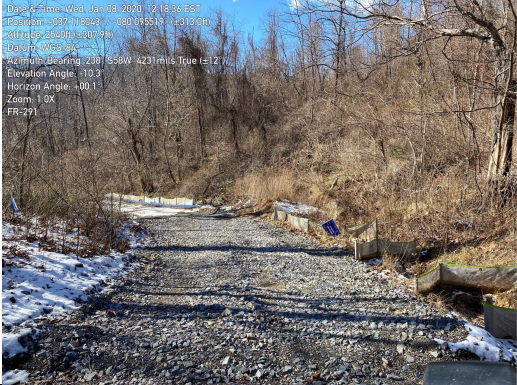
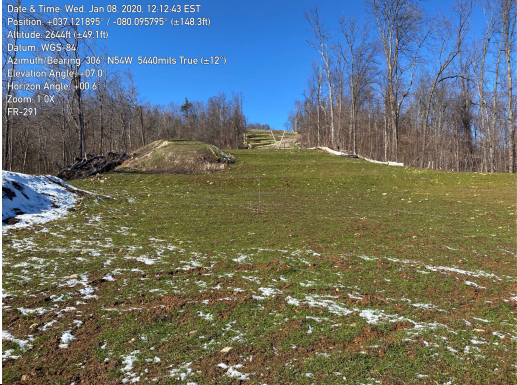
<p><small>Date & Time: Wed Jan 08 2020 12:12:43 EST Position: -937.121895, -980.095795, 13148.300 Altitude: 2644ft (+49.1ft) Datum: WGS-84 Azimuth: Bearing: 338, NSCW, Suddmills True (+12.1) Elevation Angle: +00.0 Horizon Angle: +00.0 Zoom: 1.0X FR-291</small></p>			
GPS Location	See photo for coordinates.		GPS Location	See photo for coordinates.	
Field Station#	13116+00		Field Station#	13116+00	
Pic 7 Desc.	FR-291, ECDs along access road functioning acceptably.		Pic 8 Desc.	ROW, temporary vegetation noted across ROW, waterbars and sumps functioning acceptably, soil piles stable.

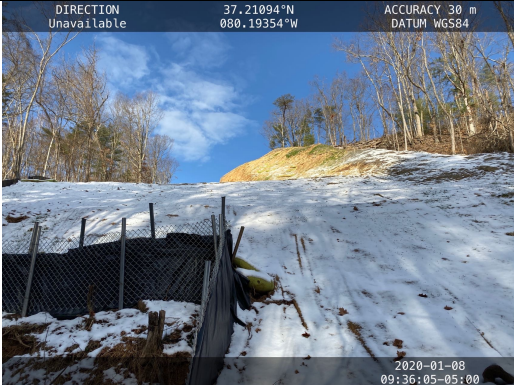
GPS Location	See picture for GPS data		GPS Location	See picture for GPS data	
Field Station#	12543+00		Field Station#	12543+56	
Pic 1 Desc.	Stabilized ROW still covered in snow.		Pic 2 Desc.	CFS lining yellow finch road protecting the wetland from muddy materials leaving the road.

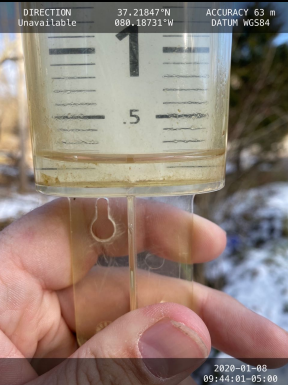
GPS Location	See picture for GPS data		GPS Location	See picture for GPS data	
Field Station#	12543+56		Field Station#	12454+00	
Pic 3 Desc.	Yellow Finch rain gauge (0.2")		Pic 4 Desc.	Portable toilet location

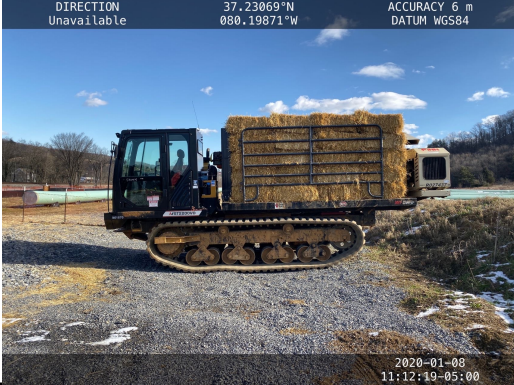
GPS Location	See picture for GPS data		GPS Location	See picture for GPS data	
Field Station#	12453+49		Field Station#	12451+23	
Pic 5 Desc.	Marooka loaded with hay for stabilization		Pic 6 Desc.	ATWS pipe storage area.
