# Visual Site Inspection Report

<b>Project Name</b>	H-600 Pipeline Spread H	<b>AFE</b>	124300138	<b>Spread</b>	H-600 Pipeline Spread H
<b>Contractor</b>	Precision			<b>Report #</b>	6276
<b>Inspector</b>	Logan Box			<b>Date/Time</b>	12/2/2019 5:32 PM
<b>Permit #</b>	TBD	<b>Inspection Type</b>	VA SWPP	<b>Station Begin</b>	13415+51
<b>State</b>	VA	<b>Inspection Area</b>	Partial	<b>Station End</b>	13670+00
<b>County</b>	Franklin	<b>Ground</b>	Wet	<b>Temperature (°F)</b>	41.00
<b>Municipality</b>	N/A	<b>Weather</b>	Cloudy	<b>Rain Gauge (in)</b>	0.00
				<b>Rain Accumulation Time (days)</b>	0.00

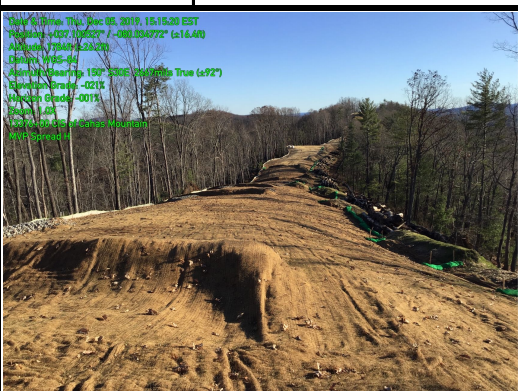
<b>Field Station#</b>	13369+00		<b>Field Station#</b>	13372+25	
<b>Pic 15 Desc.</b>	Vegetation growing through installed curlex on slope GAS of Stream S-RR11.		<b>Pic 16 Desc.</b>	Curlex installed across full width of ROW.

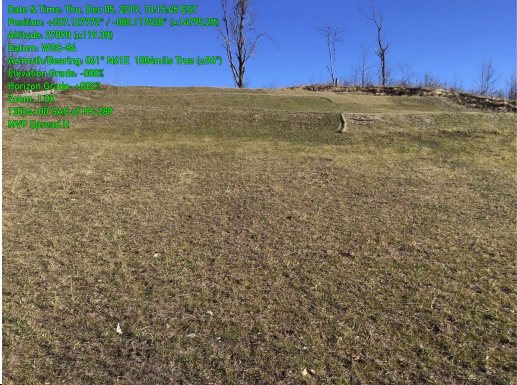
<p>Date &amp; Time: Thu, Dec 05, 2019, 12:11:19 EST Position: +037.122702° / -080.111590° (s132.00) Altitude: 26128 (s39.40) Datum: WGS-84 Azimuth/Bearing: 377° N43W 9206m True (s30°) Slope/Grade: -49.03 Horizontal/Vertical: -00023 Length: 1.00 13062+00 GAS of FR-290 MVP Spread 1</p>			
<b>GPS Location</b>	See pic for GPS location		<b>GPS Location</b>	See pic for GPS location	
<b>Field Station#</b>	13034+00		<b>Field Station#</b>	13062+00	
<b>Pic 7 Desc.</b>	Temporary vegetative stabilization and ECD's in good condition.		<b>Pic 8 Desc.</b>	No erosion concerns observed on slope above FR-290.

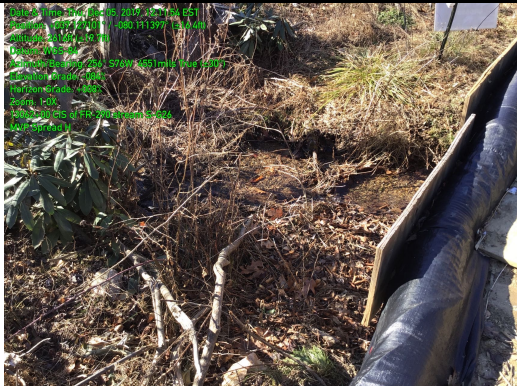
<p>Date &amp; Time: Thu, Dec 05, 2019, 12:12:26 EST Position: +037.122702° / -080.111590° (s132.00) Altitude: 26128 (s39.40) Datum: WGS-84 Azimuth/Bearing: 377° N43W 9206m True (s30°) Slope/Grade: -49.03 Horizontal/Vertical: -00023 Length: 1.00 13062+00 GAS of FR-290 MVP Spread 1</p>			
<b>GPS Location</b>	See pic for GPS location		<b>GPS Location</b>	See pic for GPS location	
<b>Field Station#</b>	13062+00		<b>Field Station#</b>	13063+00	
<b>Pic 9 Desc.</b>	No impacts observed in stream S-G26		<b>Pic 10 Desc.</b>	No impacts observed in stream S-G27

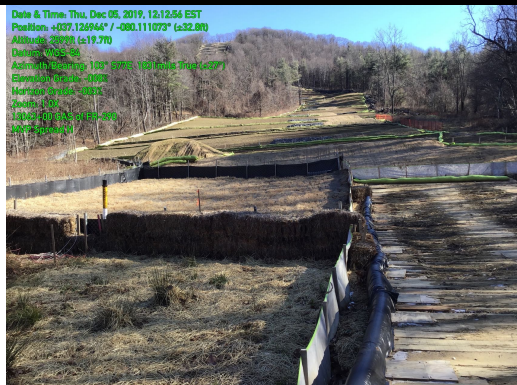
<b>GPS Location</b>	See pic for GPS location		<b>GPS Location</b>	See pic for GPS location	
<b>Field Station#</b>	13063+00		<b>Field Station#</b>	13116+00	
<b>Pic 11 Desc.</b>	Good permanent and temporary vegetative stabilization in the area on the GAS of FR-290.		<b>Pic 12 Desc.</b>	No issues or impacts observed between FR-290 and FR-291.

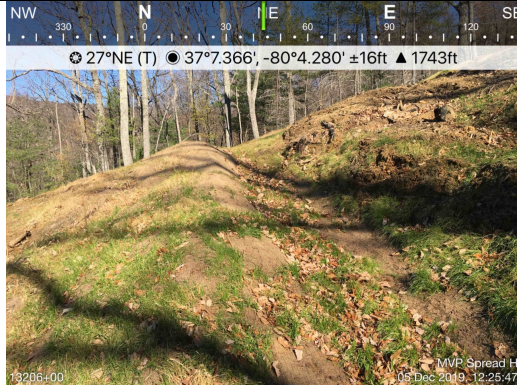
<b>Field Station#</b>	13206+00	<b>Field Station#</b>	13259+50		
<b>Pic 11 Desc.</b>	Temporary waterbar installed, vegetated, and in good condition.	<b>Pic 12 Desc.</b>	Soil stockpile stabilized, vegetated, and protected from accelerated erosion.

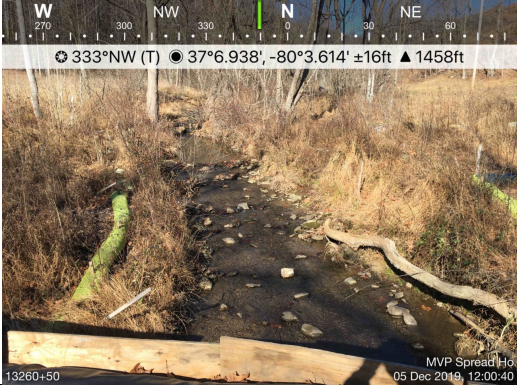
<p>Insert image here</p>			
<b>GPS Location</b>	See Picture Watermark	<b>GPS Location</b>			
<b>Field Station#</b>	13260+50	<b>Field Station#</b>			
<b>Pic 13 Desc.</b>	Stream S-II4 and buffer area remains well-vegetated and undisturbed.	<b>Pic 14 Desc.</b>			
<p>Insert image here</p>		<p>Insert image here</p>			
<b>GPS Location</b>		<b>GPS Location</b>			
<b>Field Station#</b>		<b>Field Station#</b>			
<b>Pic 15 Desc.</b>		<b>Pic 16 Desc.</b>			
<p>Insert image here</p>		<p>Insert image here</p>			
<b>GPS Location</b>		<b>GPS Location</b>			
<b>Field Station#</b>		<b>Field Station#</b>			
<b>Pic 17 Desc.</b>		<b>Pic 18 Desc.</b>
