Visual Site Inspection Report

Project Name	H-600 Pipeline Spread H	AFE	124300138	Spread	H-600 Pipeline Spread H
Contractor	Precision			Report #	6860
Inspector	Pat Davis			Date/Time	12/23/2019 4:15 PM
Permit #	TBD	Inspection Type	VA SWPP	Station Begin	+0
State	VA	Inspection Area	Partial	Station End	+0
County	Montgomery	Ground	Damp	Temperature (°F)	41.00
Municipality	N/A	Weather	Cloudy	Rain Gauge (in)	0.00
				Rain Accumulation Time (days)	0.00

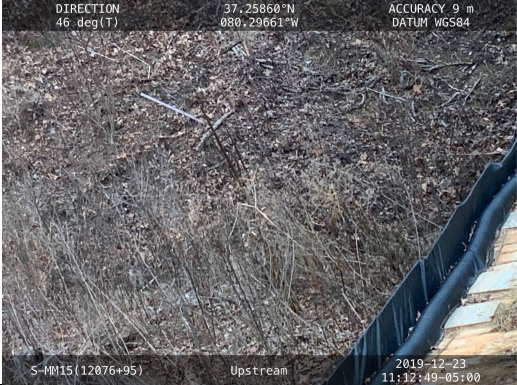
GPS Location	See photo GPS for location	GPS Location	See photo GPS for location		
Field Station#	12076+95	Field Station#	12035+12		
Pic 7 Desc.	Stream dry. No sediment off ROW.	Pic 8 Desc.	Stream running clear up and down stream. No sediment from ROW evident in this waterway.

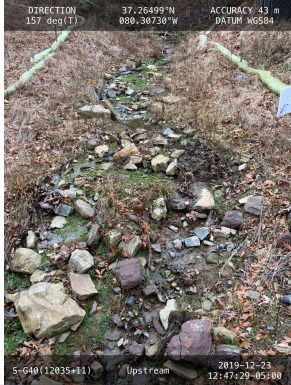
GPS Location	See photo GPS for location	GPS Location			
Field Station#	1203+51	Field Station#			
Pic 9 Desc.	Stream running clear up and down stream. No sediment from ROW evident in this waterway.	Pic 10 Desc.

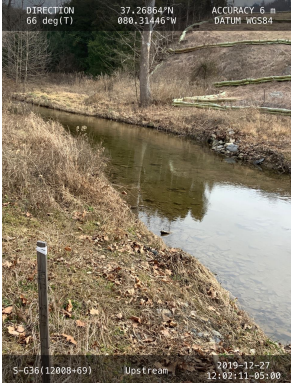
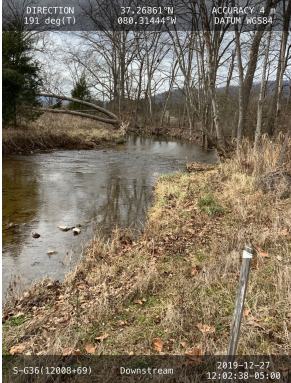
GPS Location	See photo GPS for location		GPS Location	See photo GPS for location	
Field Station#	12008+69		Field Station#	12008+69	
Pic 7 Desc.	Stream banks are stable. Stream is running clear.		Pic 8 Desc.	Stream banks are stable. Stream is running clear.

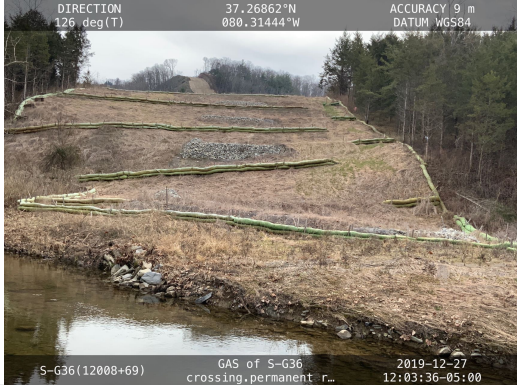
<p style="text-align: center;">Insert image here</p>			
GPS Location	See photo GPS for location		GPS Location		
Field Station#	12009+00		Field Station#		
Pic 9 Desc.	Permanent restoration area is stable with vegetation growth progressing.		Pic 10 Desc.		
<p style="text-align: center;">Insert image here</p>			<p style="text-align: center;">Insert image here</p>		
GPS Location			GPS Location		
Field Station#			Field Station#		
Pic 11 Desc.			Pic 12 Desc.

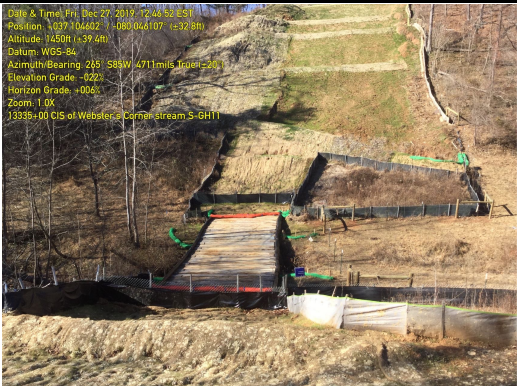
<p>Date & Time: Fri Dec 27, 2019 12:43:52 (EST) Position: -93.7106402, -4080.06402, -132.400 Altitude: 1450ft (+3.94m) Datum: WGS-84 Azimuth Bearing: 285.583W 47.11mils True (+36.1) Elevation Grade: +02% Horizon Grade: +00% Zoom: 1.0X 13335+00 GIS of Webster's Corner stream S-GH11</p>

GPS Location	See pic for GPS location		GPS Location	See pic for GPS location	
Field Station#	13335+00		Field Station#	13324+00	
Pic 15 Desc.	No impacts observed at stream S-GH11.		Pic 16 Desc.	No impacts observed at stream S-RR14.

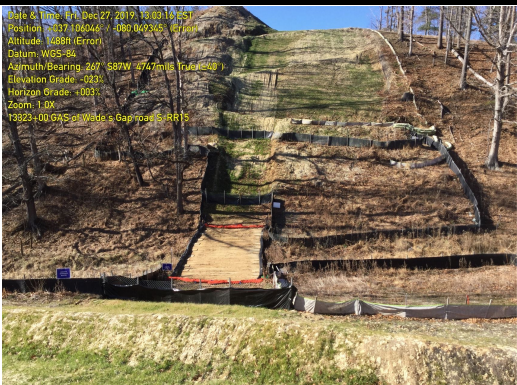
<p>Date & Time: Fri Dec 27, 2019 12:43:52 (EST) Position: -93.7106402, -4080.06402, -132.400 Altitude: 1450ft (+3.94m) Datum: WGS-84 Azimuth Bearing: 285.583W 47.11mils True (+36.1) Elevation Grade: +02% Horizon Grade: +00% Zoom: 1.0X 13323+00 GIS of Webster's Gap road S-RR15</p>

Pic 17 Desc.	No issues or impacts observed at stream S-GH15.		Pic 18 Desc.	No maintenance issues to report throughout the area.

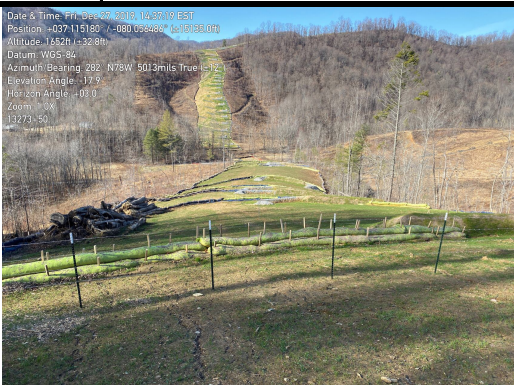
Field Station#	13273+50		Field Station#	13302+00	
Pic 5 Desc.	ROW, permanent waterbars functioning acceptably, permanent vegetation noted across ROW.		Pic 6 Desc.	ROW, permanent vegetation establishing well in agricultural field, CFS functioning acceptably, no off ROW impacts noted.
