Visual Site Inspection Report

Project Name	H-600 Pipeline Spread H	AFE	124300138	Spread	H-600 Pipeline Spread H
Contractor	Precision			Report #	8339
Inspector	Pat Davis			Date/Time	2/17/2020 4:22 PM
Permit #	TBD	Inspection Type	VA SWPP	Station Begin	+0
State	VA	Inspection Area	Partial	Station End	+0
County	Montgomery	Ground	Damp	Temperature (°F)	55.00
Municipality	N/A	Weather	Sunny	Rain Gauge (in)	0.00
				Rain Accumulation Time (days)	0.00

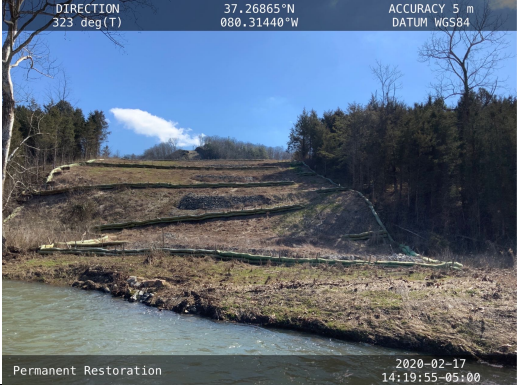
GPS Location	See GPS for location	GPS Location			
Field Station#	12008+69	Field Station#			
Pic 7 Desc.	S-G36 banks in good condition. No ROW sediment in stream. Permanent restoration vegetation is acceptable and stable.	Pic 8 Desc.			
Insert image here		Insert image here			
GPS Location		GPS Location			
Field Station#		Field Station#			
Pic 9 Desc.		Pic 10 Desc.			
Insert image here		Insert image here			
GPS Location		GPS Location			
Field Station#		Field Station#			
Pic 11 Desc.		Pic 12 Desc.

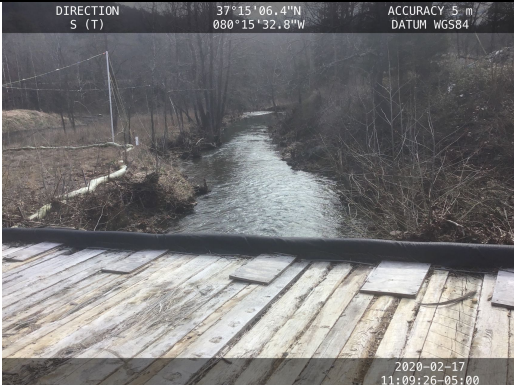
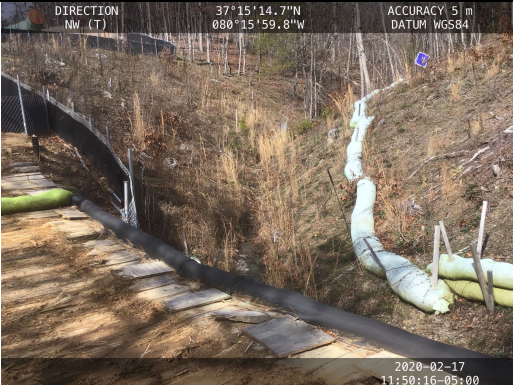
GPS Location	See photo		GPS Location	See photo	
Field Station#	12192+50		Field Station#	12166+47	
Pic 3 Desc.	Stream S-C21, Bradshaw Creek , facing south, downstream		Pic 4 Desc.	Stream S-C24, facing northwest, upstream

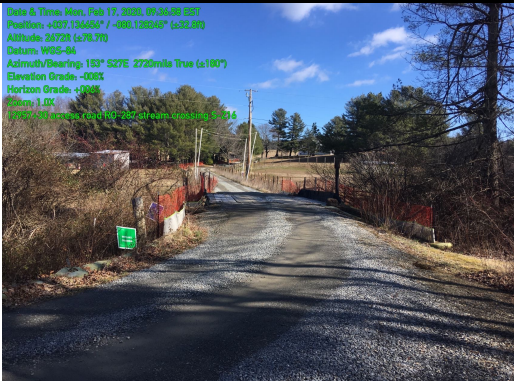
GPS Location	See pic for GPS location		GPS Location	See pic for GPS location	
Field Station#	12957+30		Field Station#	12974+29	
Pic 5 Desc.	No issues or impacts observed near stream S-Z16 on access road RO-287.		Pic 6 Desc.	No issues or impacts found along access RO-288.

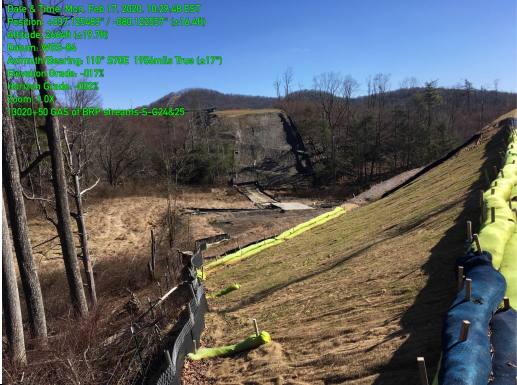
GPS Location	See pic for GPS location		GPS Location	See pic for GPS location	
Field Station#	12994+50		Field Station#	13020+50	
Pic 7 Desc.	Very good vegetative stabilization in place on the GAS of the US-221 crossing.		Pic 8 Desc.	No issues or impacts observed near streams S-G24 and S-G25.

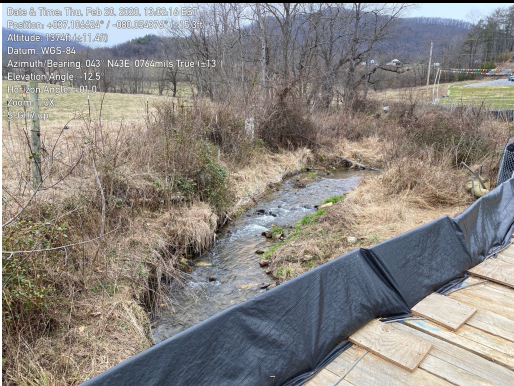
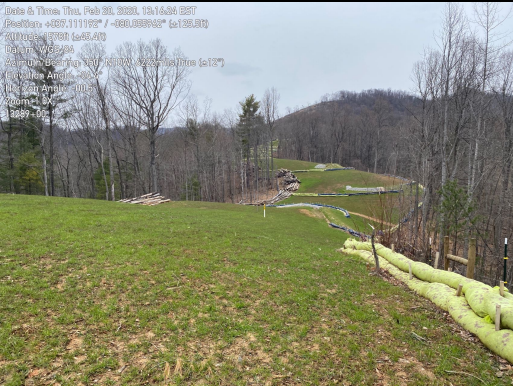
GPS Location	See photo for coordinates.		GPS Location	See photo for coordinates.	
Field Station#	13309+09		Field Station#	13289+00	
Pic 5 Desc.	S-GH7, upstream side of equipment bridge, ECDs functioning acceptably.		Pic 6 Desc.	ROW restored with moderate to good vegetative cover, permanent waterbars functioning acceptably.

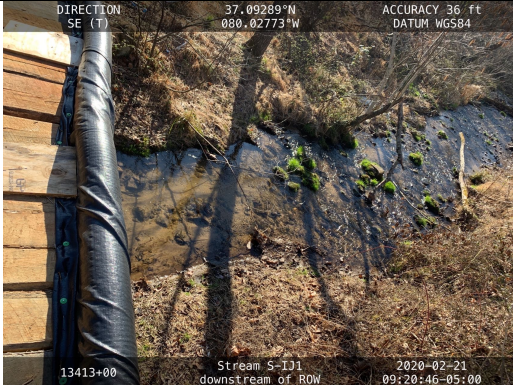
GPS Location	See photo for gps location data.		GPS Location	See photo for gps location data.	
Field Station#	13413+20		Field Station#	13413+00	
Pic 1 Desc.	Photo shows the bridge over stream S-IJ1. No environmental issues were observed.		Pic 2 Desc.	Photo shows stream S-IJ1 downstream from the ROW. No environmental issues were observed.

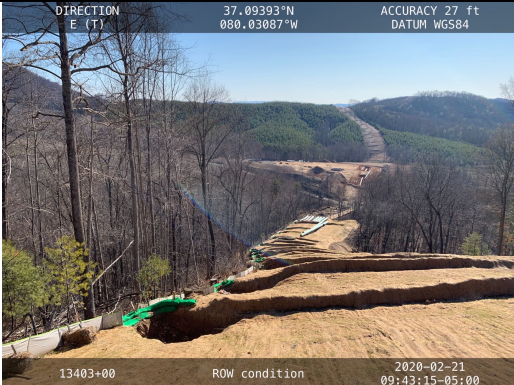
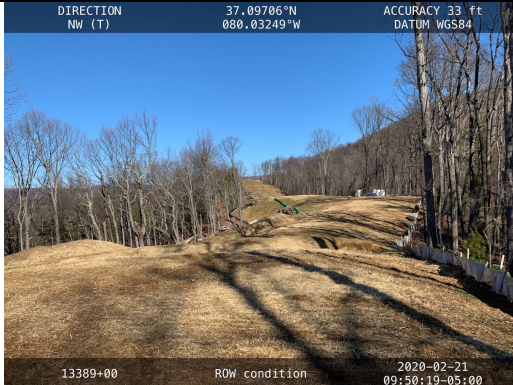
GPS Location	See photo for gps location data.		GPS Location	See photo for gps location data.	
Field Station#	13403+00		Field Station#	13389+00	
Pic 3 Desc.	Photo shows the ROW condition from about 13403+00 to 13410+00. No environmental issues were observed.		Pic 4 Desc.	Photo shows the ROW condition from about 13380+00 to 13389+00. No environmental issues were observed.

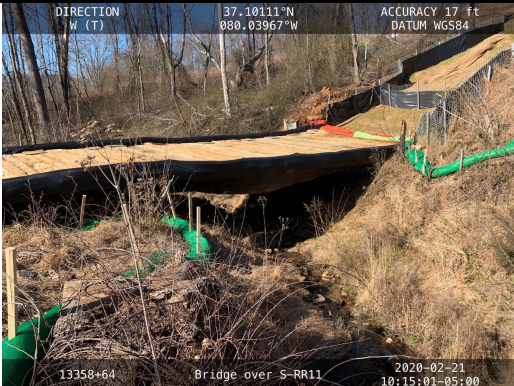
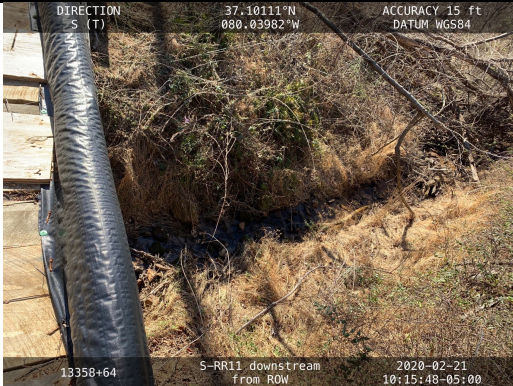
Field Station#	13358+64		Field Station#	13358+64	
Pic 5 Desc.	Photo shows the bridge over stream S-RR11. No environmental issues were observed.		Pic 6 Desc.	photo shows stream S-RR11 downstream from the ROW. No environmental issues were observed.

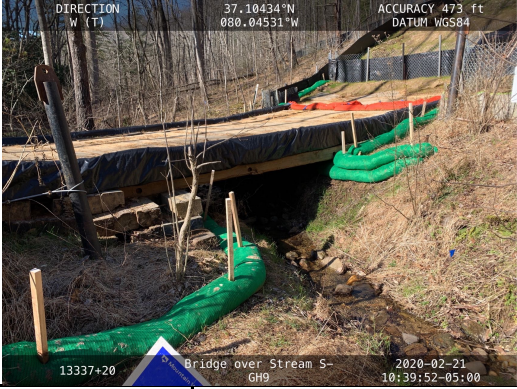
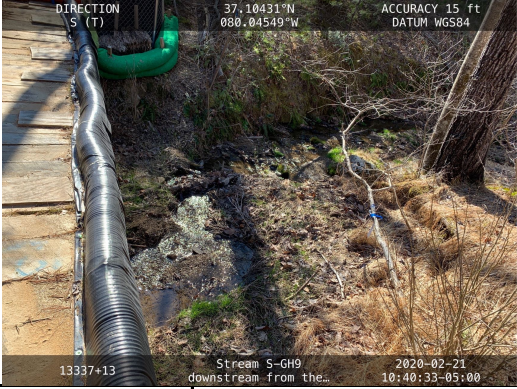
GPS Location	See photo for gps location data.		GPS Location	See photo for gps location data.	
Field Station#	13337+20		Field Station#	13337+13	
Pic 7 Desc.	Photo shows the bridge over stream S-GH9. No environmental issues were observed.		Pic 8 Desc.	Photo shows stream S-GH9 downstream from the ROW. No environmental issues were observed.

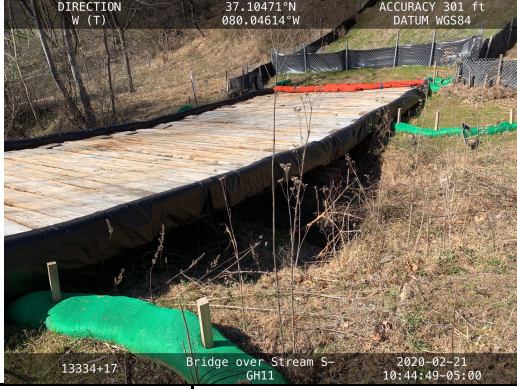
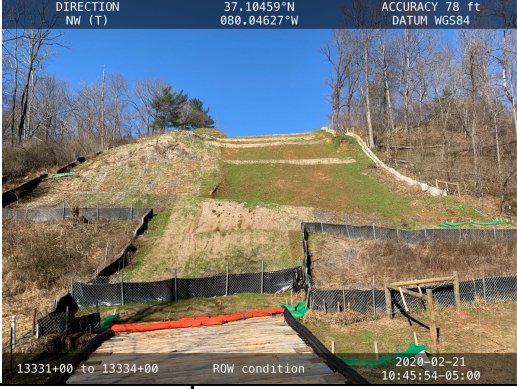
GPS Location	See photo for gps location data.		GPS Location	See photo for gps location data.	
Field Station#	13334+17		Field Station#	13334+00	
Pic 9 Desc.	Photo shows the bridge over stream S-GH11. No environmental issues were observed.		Pic 10 Desc.	Photo shows the ROW condition from about 13331+00 to 13334+00. No environmental issues were observed.

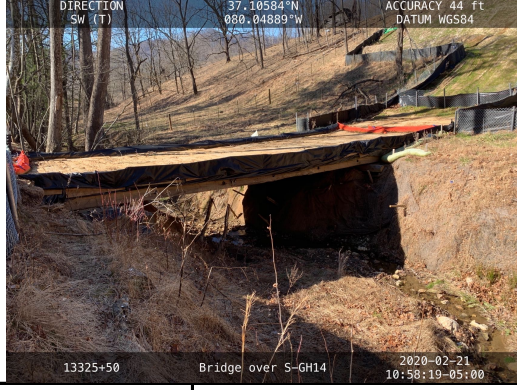
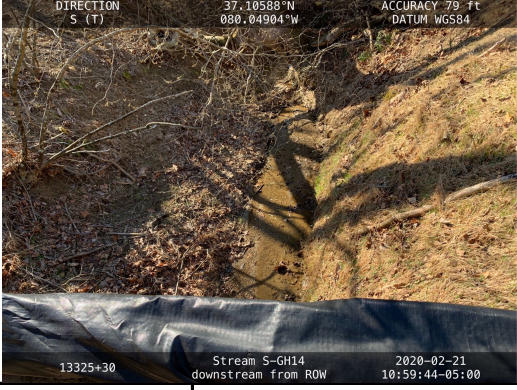
Pic 11 Desc.	Photo shows the bridge over stream S-GH14. No environmental issues were observed.		Pic 12 Desc.	Photo shows stream S-GH14 downstream from the ROW. No environmental issues were observed.

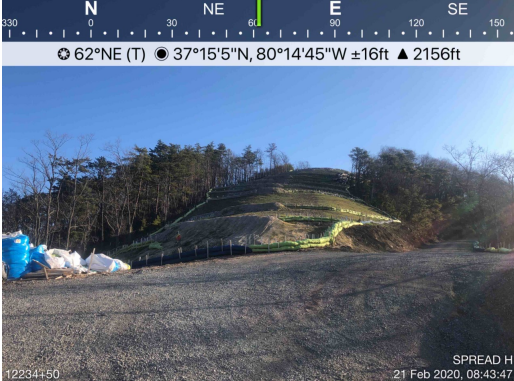
GPS Location	see photo	GPS Location	see photo		
Field Station#	12234+50	Field Station#	12284+84		
Pic 1 Desc.	From this location to AR-276.03 crossing is stabilized and controls are in place.	Pic 2 Desc.	CIS of the 'V' is stabilized

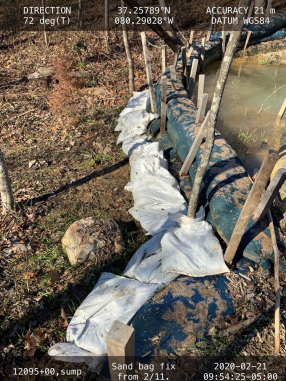
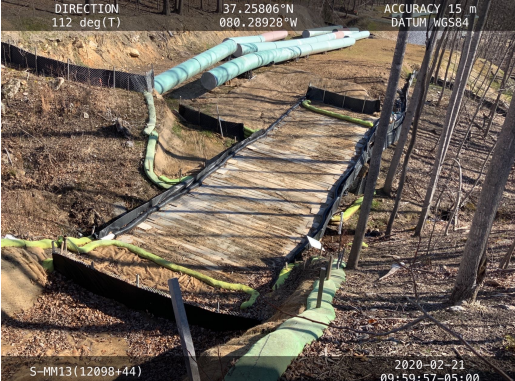
GPS Location	See GPS for location		GPS Location	See GPS for location	
Field Station#	12095+00		Field Station#	12098+44	
Pic 3 Desc.	No sediment filled water leaving the the sump.		Pic 4 Desc.	ECDs surrounding stream in acceptable condition.

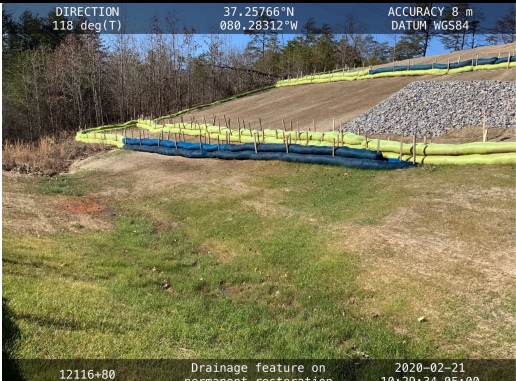
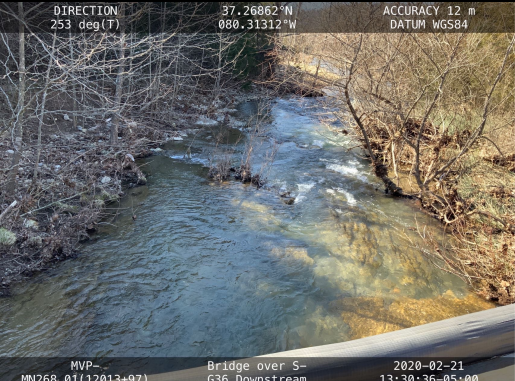
GPS Location	See GPS for location		GPS Location	See GPS for location	
Field Station#	12116+80		Field Station#	12013+97	
Pic 5 Desc.	Drainage feature and permanent restoration vegetation in acceptable condition.		Pic 6 Desc.	Stream is running clear, free of turbid water.

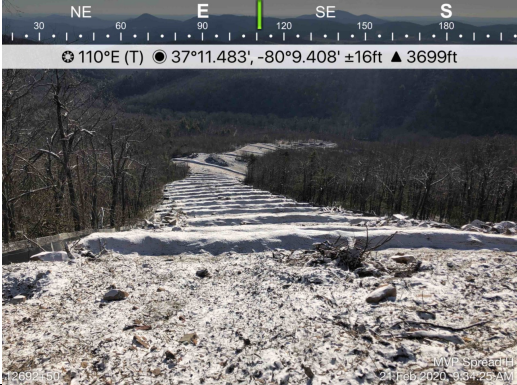
GPS Location	See Picture Watermark		GPS Location	See Picture Watermark	
Field Station#	12684+00		Field Station#	12692+00	
Pic 7 Desc.	Waterbar and end treatment frozen, stabilized, and in good condition.		Pic 8 Desc.	Waterbar on GAS Honeysuckle road in good condition and frozen.

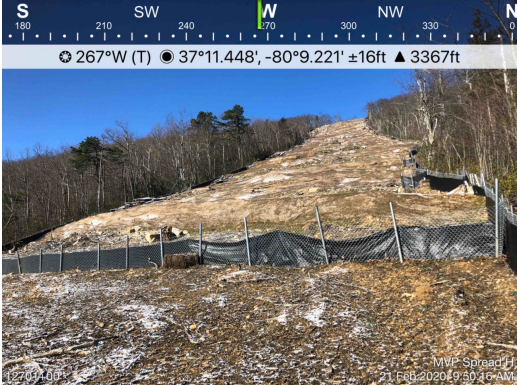
GPS Location	See Picture Watermark		GPS Location	See Picture Watermark	
Field Station#	12690+50		Field Station#	12701+00	
Pic 9 Desc.	Rock construction entrance on GAS Honeysuckle Rd. in good condition, and no tracked sediment was observed.		Pic 10 Desc.	SSF at bottom of slope on GAS Honeysuckle Rd is installed and in good condition.

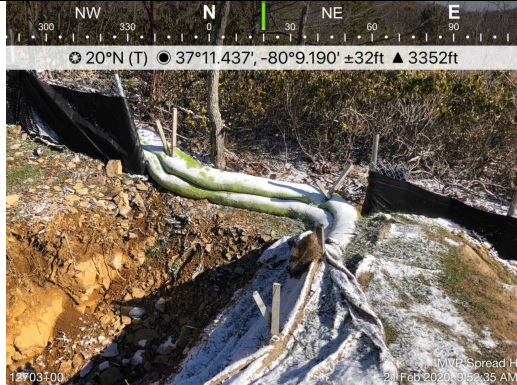
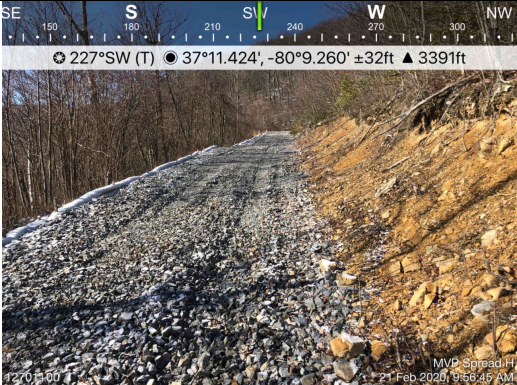
GPS Location	See Picture Watermark		GPS Location	See Picture Watermark	
Field Station#	12703+00		Field Station#	12701+00	
Pic 11 Desc.	Waterbar end treatment in good condition and functional.		Pic 12 Desc.	Access road MVP-RO-280 is in good condition.

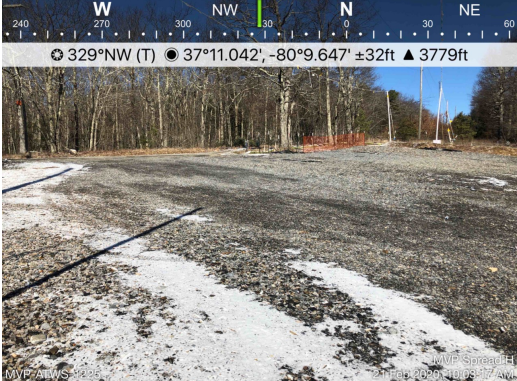
GPS Location	See Picture Watermark	GPS Location			
Field Station#	12701+00	Field Station#			
Pic 13 Desc.	MVP-ATWS-1225 in good condition.	Pic 14 Desc.			
Insert image here		Insert image here			
GPS Location		GPS Location			
Field Station#		Field Station#			
Pic 15 Desc.		Pic 16 Desc.			
Insert image here		Insert image here			
GPS Location		GPS Location			
Field Station#		Field Station#			
Pic 17 Desc.		Pic 18 Desc.
