## Visual Site Inspection Report

<b>Project Name</b>	H-600 Pipeline Spread H	<b>AFE</b>	124300138	<b>Spread</b>	H-600 Pipeline Spread H
<b>Contractor</b>	Precision			<b>Report #</b>	7929
<b>Inspector</b>	Logan Box			<b>Date/Time</b>	2/4/2020 4:59 PM
<b>Permit #</b>	TBD	<b>Inspection Type</b>	VA SWPP	<b>Station Begin</b>	13415+51
<b>State</b>	VA	<b>Inspection Area</b>	Partial	<b>Station End</b>	13670+00
<b>County</b>	Franklin	<b>Ground</b>	Damp	<b>Temperature (°F)</b>	65.00
<b>Municipality</b>	N/A	<b>Weather</b>	Cloudy	<b>Rain Gauge (in)</b>	0.00
				<b>Rain Accumulation Time (days)</b>	0.00

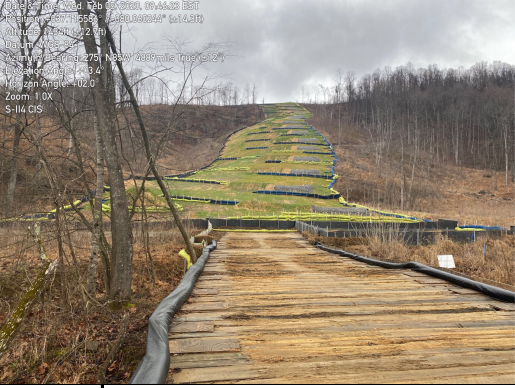
<p> Date &amp; Time: Wed, Feb 05, 2020, 09:43:17 EST  Position: +43° 11' 23.7" / -80° 02' 47.7" (+76.10)  Altitude: 1551ft (472.6m)  Datum: WGS 84  Azimuth: Bearing 192° N (True) (+11.5°)  Elevation Angle: -13.91°  Horizon Angle: -00.3°  Zoom: 1.0X  S-II4 CIS </p>		<b>GPS Location</b> See photo for coordinates.	
<b>Field Station#</b> 13260+60		<b>Field Station#</b> 13260+50		<b>Pic 1 Desc.</b> S-II4, upstream side of equipment bridge, no changes noted to stream bed or banks.

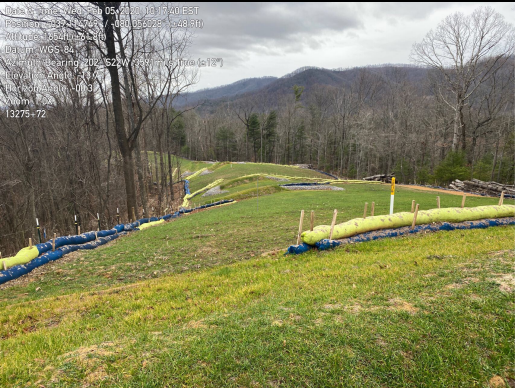
<p> Date &amp; Time: Wed, Feb 05, 2020, 10:20:07 EST  Position: +43° 11' 25.7" / -80° 02' 47.7" (+76.10)  Altitude: 1551ft (472.6m)  Datum: WGS 84  Azimuth: Bearing 202° S (True) (+11.5°)  Elevation Angle: -11.5°  Horizon Angle: +03.3°  Zoom: 1.0X  13275+72 </p>		<b>GPS Location</b> See photo for coordinates.	
<b>Field Station#</b> 13268+00		<b>Field Station#</b> 13275+72		<b>Pic 5 Desc.</b> ROW stable, additional erosion control blanket installed.

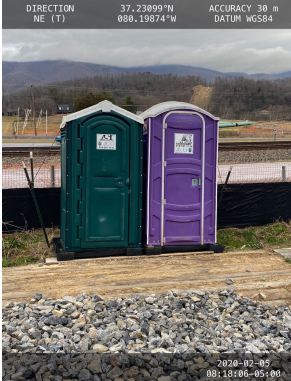
Insert image here		Insert image here	
<b>GPS Location</b>	See picture for GPS data		<b>GPS Location</b>		
<b>Field Station#</b>	12448+12		<b>Field Station#</b>		
<b>Pic 7 Desc.</b>	Portable toilet location		<b>Pic 8 Desc.</b>		
Insert image here			Insert image here		
<b>GPS Location</b>			<b>GPS Location</b>		
<b>Field Station#</b>			<b>Field Station#</b>		
<b>Pic 9 Desc.</b>			<b>Pic 10 Desc.</b>		
Insert image here			Insert image here		
<b>GPS Location</b>			<b>GPS Location</b>		
<b>Field Station#</b>			<b>Field Station#</b>		
<b>Pic 11 Desc.</b>			<b>Pic 12 Desc.</b>
