Visual Site Inspection Report

Project Name	H-600 Pipeline Spread H	AFE	124300138	Spread	H-600 Pipeline Spread H
Contractor	Precision			Report #	9190
Inspector	Pat Davis			Date/Time	3/16/2020 4:00 PM
Permit #	TBD	Inspection Type	VA SWPP	Station Begin	+0
State	VA	Inspection Area	Partial	Station End	+0
County	Montgomery	Ground	Wet	Temperature (°F)	46.00
Municipality	N/A	Weather	Cloudy	Rain Gauge (in)	0.60
				Rain Accumulation Time (days)	3.00

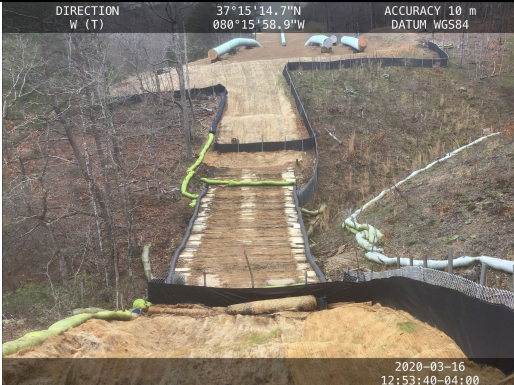
GPS Location	See photo		GPS Location	See photo	
Field Station#	12197+37		Field Station#	12192+50	
Pic 1 Desc.	Stream S-OO11, facing northwest, downstream		Pic 2 Desc.	Stream S-C21, facing northeast, upstream

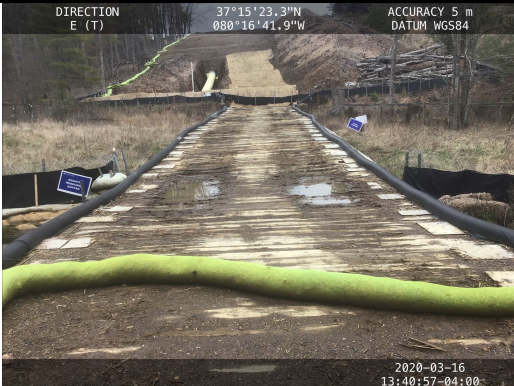
GPS Location	See photo		GPS Location	See photo	
Field Station#	12166+47		Field Station#	12163+05	
Pic 3 Desc.	Stream S-C24, facing west		Pic 4 Desc.	Stream S-C25, facing west

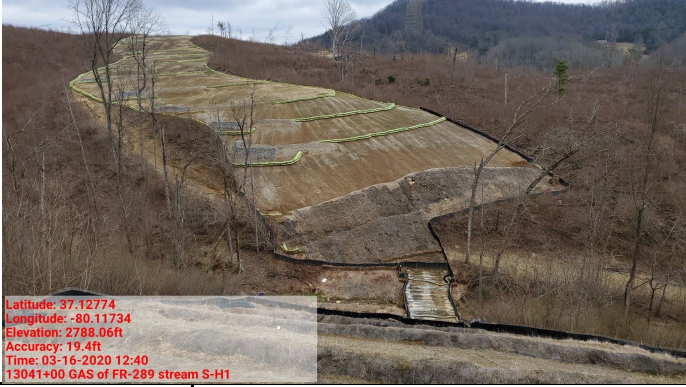
GPS Location	See pic for GPS location		GPS Location	See pic for GPS location	
Field Station#	13041+00		Field Station#	13041+00	
Pic 13 Desc.	No issues or impacts observed on the GAS of FR-289 or at stream S-H1.		Pic 14 Desc.	Good temporary vegetative stabilization on the GAS of FR-289.	
Insert image here			Insert image here		
GPS Location			GPS Location		
Field Station#			Field Station#		
Pic 15 Desc.			Pic 16 Desc.		
Insert image here			Insert image here		
GPS Location			GPS Location		
Field Station#			Field Station#		
Pic 17 Desc.			Pic 18 Desc.

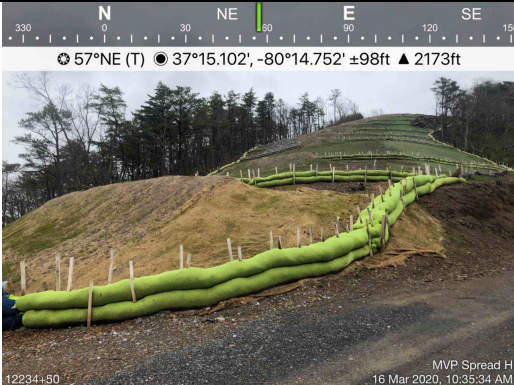
GPS Location	See Picture Coordinates		GPS Location	See Picture Coordinates	
Field Station#	12234+50		Field Station#	12239+50	
Pic 3 Desc.	Inspection start area. All controls are in functional condition and the ROW has germinated well.		Pic 4 Desc.	Waterbar end treatment level spreader and underdrain in good condition.

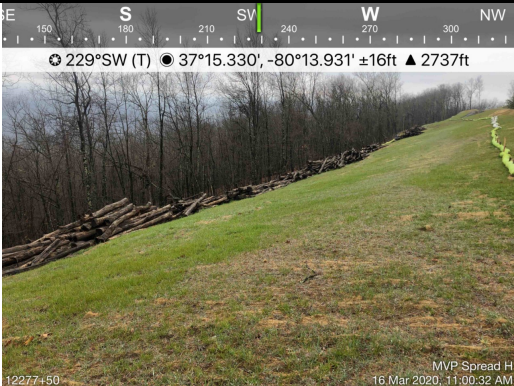
GPS Location	See Picture Coordinates		GPS Location	See Picture Coordinates	
Field Station#	12277+50		Field Station#	12284+50	
Pic 5 Desc.	ROW stabilized, germinated, and in good condition overall. All controls functional and wind-rowed trees are stable.		Pic 6 Desc.	Reese Mountain "V" remains stable and in acceptable condition.

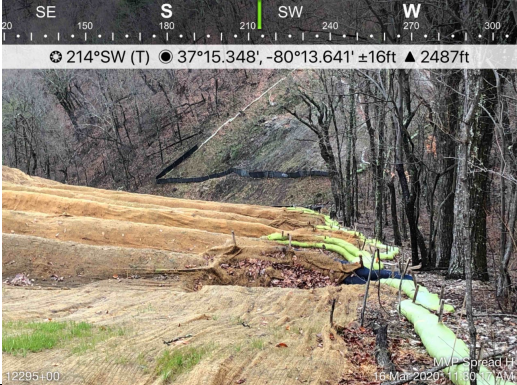
GPS Location	See Picture Coordinates		GPS Location	See Picture Coordinates	
Field Station#	12295+00		Field Station#	12380+00	
Pic 7 Desc.	GAS Reese Mountain "V" remains stable and in acceptable condition.		Pic 8 Desc.	Stream S-NN19 remains stable and unimpacted by construction.

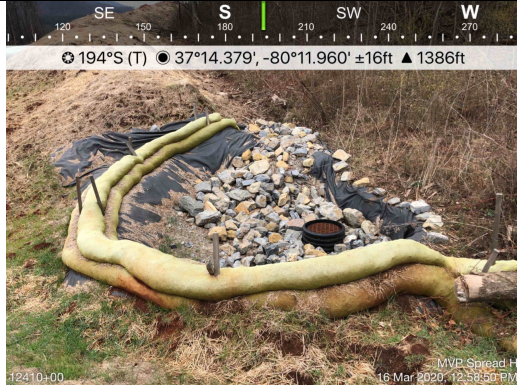
GPS Location	See Picture Coordinates		GPS Location	See Picture Coordinates	
Field Station#	12410+00		Field Station#	12410+00	
Pic 11 Desc.	Clean water diversion inlet in good condition and free of sediment.		Pic 12 Desc.	Clean water diversion plunge pool in good condition and free of sediment.

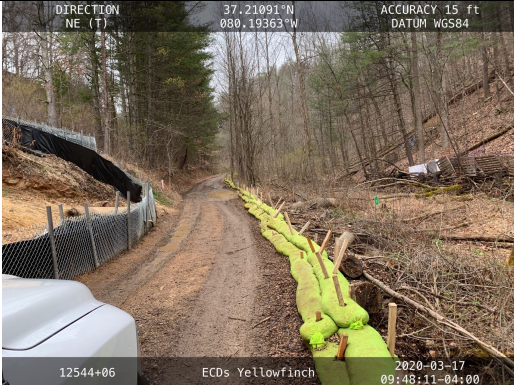
GPS Location	See photo for gps location data.		GPS Location	See photo for gps location data.	
Field Station#	12544+06		Field Station#	12543+18	
Pic 1 Desc.	Photo shows the ECDs along Yellowfinch Lane.		Pic 2 Desc.	Photo shows the ECDs from about 12542+50 to 12543+18.

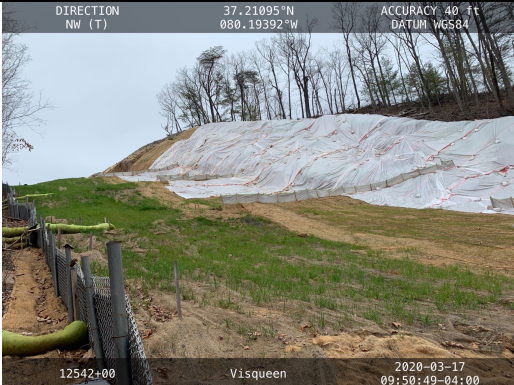
GPS Location	See photo for gps location data.		GPS Location	See photo for gps location data.	
Field Station#	12542+00		Field Station#	12542+00	
Pic 3 Desc.	Photo shows the stockpiles with vispqueen.		Pic 4 Desc.	Photo shows the ROW condition from about 12542+00 to 12543+50.

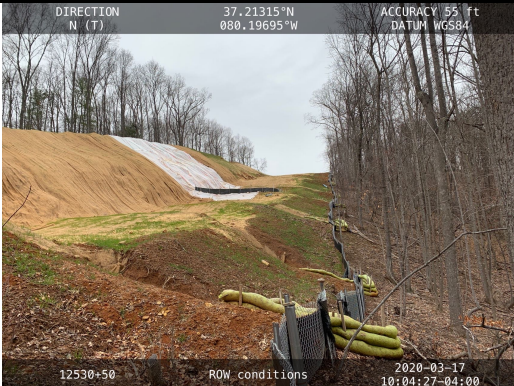
GPS Location	See photo for gps location data.		GPS Location	See photo for gps location data.	
Field Station#	12530+50		Field Station#	12519+75	
Pic 5 Desc.	Photo shows the ROW condition from about 12528+00 to 12530+50		Pic 6 Desc.	Photo shows the bridge over stream S-EF19.

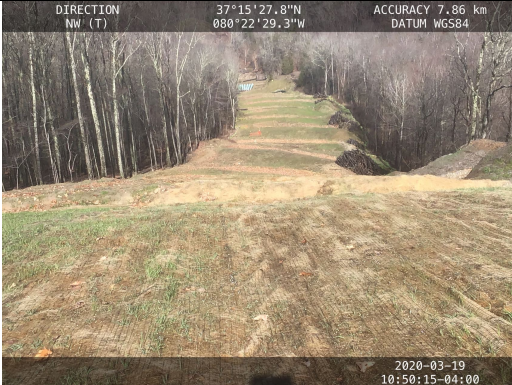
GPS Location	See photo		GPS Location	See photo	
Field Station#	12052+00		Field Station#	12035+75	
Pic 1 Desc.	ROW well vegetated and stable on the long slope going away from stream S-G40.		Pic 2 Desc.	Stream S-PP23, facing northeast, upstream

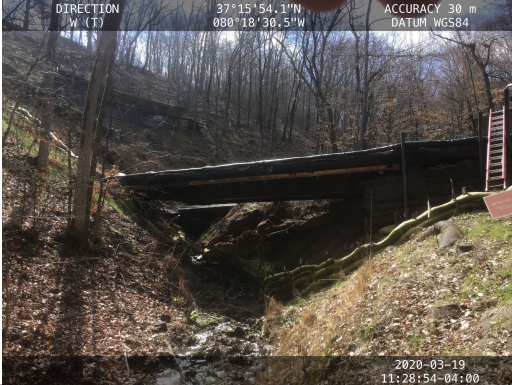
GPS Location	See photo		GPS Location	See photo	
Field Station#	12031+51		Field Station#	12013+97	
Pic 3 Desc.	Stream S-G39, facing west, upstream		Pic 4 Desc.	Stream S-G36 on access road MVP-MN-268.01, facing northwest, downstream

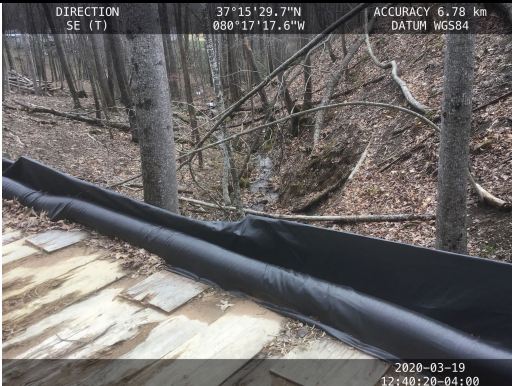
GPS Location	See photo		GPS Location	See photo	
Field Station#	12098+44		Field Station#	12083+00	
Pic 5 Desc.	Stream S-MM13, facing southeast, downstream		Pic 6 Desc.	ROW between stream S-MM15 and Half Acre Rock Road is well vegetated and stable.

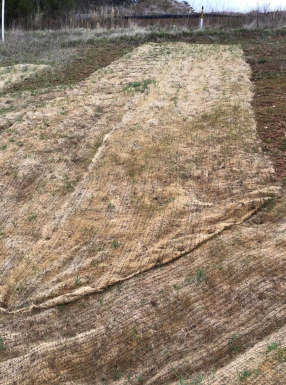
GPS Location	0000	GPS Location	0000		
Field Station#	13575+80	Field Station#	13575+12		
Pic 3 Desc.	Observed erosion control blanket to be sure it was in place and functioning properly	Pic 4 Desc.	Row photo showing vegetation		
Insert image here			Insert image here		
GPS Location		GPS Location			
Field Station#		Field Station#			
Pic 5 Desc.		Pic 6 Desc.

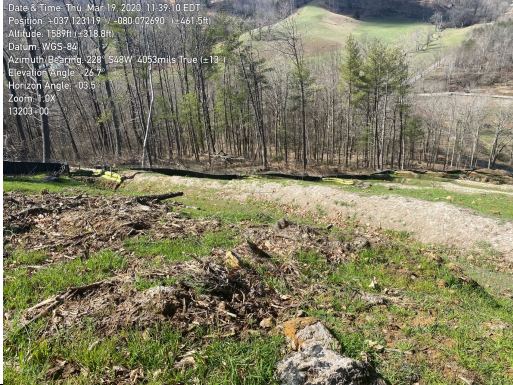
GPS Location				See photo for coordinates.				GPS Location				See photo for coordinates.			
Field Station#				13203+00				Field Station#				13210+00			
Pic 1 Desc.				ROW temporarily stabilized, waterbars, sumps, and outlets functioning acceptably.				Pic 2 Desc.				Permanent waterbars stable, moderate to good vegetative cover noted in restored area.

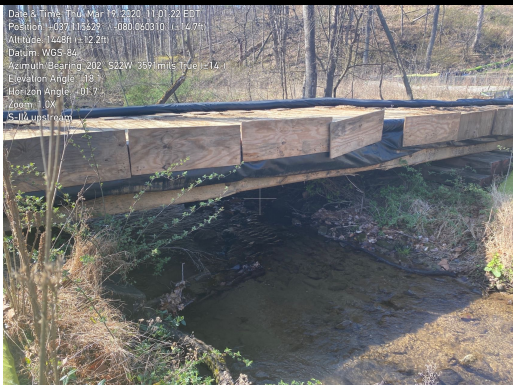
Field Station#				13260+60				Field Station#				13309+09			
Pic 5 Desc.				S-II4, upstream side of equipment bridge, no environmental concerns noted at stream.				Pic 6 Desc.				S-GH7, upstream side of equipment bridge, ECDs functioning acceptably.

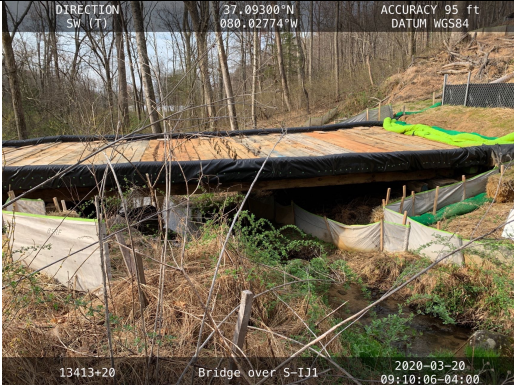
GPS Location	See photo for gps data.		GPS Location	See photo for gps data.	
Field Station#	13413+20		Field Station#	13413+00	
Pic 1 Desc.	Photo shows the bridge over stream S-IJ1.		Pic 2 Desc.	Photo shows stream S-IJ1 downstream from the ROW crossing.

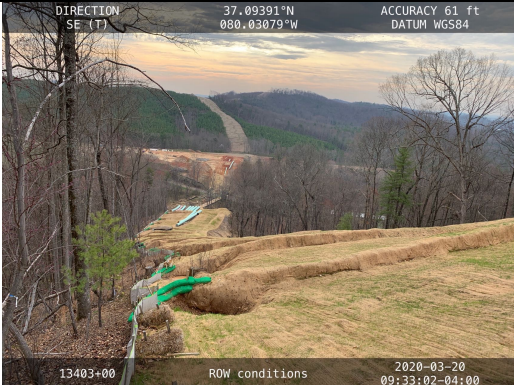
GPS Location	See photo for gps data.		GPS Location	See photo for gps data.	
Field Station#	13403+00		Field Station#	13392+00	
Pic 3 Desc.	Photo shows the ROW condition from about 13403+00 to 13411+00.		Pic 4 Desc.	Photo shows the ROW condition from about 13385+00 to 13392+00.

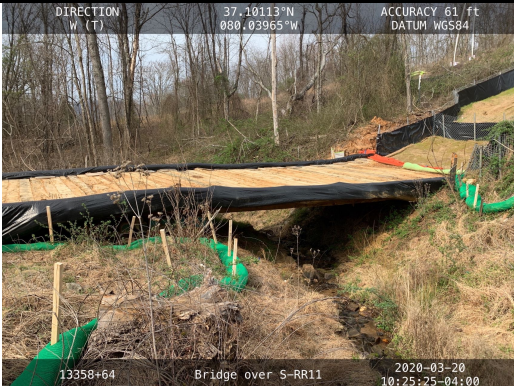
GPS Location	See photo for gps data.		GPS Location	See photo for gps data.	
Field Station#	13358+64		Field Station#	13352+23	
Pic 5 Desc.	Photo shows the bridge over stream S-RR11.		Pic 6 Desc.	Photo shows the bridge over stream S-RR09.

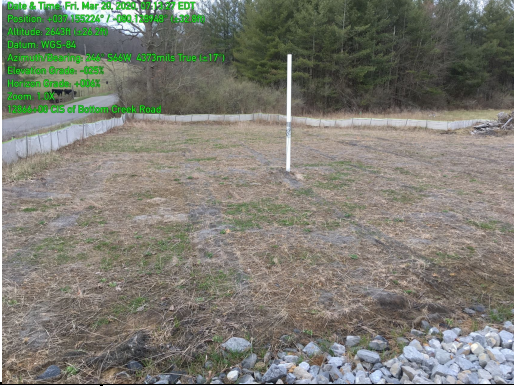
GPS Location	See pic for GPS location		GPS Location	See pic for GPS location	
Field Station#	12866+00		Field Station#	12866+00	
Pic 1 Desc.	No maintenance issues found on the CIS of the Bottom Creek Road crossing.		Pic 2 Desc.	No off ROW impacts or stream/wetland impacts on the GAS of Bottom Creek Road.

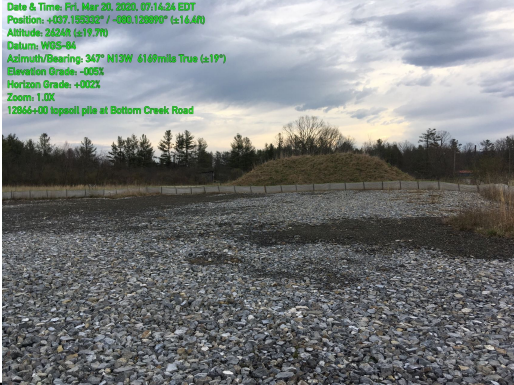
<p>Date & Time: Fri, Mar 20, 2020, 07:14:24 EDT Position: +037.153332° / -080.128990° (±16.4M) Altitude: 2624ft (±19.7M) Datum: WGS-84 Azimuth/Bearing: 343° N13W 516ft/mile True (±19°) Elevation Grade: -002% Horizon Grade: +002% Zoom: 1.0X 12866+00 topsoil pile at Bottom Creek Road</p>

GPS Location	See pic for GPS location		GPS Location	See pic for GPS location	
Field Station#	12866+00		Field Station#	12957+30	
Pic 3 Desc.	Topsoil pile in ATWS remains in compliance.		Pic 4 Desc.	Upstream side of stream S-Z17 along access road RO-287.	
<p>Date & Time: Fri, Mar 20, 2020, 07:37:19 EDT Position: +037.132634° / -080.132270° (±32.8M) Altitude: 2610ft (±39.4M) Datum: WGS-84 Azimuth/Bearing: 162° S18E 3280ft/mile True (±148°) Elevation Grade: -016% Horizon Grade: +006% Zoom: 1.0X 12974+29 Stream S-Q20 on access road RO-288</p>

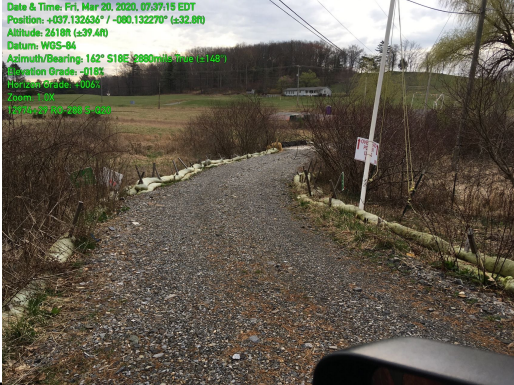
GPS Location	See pic for GPS location		GPS Location	See pic for GPS location	
Field Station#	12974+29		Field Station#	13033+59	
Pic 5 Desc.	Stream S-Q20 on access road RO-288		Pic 6 Desc.	No rain accumulation in the rain gauge for Callaway Road.

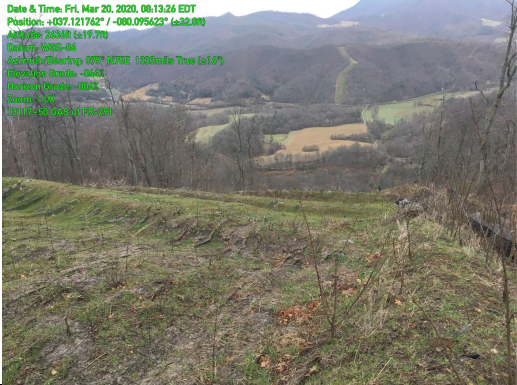
GPS Location	See pic for GPS location		GPS Location	See pic for GPS location	
Field Station#	13117+50		Field Station#	13114+50	
Pic 7 Desc.	GAS of FR-291 has not been graded and remains in temporary stabilization condition.		Pic 8 Desc.	Permanent restoration remains in good condition on the CIS of FR-291.

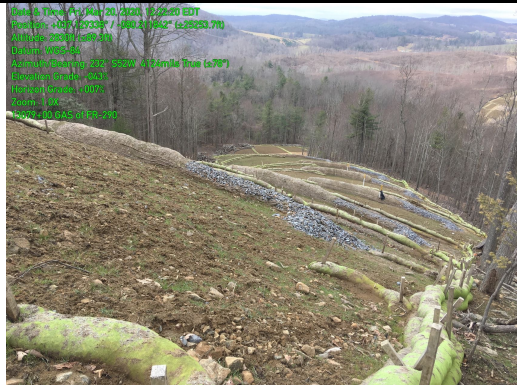
GPS Location	See pic for GPS location		GPS Location	See pic for GPS location	
Field Station#	13079+00		Field Station#	13082+50	
Pic 11 Desc.	No maintenance issues found in the area.		Pic 12 Desc.	Permanent Slope Breakers and level spreaders remain in compliance.

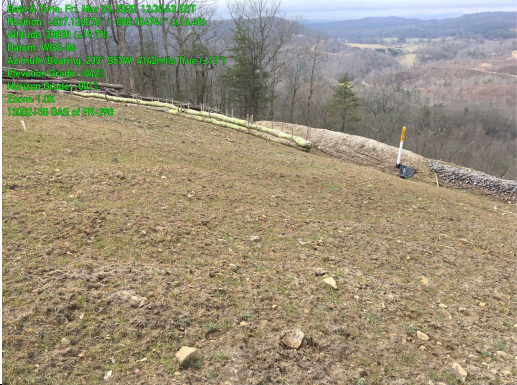
GPS Location	See pic for GPS location		GPS Location	See pic for GPS location	
Field Station#	13082+50		Field Station#	13087+00	
Pic 13 Desc.	No erosion issues found in the area.		Pic 14 Desc.	No off ROW impacts found in the area.

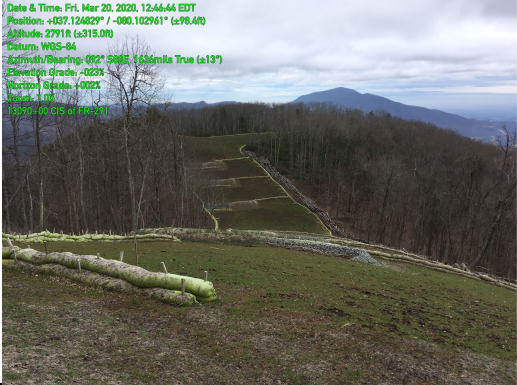
GPS Location	See pic for GPS location		GPS Location	See pic for GPS location	
Field Station#	13090+00		Field Station#	13038+00	
Pic 15 Desc.	Good vegetation growth throughout the area.		Pic 16 Desc.	Area remains in temporary stabilized condition.

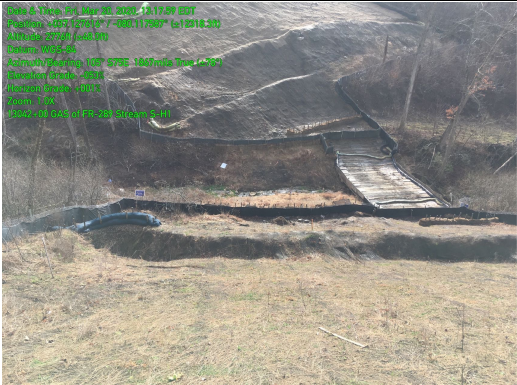
GPS Location	See pic for GPS location		GPS Location	See pic for GPS location	
Field Station#	13042+00		Field Station#	13025+00	
Pic 17 Desc.	No stream impacts observed at stream S-H1.		Pic 18 Desc.	No issues or impacts observed on the GAS of the BRP or streams S-G24 and S-G25.

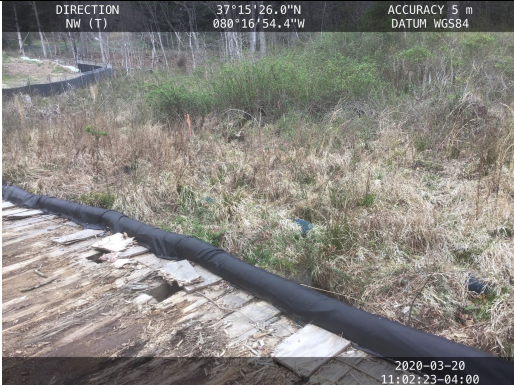
GPS Location	See photo		GPS Location	See photo	
Field Station#	12121+33		Field Station#	12121+88	
Pic 1 Desc.	Stream S-C33, facing northwest, upstream		Pic 2 Desc.	Stream S-C36, facing northwest, upstream

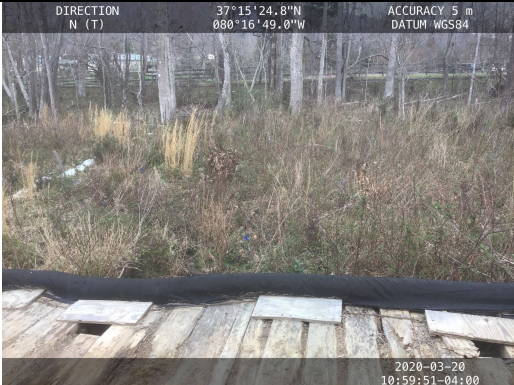
GPS Location	See photo		GPS Location	See photo	
Field Station#	12125+65		Field Station#	12132+73	
Pic 3 Desc.	Stream S-MM31, facing north, upstream		Pic 4 Desc.	Stream S-C29, facing southeast

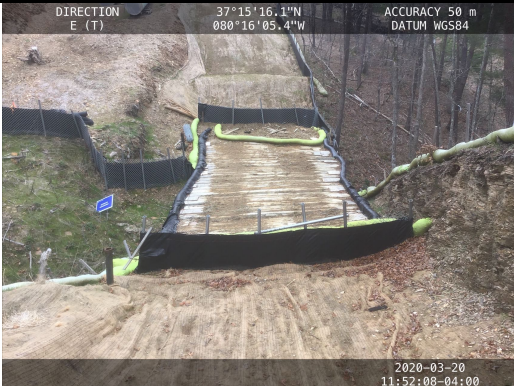
GPS Location	See photo		GPS Location	See photo	
Field Station#	12163+05		Field Station#	12166+47	
Pic 5 Desc.	Stream S-C25, facing east		Pic 6 Desc.	Stream S-C24, facing east

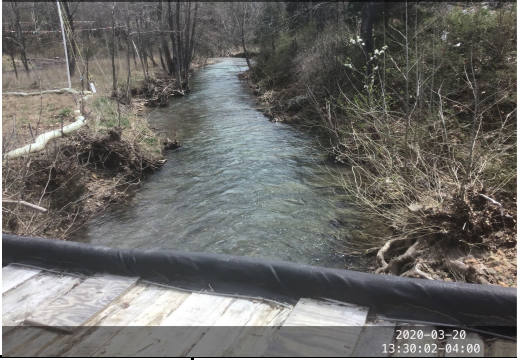
<small>37°15'06.4"N 080°15'28.1"W ACCURACY 5 m DATUM WGS84</small> <small>2020-03-20 13:32:25-04:00</small>			
GPS Location	See photo		GPS Location	See photo	
Field Station#	12192+50		Field Station#	12196+50	
Pic 7 Desc.	Stream S-C21, Bradshaw Creek, facing southwest, downstream		Pic 8 Desc.	Stream S-OO11, facing east	
Insert image here			Insert image here		
GPS Location			GPS Location		
Field Station#			Field Station#		
Pic 9 Desc.			Pic 10 Desc.		
Insert image here			Insert image here		
GPS Location			GPS Location		
Field Station#			Field Station#		
Pic 11 Desc.			Pic 12 Desc.
