Visual Site Inspection Report

Project Name	H-600 Pipeline Spread H	AFE	124300138	Spread	H-600 Pipeline Spread H
Contractor	Precision			Report #	9981
Inspector	Pat Davis			Date/Time	4/13/2020 4:00 PM
Permit #	TBD	Inspection Type	VA SWPP	Station Begin	+0
State	VA	Inspection Area	Partial	Station End	+0
County	Montgomery	Ground	Wet	Temperature (°F)	66.00
Municipality	N/A	Weather	Light Rain	Rain Gauge (in)	2.30
				Rain Accumulation Time (days)	0.00

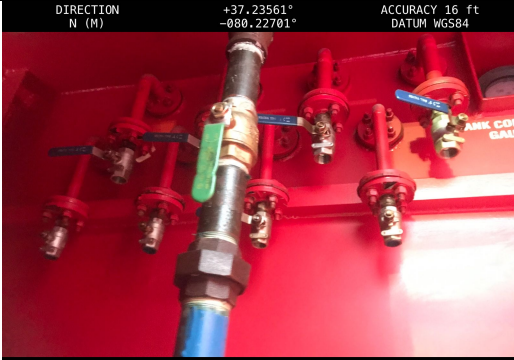
GPS Location	MVP-PY-006 See photo for gps data		GPS Location	MVP-PY-006 See photo for gps data	
Field Station#	+0		Field Station#	+0	
Pic 3 Desc.	No fuel spills south of the blue bulk fuel tanks. Looking W.		Pic 4 Desc.	Blue Bulk Fuel tanks no leaky internal fittings. Looking NW.

<p>DIRECTION N (M) +37.23561° -080.22701° ACCURACY 16 ft DATUM WGS84</p> <p>MVP-PY-006_041320 No leaky internal fittings 2020-04-13 07:32:25-04:00</p>

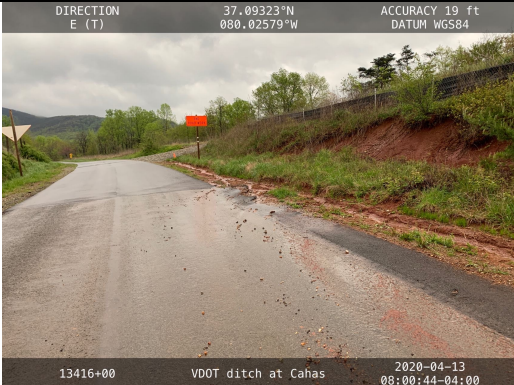
GPS Location	See photo for gps location data.		GPS Location	See photo for gps location data.	
Field Station#	13416+50		Field Station#	13414+00	
Pic 3 Desc.	Photo shows the sediment on Cahas Mountain Road. Sediment is from poorly graded road side ditch.		Pic 4 Desc.	Photo shows the bridge over stream S-IJ2.

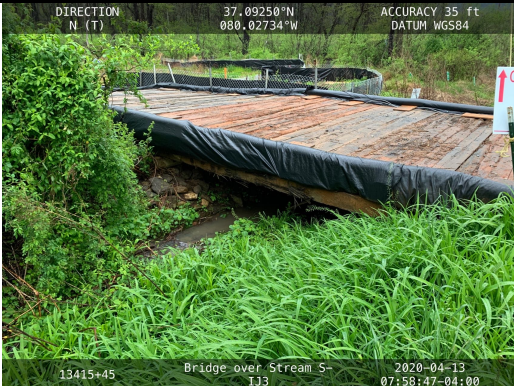
GPS Location	See photo for gps location data.		GPS Location	See photo for gps location data.	
Field Station#	13415+45		Field Station#	13413+20	
Pic 5 Desc.	Photo shows the bridge over stream S-IJ3.		Pic 6 Desc.	Photo shows the bridge over stream S-IJ1.

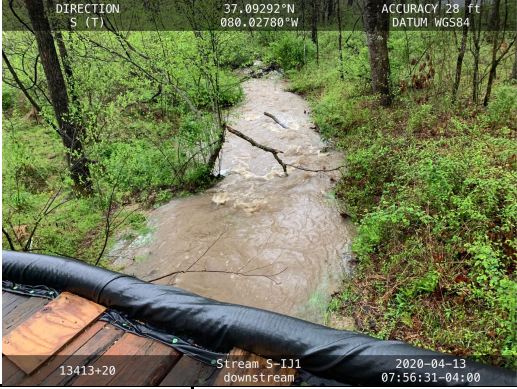
<p>DIRECTION S (T) 37.09292°N 080.02780°W ACCURACY 28 ft DATUM WGS84</p> <p>13413+20 Stream S-IJ1 downstream 2020-04-13 07:56:31-04:00</p>

<p>DIRECTION W (T) 37.10115°N 080.03957°W ACCURACY 22 ft DATUM WGS84</p> <p>13358+64 Bridge over S-RR11 2020-04-13 09:31:32-04:00</p>			
GPS Location	See photo for gps location data.		GPS Location	See photo for gps location data.	
Field Station#	13413+00		Field Station#	13358+70	
Pic 7 Desc.	Photo shows stream S-IJ1, downstream from the ROW.		Pic 8 Desc.	Photo shows the bridge over stream S-RR11.

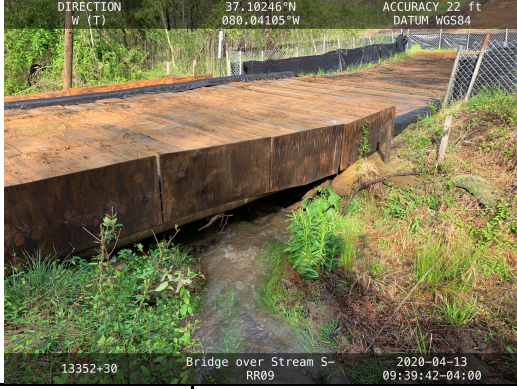
<p>DIRECTION W (T) 37.10246°N 080.04105°W ACCURACY 22 ft DATUM WGS84</p> <p>13352+30 Bridge over Stream S-RR09 2020-04-13 09:39:42-04:00</p>

GPS Location	See photo for gps location data.		GPS Location	See photo for gps location data.	
Field Station#	13352+30		Field Station#	13348+46	
Pic 9 Desc.	Photo shows the bridge over stream S-RR09.		Pic 10 Desc.	Photo shows stream S-RR08 downstream from the ROW crossing.

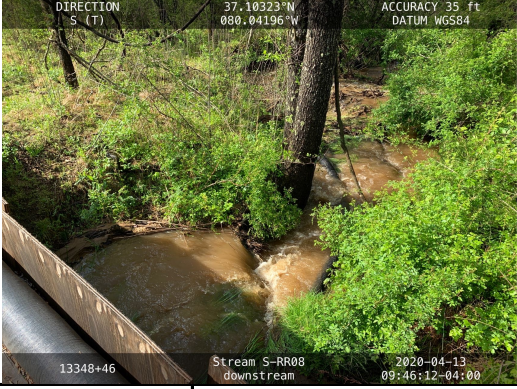
<p>DIRECTION S (T) 37.10323°N 080.04196°W ACCURACY 35 ft DATUM WGS84</p> <p>13348+46 Stream S-RR08 downstream 2020-04-13 09:46:12-04:00</p>

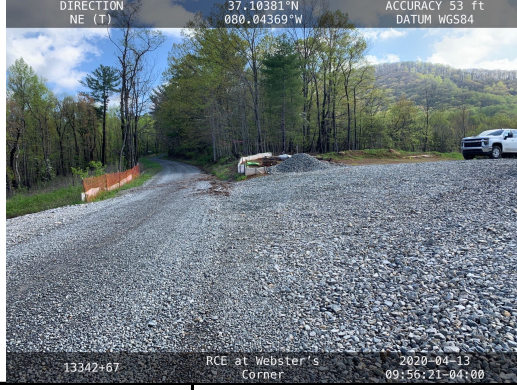
<p>DIRECTION NE (T) 37.10381°N 080.04369°W ACCURACY 53 ft DATUM WGS84</p> <p>13342+67 RCE at Webster's Corner 2020-04-13 09:56:21-04:00</p>

<p>DIRECTION W (T) 37.10439°N 080.04540°W ACCURACY 213 ft DATUM WGS84</p> <p>13337+13 Bridge over Stream S-GH9 2020-04-13 10:02:52-04:00</p>			
GPS Location	See photo for gps location data.		GPS Location	See photo for gps location data.	
Field Station#	13342+67		Field Station#	13337+20	
Pic 11 Desc.	Photo shows the RCE at the Webster's Corner Road crossing.		Pic 12 Desc.	Photo shows the bridge over stream S-GH9.

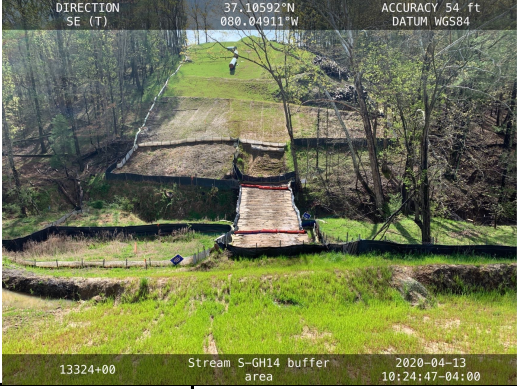
GPS Location	See photo for gps location data.		GPS Location	See photo for gps location data.	
Field Station#	13324+00		Field Station#	13322+00	
Pic 15 Desc.	Photo shows the ROW condition and buffer adjacent to stream S-GH14.		Pic 16 Desc.	Photo shows the ROW conditions and stream buffer adjacent to stream S-GH15

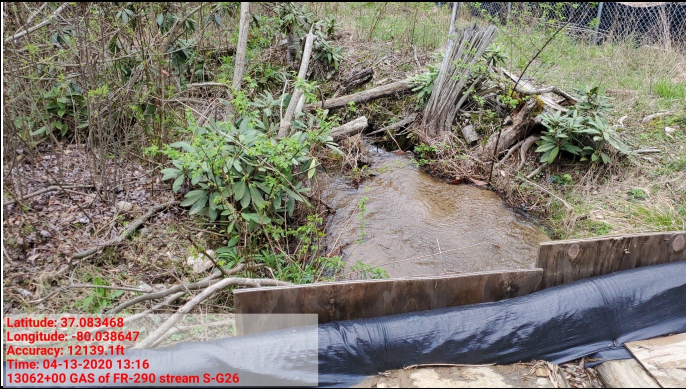
<p>Latitude: 37.083468 Longitude: -80.038647 Accuracy: 12139.1ft Time: 04-13-2020 13:16 13062+00 GAS of FR-290 stream S-G26</p>

<p>Latitude: 37.126908 Longitude: -80.111223 Elevation: 2666.24ft Accuracy: 19.7ft Time: 04-13-2020 13:15 13063+00 GAS of FR-290 stream S-G27</p>		
GPS Location	See pic for GPS location		GPS Location	See pic for GPS location	
Field Station#	13062+00		Field Station#	13063+00	
Pic 13 Desc.	No stream impacts observed at stream S-G26.		Pic 14 Desc.	No stream impacts observed at stream S-G27.

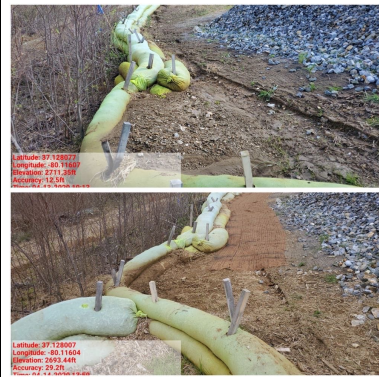
Field Station#	13046+50		Field Station#	13047+00	
Pic 15 Desc.	Triple stacked CFS needs maintenance performed.		Pic 16 Desc.	Triple stacked CFS undermined from the storm event.

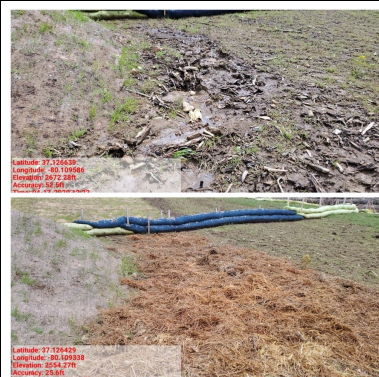
<p>Latitude: 37.126439 Longitude: -80.127467 Elevation: 2777.49ft Accuracy: 26.2ft Time: 04-13-2020 13:16</p>		
GPS Location	See pic for GPS location		GPS Location	See pic for GPS location	
Field Station#	13067+00		Field Station#	13075+00	
Pic 17 Desc.	Erosion needs repaired in the restored area on the GAS of FR-290.		Pic 18 Desc.	Triple stacked CFS needs maintenance on the GAS of FR-290.

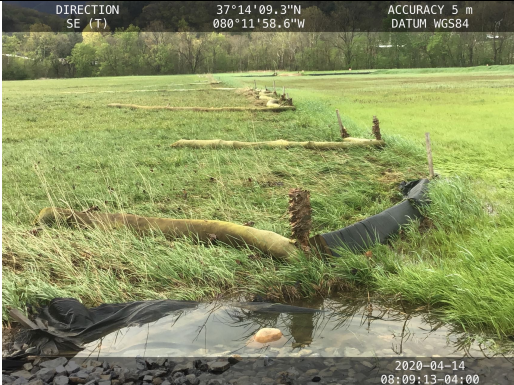
GPS Location	See photo		GPS Location	See photo	
Field Station#	12425+00		Field Station#	12543+00	
Pic 1 Desc.	Flood waters have receded on the going away side of MVP-MN-279 which makes the displaced CFS visible.		Pic 2 Desc.	Plastic sheeting remains secure on stockpiles nearest to Yellow Finch Road.

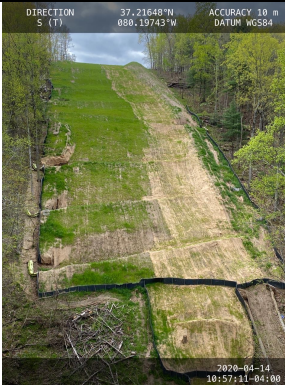
GPS Location	See photo		GPS Location	See photo	
Field Station#	12529+00		Field Station#	12522+00	
Pic 3 Desc.	Plastic sheeting has been displaced approximately 1500 feet to the coming in side of Yellow Finch Road and needs maintenance.		Pic 4 Desc.	The slope on the going away side of stream S-EF19 remains stable.

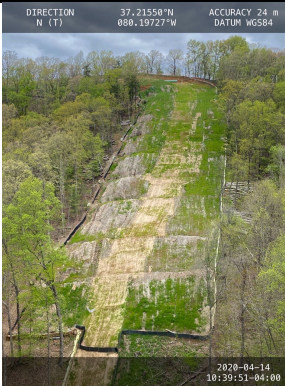
GPS Location	See photo		GPS Location	See photo	
Field Station#	12519+41		Field Station#	12517+00	
Pic 5 Desc.	Stream S-EF19, facing southwest, downstream		Pic 6 Desc.	The slope on the coming in side of stream S-EF19 remains stable.

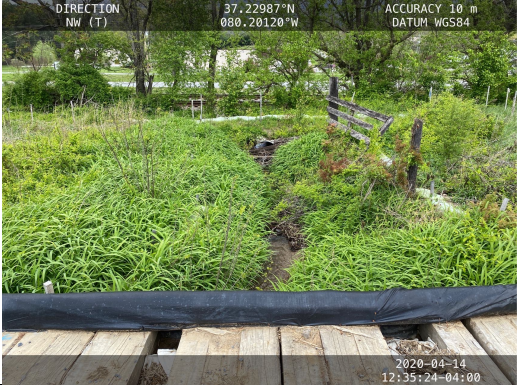
GPS Location	See photo	GPS Location	See photo		
Field Station#	12455+21	Field Station#	12129+00		
Pic 7 Desc.	Stream S-CD12, facing northwest, downstream	Pic 8 Desc.	An environmental crew added more plastic sheeting to an area where it had been opened up.		
Insert image here		Insert image here			
GPS Location		GPS Location			
Field Station#		Field Station#			
Pic 9 Desc.		Pic 10 Desc.			
Insert image here		Insert image here			
GPS Location		GPS Location			
Field Station#		Field Station#			
Pic 11 Desc.		Pic 12 Desc.

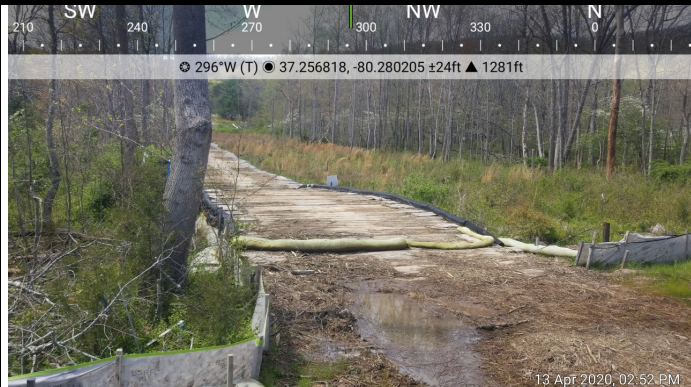
GPS Location	See Above		GPS Location	See Above	
Field Station#	12126+00		Field Station#	12139+36	
Pic 1 Desc.	Stream S-MM31, Looking NorthWest.		Pic 2 Desc.	Wetland W-C6, Looking East.

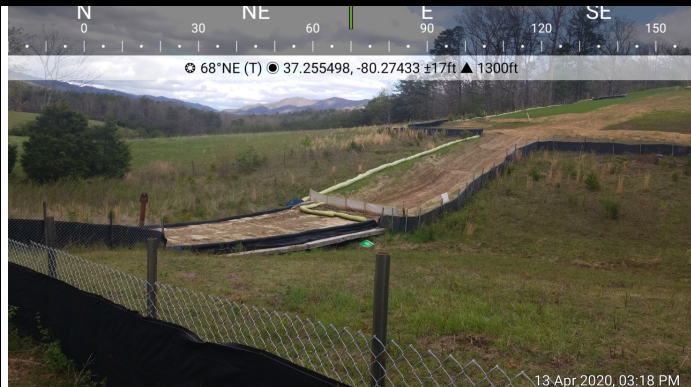
GPS Location	See Above		GPS Location	See Above	
Field Station#	12143+59		Field Station#	12158+00	
Pic 3 Desc.	Wetland W-C5, Looking East.		Pic 4 Desc.	Near Headwaters on Stream S-C23, Looking SouthEast.

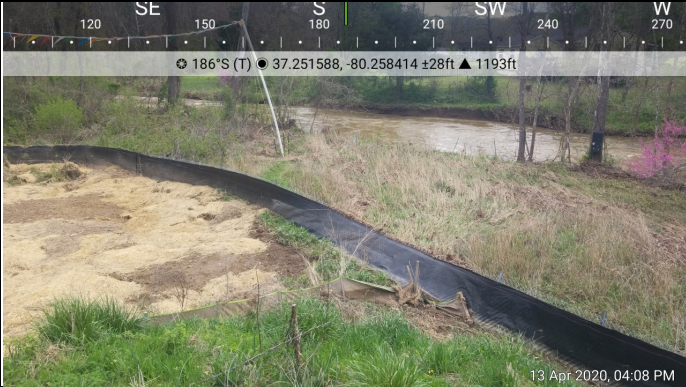
Insert image here			
GPS Location	See Above	GPS Location	See Above		
Field Station#	12194+00	Field Station#			
Pic 7 Desc.	Punchlist Item. Supersiltfence and P1 siltfence require repair near Stream S-C21.	Pic 8 Desc.			
Insert image here		Insert image here			
GPS Location		GPS Location			
Field Station#		Field Station#			
Pic 9 Desc.		Pic 10 Desc.			
Insert image here		Insert image here			
GPS Location		GPS Location			
Field Station#		Field Station#			
Pic 11 Desc.		Pic 12 Desc.

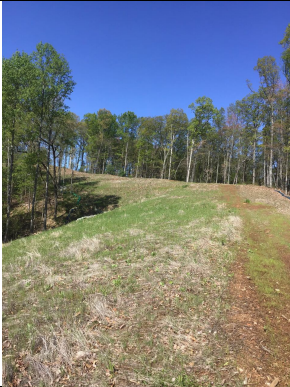
GPS Location	0000	GPS Location	0000		
Field Station#	13590+00	Field Station#	13592+00		
Pic 1 Desc.	Erosion at start of natural drain, recommend installing erosion blanket	Pic 2 Desc.	Row photo showing vegetation while inspecting areas of row

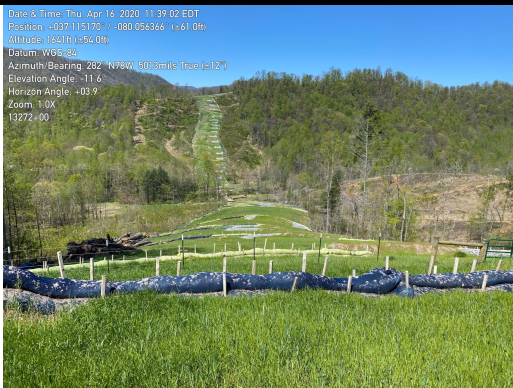
GPS Location		See photo for coordinates.		GPS Location	
Field Station#		13309+09		Field Station#	
Pic 3 Desc.		S-GH7, upstream side of equipment bridge, native stream material depositing under bridge on right descending bank.		Pic 4 Desc.	
				ROW restored, good vegetative cover noted across LOD.	
<p>Date & Time: Thu Apr 16, 2020, 11:39:02 EDT Position: -037.111372, -080.056366, 1561.01ft Altitude: 1541ft (-52.0ft) Datum: WGS 84 Azimuth/Bearing: 282° N78W, 501mils True (-12) Elevation Angle: +11.6° Horizon Angle: +03.9° Zoom: 1.0X 13272+00</p>

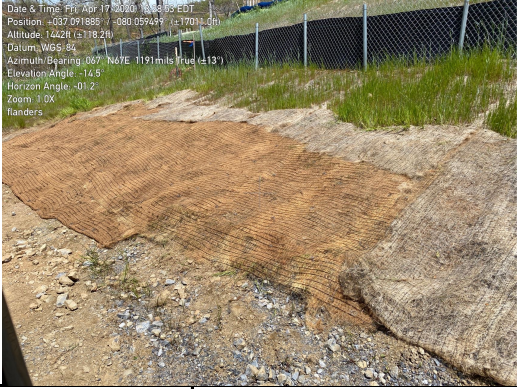
Insert image here			
GPS Location	See photo for coordinates.		GPS Location		
Field Station#	13262+50		Field Station#		
Pic 7 Desc.	Flanders Road, ground disturbance repaired with erosion control blanket and re-seeded.		Pic 8 Desc.		
Insert image here			Insert image here		
GPS Location			GPS Location		
Field Station#			Field Station#		
Pic 9 Desc.			Pic 10 Desc.		
Insert image here			Insert image here		
GPS Location			GPS Location		
Field Station#			Field Station#		
Pic 11 Desc.			Pic 12 Desc.

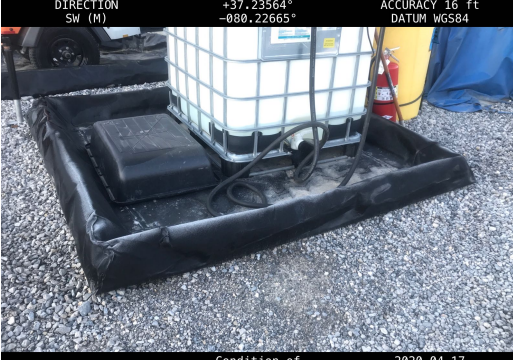
GPS Location	MVP-PY_006 See photo for gps data	GPS Location	MVP-PY_006 See photo for gps data		
Field Station#	+0	Field Station#	+0		
Pic 3 Desc.	No loose trash around dumpsters. Looking SE.	Pic 4 Desc.	Condition of containment under DEF tank. Looking SW.

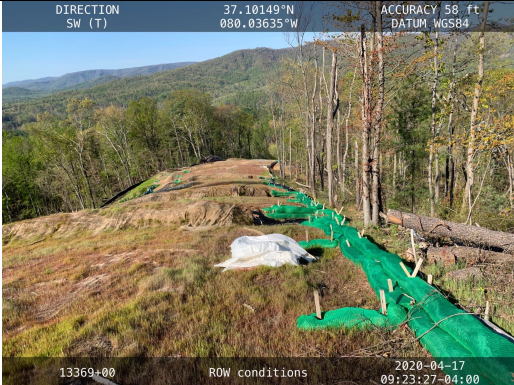
GPS Location	See photo for gps location data.		GPS Location	See photo for gps location data.	
Field Station#	13369+00		Field Station#	13382+00	
Pic 1 Desc.	Photo shows the ROW condition from about 13365+00 to 13369+00.		Pic 2 Desc.	Photo shows the ROW condition from about 13376+00 to 13382+00.

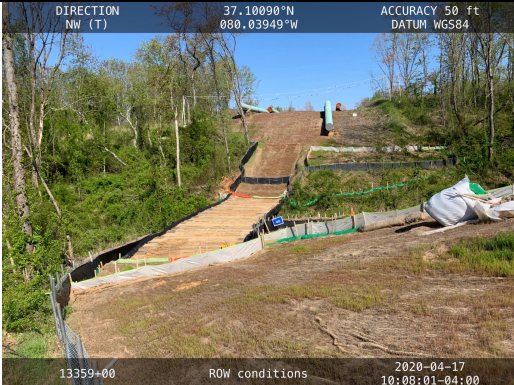
GPS Location	See photo for gps location data.		GPS Location	See photo for gps location data.	
Field Station#	13359+00		Field Station#	13358+64	
Pic 3 Desc.	Photo bridge over stream S-RR11 and adjacent ROW conditions.		Pic 4 Desc.	Photo shows stream S-RR11 downstream from the ROW crossing.

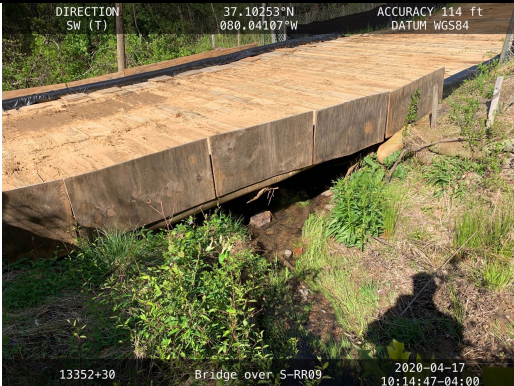
GPS Location	See photo for gps location data.		GPS Location	See photo for gps location data.	
Field Station#	13352+30		Field Station#	13352+23	
Pic 5 Desc.	Photo shows the bridge over stream S-RR09.		Pic 6 Desc.	Photo shows stream S-RR09 downstream from the ROW.

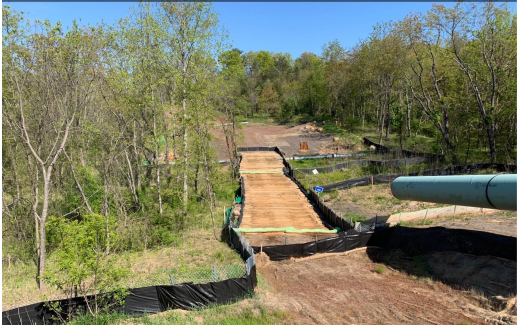
13348+46 Stream S-RR08 downstream 2020-04-17 10:10:30-04:00			
GPS Location	See photo for gps location data.		GPS Location	See photo for gps location data.	
Field Station#	13350+00		Field Station#	13348+46	
Pic 7 Desc.	Photo shows the bridge over stream S-RR08 and adjacent ROW condition.		Pic 8 Desc.	Photo shows stream S-RR08 downstream from the ROW.	
DIRECTION SE (T) 37.10632°N 080.05050°W ACCURACY 15 ft DATUM WGS84

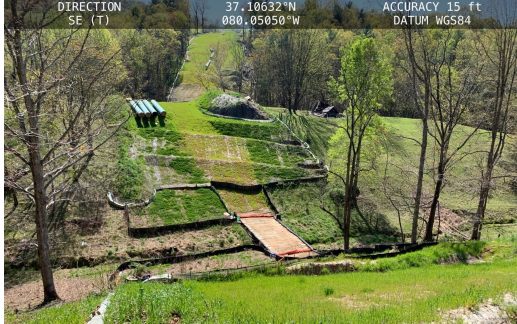
Field Station#	13319+00		Field Station#	13321+60	
Pic 9 Desc.	Photo shows the ROW conditions from about 13319+00 to 13324+00.		Pic 10 Desc.	Photo shows the bridge over stream S-GH15.	
DIRECTION E (T) 37.10604°N 080.04945°W ACCURACY 190 ft DATUM WGS84

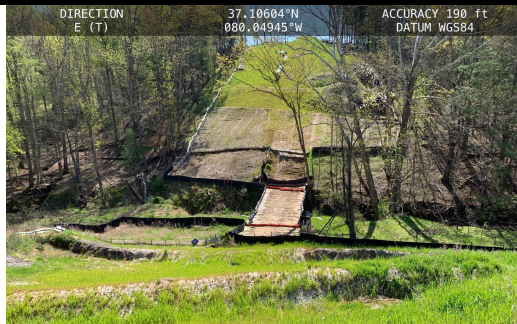
13325+25 Bridge over Stream S-GH14 2020-04-17 10:47:37-04:00			
GPS Location	See photo for gps location data.		GPS Location	See photo for gps location data.	
Field Station#	13324+00		Field Station#	13325+25	
Pic 11 Desc.	Photo shows the bridge over stream S-GH14 and adjacent ROW conditions.		Pic 12 Desc.	Photo shows the bridge over stream S-GH14.

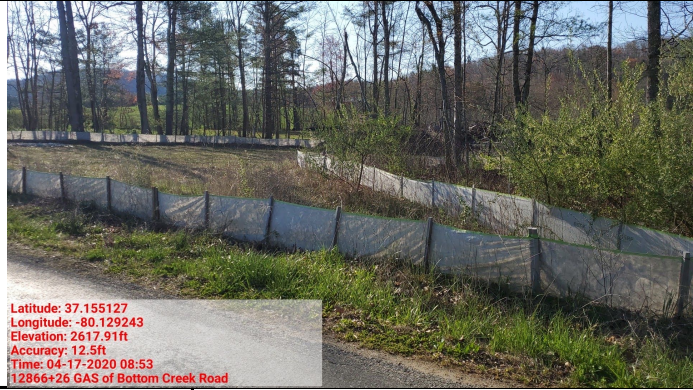
<p>Latitude: 37.155136 Longitude: -80.129243 Elevation: 2620.31ft Accuracy: 12.5ft Time: 04-17-2020 08:55 12866+26 CIS of Bottom Creek Road</p>		
GPS Location	See pic for GPS location		GPS Location	See pic for GPS location	
Field Station#	12866+26		Field Station#	12866+26	
Pic 1 Desc.	No issues or impacts observed on the GAS of Bottom Creek Road.		Pic 2 Desc.	No issues or impacts observed on the CIS of Bottom Creek Road.

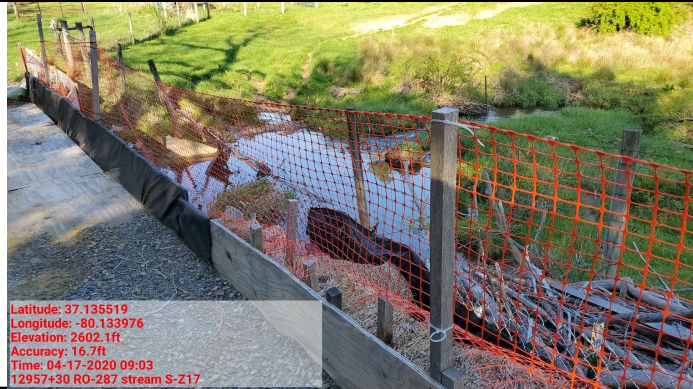
GPS Location	See pic for GPS location		GPS Location	See pic for GPS location	
Field Station#	12957+30		Field Station#	12957+30	
Pic 3 Desc.	Stream S-Z17 where it crosses access road RO-287. No issues or impacts to report.		Pic 4 Desc.	Stream S-Z16 where it crosses access road RO-287. No issues to report.

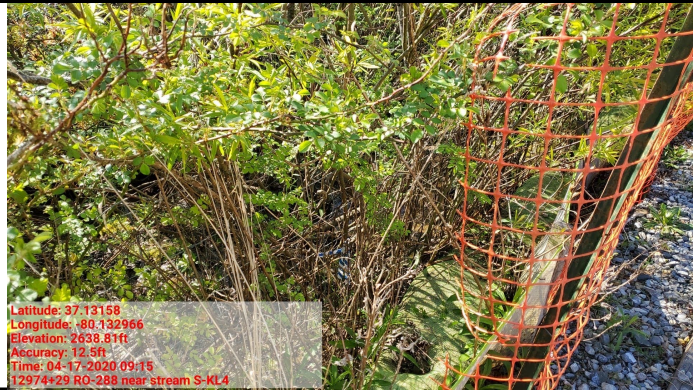
<p>Latitude: 37.132655 Longitude: -80.130853 Elevation: 422.9ft Accuracy: 422.9ft Time: 04-17-2020 09:25 12974+29 RO-288 near stream S-Q20</p>		
GPS Location	See pic for GPS location		GPS Location	See pic for GPS location	
Field Station#	12974+29		Field Station#	12974+29	
Pic 5 Desc.	Stream S-KL4. No issues or impacts observed.		Pic 6 Desc.	Access road RO-288 and stream crossing S-Q20.

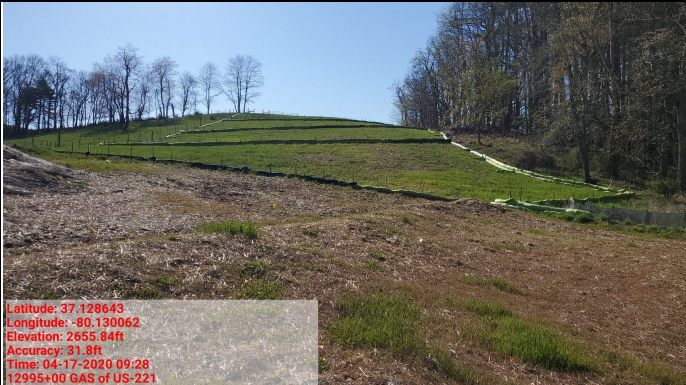
<p>Latitude: 37.12559 Longitude: -80.124588 Elevation: 2704.23ft Accuracy: 12.8ft Time: 04-17-2020 09:31 13015+00 GAS of the BRP</p>		
GPS Location	See pic for GPS location		GPS Location	See pic for GPS location	
Field Station#	12995+00		Field Station#	13015+00	
Pic 7 Desc.	Restoration performed on the GAS of US-221.		Pic 8 Desc.	Substantial vegetation growth on the BRP.

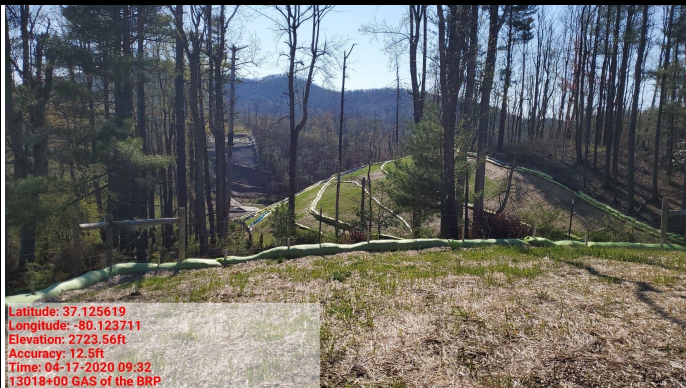
Field Station#	13018+00		Field Station#	13025+00	
Pic 9 Desc.	Permanent vegetation in the wooded portion of the BRP.		Pic 10 Desc.	No stream impacts or maintenance issues observed at streams S-G24 and S-G25.

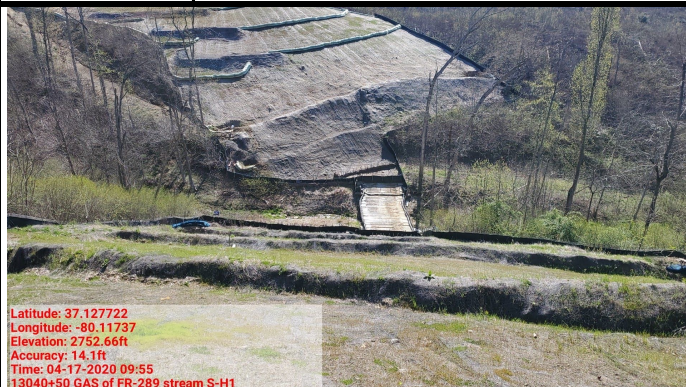
<p>Latitude: 37.127043 Longitude: -80.111494 Elevation: 2618.24ft Accuracy: 12.5ft Time: 04-17-2020 10:16 13062+00 GAS of FR-290 stream S-G26</p>		
GPS Location	See pic for GPS location		GPS Location	See pic for GPS location	
Field Station#	13040+50		Field Station#	13062+00	
Pic 11 Desc.	No issues or impacts observed near stream S-H1.		Pic 12 Desc.	No stream impacts or maintenance issues observed near stream S-G26.

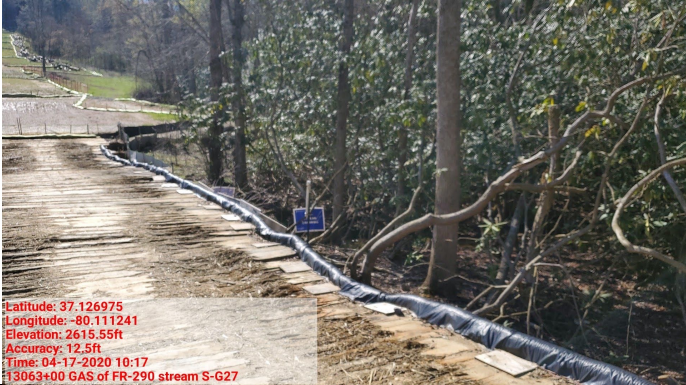
<p>Insert image here</p>			
GPS Location	See pic for GPS location		GPS Location		
Field Station#	13063+00		Field Station#		
Pic 13 Desc.	No stream impacts or maintenance issues observed near stream S-G27.		Pic 14 Desc.		
<p>Insert image here</p>			<p>Insert image here</p>		
GPS Location			GPS Location		
Field Station#			Field Station#		
Pic 15 Desc.			Pic 16 Desc.		
<p>Insert image here</p>			<p>Insert image here</p>		
GPS Location			GPS Location		
Field Station#			Field Station#		
Pic 17 Desc.			Pic 18 Desc.

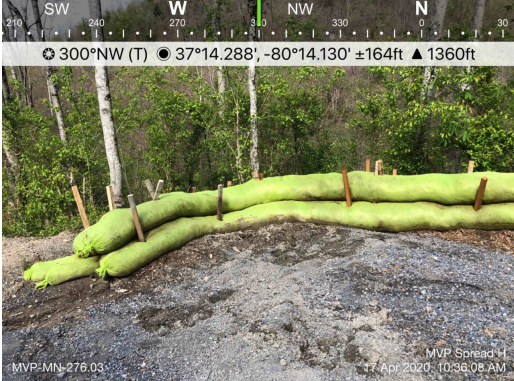
GPS Location	See Picture Watermark		GPS Location	See Picture Watermark	
Field Station#	12234+50		Field Station#	12234+50	
Pic 1 Desc.	MVP-MN-276.03 controls have been cleaned out, and are in good/functional condition.		Pic 2 Desc.	MVP-MN-276.03 controls are in good condition, and remain functional.

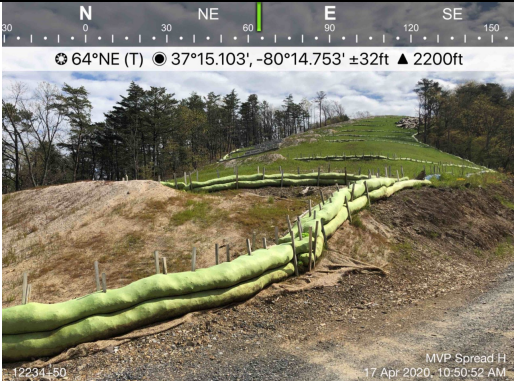
GPS Location	See Picture Watermark		GPS Location	See Picture Watermark	
Field Station#	12234+50		Field Station#	12241+50	
Pic 3 Desc.	Start of inspection. Controls and vegetation on this slope are in good condition.		Pic 4 Desc.	ROW is well vegetated and in good condition.

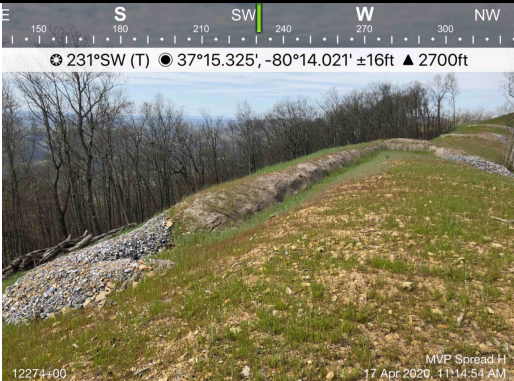
GPS Location	See Picture Watermark		GPS Location	See Picture Watermark	
Field Station#	12274+00		Field Station#	12275+00	
Pic 5 Desc.	Permanent waterbar and end treatments on Reese Mountain ridge line are in good condition and appear functional.		Pic 6 Desc.	Tree remains down on ROW. Controls are not damaged by downed tree, and remain functional.

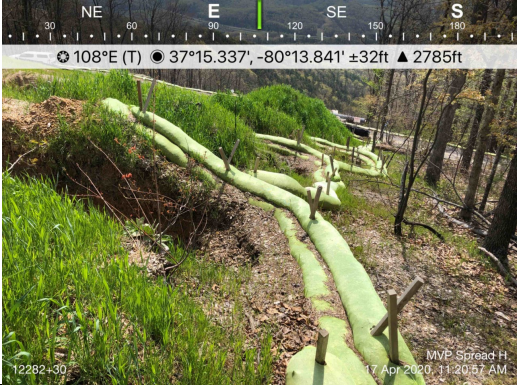
GPS Location	See Picture Watermark		GPS Location	See Picture Watermark	
Field Station#	12282+30		Field Station#	12284+50	
Pic 7 Desc.	Sump pit and end treatments in good condition on CIS slope of Reese Mntn. "V".		Pic 8 Desc.	ROW controls at MVP-MN-276.03 crossing in good condition.

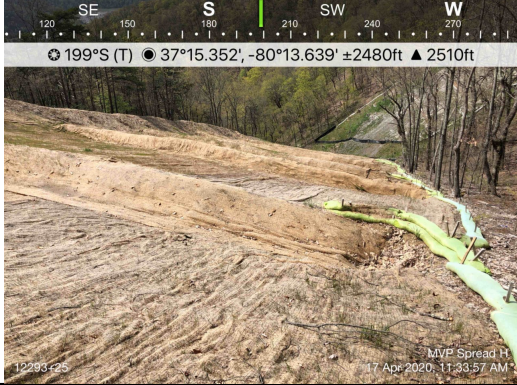
GPS Location	See Picture Watermark		GPS Location	See Picture Watermark	
Field Station#	12293+25		Field Station#	12300+25	
Pic 9 Desc.	Waterbars and ROW in good condition on GAS Reese Mntn. "V".		Pic 10 Desc.	Perimeter controls along ROW are in good condition.

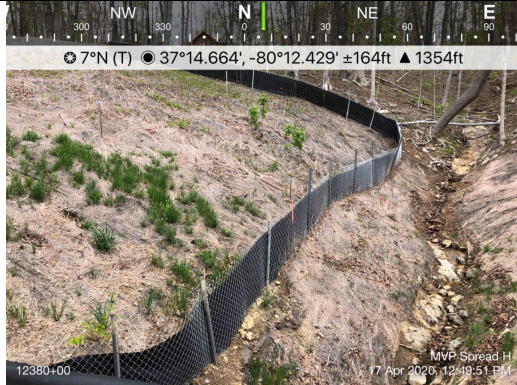
GPS Location	See Picture Watermark		GPS Location	See Picture Watermark	
Field Station#	12380+00		Field Station#	12382+30	
Pic 11 Desc.	Buffer area and controls at S-NN19 are in good condition.		Pic 12 Desc.	Equipment bridge and drainage channel are in good condition.

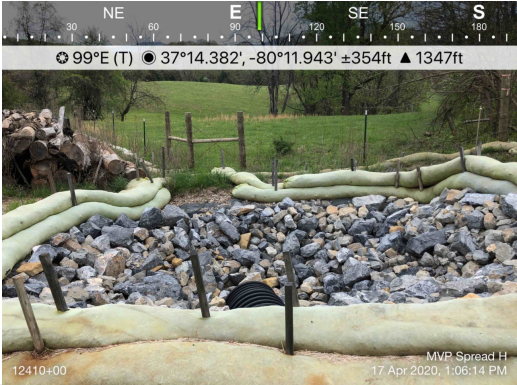
GPS Location	See Picture Watermark		GPS Location	See Picture Watermark	
Field Station#	12410+00		Field Station#	12420+00	
Pic 15 Desc.	CWD plunge pool outlet in good condition and free of sediment/material.		Pic 16 Desc.	ROW is well vegetated and control are in good condition.

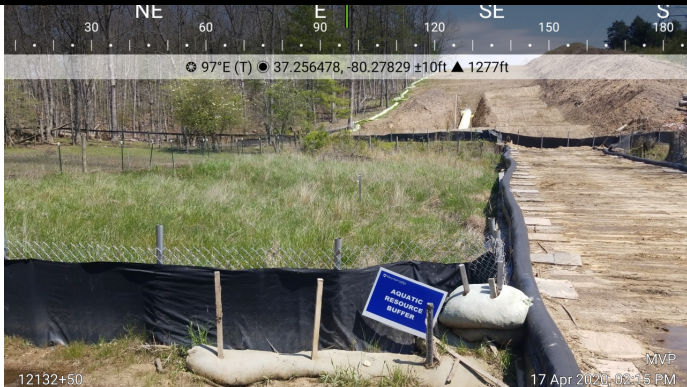
GPS Location	See Above		GPS Location	See Above	
Field Station#	12132+50		Field Station#	12151+00	
Pic 1 Desc.	Stream S-C29, Looking East.		Pic 2 Desc.	Temporary vegetation remains stable and ECDs are functional.

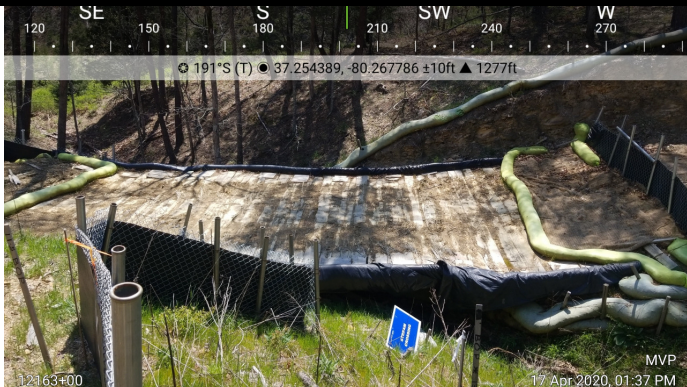
GPS Location	See Above		GPS Location	See Above	
Field Station#	12163+00		Field Station#	12167+00	
Pic 3 Desc.	Stream S-C25, Looking South.		Pic 4 Desc.	Stream S-C24, Looking West.

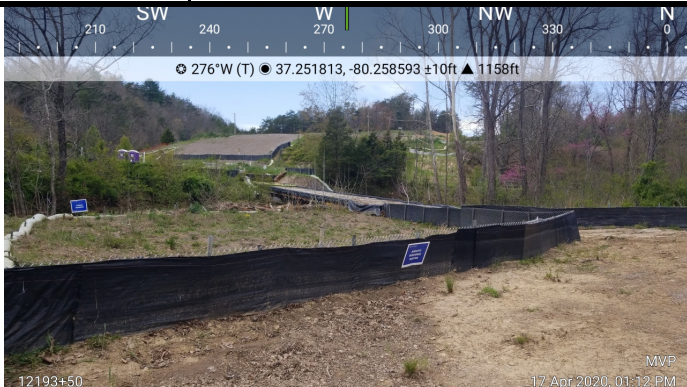
GPS Location	See Above		GPS Location	See Above	
Field Station#	12193+50		Field Station#	12199+00	
Pic 5 Desc.	Stream S-C21, Looking West.		Pic 6 Desc.	Temporary vegetation remains stable and ECDs are functional.
