Visual Site Inspection Report

Project Name	H-600 Pipeline Spread H	AFE	124300138	Spread	H-600 Pipeline Spread H
Contractor	Precision	Report #	10835		
Inspector	Pat Davis	Date/Time	5/11/2020 4:00 PM		
Permit #	TBD	Inspection Type	VA SWPP	Station Begin	+0
State	VA	Inspection Area	Partial	Station End	+0
County	Montgomery	Ground	Dry	Temperature (°F)	52.00
Municipality	N/A	Weather	Cloudy	Rain Gauge (in)	0.00
				Rain Accumulation Time (days)	0.00

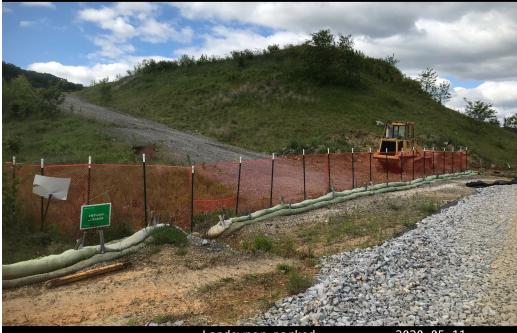
<small>MVP-LY-049_051120</small> <small>Landowner parked equipment</small> <small>2020-05-11 10:22:19-04:00</small>		<small>MVP-LY-049_051120</small> <small>Condition of CFS & safety fence</small> <small>2020-05-11 10:25:37-04:00</small>			
GPS Location	MVP-LY-049 See photo for gps data		GPS Location	MVP-LY-049 See photo for gps data	
Field Station#	+0		Field Station#	+0	
Pic 7 Desc.	Landowner has parked 2nd piece of equipment close to feature. No impacts. Looking SW.		Pic 8 Desc.	Condition of compost filter sock and safety fence along south LOD. Looking W.	
Insert image here			Insert image here

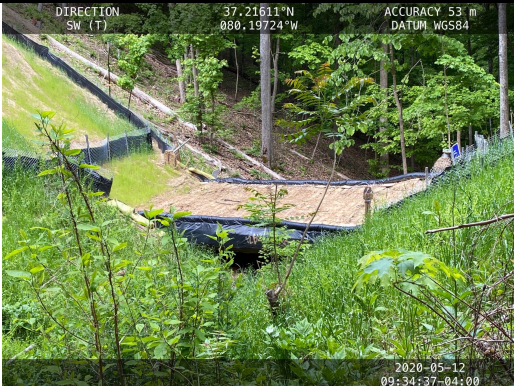
GPS Location	See photo		GPS Location	See photo	
Field Station#	12534+00		Field Station#	12529+00	
Pic 3 Desc.	Unstabilized logging roads adjacent to MVP ROW exhibit rill erosion.		Pic 4 Desc.	Plastic sheeting approximately 1500 feet from Yellow Finch Road remains intact and functional.

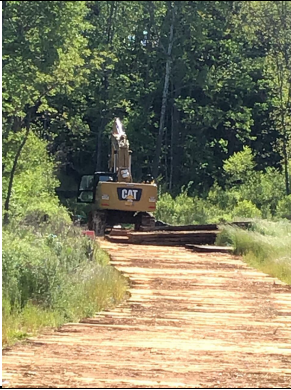
GPS Location	0000	GPS Location	000		
Field Station#	13659+03	Field Station#	13666+27		
Pic 1 Desc.	Contractor completing maintenance repairs to equipment bridge		Pic 2 Desc.	Contractor working to install new geo tech to bridge

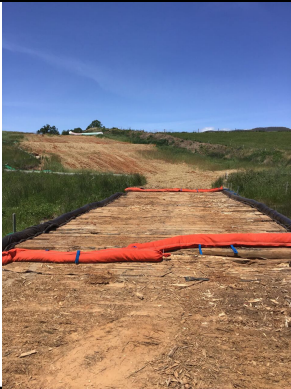
GPS Location	0000	GPS Location	00000		
Field Station#	13666+27	Field Station#	13666+27		
Pic 3 Desc.	Equipment bridge after being repaired and splash protection replaced		Pic 4 Desc.	Photo showing hill side seeded and mulched during maintenance activities throughout the row	
Insert image here			Insert image here		
GPS Location		GPS Location			
Field Station#		Field Station#			
Pic 5 Desc.			Pic 6 Desc.

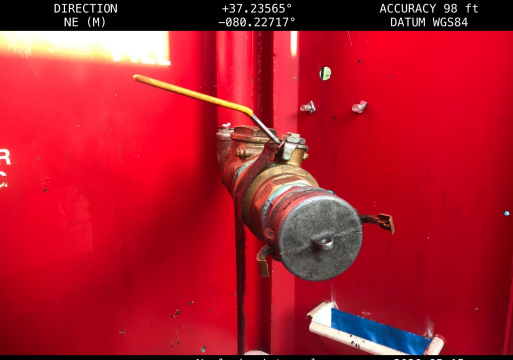
<p>DIRECTION NE (M) +37.23565° -080.22717° ACCURACY 98 ft DATUM WGS84</p> <p>MVP-PY-006_051520 No leaky internal fittings 2020-05-15 07:42:48-04:00</p>			
GPS Location	MVP-PY-006 See photo for gps data		GPS Location	MVP-PY-006 See photo for gps data	
Field Station#	+0		Field Station#	+0	
Pic 5 Desc.	Blue Bulk Fuel tanks no leaky internal fittings. Looking W.		Pic 6 Desc.	Off Road Fuel unit no leaky internal fittings. Looking NE.

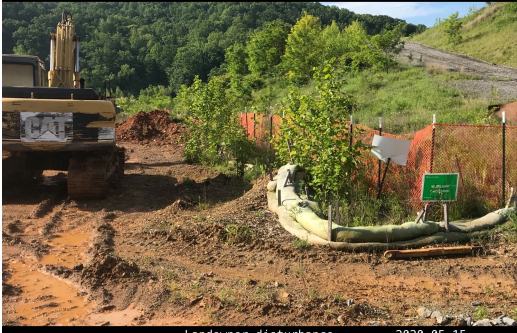
<small>+37.27029° -080.12469°</small> <small>ACCURACY 33 ft DATUM WGS84</small>			
<small>MVP-LY-049_051520</small> <small>Landowner disturbance & parked equipment</small> <small>2020-05-15 08:48:08-04:00</small>					
GPS Location	MVP-LY-049 See photo for gps data				
Field Station#	+0				
Pic 7 Desc.	Landowner disturbance and parked equipment next to compost filter sock and feature. No impacts. Looking S.				
Insert image here					
<small>DIRECTION SW (M)</small>

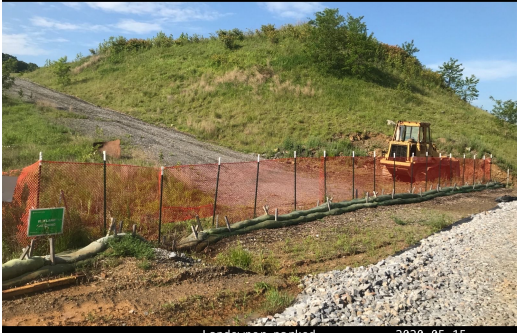
<small>+37.27040° -080.12463°</small> <small>ACCURACY 16 ft DATUM WGS84</small>			
<small>MVP-LY-049_051520</small> <small>Landowner parked equipment</small> <small>2020-05-15 08:48:16-04:00</small>					
GPS Location	MVP-LY-049 See photo for gps data				
Field Station#	+0				
Pic 8 Desc.	Landowner has parked a second piece of equipment close to feature within approximately 66 ft of feature. Looking SW.

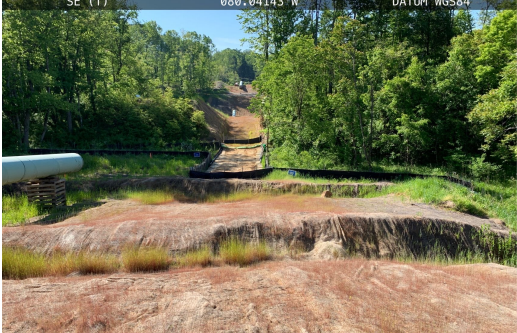
<div>13351+00</div> <div>S-RR09 bridge and buffer</div> <div>2020-05-15 09:36:02-04:00</div> </div>		<div> <div>DIRECTION S (T)</div> <div>37.10359°N 080.04219°W</div> <div>ACCURACY 15 ft DATUM WGS84</div>

<div>13348+00</div> <div>S-RR08 bridge and buffer</div> <div>2020-05-15 09:47:41-04:00</div> </div>			
GPS Location	See photo for gps location data.		GPS Location	See photo for gps location data.	
Field Station#	13351+00		Field Station#	13348+00	
Pic 7 Desc.	Photo shows the bridge over stream S-RR09 and buffer area ECDs.		Pic 8 Desc.	Photo shows the bridge over stream S-RR08 and buffer area ECDs.	
<div> <div>DIRECTION NW (T)</div> <div>37.10402°N 080.04529°W</div> <div>ACCURACY 126 ft DATUM WGS84</div>

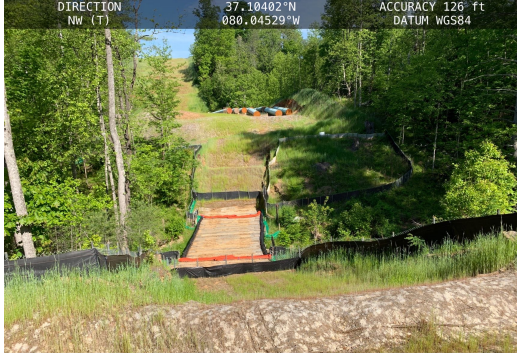
<div>13338+00</div> <div>S-GH9 buffer and bridge</div> <div>2020-05-15 09:56:38-04:00</div> </div>		<div> <div>DIRECTION S (T)</div> <div>37.10425°N 080.04538°W</div> <div>ACCURACY 840 ft DATUM WGS84</div>

GPS Location	See photo for gps location data.		GPS Location	See photo for gps location data.	
Field Station#	13338+00		Field Station#	13337+13	
Pic 9 Desc.	Photo shows the bridge over stream S-GH9 and buffer area.		Pic 10 Desc.	Photo shows stream S-GH9 downstream from the ROW crossing.	
<div> <div>DIRECTION W (T)</div> <div>37.10463°N 080.04595°W</div> <div>ACCURACY 27 ft DATUM WGS84</div>

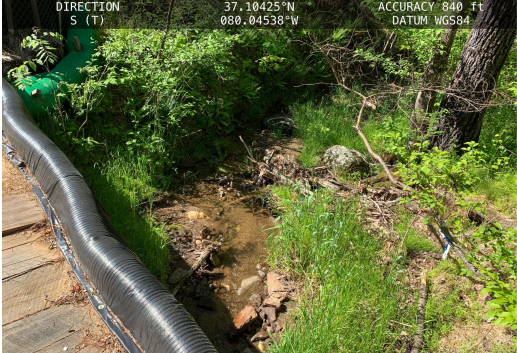
<div>13337+13</div> <div>S-GH9 downstream</div> <div>2020-05-15 09:57:41-04:00</div> </div>

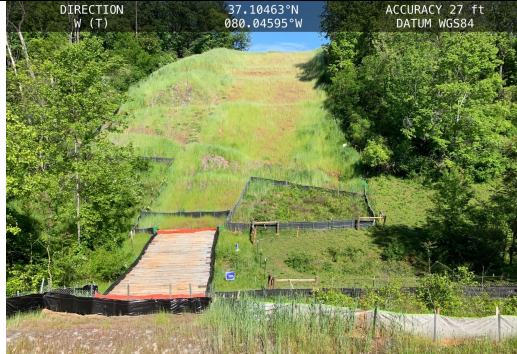
<div>13335+00</div> <div>S-GH11 bridge and buffer</div> <div>2020-05-15 09:59:39-04:00</div> </div>		<div> <div>DIRECTION W (T)</div> <div>37.10530°N 080.04726°W</div> <div>ACCURACY 38 ft DATUM WGS84</div>

<div>13331+00</div> <div>ROW and ECD conditions</div> <div>2020-05-15 10:09:43-04:00</div> </div>			
GPS Location	See photo for gps location data.		GPS Location	See photo for gps location data.	
Field Station#	13335+00		Field Station#	13331+00	
Pic 11 Desc.	Photo shows the bridge over stream S-GH11 and buffer area.		Pic 12 Desc.	Photo shows the ROW and ECD conditions from about 13327+00 to 13331+00.

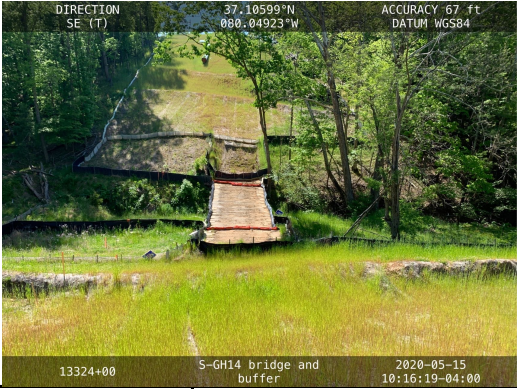
GPS Location	See photo for gps location data.		GPS Location	See photo for gps location data.	
Field Station#	13324+00		Field Station#	13322+00	
Pic 15 Desc.	Photo shows the bridge over stream S-GH14 and buffer ECDs.		Pic 16 Desc.	Photo shows the bridge over stream S-GH15 and buffer ECDs.

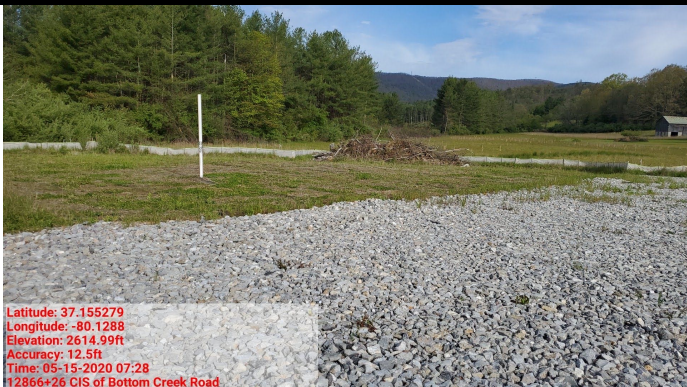
<p>Latitude: 37.155279 Longitude: -80.1288 Elevation: 2614.99ft Accuracy: 12.5ft Time: 05-15-2020 07:28 12866+26 CIS of Bottom Creek Road</p>		
GPS Location	See pic for GPS location		GPS Location	See pic for GPS location	
Field Station#	12866+26		Field Station#	12866+26	
Pic 1 Desc.	GAS of the Bottom Creek Road crossing.		Pic 2 Desc.	CIS of the Bottom Creek Road crossing.

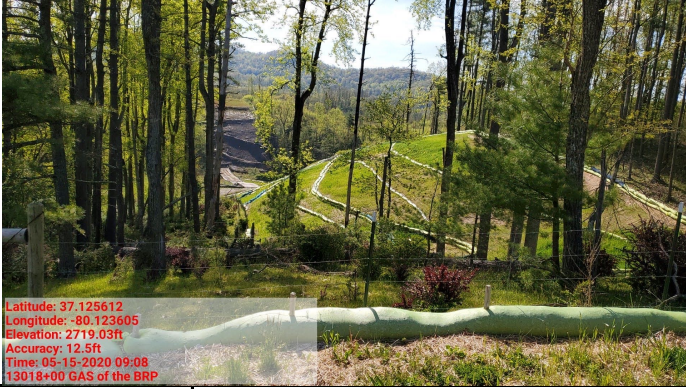
<p>Latitude: 37.123293 Longitude: -80.120936 Elevation: 2571.72ft Accuracy: 12.5ft Time: 05-15-2020 08:18 13033+59 FR-289 Callaway Road rain gauge</p>			
GPS Location	See pic for GPS location		GPS Location	See pic for GPS location	
Field Station#	13018+00		Field Station#	13033+59	
Pic 13 Desc.	Non-agricultural portion of the BRP on the GAS of the motorway.		Pic 14 Desc.	0.0" total precipitation at Callaway Road.

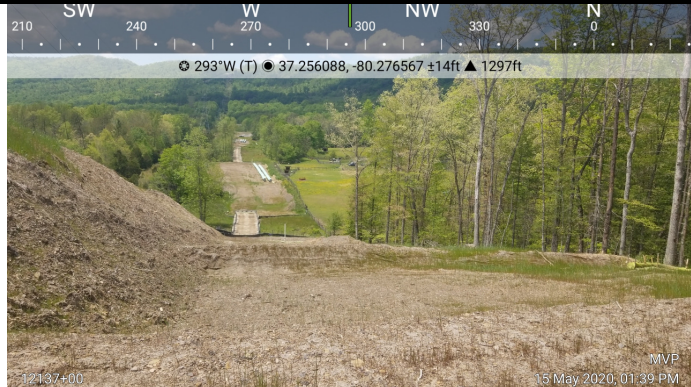
GPS Location	See Above	GPS Location	See Above		
Field Station#	12137+00	Field Station#	12140+00		
Pic 3 Desc.	Temporary vegetation remains stable and ECDs are functional.	Pic 4 Desc.	Wetland W-C6, Looking NorthWest.

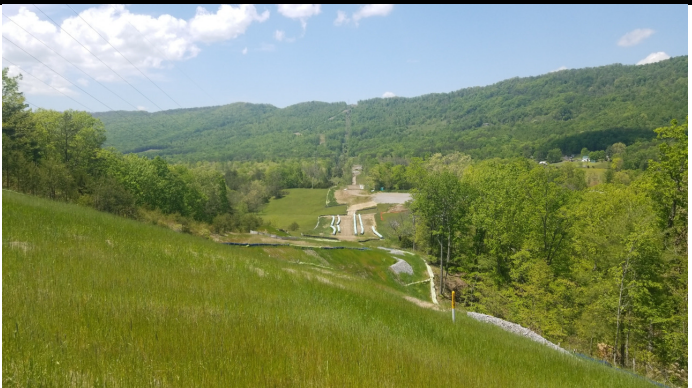
GPS Location	See Above	GPS Location	See Above		
Field Station#	12145+00	Field Station#	12151+00		
Pic 5 Desc.	Wetland W-C5, Looking West.	Pic 6 Desc.	Temporary vegetation remains stable and ECDs are functional.
