Visual Site Inspection Report

Project Name	H-600 Pipeline Spread H	AFE	124300138	Spread	H-600 Pipeline Spread H
Contractor	Precision			Report #	11052
Inspector	John Brcic			Date/Time	5/18/2020 10:43 AM
Permit #	TBD	Inspection Type	VA SWPP	Station Begin	12433+75
State	VA	Inspection Area	Partial	Station End	12544+06
County	Montgomery	Ground	Dry	Temperature (°F)	65.00
Municipality	N/A	Weather	Cloudy	Rain Gauge (in)	0.00
				Rain Accumulation Time (days)	1.00

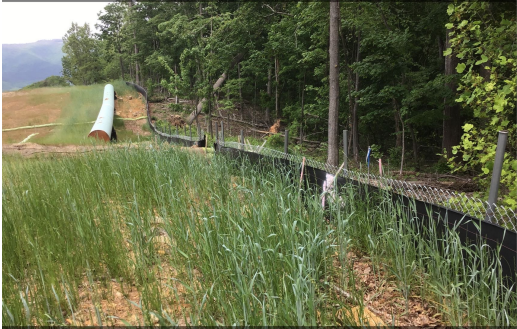
GPS Location	See photo		GPS Location	See photo	
Field Station#	12508+50		Field Station#	12506+24	
Pic 11 Desc.	Fill slope drain in satisfactory condition and functioning properly.		Pic 12 Desc.	ROW stable, blanket remains intact and effective where vegetation is negligible.

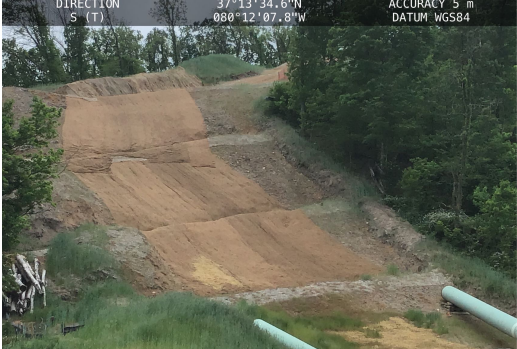
2020-05-18 12:47:53-04:00	
GPS Location	See photo		GPS Location	See photo	
Field Station#	12500+00		Field Station#	12496+00	
Pic 13 Desc.	Perimeter controls remain in satisfactory condition.		Pic 14 Desc.	Vegetative cover somewhat sparse, but sufficient blanket and straw mulch cover remains.	
DIRECTION S (T) 37°13'34.6"N 080°12'07.8"W ACCURACY 5 m DATUM WGS84

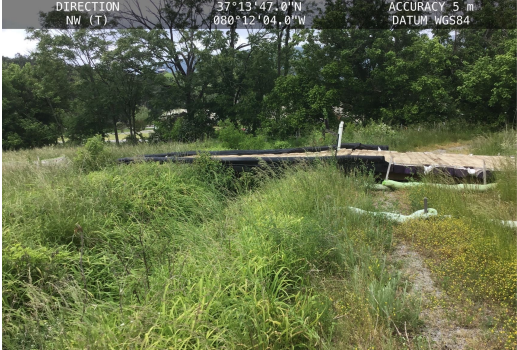
2020-05-18 13:20:14-04:00	
GPS Location	See photo		GPS Location	See photo	
Field Station#	12483+00		Field Station#	12477+00	
Pic 15 Desc.	This slope on the going away side of the "pig parts" excavation site was recently seeded and blanketed for more effective stabilization.		Pic 16 Desc.	ROW stable near Highway 11.

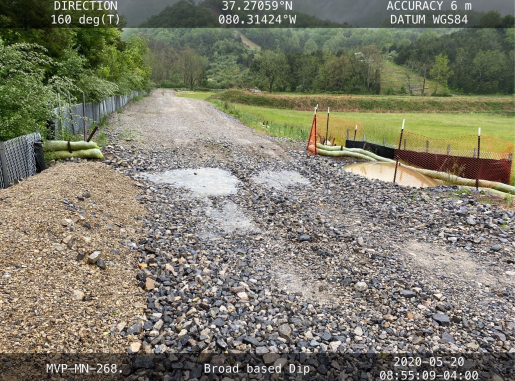
A/E	124300138	Date/Time	5/20/2020 4:17 PM	Report #	
Pictures					
  <p>DIRECTION 177 deg(T) 37.27102°N 080.31533°W ACCURACY 5 m DATUM WGS84</p> <p>12007+00, Catawba MVP-MN-268. Rain Gauge reading: 1.8" 2020-05-20 08:50:37-04:00</p>

<p>DIRECTION 160 deg(T) 37.27059°N 080.31424°W ACCURACY 6 m DATUM WGS84</p> <p>MVP-MN-268. Broad based dip 2020-05-20 08:55:09-04:00</p>			
GPS Location	See photo GPS for location		GPS Location	See photo GPS for location	
Field Station#	12007+00		Field Station#	00000+00	
Pic 1 Desc.	Rain total: 1.80"		Pic 2 Desc.	Broad based dip w/ sump outlet	
  <p>DIRECTION 333 deg(T) 37.26850°N 080.31299°W ACCURACY 6 m DATUM WGS84</p> <p>268.01 2020-05-20 11:01:21-04:00</p>		  <p>DIRECTION 322 deg(T) 37.26849°N 080.31311°W ACCURACY 10 m DATUM WGS84</p> <p>268.01 2020-05-20 11:01:40-04:00</p>			
GPS Location	See photo GPS for location		GPS Location	See photo GPS for location	
Field Station#	12013+97		Field Station#	12013+97

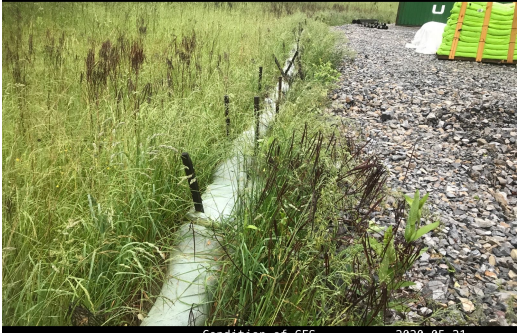
DIRECTION E (M) +37.23418° -080.22614° ACCURACY 33 ft DATUM WGS84	
MVP-PY-006_052120		Condition of CFS along East LOD 2020-05-21 07:48:54-04:00		MVP-PY-006_052120	
GPS Location	MVP-PY-006 See photo for gps data		GPS Location	MVP-PY-006 See photo for gps data	
Field Station#	+0		Field Station#	+0	
Pic 13 Desc.	Condition of compost filter sock along East LOD. Looking S.		Pic 14 Desc.	Condition of compost filter sock along the south LOD. Looking E.	
DIRECTION SW (M) +37.23420° -080.22638° ACCURACY 16 ft DATUM WGS84

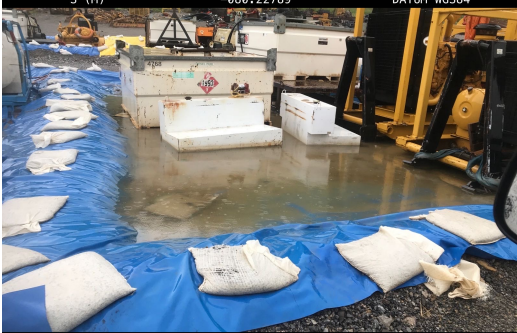
Field Station#	+0		Field Station#	+0	
Pic 15 Desc.	No debris or fluids observed around hazardous waste dumpster. Looking SW.		Pic 16 Desc.	Condition of containment under stored equipment. Looking S.	
DIRECTION S (M) +37.23458° -080.22789° ACCURACY 16 ft DATUM WGS84

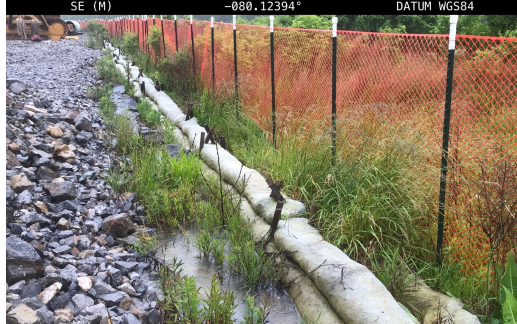
MVP-LY-049_052120 Condition of CFS around sand pile 2020-05-21 08:59:42-04:00		MVP-LY-049_052120 Condition of CFS around sand pile 2020-05-21 09:01:06-04:00

GPS Location	MVP-LY-049 See photo for gps data		GPS Location	MVP-LY-049 See photo for gps data	
Field Station#	+0		Field Station#	+0	
Pic 9 Desc.	Condition of compost filter sock around sand pile back side. Looking N		Pic 10 Desc.	Condition of compost filter sock around sand pile front. Looking W.	
DIRECTION SE (M) +37.26909° -080.12394° ACCURACY 16 ft DATUM WGS84

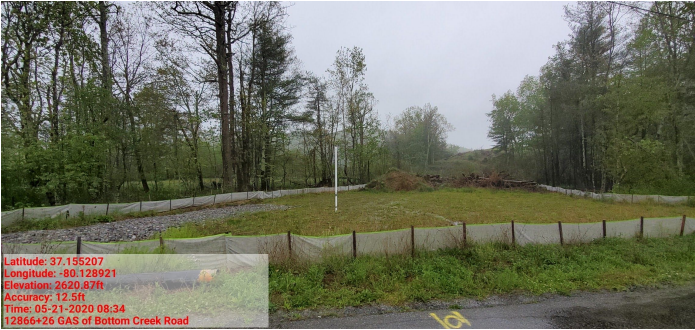
AFE	124300138	Date/Time	5/21/2020 9:22 AM	Report #	
Pictures					
  <p>Latitude: 37.123285 Longitude: -80.120946 Elevation: 2568.67ft Accuracy: 12.5ft Time: 05-21-2020 08:26 13033+59 FR-289 Callaway Road rain gauge</p>

<p>Latitude: 37.155207 Longitude: -80.128921 Elevation: 2620.87ft Accuracy: 12.5ft Time: 05-21-2020 08:34 12866+26 GAS of Bottom Creek Road</p>		
GPS Location	See pic for GPS location		GPS Location	See pic for GPS location	
Field Station#	13033+59		Field Station#	12866+26	
Pic 1 Desc.	4.0" total precipitation at Callaway Road		Pic 2 Desc.	GAS of the Bottom Creek Road crossing.	
  <p>Latitude: 37.155167 Longitude: -80.129133 Elevation: 2596.98ft Accuracy: 12.5ft Time: 05-21-2020 08:35 12866+26 CIS of Bottom Creek Road</p>

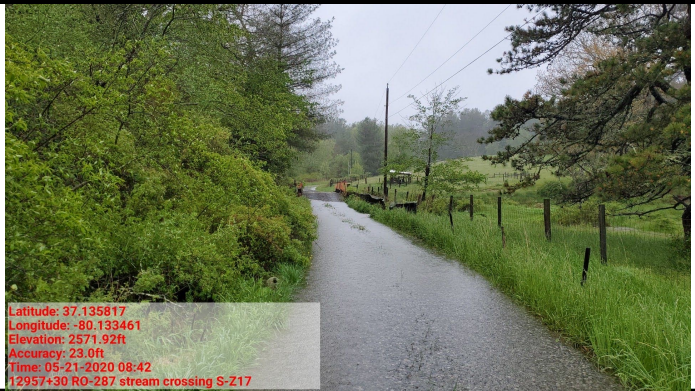
GPS Location	See pic for GPS location		GPS Location	See pic for GPS location	
Field Station#	12866+26		Field Station#	12957+30	
Pic 3 Desc.	CIS of the Bottom Creek Road crossing.		Pic 4 Desc.	Stream S-Z17 flooding over access road RO-287.	
  <p>Latitude: 37.135362 Longitude: -80.134307 Elevation: 2567.19ft Accuracy: 12.5ft Time: 05-21-2020 08:44 12957+30 RO-287 stream crossing S-Z17</p>

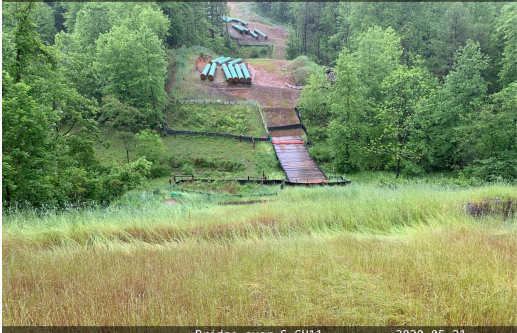
13332+00 Bridge over S-GH11 and buffer ECDs 2020-05-21 09:12:48-04:00		DIRECTION 37.10471°N ACCURACY 56 ft SE (T) 080.04628°W DATUM WGS84

13334+10 Bridge over S-GH11 2020-05-21 09:17:42-04:00			
GPS Location	See photo for gps location data.		GPS Location	See photo for gps location data.	
Field Station#	13332+00		Field Station#	13334+10	
Pic 7 Desc.	Photo shows the ROW conditions from about 13332+00 to about 13336+00, including the bridge over stream S-GH11.		Pic 8 Desc.	Photo shows the bridge over stream S-GH11.	
DIRECTION 37.10448°N ACCURACY 32 ft SE (T) 080.04563°W DATUM WGS84

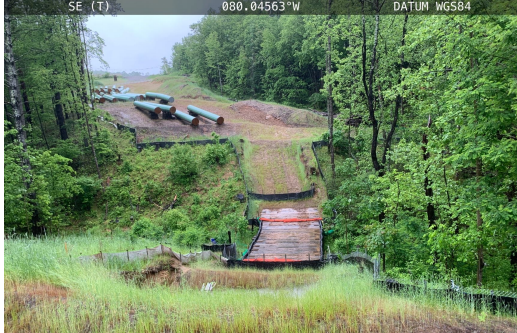
13336+50 Bridge over S-GH9 and buffer ECDs 2020-05-21 09:23:08-04:00		DIRECTION 37.10420°N ACCURACY 38 ft SE (T) 080.04535°W DATUM WGS84

GPS Location	See photo for gps location data.		GPS Location	See photo for gps location data.	
Field Station#	13336+50		Field Station#	13337+50	
Pic 9 Desc.	Photo shows the bridge over stream S-GH9 and buffer ECDs.		Pic 10 Desc.	Photo shows the perimeter ECDs from about 13337+50 to 13338+50.	
DIRECTION 37.10384°N ACCURACY 0.22 mi SE (T) 080.04291°W DATUM WGS84

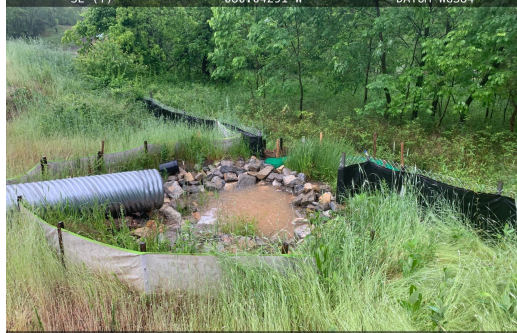
13346+00 Clean water outlet structure 2020-05-21 09:38:54-04:00		DIRECTION 37.10380°N ACCURACY 613 ft SE (T) 080.04214°W DATUM WGS84

13348+00 Bridge over S-RR08 and buffer ECDs 2020-05-21 09:40:37-04:00			
GPS Location	See photo for gps location data.		GPS Location	See photo for gps location data.	
Field Station#	13346+00		Field Station#	13348+00	
Pic 11 Desc.	Photo shows the clean water outlet structure.		Pic 12 Desc.	Photo shows the bridge over stream S-RR08 and buffer ECDs.

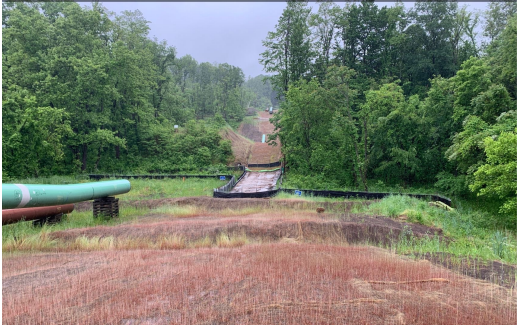
GPS Location	See photo for gps location data.		GPS Location	See photo for gps location data.	
Field Station#	13351+00		Field Station#	13354+00	
Pic 13 Desc.	Photo shows the bridge over stream S-RR09 and buffer ECDs.		Pic 14 Desc.	Photo shows the ROW and ECD conditions from about 13354+00 to 13356+00.	
DIRECTION 37.10130°N ACCURACY 116 ft SE (T) 080.03983°W DATUM WGS84

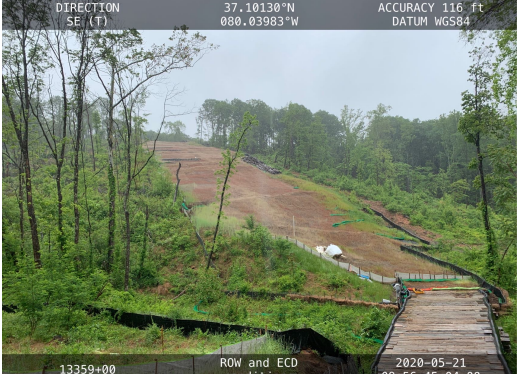
GPS Location	See photo for gps location data.		GPS Location	See photo for gps location data.	
Field Station#	13359+00		Field Station#	13386+00	
Pic 15 Desc.	Photo shows the ROW and ECD conditions from about 13359+00 to 13362+00.		Pic 16 Desc.	Photo shows the ROW and ECD conditions from about 13386+00 to 13394+00.

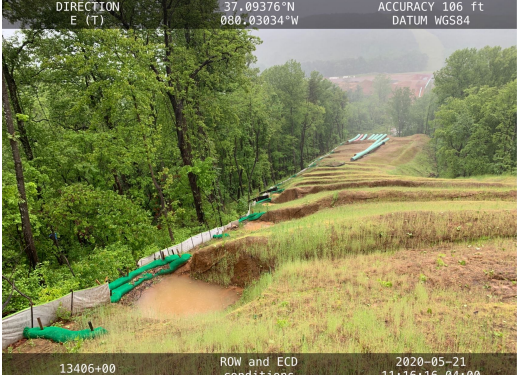
GPS Location	See photo for gps location data.		GPS Location	See photo for gps location data.	
Field Station#	13406+00		Field Station#	13412+00	
Pic 17 Desc.	Photo shows the perimeter ECDs from about 13406+00 to 13409+00.		Pic 18 Desc.	Photo shows the bridge over stream S-IJ1 and buffer ECDs.
