Visual Site Inspection Report

Project Name	H-600 Pipeline Spread H	AFE	124300138	Spread	H-600 Pipeline Spread H
Contractor	Precision			Report #	11299
Inspector	Dawn McCullough			Date/Time	5/26/2020 3:26 PM
Permit #	TBD	Inspection Type	VA SWPP	Station Begin	13140+00
State	VA	Inspection Area	Partial	Station End	13315+70
County	Franklin	Ground	Damp	Temperature (°F)	75.00
Municipality	N/A	Weather	Cloudy	Rain Gauge (in)	0.40
				Rain Accumulation Time (days)	1.00

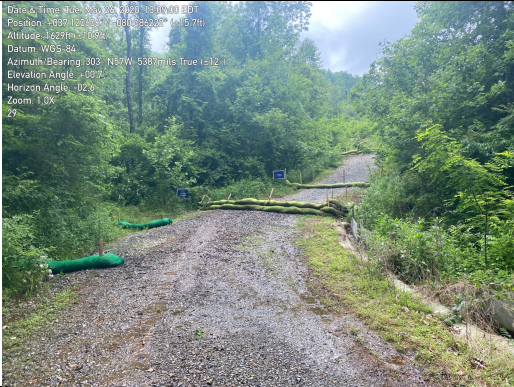
GPS Location	See photo for coordinates.		GPS Location	See photo for coordinates.	
Field Station#	13141+00		Field Station#	13190+00	
Pic 1 Desc.	MVP-FR-292, ECDs functioning acceptably.		Pic 2 Desc.	MVP-AR-29, accumulated debris along CFS added as punch list maintenance item.	
<p>Date & Time: Tue, May 26, 2020 13:05:00 EDT Position: +037.122331° / +080.075597° (+35.310) Altitude: 1434ft (+432.0ft) Datum: WGS-84 Azimuth/Bearing: 286° S88W 4729mils True (±12°) Elevation Angle: +13.6° Horizon Angle: -00.4° Zoom: 1.0X S-08</p>

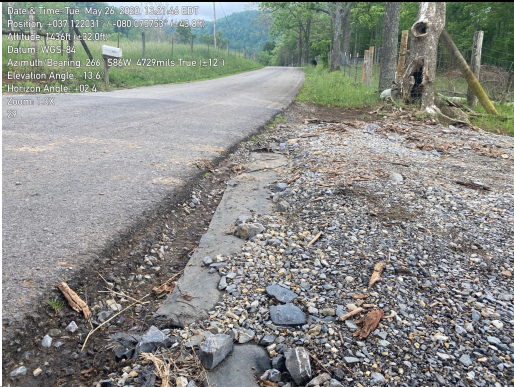
GPS Location	See photo for coordinates.		GPS Location	See photo for coordinates.	
Field Station#	13190+00		Field Station#	13197+50	
Pic 3 Desc.	MVP-AR-29, RCE washed out along Adney Gap Road, added as punch list maintenance item.		Pic 4 Desc.	S-D8, no disturbance.	
<p>Date & Time: Tue, May 26, 2020 13:04:00 EDT Position: +037.122331° / +080.075597° (+35.310) Altitude: 1434ft (+432.0ft) Datum: WGS-84 Azimuth/Bearing: 021° S89E 1618mils True (±13°) Elevation Angle: +11.9° Horizon Angle: 101.7° Zoom: 1.0X GAS dillons</p>

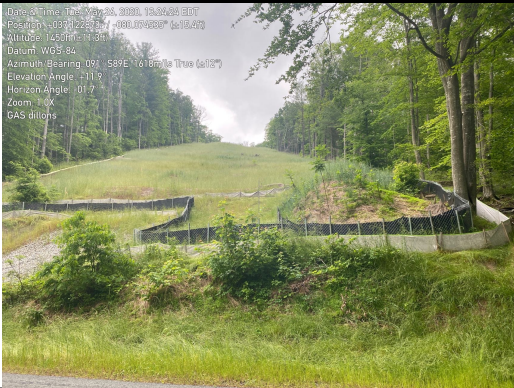
Pic 5 Desc.	GAS Dillons Mill, ECDs functioning acceptably, acceptable vegetative cover.		Pic 6 Desc.	CIS S-II4, ECDs functioning acceptably, acceptable vegetative cover.

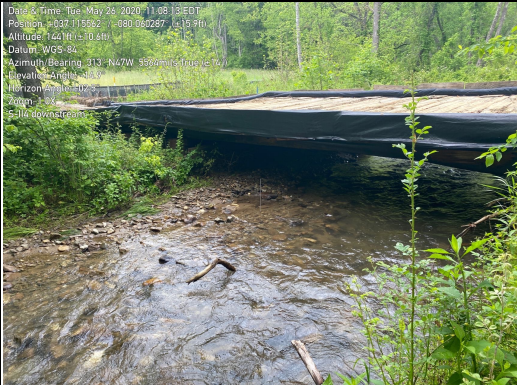
GPS Location		See photo for coordinates.		GPS Location		See photo for coordinates.
Field Station#		13260+60		Field Station#		13260+60
Pic 7 Desc.		S-II4, downstream, no impacts noted.		Pic 8 Desc.		S-II4, upstream, no impacts noted.
<p>Date & Time: Tue May 26 2020 11:13:40 EDT Position: +037.115545, -080.080367, +15.835° Altitude: 1439ft (+320.0m) Datum: WGS-84 Azimuth/Bearing: 163° S17E 2898mils True (+13.1) Elevation Angle: -10.5° Horizon Angle: -02.4° Zoom: 1.0X Flash: none</p>  			<p>Date & Time: Tue May 26 2020 11:14:38 EDT Position: +037.115748, -080.080374, +15.8311° Altitude: 1451ft (+435.0m) Datum: WGS-84 Azimuth/Bearing: 338° S22W 4551mils True (+12.7) Elevation Angle: -08.4° Horizon Angle: -011.5° Zoom: 1.0X Flash: none</p>

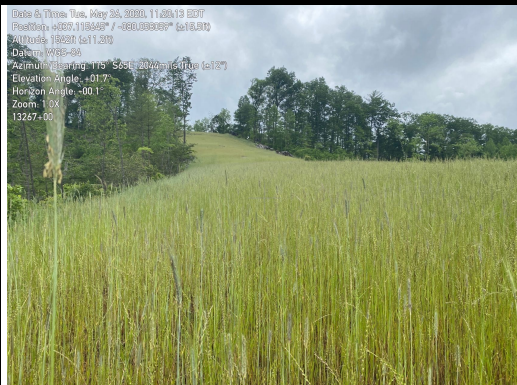
Pic 11 Desc.		ECDs functioning acceptably, good vegetative cover.		Pic 12 Desc.		ECDs functioning acceptably, good vegetative cover.

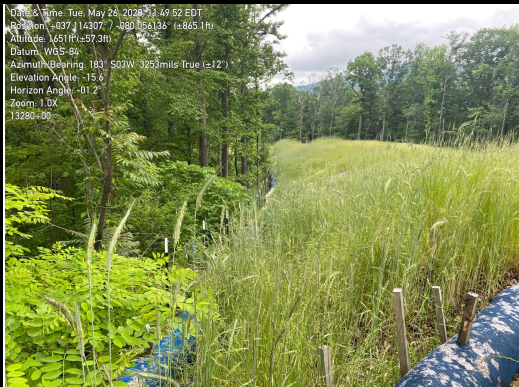
Field Station#	13278+00		Field Station#	13292+00	
Pic 13 Desc.	ECDs functioning acceptably, good vegetative cover.		Pic 14 Desc.	ECDs functioning acceptably, good vegetative cover.	
<div><div><div><div><div><div>Date & Time: Tue, May 26, 2020 13:49:03 EDT</div><div>Position: -037.146560° / -080.054269° (-836.7ft)</div><div>Altitude: 1370ft (-52.9ft)</div><div>Datum: WGS-84</div><div>Azimuth/Bearing: 314° N24W 5582mils True (±12°)</div><div>Elevation Angle: -16°</div><div>Horizon Angle: -01.3°</div><div>Zoom: 1.0X</div><div>S-GH7 downstream</div></div></div><div>

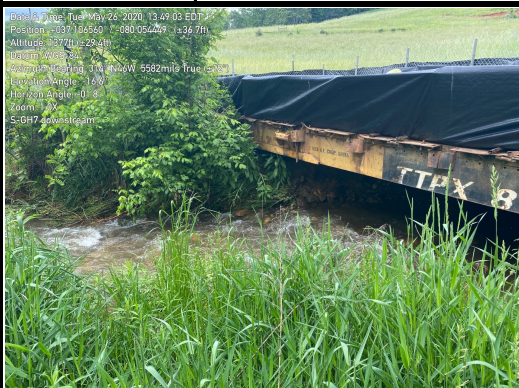
GPS Location	See photo for coordinates.		GPS Location	See photo for coordinates.	
Field Station#	13309+09		Field Station#	13320+00	
Pic 15 Desc.	S-GH7, downstream, no impacts noted.		Pic 16 Desc.	GAS S-GH7, moderate to good vegetative cover, ECDs functioning acceptably.	
<div><div><div><div><div><div>Date & Time: Wed, May 27, 2020 10:23:03 EDT</div><div>Position: -037.122146° / -080.075776° (-826.2ft)</div><div>Altitude: 1433ft (-52.8ft)</div><div>Datum: WGS-84</div><div>Azimuth/Bearing: 331° N29W 5980mils True (±12°)</div><div>Elevation Angle: -16.1°</div><div>Horizon Angle: -00.3°</div><div>Zoom: 1.0X</div><div>MVP-AR-29</div></div></div><div>

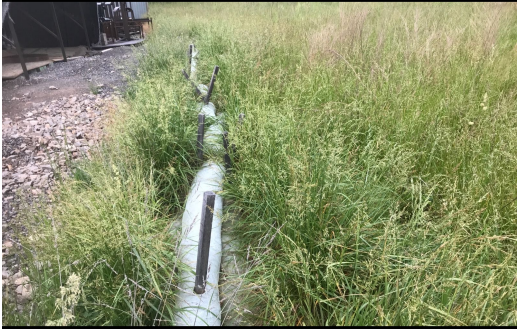
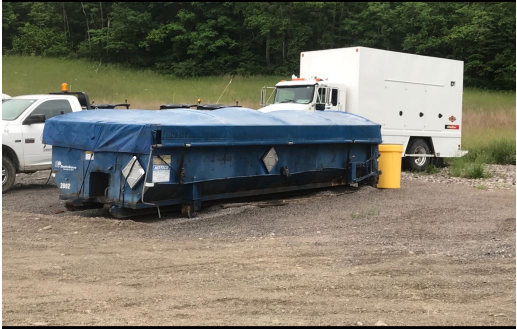
MVP-006_052720		Condition of CFS along south LOD		2020-05-27 07:34:23-04:00	
GPS Location	MVP-PY-006 See photo for gps data		GPS Location	MVP-PY-006 See photo for gps data	
Field Station#	+0		Field Station#	+0	
Pic 13 Desc.	Condition of compost filter sock along the south LOD. Looking E.		Pic 14 Desc.	No debris around hazardous waste dumpsters. Looking SE.	
DIRECTION S (M) +37.23428° -080.22750° ACCURACY 33 ft DATUM WGS84		DIRECTION S (M) +37.23438° -080.22769° ACCURACY 16 ft DATUM WGS84

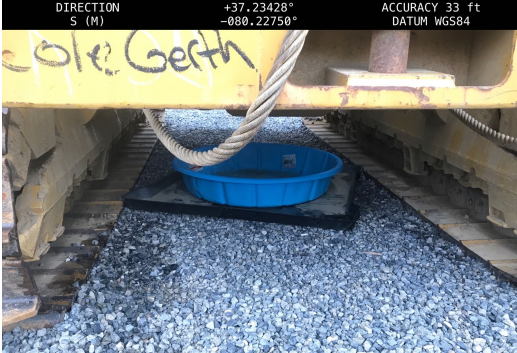
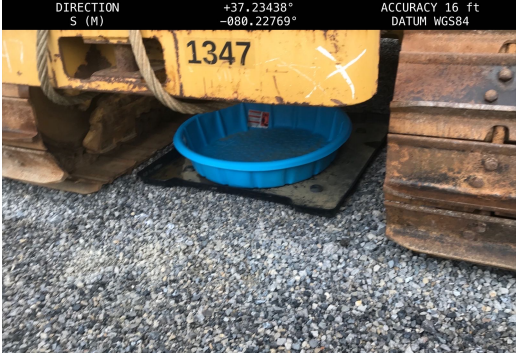
Pic 15 Desc.	Containment under stored equipment. Looking S.		Pic 16 Desc.	Containment under stored equipment. Looking S.	
DIRECTION S (M) +37.23443° -080.22810° ACCURACY 16 ft DATUM WGS84		DIRECTION NE (M) +37.23443° -080.22898° ACCURACY 16 ft DATUM WGS84

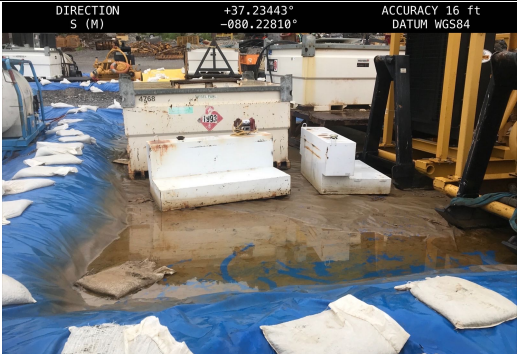
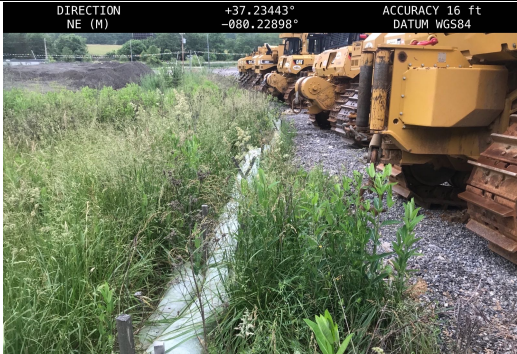
MVP-PY-006_052720		Condition of poly lined containment		2020-05-27 07:39:20-04:00	
GPS Location	MVP-PY-006 See photo for gps data		GPS Location	MVP-PY-006 See photo for gps data	
Field Station#	+0		Field Station#	+0	
Pic 17 Desc.	Condition of poly lined/rock berm containments. Looking S.		Pic 18 Desc.	Condition of compost filter sock along west LOD. Looking NE.

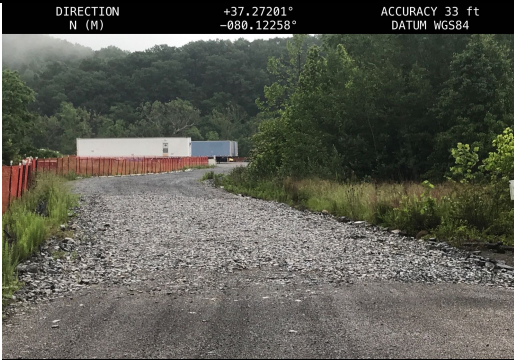
<p>DIRECTION N (M) +37.27201° -080.12258° ACCURACY 33 ft DATUM WGS84</p> <p>MVP-LY-049_052720 Condition of rock entrance 2020-05-27 07:58:11-04:00</p>

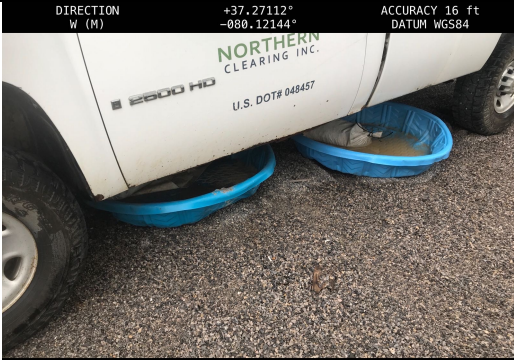
<p>DIRECTION W (M) +37.27112° -080.12144° ACCURACY 16 ft DATUM WGS84</p> <p>MVP-LY-049_052720 Containments under stored vehicle 2020-05-27 08:19:27-04:00</p>

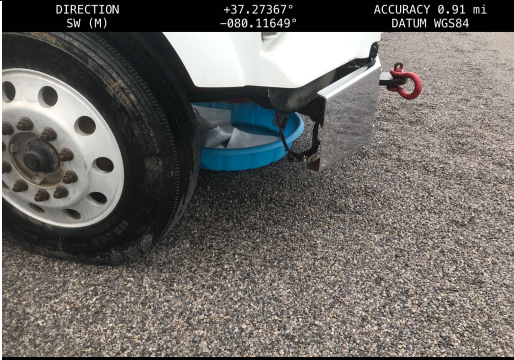
<p>DIRECTION SW (M) +37.27367° -080.11649° ACCURACY 0.91 mi DATUM WGS84</p> <p>MVP-LY-049_052720 Containment under stored vehicle 2020-05-27 08:24:05-04:00</p>

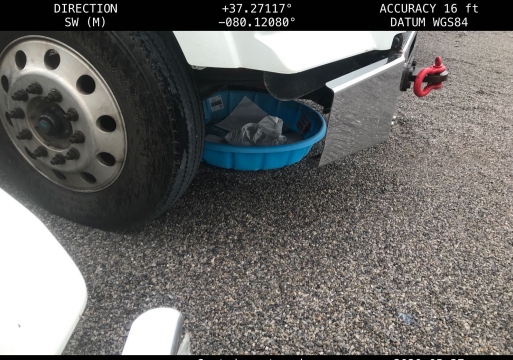
<p>DIRECTION SW (M) +37.27117° -080.12080° ACCURACY 16 ft DATUM WGS84</p> <p>MVP-LY-049_052720 Containment under stored vehicle 2020-05-27 08:24:12-04:00</p>			
GPS Location	MVP-LY-049 See photo for gps data		GPS Location	MVP-LY-049 See photo for gps data	
Field Station#	+0		Field Station#	+0	
Pic 5 Desc.	Condition of containment under stored vehicle. Looking SW.		Pic 6 Desc.	Condition of containment under stored vehicle. Looking SW.

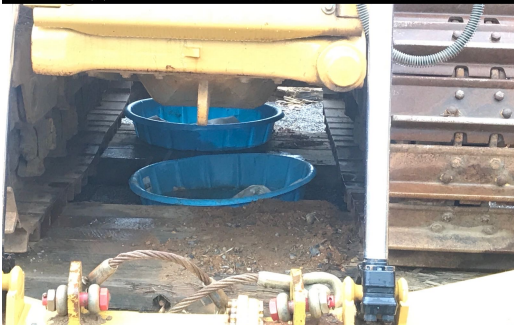
MVP-LY-049_052720 No loose trash around south dumpster 2020-05-27 08:27:15-04:00		MVP-LY-049_052720 Containment under stored equipment 2020-05-27 08:27:57-04:00			
GPS Location	MVP-LY-049 See photo for gps data		GPS Location	MVP-LY-049 See photo for gps data	
Field Station#	+0		Field Station#	+0	
Pic 7 Desc.	No loose trash around the south trash dumpster. Looking S.		Pic 8 Desc.	Condition of containments under stored equipment. Looking SW.	
<div>DIRECTION NW (M) +37.27093° -080.12198° ACCURACY 98 ft DATUM WGS84</div>

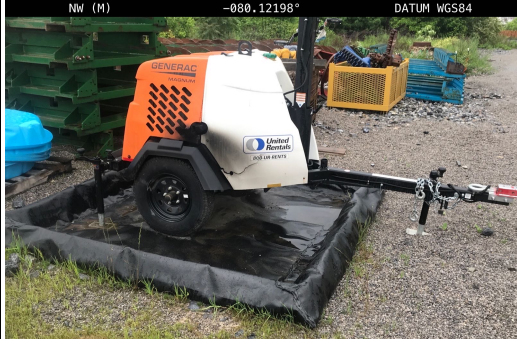
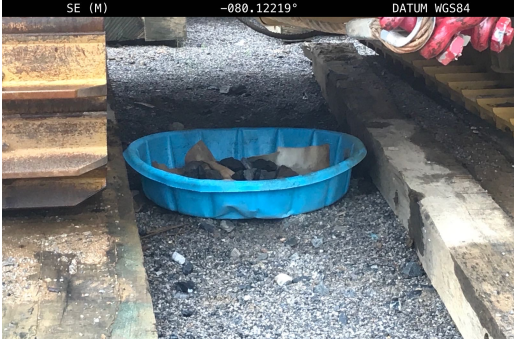
MVP-LY-049_052720 Condition of containment 2020-05-27 08:28:34-04:00		MVP-LY-049_052720 2020-05-27 08:29:45-04:00

GPS Location	MVP-LY-049 See photo for gps data		GPS Location	MVP-LY-049 See photo for gps data	
Field Station#	+0		Field Station#	+0	
Pic 9 Desc.	Condition of containment under light plant. Looking NW.		Pic 10 Desc.	Condition of containment under stored equipment. Looking SE.	
<div>DIRECTION S (M) +37.27061° -080.12246° ACCURACY 33 ft DATUM WGS84</div>

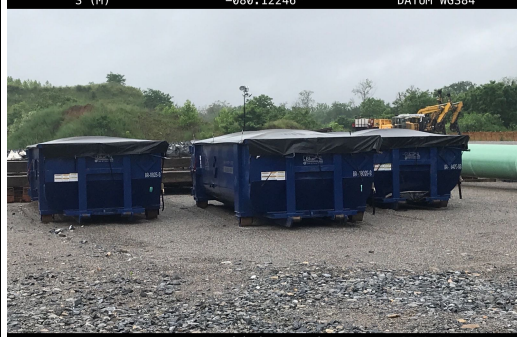
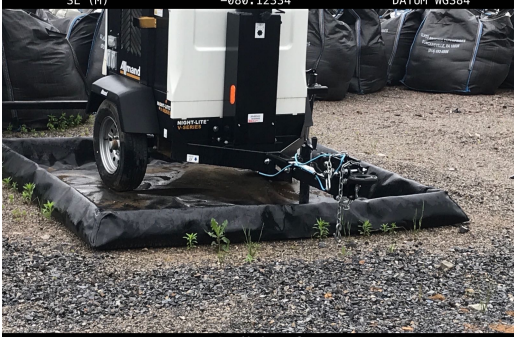
MVP-LY-049_052720 No debris around hazardous waste ... 2020-05-27 08:30:12-04:00		MVP-LY-049_052720 Condition of containment 2020-05-27 08:30:54-04:00			
GPS Location	MVP-LY-049 See photo for gps data		GPS Location	MVP-LY-049 See photo for gps data	
Field Station#	+0		Field Station#	+0	
Pic 11 Desc.	No debris around hazardous waste dumpsters. Looking NW.		Pic 12 Desc.	Condition of containment under light plant. Looking NW.

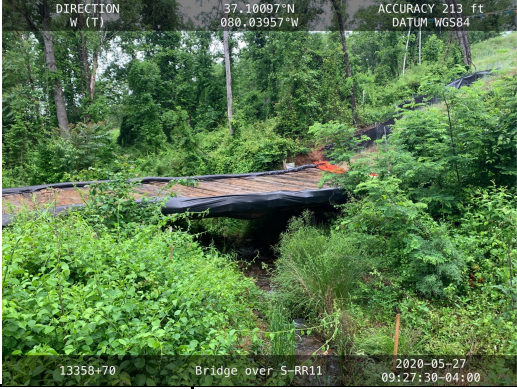
<p>DIRECTION W (T) 37.10097°N 080.03957°W ACCURACY 213 ft DATUM WGS84</p> <p>13358+70 Bridge over S-RR11 2020-05-27 09:27:30-04:00</p>

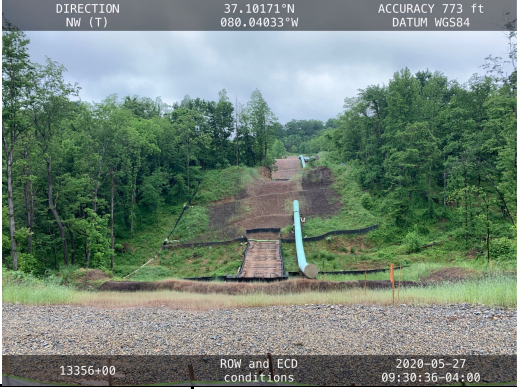
<p>DIRECTION NW (T) 37.10171°N 080.04033°W ACCURACY 773 ft DATUM WGS84</p> <p>13356+00 ROW and ECD conditions 2020-05-27 09:30:36-04:00</p>			
GPS Location	See photo for gps location data.		GPS Location	See photo for gps location data.	
Field Station#	13358+64		Field Station#	13356+00	
Pic 7 Desc.	Photo shows the bridge over stream S-RR11.		Pic 8 Desc.	Photo shows the ROW and ECD conditions from about 13354+00 to 13356+00.

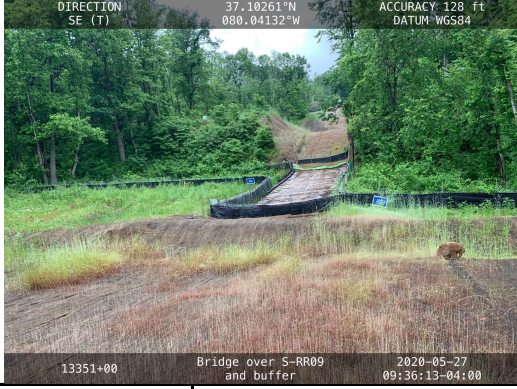
<p>DIRECTION SE (T) 37.10261°N 080.04132°W ACCURACY 128 ft DATUM WGS84</p> <p>13351+00 Bridge over S-RR09 and buffer 2020-05-27 09:36:13-04:00</p>

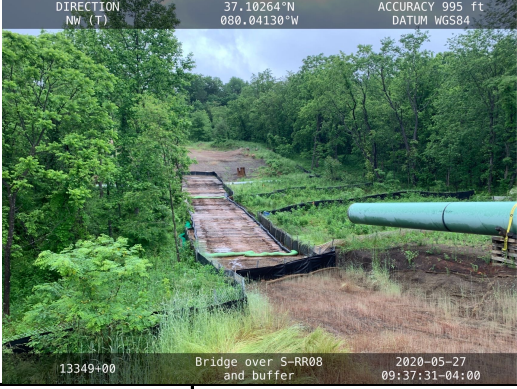
<p>DIRECTION NW (T) 37.10264°N 080.04130°W ACCURACY 995 ft DATUM WGS84</p> <p>13349+00 Bridge over S-RR08 and buffer 2020-05-27 09:37:31-04:00</p>

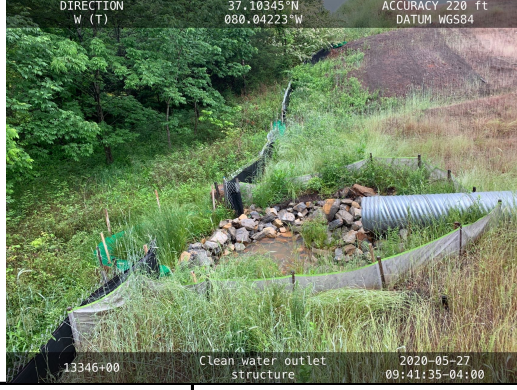
<p>DIRECTION W (T) 37.10345°N 080.04223°W ACCURACY 220 ft DATUM WGS84</p> <p>13346+00 Clean water outlet structure 2020-05-27 09:41:35-04:00</p>

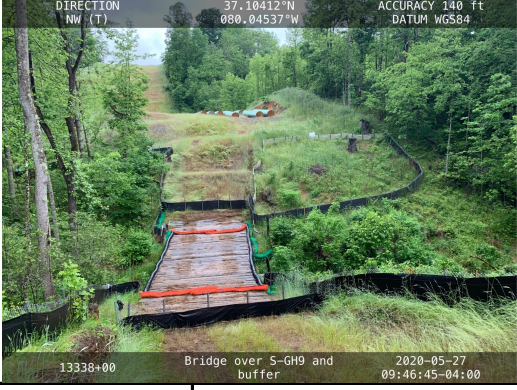
<p>DIRECTION NW (T) 37.10412°N 080.04537°W ACCURACY 140 ft DATUM WGS84</p> <p>13338+00 Bridge over S-GH9 and buffer 2020-05-27 09:46:45-04:00</p>			
GPS Location	See photo for gps location data.		GPS Location	See photo for gps location data.	
Field Station#	13346+00		Field Station#	13338+00	
Pic 11 Desc.	Photo shows the clean water outlet structure.		Pic 12 Desc.	Photo shows the bridge over stream S-GH9 and buffer ECDs.

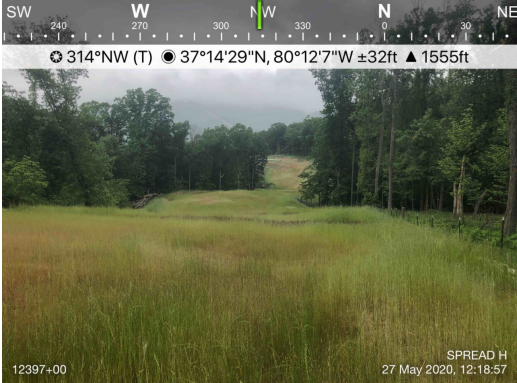
GPS Location	see photo		GPS Location	see photo	
Field Station#	12397+00		Field Station#	12408+00	
Pic 7 Desc.	Area between the GAS of I-81 and MLV-027 in good condition. Vegetation filling in.		Pic 8 Desc.	CWD at MLV-027 in good condition.

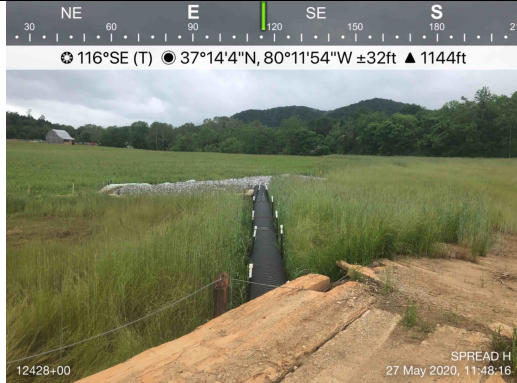
GPS Location	see photo		GPS Location	see photo	
Field Station#	12428+00		Field Station#	12446+00	
Pic 11 Desc.	CWD in good condition at this location.		Pic 12 Desc.	ROW and workspace well vegetated next to Route 11.

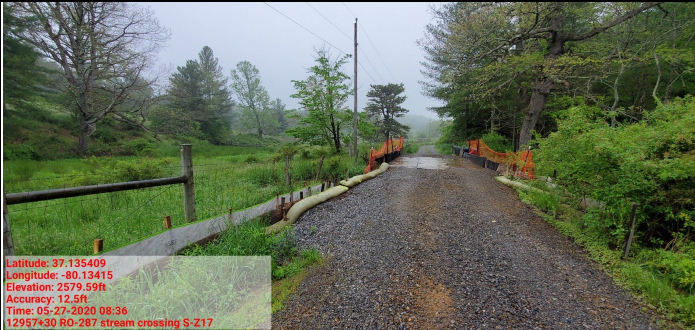
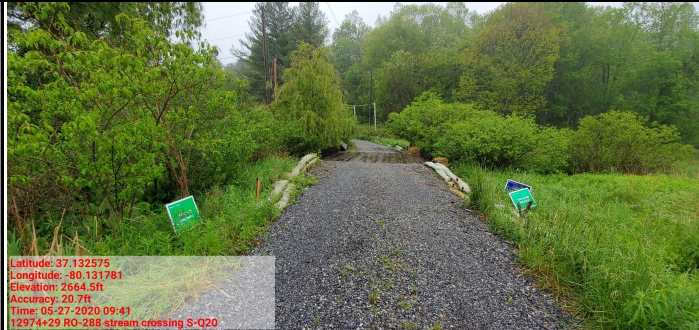
<p>Latitude: 37.135409 Longitude: -80.13415 Elevation: 2579.59ft Accuracy: 12.5ft Time: 05-27-2020 08:36 12957+30 RO-287 stream crossing S-Z17</p>			<p>Latitude: 37.132575 Longitude: -80.131781 Elevation: 2664.5ft Accuracy: 20.7ft Time: 05-27-2020 09:41 12974+29 RO-288 stream crossing S-Q20</p>		
GPS Location	See pic for GPS location		GPS Location	See pic for GPS location	
Field Station#	12957+30		Field Station#	12974+29	
Pic 7 Desc.	Access road RO-287 at stream crossing S-Z17.		Pic 8 Desc.	Access road RO-288 at stream crossing S-Q20.

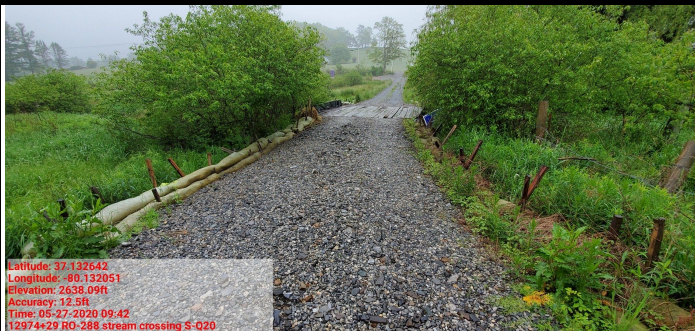
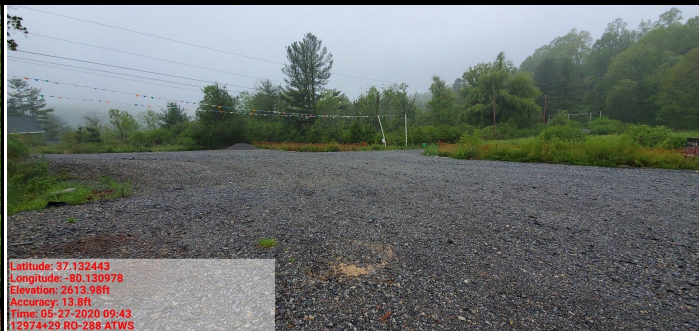
<p>Latitude: 37.132642 Longitude: -80.132051 Elevation: 2638.09ft Accuracy: 12.5ft Time: 05-27-2020 09:42 12974+29 RO-288 stream crossing S-Q20</p>			<p>Latitude: 37.132443 Longitude: -80.130978 Elevation: 2613.98ft Accuracy: 13.8ft Time: 05-27-2020 09:43 12974+29 RO-288 ATWS</p>

GPS Location	See pic for GPS location		GPS Location	See pic for GPS location	
Field Station#	12974+29		Field Station#	12974+29	
Pic 9 Desc.	Access road RO-288 at stream crossing S-Q20.		Pic 10 Desc.	Access road RO-288 ATWS near US-221.

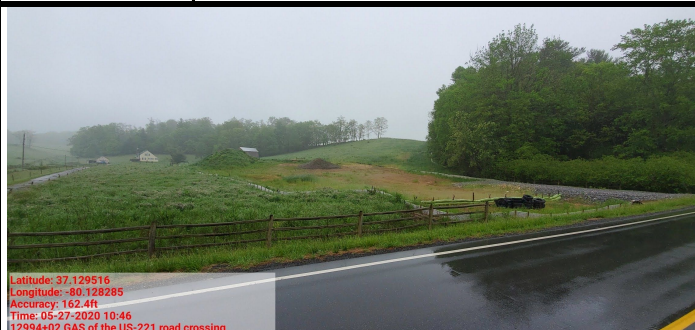
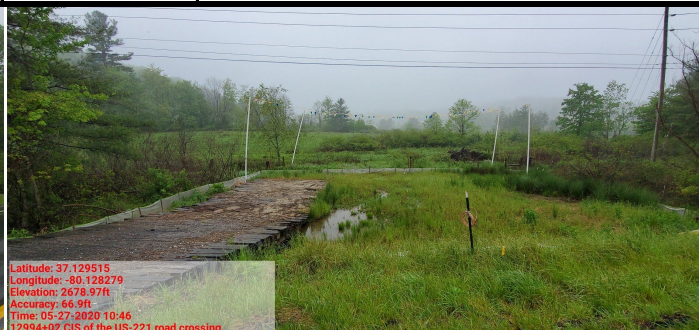
<p>Latitude: 37.129516 Longitude: -80.128285 Elevation: 2678.97ft Accuracy: 162.4ft Time: 05-27-2020 10:46 12994+02 GAS of the US-221 road crossing</p>			<p>Latitude: 37.129515 Longitude: -80.128279 Elevation: 2678.97ft Accuracy: 66.9ft Time: 05-27-2020 10:46 12994+02 CIS of the US-221 road crossing</p>		
GPS Location	See pic for GPS location		GPS Location	See pic for GPS location	
Field Station#	12994+02		Field Station#	12994+02	
Pic 11 Desc.	GAS of the US-221 road crossing.		Pic 12 Desc.	CIS of the US-221 road crossing.

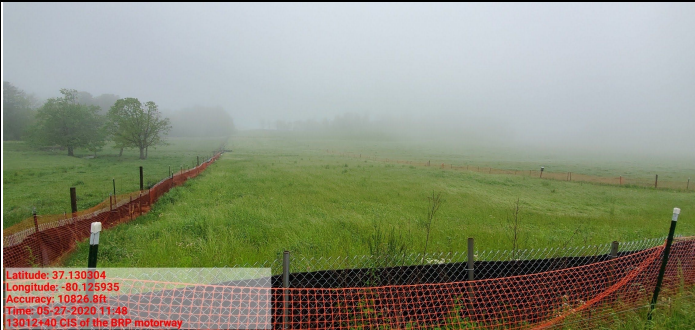
<p>Latitude: 37.130304 Longitude: -80.125935 Accuracy: 10826.8ft Time: 05-27-2020 11:48 13012+40 CIS of the BRP motorway</p>

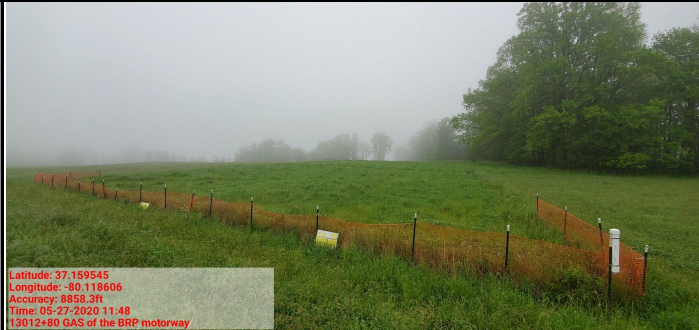
<p>Latitude: 37.159545 Longitude: -80.118606 Accuracy: 8858.3ft Time: 05-27-2020 11:48 13012+80 GAS of the BRP motorway</p>		
GPS Location	See pic for GPS location		GPS Location	See pic for GPS location	
Field Station#	13012+40		Field Station#	13012+80	
Pic 13 Desc.	CIS of the BRP motorway.		Pic 14 Desc.	GAS of the BRP motorway.

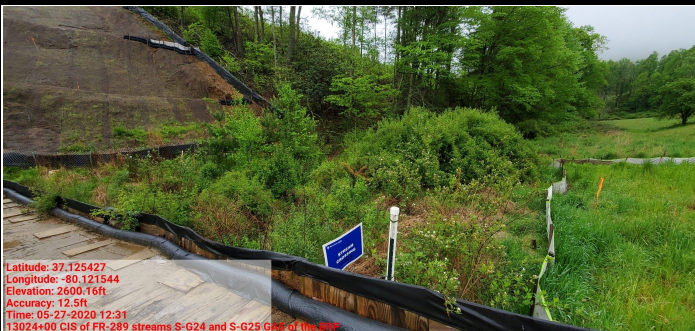
<p>Latitude: 37.125427 Longitude: -80.121544 Elevation: 2600.16ft Accuracy: 12.5ft Time: 05-27-2020 12:31 13024+00 CIS of FR-289 streams S-G24 and S-G25 GAS of the BRP</p>

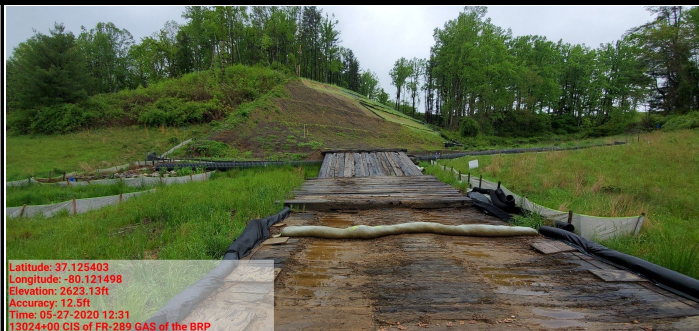
<p>Latitude: 37.125403 Longitude: -80.121498 Elevation: 2623.13ft Accuracy: 12.5ft Time: 05-27-2020 12:31 13024+00 CIS of FR-289 GAS of the BRP</p>		
GPS Location	See pic for GPS location		GPS Location	See pic for GPS location

Field Station#	13024+00		Field Station#	13024+00	
Pic 15 Desc.	Streams S-G24 and S-G25.		Pic 16 Desc.	GAS of the BRP Cleanwater Diversion Pipe and Plunge pool.

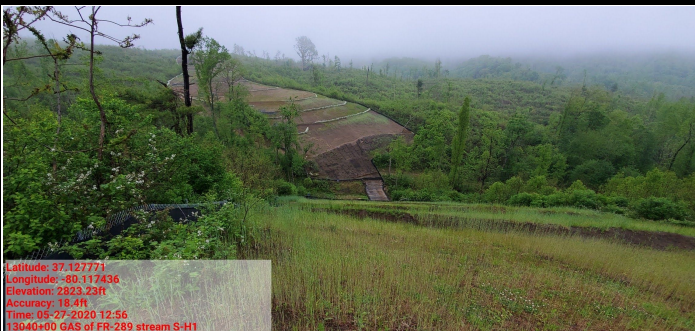
<p>Latitude: 37.127771 Longitude: -80.117436 Elevation: 2823.23ft Accuracy: 18.4ft Time: 05-27-2020 12:56 13040+00 GAS of FR-289 stream S-H1</p>

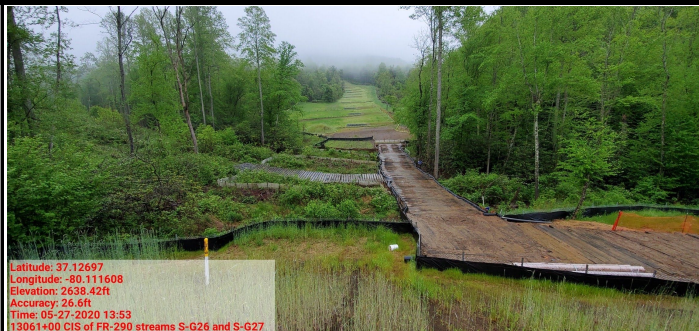
<p>Latitude: 37.12697 Longitude: -80.111608 Elevation: 2638.42ft Accuracy: 26.6ft Time: 05-27-2020 13:53 13061+00 CIS of FR-290 streams S-G26 and S-G27</p>		
GPS Location	See pic for GPS location		GPS Location	See pic for GPS location	
Field Station#	13040+00		Field Station#	13061+00	
Pic 17 Desc.	GAS of access road FR-289, stream crossing S-H1.		Pic 18 Desc.	Streams S-G26 and S-G27 at access road FR-290.

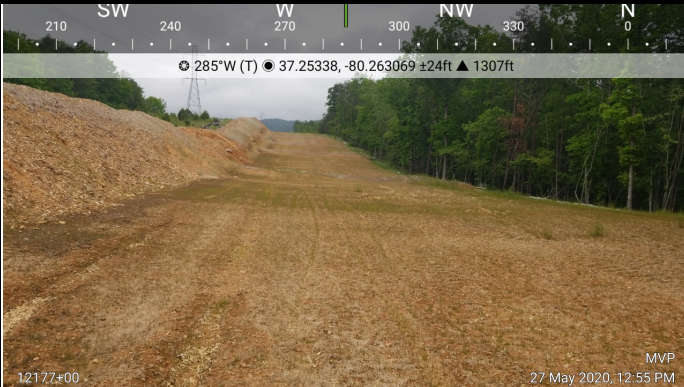
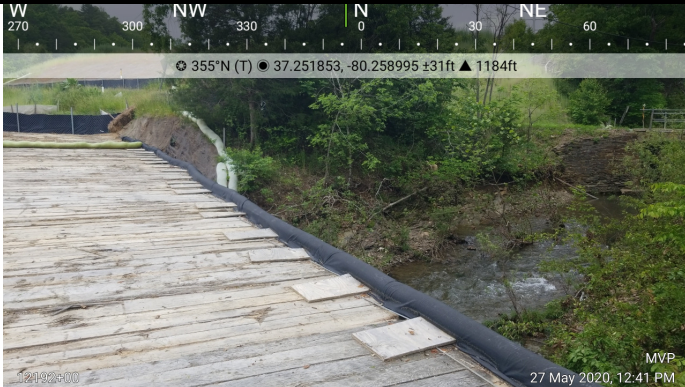
GPS Location	See Above		GPS Location	See Above	
Field Station#	12177+00		Field Station#	12192+00	
Pic 7 Desc.	Temporary vegetation remains stable and ECDs are functional.		Pic 8 Desc.	Stream S-C21, Looking South. ECDs are functional.

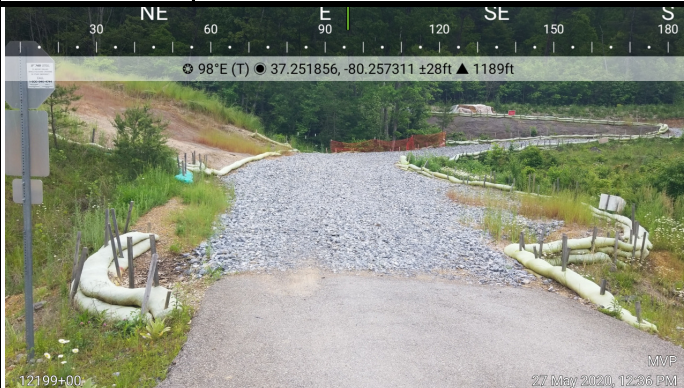
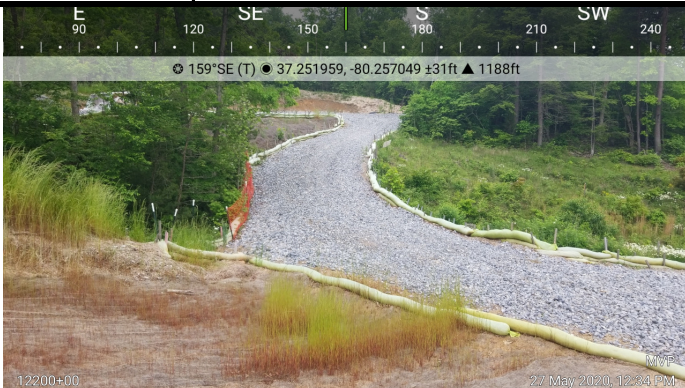
GPS Location	See Above		GPS Location	See Above	
Field Station#	12199+00		Field Station#	12200+00	
Pic 9 Desc.	Near Stream S-0011, Looking East. Temporary vegetation remains stable and ECDs are functional.		Pic 10 Desc.	Near Stream S-0011, Looking South. Temporary vegetation remains stable and ECDs are functional.

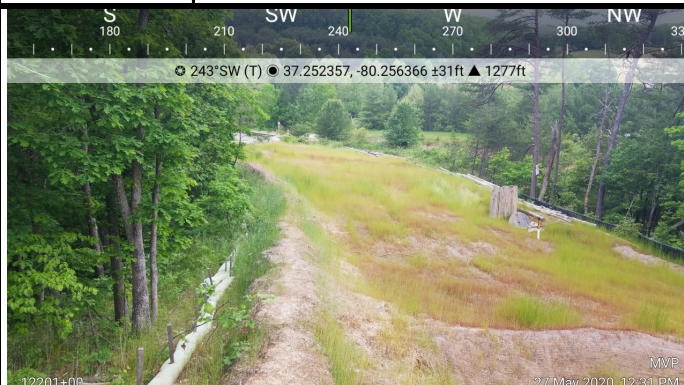
GPS Location	See Above		GPS Location	See Above	
Field Station#	12201+00		Field Station#	12209+00	
Pic 11 Desc.	Temporary vegetation remains stable and ECDs are functional. Looking SouthWest.		Pic 12 Desc.	Temporary and permanent vegetation remain stable and ECDs are functional. Looking South.

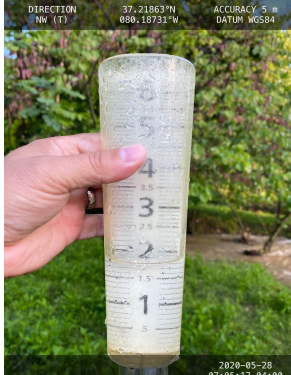
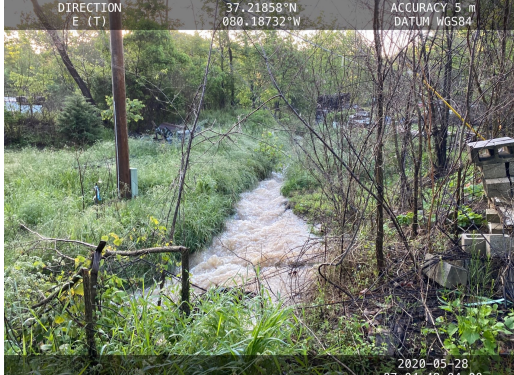
GPS Location	See photo		GPS Location	See photo	
Field Station#	+0		Field Station#	+0	
Pic 1 Desc.	There was 1.9 inches of precipitation accumulated in the rain gauge at Yellow Finch Road this morning.		Pic 2 Desc.	Stream S-KL32, facing east, upstream from where it crosses Yellow Finch Road

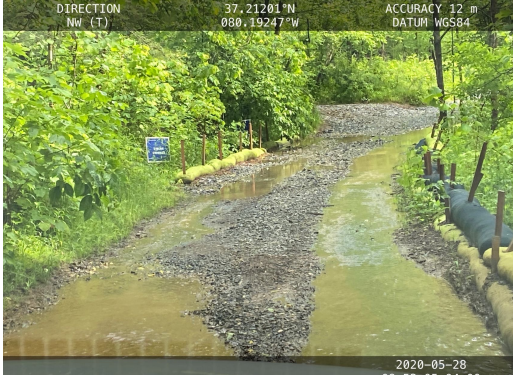
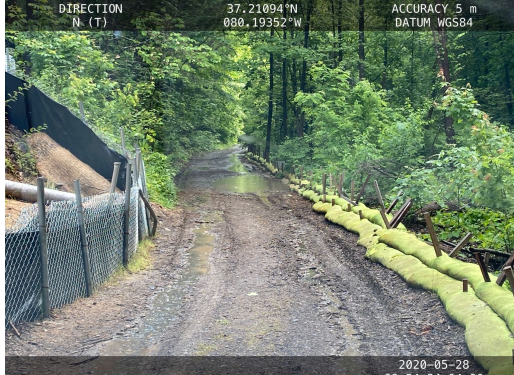
GPS Location	See photo		GPS Location	See photo	
Field Station#	+0		Field Station#	12544+06	
Pic 3 Desc.	Stream S-EF54 where it crosses Yellow Finch Road, facing northwest		Pic 4 Desc.	Yellow Finch Road at ROW crossing, facing north.

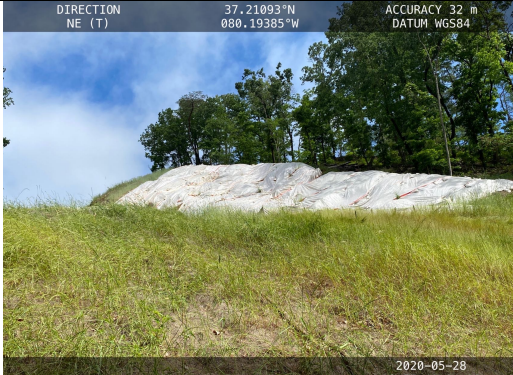
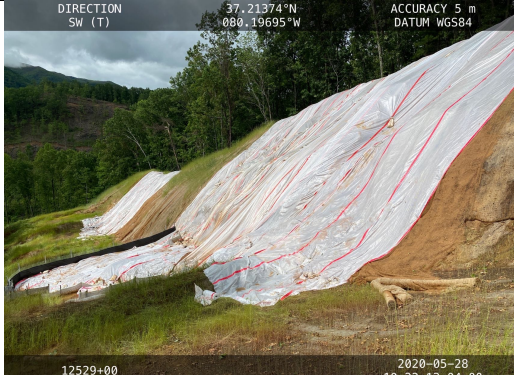
GPS Location	See photo		GPS Location	See photo	
Field Station#	12543+00		Field Station#	12529+00	
Pic 5 Desc.	Plastic sheeting intact just uphill from Yellow Finch Road.		Pic 6 Desc.	Plastic sheeting intact on stockpiles approximately 1500 feet from Yellow Finch Road.

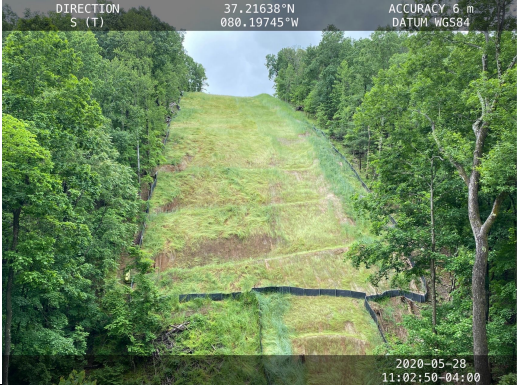
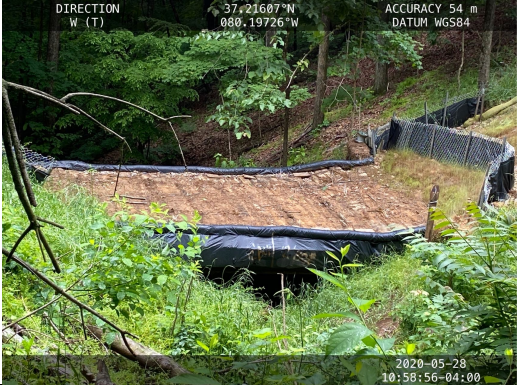
GPS Location	See photo		GPS Location	See photo	
Field Station#	12522+00		Field Station#	12519+41	
Pic 7 Desc.	Slope on going away side of stream S-EF19 well vegetated and stable.		Pic 8 Desc.	Stream S-EF19, facing west, downstream

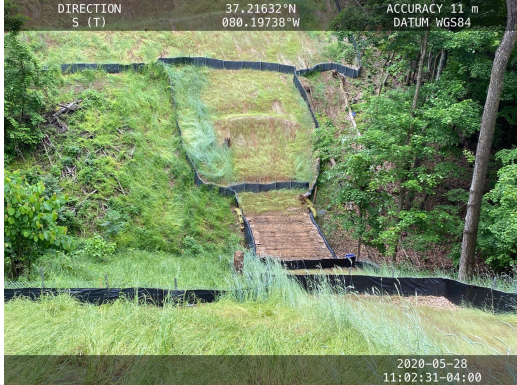
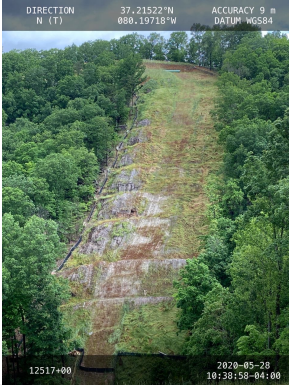
GPS Location	See photo		GPS Location	See photo	
Field Station#	12519+41		Field Station#	12517+00	
Pic 9 Desc.	Bridge and buffer zone of stream S-EF19, facing south		Pic 10 Desc.	Slope on coming in side of stream S-EF19 remains stable.

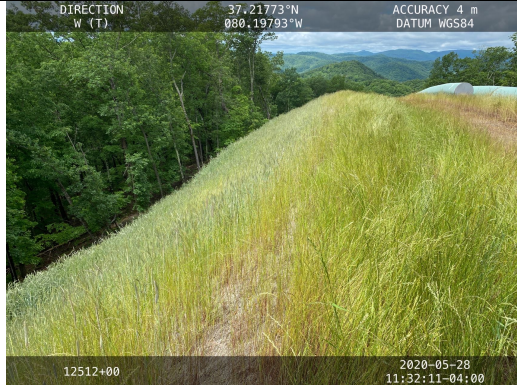
GPS Location	See photo		GPS Location	See photo	
Field Station#	12512+00		Field Station#	12506+75	
Pic 11 Desc.	Top of hill on coming in side of stream S-EF19, well vegetated.		Pic 12 Desc.	Vegetative cover more sparse in this section, but still effectively protected by blanket with no signs of erosion.

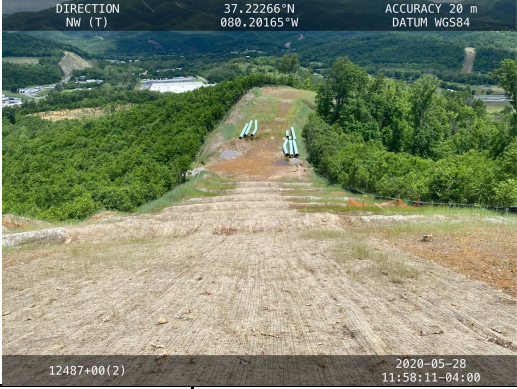
GPS Location	See photo		GPS Location	See photo	
Field Station#	12487+00		Field Station#	12487+00	
Pic 13 Desc.	Top of hill on going away side of MLV-28, facing down to valve site. Sparse vegetation, but blanket intact and slope stable.		Pic 14 Desc.	Slope stable with blanket, vegetative cover developing.

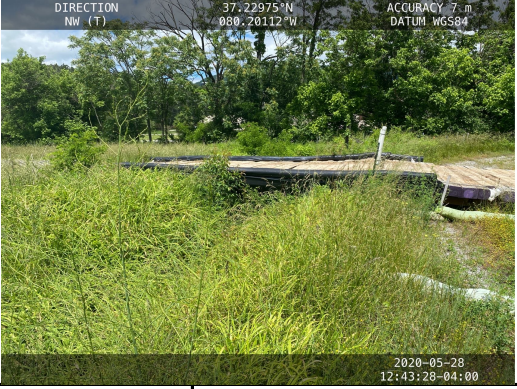
GPS Location	See photo		GPS Location	See photo	
Field Station#	12483+00		Field Station#	12455+21	
Pic 15 Desc.	End of stockpile sloughed into waterbar. Will be added to the punch list.		Pic 16 Desc.	Stream S-CD12, facing northwest, downstream
