# Visual Site Inspection Report

<b>Project Name</b> H-600 Pipeline Spread H		<b>AFE</b> 124300138	<b>Spread</b> H-600 Pipeline Spread H
<b>Contractor</b> Precision		<b>Report #</b> 10637	
<b>Inspector</b> Logan Box		<b>Date/Time</b> 5/4/2020 5:12 PM	
<b>Permit #</b> TBD	<b>Inspection Type</b> VA SWPP	<b>Station Begin</b> 13415+51	
<b>State</b> VA	<b>Inspection Area</b> Partial	<b>Station End</b> 13670+00	
<b>County</b> Franklin	<b>Ground</b> Dry	<b>Temperature (°F)</b> 74.00	
<b>Municipality</b> N/A	<b>Weather</b> Sunny	<b>Rain Gauge (in)</b> 2.30	
			<b>Rain Accumulation Time (days)</b> 6.00

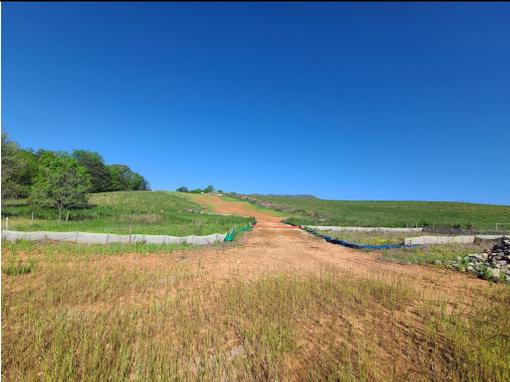
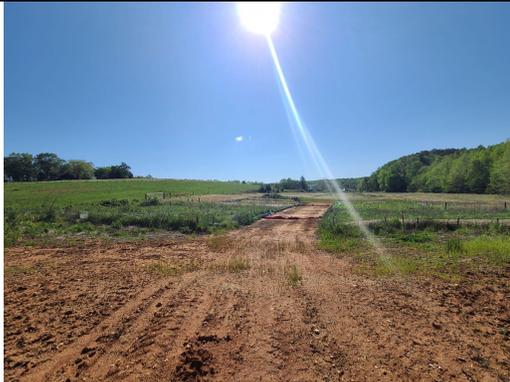
<b>GPS Location</b>	00000	<b>GPS Location</b>	00000		
<b>Field Station#</b>	13568+79	<b>Field Station#</b>	13568+79		
<b>Pic 1 Desc.</b>	Photo of natural drain crossing facing upstream showing vegetation		<b>Pic 2 Desc.</b>	Photo of natural drain crossing facing downstream

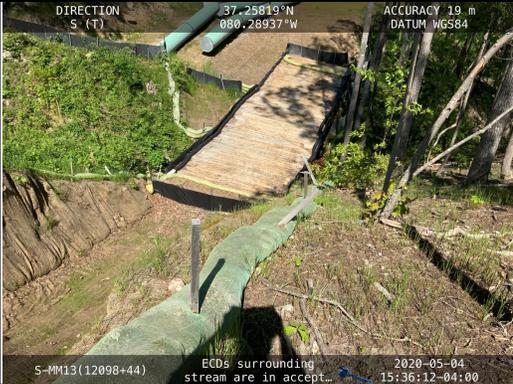
<b>Pic 7 Desc.</b>	Bridge and ECDs are in acceptable condition.	<b>Pic 8 Desc.</b>	
--------------------	--	--------------------	--

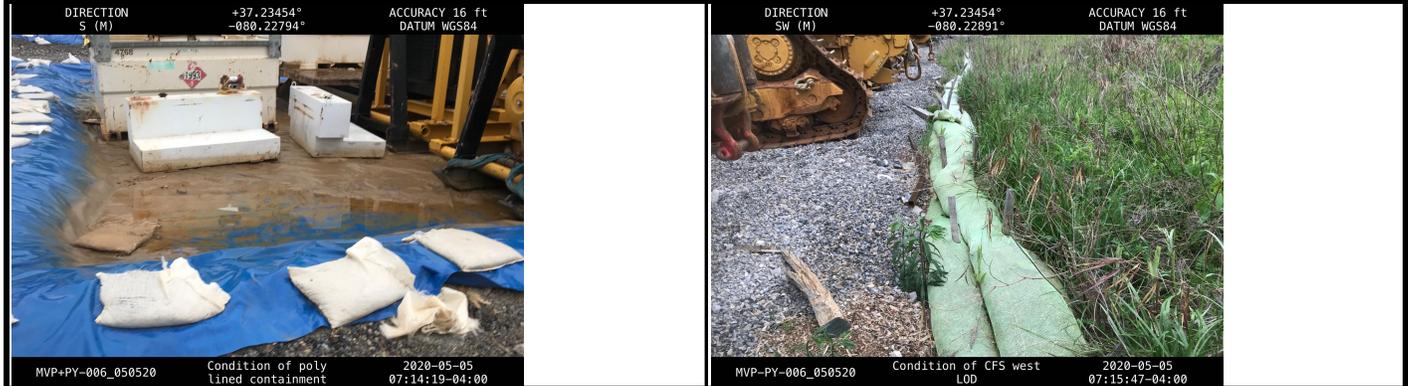
<b>Pic 7 Desc.</b>	Condition of poly lined containment. Looking S.	<b>Pic 8 Desc.</b>	Condition of compost filter sock along west LOD.
--------------------	---	--------------------	--

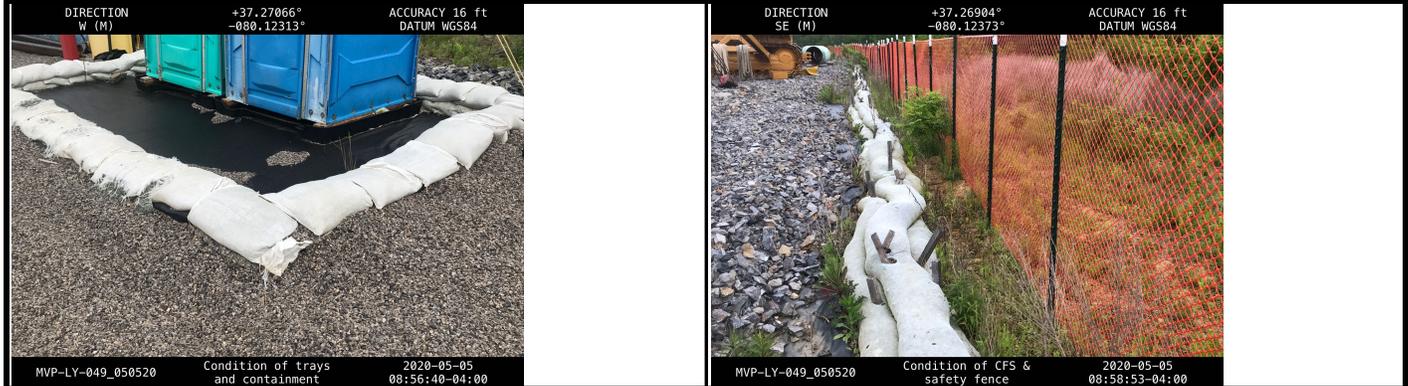
<b>Pic 7 Desc.</b>	Condition of trays and containment under toilets. Looking W.	<b>Pic 8 Desc.</b>	Condition of compost filter sock and safety fence along south LOD. Looking SE.
--------------------	--	--------------------	--

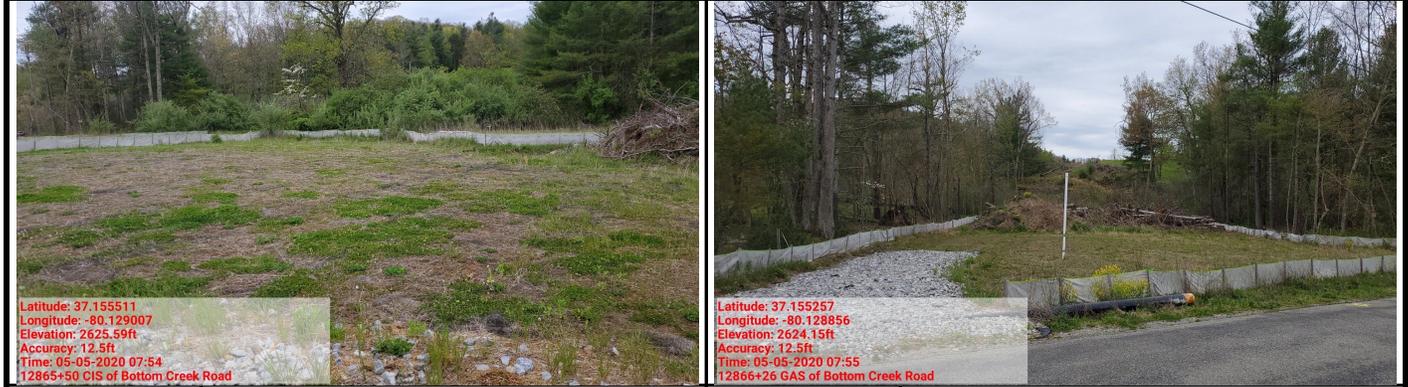
Latitude: 37.155511  
Longitude: -80.129007  
Elevation: 2625.59ft  
Accuracy: 12.5ft  
Time: 05-05-2020 07:54  
12865+50 CIS of Bottom Creek Road

Latitude: 37.155257  
Longitude: -80.128856  
Elevation: 2624.15ft  
Accuracy: 12.5ft  
Time: 05-05-2020 07:55  
12866+26 GAS of Bottom Creek Road

<b>GPS Location</b>	See pic for GPS location	<b>GPS Location</b>	See pic for GPS location
<b>Field Station#</b>	12865+50	<b>Field Station#</b>	12866+26
<b>Pic 1 Desc.</b>	CIS of the Bottom Creek Road crossing.	<b>Pic 2 Desc.</b>	GAS of the Bottom Creek Road crossing

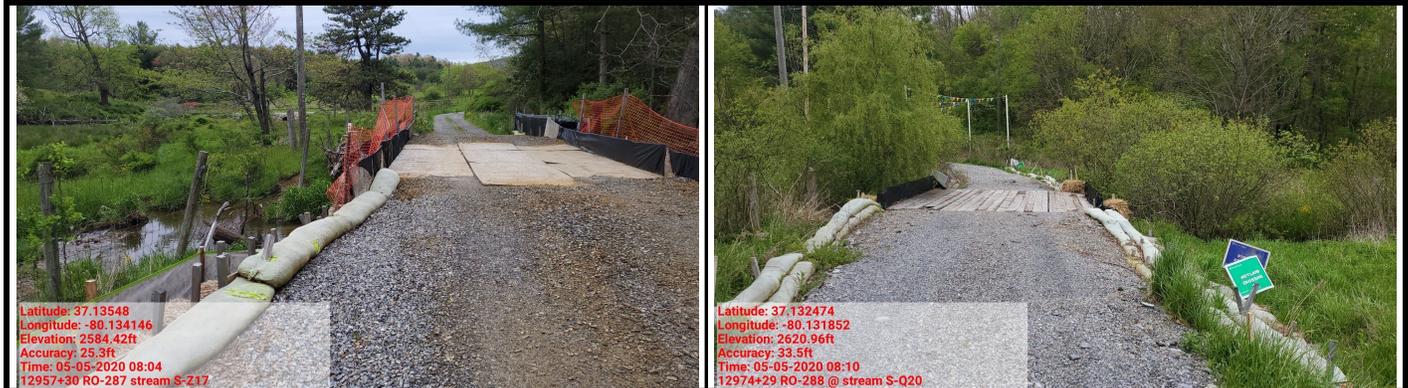
Latitude: 37.13548  
Longitude: -80.134146  
Elevation: 2584.42ft  
Accuracy: 25.3ft  
Time: 05-05-2020 08:04  
12957+30 RO-287 stream S-Z17

Latitude: 37.132474  
Longitude: -80.131852  
Elevation: 2620.96ft  
Accuracy: 33.5ft  
Time: 05-05-2020 08:10  
12974+29 RO-288 @ stream S-Q20

<b>GPS Location</b>	See pic for GPS location	<b>GPS Location</b>	See pic for GPS location
<b>Field Station#</b>	12957+30	<b>Field Station#</b>	12974+29
<b>Pic 3 Desc.</b>	Stream crossing S-Z17 on access road RO-287	<b>Pic 4 Desc.</b>	Stream crossing S-Q20 on access road RO-288.

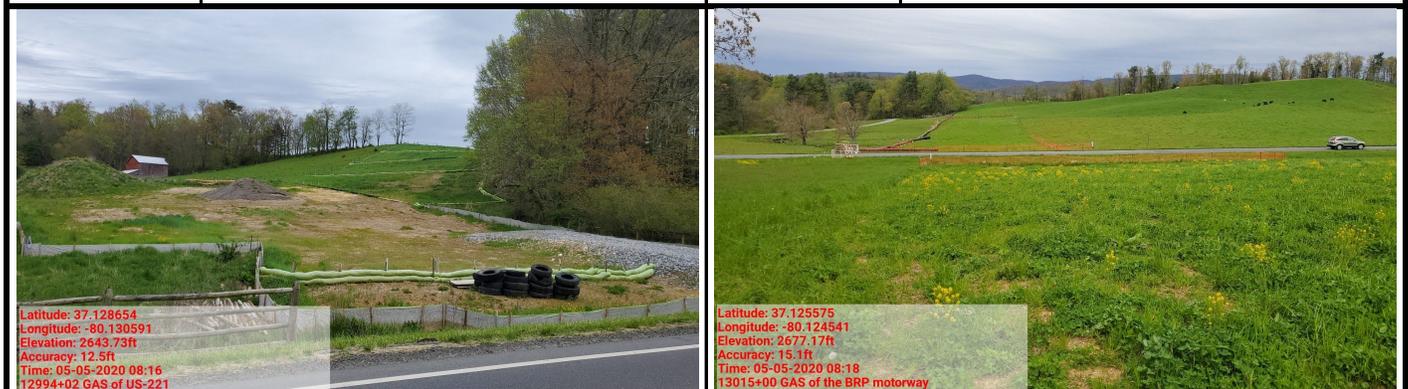
Latitude: 37.128654  
Longitude: -80.130591  
Elevation: 2643.73ft  
Accuracy: 12.5ft  
Time: 05-05-2020 08:16  
12994+02 GAS of US-221

Latitude: 37.125575  
Longitude: -80.124541  
Elevation: 2677.17ft  
Accuracy: 15.1ft  
Time: 05-05-2020 08:18  
13015+00 GAS of the BRP motorway

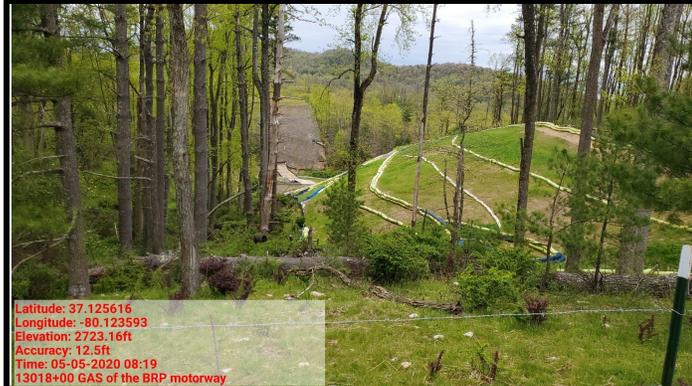
<b>Pic 7 Desc.</b>	GAS of the BRP in the non-agricultural portion.
--------------------	---

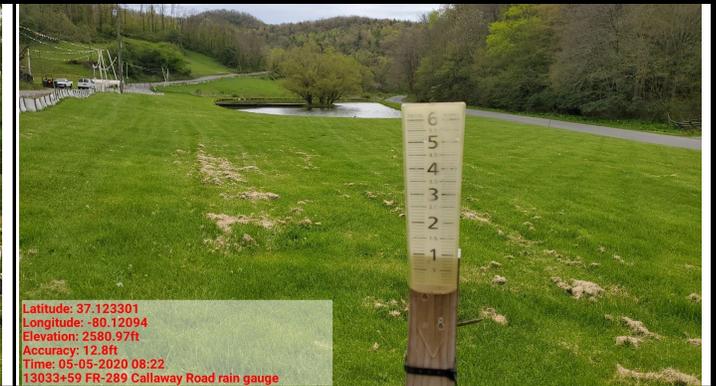
<b>Pic 8 Desc.</b>	0.0" total precipitation at Callaway Road
--------------------	---

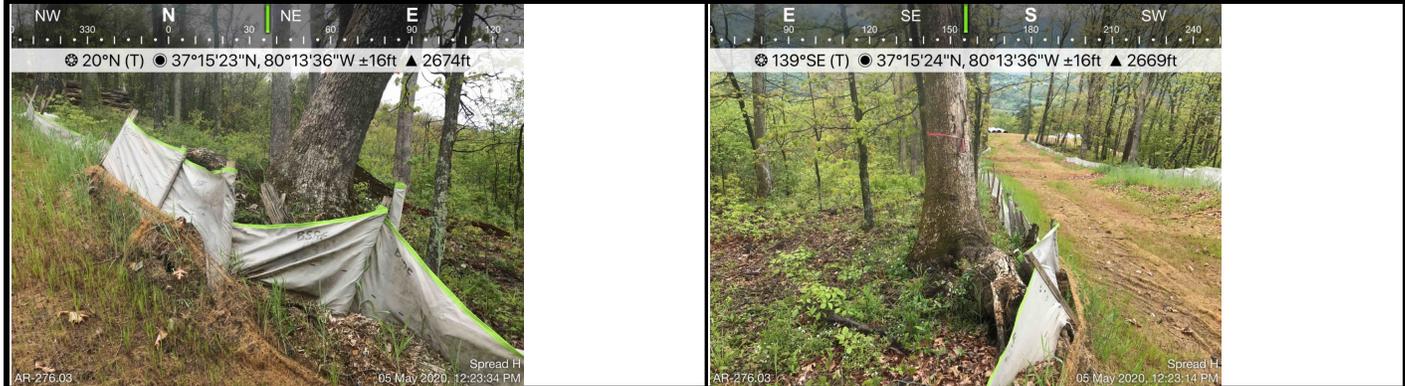
<b>GPS Location</b>	See photo	<b>GPS Location</b>	See photo
<b>Field Station#</b>	276+03	<b>Field Station#</b>	276+03
<b>Pic 13 Desc.</b>	Tree roots have undermined SF controls on AR-276.03. Monitor this area.	<b>Pic 14 Desc.</b>	Roots have undermined controls. Monitor this area, Tree has potential on falling in near future.

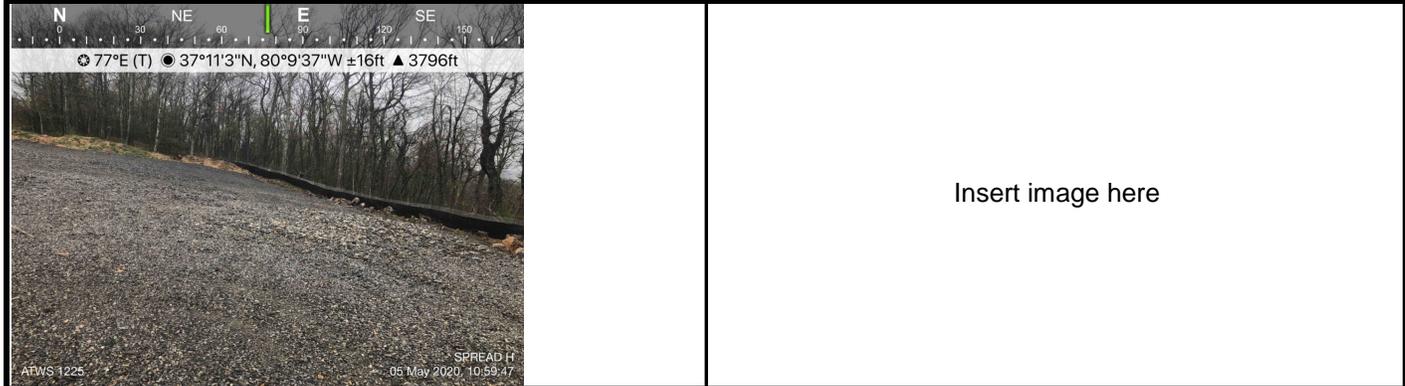
<b>Pic 13 Desc.</b>	ATWS-1225 remains dormant with controls in place.	<b>Pic 14 Desc.</b>	
---------------------	---	---------------------	--

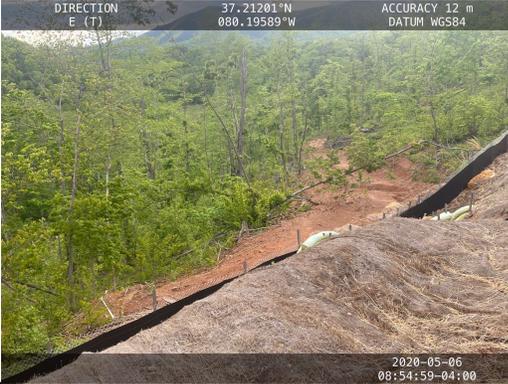
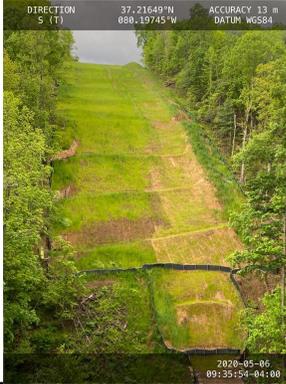
<b>GPS Location</b> See photo		<b>GPS Location</b> See photo		<b>GPS Location</b> See photo	
<b>Field Station#</b> 12536+00		<b>Field Station#</b> 12522+50		<b>Field Station#</b> 12522+50	
<b>Pic 3 Desc.</b> Erosion was observed on the unstabilized logging road adjacent to MVP ROW approximately 800 feet from Yellow Finch Rd.		<b>Pic 4 Desc.</b> The slope on the going away side of stream S-EF19 remains stable.		<b>Pic 4 Desc.</b> The slope on the going away side of stream S-EF19 remains stable.

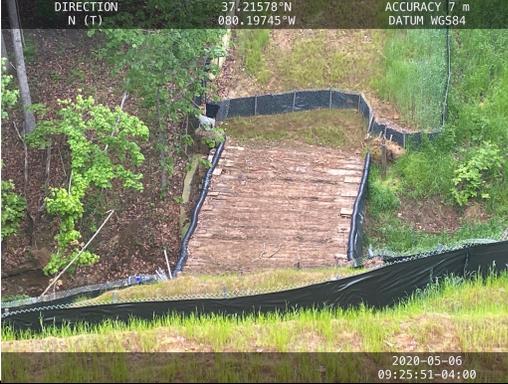
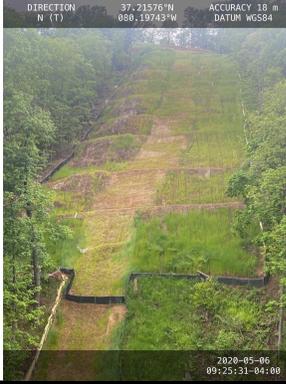
<p>DIRECTION N (T) 37.21576°N 080.19745°W ACCURACY 18 m DATUM WGS84 2020-05-06 09:25:31-04:00</p>	
<b>GPS Location</b> See photo		<b>GPS Location</b> See photo		<b>GPS Location</b> See photo	
<b>Field Station#</b> 12519+41		<b>Field Station#</b> 12517+00		<b>Field Station#</b> 12517+00	
<b>Pic 5 Desc.</b> Stream S-EF19, facing north		<b>Pic 6 Desc.</b> The slope on the coming in side of stream S-EF19 shows no signs of erosion.		<b>Pic 6 Desc.</b> The slope on the coming in side of stream S-EF19 shows no signs of erosion.

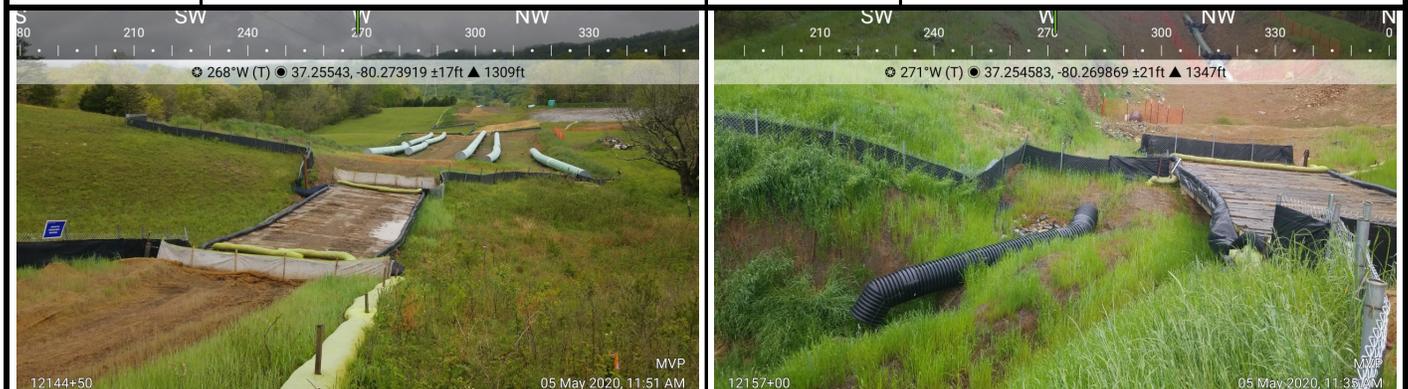
<b>GPS Location</b> See Above	<b>GPS Location</b> See Above
<b>Field Station#</b> 12144+50	<b>Field Station#</b> 12157+00
<b>Pic 3 Desc.</b> Wetland W-C5, Looking West.	<b>Pic 4 Desc.</b> Head-water area Stream S-C23, Looking West.

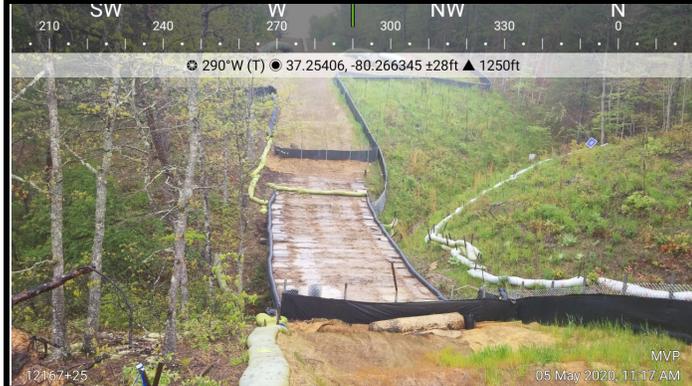
<b>GPS Location</b>	See Above
<b>Field Station#</b>	12167+25

<b>Pic 7 Desc.</b>	Stream S-C24, Looking West.
--------------------	-----------------------------

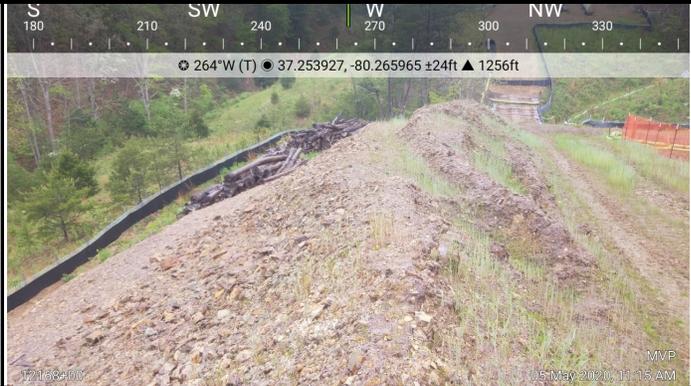
<b>GPS Location</b>	See Above
<b>Field Station#</b>	12168+00

<b>Pic 8 Desc.</b>	Temporary vegetation remain stable and ECDs are functional.
--------------------	---

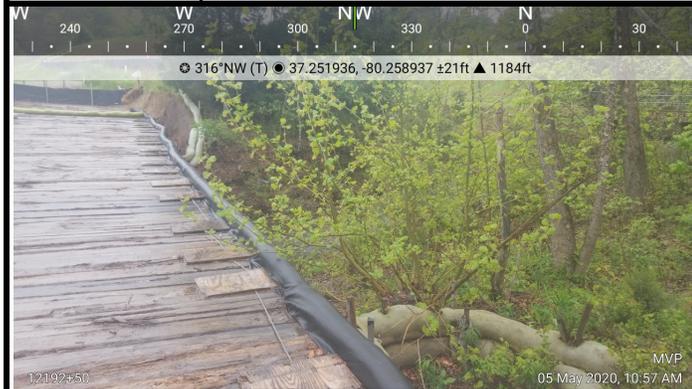
<b>GPS Location</b>	See Above
<b>Field Station#</b>	12192+50

<b>Pic 9 Desc.</b>	Stream S-C21, Looking NorthWest.
--------------------	----------------------------------

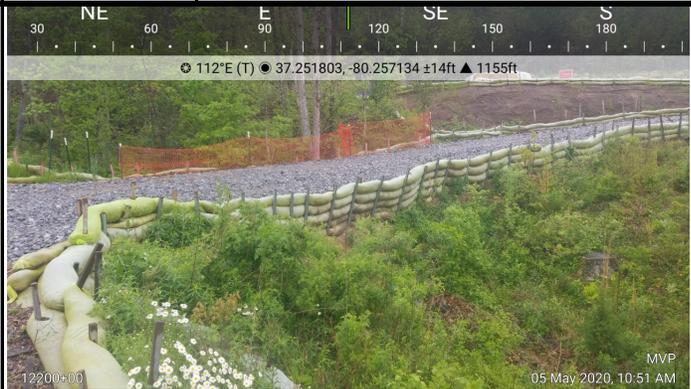
<b>GPS Location</b>	See Above
<b>Field Station#</b>	12200+00

<b>Pic 10 Desc.</b>	Near Stream S-OO11, Looking East. Temporary vegetation remains stable and ECDs are functional.
---------------------	--

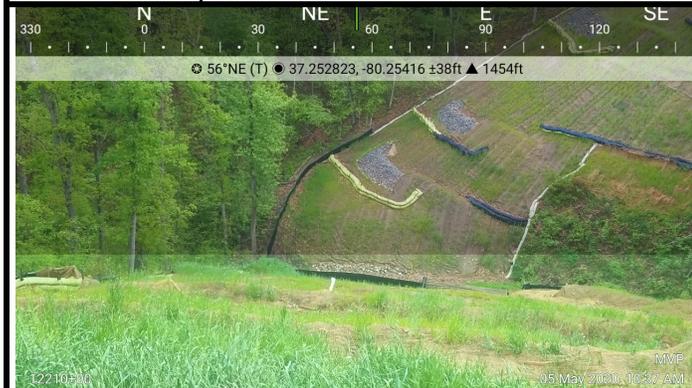
<b>GPS Location</b>	See Above
<b>Field Station#</b>	12210+00

<b>Pic 11 Desc.</b>	Temporary and permanent vegetation remain stable and ECDs are functional.
---------------------	---

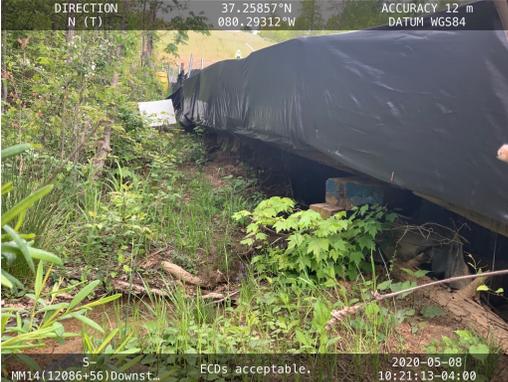
<p>DIRECTION N (T) 37.25857°N 080.29312°W ACCURACY 12 m DATUM WGS84 S-MM14(12086+56)Downst. ECDs acceptable. 2020-05-08 10:21:13-04:00</p>

<b>GPS Location</b> See photo GPS for location		<b>GPS Location</b> See photo GPS for location			
<b>Field Station#</b> 12086+56		<b>Field Station#</b> 12098+44			
<b>Pic 3 Desc.</b> Bridge and ECDs are in acceptable condition.		<b>Pic 4 Desc.</b> Bridge and ECDs are in acceptable condition.

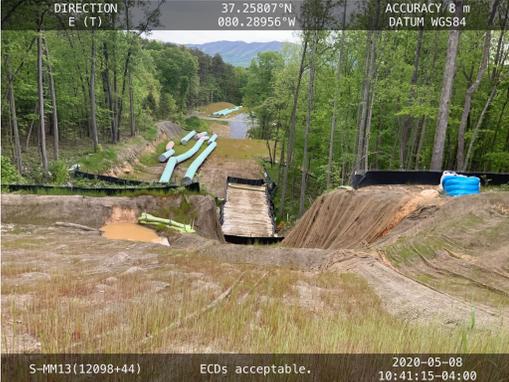
<p>DIRECTION E (T) 37.25807°N 080.28956°W ACCURACY 8 m DATUM WGS84 S-MM13(12098+44) ECDs acceptable. 2020-05-08 10:41:15-04:00</p>

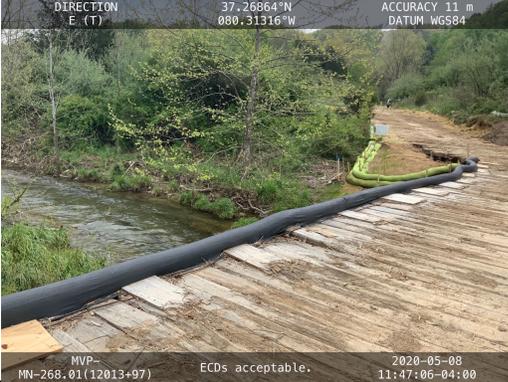
<p>DIRECTION E (T) 37.26864°N 080.31316°W ACCURACY 11 m DATUM WGS84 MVP-MN-268.01(12013+97) ECDs acceptable. 2020-05-08 11:47:06-04:00</p>

<p>DIRECTION E (T) 37.26799°N 080.31302°W ACCURACY 4 m DATUM WGS84 ATWS-47,12014+94,In process Damaged black silt removed. P1 install... 2020-05-08 11:59:47-04:00</p>			
<b>GPS Location</b> See photo GPS for location		<b>GPS Location</b> See photo GPS for location			
<b>Field Station#</b> 12013+97		<b>Field Station#</b> 12014+94			
<b>Pic 5 Desc.</b> ECDs surrounding bridge are in acceptable condition.		<b>Pic 6 Desc.</b> Damaged black silt fence was removed, gully repaired, and some P1 installed. Work is in progress.

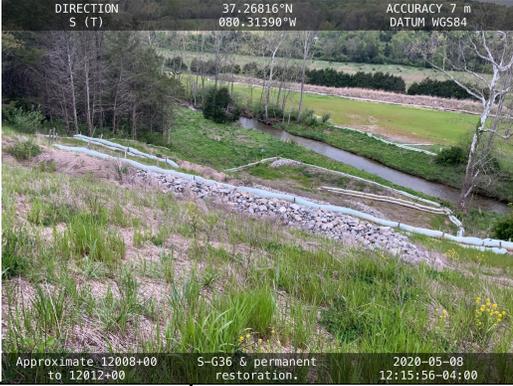
<p>DIRECTION S (T) 37.26816°N 080.31390°W ACCURACY 7 m DATUM WGS84</p> <p>Approximate 12008+00 to 12012+00 S-G36 &amp; permanent restoration. 2020-05-08 12:15:56-04:00</p>

<p>DIRECTION S (T) 37.26816°N 080.31391°W ACCURACY 5 m DATUM WGS84</p> <p>Approximate 12008+00 to 12012+00 S-G36 &amp; permanent restoration. 2020-05-08 12:16:19-04:00</p>	
<b>GPS Location</b>	See photo GPS for location		<b>GPS Location</b>	See photo GPS for location	
<b>Field Station#</b>	12012+00		<b>Field Station#</b>	12008+00	
<b>Pic 7 Desc.</b>	Banks of stream are well vegetated. Permanent restoration vegetation is progressing.		<b>Pic 8 Desc.</b>	Banks of stream are well vegetated. Permanent restoration vegetation is progressing.

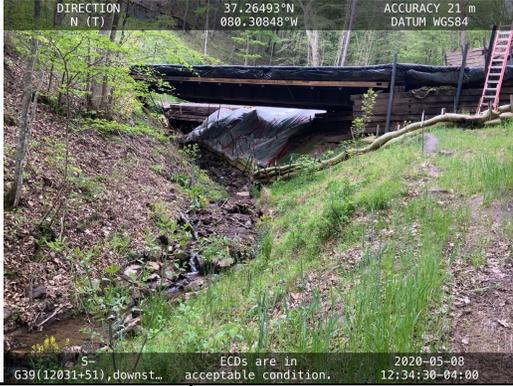
<p>DIRECTION N (T) 37.26493°N 080.30848°W ACCURACY 21 m DATUM WGS84</p> <p>S-G39(12031+51), downst... ECDs are in acceptable condition. 2020-05-08 12:34:30-04:00</p>				Insert image here

<b>GPS Location</b>	See photo GPS for location		<b>GPS Location</b>		
<b>Field Station#</b>	12031+51		<b>Field Station#</b>		
<b>Pic 9 Desc.</b>	ECDs are in acceptable condition.		<b>Pic 10 Desc.</b>		
Insert image here			Insert image here		
<b>GPS Location</b>			<b>GPS Location</b>		
<b>Field Station#</b>			<b>Field Station#</b>		
<b>Pic 11 Desc.</b>			<b>Pic 12 Desc.</b>

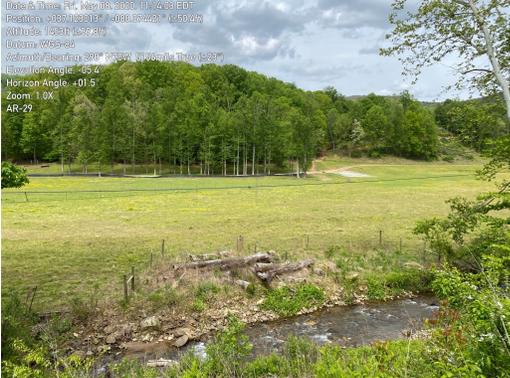
<p><small>Date &amp; Time: Fri, May 08, 2020, 11:12:03 EDT Position: +37.115439 / -80.060302 (-45.81) Altitude: 1437ft (+38.1m) Datum: WGS-84 Azimuth/Bearing: 35° S 59W 3340mils True (+12°) Elevation Angle: -05.4 Horizon Angle: +01.5 Zoom: 1.0X S-II4 up AR-29</small></p>

<p><small>Date &amp; Time: Fri, May 08, 2020, 11:33:22 EDT Position: +37.115439 / -80.060302 (-45.81) Altitude: 1447ft (+38.1m) Datum: WGS-84 Azimuth/Bearing: 35° S 59W 3340mils True (+12°) Elevation Angle: -05.4 Horizon Angle: +06.8 Zoom: 1.0X S-II4 up</small></p>			
<b>GPS Location</b>	See photo for coordinates.	<b>GPS Location</b>	See photo for coordinates.	
<b>Field Station#</b>	13197+50	<b>Field Station#</b>	13260+60	
<b>Pic 1 Desc.</b>	S-D8, looking towards MVP-AR-29, no disturbance at stream crossing or field.	<b>Pic 2 Desc.</b>	S-II4, upstream side of equipment bridge, no environmental issues noted.

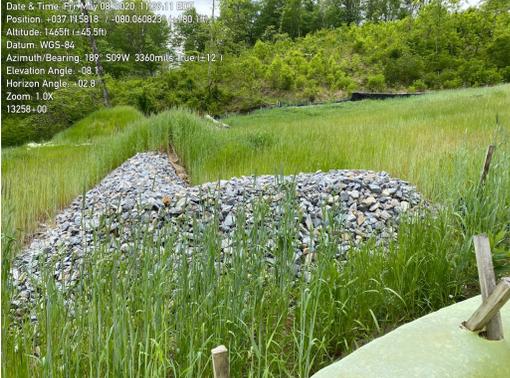
<p><small>Date &amp; Time: Fri, May 08, 2020, 11:55:11 EDT Position: +37.115818 / -80.060823 (-45.81) Altitude: 1465ft (+45.5m) Datum: WGS-84 Azimuth/Bearing: 109° S 99W 3340mils True (+12°) Elevation Angle: -08.1 Horizon Angle: -02.8 Zoom: 1.0X 13258+00</small></p>

<p><small>Date &amp; Time: Fri, May 08, 2020, 11:58:02 EDT Position: +37.115818 / -80.060919 (-45.81) Altitude: 1473ft (+45.7m) Datum: WGS-84 Azimuth/Bearing: 059° NSPE 1049mils True (+12°) Elevation Angle: -08.4 Horizon Angle: -00.1 Zoom: 1.0X 13258+00</small></p>			
<b>GPS Location</b>	See photo for coordinates.	<b>GPS Location</b>	See photo for coordinates.	
<b>Field Station#</b>	13258+00	<b>Field Station#</b>	13258+00	
<b>Pic 3 Desc.</b>	Permanent waterbar and rock weir stable with good vegetative cover.	<b>Pic 4 Desc.</b>	S-II4, CIS, are permanently restored, good vegetative cover noted across LOD.

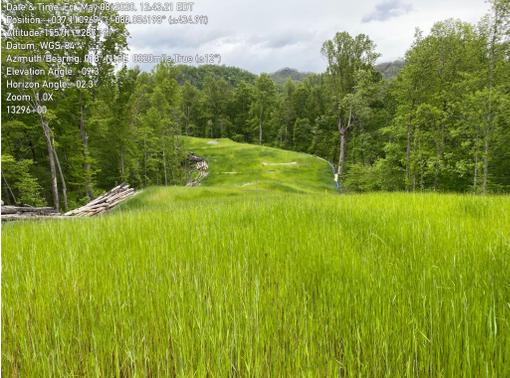
<p><small>Date &amp; Time: Fri, May 08, 2020, 12:02:01 EDT Position: +37.115818 / -80.061197 (-45.81) Altitude: 1455ft (+45.2m) Datum: WGS-84 Azimuth/Bearing: 110° S 97W 3340mils True (+12°) Elevation Angle: -09.0 Horizon Angle: -02.3 Zoom: 1.0X 13296+00</small></p>

<b>GPS Location</b>	See photo for coordinates.	<b>GPS Location</b>	See photo for coordinates.	
<b>Field Station#</b>	13296+00	<b>Field Station#</b>	13301+00	
<b>Pic 5 Desc.</b>	Permanently restored ROW stable, good vegetative cover noted across LOD.	<b>Pic 6 Desc.</b>	Permanently restored ROW stable, good vegetative cover noted across LOD.
