Visual Site Inspection Report

| Project Name | H-600 Pipeline Spread I | AFE | 124300139 | Spread | H-600 Pipeline Spread I |

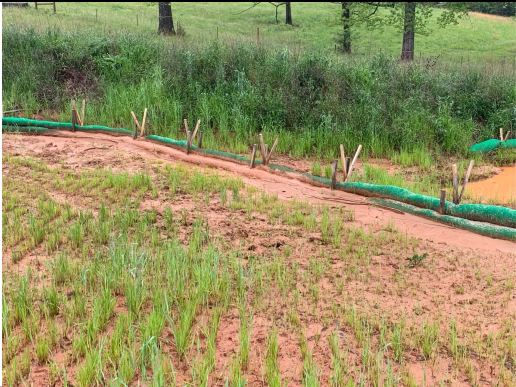
| Pic 1 Desc. | Observing p1 that requires maintenance. | Pic 2 Desc. | Observing cfs that requires maintenance. | | |

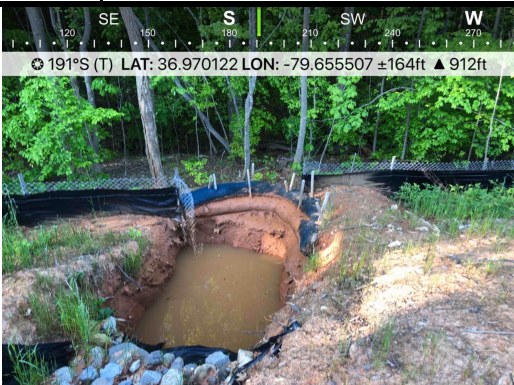
| Pic 3 Desc. | CFS on end treatment needs to be cleaned so that it filters properly | | Pic 4 Desc. | CFS on end treatment needs to be cleaned so that it filters properly | |

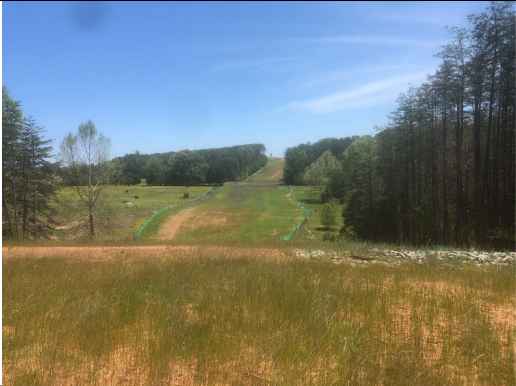
| Pic 3 Desc. | Equipment bridge and ECD's at crossing of S-H9 in good condition. | | Pic 4 Desc. | Equipment bridge and ECD's at crossing of S-C7 in good condition. | |

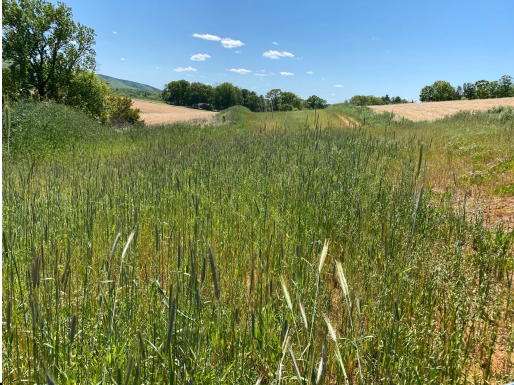
| Pic 1 Desc. | Approximately 13895+00. Overview of ROW. ROW temporarily stabilized and has winter vegetation growing. | Pic 2 Desc. | Approximately 13998+15. Overview of stream crossing, equipment bridge and ECDs at stream S-KL36. | | |

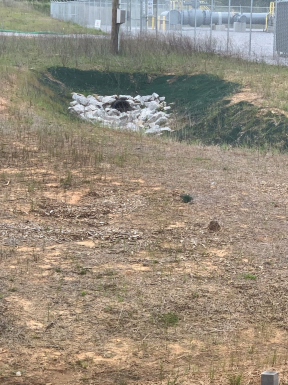
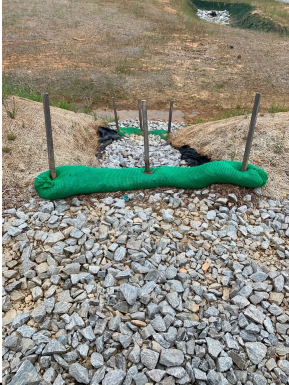
| Pic 1 Desc. | Observing ECD's performing as they should. | Pic 2 Desc. | Observing ECD's performing as they should. | | |
