# Visual Site Inspection Report

<b>Project Name</b> H-600 Pipeline Spread I		<b>AFE</b> 124300139	<b>Spread</b> H-600 Pipeline Spread I
<b>Contractor</b> Precision		<b>Report #</b> 7281	
<b>Inspector</b> Ben Davenport		<b>Date/Time</b> 1/13/2020 5:00 PM	
<b>Permit #</b> TBD	<b>Inspection Type</b> VA SWPP	<b>Station Begin</b> 14928+52	
<b>State</b> VA	<b>Inspection Area</b> Partial	<b>Station End</b> 15296+00	
<b>County</b> Franklin/Pittsylvania	<b>Ground</b> Muddy	<b>Temperature (°F)</b> 61.00	
<b>Municipality</b> Chatham	<b>Weather</b> Cloudy	<b>Rain Gauge (in)</b> 0.00	
			<b>Rain Accumulation Time (days)</b> 0.00

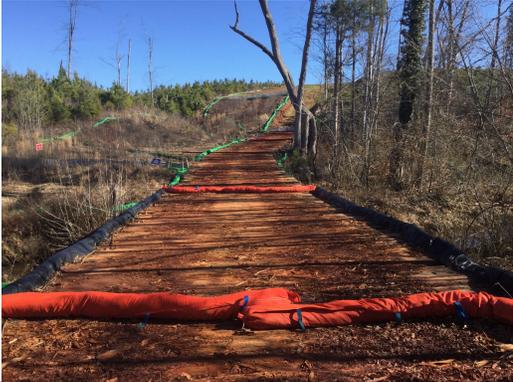
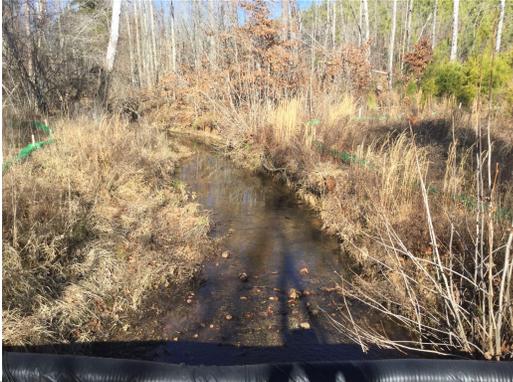
<b>GPS Location</b>	7	<b>GPS Location</b>	8	<b>Field Station#</b>	15026+50
<b>Field Station#</b>	15026+50	<b>Field Station#</b>	15026+00	<b>Pic 7 Desc.</b>	Bridge crossing at streams S-D3 and S-D4
<b>Pic 7 Desc.</b>	Bridge crossing at streams S-D3 and S-D4	<b>Pic 8 Desc.</b>	Upstream view of S-D3

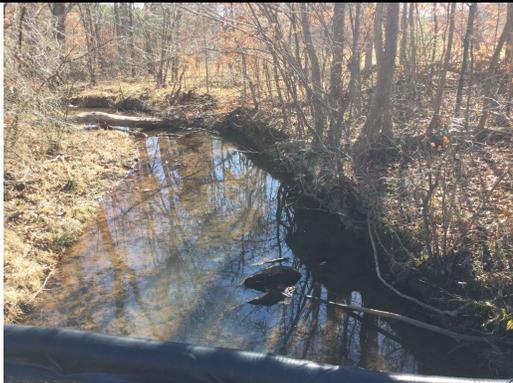
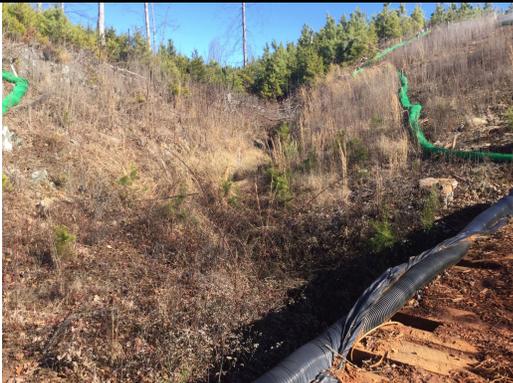
<b>GPS Location</b>	9	<b>GPS Location</b>	10	<b>Field Station#</b>	15026+00
<b>Field Station#</b>	15026+00	<b>Field Station#</b>	15027+97	<b>Pic 9 Desc.</b>	Downstream view of S-D3
<b>Pic 9 Desc.</b>	Downstream view of S-D3	<b>Pic 10 Desc.</b>	Upstream view of S-D4

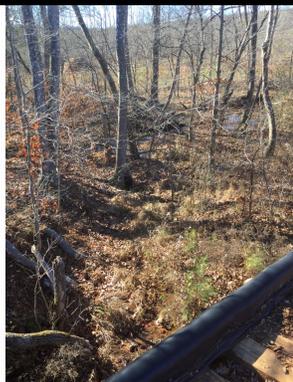
Insert image here	
<b>GPS Location</b>	11	<b>GPS Location</b>		<b>Field Station#</b>	15027+97
<b>Field Station#</b>	15027+97	<b>Field Station#</b>		<b>Pic 11 Desc.</b>	Downstream view of S-D4
<b>Pic 11 Desc.</b>	Downstream view of S-D4	<b>Pic 12 Desc.</b>

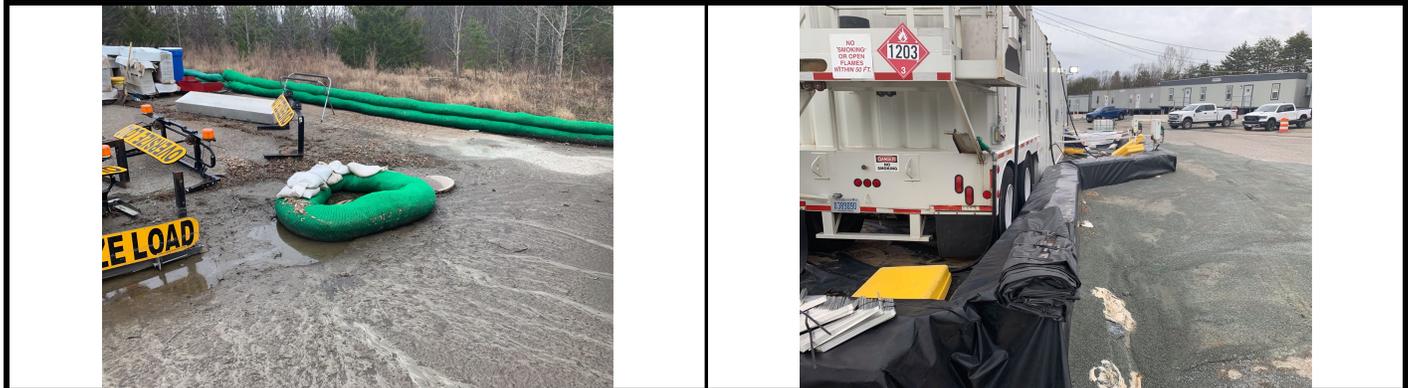
Preformed SWPPP inspection of Spread I main Laydown yard. All perimeter ECD's were inspected and one issue was found with the triple stacked CFS need to be restacked in the northwest corner of paved yard. The inlet protection for the parking lot drains in the paved yard were in good condition. The RCE at the gravel yard was clean and the road was clear of debris. All secondary containment structures were found to be in acceptable condition. The General Construction permits are posted at the main entrance of the paved yard as required. Any issues observed during the inspection were placed on a punch list and given to the contractor to address.

<b>GPS Location</b>	0000000000	<b>GPS Location</b>	0000000000
<b>Field Station#</b>	0000+00	<b>Field Station#</b>	0000+00
<b>Pic 1 Desc.</b>	Triple stack CFS at northwest corner of paved yard needs to be restacked.	<b>Pic 2 Desc.</b>	Perimeter ECD's on west side of paved yard in good condition.

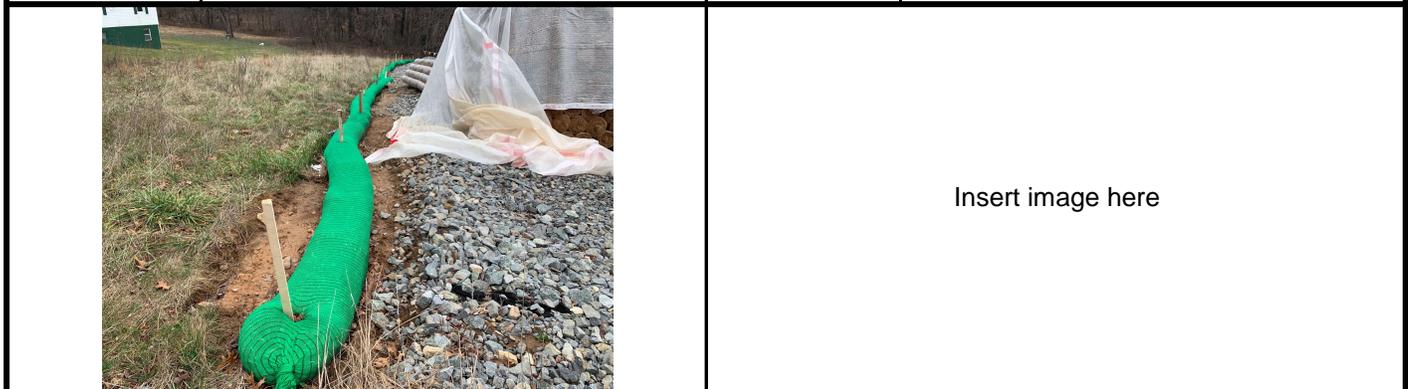
<b>GPS Location</b>	0000000000	<b>GPS Location</b>	0000000000
<b>Field Station#</b>	0000+00	<b>Field Station#</b>	0000+00
<b>Pic 3 Desc.</b>	Perimeter ECD's and inlet protection for parking lot drain on south end of paved yard in acceptable condition.	<b>Pic 4 Desc.</b>	Secondary containment structure for fuel cell in compliance

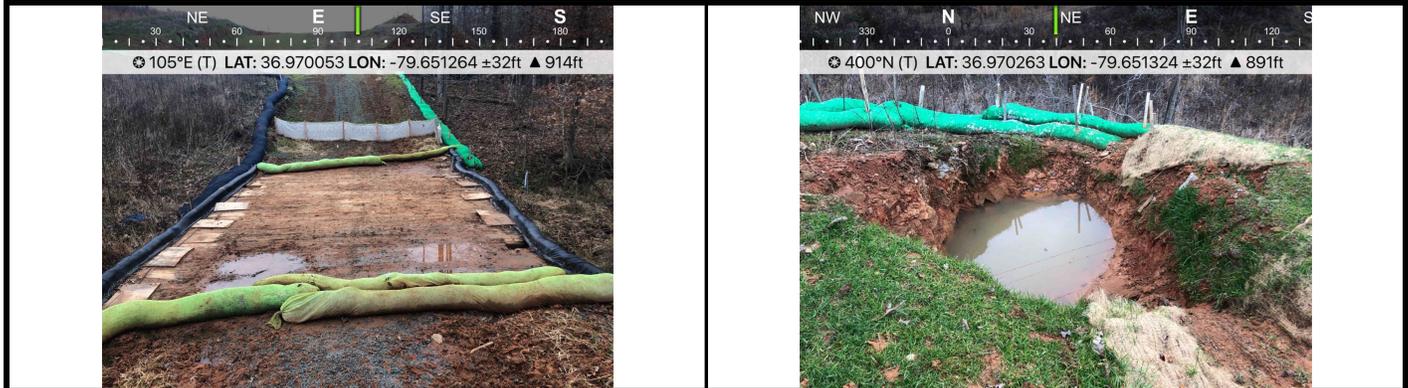
<b>GPS Location</b>	0	<b>GPS Location</b>	0
<b>Field Station#</b>	14865+00	<b>Field Station#</b>	14870+43
<b>Pic 1 Desc.</b>	Sump pit functioning as intended on the GAS of Bar Ridge Road	<b>Pic 2 Desc.</b>	Equipment bridge clean at stream S-SS8

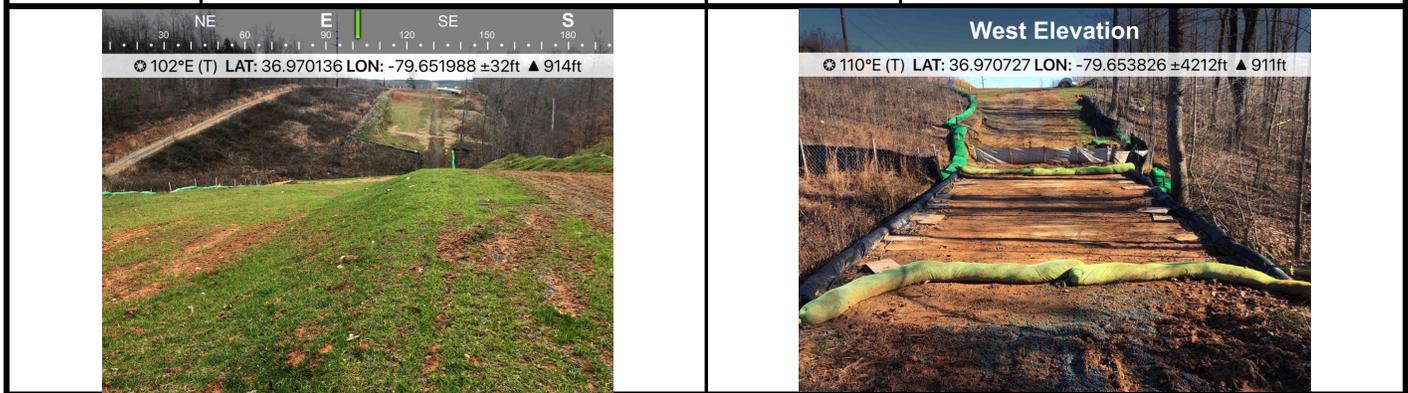
<b>GPS Location</b>	0	<b>GPS Location</b>	0
<b>Field Station#</b>	14888+69	<b>Field Station#</b>	14880+00
<b>Pic 3 Desc.</b>	Equipment bridge clean at stream S-AB8	<b>Pic 4 Desc.</b>	Sump pit functioning as intended on the GAS of Bar Ridge Road

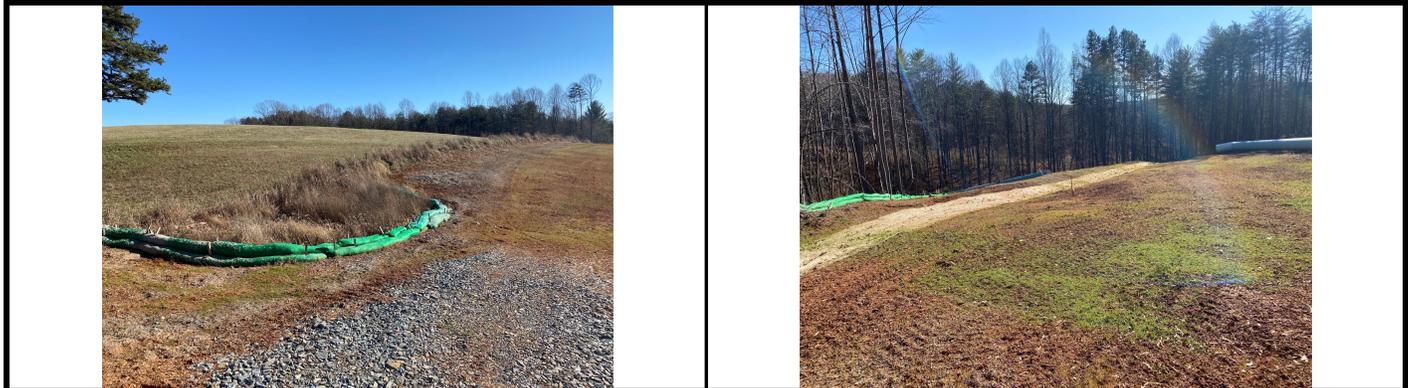
<b>Pic 1 Desc.</b>	Approximately 13998+15. Overview of stream crossing, equipment bridge and ECDs at stream S-KL36.	<b>Pic 2 Desc.</b>	Approximately 13947+00. Overview of ROW. ROW temporarily stabilized and has winter vegetation growing.
--------------------	--	--------------------	--

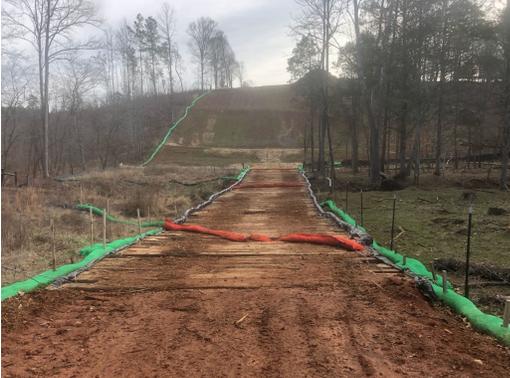
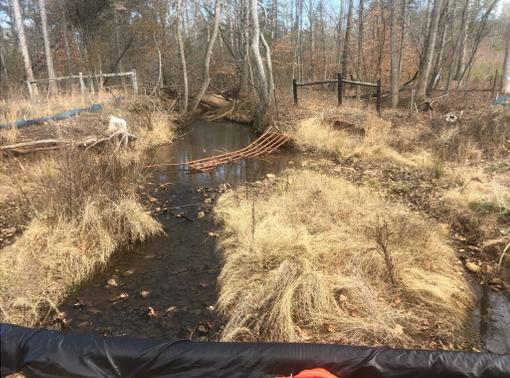
GPS Location 1		GPS Location 2			
Field Station# 15169+00		Field Station# 15169+00			
Pic 1 Desc. Equipment bridge crossing at S-C7. ECD's in place and functional.		Pic 2 Desc. Upstream view of S-C7.

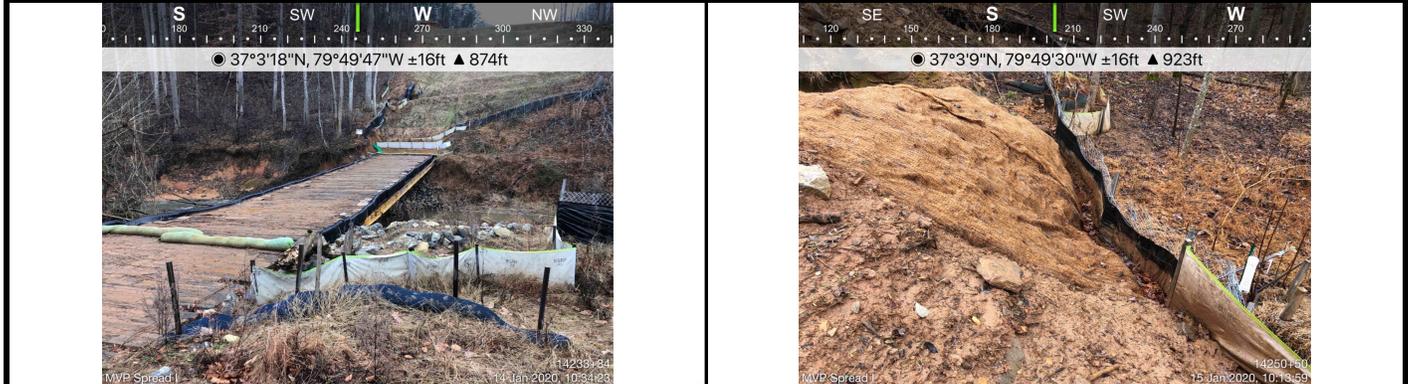
<b>GPS Location</b> 0	<b>GPS Location</b> 0
<b>Field Station#</b> 14233+84	<b>Field Station#</b> 14250+50
<b>Pic 1 Desc.</b> Equipment bridge in acceptable condition	<b>Pic 2 Desc.</b> Erosion control blanket in acceptable condition

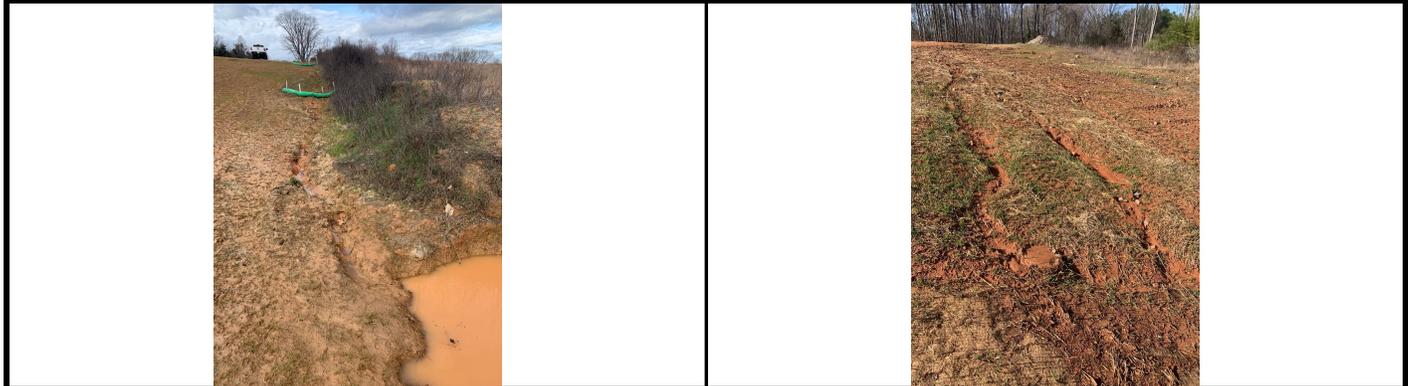
<b>Pic 1 Desc.</b>	Observing erosion that needs to be repaired.	<b>Pic 2 Desc.</b>	Observing end treatment that requires maintenance.
--------------------	--	--------------------	--

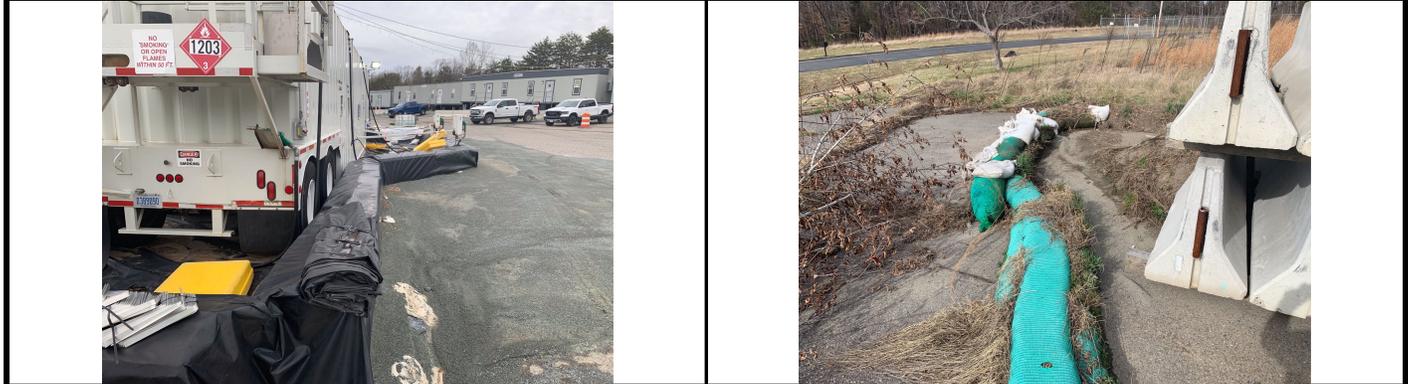
<b>GPS Location</b>	0000000000	<b>GPS Location</b>	0000000000
<b>Field Station#</b>	0000+00	<b>Field Station#</b>	0000+00
<b>Pic 1 Desc.</b>	Secondary containment structure for fuel cell in compliance	<b>Pic 2 Desc.</b>	Perimeter ECD issue on northwest corner of paved yard addressed by contractor.

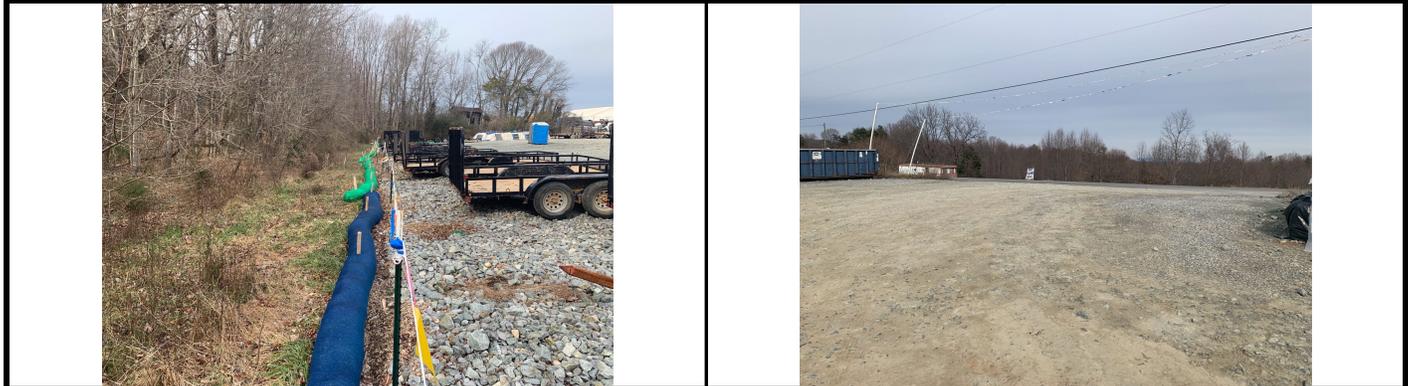
<b>GPS Location</b>	0000000000	<b>GPS Location</b>	0000000000
<b>Field Station#</b>	0000+00	<b>Field Station#</b>	0000+00
<b>Pic 3 Desc.</b>	Perimeter ECD's on west side of gravel yard.	<b>Pic 4 Desc.</b>	RCE at gravel yard in good condition.

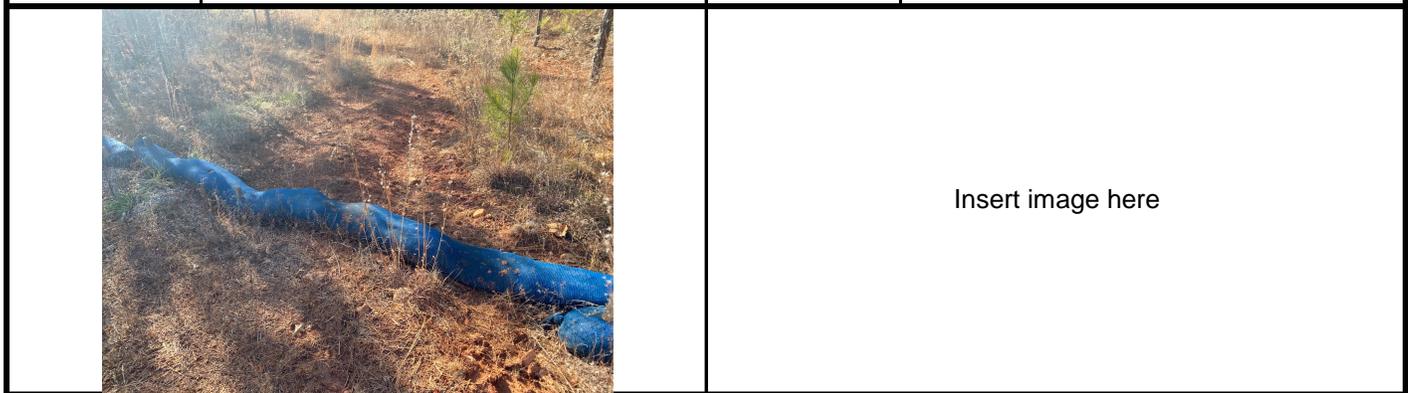
<b>Pic 3 Desc.</b>	Erosion occurring in multiple places along ROW due to poor vegetative cover.	<b>Pic 4 Desc.</b>	ECDs at breaker are in good condition and functioning properly.
--------------------	--	--------------------	---

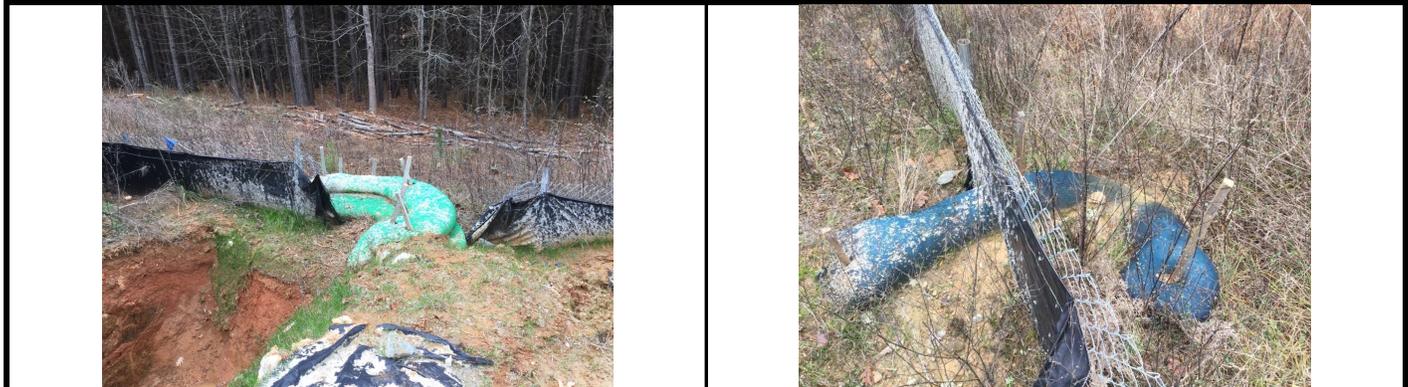
<b>Pic 3 Desc.</b>	Triple stack undermining and not escaping right of way	<b>Pic 4 Desc.</b>	Erosion channel in throat of water bar. Recommend curlex
--------------------	--	--------------------	--

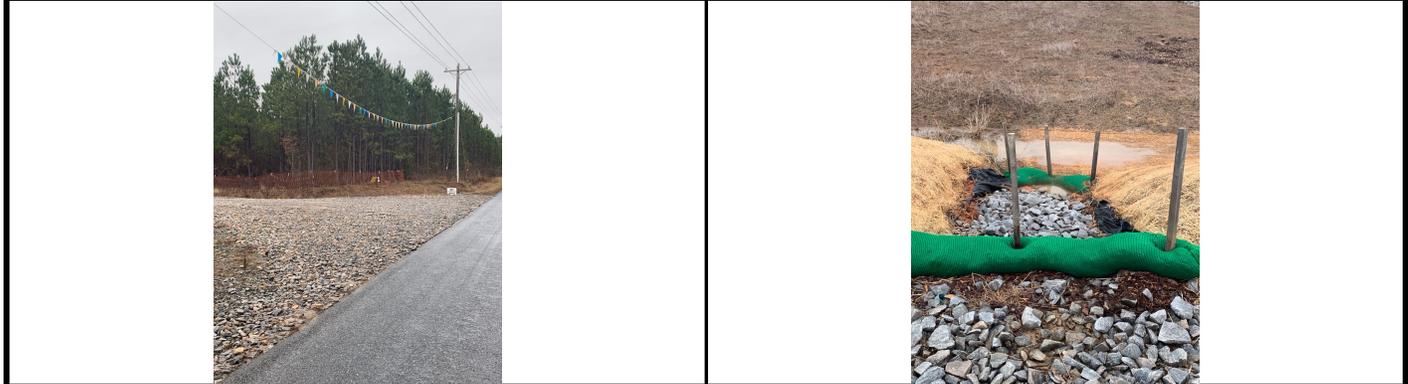
<b>Pic 1 Desc.</b> Observing RCE.	<b>Pic 2 Desc.</b> Observing ECD's performing as they should.
-----------------------------------	---

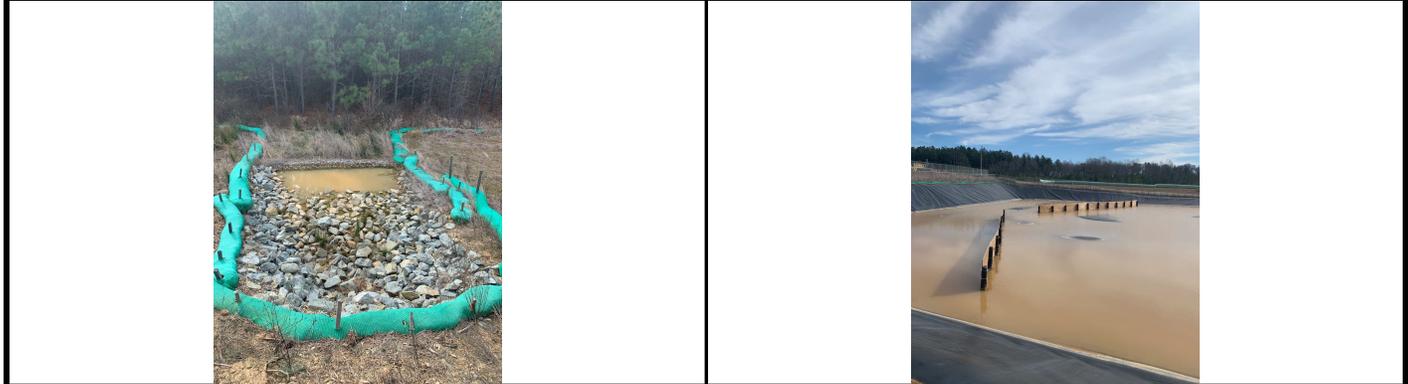
<b>Pic 1 Desc.</b> Observing storm water outlet and outlet protection performing as it should.	<b>Pic 2 Desc.</b> Observing storm water pond.
--	--
