Visual Site Inspection Report

| Project Name | H-600 Pipeline Spread I | AFE | 124300139 | Spread | H-600 Pipeline Spread I |
| Contractor | Precision | | | Report # | 7576 |

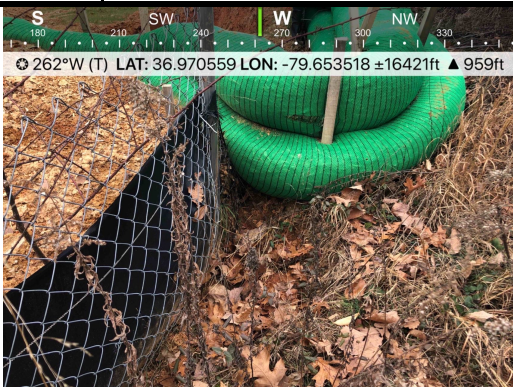
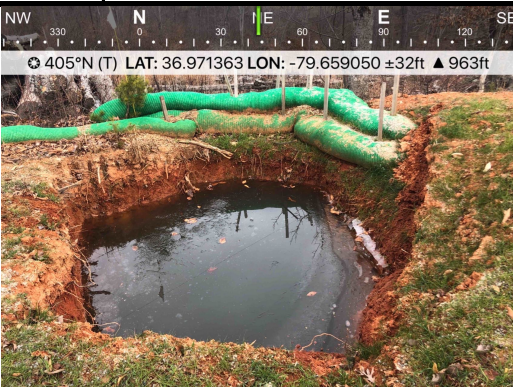
| Field Station# | 14880+00 | Field Station# | 14868+00 | | |

| Pic 3 Desc. | Gap between SSF and triple stack is allowing water/sediment to wash past without being filtered | Pic 4 Desc. | CFS damaged by land owner | | |

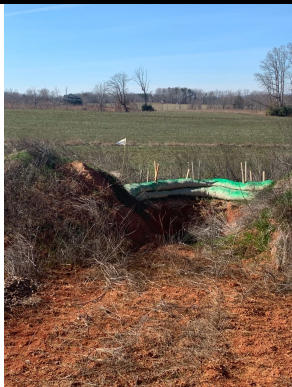
| Field Station# | 15696+00 | Field Station# | 15707+47 | | |

| Pic 1 Desc. | Observing water bar that requires maintenance. | Pic 2 Desc. | Observing CFS that requires maintenance. | | |
