Visual Site Inspection Report

Project Name H-600 Pipeline Spread I		AFE 124300139	Spread H-600 Pipeline Spread I
Contractor Precision		Report # 9466	
Inspector Ben Davenport		Date/Time 3/25/2020 5:00 PM	
Permit # TBD	Inspection Type VA SWPP	Station Begin 14928+52	
State VA	Inspection Area Partial	Station End 15296+00	
County Franklin/Pittsylvania	Ground Wet	Temperature (°F) 58.00	
Municipality Chatham	Weather Light Rain	Rain Gauge (in) 1.60	
Rain Accumulation Time (days)			4.00

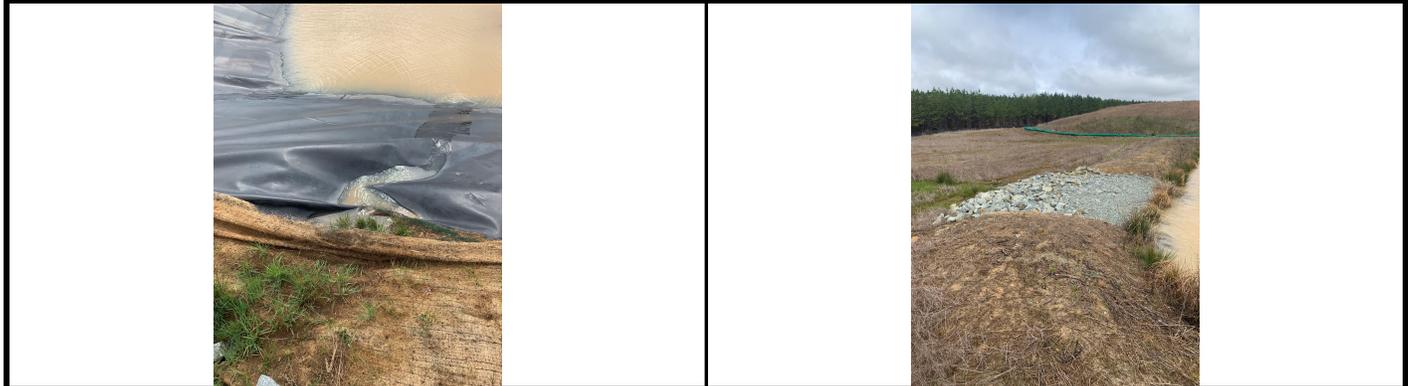
Pic 3 Desc. Observing drain entering the storm water pond.	Pic 4 Desc. Observing rock overflow.
---	---
