Visual Site Inspection Report

Project Name	H-600 Pipeline Spread G	AFE	124300137	Spread	H-600 Pipeline Spread G
Contractor	Precision			Report #	11443
Inspector	Chris Burns			Date/Time	6/1/2020 7:55 AM
Permit #	TBD	Inspection Type	VA SWPP	Station Begin	11254+99
State	VA	Inspection Area	Partial	Station End	11353+67
County	Giles	Ground	Dry	Temperature (°F)	72.00
Municipality	N/A	Weather	Sunny	Rain Gauge (in)	0.00
				Rain Accumulation Time (days)	1.00

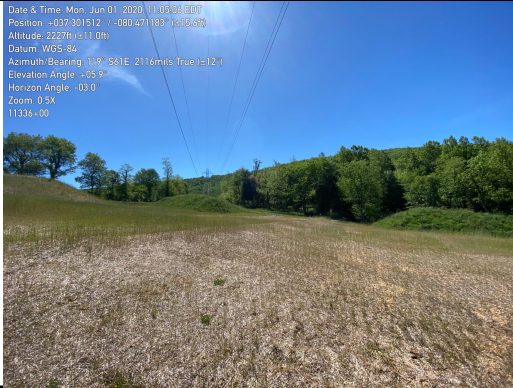
GPS Location	5	GPS Location	6		
Field Station#	11336+00	Field Station#	11352+97		
Pic 5 Desc.	RoW conditions.	Pic 6 Desc.	S-NN11 and controls.

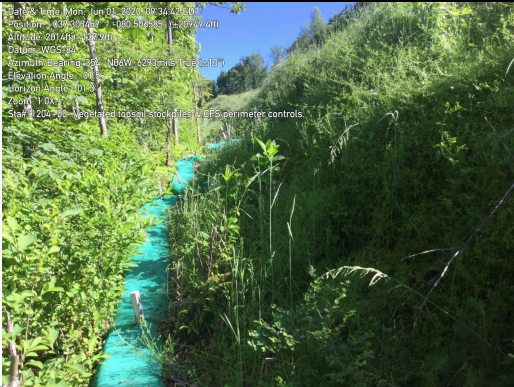
GPS Location	See photo GPS		GPS Location	See photo GPS	
Field Station#	11204+00		Field Station#	11191+00	
Pic 3 Desc.	CFS perimeter controls & vegetated topsoil stockpiles.		Pic 4 Desc.	Drainage feature & controls.

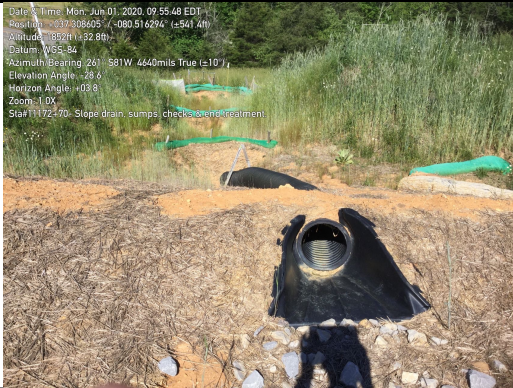
GPS Location	See photo GPS		GPS Location	See photo GPS	
Field Station#	11184+00		Field Station#	11172+70	
Pic 5 Desc.	CWD pipe and plunge pool are in good condition.		Pic 6 Desc.	Slope drain, checks, sump pit, end treatment

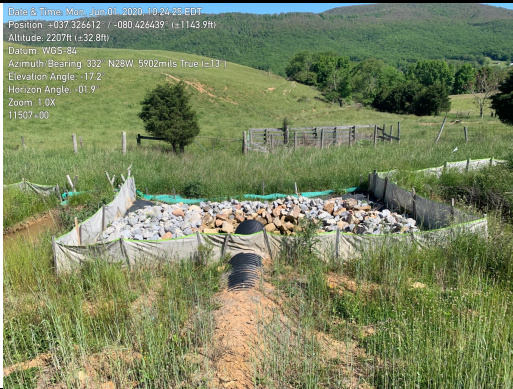
GPS Location		See photo for GPS location.						GPS Location		See photo for GPS location.	
Field Station#		11507+00						Field Station#		11505+00	
Pic 1 Desc.		Clean water diversion pipe and plunge pool in place.						Pic 2 Desc.		Clean water diversion pipe and clean water diversion berm in place.

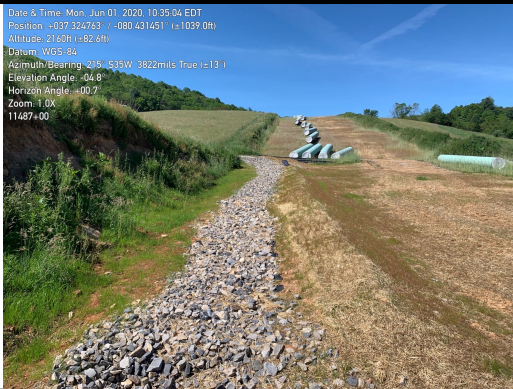
GPS Location		See photo for GPS location.						GPS Location		See photo for GPS location.	
Field Station#		11487+00						Field Station#		11478+00	
Pic 3 Desc.		Rock lined channel in place.						Pic 4 Desc.		Two-tone stabilized with ECB and slope drains in place to minimize erosion.

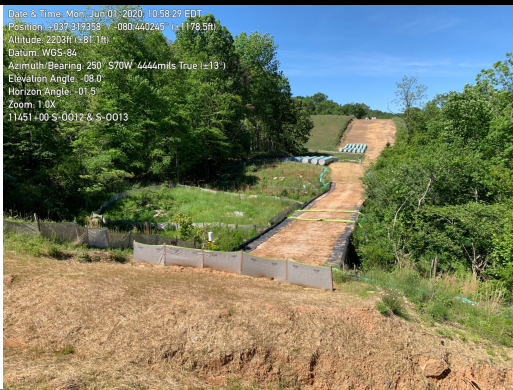
GPS Location		See photo for GPS location.						GPS Location		See photo for GPS location.	
Field Station#		11451+00						Field Station#		11380+00	
Pic 5 Desc.		Sensitive resource buffer in place at stream S-0012 and S-0013.						Pic 6 Desc.		Triple barrier ECDs in place at off ROW karst feature.

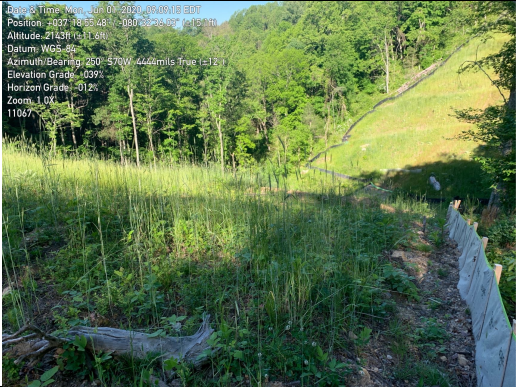
GPS Location	See picture above for GPS coordinates		GPS Location	See picture above for GPS coordinates	
Field Station#	11067+00		Field Station#	11073+00	
Pic 1 Desc.	ECD's and row conditions		Pic 2 Desc.	Trees cut by land owner

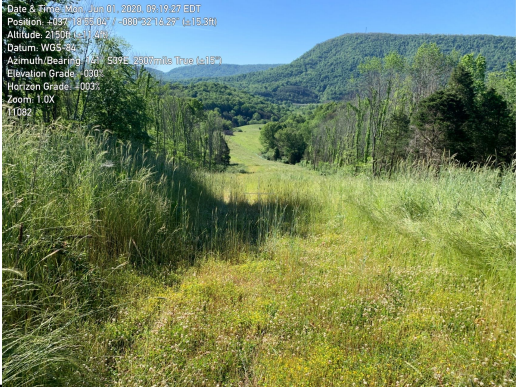
GPS Location	See picture above for GPS coordinates		GPS Location	See picture above for GPS coordinates	
Field Station#	11082+00		Field Station#	11084+00	
Pic 3 Desc.	ECD's and row conditions		Pic 4 Desc.	ECD's and row conditions

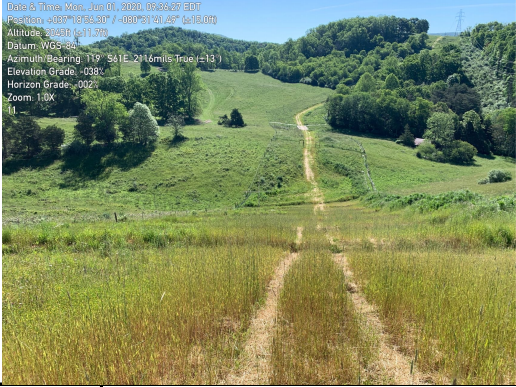
GPS Location	See picture above for GPS coordinates		GPS Location	See picture above for GPS coordinates	
Field Station#	11120+00		Field Station#	11130+00	
Pic 5 Desc.	ECD's and row conditions		Pic 6 Desc.	ECD's and row conditions

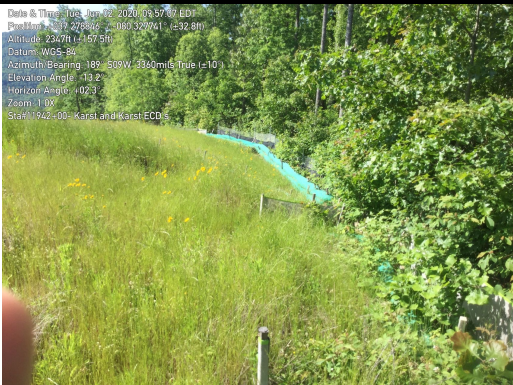
<p>Date & Time: Tue Jun 02, 2020, 09:47:10 EDT Position: +037.280534° / +080.328480° (±656.2 ft) Altitude: 255 ft (±1003.1 ft) Datum: WGS-84 Azimuth/Bearing: 197° S17W 3502mils True (±10°) Elevation Angle: -27.6° Horizon Angle: +02.1° Zoom: 1.0X AR-266.00- Sump cleaned, broad base dips, stabilized, mulched spoil stockpiles.</p>

GPS Location	See photo GPS		GPS Location	See photo GPS	
Field Station#	11930+00		Field Station#	11942+00	
Pic 3 Desc.	Contractor has cleaned sump pits, stabilized broad base dips, mulched spoil stockpiles, on AR- 266.00		Pic 4 Desc.	Karst ECD's

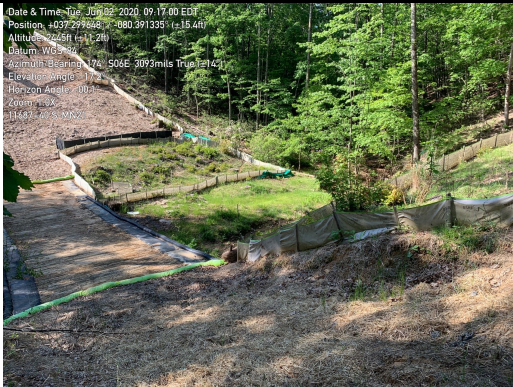
GPS Location		See photo for GPS location.						GPS Location		See photo for GPS location.	
Field Station#		11687+40						Field Station#		11767+00	
Pic 1 Desc.		Sensitive resource buffer in place at stream S-MN21.						Pic 2 Desc.		RCE in place at Main Line Valve 26.

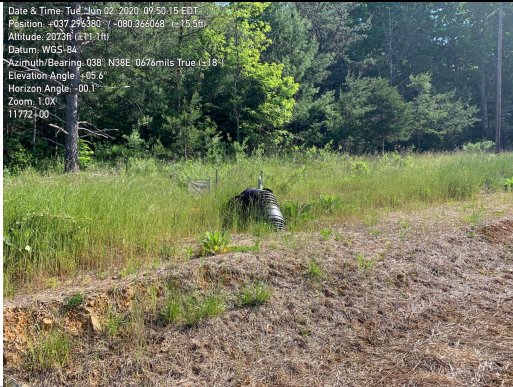
GPS Location		See photo for GPS location.						GPS Location		See photo for GPS location.	
Field Station#		11772+00						Field Station#		11665+00	
Pic 3 Desc.		Clean water diversion pipe inlet and clean water diversion berm in place.						Pic 4 Desc.		ROW is stabilized with vegetation growth.

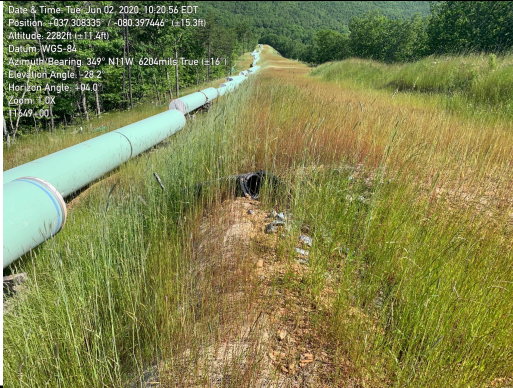
GPS Location		See photo for GPS location.						GPS Location		See photo for GPS location.	
Field Station#		11649+00						Field Station#		11620+00	
Pic 5 Desc.		Slope drain in place with rock inlet and outlet to minimize erosion on two-tone.						Pic 6 Desc.		Clean water diversion pipe and plunge pool in place.

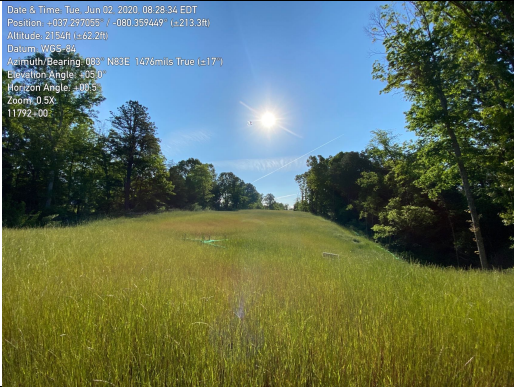
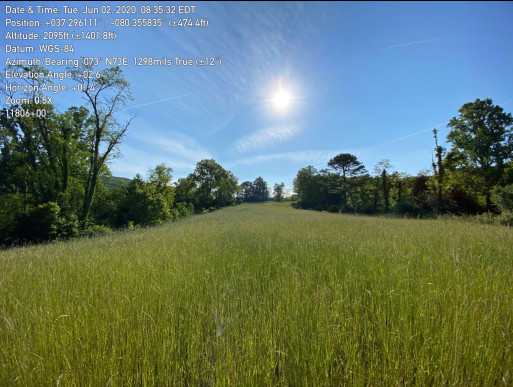
GPS Location	1	GPS Location	2		
Field Station#	11792+00	Field Station#	11806+00		
Pic 1 Desc.	Section of restored RoW showing conditions and controls.		Pic 2 Desc.	Section of restored RoW showing conditions and controls.	
<p>Date & Time: Tue Jun 02, 2020 08:48:08 EDT Position: +037 239237 / -080 353807 (+1968.0ft) Altitude: 2223ft (+27.7ft) Datum: WGS 84 Azimuth/Bearing: 191 S19W 3449mils True (+12.1) Elevation Angle: +03.0 Horizon Angle: +02.4 Zoom: 0.5x 11828+00</p>

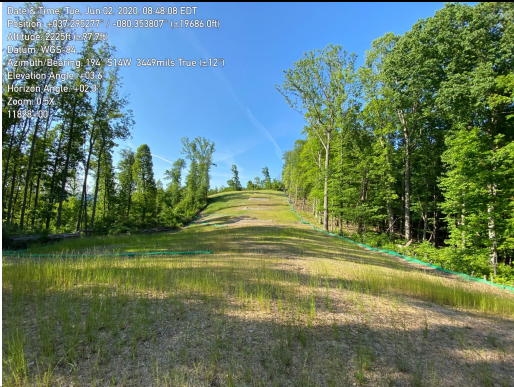
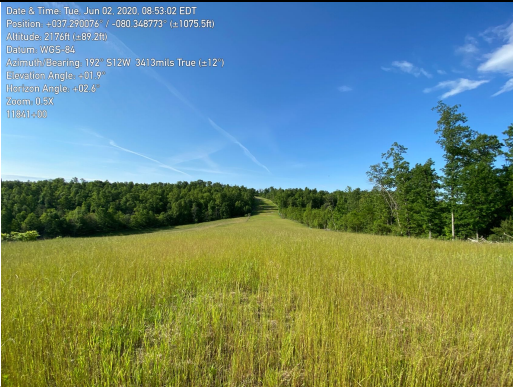
GPS Location	3	GPS Location	4		
Field Station#	11828+00	Field Station#	11841+00		
Pic 3 Desc.	Section of restored RoW showing conditions and controls.		Pic 4 Desc.	Section of restored RoW showing conditions and controls.	
<p>Date & Time: Tue Jun 02, 2020 09:02:26 EDT Position: +037 239272 / -080 344193 (+20.7ft) Altitude: 2188ft (+25.5ft) Datum: WGS 84 Azimuth/Bearing: 315 N45W 5400mils True (+12.1) Elevation Angle: +07.1 Horizon Angle: +00.8 Zoom: 1.0x P-KL2</p>

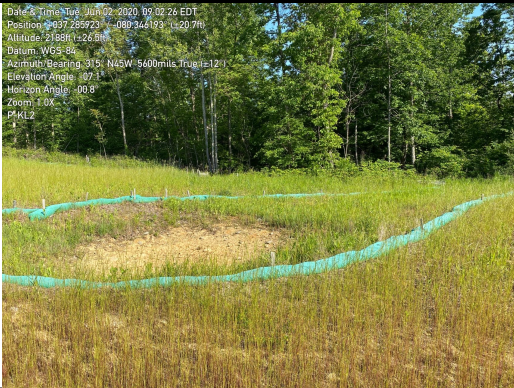
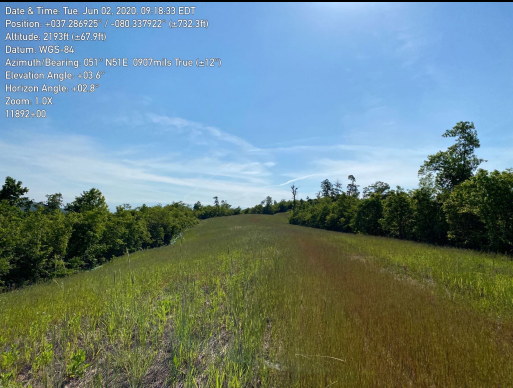
GPS Location	5	GPS Location	6		
Field Station#	11863+65	Field Station#	11892+00		
Pic 5 Desc.	P-KL2 and controls.		Pic 6 Desc.	Section of restored RoW showing conditions and controls.

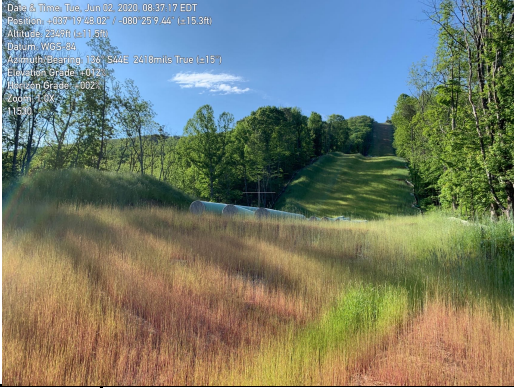
<p>Date & Time: Tue, Jun 02, 2020 08:37:17 EDT Position: +037°10'53.02" / -080°25'9.42" (+15.3N) Altitude: 2340ft (+11.5N) Datum: WGS-84 Azimuth/Bearing: 132° S44E 32.8mils True (+15.1) Elevation Grade: -019 Horizon Grade: -002 Zoom: 1.0x 11530</p>

<p>Date & Time: Tue, Jun 02, 2020 09:00:12 EDT Position: +037°11'12.75" / -080°24'36.13" S44E Altitude: 2340ft (+11.5N) Datum: WGS-84 Azimuth/Bearing: 344° N16W 6.11mils True (+12) Elevation Grade: -019 Horizon Grade: -002 Zoom: 1.0x 11550</p>			
GPS Location	See picture above for GPS coordinates		GPS Location	See picture above for GPS coordinates	
Field Station#	11530+00		Field Station#	11550+00	
Pic 1 Desc.	ECD's and row conditions		Pic 2 Desc.	ECD's and row conditions

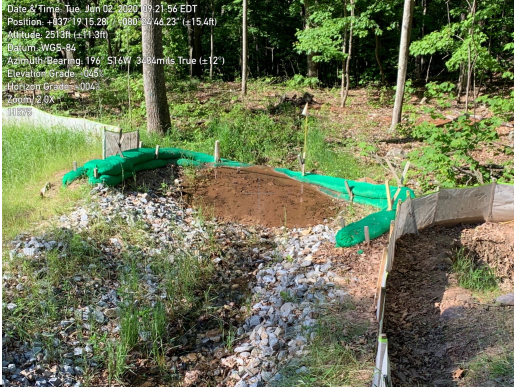
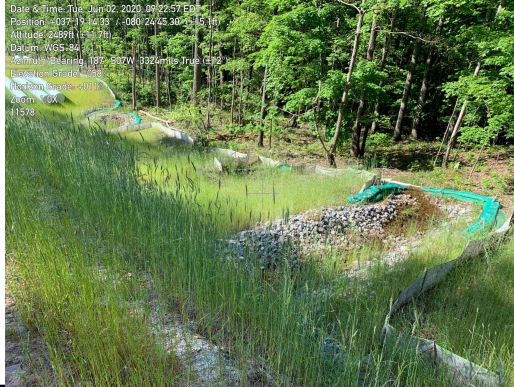
GPS Location	See picture above for GPS coordinates		GPS Location	See picture above for GPS coordinates	
Field Station#	11575+00		Field Station#	11578+00	
Pic 3 Desc.	ECD's and row conditions		Pic 4 Desc.	ECD's and row conditions

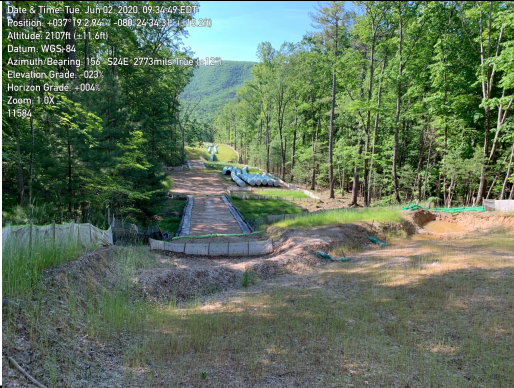
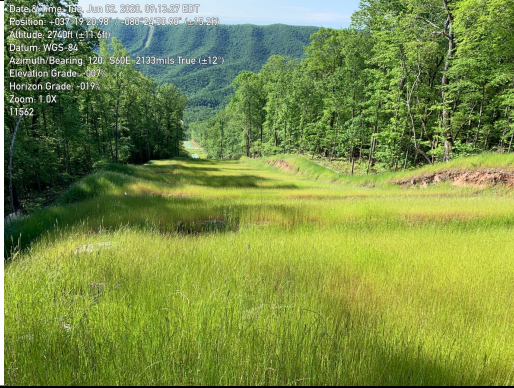
<p>Date & Time: Tue, Jun 02, 2020 09:13:29 EDT Position: +037°19'22.84" / -080°24'34.51" (+15.3N) Altitude: 2107ft (+11.4N) Datum: WGS-84 Azimuth/Bearing: 120° S40E 21.33mils True (+12) Elevation Grade: -007 Horizon Grade: -019 Zoom: 1.0x 11562</p>			
GPS Location	See picture above for GPS coordinates		GPS Location	See picture above for GPS coordinates	
Field Station#	11584+00		Field Station#	11562+00	
Pic 5 Desc.	ECD's and row conditions		Pic 6 Desc.	ECD's and row conditions

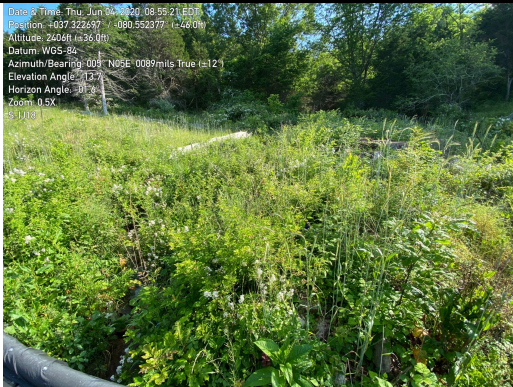
GPS Location	1	GPS Location	2		
Field Station#	11025+50	Field Station#	11034+00		
Pic 1 Desc.	S-IJ18 and controls.	Pic 2 Desc.	Section of RoW showing conditions and controls.

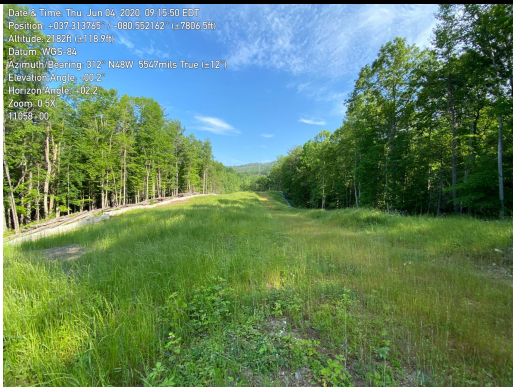
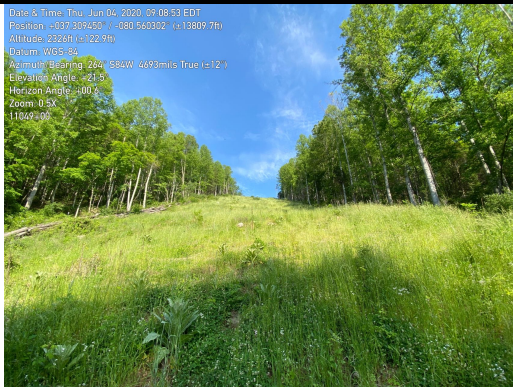
GPS Location	3	GPS Location	4		
Field Station#	11058+00	Field Station#	11049+00		
Pic 3 Desc.	Section of RoW showing conditions and controls.	Pic 4 Desc.	Section of RoW showing conditions and controls.

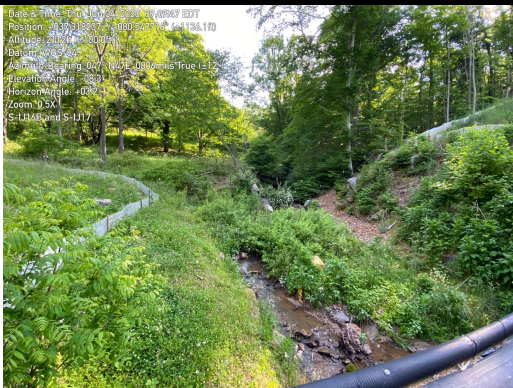
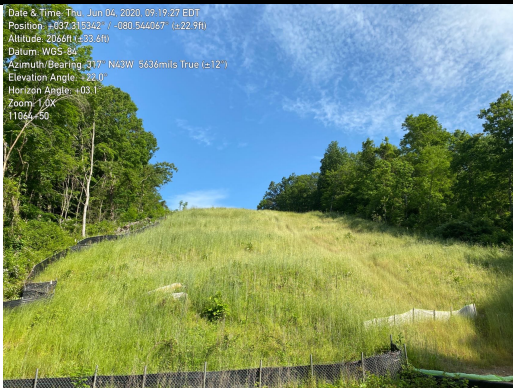
GPS Location	5	GPS Location	6		
Field Station#	11050+10	Field Station#	11064+50		
Pic 5 Desc.	S-IJ16B/S-IJ17 and controls.	Pic 6 Desc.	Section of RoW showing conditions and controls.

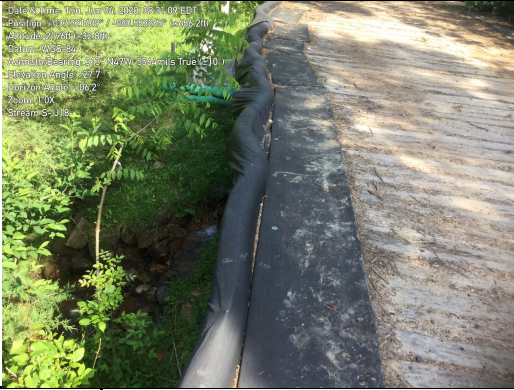
<p>Date & Time: Thu, Jun 04, 2020, 10:33:03 EDT Position: +037.325610 / -080.564912 (+32.0ft) Altitude: 2374ft (+39.4ft) Datum: WGS-84 Azimuth Bearing: 095° 58.4E 1707mils True (+10.1) Elevation Angle: +08.0° Horizon Angle: +01.9° Zoom: 1.0X Stream S-IJ18</p>

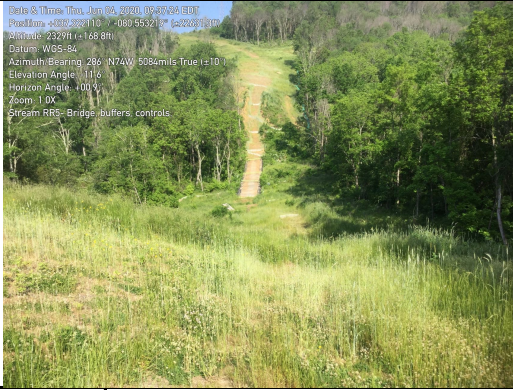
<p>Date & Time: Thu, Jun 04, 2020, 10:30:59 EDT Position: +037.325610 / -080.564912 (+32.0ft) Altitude: 2374ft (+39.4ft) Datum: WGS-84 Azimuth Bearing: 286° N24W 508mils True (+10.1) Elevation Angle: +11.0° Horizon Angle: +00.9° Zoom: 1.0X Stream RRS- Bridge, buffers, controls</p>		GPS Location	See photo GPS
Field Station#	11024+00	Field Station#	11017+00	GPS Location	See photo GPS
Pic 1 Desc.	Stream S-IJ18	Pic 2 Desc.	Row and stream S-RR5

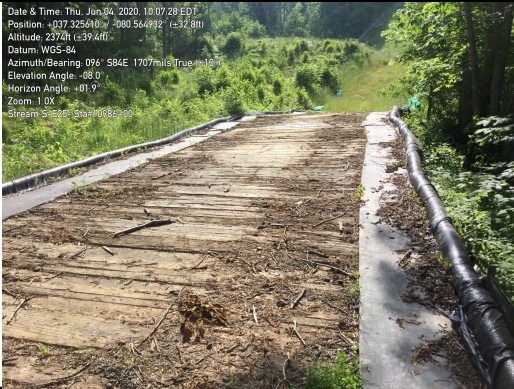
<p>Date & Time: Thu, Jun 04, 2020, 10:07:28 EDT Position: +037.325610 / -080.564912 (+32.0ft) Altitude: 2374ft (+39.4ft) Datum: WGS-84 Azimuth Bearing: 095° 58.4E 1707mils True (+10.1) Elevation Angle: +08.0° Horizon Angle: +01.9° Zoom: 1.0X Stream S-E25- Start 10986+00</p>

Field Station#	10986+00	Field Station#	10985+00	GPS Location	See photo GPS
Pic 3 Desc.	Stream S- E25	Pic 4 Desc.	Stream S- E24

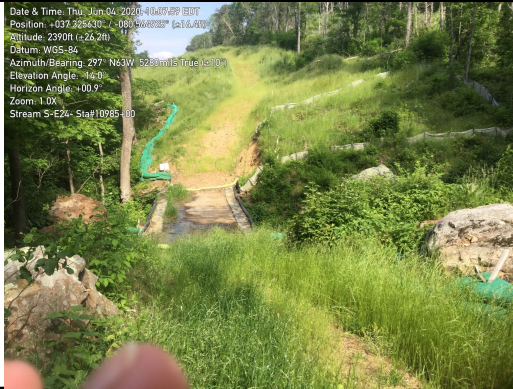
<p>Date & Time: Thu, Jun 04, 2020, 10:04:59 EDT Position: +037.325610 / -080.564912 (+32.0ft) Altitude: 2370ft (+26.2ft) Datum: WGS-84 Azimuth Bearing: 297° N43W 528mils True (+10.1) Elevation Angle: +14.0° Horizon Angle: +00.9° Zoom: 1.0X Stream S-E24- Start 10985+00</p>		GPS Location	See photo GPS

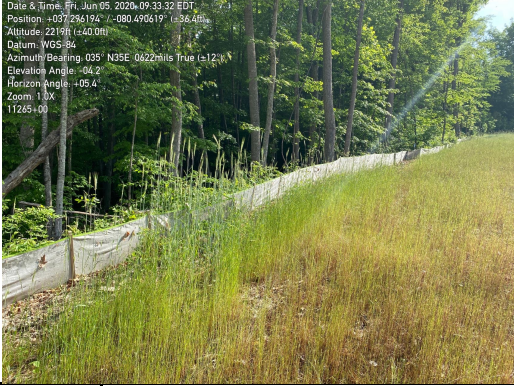
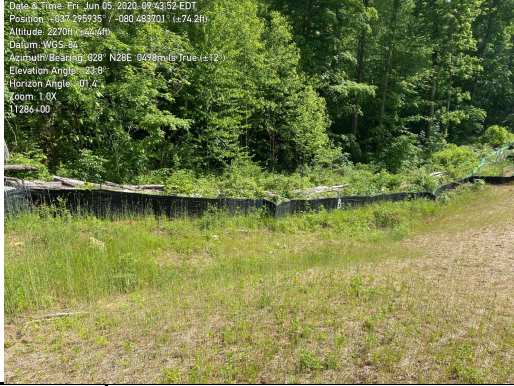
GPS Location	1	GPS Location	2		
Field Station#	11265+00	Field Station#	11286+00		
Pic 1 Desc.	Perimeter controls functional.		Pic 2 Desc.	Perimeter controls functional.	
<p>Date & Time: Fri Jun 05, 2020, 09:48:53 EDT Position: +037.296177° / -080.481334° (±108.9ft) Altitude: 2100ft (±36ft) Datum: WGS-84 Azimuth/Bearing: 032° S32W 4124mils True (±12°) Elevation Angle: -07.4° Horizon Angle: -00.6° Zoom: 0.5X S-JJ18</p>

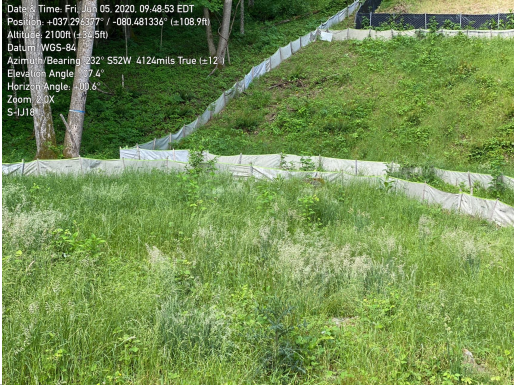
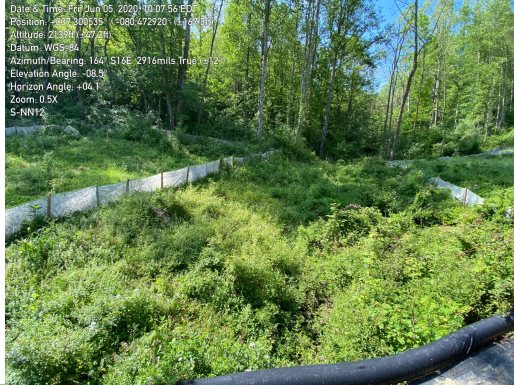
GPS Location	3	GPS Location	4		
Field Station#	11292+80	Field Station#	11327+85		
Pic 3 Desc.	S-MM18 and buffers and controls.		Pic 4 Desc.	S-NN12 and controls.	
<p>Date & Time: Fri Jun 05, 2020, 10:13:44 EDT Position: +037.30439° / -080.46539° (±34.1ft) Altitude: 2078ft (±41.6ft) Datum: WGS-84 Azimuth/Bearing: 032° N32E 0569mils True (±12°) Elevation Angle: -25.1° Horizon Angle: +05.2° Zoom: 1.0X 11349+00</p>

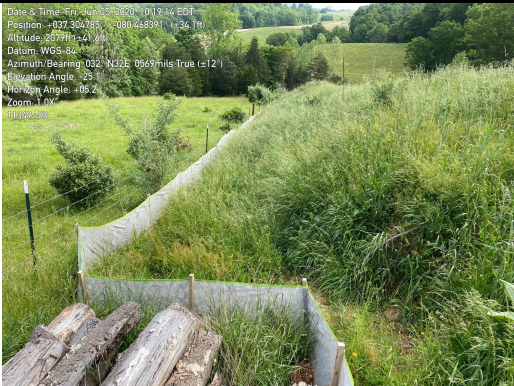
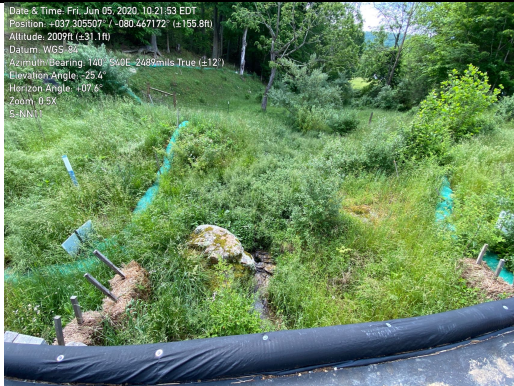
GPS Location	5	GPS Location	6		
Field Station#	11349+00	Field Station#	11352+97		
Pic 5 Desc.	Perimeter controls functional.		Pic 6 Desc.	S-NN11 and controls.

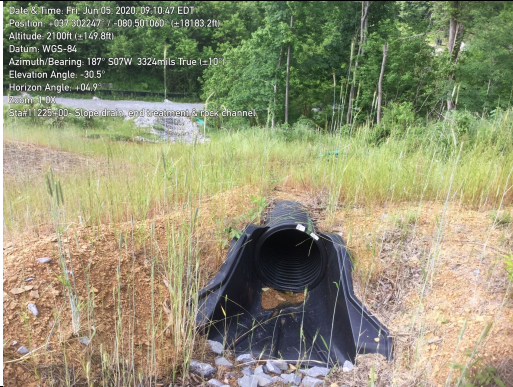
<p>Date & Time: Fri, Jun 05, 2020, 09:10:47 EDT Position: -037.310224 / -080.501060 (-16183.28) Altitude: 2100ft (-149.8m) (-45.72) Datum: WGS-84 Azimuth/Bearing: 187° S07°W 332mils True (-10°) Elevation Angle: -30.5° Horizon Angle: +04.9° Zoom: 1.0X Sta#11225+00- Slope drain, end treatment, rock channel</p>			
GPS Location	See photo GPS	GPS Location	See photo GPS		
Field Station#	11232+00	Field Station#	11225+00		
Pic 1 Desc.	Row vegetation and controls	Pic 2 Desc.	Slope drain, end treatment, rock channel.

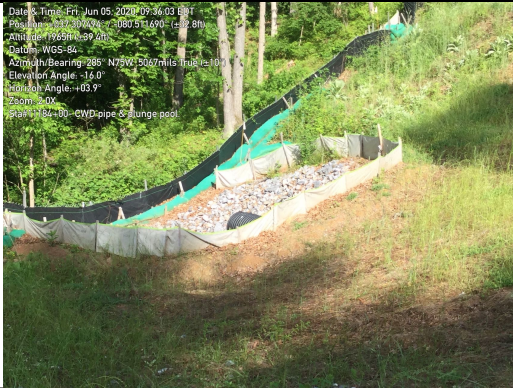
<p>Date & Time: Fri, Jun 05, 2020, 09:36:03 EDT Position: -037.305816 / -080.501627 (-169820.77) Altitude: 1959ft (-149.8m) (-45.72) Datum: WGS-84 Azimuth/Bearing: 285° N75°W 5007mils True (-10°) Elevation Angle: -16.0° Horizon Angle: +03.9° Zoom: 1.0X Sta#11184+00- CWD pipe & plunge pool</p>			
GPS Location	See photo GPS	GPS Location	See photo GPS		
Field Station#	11191+00	Field Station#	11184+00

Pic 5 Desc.	Drainage feature and ECD's	Pic 6 Desc.	CWD pipe and plunge pool.

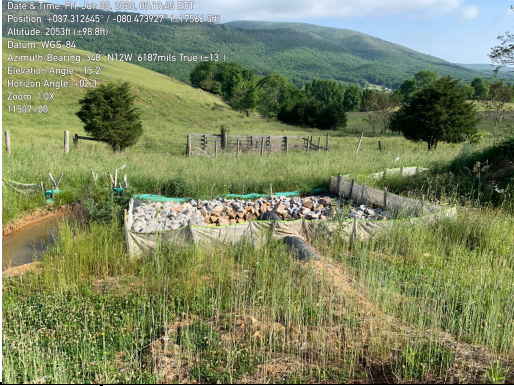
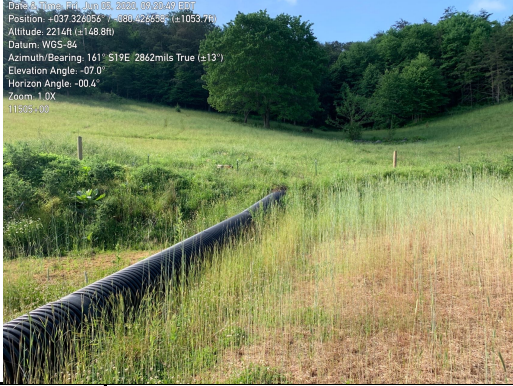
GPS Location	See photo for GPS location.		GPS Location	See photo for GPS location.	
Field Station#	11507+00		Field Station#	11505+00	
Pic 1 Desc.	Clean water diversion pipe and plunge pool in place.		Pic 2 Desc.	Clean water diversion pipe and clean water diversion berm in place.

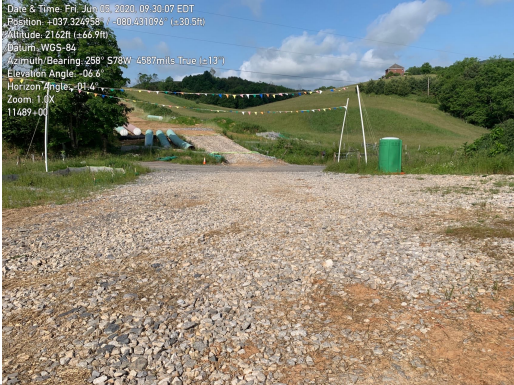
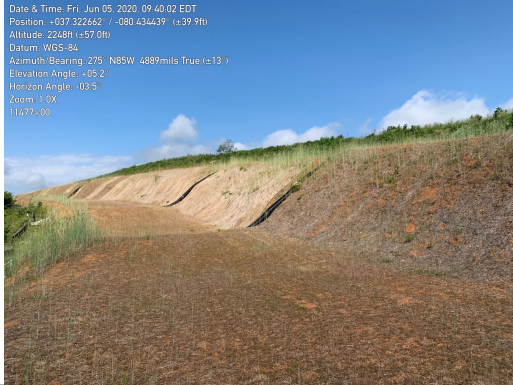
GPS Location	See photo for GPS location.		GPS Location	See photo for GPS location.	
Field Station#	11489+00		Field Station#	11477+00	
Pic 3 Desc.	RCE in place at Stevers Gap Road.		Pic 4 Desc.	Two-tone stabilized with ECB and slope drain in place over two-tone to minimize erosion.

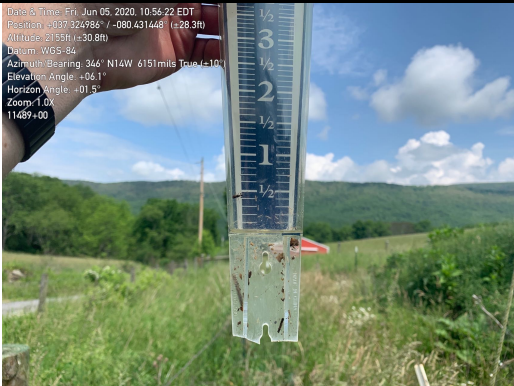
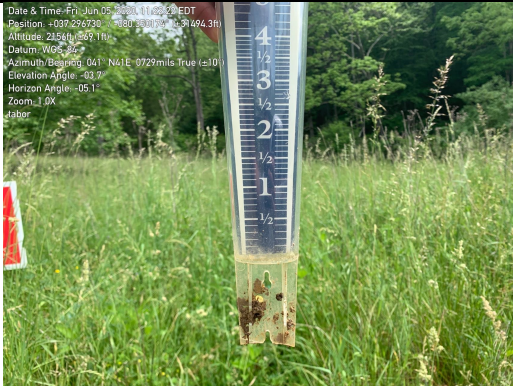
GPS Location	See photo for GPS location.		GPS Location	See photo for GPS location.	
Field Station#	11489+00		Field Station#	11767+00	
Pic 5 Desc.	Trace amount of rain in gauge Stevers Gap Road.		Pic 6 Desc.	Rain gauge at Mount Tabor Road reads 0.0 inches.
