# Visual Site Inspection Report

<b>Project Name</b>	H-600 Pipeline Spread G	<b>AFE</b>	124300137	<b>Spread</b>	H-600 Pipeline Spread G
<b>Contractor</b>	Precision			<b>Report #</b>	12240
<b>Inspector</b>	Len Kruizenga			<b>Date/Time</b>	6/29/2020 11:31 AM
<b>Permit #</b>	TBD	<b>Inspection Type</b>	VA SWPP	<b>Station Begin</b>	11254+99
<b>State</b>	VA	<b>Inspection Area</b>	Full	<b>Station End</b>	11158+27
<b>County</b>	Giles	<b>Ground</b>	Dry	<b>Temperature (°F)</b>	72.00
<b>Municipality</b>	N/A	<b>Weather</b>	Sunny	<b>Rain Gauge (in)</b>	0.10
				<b>Rain Accumulation Time (days)</b>	1.00

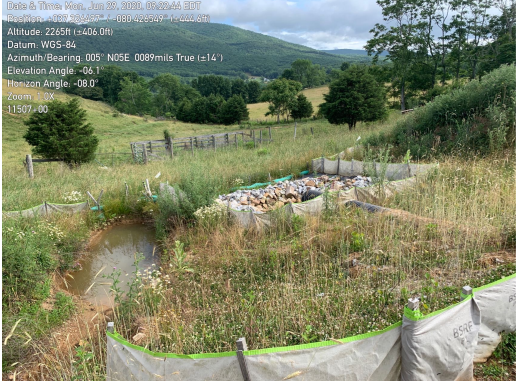
<p>Date &amp; Time: Mon, Jun 29, 2020, 09:22:44 EDT Position: +037322507 / +080425947 (+1000m) Altitude: 2265ft (+406.0m) Datum: WGS-84 Azimuth/Bearing: 005° N05E 0089mils True (±14°) Elevation Angle: -06.1° Horizon Angle: -09.0° Zoom: 1.0X 11507+00</p>

<p>Date &amp; Time: Mon, Jun 29, 2020, 09:21:13 EDT Position: +037322507 / +080425947 (+1000m) Altitude: 2196ft (+100.0m) Datum: WGS-84 Azimuth/Bearing: 276° N27W 400mils True (±14°) Elevation Angle: -06.5° Horizon Angle: -07.9° Zoom: 1.0X 11489+00</p>			
<b>GPS Location</b>	See photo for GPS location.		<b>GPS Location</b>	See photo for GPS location.	
<b>Field Station#</b>	11507+00		<b>Field Station#</b>	11489+00	
<b>Pic 1 Desc.</b>	Plunge pool and clean water diversion pipe in place.		<b>Pic 2 Desc.</b>	RCE in place at Stevers Gap Road.

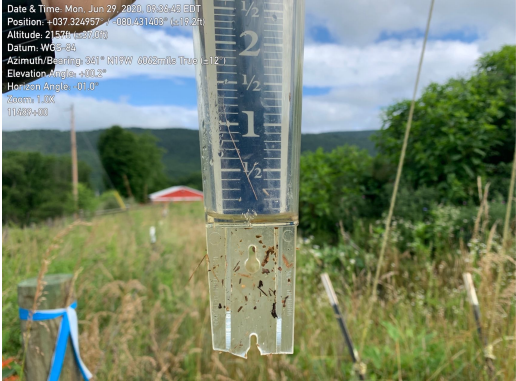
<p>Date &amp; Time: Mon, Jun 29, 2020, 09:26:22 EDT Position: +037324957 / +080431008 (+1020m) Altitude: 2150ft (+102.0m) Datum: WGS-84 Azimuth/Bearing: 361° 007W 406mils True (±12°) Elevation Angle: -00.3° Horizon Angle: -01.0° Zoom: 1.0X 11489+00</p>

<b>GPS Location</b>	See photo for GPS location.		<b>GPS Location</b>	See photo for GPS location.	
<b>Field Station#</b>	11489+00		<b>Field Station#</b>	11451+00	
<b>Pic 3 Desc.</b>	Rain gauge at Stevers Gap Road reads 0.05 inches.		<b>Pic 4 Desc.</b>	Sensitive resource buffer in place at stream S-0012 and S-0013 in place.

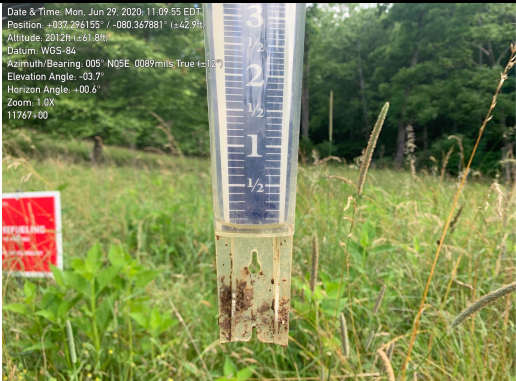
<p>Date &amp; Time: Mon, Jun 29, 2020, 11:09:55 EDT Position: +037329155 / +080367881 (+142.9m) Altitude: 2012ft (+142.8m) Datum: WGS-84 Azimuth/Bearing: 005° N05E 0089mils True (±12°) Elevation Angle: -03.7° Horizon Angle: -00.8° Zoom: 1.0X 11767+00</p>

<b>Field Station#</b>	11767+00		<b>Field Station#</b>	11990+00	
<b>Pic 5 Desc.</b>	Rain gauge at Mount Tabor Road reads 0.05 inches.		<b>Pic 6 Desc.</b>	Rain gauge at Catawba Road reads 0.05 inches.

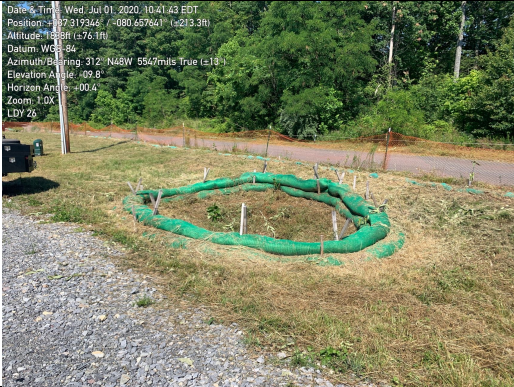
<p>Date &amp; Time: Wed Jul 01, 2020 10:41:43 EDT Position: +037 319344 / -080 657624 / (+213.3ft) Altitude: 1792ft (+213.3ft) Datum: WGS-84 Azimuth/Bearing: 312° N45W 5547mils True (+13.1°) Elevation Angle: +09.8° Horizon Angle: +06.4° Zoom: 1.0x LDY 26</p>

<p>Date &amp; Time: Wed Jul 01, 2020 10:45:00 EDT Position: +037 319310 / -080 658323 / (+100.4ft) Altitude: 1792ft (+100.4ft) Datum: WGS-84 Azimuth/Bearing: 312° N41W 5671mils True (+13.1°) Elevation Angle: +13.0° Horizon Angle: +06.4° Zoom: 1.0x LDY 26</p>			
<b>GPS Location</b>	See photo for GPS location.		<b>GPS Location</b>	See photo for GPS location.	
<b>Field Station#</b>	12005+00		<b>Field Station#</b>	12005+00	
<b>Pic 1 Desc.</b>	Triple stack compost filter sock in place around drainage.		<b>Pic 2 Desc.</b>	RCE in place at Lay Down Yard 26 entrance.

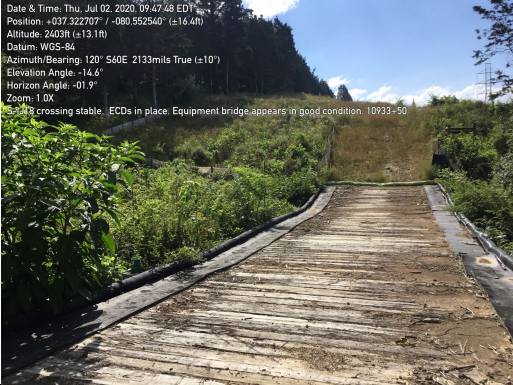
<p>Date &amp; Time: Thu, Jul 02, 2020, 09:47:48 EDT Position: +037.322707° / -080.552540° (±16.4ft) Altitude: 2403ft (±13.1ft) Datum: WGS-84 Azimuth/Bearing: 120° S 60E 213mils True (±10°) Elevation Angle: -14.6° Horizon Angle: -01.9° Zoom: 1.0X S-IJ18 crossing stable. ECDs in place. Equipment bridge appears in good condition. 10933+50</p>			
<b>GPS Location</b>	On photo	<b>GPS Location</b>	On photo		
<b>Field Station#</b>	10937+00	<b>Field Station#</b>	10933+50

<b>Pic 1 Desc.</b>	Perimeter controls in place and functional.	<b>Pic 2 Desc.</b>	S-IJ18 crossing is stable with ECDs in place. No visible impact to resource.

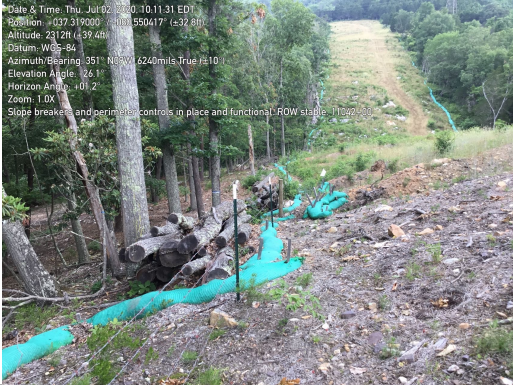
<p>Date &amp; Time: Thu, Jul 02, 2020, 10:11:31 EDT Position: +037.319000° / -080.550417° (±32.8ft) Altitude: 2312ft (±39.4ft) Datum: WGS-84 Azimuth/Bearing: 151° N 60W 424mils True (±10°) Elevation Angle: -26.1° Horizon Angle: -01.2° Zoom: 1.0X Slope breakers and perimeter controls in place and functional. ROW stable. 11042+00</p>			
<b>GPS Location</b>	On photo	<b>GPS Location</b>	On photo		
<b>Field Station#</b>	11034+00	<b>Field Station#</b>	11042+00

<b>Pic 3 Desc.</b>	Perimeter controls are in place and functional.	<b>Pic 4 Desc.</b>	No sediment migration. Perimeter controls in place.

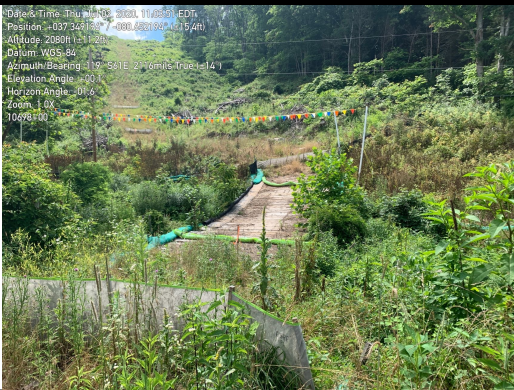
<b>Pic 5 Desc.</b>	Sensitive resource buffer in place at stream S-G32.		<b>Pic 6 Desc.</b>	RCE in place at Buffalo Anklets Road.

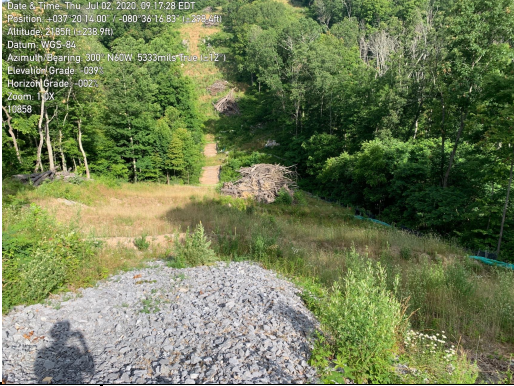
<b>GPS Location</b>	See picture above for GPS coordinates		<b>GPS Location</b>	See picture above for GPS coordinates	
<b>Field Station#</b>	10858+00		<b>Field Station#</b>	10862+00	
<b>Pic 1 Desc.</b>	ECD's and row conditions		<b>Pic 2 Desc.</b>	ECD's and row conditions

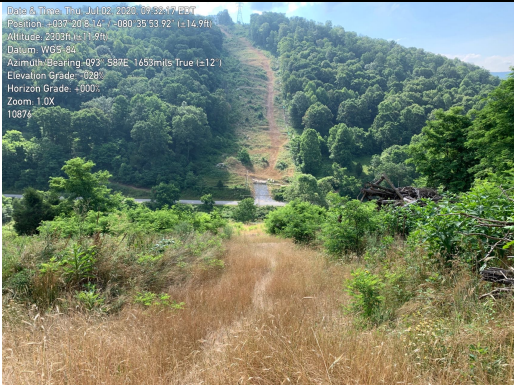
<b>GPS Location</b>	See picture above for GPS coordinates		<b>GPS Location</b>	See picture above for GPS coordinates	
<b>Field Station#</b>	10876+00		<b>Field Station#</b>	10893+00	
<b>Pic 3 Desc.</b>	ECD's and row conditions		<b>Pic 4 Desc.</b>	ECD's and row conditions

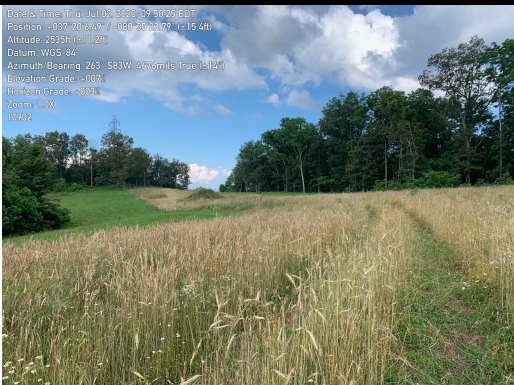
<b>GPS Location</b>	See picture above for GPS coordinates		<b>GPS Location</b>	See picture above for GPS coordinates	
<b>Field Station#</b>	10902+00		<b>Field Station#</b>	10915+00	
<b>Pic 5 Desc.</b>	ECD's and row conditions		<b>Pic 6 Desc.</b>	ECD's and row conditions
