Visual Site Inspection Report

Project Name	H-600 Pipeline Spread G	AFE	124300137	Spread	H-600 Pipeline Spread G
Contractor	Precision			Report #	12639
Inspector	Len Kruizenga			Date/Time	7/13/2020 8:56 AM
Permit #	TBD	Inspection Type	VA SWPP	Station Begin	12005+00
State	VA	Inspection Area	Full	Station End	12005+00
County	Giles	Ground	Wet	Temperature (°F)	80.00
Municipality	N/A	Weather	Sunny	Rain Gauge (in)	0.10
				Rain Accumulation Time (days)	1.00

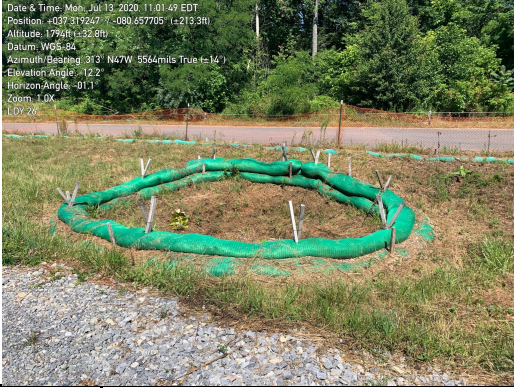
<p>Date & Time: Mon, Jul 13, 2020, 11:01:47 EDT Position: +037 319241 / -080 657705 (+213.3ft) Altitude: 1794ft (+52.8ft) Datum: WGS 84 Azimuth/Bearing: 313° N47W 5564mils True (+14°) Elevation Angle: -12.2° Horizon Angle: -01.1° Zoom: 1.0X LDY 26</p>

<p>Date & Time: Mon, Jul 13, 2020, 11:02:33 EDT Position: +037 319241 / -080 658444 (+135.2ft) Altitude: 1792ft (+52.8ft) Datum: WGS 84 Azimuth/Bearing: 276° N84W 4907mils True (+13°) Elevation Angle: -07.1° Horizon Angle: -03.1° Zoom: 1.0X LDY 26</p>			
GPS Location	See photo for GPS location.		GPS Location	See photo for GPS location.	
Field Station#	12005+00		Field Station#	12005+00	
Pic 1 Desc.	Triple stack compost filter sock in place around drainage.		Pic 2 Desc.	RCE in place at LDY 26 entrance.

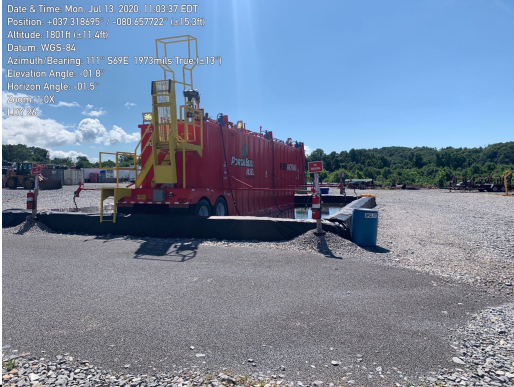
<p>Date & Time: Mon, Jul 13, 2020, 11:03:37 EDT Position: +037 318695 / -080 657722 (+115.3ft) Altitude: 1801ft (+51.4ft) Datum: WGS 84 Azimuth/Bearing: 171° S49E 1973mils True (+13°) Elevation Angle: -01.8° Horizon Angle: -01.5° Zoom: 1.0X LDY 26</p>

GPS Location	See photo for GPS location.		GPS Location	See photo for GPS location.	
Field Station#	12005+00		Field Station#	11613+00	
Pic 3 Desc.	Secondary containment in place under fuel cell.		Pic 4 Desc.	Rain gauge at Craig Creek reads 0.2 inches.

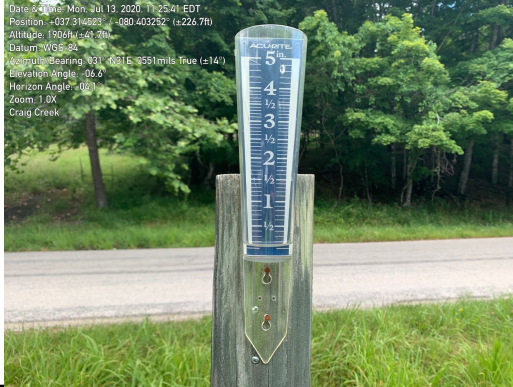
<p>Date & Time: Mon, Jul 13, 2020, 11:25:01 EDT Position: +037 316823 / -080 403252 (+226.7ft) Altitude: 1906ft (+49.7ft) Datum: WGS 84 Azimuth/Bearing: 101° N31E 9551mils True (+14°) Elevation Angle: -06.6° Horizon Angle: -00.1° Zoom: 1.0X Craig Creek</p>

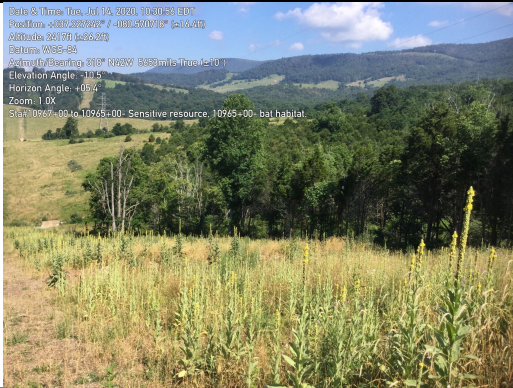
<p>Date & Time: Tue, Jul 14, 2020, 10:00:39 EDT Position: +43°13'22.94"N / -70°46'40.21"W (+32.8m) Altitude: 2317ft (+70.2m) Datum: WGS-84 Azimuth/Bearing: 310° N63W 533mils True (±10°) Elevation Angle: -11.5° Horizon Angle: -10.7° Zoom: 1.0x Sta# 10967+00 to 10965+00- Sensitive resource, 10965+00- bat habitat.</p>			
GPS Location	See photo GPS	GPS Location	See photo GPS		
Field Station#	10985+00	Field Station#	10967+00

Pic 5 Desc.	Stream S- E24, equipment bridge and controls	Pic 6 Desc.	Sta# 10967+00 to 10965+00- sensitive resource, 10965+00- bat habitat.

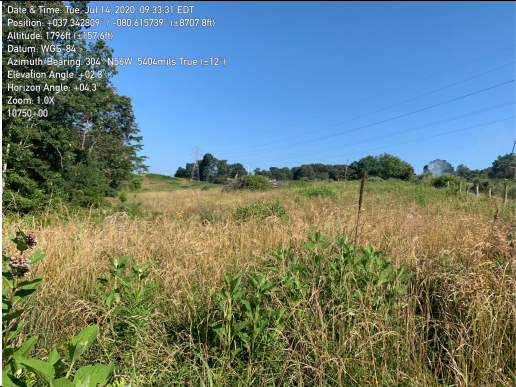
<p>Date & Time: Tue, Jul 14, 2020 09:33:31 EDT Position: +037.342047, -080.615739 (+8707.8ft) Altitude: 1796ft (+11.2ft) Datum: WGS-84 Azimuth/Bearing: 304° N56W 560mils True (+12.1°) Elevation Angle: +02.6° Horizon Angle: +04.3° Zoom: 1.0X 10750+00</p>

<p>Date & Time: Tue, Jul 14, 2020 10:23:59 EDT Position: +037.345978, -080.647505 (+15.4ft) Altitude: 2265ft (+11.2ft) Datum: WGS-84 Azimuth/Bearing: 098° S82E 1742mils True (+18°) Elevation Angle: +10.6° Horizon Angle: +03.1° Zoom: 1.0X 10712+50 S-G33</p>			
GPS Location	See photo for GPS location.		GPS Location	See photo for GPS location.	
Field Station#	10750+00		Field Station#	10712+50	
Pic 1 Desc.	ROW is stabilized with natural vegetation.		Pic 2 Desc.	Sensitive resource buffer in place at stream S-G33.

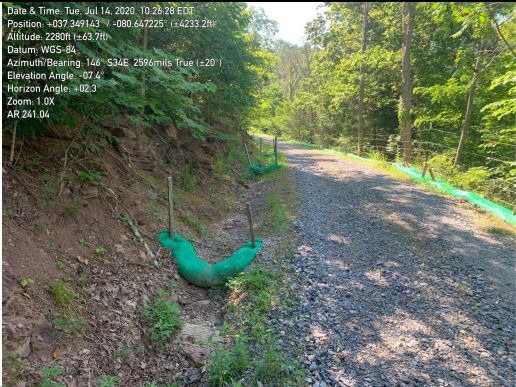
<p>Date & Time: Tue, Jul 14, 2020 10:28:28 EDT Position: +037.349143, -080.647225 (+4233.2ft) Altitude: 2280ft (+63.7ft) Datum: WGS-84 Azimuth/Bearing: 164° S34E 2596mils True (+20°) Elevation Angle: +07.4° Horizon Angle: +02.3° Zoom: 1.0X AR 241.04</p>

GPS Location	See photo for GPS location.		GPS Location	See photo for GPS location.	
Field Station#	10710+00		Field Station#	10701+00	
Pic 3 Desc.	CFS checks in place in bar ditch along access road.		Pic 4 Desc.	Priority one silt fence and ECB in place in travel lane.

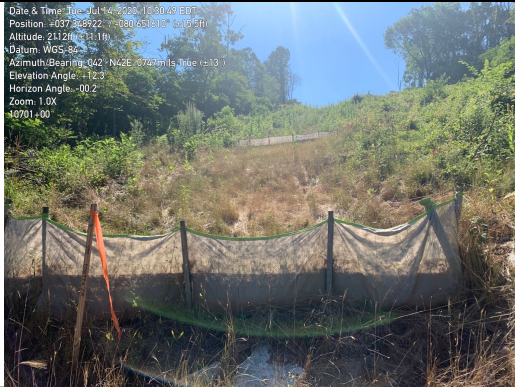
<p>Date & Time: Tue, Jul 14, 2020 10:30:00 EDT Position: +037.349227, -080.651318 (+4166ft) Altitude: 2112ft (+11.1ft) Datum: WGS-84 Azimuth/Bearing: 842° N42E 3741mils True (+13°) Elevation Angle: +12.3° Horizon Angle: +00.2° Zoom: 1.0X 10701+00</p>

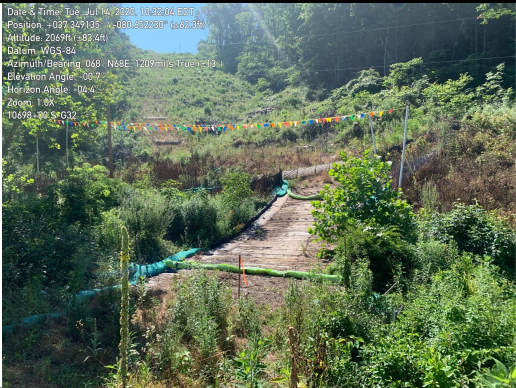
<p>Date & Time: Tue, Jul 14, 2020 10:30:00 EDT Position: +037.349155, -080.655307 (+4223ft) Altitude: 2059ft (+93.4ft) Datum: WGS-84 Azimuth/Bearing: 048° N58E 1209mils True (+13.4°) Elevation Angle: +09.9° Horizon Angle: +06.4° Zoom: 1.0X 10698+00 S-G32</p>

Pic 5 Desc.	Sensitive resource buffer in place at stream S-G32.		Pic 6 Desc.	RCE in place at Buffalo Anklets Road.

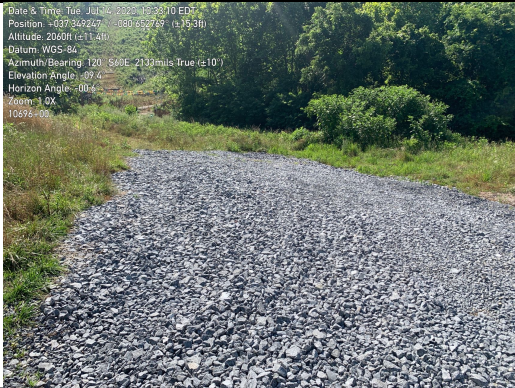
<p>Date & Time: Tue, Jul 14, 2020 10:30:10 EDT Position: +037.349229, -080.655739 (+4193ft) Altitude: 2050ft (+11.4ft) Datum: WGS-84 Azimuth/Bearing: 120° S60E 2133mils True (+10°) Elevation Angle: +09.4° Horizon Angle: +00.4° Zoom: 1.0X 10696+00</p>			
GPS Location	See photo for GPS location.		GPS Location	See photo for GPS location.	
Field Station#	10698+00		Field Station#	10696+00

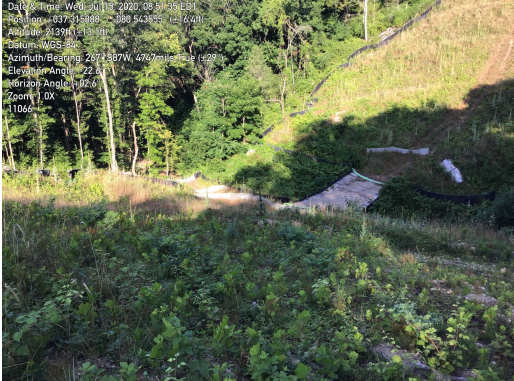
GPS Location	See picture above for GPS coordinates		GPS Location	See picture above for GPS coordinates	
Field Station#	11066+00		Field Station#	11075+00	
Pic 1 Desc.	ECD's and row conditions		Pic 2 Desc.	ECD's and row conditions

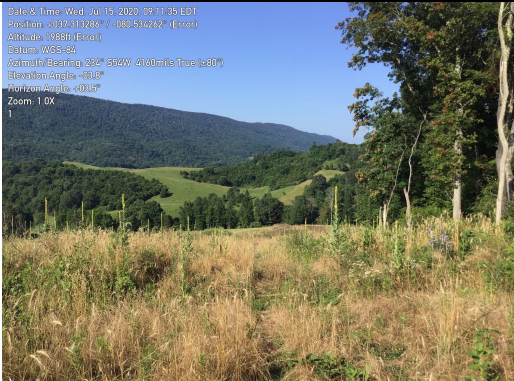
GPS Location	See picture above for GPS coordinates		GPS Location	See picture above for GPS coordinates	
Field Station#	11010+00		Field Station#	11023+00	
Pic 3 Desc.	ECD's and row conditions		Pic 4 Desc.	ECD's and row conditions

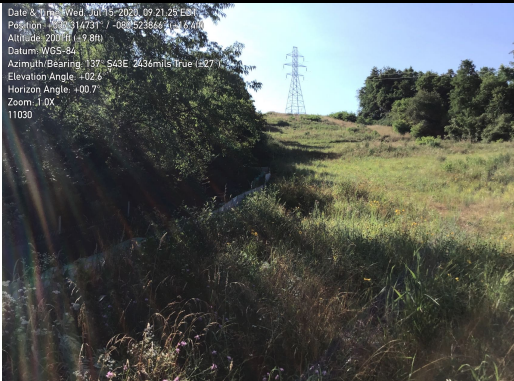
GPS Location	See picture above for GPS coordinates		GPS Location	See picture above for GPS coordinates	
Field Station#	11030+00		Field Station#	11040+00	
Pic 5 Desc.	ECD's and row conditions		Pic 6 Desc.	ECD's and row conditions

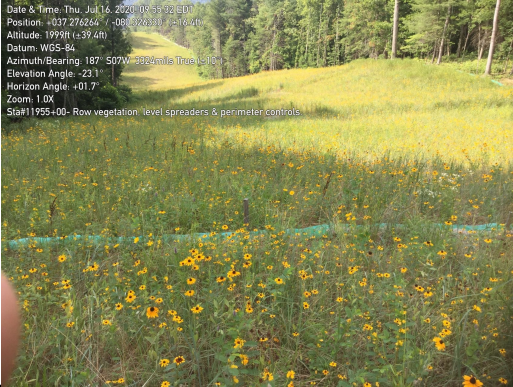
<p>Date & Time: Thu, Jul 16, 2020, 10:45:00 EDT Position: +037.278264° / -080.328111° (+16.4ft) Altitude: 1999ft (+39.4ft) Datum: WGS-84 Azimuth Bearing: 187° 50'20" 3024mils True (+10°) Elevation Angle: -23.1° Horizon Angle: +01.7° Zoom: 1.0X Sta#11955+00- Row vegetation, level spreaders & perimeter controls.</p>			
GPS Location	See photo GPS		GPS Location	See photo GPS	
Field Station#	11942+00		Field Station#	11955+00	
Pic 3 Desc.	Karst ECD's		Pic 4 Desc.	Row vegetation, level spreaders, ECD's.

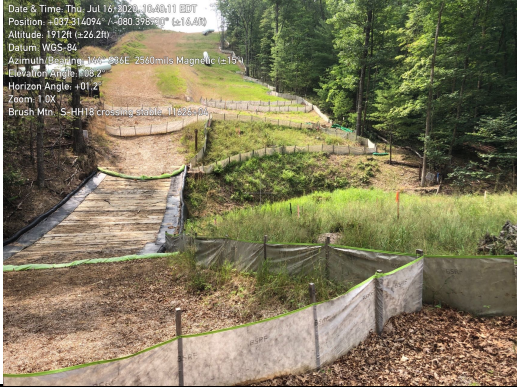
<p>Date & Time: Thu, Jul 16, 2020, 10:44:11 EDT Position: +037.314094 / -080.338807 (+86.44ft) Altitude: 1912ft (+26.2ft) Datum: WGS-84 Azimuth/Bearing: 160° S00E 250mils Magnetic (+15°) Elevation Angle: +08.0° Horizon Angle: +01.2° Zoom: 1.0X Brush Mtn. S-HH18 crossing stable. 11626+04</p>

GPS Location	On photo	GPS Location	On photo		
Field Station#	11630+00	Field Station#	11626+04		
Pic 7 Desc.	Slope breakers in place and functional. ECDs in place.	Pic 8 Desc.	S-HH18 crossing stable with ECDs in place.		
<p>Date & Time: Thu, Jul 16, 2020, 10:47:55 EDT Position: +037.313451 / -080.401916 (+115.44ft) Altitude: 2224ft (+42.0ft) Datum: WGS-84 Azimuth/Bearing: 094° S30E 167mils Magnetic (+15°) Elevation Angle: +08.3° Horizon Angle: +01.7° Zoom: 1.0X Brush Mtn. Perimeter controls in place. 11614+75</p>

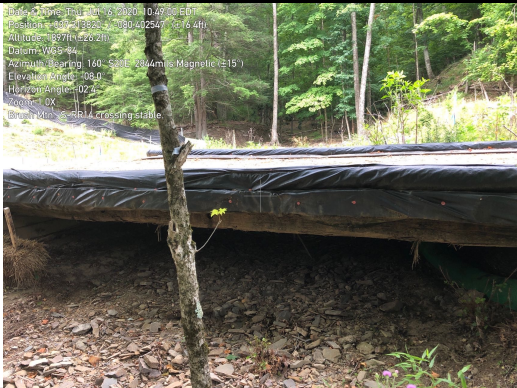
<p>Date & Time: Thu, Jul 16, 2020, 10:47:55 EDT Position: +037.313451 / -080.401916 (+115.44ft) Altitude: 2224ft (+42.0ft) Datum: WGS-84 Azimuth/Bearing: 160° S00E 250mils Magnetic (+15°) Elevation Angle: +08.0° Horizon Angle: +02.2° Zoom: 1.0X Brush Mtn. S-RR14 crossing stable. 11614+20</p>

GPS Location	On photo	GPS Location	On photo		
Field Station#	11614+75	Field Station#	11614+20		
Pic 9 Desc.	Perimeter controls are in place and functional.	Pic 10 Desc.	S-RR14 crossing stable with ECDs in place.		
<p>Date & Time: Thu, Jul 16, 2020, 10:54:38 EDT Position: +037.313877 / -080.404344 (+98.44ft) Altitude: 1928ft (+157.5ft) Datum: WGS-84 Azimuth/Bearing: 150° S30E 245mils Magnetic (+15°) Elevation Angle: +08.5° Horizon Angle: +00.7° Zoom: 1.0X Brush Mtn. S-006 crossing stable. 11607+81</p>

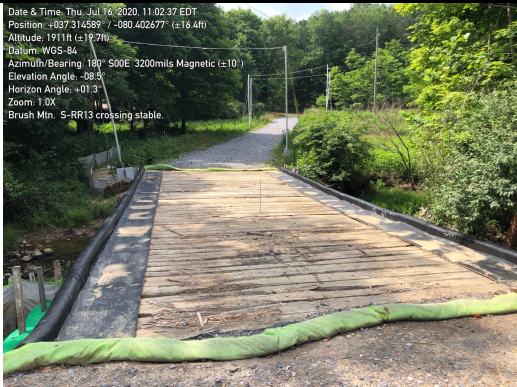
<p>Date & Time: Thu, Jul 16, 2020, 11:02:37 EDT Position: +037.314589 / -080.402677 (+16.44ft) Altitude: 1911ft (+19.7ft) Datum: WGS-84 Azimuth/Bearing: 160° S00E 320mils Magnetic (+10°) Elevation Angle: +08.5° Horizon Angle: +01.3° Zoom: 1.0X Brush Mtn. S-RR13 crossing stable. 11613+69</p>

Pic 11 Desc.	S-006 crossing stable with ECDs in place.	Pic 12 Desc.	S-RR13 crossing at MN-258.04 is stable with ECDs in place.

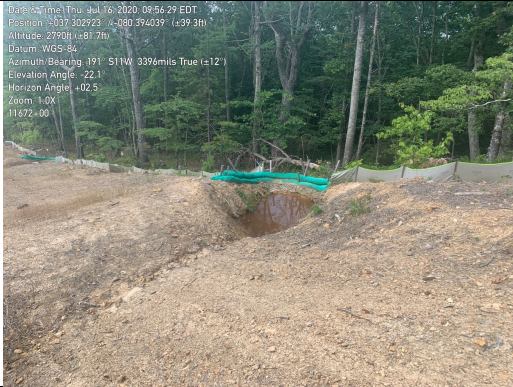
GPS Location	See photo for GPS location.		GPS Location	See photo for GPS location.	
Field Station#	11670+00		Field Station#	11672+00	
Pic 1 Desc.	Triple stack compost filter sock and priority one silt in place along LOD.		Pic 2 Desc.	Waterbar, sump pit, and waterbar end treatment in place.

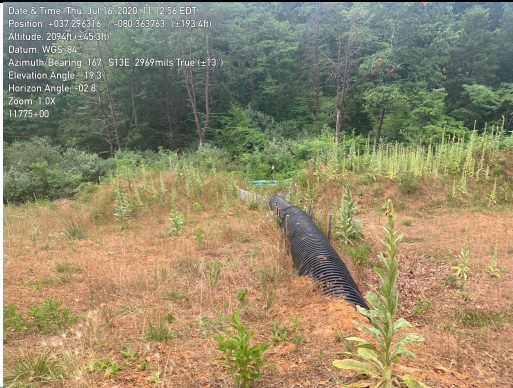
GPS Location	See photo for GPS location.		GPS Location	See photo for GPS location.	
Field Station#	11687+40		Field Station#	11760+00	
Pic 3 Desc.	Sensitive resource buffer in place at stream S-MN21.		Pic 4 Desc.	Priority one silt fence checks in place.

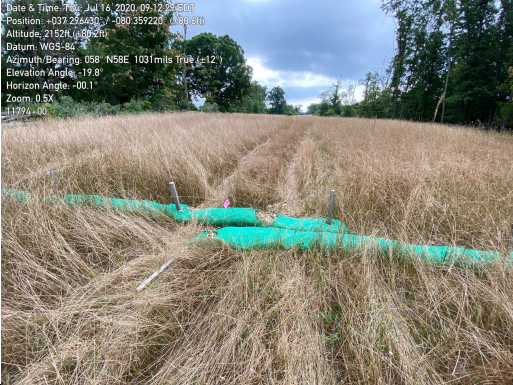
<p>Date & Time: Thu, Jul 16, 2020, 09:12:53 EDT Position: +037.25630° / +080.35922° (-65.00) Altitude: 2152ft (+65.00) Datum: WGS-84 Azimuth/Bearing: 058° NSBE 1031mils True (+12°) Elevation Angle: +19.8° Horizon Angle: -00.1° Zoom: 0.5X +11794+00</p>			
GPS Location	1	GPS Location	2		
Field Station#	11789+00	Field Station#	11794+00		
Pic 1 Desc.	RCE on the South side of Mt Tabor rd.	Pic 2 Desc.	Damage caused by others during lateral ATV/UTV travel within restored RoW.

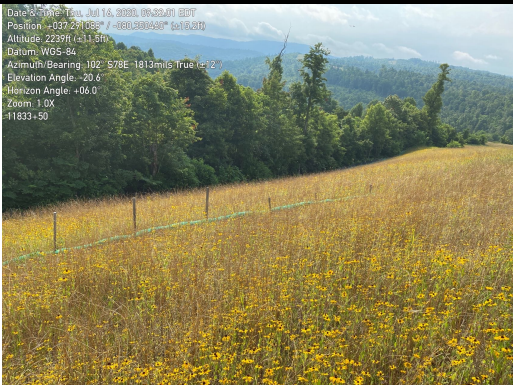
GPS Location	3	GPS Location	4		
Field Station#	11805+00	Field Station#	11833+50		
Pic 3 Desc.	Section of restored RoW showing conditions as well as continued lateral travel by others.	Pic 4 Desc.	Side slope showing conditions and controls.

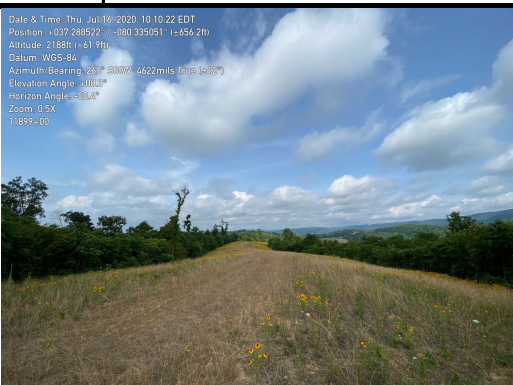
<p>Date & Time: Thu, Jul 16, 2020, 10:10:22 EDT Position: +037.285522° / +080.335051° (-65.00) Altitude: 2189ft (+65.00) Datum: WGS-84 Azimuth/Bearing: 263° S00W 4622mils True (+12°) Elevation Angle: +08.0° Horizon Angle: -00.2° Zoom: 0.5X +11899+00</p>			
GPS Location	5	GPS Location	6		
Field Station#	11863+65	Field Station#	11899+00		
Pic 5 Desc.	P-KL2 and controls.	Pic 6 Desc.	Section of restored RoW showing conditions.

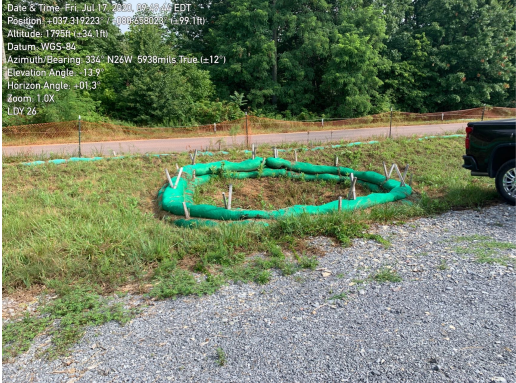
<p>Date & Time: Fri Jul 17, 2020, 10:30:00 EDT Position: +097.317222° / +030.633222° (+49.70) Altitude: 1795ft (+241m) Datum: WGS-84 Azimuth/Bearing: 334° N26W 5938mils True (+12°) Elevation Angle: -13.7° Horizon Angle: -101.3° Zoom: 1.0x LDY 26</p>			
GPS Location	See photo for GPS location.		GPS Location	See photo for GPS location.	
Field Station#	12005+00		Field Station#	12005+00	
Pic 1 Desc.	Triple stack compost filter sock in place around drainage.		Pic 2 Desc.	RCE in place at LDY 26 entrance.

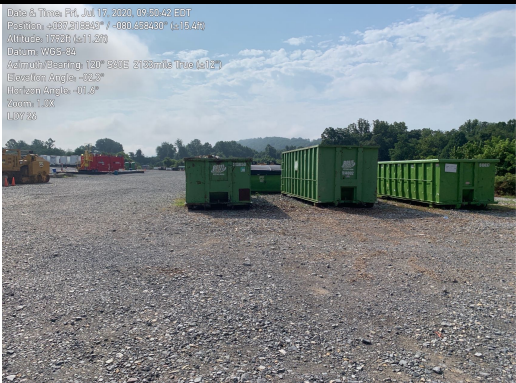
GPS Location	See photo for GPS location.		GPS Location	See photo for GPS location.	
Field Station#	12005+00		Field Station#	12005+00	
Pic 3 Desc.	Dumpsters being utilized for trash management.		Pic 4 Desc.	Secondary containment in place under fuel cell.

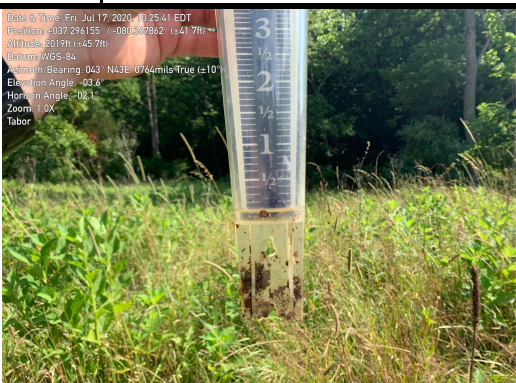
<p>Date & Time: Fri Jul 17, 2020, 10:30:00 EDT Position: +097.317222° / +030.633222° (+49.70) Altitude: 1795ft (+241m) Datum: WGS-84 Azimuth/Bearing: 334° N26W 5938mils True (+12°) Elevation Angle: -13.7° Horizon Angle: -101.3° Zoom: 1.0x Catawba</p>			
GPS Location	See photo for GPS location.		GPS Location	See photo for GPS location.	
Field Station#	11767+00		Field Station#	11990+00	
Pic 5 Desc.	Rain gauge at Mount Tabor Road reads 0.1 inches.		Pic 6 Desc.	Rain gauge at Catawba Road reads 0.15 inches.
