Visual Site Inspection Report

Project Name	H-600 Pipeline Spread G	AFE	124300137	Spread	H-600 Pipeline Spread G
Contractor	Precision			Report #	12991
Inspector	Chris Burns			Date/Time	7/27/2020 8:00 AM
Permit #	TBD	Inspection Type	VA SWPP	Station Begin	11254+99
State	VA	Inspection Area	Partial	Station End	11353+67
County	Giles	Ground	Wet	Temperature (°F)	88.00
Municipality	N/A	Weather	Sunny	Rain Gauge (in)	0.25
				Rain Accumulation Time (days)	1.00

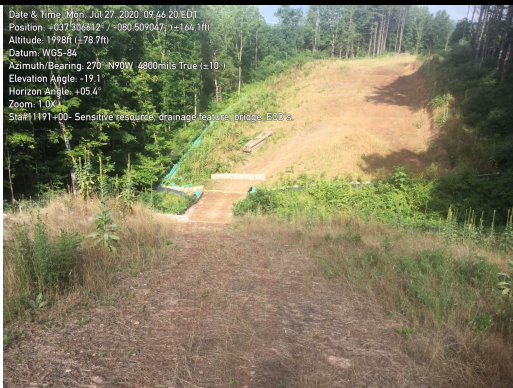
<p>Date & Time: Mon, Jul 27, 2020, 09:46:20 EDT Position: +037.303812° / -080.509047° (±16.4ft) Altitude: 1998ft (±39.7ft) Datum: WGS-84 Azimuth/Bearing: 270° N70W 4800mils True (±10°) Elevation Angle: -19.1° Horizon Angle: +05.4° Zoom: 1.0x Sta# 11191+00 - Sensitive resource, drainage feature, ECD's.</p>

Pic 5 Desc.	Sensitive resource area, drainage feature.		Pic 6 Desc.	CWD pipe and plunge pool, ECD's

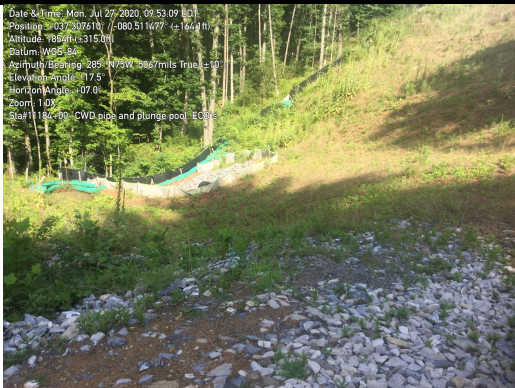
<p>Date & Time: Mon, Jul 27, 2020, 09:53:09 EDT Position: +037.302614° / -080.511477° (±16.4ft) Altitude: 1858ft (±315.1ft) Datum: WGS-84 Azimuth/Bearing: 285° N73W 5027mils True (±10°) Elevation Angle: -17.5° Horizon Angle: -07.0° Zoom: 1.0x Sta# 11184+00 - CWD pipe and plunge pool, ECD's.</p>			
GPS Location	See photo GPS		GPS Location	See photo GPS	
Field Station#	11191+00		Field Station#	11184+00

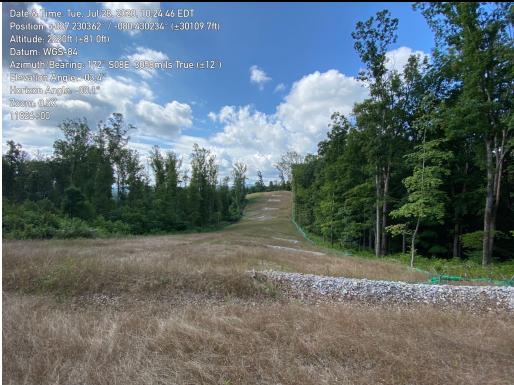
GPS Location	3	GPS Location	4		
Field Station#	11826+00	Field Station#	11848+00		
Pic 3 Desc.	Section of restored RoW showing conditions and controls.	Pic 4 Desc.	Section of restored RoW showing conditions and controls.

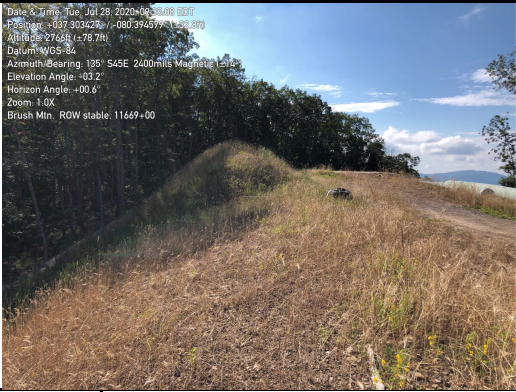
<p>Date & Time: Tue, Jul 28, 2020 09:48:00 EDT Position: +37.303426° / -080.394511° (+52.8ft) Altitude: 2479ft (+10.1ft) Datum: WGS-84 Azimuth/Bearing: 217° S37W 3880mils Magnetic (+16) Elevation Angle: +03.6° Horizon Angle: +00.6° Zoom: 1.0x Brush Min. Perimeter ECDs in place. 11663+00</p>

GPS Location	On photo	GPS Location	On photo
Field Station#	11669+00	Field Station#	11663+00
Pic 1 Desc.	ROW stable near JNF property line	Pic 2 Desc.	End treatments are functioning as designed
<p>Date & Time: Tue, Jul 28, 2020 10:51:11 EDT Position: +37.306915° / -080.393810° (+52.8ft) Altitude: 2343ft (+19.7ft) Datum: WGS-84 Azimuth/Bearing: 197° S11E 3080mils Magnetic (+12) Elevation Angle: +05.3° Horizon Angle: +05.3° Zoom: 1.0x Brush Min. Slope breakers effective. Perimeter ECDs in place. 11659+00</p>

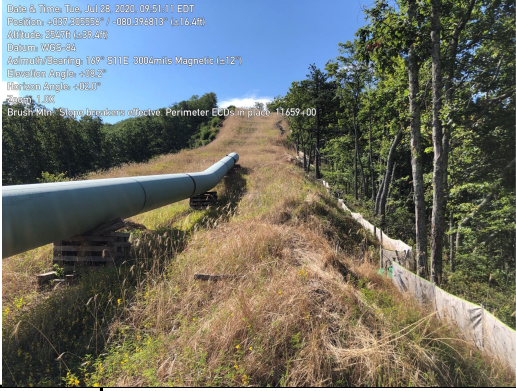
<p>Date & Time: Tue, Jul 28, 2020 10:01:02 EDT Position: +37.306915° / -080.393810° (+52.8ft) Altitude: 2343ft (+19.7ft) Datum: WGS-84 Azimuth/Bearing: 011° N 11E 3180mils Magnetic (+12) Elevation Angle: +0.5° Horizon Angle: +00.5° Zoom: 1.0x Brush Min. Perimeter controls in place. 11653+00</p>

GPS Location	On photo	GPS Location	On photo
Field Station#	11659+00	Field Station#	11653+00
Pic 3 Desc.	Perimeter controls are in place and functional. ROW stable.	Pic 4 Desc.	Perimeter controls are in place and functional. ROW stable.
<p>Date & Time: Tue, Jul 28, 2020 10:20:32 EDT Position: +37.310142° / -080.397499° (+52.8ft) Altitude: 2053ft (+52.8ft) Datum: WGS-84 Azimuth/Bearing: 311° N47W 5520mils Magnetic (+13) Elevation Angle: +17.6° Horizon Angle: +00.2° Zoom: 1.0x Brush Min. Perimeter controls in place. ROW stable. 11631+00</p>

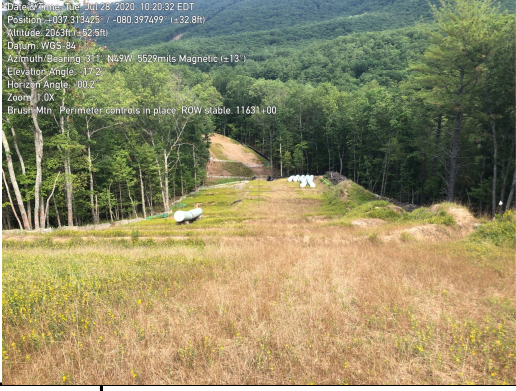
<p>Date & Time: Tue, Jul 28, 2020 10:26:22 EDT Position: +37.314268° / -080.398228° (+52.8ft) Altitude: 1951ft (+39.4ft) Datum: WGS-84 Azimuth/Bearing: 133° S25E 2750mils Magnetic (+13) Elevation Angle: +01.0° Horizon Angle: +02.1° Zoom: 1.0x Brush Min. S-HH18 buffers stable. 11626+04</p>

Pic 5 Desc.	Slope breakers functional. Perimeter controls in place. ROW stable.	Pic 6 Desc.	S-HH18 crossing stable. ECDs in place.

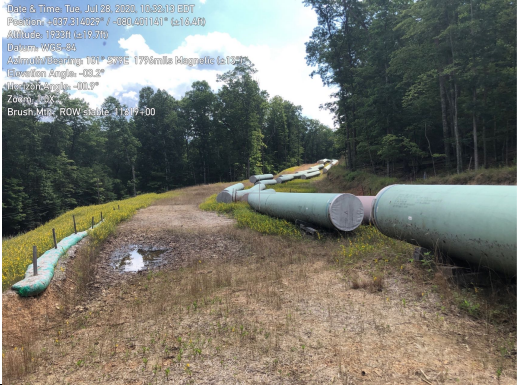
<p>Date & Time: Tue, Jul 28, 2020, 10:55:19 EDT Position: +037.514282° / -080.402145° (±16.4ft) Altitude: 1938ft (±19.7ft) Datum: WGS-84 Azimuth/Bearing: 191° S14W 1796mils Magnetic (±10°) Elevation Angle: -00.2° Horizon Angle: -00.3° Zoom: 1.0X Brush Min: S-RR14 crossing stable.</p>

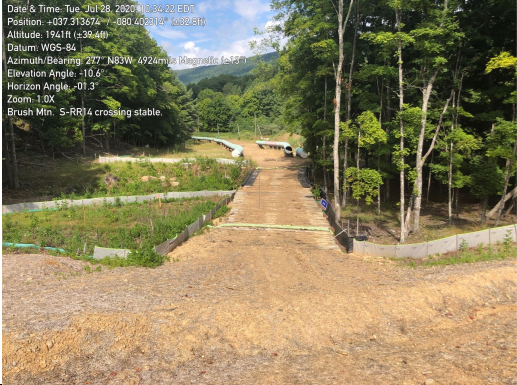
<p>Date & Time: Tue, Jul 28, 2020, 10:54:59 EDT Position: +037.513674° / -080.402145° (±16.4ft) Altitude: 1941ft (±19.7ft) Datum: WGS-84 Azimuth/Bearing: 227° N83W 6924mils Magnetic (±10°) Elevation Angle: -10.3° Horizon Angle: -01.3° Zoom: 1.0X Brush Min: S-RR14 crossing stable.</p>			
GPS Location	On photo	GPS Location	On photo		
Field Station#	11619+00	Field Station#	11614+20		
Pic 7 Desc.	ROW stable. ECDs in place.	Pic 8 Desc.	S-RR14 crossing stable with ECDs in place.

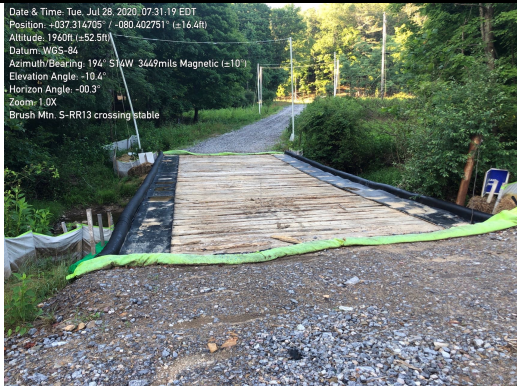
<p>Date & Time: Tue, Jul 28, 2020, 07:31:19 EDT Position: +037.514705° / -080.402751° (±16.4ft) Altitude: 1940ft (±19.7ft) Datum: WGS-84 Azimuth/Bearing: 194° S14W 3449mils Magnetic (±10°) Elevation Angle: -10.4° Horizon Angle: -00.3° Zoom: 1.0X Brush Min: S-RR13 crossing stable.</p>

GPS Location	On photo	GPS Location	On photo		
Field Station#	11613+69	Field Station#	11607+81		
Pic 9 Desc.	S-RR13 crossing on access road MN-258.04 is stable. ECDs in place.	Pic 10 Desc.	S-006 crossing stable. ECDs in place.		
Insert image here		Insert image here			
GPS Location		GPS Location			
Field Station#		Field Station#			
Pic 11 Desc.		Pic 12 Desc.

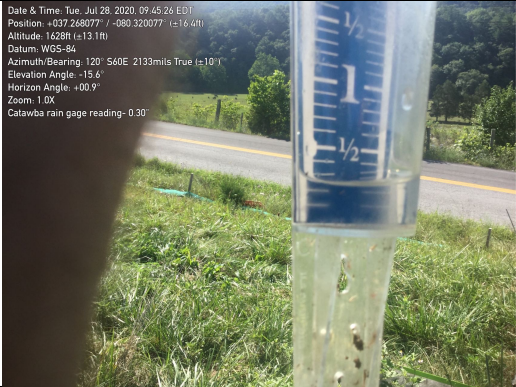
<p>Date & Time: Tue, Jul 28, 2020, 10:36:33 EDT Position: +037.269107 / -080.320077 (-16.4ft) Altitude: 2265ft (-13.2ft) Datum: WGS-84 Azimuth/Bearing: 305° 00W 6930mils True (±10°) Elevation Angle: -40.72° Horizon Angle: +00.9° Zoom: 1.0X Weed control & riprap checks in rain ditch</p>

GPS Location	See photo GPS	GPS Location	See photo GPS		
Field Station#	11989+00	Field Station#	11900+00		
Pic 1 Desc.	Catawba rain gauge reading- 0.30"	Pic 2 Desc.	AR-266.03 access road with CFS ditch checks.		
<p>Date & Time: Tue, Jul 28, 2020, 10:37:20 EDT Position: +037.283167 / -080.330167 (-16.4ft) Altitude: 2376ft (-19.7ft) Datum: WGS-84 Azimuth/Bearing: 120° S60E 2133mils True (±25°) Elevation Angle: -29° Horizon Angle: +00.1° Zoom: 1.0X Start 11924+00- Contractor has repaired CFS fabric after bear damage</p>

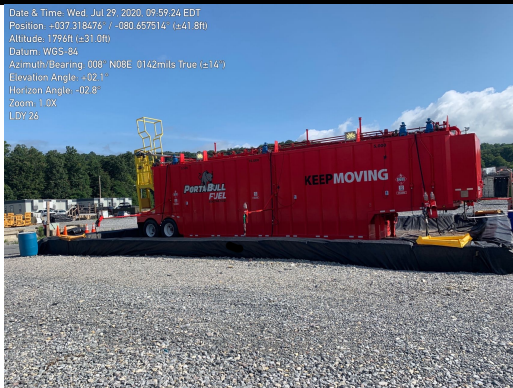
GPS Location	See photo for GPS location.		GPS Location	See photo for GPS location.	
Field Station#	12005+00		Field Station#	12005+00	
Pic 5 Desc.	Checked staged equipment for leaks.		Pic 6 Desc.	Secondary containment in place under fuel cell.

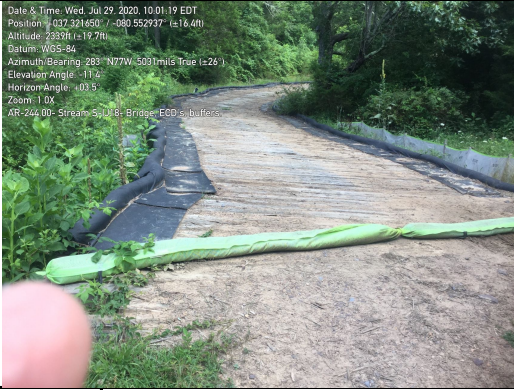
<p>Date & Time: Wed, Jul 29, 2020, 10:01:19 EDT Position: +037.329458° / -080.552937° (-18.4ft) Altitude: 2330ft (+19.7ft) Datum: WGS-84 Azimuth/Bearing: 283° N77W 503mils True (+26°) Elevation Angle: -11.3° Horizon Angle: +03.5° Magnetic Angle: +02.7° Zoom: 1.0x Station: 11024+00- Stream S-IJ18- Bridge, ECD's, buffers.</p>

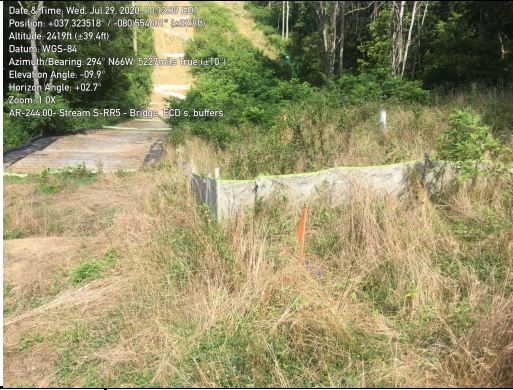
<p>Date & Time: Wed, Jul 29, 2020, 10:03:09 EDT Position: +037.322518° / -080.550401° (-18.4ft) Altitude: 2419ft (+20.4ft) Datum: WGS-84 Azimuth/Bearing: 294° N66W 522mils True (+10°) Elevation Angle: -09.9° Horizon Angle: +02.7° Magnetic Angle: +02.7° Zoom: 1.0x Station: 11017+00- Stream S-RR5- Bridge, ECD's, buffers.</p>			
GPS Location	See photo GPS	GPS Location	See photo GPS		
Field Station#	11024+00	Field Station#	11017+00		
Pic 1 Desc.	Stream S-IJ18- equipment bridge, buffers and stream controls are in acceptable condition.	Pic 2 Desc.	Stream S- RR5 ECD's, are in acceptable condition.

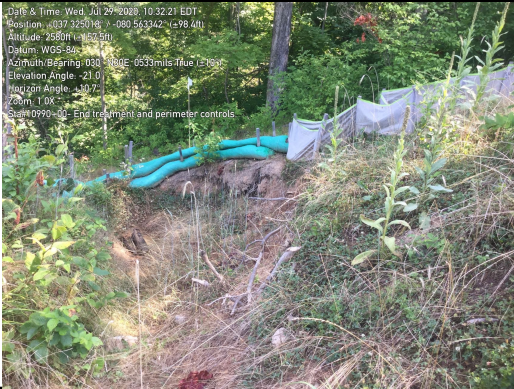
<p>Date & Time: Wed, Jul 29, 2020, 10:32:21 EDT Position: +037.325018° / -080.543342° (-19.4ft) Altitude: 2550ft (+21.5ft) Datum: WGS-84 Azimuth/Bearing: 038° S82E 053mils True (+10°) Elevation Angle: -21.0° Horizon Angle: +02.7° Magnetic Angle: +02.7° Zoom: 1.0x Station: 10990+00- End treatment and perimeter controls.</p>

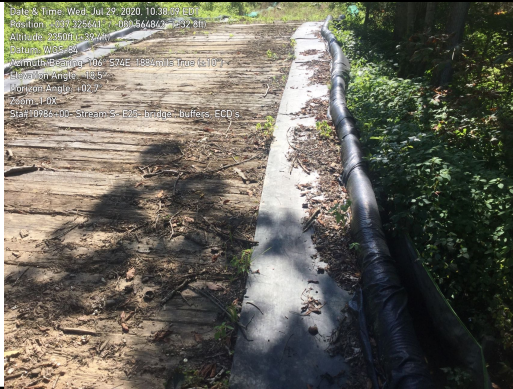
<p>Date & Time: Wed, Jul 29, 2020, 10:30:50 EDT Position: +037.325041° / -080.540843° (-19.4ft) Altitude: 2500ft (+20.5ft) Datum: WGS-84 Azimuth/Bearing: 038° S82E 053mils True (+10°) Elevation Angle: -21.0° Horizon Angle: +02.7° Magnetic Angle: +02.7° Zoom: 1.0x Station: 10986+00- Stream S-E25- Bridge, ECD's, buffers.</p>			
GPS Location	See photo GPS	GPS Location	See photo		
Field Station#	10990+00	Field Station#	10986+00		
Pic 3 Desc.	Triple stack end treatment and perimeter controls.	Pic 4 Desc.	Stream S- E25- stream ECD's & equipment bridge.

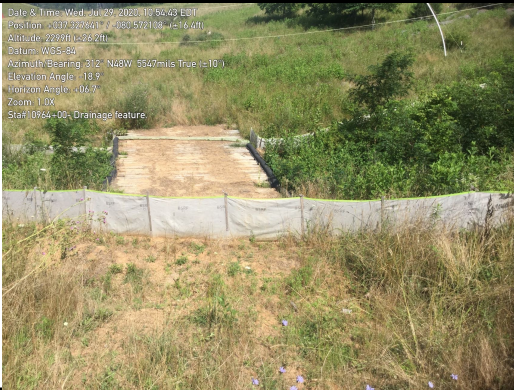
<p>Date & Time: Wed, Jul 29, 2020, 10:56:43 EDT Position: +037.329258° / -080.547104° (-18.4ft) Altitude: 2230ft (+19.2ft) Datum: WGS-84 Azimuth/Bearing: 312° N48W 5347mils True (+10°) Elevation Angle: -18.9° Horizon Angle: +00.7° Magnetic Angle: +00.7° Zoom: 1.0x Station: 10964+00- Drainage feature.</p>

GPS Location	See photo GPS	GPS Location	See photo GPS		
Field Station#	10964+00	Field Station#	10950+00		
Pic 5 Desc.	Drainage feature and ECD's.	Pic 6 Desc.	Cattle gates remain open allowing cattle to graze on the row.

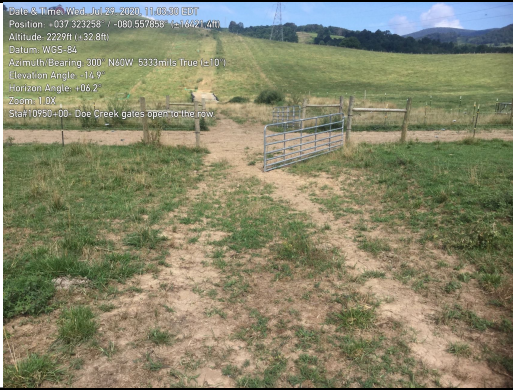
<p>Date & Time: Wed, Jul 29, 2020, 11:08:30 EDT Position: +037.322558° / -080.557838° (-18.4ft) Altitude: 2229ft (+19.2ft) Datum: WGS-84 Azimuth/Bearing: 300° N48W 5333mils True (+10°) Elevation Angle: -16.9° Horizon Angle: +00.7° Magnetic Angle: +00.7° Zoom: 1.0x Station: 10950+00- Doe Creek gates open to the row.</p>

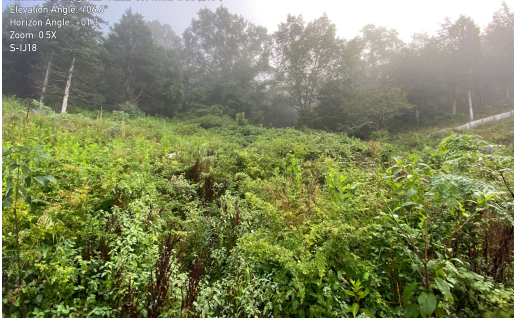
GPS Location	1	GPS Location	2		
Field Station#	11025+50	Field Station#	11028+00		
Pic 1 Desc.	S-IJ18 and controls.	Pic 2 Desc.	Perimeter controls functional.		
<p> <small> Date & Time: Thu, Jul 30, 2020, 07:46:47 EDT Position: +487.322222° / -400.522222° (±77.2M) Altitude: 358M (±31.2M) Datum: WGS-84 Azimuth/Heading: 035° 035M Offshore True (±12°) Elevation Angle: +0.5° Horizon Angle: +0.1° Zoom: 0.5X S-IJ18+00 </small> </p>

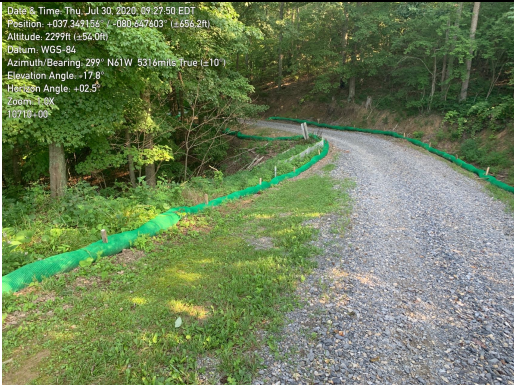
GPS Location	See photo for GPS location.		GPS Location	See photo for GPS location.	
Field Station#	10710+00		Field Station#	10698+00	
Pic 3 Desc.	CFS in place along AR 241.04 LOD.		Pic 4 Desc.	Sensitive resource buffer in place at stream S-G32.	
<p>Date & Time: Thu Jul 30 2020 09:40:32 EDT Position: +037.345267 -080.626328 (+1570.4ft) Altitude: 2053ft (+44.4ft) Datum: WGS-84 Azimuth/Bearing: 116.544E 2042mils True (+10.1) Elevation Angle: -11.6 Horizon Angle: -04.0 Zoom: 1.0x 10696+00</p>

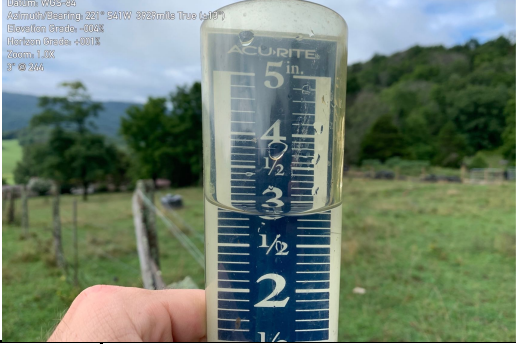
GPS Location		See picture above for GPS coordinates		GPS Location	
Field Station#		+1		Field Station#	
Pic 1 Desc.		3" of rain recorded @ AR 244		Pic 2 Desc.

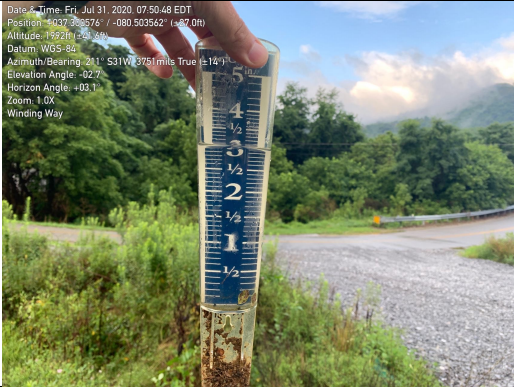
GPS Location	See photo for GPS location.		GPS Location	See photo for GPS location.	
Field Station#	11112+00		Field Station#	11990+00	
Pic 1 Desc.	Rain gauge at Winding way reads 3.0 inches.		Pic 2 Desc.	Rain gauge at Catawba Road reads 2.2 inches.

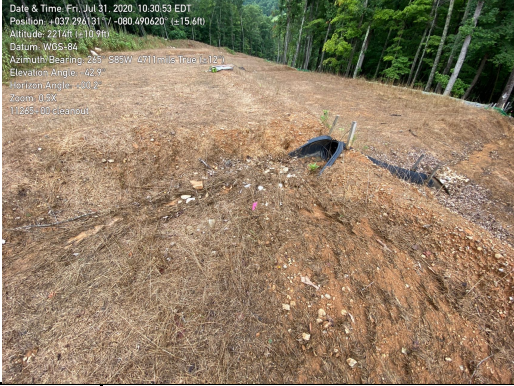
GPS Location	1	GPS Location	2		
Field Station#	11265+00	Field Station#	11280+00		
Pic 1 Desc.	Slope drain inlet requiring maintenance.	Pic 2 Desc.	CFS end treatment damaged by water flow.

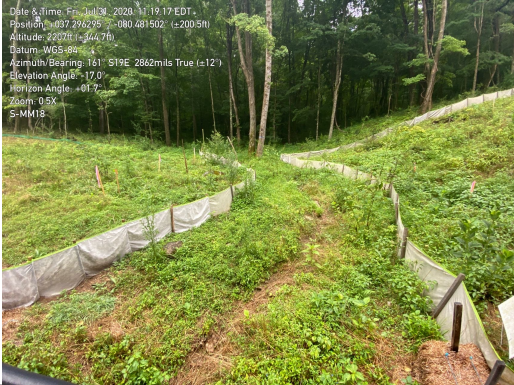
GPS Location	3	GPS Location	4		
Field Station#	11292+80	Field Station#	11309+00		
Pic 3 Desc.	S-MM18 and controls.	Pic 4 Desc.	Section of RoW showing conditions and controls.

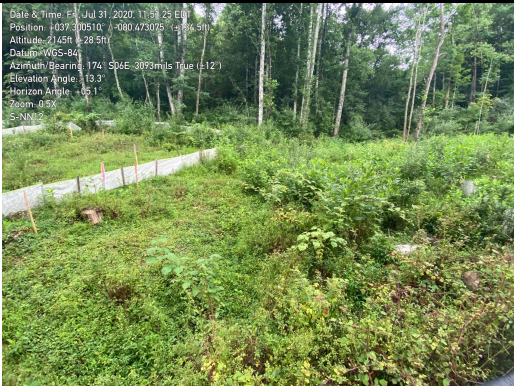
GPS Location	5	GPS Location	6		
Field Station#	11327+85	Field Station#	11352+97		
Pic 5 Desc.	S-NN12 and controls.	Pic 6 Desc.	S-NN11 and controls.
