# Visual Site Inspection Report

<b>Project Name</b>	H-600 Pipeline Spread G	<b>AFE</b>	124300137	<b>Spread</b>	H-600 Pipeline Spread G
<b>Contractor</b>	Precision			<b>Report #</b>	13489
<b>Inspector</b>	Garrett Barclay			<b>Date/Time</b>	8/10/2020 8:23 AM
<b>Permit #</b>	TBD	<b>Inspection Type</b>	VA SWPP	<b>Station Begin</b>	12005+00
<b>State</b>	VA	<b>Inspection Area</b>	Partial	<b>Station End</b>	12005+00
<b>County</b>	Giles	<b>Ground</b>	Damp	<b>Temperature (°F)</b>	82.00
<b>Municipality</b>	N/A	<b>Weather</b>	Sunny	<b>Rain Gauge (in)</b>	0.00
				<b>Rain Accumulation Time (days)</b>	1.00

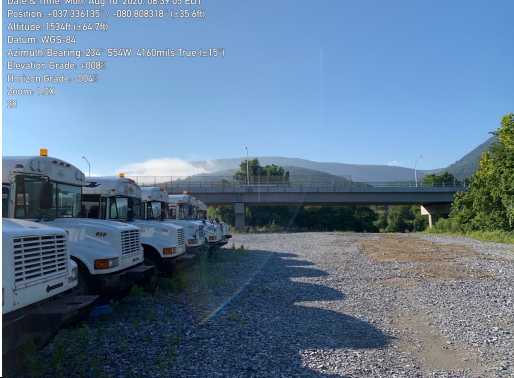
<b>GPS Location</b>	See picture above for GPS coordinates		<b>GPS Location</b>	See picture above for GPS coordinates	
<b>Field Station#</b>	12005+00		<b>Field Station#</b>	12005+00	
<b>Pic 1 Desc.</b>	ECD's and row conditions		<b>Pic 2 Desc.</b>	ECD's and row conditions	
<p>Date &amp; Time: Mon Aug 10 2020 08:50:23 EDT  Position: +037.333134 / -080.803150 (±15.1ft)  Altitude: 1534ft (±62.7ft)  Datum: WGS-84  Azimuth/Bearing: 182.143W 4330mils (±27°)  Elevation Grade: +000%  Horizon Grade: +003%  Zoom: 1.0X  28</p>

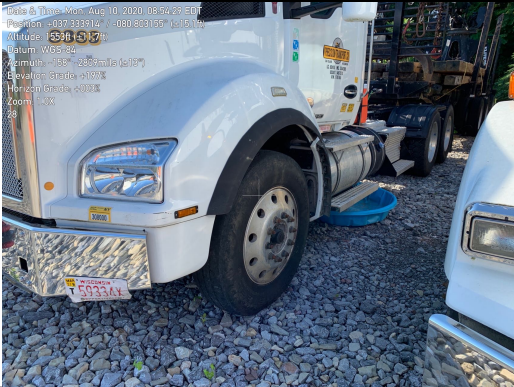
<b>GPS Location</b>	See picture above for GPS coordinates		<b>GPS Location</b>	See picture above for GPS coordinates	
<b>Field Station#</b>	12005+00		<b>Field Station#</b>	12005+00	
<b>Pic 3 Desc.</b>	Secondary containment		<b>Pic 4 Desc.</b>	ECD's and row conditions	
<p>Date &amp; Time: Mon Aug 10 2020 08:54:32 EDT  Position: +037.333912 / -080.803158 (±15.1ft)  Altitude: 1558ft (±11.4ft)  Datum: WGS-84  Azimuth/Bearing: -046.0818mils (±12.1)  Elevation Grade: +488%  Horizon Grade: +004%  Zoom: 1.0X  28</p>

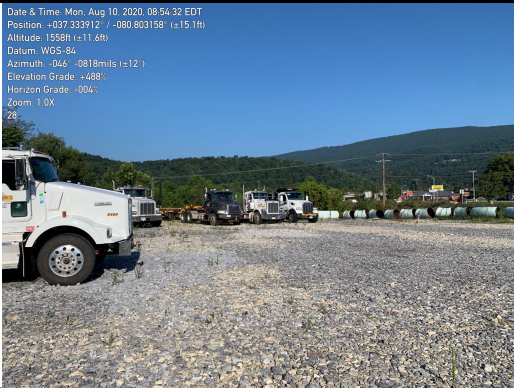
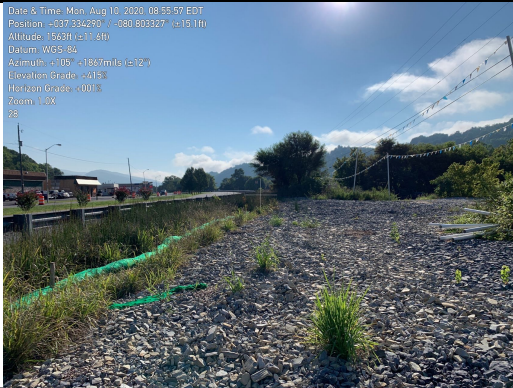
<b>Pic 5 Desc.</b>	ECD's and row conditions		<b>Pic 6 Desc.</b>	ECD's and row conditions

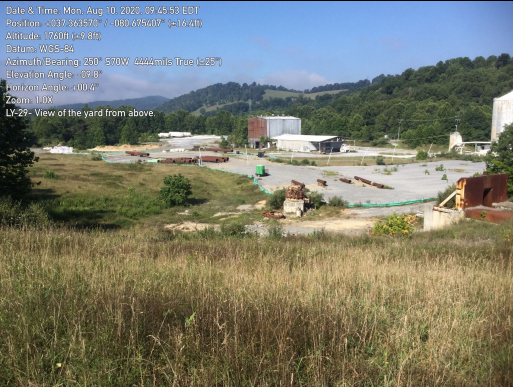
<b>GPS Location</b>	See photo GPS	<b>GPS Location</b>	See photo GPS		
<b>Field Station#</b>	12005+00	<b>Field Station#</b>	12005+00		
<b>Pic 1 Desc.</b>	AR-238.00- Access road serving LY-29.	<b>Pic 2 Desc.</b>	LY-29- View of the yard from above.

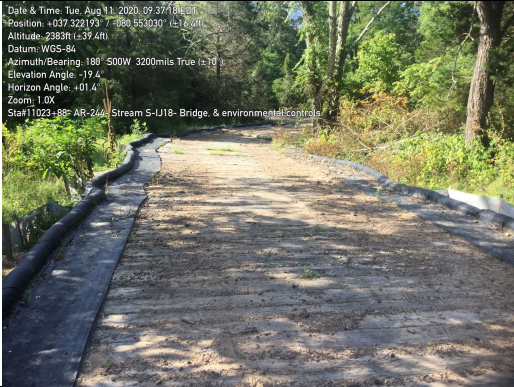
<p>Date &amp; Time: Tue, Aug 11, 2020, 09:37:18 EDT Position: +037.322193 / -080.553030 (+16.4 mi) Altitude: 2383ft (+39.4ft) Datum: WGS-84 Azimuth/Bearing: 186° S00W 3200mils True (+10°) Elevation Angle: -19.4° Horizon Angle: +01.4° Zoom: 1.0X Sta#11023+88- Stream S-IJ18- Bridge &amp; environmental controls</p>

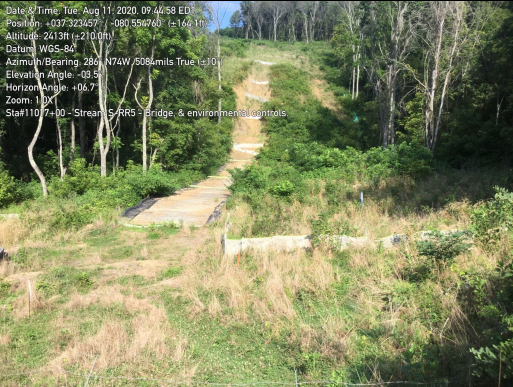
<p>Date &amp; Time: Tue, Aug 11, 2020, 09:44:58 EDT Position: +037.322457 / -080.556760 (+16.4 mi) Altitude: 2413ft (+210 ft) Datum: WGS-84 Azimuth/Bearing: 286° N74W 5088mils True (+10°) Elevation Angle: -03.5° Horizon Angle: +06.7° Zoom: 1.0X Sta#11017+00- Stream S-RR5- Bridge &amp; environmental controls</p>		<b>GPS Location</b>	See photo GPS
<b>Field Station#</b>	11023+88	<b>Field Station#</b>	11017+00	<b>GPS Location</b>	See photo GPS
<b>Pic 1 Desc.</b>	Stream S-IJ18- Equipment bridge, ECD's	<b>Pic 2 Desc.</b>	Sta#11017+00- Stream S-RR5

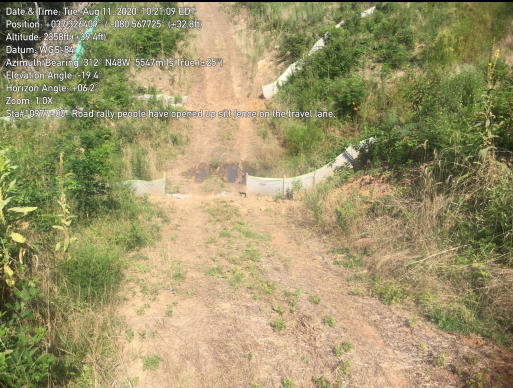
<p>Date &amp; Time: Tue, Aug 11, 2020, 10:21:09 EDT Position: +037.325922 / -080.567725 (+16.4 mi) Altitude: 2358ft (+39.4ft) Datum: WGS-84 Azimuth/Bearing: 312° N48W 5527mils True (+10°) Elevation Angle: -19.4° Horizon Angle: +06.2° Zoom: 1.0X Sta#10977+00- Road rally people have opened up old fence on the travel lane.</p>		<b>GPS Location</b>	See photo GPS

<b>Field Station#</b>	10985+00	<b>Field Station#</b>	10977+00	<b>GPS Location</b>	See photo GPS
<b>Pic 5 Desc.</b>	Stream S- E24- Bridge, buffers, ECD's	<b>Pic 6 Desc.</b>	P1 silt fence removed by off road club,

<b>A/E</b>	124300137	<b>Date/Time</b>	8/11/2020 8:36 AM	<b>Report #</b>	13490
<b>6. PCSM BMPs</b> (List BMPs and note if installed and maintained as per the plan. If corrective action is needed, a picture is required.)					
<b>PCSM BMPs</b>	<b>Compliance Level</b>	<b>Corrective Action</b>	<b>Corrective Time Frame</b>	<b>Date Repaired</b>	
<b>7. Identify all remedial measures that have been taken since the previous inspection was conducted.</b>					
<b>Comments</b> (Reference above questions as appropriate.)					
Met with EI's at work trailer SWPPP inspection: Sta#11023+88 to 10930+00. MP-208.6 to 206.2 Streams S- IJ18, at AR-244, S- RR5, S- E24, S- E25 are in good condition, ECD's, equipment bridge's, buffers and signage are in acceptable condition. AR-244.00 and Doe Creek RCE are maintained in acceptable condition. Temporary stabilization is acceptable, vegetation is acceptable. Perimeter controls, silt fence, CFS, & SSF are in acceptable condition. Water bars, sump pits and end treatments are in acceptable condition. Sensitive resource area is in acceptable condition. There is damage to CFS and silt fence buy off road rally club at sta# 10984+00, 10977+00, 10969+00. Items will be added to the punch list.

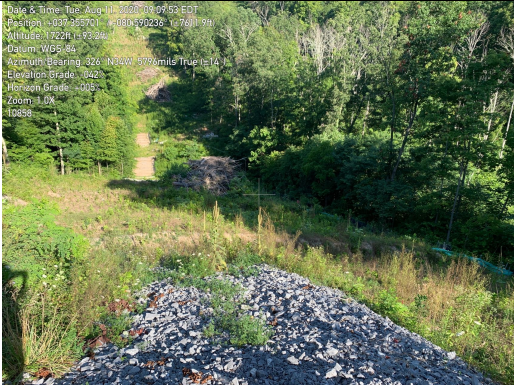
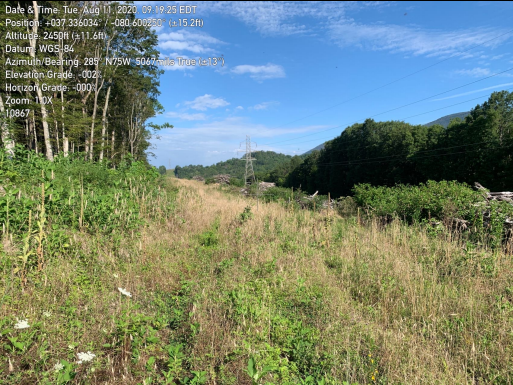
<b>GPS Location</b>	See picture above for GPS coordinates		<b>GPS Location</b>	See picture above for GPS coordinates	
<b>Field Station#</b>	10850+00		<b>Field Station#</b>	10867+00	
<b>Pic 1 Desc.</b>	ECD's and row conditions		<b>Pic 2 Desc.</b>	ECD's and row conditions

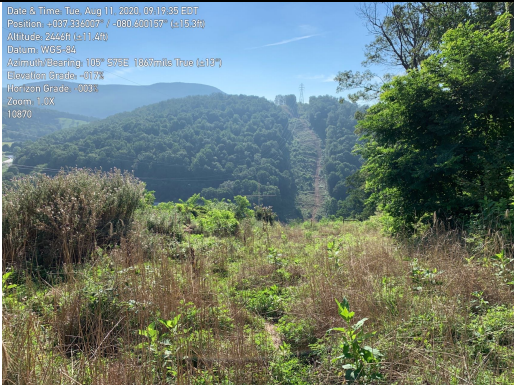
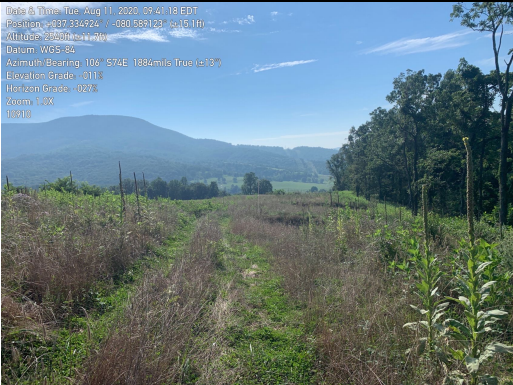
<b>GPS Location</b>	See picture above for GPS coordinates		<b>GPS Location</b>	See picture above for GPS coordinates	
<b>Field Station#</b>	10870+00		<b>Field Station#</b>	10910+00	
<b>Pic 3 Desc.</b>	ECD's and row conditions		<b>Pic 4 Desc.</b>	ECD's and row conditions

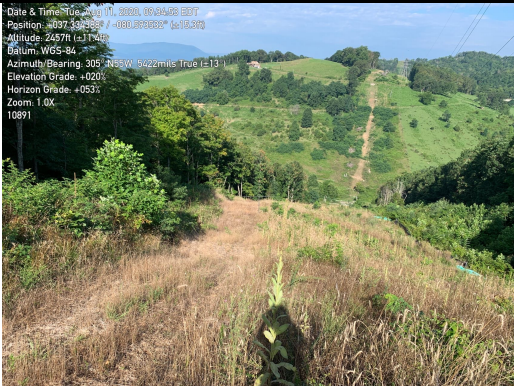
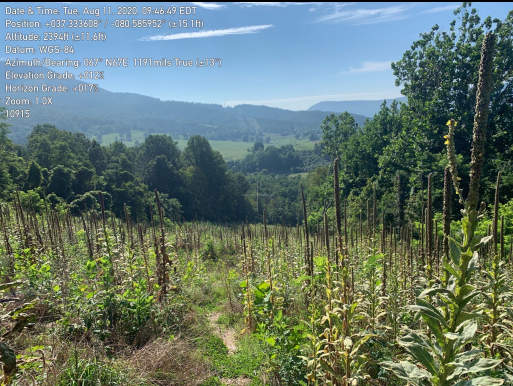
<b>GPS Location</b>	See picture above for GPS coordinates		<b>GPS Location</b>	See picture above for GPS coordinates	
<b>Field Station#</b>	10891+00		<b>Field Station#</b>	109105+00	
<b>Pic 5 Desc.</b>	ECD's and row conditions		<b>Pic 6 Desc.</b>	ECD's and row conditions

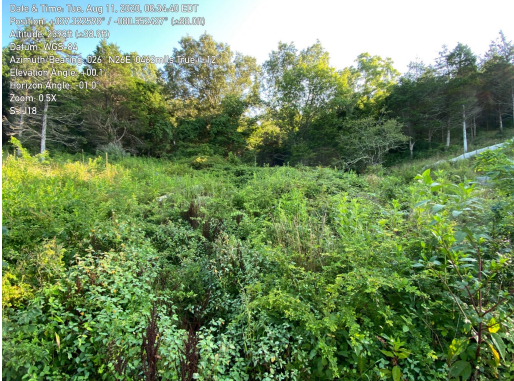
<p>Date &amp; Time: Tue, Aug 11, 2020, 08:41:12 EDT Position: +037.102286, -080.551529, 1-451.2ft Altitude: 2344ft (724m) Datum: WGS84 Azimuth/Bearing: 025.1 SSW 459mils True (±12.1) Elevation/Angle: 0.0° Horizon Angle: 01.0° Zoom: 0.5X Scale: 11027+50</p>			
<b>GPS Location</b>	1	<b>GPS Location</b>	2		
<b>Field Station#</b>	11025+50	<b>Field Station#</b>	11027+50		
<b>Pic 1 Desc.</b>	S-IJ18 and controls.	<b>Pic 2 Desc.</b>	Perimeter controls functional.

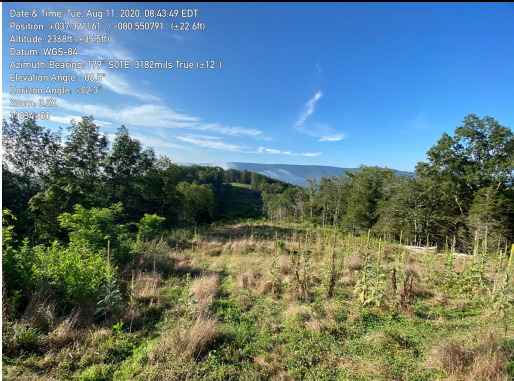
<b>GPS Location</b>	3	<b>GPS Location</b>	4		
<b>Field Station#</b>	11034+00	<b>Field Station#</b>	11050+10		
<b>Pic 3 Desc.</b>	Section of RoW showing conditions and controls.	<b>Pic 4 Desc.</b>	S-IJ16B/S-IJ17 and controls.

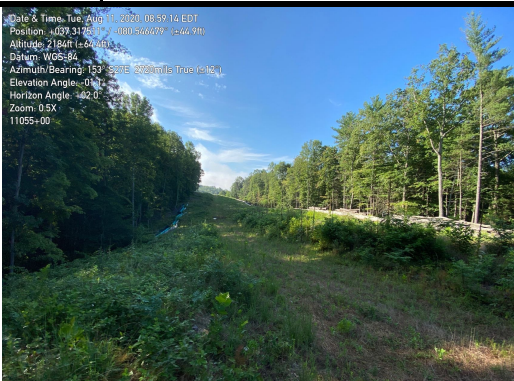
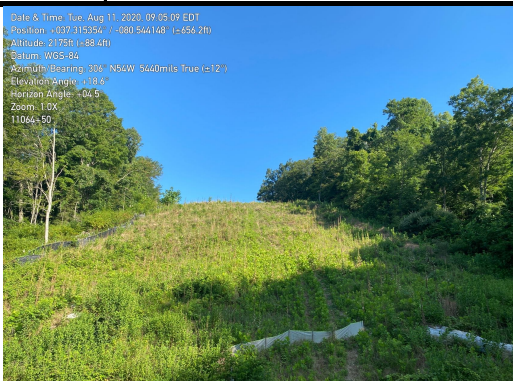
<p>Date &amp; Time: Tue, Aug 11, 2020, 09:05:09 EDT Position: +037.115156, -080.566148, 1-458.2ft Altitude: 2175ft (663m) Datum: WGS84 Azimuth/Bearing: 306.1 N6W 5640mils True (±12.1) Elevation/Angle: +18.4° Horizon Angle: 04.5° Zoom: 1.0X Scale: 11064+50</p>			
<b>GPS Location</b>	5	<b>GPS Location</b>	6		
<b>Field Station#</b>	11055+00	<b>Field Station#</b>	11064+50		
<b>Pic 5 Desc.</b>	Section of RoW showing conditions and controls.	<b>Pic 6 Desc.</b>	Section of RoW showing conditions and controls.

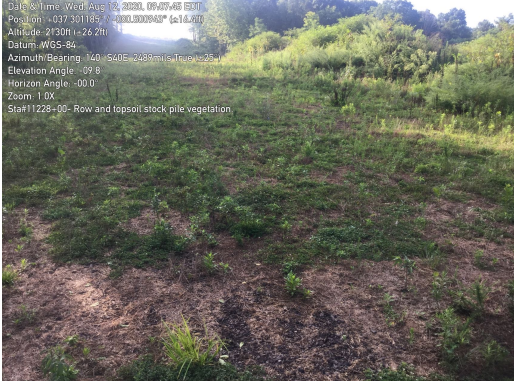
<b>AFE</b>	124300137	<b>Date/Time</b>	8/12/2020 8:37 AM	<b>Report #</b>	
<b>Pictures</b>					
<p>Date &amp; Time: Wed Aug 12, 2020, 09:07:48 EDT  Position: +037.301184° / -080.500949° (+32.8m)  Altitude: 2130ft (+26.2m)  Datum: WGS-84  Azimuth/Bearing: 120° S40E 263mils True (+2.4)  Elevation Angle: -09.8  Horizon Angle: -00.0  Zoom: 1.0X  Sta#11228+00- Row and topsoil stock pile vegetation.</p>

<b>GPS Location</b>	See photo GPS	<b>GPS Location</b>	See photo GPS		
<b>Field Station#</b>	11228+00	<b>Field Station#</b>	11225+00		
<b>Pic 1 Desc.</b>	Row and topsoil stockpiles vegetation.	<b>Pic 2 Desc.</b>	Slope drain pipe, end treatment, rock channel.

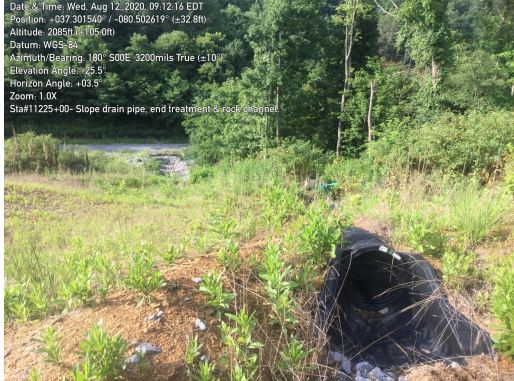
<p>Date &amp; Time: Wed Aug 12, 2020, 09:12:16 EDT  Position: +037.301540° / -080.502619° (+32.8m)  Altitude: 2085ft (+105.0m)  Datum: WGS-84  Azimuth/Bearing: 180° S00E 320mils True (+10)  Elevation Angle: -25.5  Horizon Angle: +03.5  Zoom: 1.0X  Sta#11225+00- Slope drain pipe, end treatment &amp; rock channel.</p>

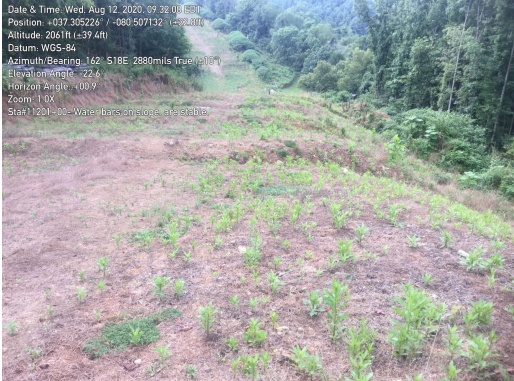
<p>Date &amp; Time: Wed Aug 12, 2020, 09:38:08 EDT  Position: +037.305224° / -080.507132° (+32.8m)  Altitude: 2061ft (+39.4ft)  Datum: WGS-84  Azimuth/Bearing: 162° S18E 288mils True (+10)  Elevation Angle: -22.4  Horizon Angle: -00.9  Zoom: 1.0X  Sta#11201+00- Water bars on slope, are stable.</p>

<b>GPS Location</b>	See photo GPS	<b>GPS Location</b>	See photo GPS		
<b>Field Station#</b>	11201+00	<b>Field Station#</b>	11191+00		
<b>Pic 3 Desc.</b>	Water bars on slope.	<b>Pic 4 Desc.</b>	Drainage feature and ECD's		
<p>Date &amp; Time: Wed Aug 12, 2020, 09:45:00 EDT  Position: +037.306414° / -080.507807° (+32.8m)  Altitude: 2030ft (+315.6ft)  Datum: WGS-84  Azimuth/Bearing: 224° S26W 4018mils Tr  Elevation Angle: -36.2  Horizon Angle: +13.2  Zoom: 1.0X  Sta#11191+00- Drainage feature &amp; ECD's  P1 stakes broken off</p>

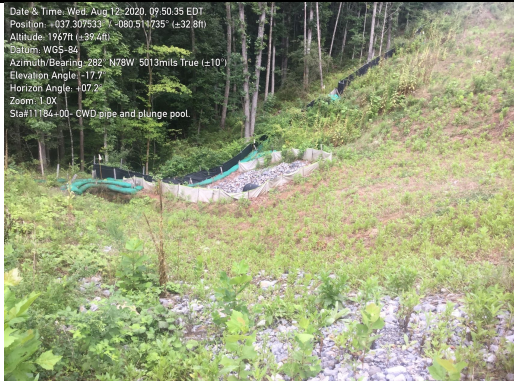
<p>Date &amp; Time: Wed Aug 12, 2020, 09:50:35 EDT  Position: +037.309533° / -080.511735° (+32.8m)  Altitude: 1967ft (+78.7ft)  Datum: WGS-84  Azimuth/Bearing: 282° N78W 5013mils True (+10)  Elevation Angle: -17.7  Horizon Angle: -07.2  Zoom: 1.0X  Sta#11184+00- CWD pipe and plunge pool.</p>

<b>GPS Location</b>	See photo GPS	<b>GPS Location</b>	See photo GPS		
<b>Field Station#</b>	11191+00	<b>Field Station#</b>	11184+00		
<b>Pic 5 Desc.</b>	Three P1 silt fence stakes broken off at drainage feature	<b>Pic 6 Desc.</b>	CWD pipe and plunge pool.

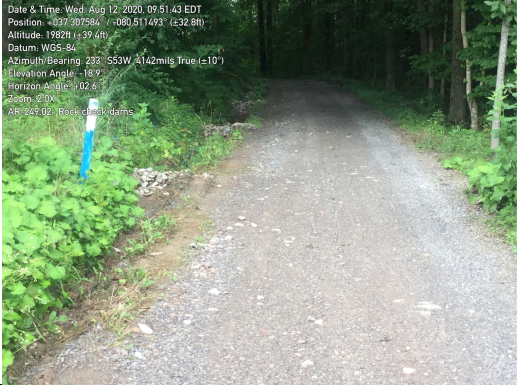
<b>GPS Location</b>	See photo GPS		<b>GPS Location</b>	See photo GPS	
<b>Field Station#</b>	11184+50		<b>Field Station#</b>	11989+00	
<b>Pic 7 Desc.</b>	AR-249.02 - Access road & rock check dams		<b>Pic 8 Desc.</b>	Catawba rain gauge reading- 0.00"	
Insert image here			Insert image here		
<b>GPS Location</b>			<b>GPS Location</b>		
<b>Field Station#</b>			<b>Field Station#</b>		
<b>Pic 9 Desc.</b>			<b>Pic 10 Desc.</b>		
Insert image here			Insert image here		
<b>GPS Location</b>			<b>GPS Location</b>		
<b>Field Station#</b>			<b>Field Station#</b>		
<b>Pic 11 Desc.</b>			<b>Pic 12 Desc.</b>

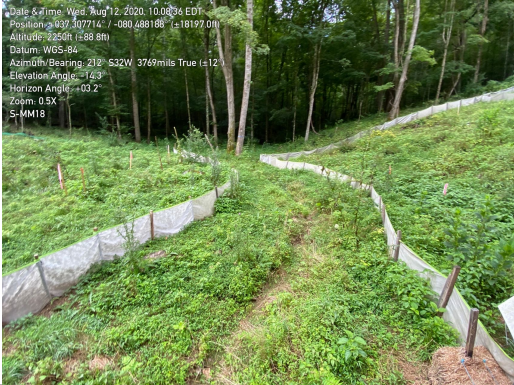
<b>GPS Location</b>	3	<b>GPS Location</b>	4		
<b>Field Station#</b>	11292+80	<b>Field Station#</b>	11327+85		
<b>Pic 3 Desc.</b>	S-MM18 and controls.		<b>Pic 4 Desc.</b>	S-NN12 and controls.

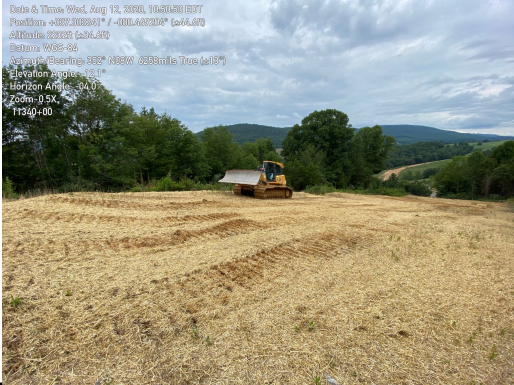
<b>GPS Location</b>	5	<b>GPS Location</b>	6		
<b>Field Station#</b>	11340+00	<b>Field Station#</b>	11352+97		
<b>Pic 5 Desc.</b>	Crimping in fresh mulch.		<b>Pic 6 Desc.</b>	S-NN11 and controls.

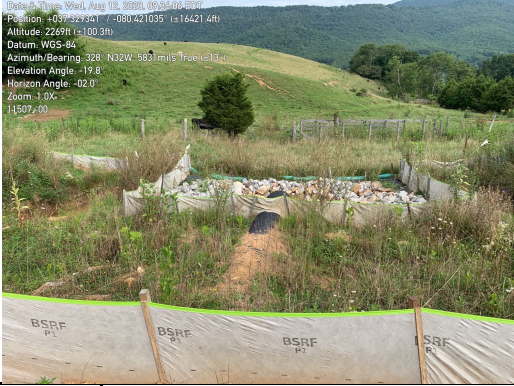
<p>Date &amp; Time: Wed, Aug 12, 2020, 09:45:40 EDT Position: +409.234887° / -80.631702° (+60.47) Altitude: 2169ft (+20.0ft) Datum: WGS-84 Azimuth/Bearing: 267° S67W 440mils True (+13°) Elevation Angle: -09.6° Horizon Angle: -01.2° Zoom: 1.0X 11489+00</p>			
<b>GPS Location</b>		See photo for GPS location.		<b>GPS Location</b>	
<b>Field Station#</b>		11507+00		<b>Field Station#</b>	
<b>Pic 1 Desc.</b>		Plunge pool in place.		<b>Pic 2 Desc.</b>

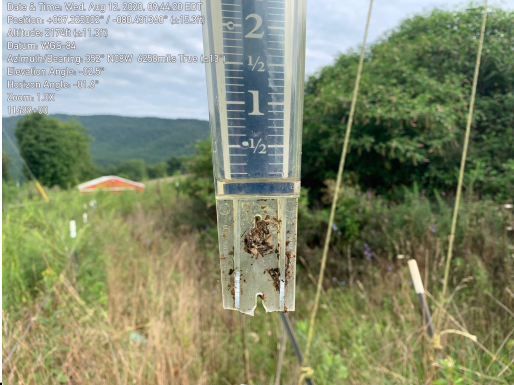
<b>GPS Location</b>		See photo for GPS location.		<b>GPS Location</b>	
<b>Field Station#</b>		11489+00		<b>Field Station#</b>	
<b>Pic 3 Desc.</b>		Rain gauge at Stevers Gap Road reads 0.1 inches.		<b>Pic 4 Desc.</b>

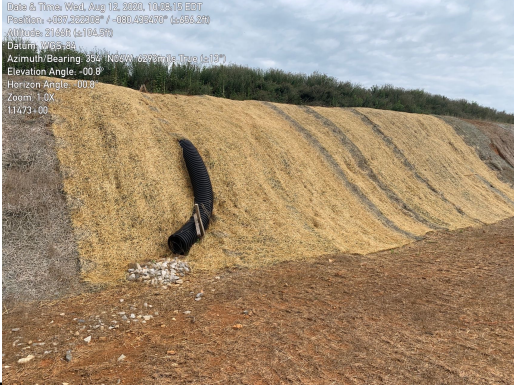
<p>Date &amp; Time: Wed, Aug 12, 2020, 11:48:40 EDT Position: +409.234887° / -80.631702° (+60.47) Altitude: 2070ft (+2.0ft) Datum: WGS-84 Azimuth/Bearing: 036° N36E 0440mils True (+13°) Elevation Angle: -05.3° Horizon Angle: -02.0° Zoom: 1.0X 11535+00</p>			
<b>GPS Location</b>		See photo for GPS location.		<b>GPS Location</b>	
<b>Field Station#</b>		11473+00		<b>Field Station#</b>	
<b>Pic 5 Desc.</b>		Two tone stabilized with ECB. Slope drains in place.		<b>Pic 6 Desc.</b>

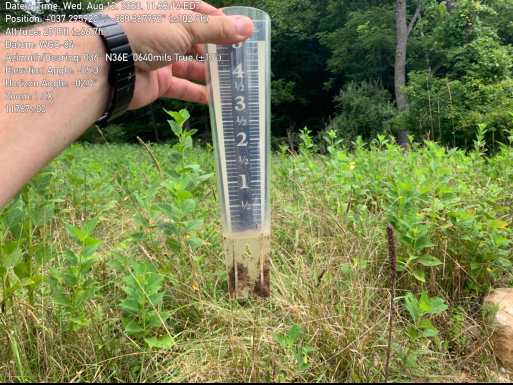
Rain gauge at Mount Tabor Road reads 0.0 inches.

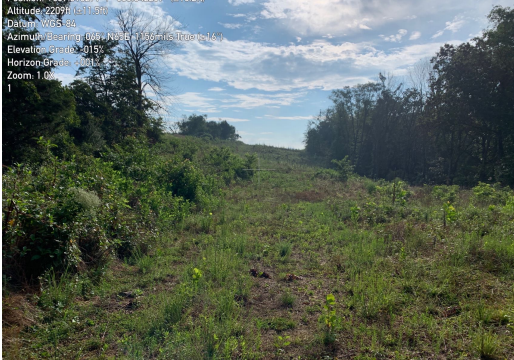
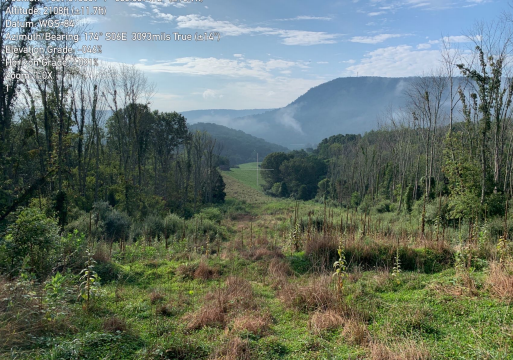
<b>GPS Location</b>	See picture above for GPS coordinates		<b>GPS Location</b>	See picture above for GPS coordinates	
<b>Field Station#</b>	11070+00		<b>Field Station#</b>	11090+00	
<b>Pic 1 Desc.</b>	ECD's and row conditions		<b>Pic 2 Desc.</b>	ECD's and row conditions	
<p><small>Date &amp; Time: Wed, Aug 12, 2020 09:07:46 EDT Position: +49.3451358° / +80.836618° (+10.2m) Altitude: 1829ft (+51.5m) Datum: WGS-84 Azimuth/Bearing: 124° 58'55.136"mile True (+14°) Elevation Grade: -014° Horizon Grade: +003° Zoom: 1.0X 1</small></p>

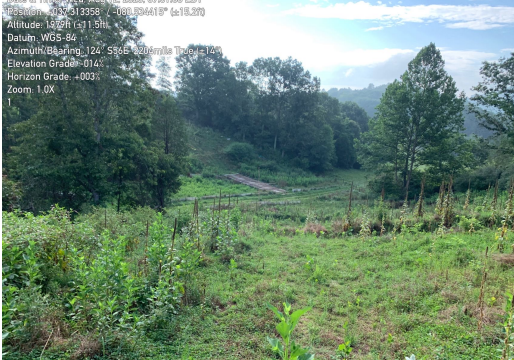
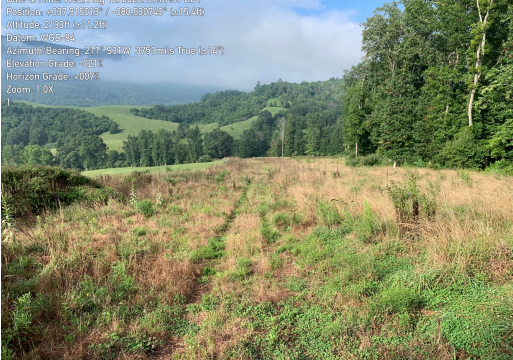
<b>GPS Location</b>	See picture above for GPS coordinates		<b>GPS Location</b>	See picture above for GPS coordinates	
<b>Field Station#</b>	11100+00		<b>Field Station#</b>	11110+00	
<b>Pic 3 Desc.</b>	ECD's and row conditions		<b>Pic 4 Desc.</b>	ECD's and row conditions	
<p><small>Date &amp; Time: Wed, Aug 12, 2020 09:14:47 EDT Position: +49.3451447° / +80.836618° (+10.2m) Altitude: 2340ft (+70.7m) Datum: WGS-84 Azimuth/Bearing: 104° 59'55.136"mile True (+14°) Elevation Grade: -001° Horizon Grade: -001° Zoom: 1.0X 1</small></p>

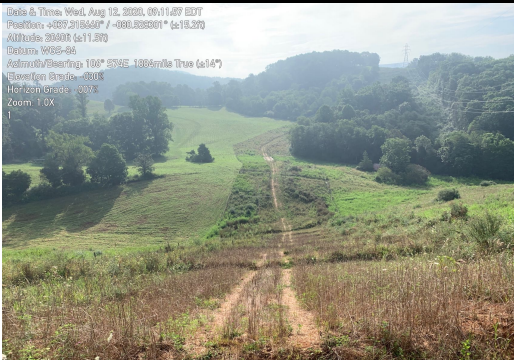
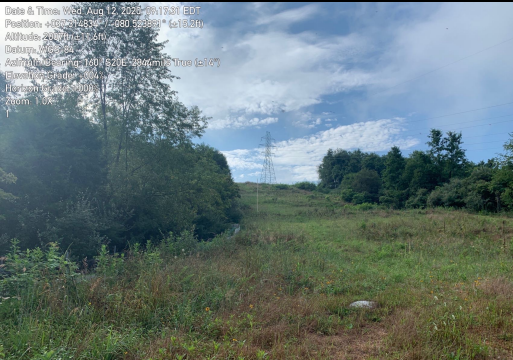
<b>Field Station#</b>	11120+00		<b>Field Station#</b>	11140+00	
<b>Pic 5 Desc.</b>	ECD's and row conditions		<b>Pic 6 Desc.</b>	ECD's and row conditions

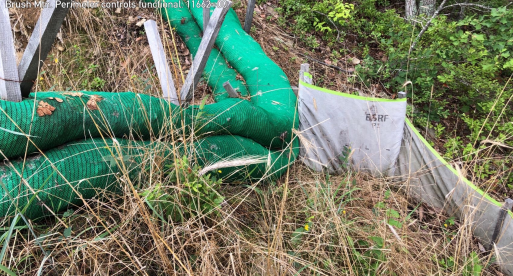
<p>Date &amp; Time: Thu, Aug 13, 2020, 09:30:43 EDT  Position: +482.29599° / -880.39599° (+14.47)  Altitude: 2220 (+19.37)  Datum: WGS-84  Azimuth/Bearing: 179° 501E 3162mils Magnetic (+15°)  Elevation Angle: 23.6°  Horizon Angle: -08.4°  Zoom: 1.0x  Brush Min. Slope breakers functional, 11662+00</p>

<b>GPS Location</b>	On photo	<b>GPS Location</b>	On photo		
<b>Field Station#</b>	11667+00	<b>Field Station#</b>	11662+00		
<b>Pic 1 Desc.</b>	Slope breakers functional. ROW stable.	<b>Pic 2 Desc.</b>	Perimeter controls in place and functioning.

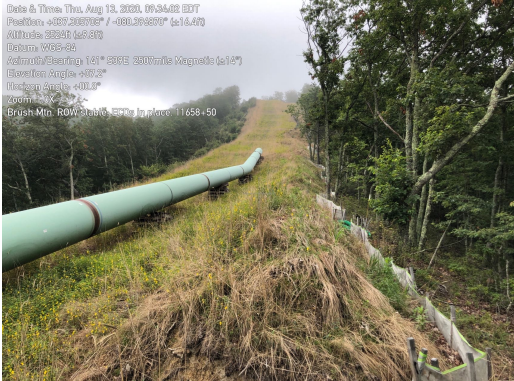
<p>Date &amp; Time: Thu, Aug 13, 2020, 09:34:05 EDT  Position: +482.29599° / -880.39599° (+14.47)  Altitude: 2241 (+19.87)  Datum: WGS-84  Azimuth/Bearing: 141° 5825' 3300mils Magnetic (+12°)  Elevation Angle: -07.2°  Horizon Angle: -00.8°  Zoom: 1.0x  Brush Min. ROW stable. Signs in place, 11658+50</p>

<b>GPS Location</b>	On photo	<b>GPS Location</b>	On photo		
<b>Field Station#</b>	11658+50	<b>Field Station#</b>	11644+00		
<b>Pic 3 Desc.</b>	ROW stable. Perimeter controls in place.	<b>Pic 4 Desc.</b>	ROW stable. Perimeter controls in place.		
<p>Date &amp; Time: Thu, Aug 13, 2020, 10:06:34 EDT  Position: +491.43244° / -880.399107° (+16.48)  Altitude: 1945ft (+26.2ft)  Datum: WGS-84  Azimuth/Bearing: 048° N45E 0853mils Magnetic (+13°)  Elevation Angle: -07.3°  Horizon Angle: +00.1°  Zoom: 1.0x  S-HH18 crossing stable, 11626+04</p>

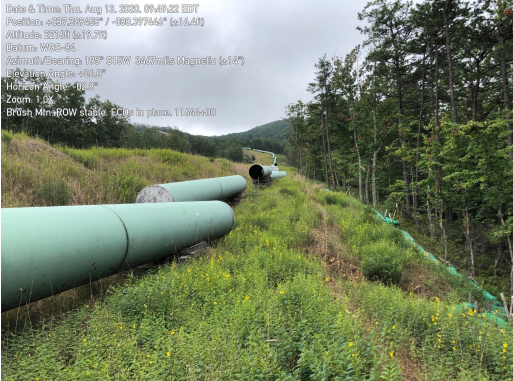
<p>Date &amp; Time: Thu, Aug 13, 2020, 09:45:05 EDT  Position: +482.29599° / -880.39599° (+14.47)  Altitude: 2240 (+19.87)  Datum: WGS-84  Azimuth/Bearing: 139° 581W 3460mils Magnetic (+12°)  Elevation Angle: -04.0°  Horizon Angle: -00.8°  Zoom: 1.0x  Brush Min. ROW stable. Signs in place, 11644+00</p>

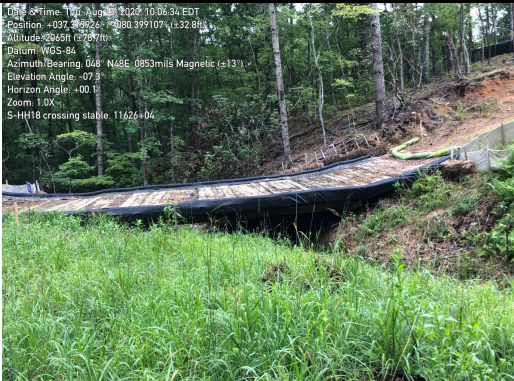
<b>GPS Location</b>	On photo	<b>GPS Location</b>	On photo		
<b>Field Station#</b>	11626+04	<b>Field Station#</b>	11614+20		
<b>Pic 5 Desc.</b>	The S-HH18 crossing.	<b>Pic 6 Desc.</b>	The S-RR14 crossing is stable

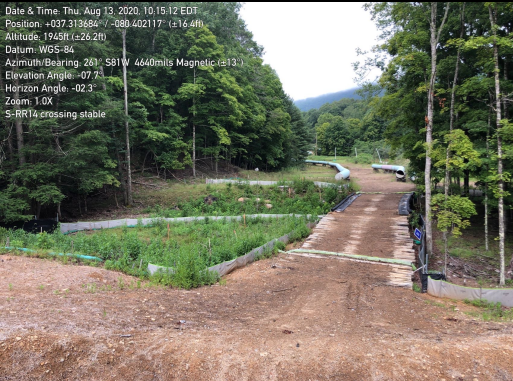
<p>Date &amp; Time: Thu, Aug 13, 2020, 10:15:12 EDT  Position: +491.43244° / -880.402117° (+16.48)  Altitude: 1945ft (+26.2ft)  Datum: WGS-84  Azimuth/Bearing: 261° S81W 4640mils Magnetic (+13°)  Elevation Angle: -07.3°  Horizon Angle: -02.3°  Zoom: 1.0x  S-RR14 crossing stable</p>

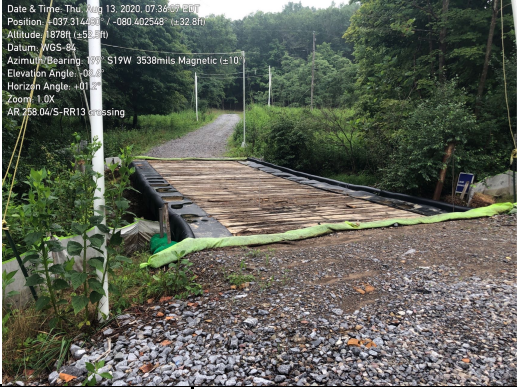
<p><small>Date &amp; Time: Thu Aug 13, 2020 07:36:33PT Position: +037.31421° / -090.402548° (±32.8ft) Altitude: 1878ft (±5.1ft) Datum: WGS-84 Azimuth/Bearing: 104° S19W 3538mils Magnetic (±10°) Elevation Angle: -00.3° Horizontal Angle: +01.3° Zoom: 1.0X AR 258.04/S-RR13 crossing</small></p>

<p><small>Date &amp; Time: Thu Aug 13, 2020 10:33:34 EDT Position: +037.313592° / -090.404448° (±16.4ft) Altitude: 1908ft (±5.3ft) Datum: WGS-84 Azimuth/Bearing: 104° S19W 1040mils Magnetic (±13°) Elevation Angle: -00.3° Horizontal Angle: +00.5° Zoom: 1.0X S-006 crossing stable</small></p>			
<b>GPS Location</b>	On photo	<b>GPS Location</b>	On photo		
<b>Field Station#</b>	11613+69	<b>Field Station#</b>	11608+17		
<b>Pic 7 Desc.</b>	AR MN-258.04 and equipment bridge at S-RR13 in good condition.	<b>Pic 8 Desc.</b>	The S-006 crossing is stable.

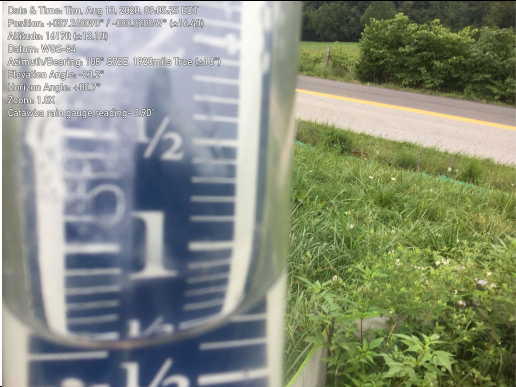
<b>AFE</b>	124300137	<b>Date/Time</b>	8/13/2020 2:10 PM	<b>Report #</b>	
<b>Pictures</b>					
<p>Date &amp; Time: Thu, Aug 13, 2020, 09:45:55 EDT  Position: +409.233797° / -080.333688° (±16.4m)  Altitude: 1419ft (±16.4m)  Datum: WGS-84  Azimuth/Bearing: 185° S85E 185°mils True (±10°)  Elevation Angle: -33.3°  Horizon Angle: +01.3°  Zoom: 1.0x  Catawba rain gauge reading: 0.90"</p>

<b>GPS Location</b>	See photo GPS	<b>GPS Location</b>	See photo GPS		
<b>Field Station#</b>	11989+00	<b>Field Station#</b>	11901+00		
<b>Pic 1 Desc.</b>	Catawba rain gauge reading- 0.90"	<b>Pic 2 Desc.</b>	AR-266.03- Access road and CFS check dams

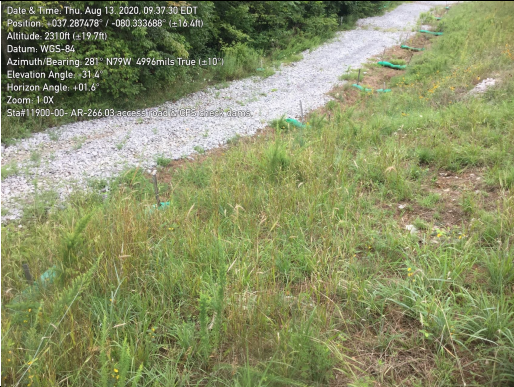
<p>Date &amp; Time: Thu, Aug 13, 2020, 09:37:30 EDT  Position: +407.269797° / -080.333688° (±16.4m)  Altitude: 2310ft (±16.9m)  Datum: WGS-84  Azimuth/Bearing: 281° N79W 499°mils True (±10°)  Elevation Angle: -31.4°  Horizon Angle: +01.8°  Zoom: 1.0x  Sta#11900+00- AR-266.03 access road and CFS check dams</p>

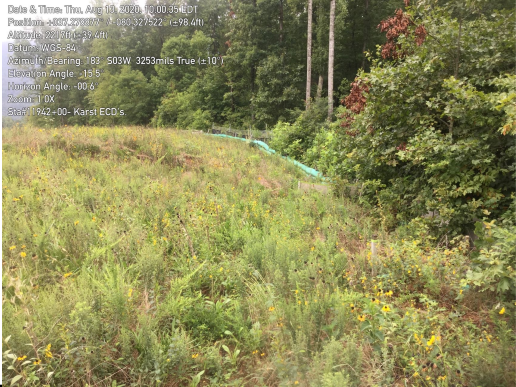
<p>Date &amp; Time: Thu, Aug 13, 2020, 10:00:00 EDT  Position: +409.277121° / -080.327524° (±19.4m)  Altitude: 2148ft (±21.0m)  Datum: WGS-84  Azimuth/Bearing: 183° S83W 325°mils True (±10°)  Elevation Angle: -13.5°  Horizon Angle: -00.6°  Zoom: 1.0x  Sta#11942+00- Karst ECD's</p>

<b>GPS Location</b>	See photo GPS	<b>GPS Location</b>	See photo GPS		
<b>Field Station#</b>	11942+00	<b>Field Station#</b>	11949+00		
<b>Pic 3 Desc.</b>	Karst ECD's and row vegetation	<b>Pic 4 Desc.</b>	Row vegetation, level spreaders, perimeter controls.		
<p>Date &amp; Time: Thu, Aug 13, 2020, 10:27:07 EDT  Position: +413.269711° / -080.322703° (±32.8m)  Altitude: 1781ft (±32.8m)  Datum: WGS-84  Azimuth/Bearing: 344° N14W 615°mils True (±25°)  Elevation Angle: -19.2°  Horizon Angle: -07.9°  Zoom: 1.0x  Sta#11978+00- Karst ECD's</p>

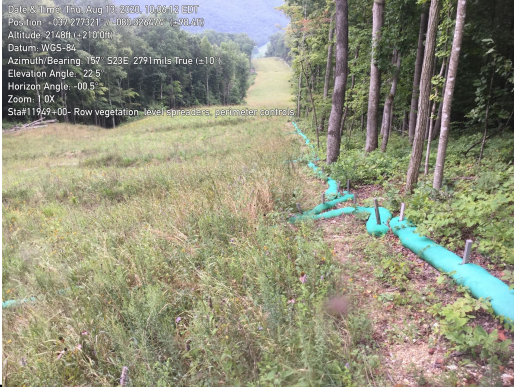
<p>Date &amp; Time: Thu, Aug 13, 2020, 10:04:00 EDT  Position: +407.9277121° / -080.327524° (±19.4m)  Altitude: 2148ft (±21.0m)  Datum: WGS-84  Azimuth/Bearing: 185° S85E 279°mils True (±10°)  Elevation Angle: -22.5°  Horizon Angle: -00.5°  Zoom: 1.0x  Sta#11949+00- Row vegetation, level spreaders, perimeter controls</p>

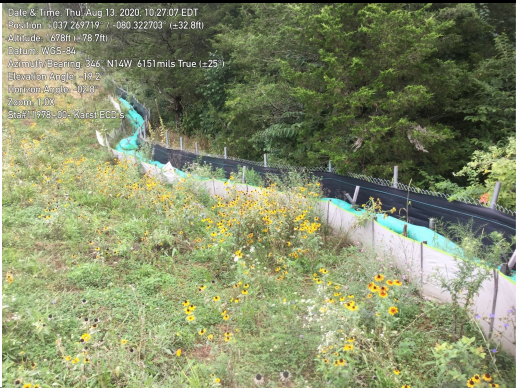
<b>GPS Location</b>	See photo GPS	<b>GPS Location</b>	See photo GPS		
<b>Field Station#</b>	11978+00	<b>Field Station#</b>	12001+00		
<b>Pic 5 Desc.</b>	Karst ECD's	<b>Pic 6 Desc.</b>	Wetland and cattle crossing.

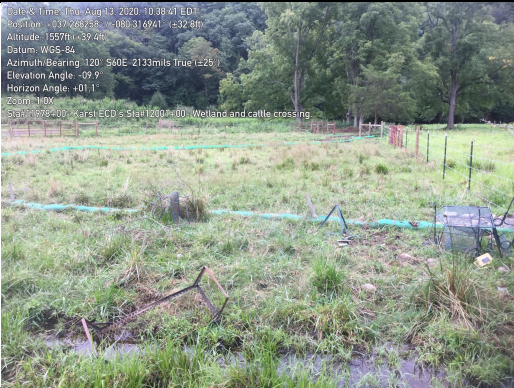
<p>Date &amp; Time: Thu, Aug 13, 2020, 10:38:41 EDT  Position: +413.269711° / -080.316941° (±32.8m)  Altitude: 1557ft (±32.8m)  Datum: WGS-84  Azimuth/Bearing: 120° S40E 213°mils True (±25°)  Elevation Angle: -09.9°  Horizon Angle: +01.1°  Zoom: 1.0x  Sta#11200+00- Karst ECD's Sta#12001+00- Wetland and cattle crossing</p>

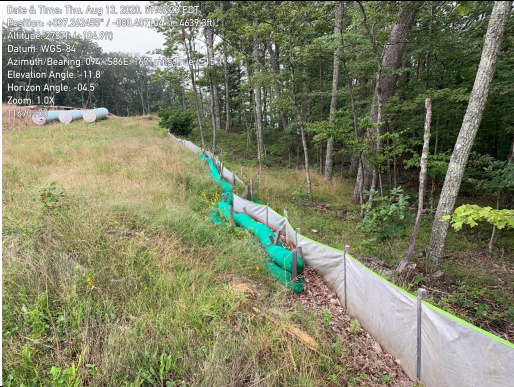
<b>GPS Location</b>	See photo for GPS location.		<b>GPS Location</b>	See photo for GPS location.	
<b>Field Station#</b>	11670+00		<b>Field Station#</b>	11730+00	
<b>Pic 1 Desc.</b>	Triple stack compost filter sock and priority one silt fence in place along LOD.		<b>Pic 2 Desc.</b>	ROW stabilized with seed and mulch.

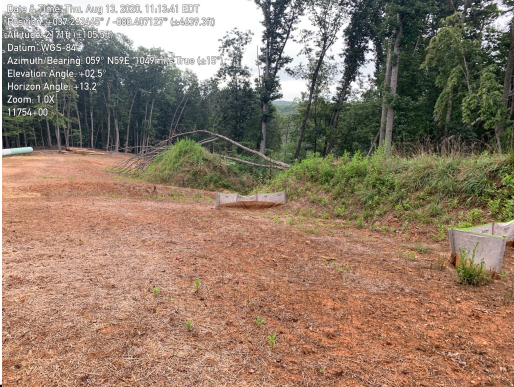
<b>GPS Location</b>	See photo for GPS location.		<b>GPS Location</b>	See photo for GPS location.	
<b>Field Station#</b>	11754+00		<b>Field Station#</b>	11767+00	
<b>Pic 3 Desc.</b>	Priority one silt fence checks in place.		<b>Pic 4 Desc.</b>	RCE in place at Mount Tabor Road.

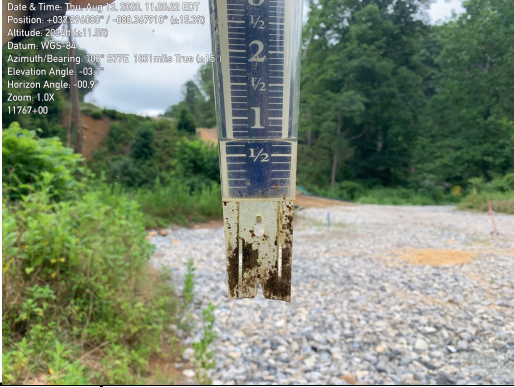
<b>GPS Location</b>	See photo for GPS location.		<b>GPS Location</b>	See photo for GPS location.	
<b>Field Station#</b>	11767+00		<b>Field Station#</b>	11778+00	
<b>Pic 5 Desc.</b>	Rain gauge at Mount Tabor Road reads 0.7 inches.		<b>Pic 6 Desc.</b>	Clean water diversion pipe inlet and clean water diversion berm in place.

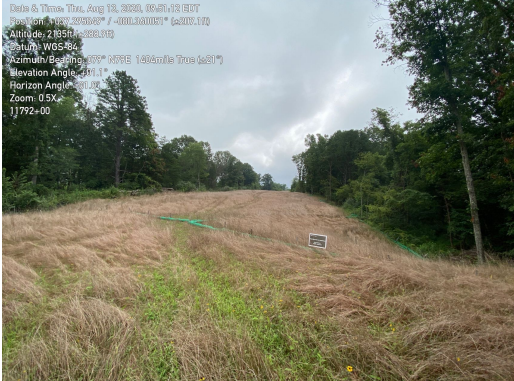
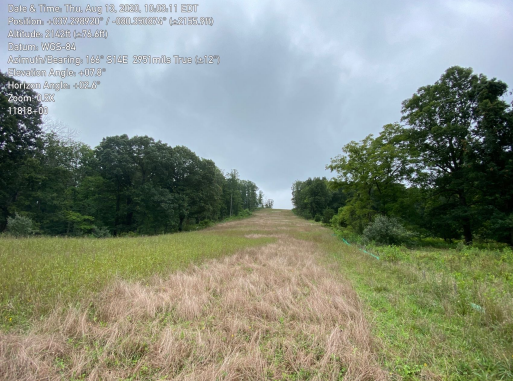
<b>GPS Location</b>	1	<b>GPS Location</b>	2		
<b>Field Station#</b>	11792+00	<b>Field Station#</b>	11818+00		
<b>Pic 1 Desc.</b>	Section of restored RoW showing conditions and controls.		<b>Pic 2 Desc.</b>	Section of restored RoW showing conditions and controls.

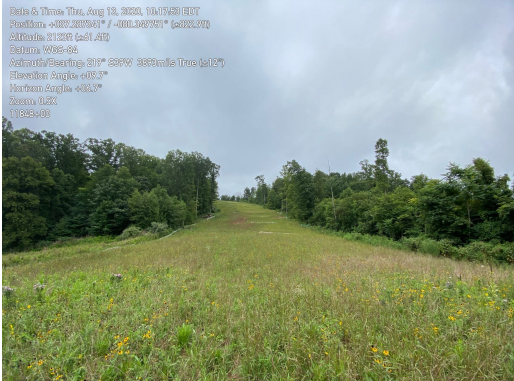
<b>GPS Location</b>	3	<b>GPS Location</b>	4		
<b>Field Station#</b>	11848+00	<b>Field Station#</b>	11863+65		
<b>Pic 3 Desc.</b>	Section of restored RoW showing conditions and controls.		<b>Pic 4 Desc.</b>	P-KL2 and conditions.

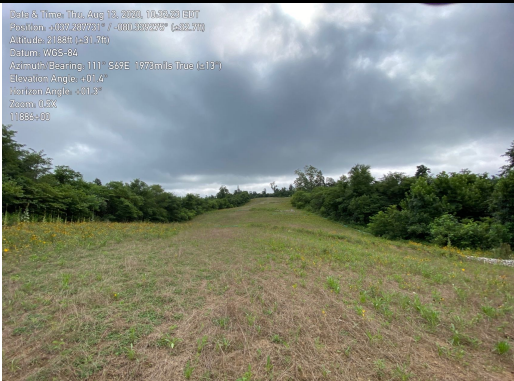
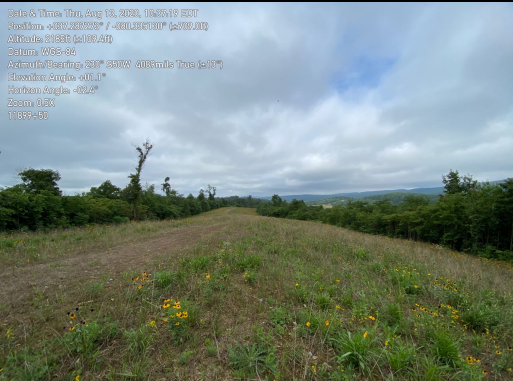
<b>GPS Location</b>	5	<b>GPS Location</b>	6		
<b>Field Station#</b>	11886+00	<b>Field Station#</b>	11899+50		
<b>Pic 5 Desc.</b>	Section of restored RoW showing conditions and controls.		<b>Pic 6 Desc.</b>	Section of restored RoW showing conditions and controls.

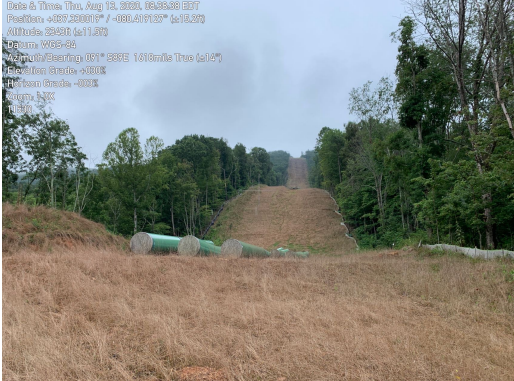
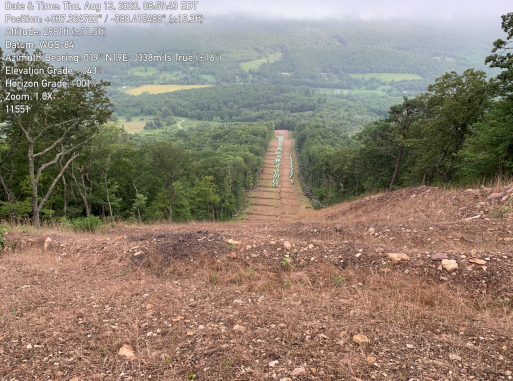
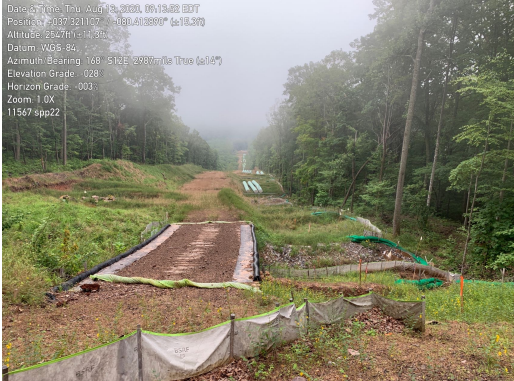
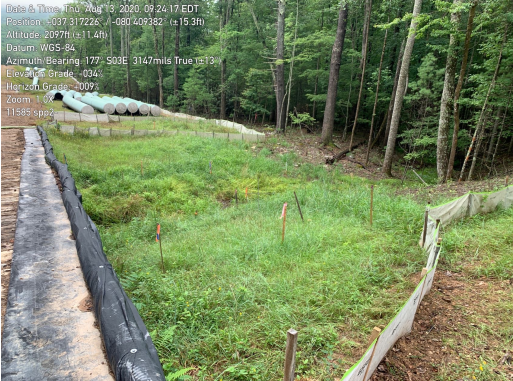
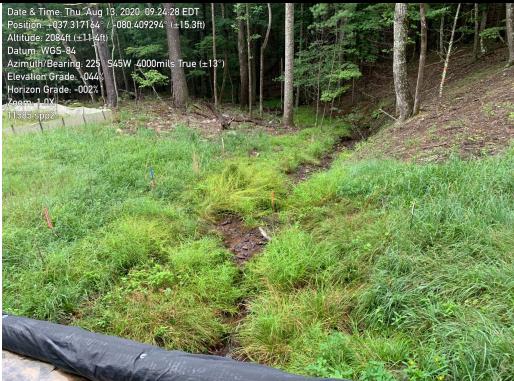
<b>GPS Location</b>	See picture above for GPS coordinates		<b>GPS Location</b>	See picture above for GPS coordinates	
<b>Field Station#</b>	11530+00		<b>Field Station#</b>	11551+00	
<b>Pic 1 Desc.</b>	ECD's and row conditions		<b>Pic 2 Desc.</b>	ECD's and row conditions

<b>GPS Location</b>	See picture above for GPS coordinates		<b>GPS Location</b>	See picture above for GPS coordinates	
<b>Field Station#</b>	11567+00		<b>Field Station#</b>	11585+00	
<b>Pic 3 Desc.</b>	ECD's and row conditions		<b>Pic 4 Desc.</b>	ECD's and row conditions

<b>GPS Location</b>	See picture above for GPS coordinates		<b>GPS Location</b>	See picture above for GPS coordinates	
<b>Field Station#</b>	11585+00		<b>Field Station#</b>	+1	
<b>Pic 5 Desc.</b>	ECD's and row conditions		<b>Pic 6 Desc.</b>	No rain recorded

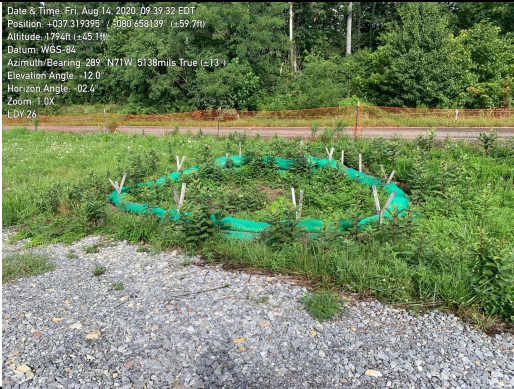
<b>GPS Location</b>	See photo for GPS location.		<b>GPS Location</b>	See photo for GPS location.	
<b>Field Station#</b>	12005+00		<b>Field Station#</b>	12005+00	
<b>Pic 3 Desc.</b>	Triple stack CFS around drainage feature.		<b>Pic 4 Desc.</b>	RCE in place at Lay Down Yard 26 entrance.

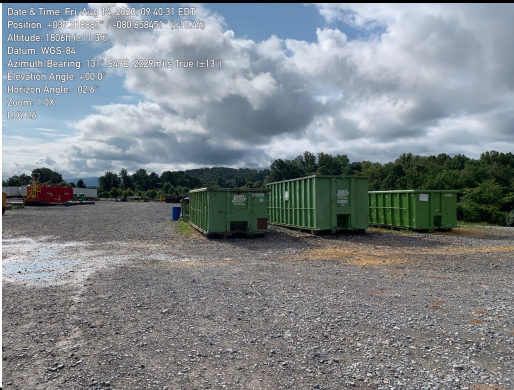
<b>GPS Location</b>	See photo for GPS location.		<b>GPS Location</b>	See photo for GPS location.	
<b>Field Station#</b>	12005+00		<b>Field Station#</b>	12005+00	
<b>Pic 5 Desc.</b>	Dumpsters being utilized for trash management.		<b>Pic 6 Desc.</b>	Secondary containment in place under fuel cell.

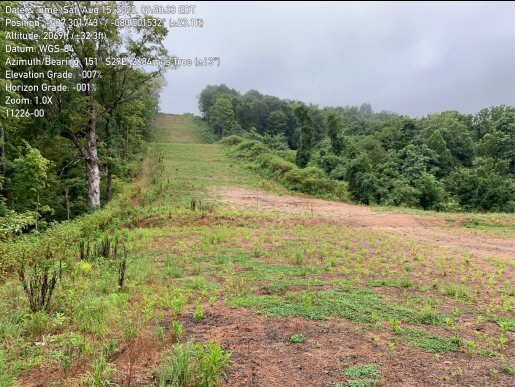
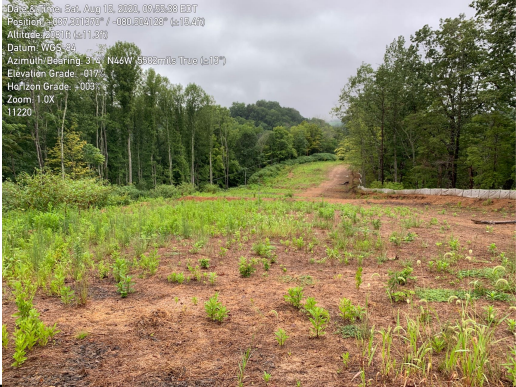
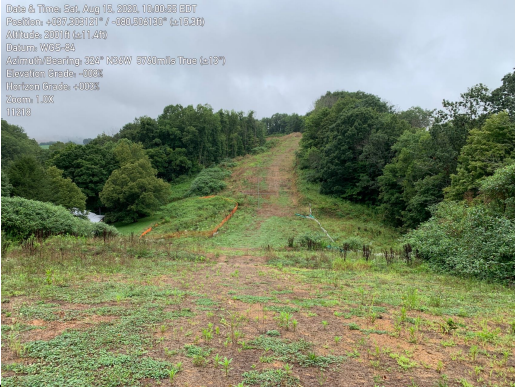
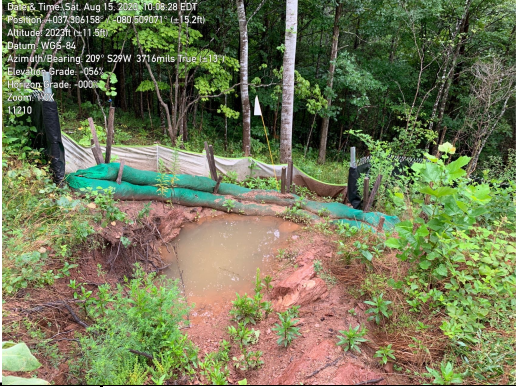
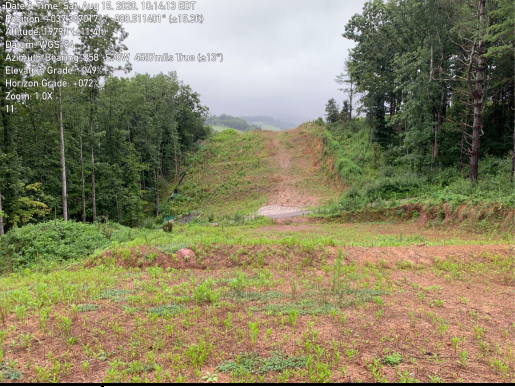
<b>GPS Location</b>	See picture above for GPS coordinates		<b>GPS Location</b>	See picture above for GPS coordinates	
<b>Field Station#</b>	+1		<b>Field Station#</b>	11226+00	
<b>Pic 1 Desc.</b>	.4" of rain recorded		<b>Pic 2 Desc.</b>	ECD's and row conditions

<b>GPS Location</b>	See picture above for GPS coordinates		<b>GPS Location</b>	See picture above for GPS coordinates	
<b>Field Station#</b>	11220+00		<b>Field Station#</b>	11218+00	
<b>Pic 3 Desc.</b>	ECD's and row conditions		<b>Pic 4 Desc.</b>	ECD's and row conditions

<b>GPS Location</b>	See picture above for GPS coordinates		<b>GPS Location</b>	See picture above for GPS coordinates	
<b>Field Station#</b>	11210+00		<b>Field Station#</b>	112209+00	
<b>Pic 5 Desc.</b>	ECD's and row conditions		<b>Pic 6 Desc.</b>	ECD's and row conditions

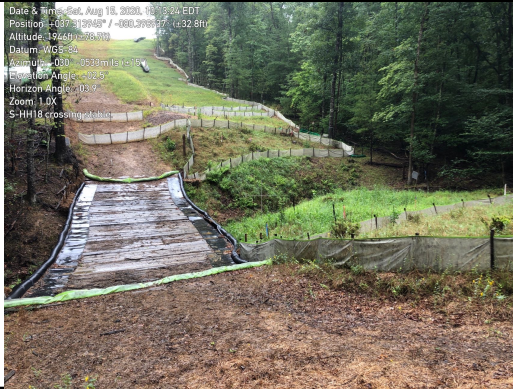
<p>Date &amp; Time Sat, Aug 15, 2020, 10:12:24 EDT Position: +037°31'39.48" / -080°39'59.77" (±16.4m) Altitude: 1944m (±26.8m) Datum: WGS-84 Azimuth: +008° - 033°mils (±13°) Elevation Angle: +04.9° Horizon Angle: -03.9° Zoom: 1.0X S-HH18 crossing stable.</p>

<b>GPS Location</b>	On photo	<b>GPS Location</b>	On photo
<b>Field Station#</b>	11614+20	<b>Field Station#</b>	11626+04
<b>Pic 3 Desc.</b>	S-RR14 crossing stable. ECDs in place and functional.	<b>Pic 4 Desc.</b>	S-HH18 crossing stable with ECDs in place and functional.

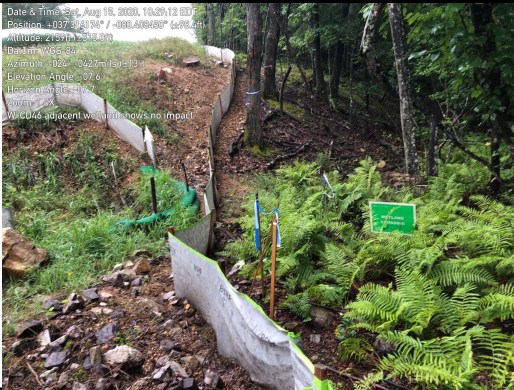
<p>Date &amp; Time Sat, Aug 15, 2020, 10:25:12 EDT Position: +037°31'47.47" / -080°40'56.67" (±16.4m) Altitude: 1912m (±26.8m) Datum: WGS-84 Azimuth: 102° - 022°mils (±13°) Elevation Angle: +07.6° Horizon Angle: -06.3° Zoom: 1.0X W-CD46 adjacent wetland shows no impact.</p>

<b>Pic 5 Desc.</b>	Adjacent wetland W-CD46 shows no impact.	<b>Pic 6 Desc.</b>	S-PP20 crossing stable with ECDs in place and functional.

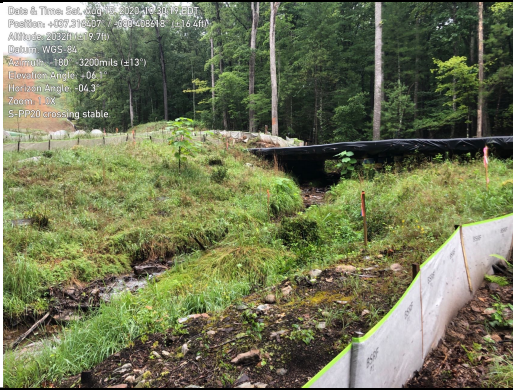
<p>Date &amp; Time Sat, Aug 15, 2020, 10:31:17 EDT Position: +037°31'43.51" / -080°40'56.16" (±16.4m) Altitude: 1937m (±26.8m) Datum: WGS-84 Azimuth: +160° - 320°mils (±13°) Elevation Angle: +06.1° Horizon Angle: -06.3° Zoom: 1.0X S-PP20 crossing stable.</p>	
<b>GPS Location</b>	On photo	<b>GPS Location</b>	On photo
<b>Field Station#</b>	11589+75	<b>Field Station#</b>	11588+41

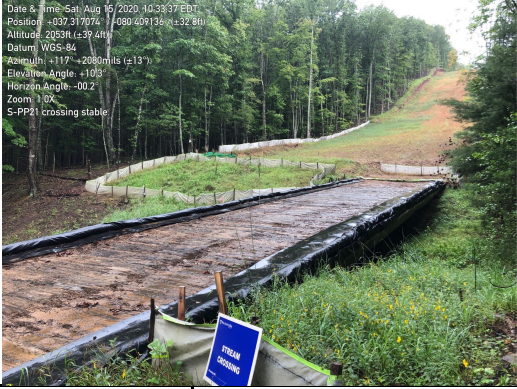
Insert image here			
<b>GPS Location</b>	On photo	<b>GPS Location</b>			
<b>Field Station#</b>	11585+48	<b>Field Station#</b>			
<b>Pic 7 Desc.</b>	S-PP21 crossing stable with effective controls in place.	<b>Pic 8 Desc.</b>			
Insert image here		Insert image here			
<b>GPS Location</b>		<b>GPS Location</b>			
<b>Field Station#</b>		<b>Field Station#</b>			
<b>Pic 9 Desc.</b>		<b>Pic 10 Desc.</b>			
Insert image here		Insert image here			
<b>GPS Location</b>		<b>GPS Location</b>			
<b>Field Station#</b>		<b>Field Station#</b>			
<b>Pic 11 Desc.</b>		<b>Pic 12 Desc.</b>
