Visual Site Inspection Report

Project Name	H-600 Pipeline Spread G	AFE	124300137	Spread	H-600 Pipeline Spread G
Contractor	Precision			Report #	13658
Inspector	Len Kruizenga			Date/Time	8/17/2020 8:36 AM
Permit #	TBD	Inspection Type	VA SWPP	Station Begin	11023+88
State	VA	Inspection Area	Full	Station End	10930+00
County	Giles	Ground	Muddy	Temperature (°F)	81.00
Municipality	N/A	Weather	Light Rain	Rain Gauge (in)	1.20
				Rain Accumulation Time (days)	2.00

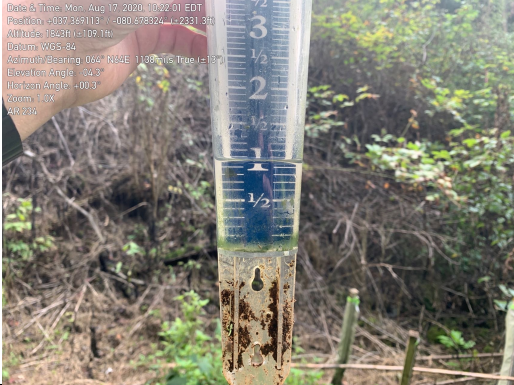
<p>Date & Time: Mon Aug 17 2020 10:31:12 EDT Position: +037 352431 / -080 647316 (+1326.31) Altitude: 1910ft (+882.6ft) Datum: WGS 84 Azimuth/Bearing: 133° S47E 2344mils True (+10°) Elevation Angle: +03.9° Horizon Angle: +02.0° Zoom: 1.0X AR 241.04</p>		GPS Location	See photo for GPS location.
Field Station#	12005+00	Field Station#	10710+00	GPS Location	See photo for GPS location.
Pic 1 Desc.	Rain gauge at AR 234 reads 1.1 inches.	Pic 2 Desc.	CFS along access road 241.04.	GPS Location	See photo for GPS location.

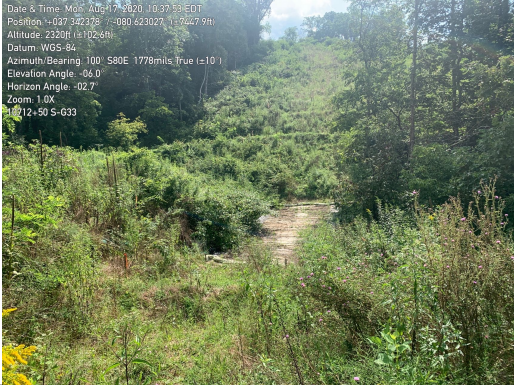
Field Station#	10712+50	Field Station#	10710+00	GPS Location	See photo for GPS location.
Pic 3 Desc.	Sensitive resource buffer in place at stream.	Pic 4 Desc.	ROW stabilized with natural vegetation.	GPS Location	See photo for GPS location.

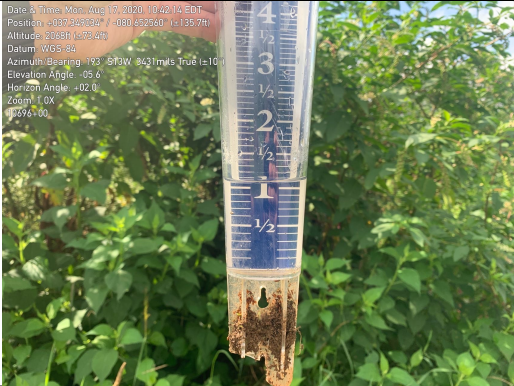
<p>Date & Time: Mon Aug 17 2020 10:42:14 EDT Position: +037 347436 / -080 652577 (+135.6ft) Altitude: 2068ft (+629.4ft) Datum: WGS 84 Azimuth/Bearing: 133° S47E 2344mils True (+10°) Elevation Angle: -10.4° Horizon Angle: -05.0° Zoom: 1.0X 10696+00</p>		GPS Location	See photo for GPS location.
Field Station#	10696+00	Field Station#	10696+00	GPS Location	See photo for GPS location.
Pic 5 Desc.	Rain gauge at Buffalo Anklets Road reads 1.0 inches.	Pic 6 Desc.	RCE in place at Buffalo Anklets Road.	GPS Location	See photo for GPS location.

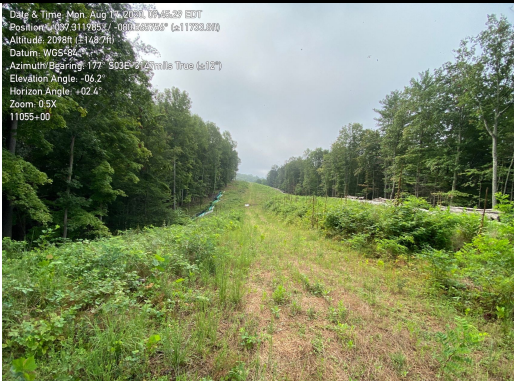
GPS Location	5	GPS Location	6		
Field Station#	11055+00	Field Station#	11064+50		
Pic 5 Desc.	Section of RoW showing conditions and controls.	Pic 6 Desc.	Section of RoW showing conditions and controls.

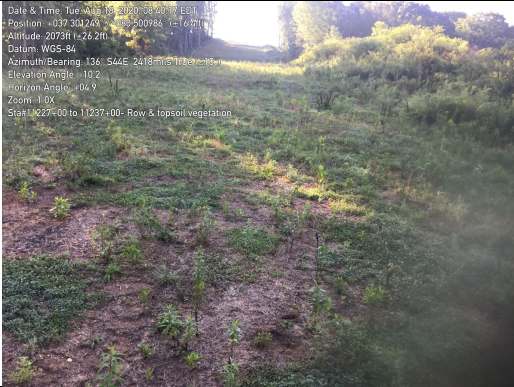
<p>Date & Time: Tue, Aug 18, 2020, 08:40:17 EDT Position: +037.304241° / -080.90788° (-56m) Altitude: 2073ft (-262m) Datum: WGS-84 Azimuth/Bearing: 134.544E-2418m(-11.6m) Elevation Angle: -10.2° Horizon Angle: -04.9° Zoom: 1.0x Sta#11227+00 to 11227+00- Row & topsoil vegetation.</p>

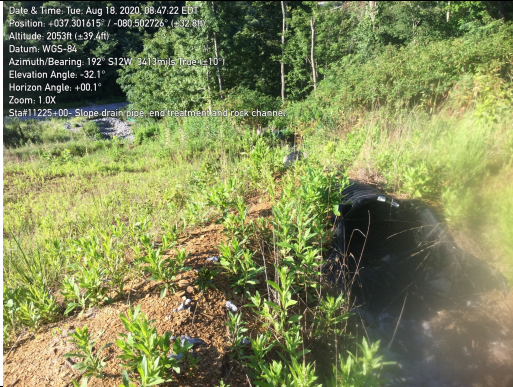
<p>Date & Time: Tue, Aug 18, 2020, 08:47:22 EDT Position: +037.301415° / -080.902728° (-52m) Altitude: 2053ft (-294m) Datum: WGS-84 Azimuth/Bearing: 192° S12W-3413m(-10.1) Elevation Angle: -32.1° Horizon Angle: +00.1° Zoom: 1.0x Sta#11225+00- Slope drain, pipe, end treatment, rock channel.</p>		GPS Location	See photo GPS
Field Station#	11227+00	Field Station#	11225+00	GPS Location	See photo GPS
Pic 1 Desc.	Row and topsoil stockpile vegetation.	Pic 2 Desc.	Slope drain, sump, end treatment, rock channel.	GPS Location	See photo GPS

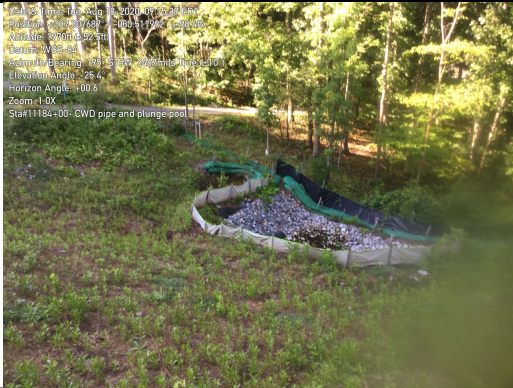
<p>Date & Time: Tue, Aug 18, 2020, 09:15:41 EDT Position: +037.301648° / -080.892222° (-51m) Altitude: 2011ft (-32m) Datum: WGS-84 Azimuth/Bearing: 103° S05E-234m(-11.6m) Elevation Angle: -17.1° Horizon Angle: -01.9° Zoom: 1.0x Sta#11184+00- CWD pipe and plunge pool.</p>		GPS Location	See photo GPS
Field Station#	11190+00	Field Station#	11185+00	GPS Location	See photo GPS
Pic 5 Desc.	Row on slope coming into a drainage feature.	Pic 6 Desc.	CWD pipe and plunge pool.	GPS Location	See photo GPS

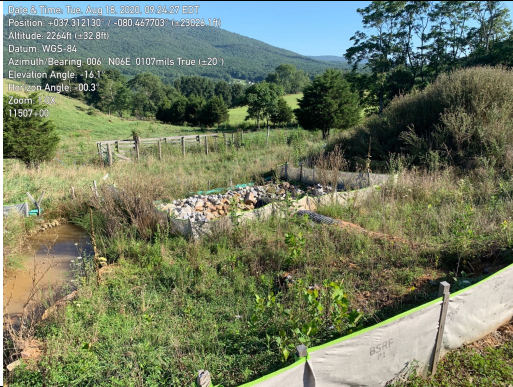
GPS Location		See photo for GPS location.						GPS Location		See photo for GPS location.	
Field Station#		11507+00						Field Station#		11491+00	
Pic 1 Desc.		Plunge pool and clean water diversion pipe in place.						Pic 2 Desc.		Waterbar throat channeling. Item added to the punchlist.

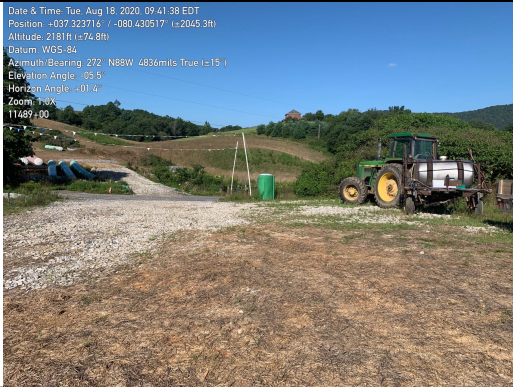
GPS Location		See photo for GPS location.						GPS Location		See photo for GPS location.	
Field Station#		11489+00						Field Station#		11487+00	
Pic 3 Desc.		RCE in place at Stevers Gap Road.						Pic 4 Desc.		Rock lined channel in place.

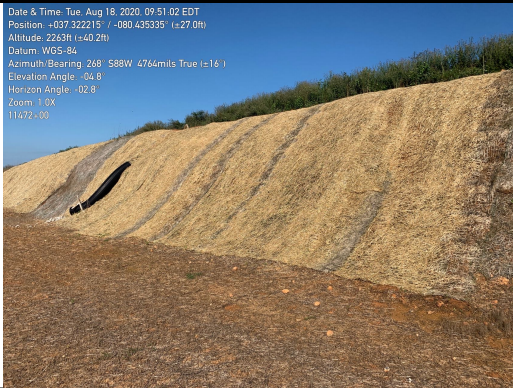
GPS Location		See photo for GPS location.						GPS Location		See photo for GPS location.	
Field Station#		11772+00						Field Station#		11393+00	
Pic 5 Desc.		ECB and slope drain in place over two-tone.						Pic 6 Desc.		Priority one silt fence stakes broken at end treatment.

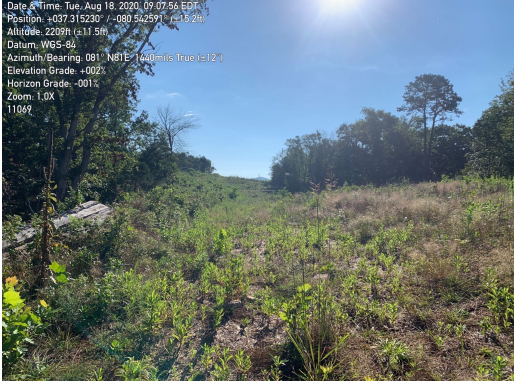
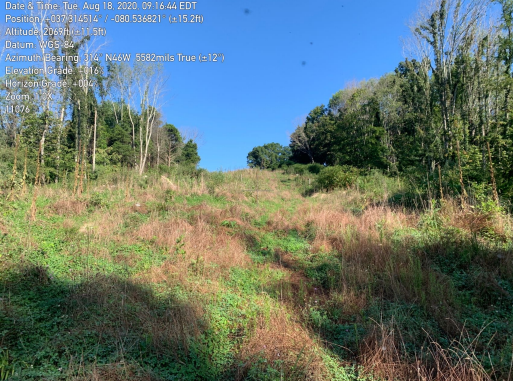
GPS Location	See picture above for GPS coordinates		GPS Location	See picture above for GPS coordinates	
Field Station#	11069+00		Field Station#	11076+00	
Pic 1 Desc.	ECD's and row conditions		Pic 2 Desc.	ECD's and row conditions

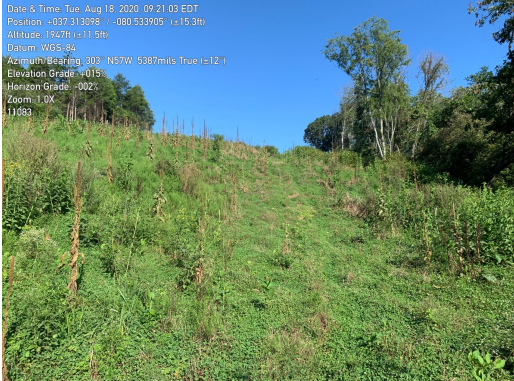
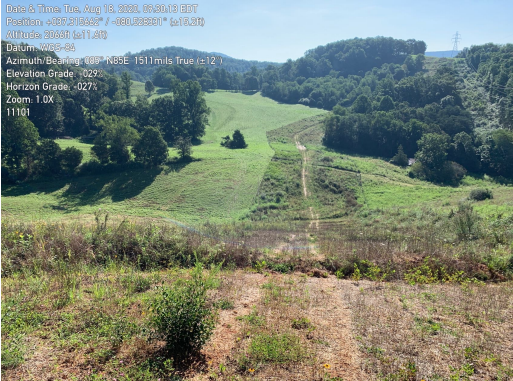
GPS Location	See picture above for GPS coordinates		GPS Location	See picture above for GPS coordinates	
Field Station#	11083+00		Field Station#	11101+00	
Pic 3 Desc.	ECD's and row conditions		Pic 4 Desc.	ECD's and row conditions

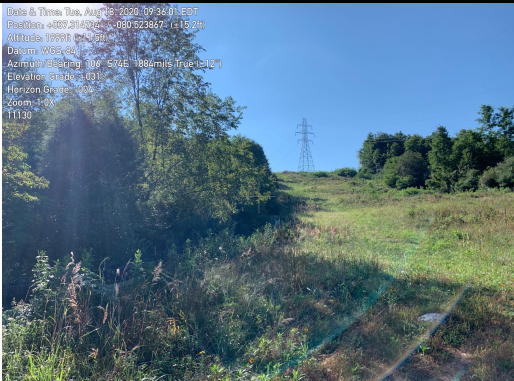
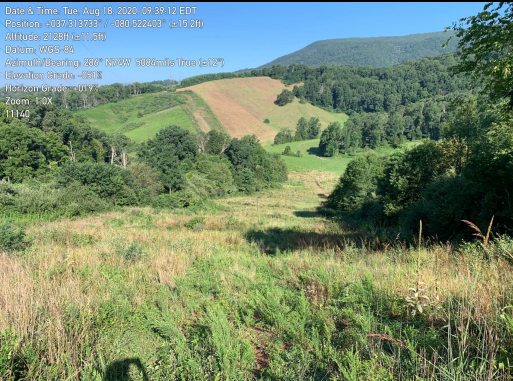
GPS Location	See picture above for GPS coordinates		GPS Location	See picture above for GPS coordinates	
Field Station#	11130+00		Field Station#	11140+00	
Pic 5 Desc.	ECD's and row conditions		Pic 6 Desc.	ECD's and row conditions

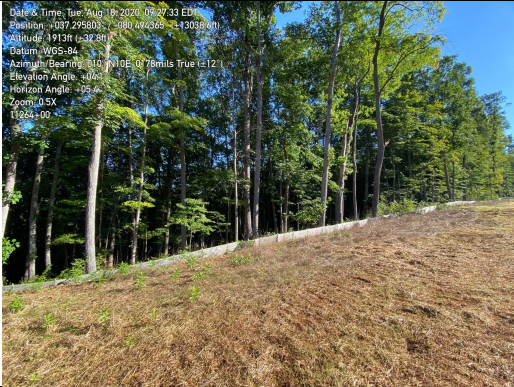
GPS Location	1	GPS Location	2		
Field Station#	11264+00	Field Station#	11292+80		
Pic 1 Desc.	Perimeter controls functional.	Pic 2 Desc.	S-MM18 and controls.

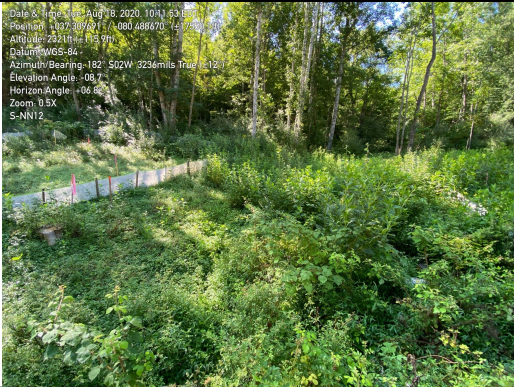
GPS Location	3	GPS Location	4		
Field Station#	11327+85	Field Station#	11329+50		
Pic 3 Desc.	S-NN12 and controls.	Pic 4 Desc.	Crews applying mulch.

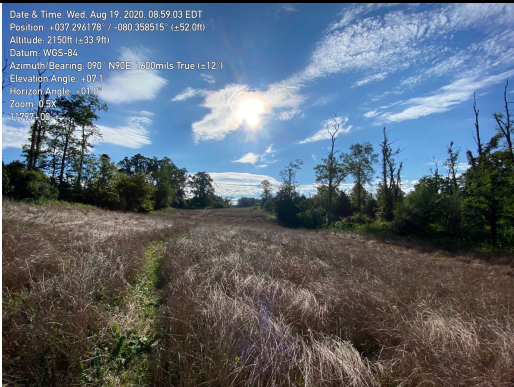
GPS Location	1	GPS Location	2		
Field Station#	11797+00	Field Station#	11826+00		
Pic 1 Desc.	Section of restored RoW showing conditions and controls.		Pic 2 Desc.	Section of restored RoW showing conditions and controls	
<p>Date & Time: Wed, Aug 19, 2020 09:17:30 EDT Position: +037 287766 / -080 368712 (+15.1ft) Altitude: 2117ft (+11.6ft) Datum: WGS-84 Azimuth/Bearing: 200 S20W 3556mils True (+12.1) Elevation Angle: +01.4 Horizon Angle: +04.3 Zoom: 0.5X 11849+00</p>

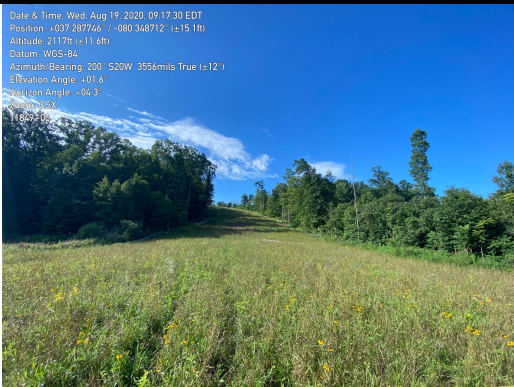
GPS Location	3	GPS Location	4		
Field Station#	11849+00	Field Station#	11866+25		
Pic 3 Desc.	Section of restored RoW showing conditions and controls.		Pic 4 Desc.	Crews beginning repairs to damages caused by unknown parties.	
<p>Date & Time: Wed, Aug 19, 2020 11:48:32 EDT Position: +037 286856 / -080 362857 (+2696.2ft) Altitude: 2224ft (+71.5ft) Datum: WGS-84 Azimuth/Bearing: 315 N45W 5600mils True (+14.1) Elevation Angle: +25.2 Horizon Angle: +00.1 Zoom: 0.5X 11875+30</p>

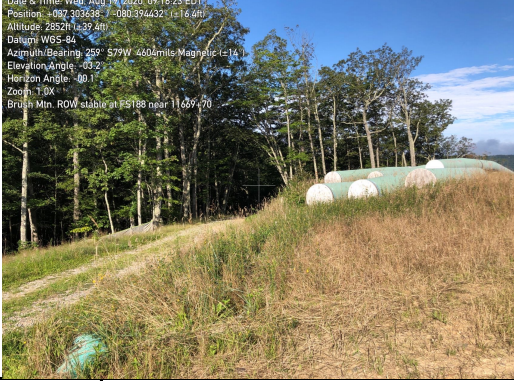
AFE 124300137		Date/Time 8/19/2020 11:03 AM	Report #
Pictures			
<p>Date & Time: Wed, Aug 19, 2020, 09:16:29 EDT Position: +492.393342° / -880.374432° (±16.4m) Altitude: 2852ft (±39.4m) Datum: WGS-84 Azimuth/Bearing: 259° S79W 4604mils Magnetic (±14.1) Elevation Angle: -03.2° Horizon Angle: -40.1° Zoom: 1.0X Brush Mtn. ROW stable at FS188 near 11659+70</p>

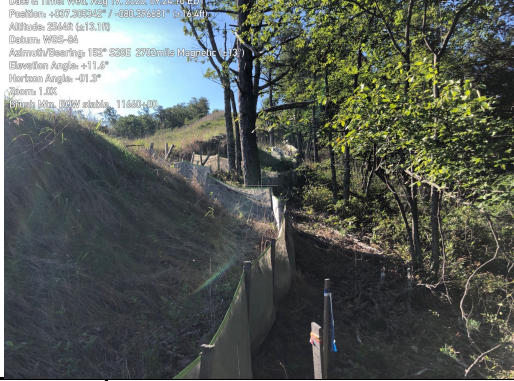
<p>Date & Time: Wed, Aug 19, 2020, 09:22:45 EDT Position: +497.388342° / -880.364432° (±16.4m) Altitude: 2844ft (±13.1m) Datum: WGS-84 Azimuth/Bearing: 182° S88E 2700mils Magnetic (±13.1) Elevation Angle: +11.6° Horizon Angle: -01.5° Zoom: 1.0X Brush Mtn. ROW stable 11660+00</p>

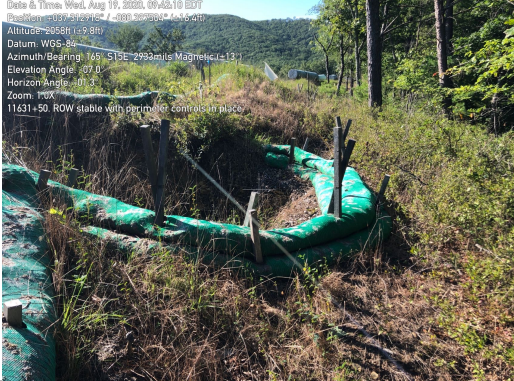
GPS Location	On photo	GPS Location	On photo
Field Station#	11669+70	Field Station#	11660+00
Pic 1 Desc.	ROW stable at FS188.	Pic 2 Desc.	Permit ECDs are in place.
<p>Date & Time: Wed, Aug 19, 2020, 09:40:19 EDT Position: +493.412142° / -880.388642° (±16.4m) Altitude: 2958ft (±9.8m) Datum: WGS-84 Azimuth/Bearing: 165° S15E 2992mils Magnetic (±13.1) Elevation Angle: -07.1° Horizon Angle: -01.3° Zoom: 1.0X 11631+50. ROW stable with perimeter controls in place.</p>

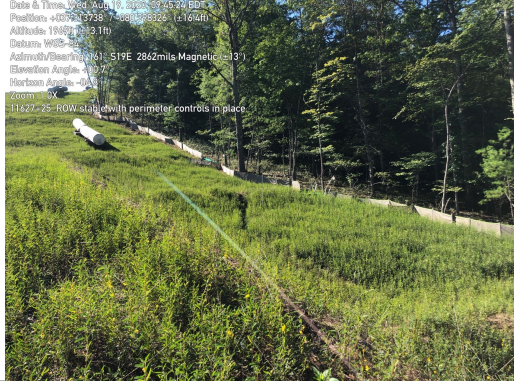
<p>Date & Time: Wed, Aug 19, 2020, 09:49:50 EDT Position: +495.712738° / -880.389320° (±16.4m) Altitude: 1949ft (±13.1m) Datum: WGS-84 Azimuth/Bearing: 116° S19E 2862mils Magnetic (±13.1) Elevation Angle: -01.2° Horizon Angle: -04.1° Zoom: 1.0X 11627+25. ROW stable with perimeter controls in place.</p>

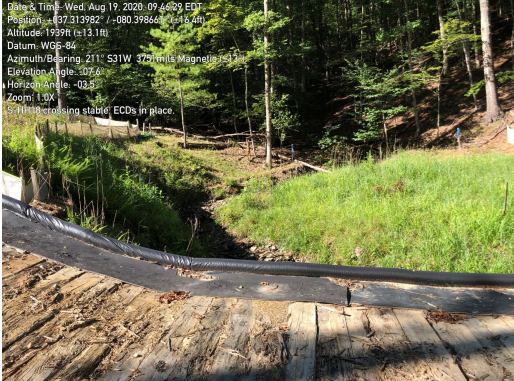
GPS Location	On photo	GPS Location	On photo
Field Station#	11631+50	Field Station#	11627+25
Pic 3 Desc.	End treatments are functioning properly as designed.	Pic 4 Desc.	Perimeter controls are functional.
<p>Date & Time: Wed, Aug 19, 2020, 09:46:29 EDT Position: +497.310392° / -880.376642° (±16.4m) Altitude: 1939ft (±13.1m) Datum: WGS-84 Azimuth/Bearing: 211° S31W 3757mils Magnetic (±13.1) Elevation Angle: -07.4° Horizon Angle: -03.5° Zoom: 1.0X S-HH18 crossing stable. ECDs in place.</p>

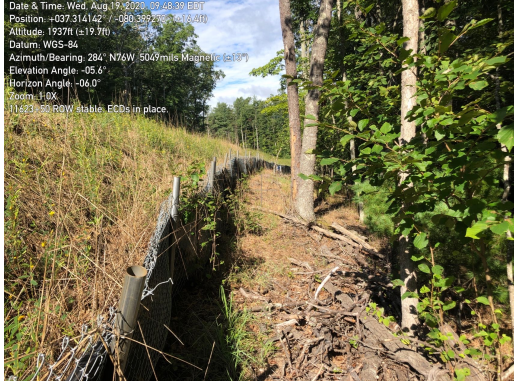
<p>Date & Time: Wed, Aug 19, 2020, 09:48:30 EDT Position: +497.314142° / -880.376642° (±16.4m) Altitude: 1937ft (±13.1m) Datum: WGS-84 Azimuth/Bearing: 284° N76W 5049mils Magnetic (±13.1) Elevation Angle: -05.6° Horizon Angle: -06.0° Zoom: 1.0X 11623+50. ROW stable. ECDs in place.</p>

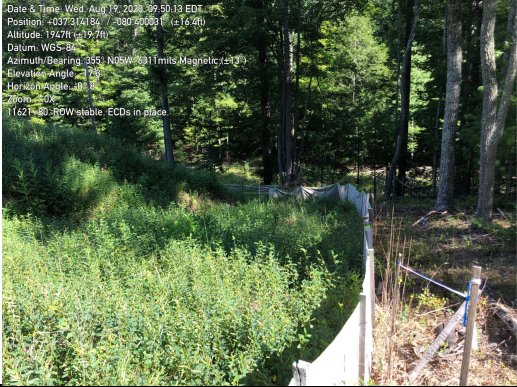
AFE	124300137	Date/Time	8/19/2020 11:03 AM	Report #	
Pictures					
<small>Date & Time: Wed, Aug 19, 2020, 09:50:13 EDT Position: +037.314184 / -080.400031 (±16.4ft) Altitude: 1947ft (±19.7ft) Datum: WGS-84 Azimuth/Bearing: 365° N85W 0311mits Magnetic (±1°) Elevation Angle: -08.9° Horizon Angle: -08.9° Zoom: 1.0X 11621+80 ROW stable, ECDs in place.</small>

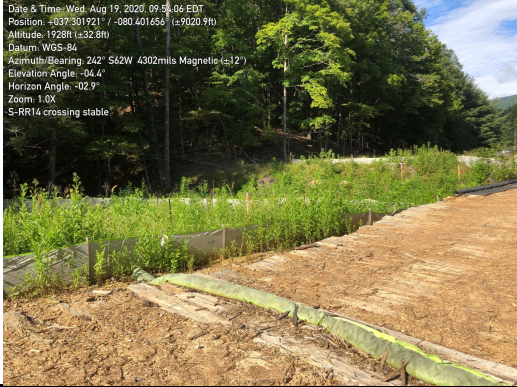
<small>Date & Time: Wed, Aug 19, 2020, 09:54:06 EDT Position: +037.301921 / -080.401656 (±9020.9ft) Altitude: 1928ft (±32.8ft) Datum: WGS-84 Azimuth/Bearing: 242° S42W 4302mits Magnetic (±12°) Elevation Angle: -04.4° Horizon Angle: -02.9° Zoom: 1.0X S-RR14 crossing stable.</small>

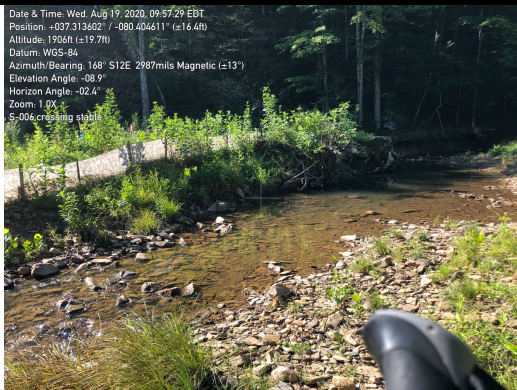
GPS Location	On photo	GPS Location	On photo		
Field Station#	11621+80	Field Station#	11614+20		
Pic 7 Desc.	Perimeter ECDs in place.	Pic 8 Desc.	The S-RR14 crossing is stable with ECDs in place.		
<small>Date & Time: Wed, Aug 19, 2020, 09:57:29 EDT Position: +037.313602 / -080.404611 (±16.4ft) Altitude: 1908ft (±19.7ft) Datum: WGS-84 Azimuth/Bearing: 168° S12E 2987mits Magnetic (±13°) Elevation Angle: -08.9° Horizon Angle: -02.4° Zoom: 1.0X S-006 crossing stable.</small>

GPS Location	On photo	GPS Location			
Field Station#	11608+17	Field Station#			
Pic 9 Desc.	The S-006 crossing is stable with ECDs in place.	Pic 10 Desc.			
Insert image here		Insert image here			
GPS Location		GPS Location			
Field Station#		Field Station#			
Pic 11 Desc.		Pic 12 Desc.

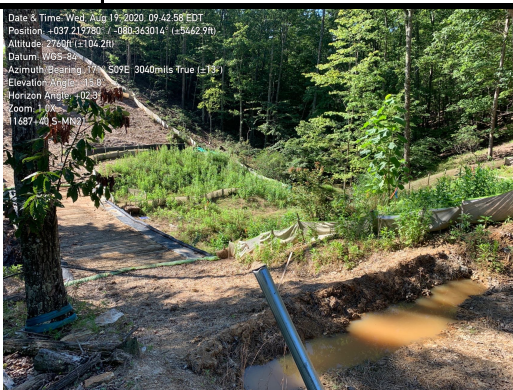
<p>Date & Time: Wed Aug 19, 2020, 09:42:58 EDT Position: +037 212762 / -080 363014 (+5462.9ft) Altitude: 2760ft (+841m) Datum: WGS-84 Azimuth/Bearing: 175° S53E 3040mils True (±13°) Elevation Angle: -15.8° Horizon Angle: -02.3° Zoom: 1.0X 11687+40 S-MN21</p>

GPS Location	See photo for GPS location.		GPS Location	See photo for GPS location.	
Field Station#	11687+40		Field Station#	11767+00	
Pic 3 Desc.	Sensitive resource buffer in place at stream S-MN21.		Pic 4 Desc.	RCE in place at Main Line Valve 26.

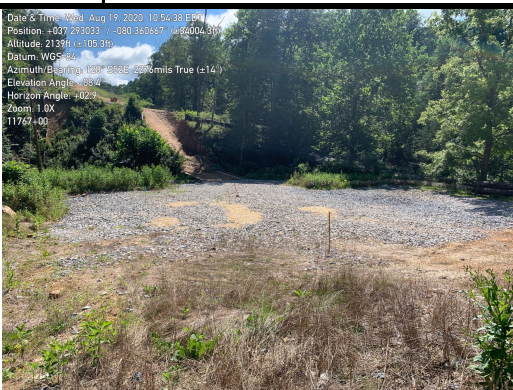
<p>Date & Time: Wed Aug 19, 2020, 10:56:38 EDT Position: +037 293033 / -080 360657 (+56004.3ft) Altitude: 2136ft (+651m) Datum: WGS-84 Azimuth/Bearing: 180° S89E 3206mils True (±14°) Elevation Angle: -08.4° Horizon Angle: -00.2° Zoom: 1.0X 11767+00</p>

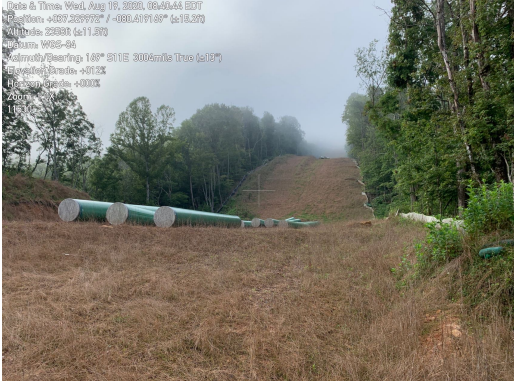
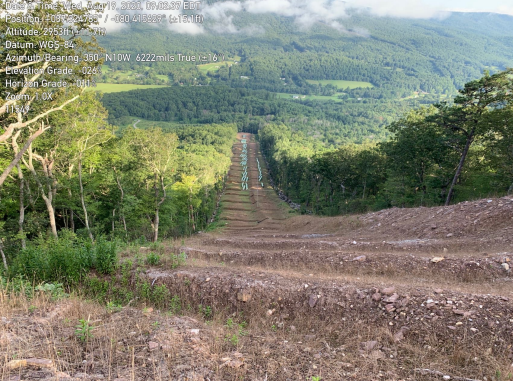
GPS Location	See picture above for GPS coordinates		GPS Location	See picture above for GPS coordinates	
Field Station#	11530+00		Field Station#	11549+00	
Pic 1 Desc.	ECD's and row conditions		Pic 2 Desc.	ECD's and row conditions

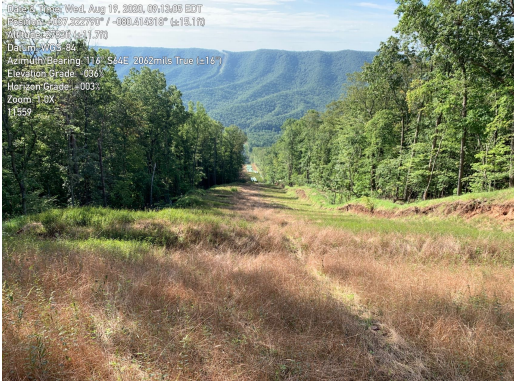
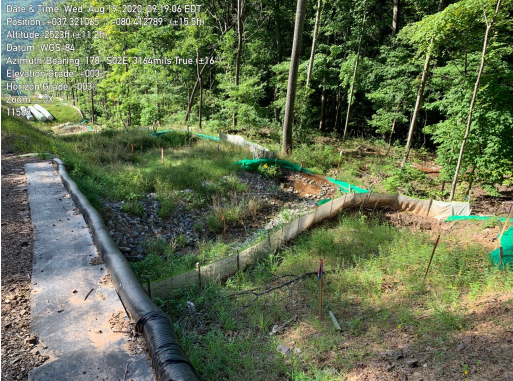
GPS Location	See picture above for GPS coordinates		GPS Location	See picture above for GPS coordinates	
Field Station#	11559+00		Field Station#	11568+00	
Pic 3 Desc.	ECD's and row conditions		Pic 4 Desc.	ECD's and row conditions

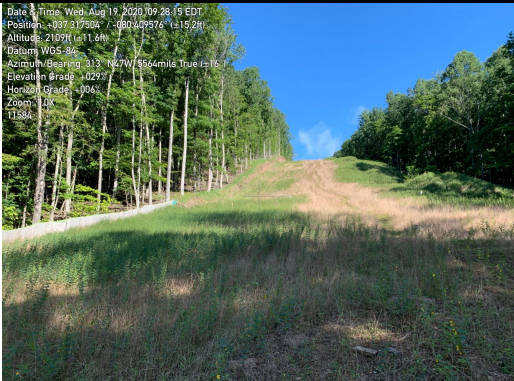
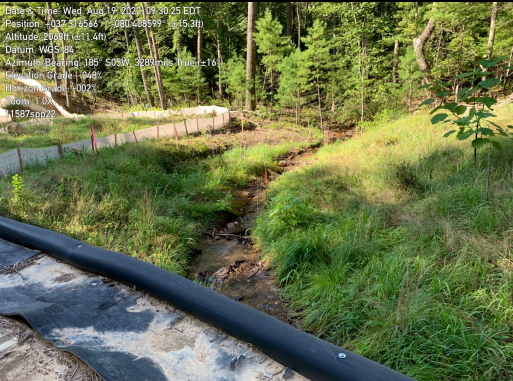
GPS Location	See picture above for GPS coordinates		GPS Location	See picture above for GPS coordinates	
Field Station#	11584+00		Field Station#	11587+00	
Pic 5 Desc.	ECD's and row conditions		Pic 6 Desc.	ECD's and row conditions

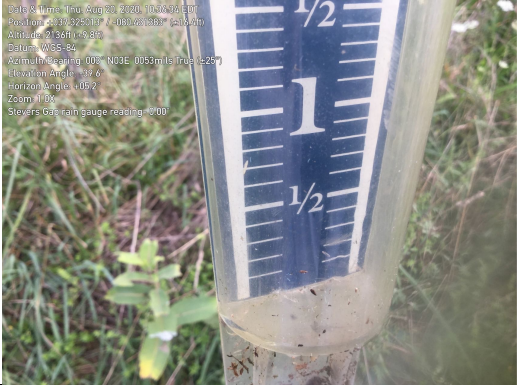
Insert image here			
GPS Location	See photo GPS	GPS Location			
Field Station#	11471+00	Field Station#			
Pic 7 Desc.	Stevens Gap rain gauge reading- 0.00"	Pic 8 Desc.			
Insert image here		Insert image here			
GPS Location		GPS Location			
Field Station#		Field Station#			
Pic 9 Desc.		Pic 10 Desc.			
Insert image here		Insert image here			
GPS Location		GPS Location			
Field Station#		Field Station#			
Pic 11 Desc.		Pic 12 Desc.

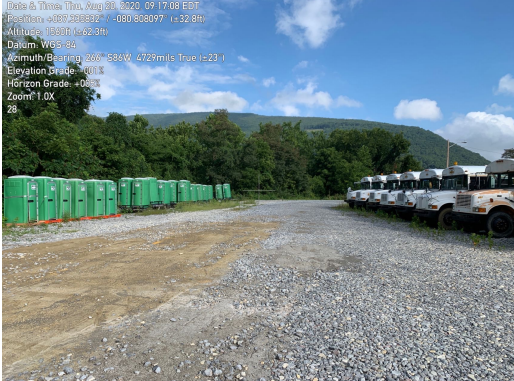
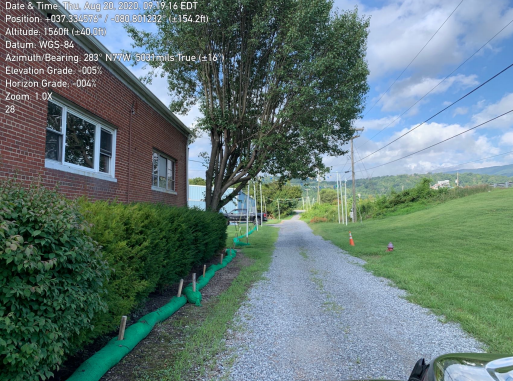
<p>Date & Time: Thu, Aug 20, 2020, 09:19:16 EDT Position: +37°23'55.92" N / -080°50'07.7" W (+52.8m) Altitude: 1560ft (+20.3m) Datum: WGS-84 Azimuth/Bearing: 283° N429mils True (±16) Elevation Grade: -0.05% Horizon Grade: -0.04% Zoom: 1.0x 28</p>			
GPS Location	See picture above for GPS coordinates		GPS Location	See picture above for GPS coordinates	
Field Station#	12005+00		Field Station#	12005+00	
Pic 1 Desc.	ECD's and row conditions		Pic 2 Desc.	ECD's and row conditions

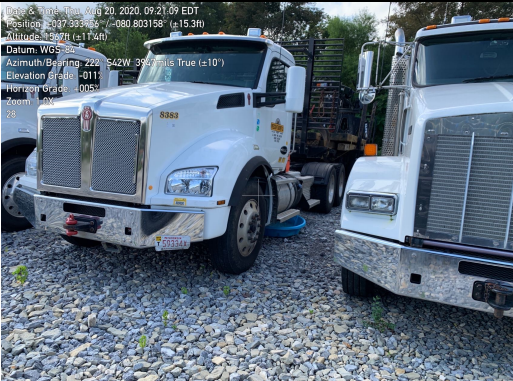
GPS Location	See picture above for GPS coordinates		GPS Location	See picture above for GPS coordinates	
Field Station#	12005+00		Field Station#	12005+00	
Pic 3 Desc.	ECD's and row conditions		Pic 4 Desc.	Secondary containment

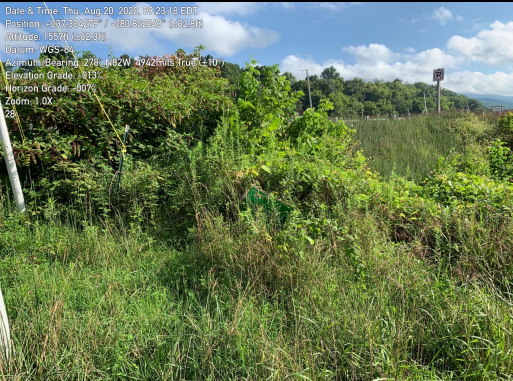
<p>Date & Time: Thu, Aug 20, 2020, 09:23:13 EDT Position: +37°23'55.92" N / -080°50'07.7" W (+52.8m) Altitude: 1560ft (+20.3m) Datum: WGS-84 Azimuth/Bearing: 278° N62W 492mils True (±10") Elevation Grade: -0.13% Horizon Grade: -0.0% Zoom: 1.0x 28</p>			
GPS Location	See picture above for GPS coordinates		GPS Location	See picture above for GPS coordinates	
Field Station#	12005+00		Field Station#	12005+00	
Pic 5 Desc.	ECD's and row conditions		Pic 6 Desc.	ECD's and row conditions

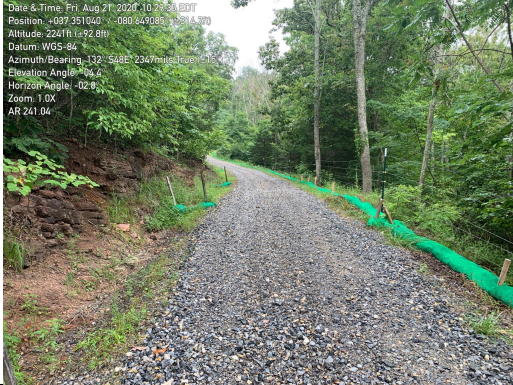
GPS Location		See photo for GPS location.				GPS Location		See photo for GPS location.			
Field Station#		10710+00				Field Station#		10712+50			
Pic 1 Desc.		CFS in place along AR 241.04.				Pic 2 Desc.		Sensitive resource buffer in place at stream S-G33.			
<p>Date & Time: Fri, Aug 21, 2020, 15:45:04 EDT Position: +097.346941° / -080.649891° (+36.2m) Altitude: 2393ft (+93.8m) Datum: WGS-84 Azimuth/Bearing: 301° S89W 4323mils True (±15°) Elevation Angle: -07.3° Horizon Angle: -05.4° Zoom: 1.0X 10710+00</p>

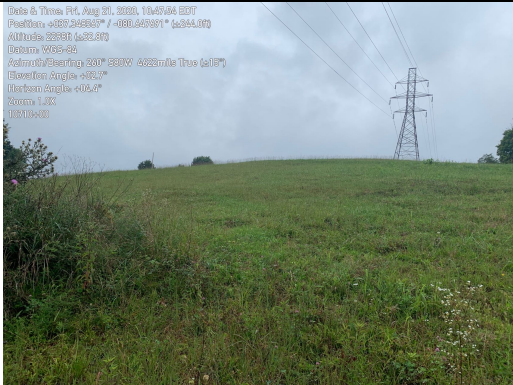
GPS Location		See photo for GPS location.				GPS Location		See photo for GPS location.			
Field Station#		10710+00				Field Station#		10698+00			
Pic 3 Desc.		ROW stabilized with natural vegetation growth.				Pic 4 Desc.		Sensitive resource buffer in place at stream S-G32.			
<p>Date & Time: Fri, Aug 21, 2020, 16:03:10 EDT Position: +097.349273° / -080.653667° (+36.2m) Altitude: 2102ft (+11.1m) Datum: WGS-84 Azimuth/Bearing: 118° S42E 2098mils True (±10°) Elevation Angle: -09.3° Horizon Angle: -01.1° Zoom: 1.0X 10696+00</p>

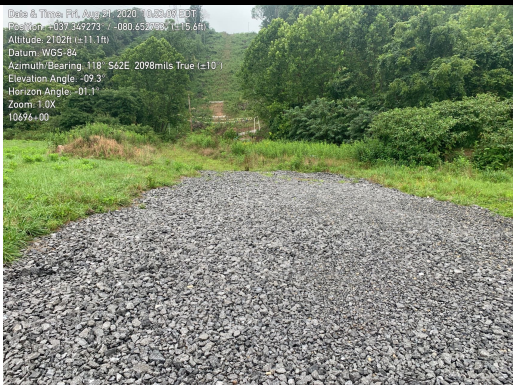
Pic 5 Desc.		RCE in place at Buffalo Anklets Road.				Pic 6 Desc.		Reinforced super silt fence in place along LOD.

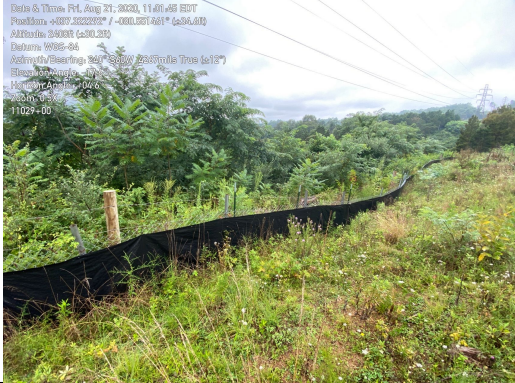
GPS Location	1	GPS Location	2		
Field Station#	11025+50	Field Station#	11029+00		
Pic 1 Desc.	S-IJ18 and controls.	Pic 2 Desc.	Perimeter controls functional.

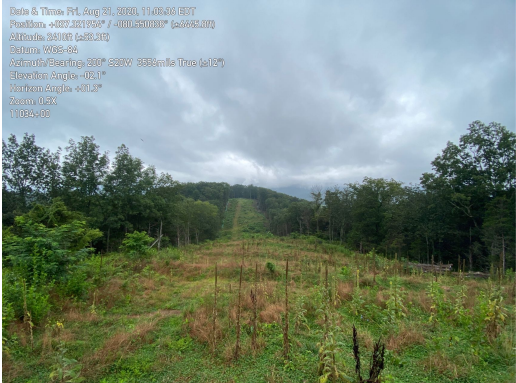
GPS Location	3	GPS Location	4		
Field Station#	11034+00	Field Station#	11024+00		
Pic 3 Desc.	Section of RoW showing conditions and controls.	Pic 4 Desc.	AWS showing conditions.

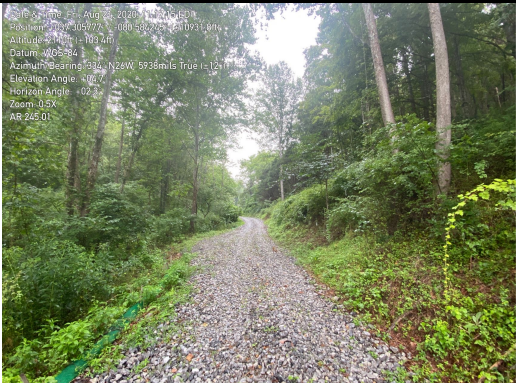
GPS Location	5	GPS Location	6		
Field Station#	11064+53	Field Station#	11064+50		
Pic 5 Desc.	AR 245.01 showing conditions and controls.	Pic 6 Desc.	Section of RoW showing conditions and controls.

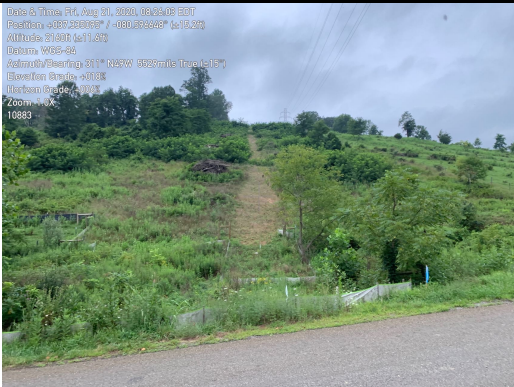
GPS Location	See picture above for GPS coordinates		GPS Location	See picture above for GPS coordinates	
Field Station#	10883+00		Field Station#	10858+00	
Pic 1 Desc.	ECD's and row conditions		Pic 2 Desc.	ECD's and row conditions	
<p>Date & Time: Fri, Aug 21, 2020, 06:41:49 EDT Position: +40°23'59"N / -80°03'59"W (±12.2M) Altitude: 5193ft (±11.5M) Datum: WGS-84 Azimuth/Bearing: 110° S28E 1776mils True (±12.2M) Elevation Grade: +03% Horizon Grade: +01% Zoom: 1.0X 10862</p>

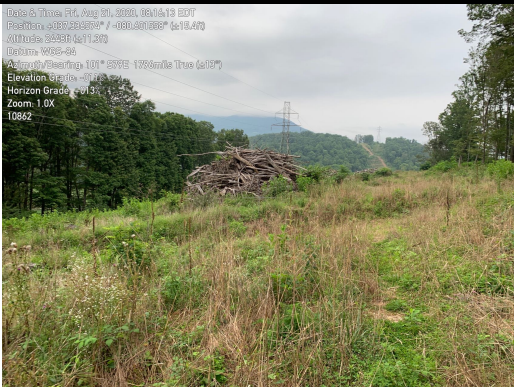
GPS Location	See picture above for GPS coordinates		GPS Location	See picture above for GPS coordinates	
Field Station#	10862+00		Field Station#	10901+00	
Pic 3 Desc.	ECD's and row conditions		Pic 4 Desc.	ECD's and row conditions	
<p>Date & Time: Fri, Aug 21, 2020, 06:44:00 EDT Position: +40°23'59"N / -80°03'59"W (±12.2M) Altitude: 5193ft (±11.5M) Datum: WGS-84 Azimuth/Bearing: 272° N38W 5193mils True (±12.2M) Elevation Grade: +03% Horizon Grade: +04% Zoom: 1.0X 108891</p>

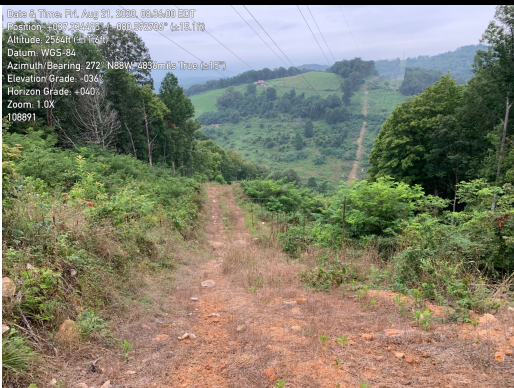
GPS Location	See picture above for GPS coordinates		GPS Location	See picture above for GPS coordinates	
Field Station#	108891+00		Field Station#	10923+00	
Pic 5 Desc.	ECD's and row conditions		Pic 6 Desc.	ECD's and row conditions
