# Visual Site Inspection Report

<b>Project Name</b>	H-600 Pipeline Spread G	<b>AFE</b>	124300137	<b>Spread</b>	H-600 Pipeline Spread G
<b>Contractor</b>	Precision			<b>Report #</b>	13868
<b>Inspector</b>	Len Kruizenga			<b>Date/Time</b>	8/24/2020 8:17 AM
<b>Permit #</b>	TBD	<b>Inspection Type</b>	VA SWPP	<b>Station Begin</b>	11254+99
<b>State</b>	VA	<b>Inspection Area</b>	Full	<b>Station End</b>	11158+27
<b>County</b>	Giles	<b>Ground</b>	Dry	<b>Temperature (°F)</b>	82.00
<b>Municipality</b>	N/A	<b>Weather</b>	Cloudy	<b>Rain Gauge (in)</b>	0.00
				<b>Rain Accumulation Time (days)</b>	1.00

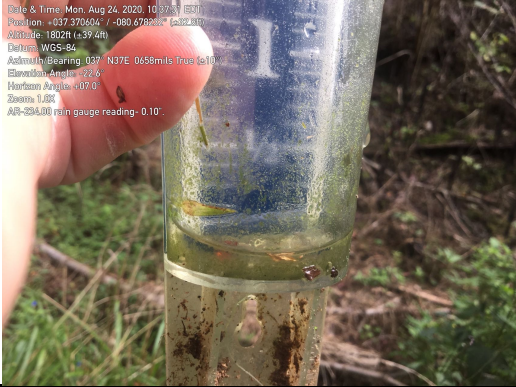
Insert image here			
<b>GPS Location</b>	See photo GPS	<b>GPS Location</b>			
<b>Field Station#</b>	11561+00	<b>Field Station#</b>			
<b>Pic 7 Desc.</b>	AR-234.00- rain gauge reading- 0.10".	<b>Pic 8 Desc.</b>			
Insert image here		Insert image here			
<b>GPS Location</b>		<b>GPS Location</b>			
<b>Field Station#</b>		<b>Field Station#</b>			
<b>Pic 9 Desc.</b>		<b>Pic 10 Desc.</b>			
Insert image here		Insert image here			
<b>GPS Location</b>		<b>GPS Location</b>			
<b>Field Station#</b>		<b>Field Station#</b>			
<b>Pic 11 Desc.</b>		<b>Pic 12 Desc.</b>

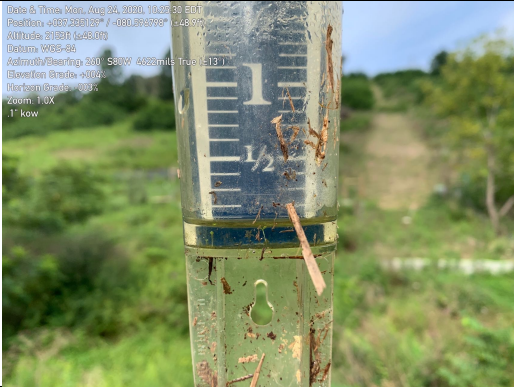
<b>GPS Location</b>	See picture above for GPS coordinates		<b>GPS Location</b>	See picture above for GPS coordinates	
<b>Field Station#</b>	+1		<b>Field Station#</b>	11080+00	
<b>Pic 1 Desc.</b>	.1" of rain recorded		<b>Pic 2 Desc.</b>	ECD's and row conditions

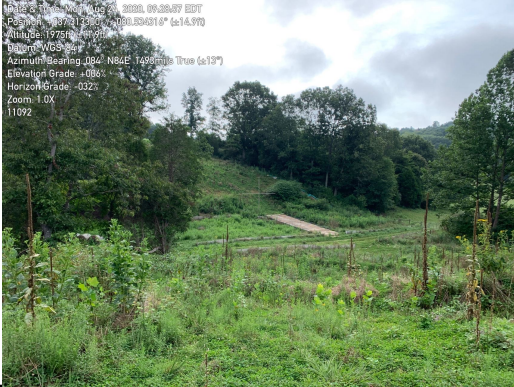
<b>GPS Location</b>	See picture above for GPS coordinates		<b>GPS Location</b>	See picture above for GPS coordinates	
<b>Field Station#</b>	11092+00		<b>Field Station#</b>	11120+00	
<b>Pic 3 Desc.</b>	ECD's and row conditions		<b>Pic 4 Desc.</b>	ECD's and row conditions

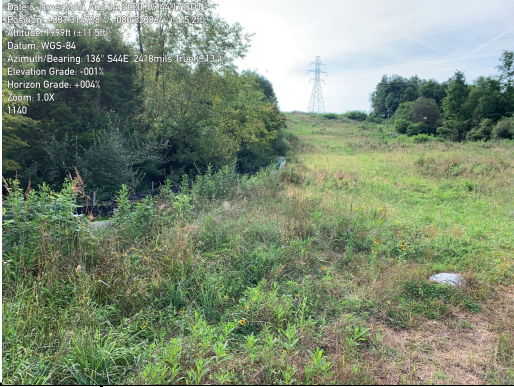
<b>GPS Location</b>	See picture above for GPS coordinates		<b>GPS Location</b>	See picture above for GPS coordinates	
<b>Field Station#</b>	11130+00		<b>Field Station#</b>	11140+00	
<b>Pic 5 Desc.</b>	ECD's and row conditions		<b>Pic 6 Desc.</b>	ECD's and row conditions

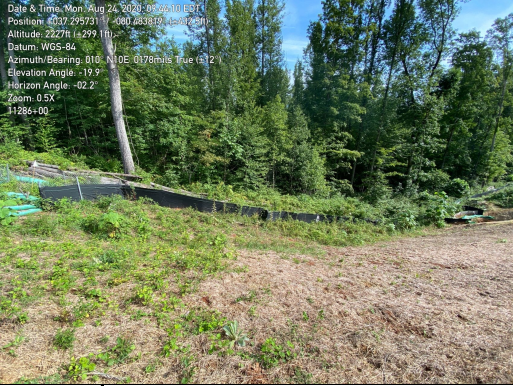
<b>GPS Location</b>	1	<b>GPS Location</b>	2		
<b>Field Station#</b>	11263+75	<b>Field Station#</b>	11286+00		
<b>Pic 1 Desc.</b>	Perimeter controls functional.	<b>Pic 2 Desc.</b>	Perimeter controls functional.

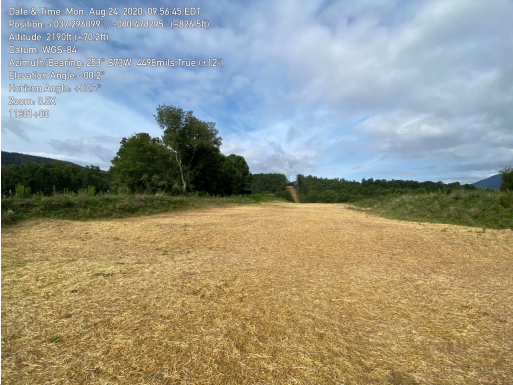
<b>GPS Location</b>	3	<b>GPS Location</b>	4		
<b>Field Station#</b>	11292+80	<b>Field Station#</b>	11301+00		
<b>Pic 3 Desc.</b>	S-MM18 and controls.	<b>Pic 4 Desc.</b>	Section of RoW showing conditions and controls.

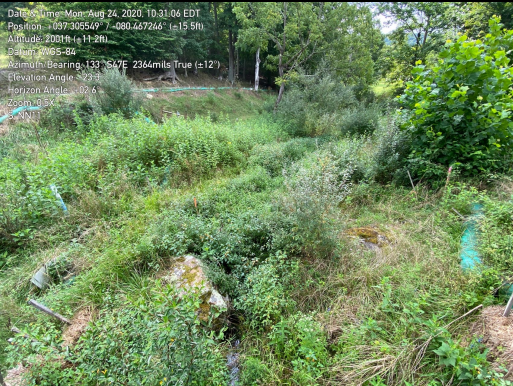
<b>GPS Location</b>	5	<b>GPS Location</b>	6		
<b>Field Station#</b>	11327+85	<b>Field Station#</b>	11352+97		
<b>Pic 5 Desc.</b>	S-NN12 and controls.	<b>Pic 6 Desc.</b>	S-NN11 and controls.

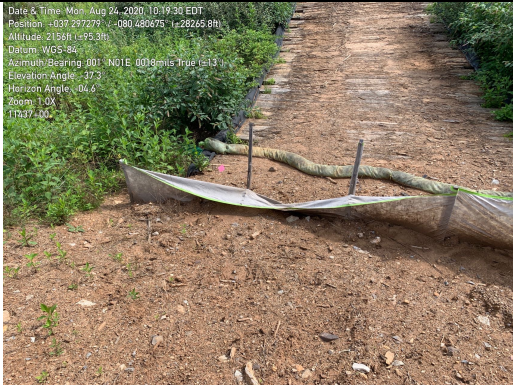
<p>Date &amp; Time: Mon, Aug 24, 2020, 10:19:38 EDT Position: +037.297272° / -080.452675° (+28265.8ft) Altitude: 2156ft (+95.3ft) Datum: WGS-84 Azimuth/Bearing: 001° N61E 808mils True (+13°) Elevation Angle: +37.3° Horizon Angle: -04.6° Zoom: 1.0X 11437+00</p>

GPS Location	See photo for GPS location.		GPS Location	See photo for GPS location.	
Field Station#	11437+00		Field Station#	11403+00	
Pic 3 Desc.	Priority one silt fence ripped off of stakes.		Pic 4 Desc.	Hole in priority one silt fence. Appears to be from animals.

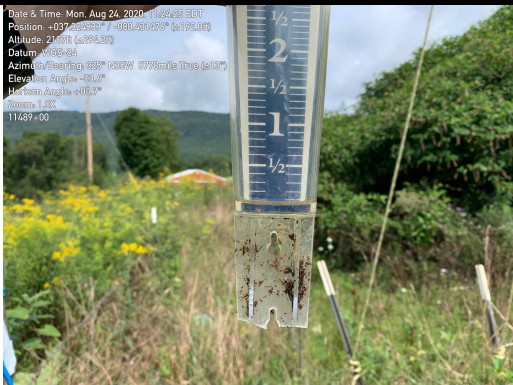
Pic 5 Desc.	Rain gauge at Stevers Gap Road reads 0.1 inches.		Pic 6 Desc.	Rain gauge at Mount Tabor Road reads 0.35 inches.

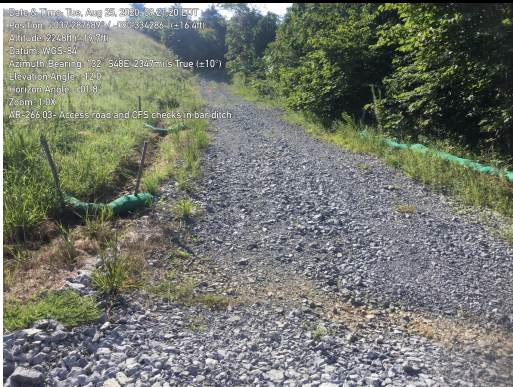
<p>Date &amp; Time: Tue, Aug 25, 2020, 08:01:20 EDT Position: +037 283244 / -080 331478 (+16.2m) Altitude: 2314ft (+197m) Datum: WGS-84 Azimuth/Bearing: 132.548E (+327mils True (+10°)) Elevation Angle: -04.8° Horizon Angle: +01.0° Zoom: 1.0X Sta#11919+00- Access road and CFS checks in bar ditch.</p>		<p>Date &amp; Time: Tue, Aug 25, 2020, 09:30:15 EDT Position: +037 283244 / -080 331478 (+16.2m) Altitude: 2314ft (+197m) Datum: WGS-84 Azimuth/Bearing: 128° 552E 2276mils True (+10°) Elevation Angle: -04.8° Horizon Angle: +01.0° Zoom: 1.0X Sta#11919+00- Water bars, water bar outlet protection, no vegetation.</p>			
<b>GPS Location</b>	See photo GPS	<b>GPS Location</b>	See photo GPS		
<b>Field Station#</b>	11900+00	<b>Field Station#</b>	11919+00		
<b>Pic 1 Desc.</b>	AR-266.03 Acces road and CFS checks.	<b>Pic 2 Desc.</b>	Row vegetation, water bars, water bar outlet protection.

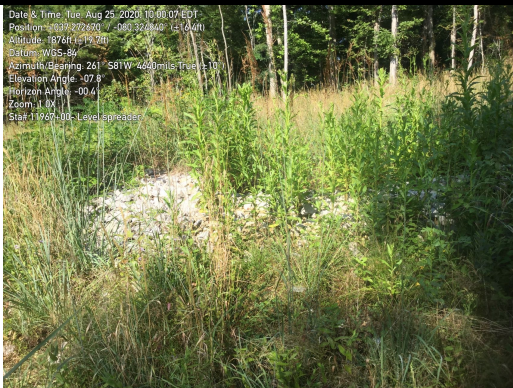
<p>Date &amp; Time: Tue, Aug 25, 2020, 10:00:07 EDT Position: +037 283244 / -080 332440 (+16.4m) Altitude: 1972ft (+197m) Datum: WGS-84 Azimuth/Bearing: 261° 581W 440mils True (+10°) Elevation Angle: -07.9° Horizon Angle: -00.4° Zoom: 1.0X Sta#11967+00- Level spreader.</p>		<p>Date &amp; Time: Tue, Aug 25, 2020, 10:04:50 EDT Position: +037 283244 / -080 332440 (+16.4m) Altitude: 1972ft (+197m) Datum: WGS-84 Azimuth/Bearing: 027° N27E 0480mils True (+25°) Elevation Angle: -11.7° Horizon Angle: +04.3° Zoom: 1.0X AR-266.00- Access road and rock check dams.</p>

<b>GPS Location</b>	See photo GPS	<b>GPS Location</b>	See photo GPS		
<b>Field Station#</b>	11967+00	<b>Field Station#</b>	11989+00		
<b>Pic 5 Desc.</b>	Level spreader	<b>Pic 6 Desc.</b>	AR-266.00- Access road, rock check dams.

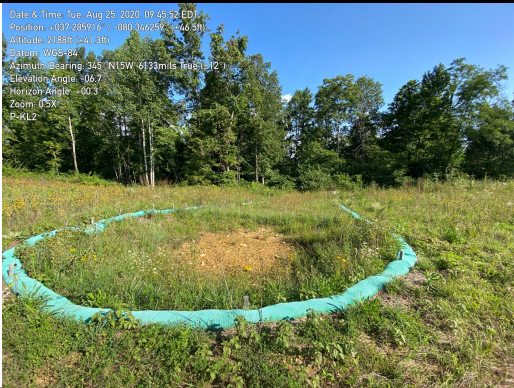
<p>Date &amp; Time: Tue, Aug 25, 2020, 09:45:52 EDT Position: +037 285976 / -080 346957 (-1246.5ft) Altitude: 2253ft (+11.2ft) Datum: WGS-84 Azimuth/Bearing: 345 N15W 4133mils True (+12.1) Elevation Angle: +06.7 Horizon Angle: +00.3 Zoom: 0.5X P-KL2</p>

<p>Date &amp; Time: Tue, Aug 25, 2020, 10:06:52 EDT Position: +037 287903 / -080 334665 (-115.5ft) Altitude: 2253ft (+11.2ft) Datum: WGS-84 Azimuth/Bearing: 264 S84W 4693mils True (+12.1) Elevation Angle: +05.1 Horizon Angle: +01.3 Zoom: 0.5X 11899+00</p>			
<b>GPS Location</b>	5	<b>GPS Location</b>	6		
<b>Field Station#</b>	11863+65	<b>Field Station#</b>	11899+99		
<b>Pic 5 Desc.</b>	P-KL2 and controls.		<b>Pic 6 Desc.</b>	Section of restored RoW showing conditions and controls.

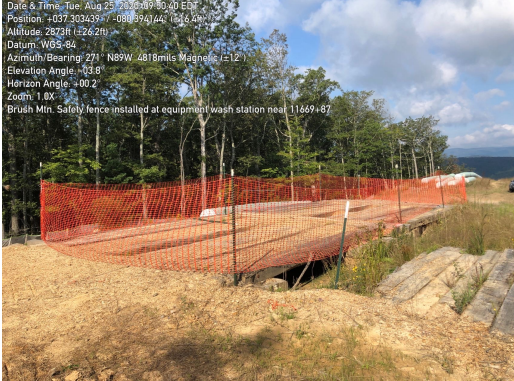
<b>AFE</b>	124300137	<b>Date/Time</b>	8/25/2020 1:08 PM	<b>Report #</b>	
<b>Pictures</b>					
<p>Date &amp; Time: Tue, Aug 25, 2020, 10:40:00 EDT  Position: +037.200397° / -080.394544° (±16.4ft)  Altitude: 2627ft (±262m)  Datum: WGS-84  Azimuth/Bearing: 271° N89W 4818mils Magnetic (±12°)  Elevation Angle: +03.6°  Horizon Angle: +00.2°  Zoom: 1.0X  Brush Mtn. Safety fence installed at equipment wash station near 11669+87</p>

<p>Date &amp; Time: Tue, Aug 25, 2020, 10:16:49 EDT  Position: +037.200397° / -080.394544° (±16.4ft)  Altitude: 2629ft (±19.7ft)  Datum: WGS-84  Azimuth/Bearing: 156° S34E 2773mils Magnetic (±12°)  Elevation Angle: +06.5°  Horizon Angle: -01.2°  Zoom: 1.0X  Brush Mtn. 11660+00. Perimeter controls in place</p>  			
<b>GPS Location</b>	On photo	<b>GPS Location</b>	On photo		
<b>Field Station#</b>	11667+00	<b>Field Station#</b>	11660+00		
<b>Pic 1 Desc.</b>	Orange barricade fence around the equipment cleaning station installed per landowner request.	<b>Pic 2 Desc.</b>	Perimeter controls in place and functional.

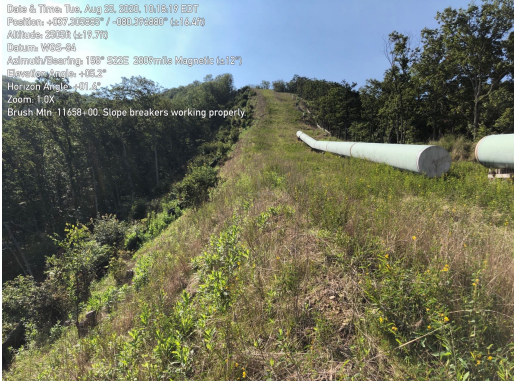
<p>Date &amp; Time: Tue, Aug 25, 2020, 15:15:10 EDT  Position: +037.200397° / -080.394544° (±16.4ft)  Altitude: 2600ft (±19.7ft)  Datum: WGS-84  Azimuth/Bearing: 189° S22E 2909mils Magnetic (±12°)  Elevation Angle: +05.2°  Horizon Angle: -01.6°  Zoom: 1.0X  Brush Mtn. 11658+00. Slope breakers working properly.</p>

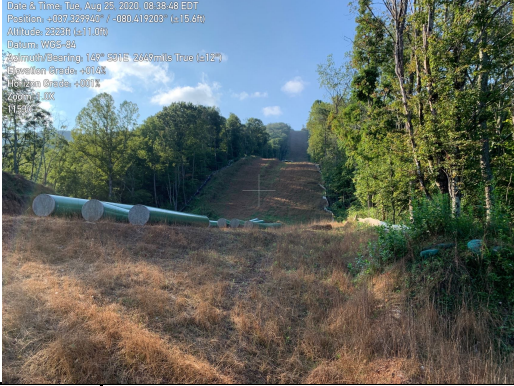
<b>GPS Location</b>	See picture above for GPS coordinates		<b>GPS Location</b>	See picture above for GPS coordinates	
<b>Field Station#</b>	11530+00		<b>Field Station#</b>	11551+00	
<b>Pic 1 Desc.</b>	ECD's and row conditions		<b>Pic 2 Desc.</b>	ECD's and row conditions

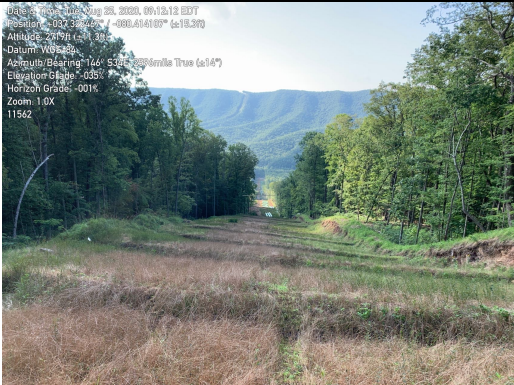
<b>GPS Location</b>	See picture above for GPS coordinates		<b>GPS Location</b>	See picture above for GPS coordinates	
<b>Field Station#</b>	11562+00		<b>Field Station#</b>	11567+00	
<b>Pic 3 Desc.</b>	ECD's and row conditions		<b>Pic 4 Desc.</b>	ECD's and row conditions

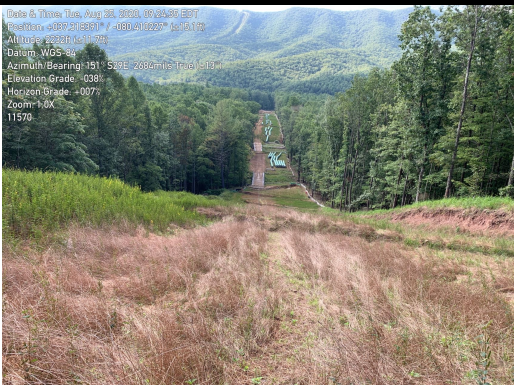
<b>GPS Location</b>	See picture above for GPS coordinates		<b>GPS Location</b>	See picture above for GPS coordinates	
<b>Field Station#</b>	11570+00		<b>Field Station#</b>	11585+00	
<b>Pic 5 Desc.</b>	ECD's and row conditions		<b>Pic 6 Desc.</b>	ECD's and row conditions

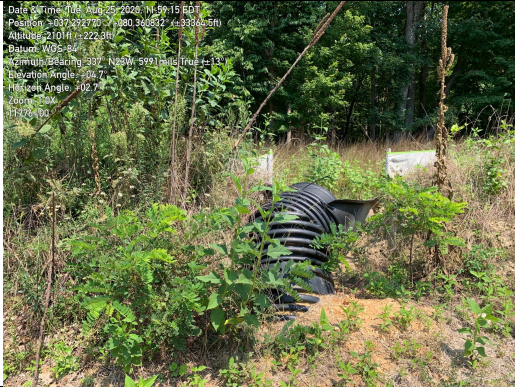
<p>Date &amp; Time: Tue, Aug 25, 2020, 11:59:15 EDT Position: +037 235327 / -080 35478 (±50.9ft) Altitude: 2101ft (±107.3ft) Datum: WGS-84 Azimuth/Bearing: 337.284° / 591ftils True (±13°) Elevation Angle: +06.7° Horizon Angle: +02.7° Zoom: 1.0X 11775+00</p>			
<b>GPS Location</b>	See photo for GPS location.		<b>GPS Location</b>	See photo for GPS location.	
<b>Field Station#</b>	11775+00		<b>Field Station#</b>	11775+00	
<b>Pic 1 Desc.</b>	Clean water diversion pipe and plunge pool in place.		<b>Pic 2 Desc.</b>	Clean water diversion berm and clean water diversion pipe inlet in place.

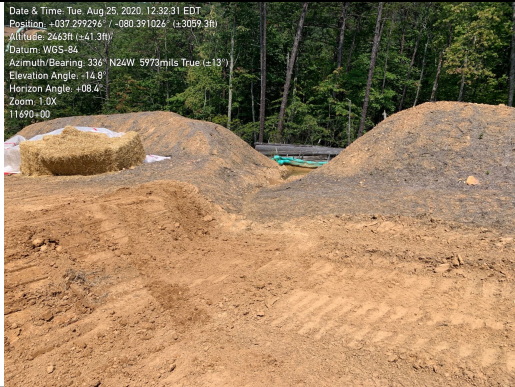
<p>Date &amp; Time: Tue, Aug 25, 2020, 12:32:31 EDT Position: +037 239294 / -080 391026 (±3059.3ft) Altitude: 2463ft (±41.3ft) Datum: WGS-84 Azimuth/Bearing: 336.244° / 597ftils True (±13°) Elevation Angle: +14.8° Horizon Angle: +08.4° Zoom: 1.0X 11690+00</p>			
<b>GPS Location</b>	See photo for GPS location.		<b>GPS Location</b>	See photo for GPS location.	
<b>Field Station#</b>	11687+40		<b>Field Station#</b>	11690+00	
<b>Pic 3 Desc.</b>	Sensitive resource buffer in place at stream S-MN21.		<b>Pic 4 Desc.</b>	Waterbar, sump pit, and waterbar end treatment in place.

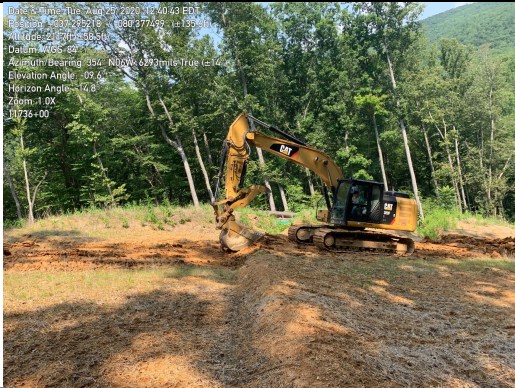
<b>GPS Location</b>	See photo for GPS location.		<b>GPS Location</b>	See photo for GPS location.	
<b>Field Station#</b>	11710+00		<b>Field Station#</b>	11736+00	
<b>Pic 5 Desc.</b>	ROW stabilized with mulch.		<b>Pic 6 Desc.</b>	Track hoe installing waterbars.

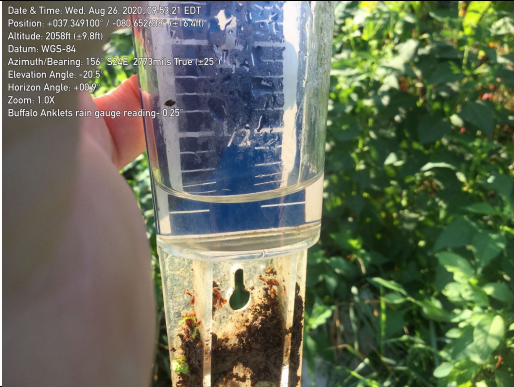
<b>GPS Location</b>	See photo GPS	<b>GPS Location</b>	See photo GPS		
<b>Field Station#</b>	12005+00	<b>Field Station#</b>	12005+00		
<b>Pic 1 Desc.</b>	Buffalo Anklets rain gauge reading- 0.25"	<b>Pic 2 Desc.</b>	AR-234.00 rain gauge reading- 0.30"

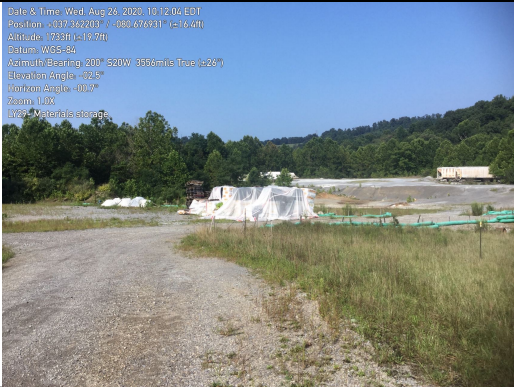
<b>GPS Location</b>	See photo GPS	<b>GPS Location</b>	See photo GPS		
<b>Field Station#</b>	12005+00	<b>Field Station#</b>	12005+00		
<b>Pic 3 Desc.</b>	LY-29- Materials storage.	<b>Pic 4 Desc.</b>	LY- 29- triple stack CFS perimeter controls.		
<p>Date &amp; Time: Wed Aug 26 2020 10:16:56 EDT  Position: +037.368667 / +080.076931 (+16.4m)  Altitude: 1708ft (+18.7m)  Datum: WGS-84  Azimuth/Bearing: 229.845W 5000mils True (+26°)  Elevation Angle: +07.4°  Horizon Angle: +01.0°  Zoom: 1.0x  LY29- Pipe stored in yard.</p>

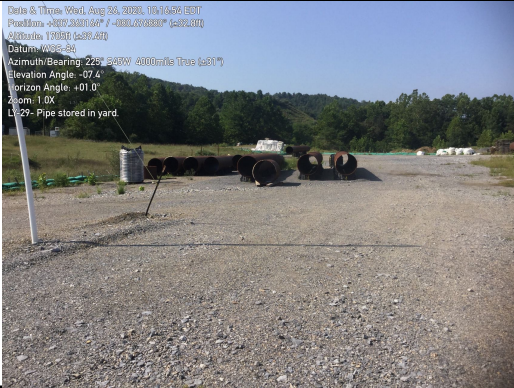
<b>GPS Location</b>	See photo GPS	<b>GPS Location</b>	See photo GPS		
<b>Field Station#</b>	12005+00	<b>Field Station#</b>	12005+00		
<b>Pic 5 Desc.</b>	LY-29- Pipe stored in the yard.	<b>Pic 6 Desc.</b>	Culvert and drainage feature

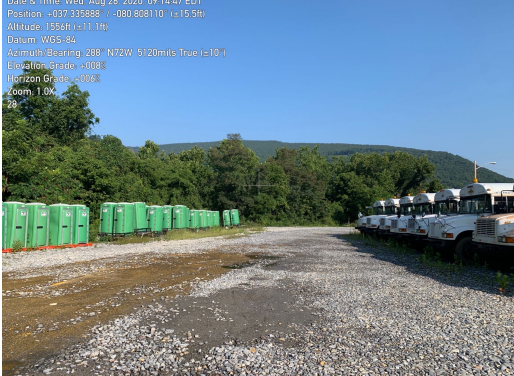
<b>GPS Location</b>	See picture above for GPS coordinates		<b>GPS Location</b>	See picture above for GPS coordinates	
<b>Field Station#</b>	12005+00		<b>Field Station#</b>	12005+00	
<b>Pic 1 Desc.</b>	ECD's and row conditions		<b>Pic 2 Desc.</b>	ECD's and row conditions	
<p>Date &amp; Time: Wed Aug 26, 2020 09:18:15 EDT  Position: -037.334229 / -080.802954 (-15.4024m)  Altitude: 1537ft (+14.685m)  Datum: WGS-84  Azimuth/Bearing: 205° S28W 3662mils True (+16.1)  Elevation Grade: +003%  Horizon Grade: +012%  Zoom: 1.0X  28</p>

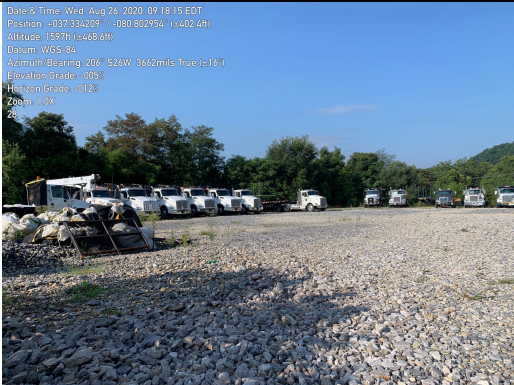
<b>GPS Location</b>	See picture above for GPS coordinates		<b>GPS Location</b>	See picture above for GPS coordinates	
<b>Field Station#</b>	12005+00		<b>Field Station#</b>	12005+00	
<b>Pic 3 Desc.</b>	ECD's and row conditions		<b>Pic 4 Desc.</b>	Secondary containment	
<p>Date &amp; Time: Wed Aug 26, 2020 09:45:57 EDT  Position: -037.316589 / -080.553612 (+20.5m)  Altitude: 2154ft (+33.8m)  Datum: WGS-84  Azimuth/Bearing: 357° S19W 400mils True (+18.1)  Elevation Grade: +001%  Horizon Grade: +001%  Zoom: 1.0X  05</p>

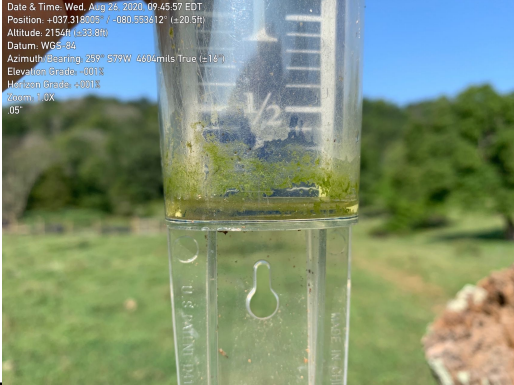
<b>Field Station#</b>	+1		<b>Field Station#</b>	+1	
<b>Pic 5 Desc.</b>	.05" of rain recorded @ AR 244		<b>Pic 6 Desc.</b>	.2" of rain recorded @ Catawba

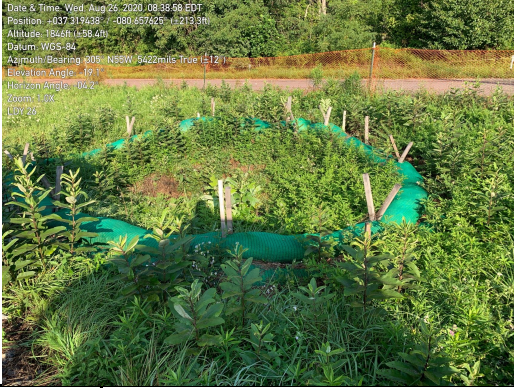
<p>Date &amp; Time: Wed, Aug 26, 2020 08:39:48 EDT Position: +337 319432 / -080 658431 / -1219.5N Altitude: 1841ft (-89.3m) Datum: WGS 84 Azimuth/Bearing: 281° N79W 4996mils True (-12°) Elevation Angle: -58.4° Horizon Angle: -101.8° Horizon Angle: -101.8° Zoom: 1.0X LDY 26</p>			
<b>GPS Location</b>	See photo for GPS location.		<b>GPS Location</b>	See photo for GPS location.	
<b>Field Station#</b>	12005+00		<b>Field Station#</b>	12005+00	
<b>Pic 1 Desc.</b>	Triple stack compost filter sock in place around drainage.		<b>Pic 2 Desc.</b>	RCE in place at entrance of LDY 26.

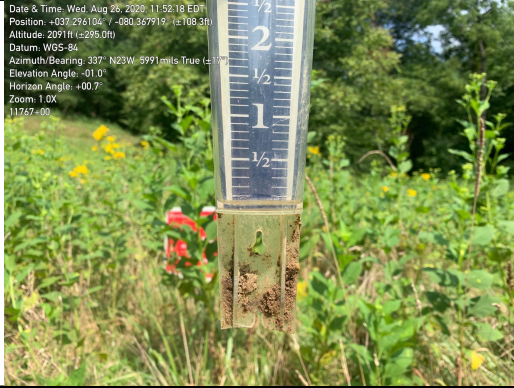
<p>Date &amp; Time: Wed, Aug 26, 2020 11:52:18 EDT Position: +337 324104 / -080 379119 / -1108.3N Altitude: 2091ft (-299.0m) Datum: WGS 84 Azimuth/Bearing: 337° N23W 5991mils True (-12°) Elevation Angle: -51.0° Horizon Angle: -100.7° Horizon Angle: -100.7° Zoom: 1.0X 11267-00</p>

<b>GPS Location</b>	See photo for GPS location.		<b>GPS Location</b>	See photo for GPS location.	
<b>Field Station#</b>	10883+50		<b>Field Station#</b>	11767+00	
<b>Pic 5 Desc.</b>	Rain gauge at Kow Camp Road reads 0.2 inches.		<b>Pic 6 Desc.</b>	Rain gauge at Mount Tabor Road read 0.1 inches.

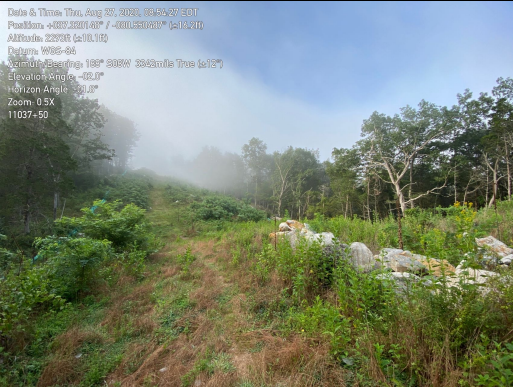
<b>GPS Location</b>	1	<b>GPS Location</b>	2		
<b>Field Station#</b>	11025+50	<b>Field Station#</b>	11037+50		
<b>Pic 1 Desc.</b>	S-IJ18 and controls.	<b>Pic 2 Desc.</b>	Section of RoW showing conditions and controls.

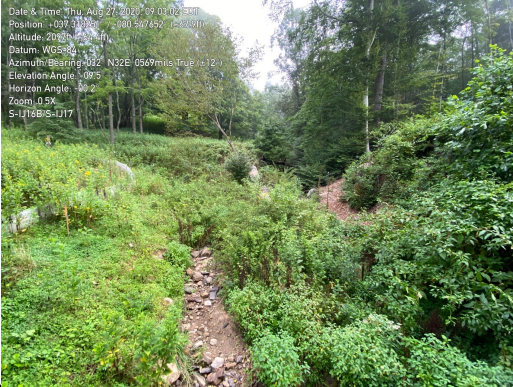
<b>GPS Location</b>	3	<b>GPS Location</b>	4		
<b>Field Station#</b>	11049+00	<b>Field Station#</b>	11050+10		
<b>Pic 3 Desc.</b>	Section of RoW showing conditions and controls.	<b>Pic 4 Desc.</b>	S-IJ16B/S-IJ17 and controls.

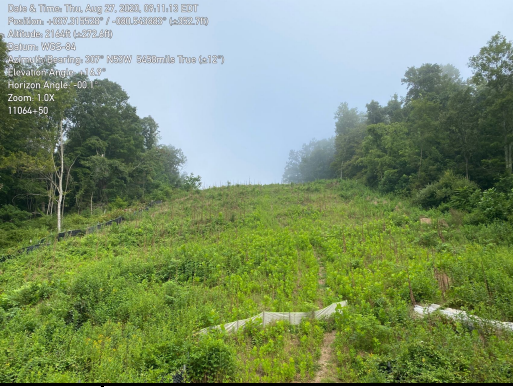
<b>GPS Location</b>	5	<b>GPS Location</b>	6		
<b>Field Station#</b>	11057+00	<b>Field Station#</b>	11064+50		
<b>Pic 5 Desc.</b>	Karst perimeter controls functional.	<b>Pic 6 Desc.</b>	Section of RoW showing conditions and controls.

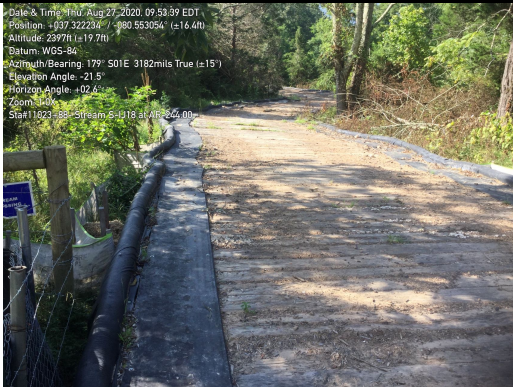
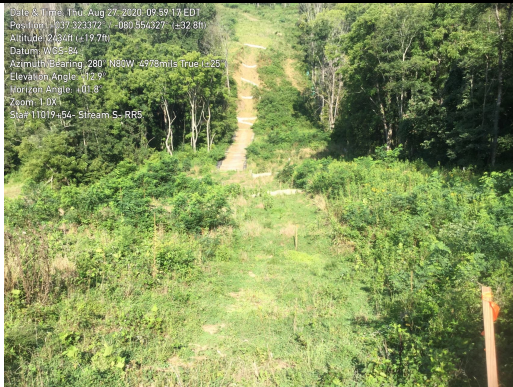
Date & Time: Thu, Aug 27, 2020, 09:53:39 EDT Position: +037 322238 / -080 553054 (+16.4ft) Altitude: 2397ft (+19.7ft) Datum: WGS-84 Azimuth/Bearing: 179° S01E 3182mils True (+15°) Elevation Angle: -21.5° Horizon Angle: +02.8° Zoom: 1.0X Sta#11023+88- Stream S- IJ18 at AR-244.00-		Date & Time: Thu, Aug 27, 2020, 09:58:13 EDT Position: +037 31933292 / -080 556327 (+16.4ft) Altitude: 2454ft (+19.7ft) Datum: WGS-84 Azimuth/Bearing: 280° N80W 4098mils True (+25°) Elevation Angle: -12.7° Horizon Angle: 01.8° Zoom: 1.0X Sta#11019+54- Stream S- RR5			
GPS Location	See photo GPS		GPS Location	See photo GPS	
Field Station#	11023+88		Field Station#	11019+54	
Pic 1 Desc.	S-IJ18 stream bridge at AR-244.00		Pic 2 Desc.	Slopes coming into stream S- RR5

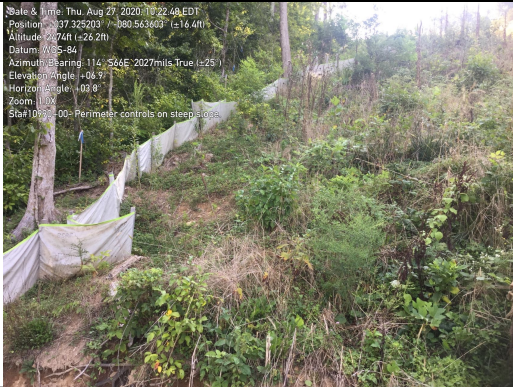
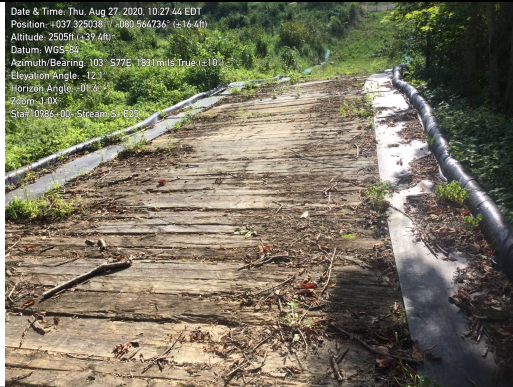
Date & Time: Thu, Aug 27, 2020, 10:22:48 EDT Position: +037 325203 / -080 563602 (+16.4ft) Altitude: 2747ft (+26.2ft) Datum: WGS-84 Azimuth/Bearing: 114° S34E 2027mils True (+25°) Elevation Angle: +04.9° Horizon Angle: +03.6° Zoom: 1.0X Sta#10990+00- Perimeter controls on steep slope.		Date & Time: Thu, Aug 27, 2020, 10:27:44 EDT Position: +037 325038 / -080 566736 (+16.4ft) Altitude: 2505ft (+39.4ft) Datum: WGS-84 Azimuth/Bearing: 103° S27E 1881mils True (+18°) Elevation Angle: -12.1° Horizon Angle: 01.6° Zoom: 1.0X Sta#10986+00- Stream S- E25

GPS Location	See photo GPS		GPS Location	See photo GPS	
Field Station#	10990+00		Field Station#	10986+00	
Pic 3 Desc.	Perimeter controls on steep slope.		Pic 4 Desc.	Stream S- E25- Equipment bridge and ECD's.

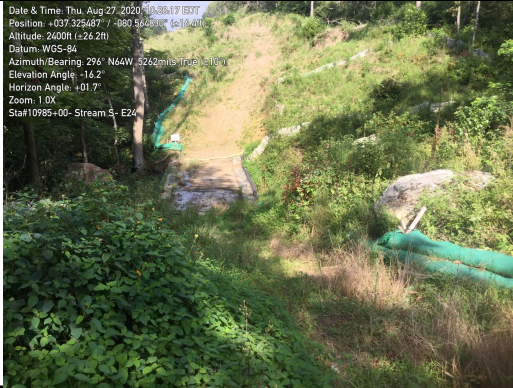
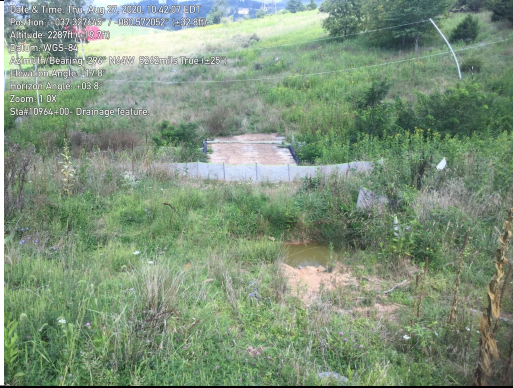
Date & Time: Thu, Aug 27, 2020, 10:36:17 EDT Position: +037 325497 / -080 562507 (+16.4ft) Altitude: 2400ft (+26.2ft) Datum: WGS-84 Azimuth/Bearing: 296° N64W 5262mils True (+10°) Elevation Angle: -16.2° Horizon Angle: +01.7° Zoom: 1.0X Sta#10985+00- Stream S- E24		Date & Time: Thu, Aug 27, 2020, 10:45:03 EDT Position: +037 32212309 / -080 562057 (+16.4ft) Altitude: 2297ft (+19.7ft) Datum: WGS-84 Azimuth/Bearing: 89° N89W 9343mils True (+24°) Elevation Angle: +07.9° Horizon Angle: +03.6° Zoom: 1.0X Sta#10964+00- Drainage feature			
GPS Location	See photo GPS		GPS Location	See photo GPS	
Field Station#	10985+00		Field Station#	10964+00	
Pic 5 Desc.	Stream S- E24- Bridge, buffers, travel lane.		Pic 6 Desc.	Drainage feature & controls.

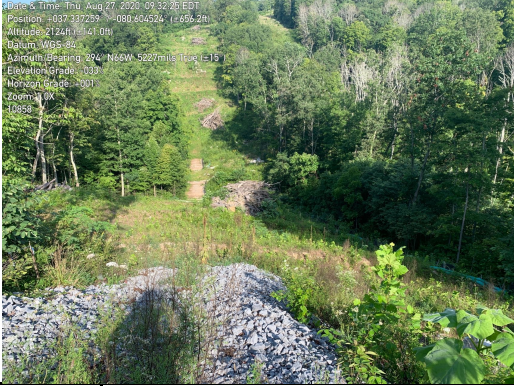
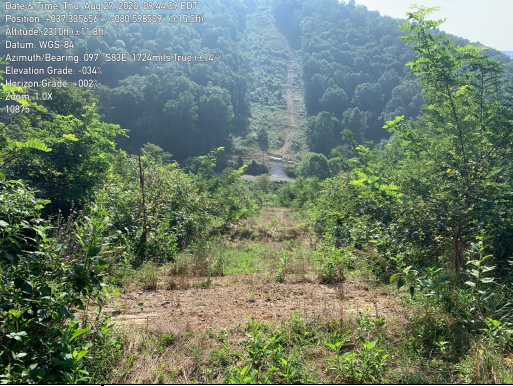
<b>GPS Location</b>	See picture above for GPS coordinates		<b>GPS Location</b>	See picture above for GPS coordinates	
<b>Field Station#</b>	10858+00		<b>Field Station#</b>	10875+00	
<b>Pic 1 Desc.</b>	ECD's and row conditions		<b>Pic 2 Desc.</b>	ECD's and row conditions	
<p>Date &amp; Time: Thu, Aug 27, 2020 09:53:35 EDT  Position: +097.334472 / -080.594948 (s15.26)  Altitude: 2340ft (s15.50)  Datum: WGS-84  Azimuth/Bearing: 002° N09E 0149mils True (s14°)  Elevation Grade: -003%  Horizon Grade: -1004%  Zoom: 1.0X  10890</p>

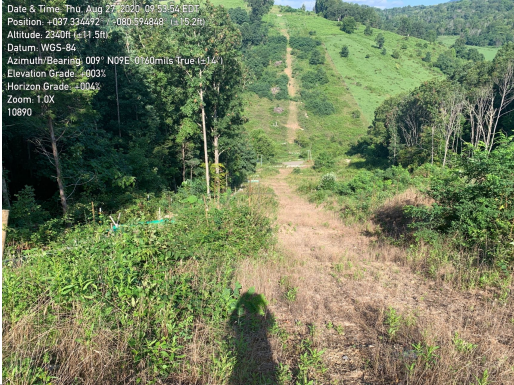
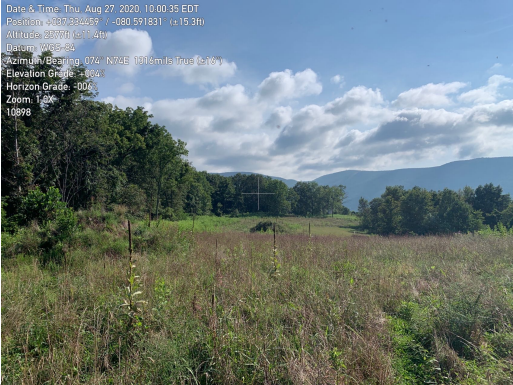
<b>GPS Location</b>	See picture above for GPS coordinates		<b>GPS Location</b>	See picture above for GPS coordinates	
<b>Field Station#</b>	10890+00		<b>Field Station#</b>	10898+00	
<b>Pic 3 Desc.</b>	ECD's and row conditions		<b>Pic 4 Desc.</b>	ECD's and row conditions	
<p>Date &amp; Time: Thu, Aug 27, 2020 10:06:29 EDT  Position: +097.334464 / -080.591928 (s15.31)  Altitude: 2517ft (s16.46)  Datum: WGS-84  Azimuth/Bearing: 152° S28E 2702mils True (s125°)  Elevation Grade: -072%  Horizon Grade: -001%  Zoom: 1.0X  10901</p>

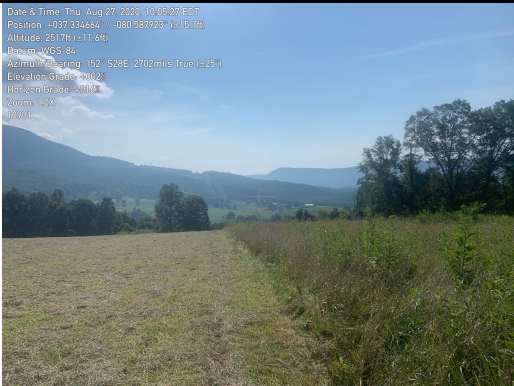
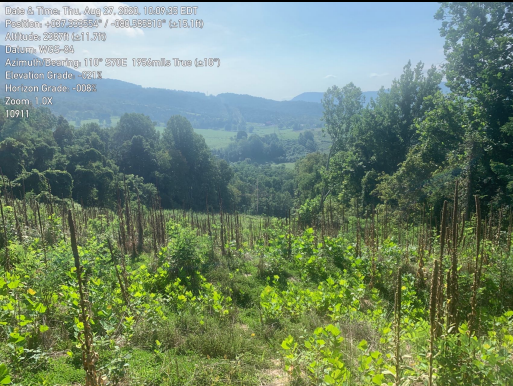
<b>Field Station#</b>	10901+00		<b>Field Station#</b>	10910+00	
<b>Pic 5 Desc.</b>	ECD's and row conditions		<b>Pic 6 Desc.</b>	ECD's and row conditions

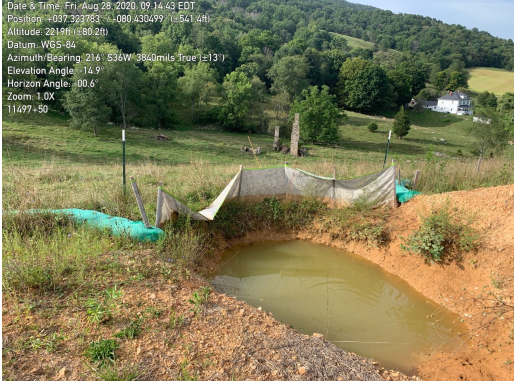
<b>AFE</b>	124300137	<b>Date/Time</b>	8/28/2020 2:28 PM	<b>Report #</b>	14072
<b>6. PCSM BMPs</b> (List BMPs and note if installed and maintained as per the plan. If corrective action is needed, a picture is required.)					
<b>PCSM BMPs</b>	<b>Compliance Level</b>	<b>Corrective Action</b>	<b>Corrective Time Frame</b>	<b>Date Repaired</b>	
<b>7. Identify all remedial measures that have been taken since the previous inspection was conducted.</b>					
<b>Comments</b> (Reference above questions as appropriate.)					
Conducted VA SWPPP inspection from MP 215 to MP 218.3. Since last inspection Precision Pipeline has conducted ECD maintenance and ECD upgrades where needed. No forward progress has been completed due to FERC shut down. Right of way has been stabilized using seed, mulch, and natural vegetation. Deficiencies located at station numbers; 11497+50 - broken priority one silt fence stake. 11487+00 - silt foam dike damaged 11447+75 - holes in priority one silt fence.

<b>GPS Location</b>	See photo for GPS location.		<b>GPS Location</b>	See photo for GPS location.	
<b>Field Station#</b>	11497+50		<b>Field Station#</b>	11487+00	
<b>Pic 1 Desc.</b>	Broken priority one silt fence.		<b>Pic 2 Desc.</b>	Silt foam dike damaged at landowner access point.

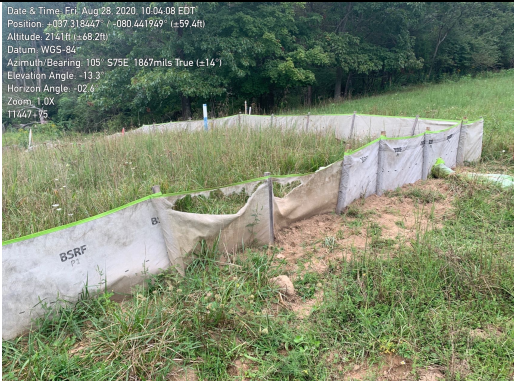
<p>Date &amp; Time: Fri, Aug 28, 2020, 10:04:08 EDT  Position: +037.31844° / -080.44194° (+59.4ft)  Altitude: 2141ft (+68.2ft)  Datum: WGS-84  Azimuth/Bearing: 105° S75E 1867mils True (+14°)  Elevation Angle: -13.3°  Horizon Angle: +02.4°  Zoom: 1.0X  11447+75</p>

<b>GPS Location</b>	See photo for GPS location.		<b>GPS Location</b>	See photo for GPS location.	
<b>Field Station#</b>	11447+75		<b>Field Station#</b>	11473+00	
<b>Pic 3 Desc.</b>	Holes in priority one silt fence.		<b>Pic 4 Desc.</b>	ECB used to stabilize two-tone.	
<p>Date &amp; Time: Fri, Aug 28, 2020, 10:20:30 EDT  Position: +037.25552° / -080.42614° (+1584.2ft)  Altitude: 2555ft (+160.2ft)  Datum: WGS-84  Azimuth/Bearing: 243° S33W 4010mils True (+10°)  Elevation Angle: -10.2°  Horizon Angle: +01.3°  Zoom: 1.0X  11489+00</p>

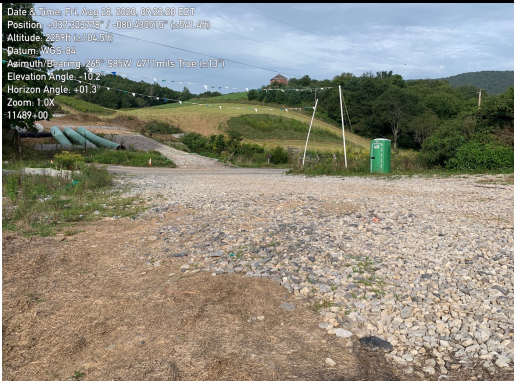
<b>GPS Location</b>	See photo for GPS location.		<b>GPS Location</b>	See photo for GPS location.	
<b>Field Station#</b>	11489+00		<b>Field Station#</b>	11403+00	
<b>Pic 5 Desc.</b>	RCE in place at Stevers Gap Road.		<b>Pic 6 Desc.</b>	Priority one silt fence repaired where holes were found previous inspection.

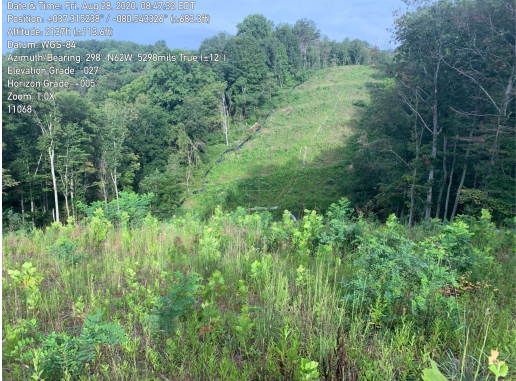
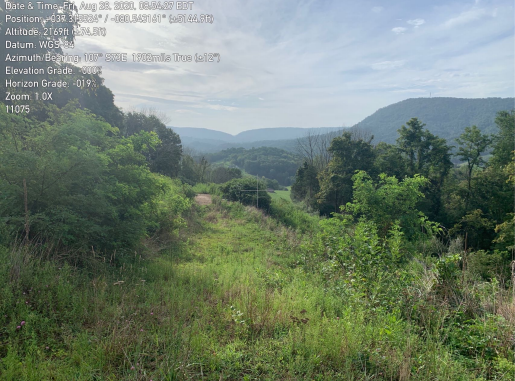
<b>GPS Location</b>	See picture above for GPS coordinates		<b>GPS Location</b>	See picture above for GPS coordinates	
<b>Field Station#</b>	11068+00		<b>Field Station#</b>	11075+00	
<b>Pic 1 Desc.</b>	ECD's and row conditions		<b>Pic 2 Desc.</b>	ECD's and row conditions

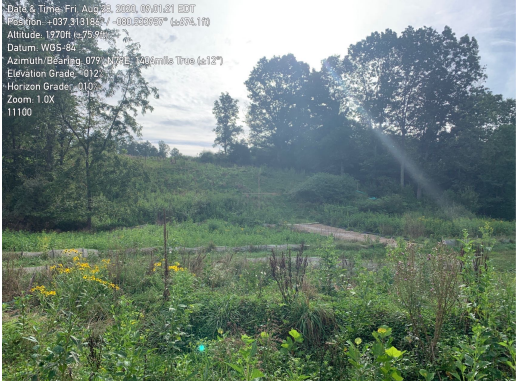
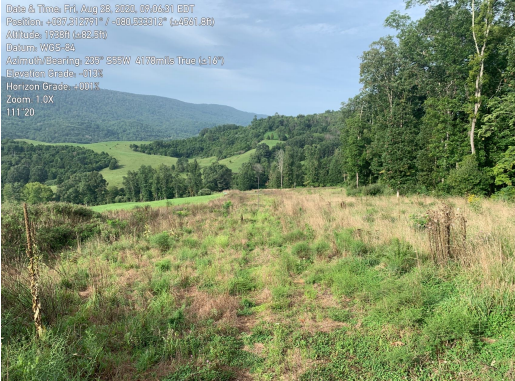
<b>GPS Location</b>	See picture above for GPS coordinates		<b>GPS Location</b>	See picture above for GPS coordinates	
<b>Field Station#</b>	11100+00		<b>Field Station#</b>	11120+00	
<b>Pic 3 Desc.</b>	ECD's and row conditions		<b>Pic 4 Desc.</b>	ECD's and row conditions

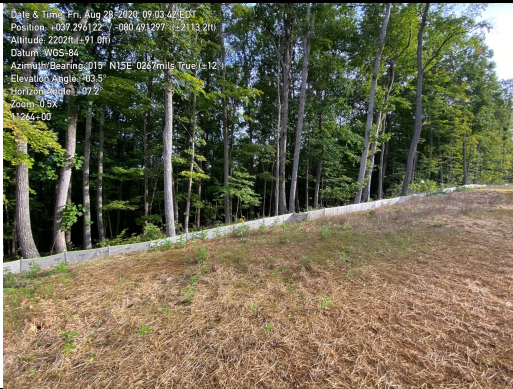
<p>Date &amp; Time: Fri, Aug 28, 2020, 09:03:42 EDT Position: +037 296122° / -080 491297° (+2113.2ft) Altitude: 2202ft (+51.0ft) Datum: WGS-84 Azimuth/Bearing: 019° N15E 022mils True (+12°) Elevation Angle: +03.5° Horizon Angle: +07.2° Zoom: 0.5X 11264+00</p>

<p>Date &amp; Time: Fri, Aug 28, 2020, 09:21:34 EDT Position: +037 295292° / -080 481382° (+13.5ft) Altitude: 2198ft (+11.3ft) Datum: WGS-84 Azimuth/Bearing: 163° S17E 289mils True (+12°) Elevation Angle: +07.4° Horizon Angle: +01.7° Zoom: 0.5X S-MM18</p>			
GPS Location	1	GPS Location	2		
Field Station#	11264+00	Field Station#	11292+80		
Pic 1 Desc.	Perimeter controls functional.	Pic 2 Desc.	S-MM18 and controls.

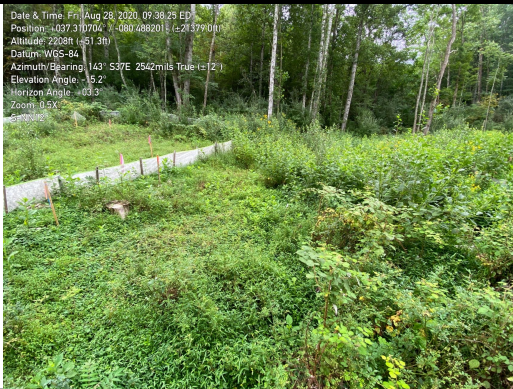
<p>Date &amp; Time: Fri, Aug 28, 2020, 09:30:29 EDT Position: +037 310704° / -080 488201° (+21379.0ft) Altitude: 2208ft (+51.3ft) Datum: WGS-84 Azimuth/Bearing: 143° S37E 2542mils True (+12°) Elevation Angle: +15.2° Horizon Angle: +03.3° Zoom: 0.5X S-MM12</p>

GPS Location	3	GPS Location	4		
Field Station#	11327+85	Field Station#	11331+25		
Pic 3 Desc.	S-NN12 and controls.	Pic 4 Desc.	Rock lined channel functional.

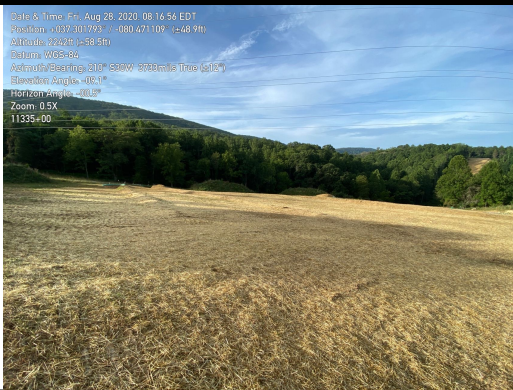
<p>Date &amp; Time: Fri, Aug 28, 2020, 08:16:56 EDT Position: +037 301793° / -080 471109° (+68.9ft) Altitude: 2220ft (+58.5ft) Datum: WGS-84 Azimuth/Bearing: 310° S90W 2033mils True (+10°) Elevation Angle: +08.1° Horizon Angle: +00.1° Zoom: 0.5X 11335+00</p>

<p>Date &amp; Time: Fri, Aug 28, 2020, 08:22:09 EDT Position: +037 305525° / -080 467198° (+52.7ft) Altitude: 2011ft (+27.7ft) Datum: WGS-84 Azimuth/Bearing: 144° S38E 2500mils True (+12°) Elevation Angle: +15.5° Horizon Angle: +02.2° Zoom: 0.5X S-NN11</p>			
GPS Location	5	GPS Location	6		
Field Station#	11335+00	Field Station#	11352+97		
Pic 5 Desc.	Section of RoW showing conditions and controls.	Pic 6 Desc.	S-NN11 and controls.
