# Visual Site Inspection Report

<b>Project Name</b>	H-600 Pipeline Spread G	<b>AFE</b>	124300137	<b>Spread</b>	H-600 Pipeline Spread G
<b>Contractor</b>	Precision			<b>Report #</b>	14137
<b>Inspector</b>	Rob Robertson			<b>Date/Time</b>	8/31/2020 12:30 PM
<b>Permit #</b>	TBD	<b>Inspection Type</b>	VA SWPP	<b>Station Begin</b>	11600+01
<b>State</b>	VA	<b>Inspection Area</b>	Full	<b>Station End</b>	11670+00
<b>County</b>	Montgomery	<b>Ground</b>	Muddy	<b>Temperature (°F)</b>	68.00
<b>Municipality</b>	N/A	<b>Weather</b>	Light Rain	<b>Rain Gauge (in)</b>	0.50
				<b>Rain Accumulation Time (days)</b>	1.00

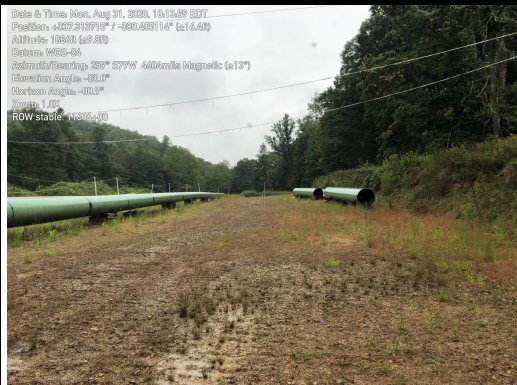
Insert image here		
GPS Location	On photo		GPS Location		
Field Station#	11606+00		Field Station#		
Pic 11 Desc.	ROW stable currently. Perimeter controls are in place.		Pic 12 Desc.

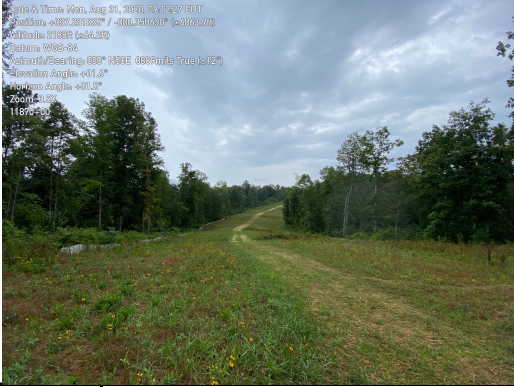
<b>GPS Location</b>	5	<b>GPS Location</b>	6		
<b>Field Station#</b>	11870+00	<b>Field Station#</b>	11899+75		
<b>Pic 5 Desc.</b>	Section of restored RoW showing conditions and controls.		<b>Pic 6 Desc.</b>	Section of restored RoW showing conditions and controls.

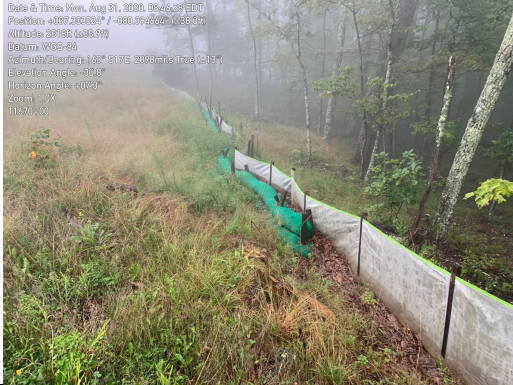
GPS Location	See photo for GPS location.		GPS Location	See photo for GPS location.	
Field Station#	11670+00		Field Station#	11670+75	
Pic 1 Desc.	Triple stack CFS and priority one silt fence in place along LOD.		Pic 2 Desc.	Fence and gate installed to prevent ATV trespassing.

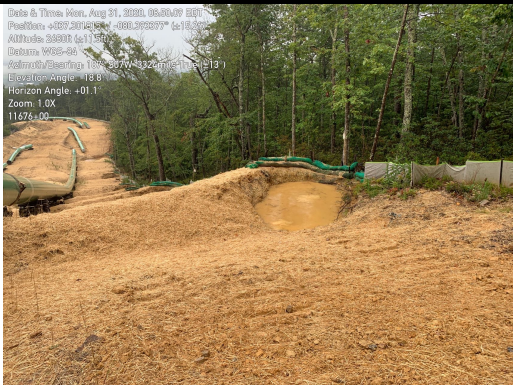
GPS Location	See photo for GPS location.		GPS Location	See photo for GPS location.	
Field Station#	11676+00		Field Station#	11687+40	
Pic 3 Desc.	Waterbar, sump pit, and waterbar end treatment in place. ROW stabilized with seed and mulch.		Pic 4 Desc.	Sensitive resource buffer in place at stream S-MN21.

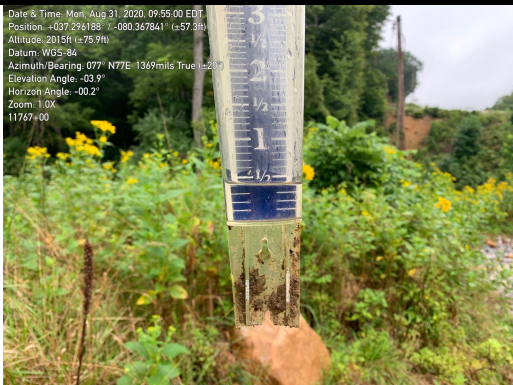
GPS Location	See photo for GPS location.		GPS Location	See photo for GPS location.	
Field Station#	11767+00		Field Station#	11767+00	
Pic 5 Desc.	Rain gauge at Mount Tabor Road reads 0.4 inches.		Pic 6 Desc.	RCE in place at Main Line Valve 26.

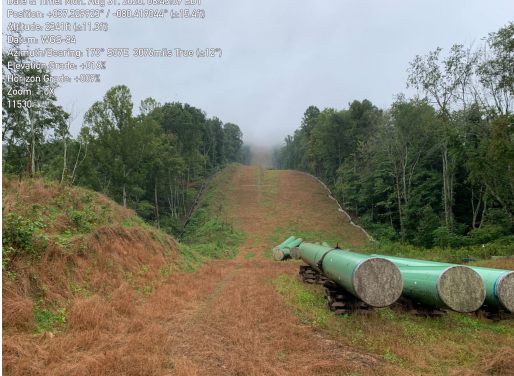
<b>GPS Location</b>	See picture above for GPS coordinates		<b>GPS Location</b>	See picture above for GPS coordinates	
<b>Field Station#</b>	11530+00		<b>Field Station#</b>	11545+00	
<b>Pic 1 Desc.</b>	ECD's and row conditions		<b>Pic 2 Desc.</b>	ECD's and row conditions

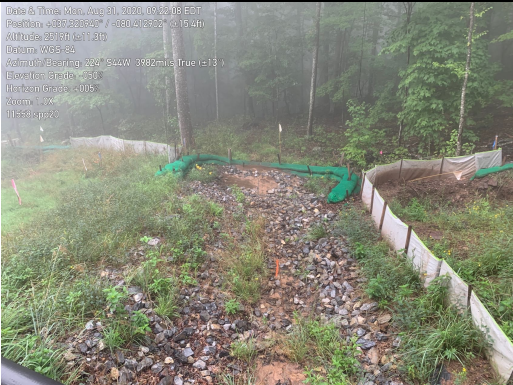
<b>GPS Location</b>	See picture above for GPS coordinates		<b>GPS Location</b>	See picture above for GPS coordinates	
<b>Field Station#</b>	11557+00		<b>Field Station#</b>	11558+00	
<b>Pic 3 Desc.</b>	Damaged P1		<b>Pic 4 Desc.</b>	ECD's and row conditions SPP22

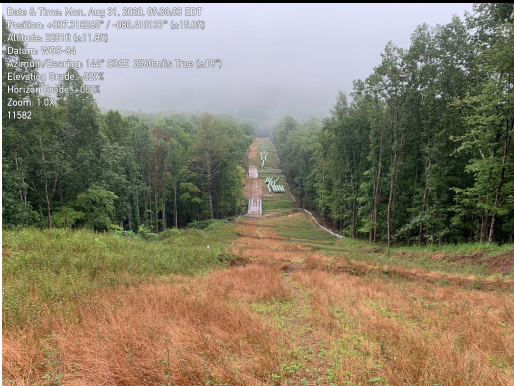
<b>GPS Location</b>	See picture above for GPS coordinates		<b>GPS Location</b>	See picture above for GPS coordinates	
<b>Field Station#</b>	11582+00		<b>Field Station#</b>	11585+00	
<b>Pic 5 Desc.</b>	ECD's and row conditions		<b>Pic 6 Desc.</b>	Damaged P1

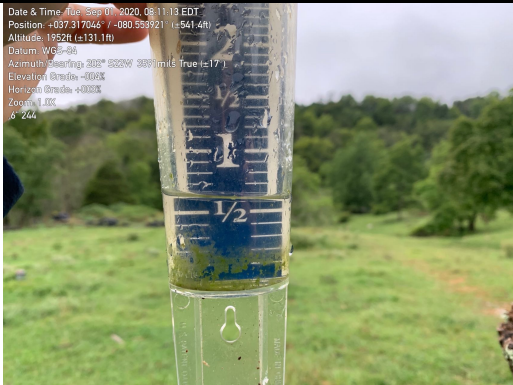
GPS Location	See picture above for GPS coordinates		GPS Location	See picture above for GPS coordinates	
Field Station#	+1		Field Station#	+1	
Pic 1 Desc.	.6" of rain recorded		Pic 2 Desc.	.7" of rain recorded

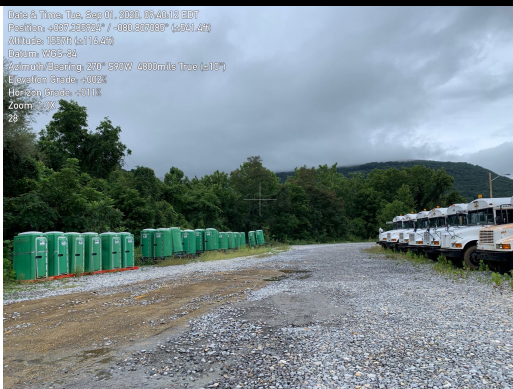
GPS Location	See picture above for GPS coordinates		GPS Location	See picture above for GPS coordinates	
Field Station#	12005+00		Field Station#	12005+00	
Pic 3 Desc.	ECD's and row conditions		Pic 4 Desc.	Secondary containment

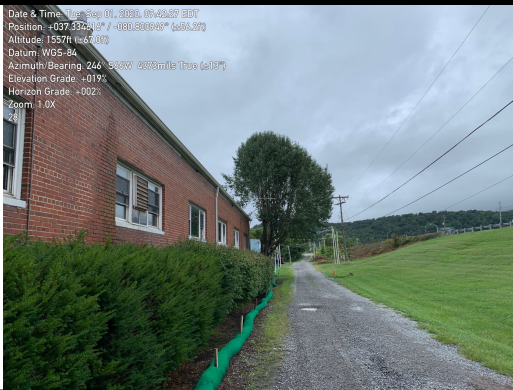
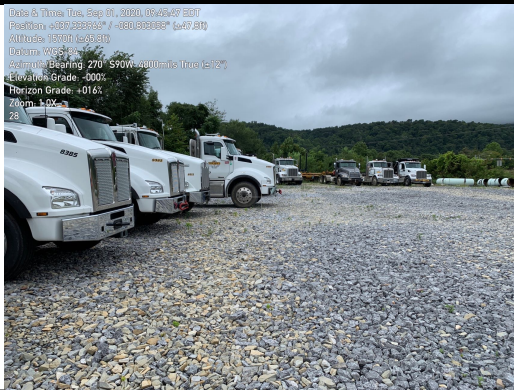
GPS Location	See picture above for GPS coordinates		GPS Location	See picture above for GPS coordinates	
Field Station#	12005+00		Field Station#	12005+00	
Pic 5 Desc.	ECD's and row conditions		Pic 6 Desc.	ECD's and row conditions

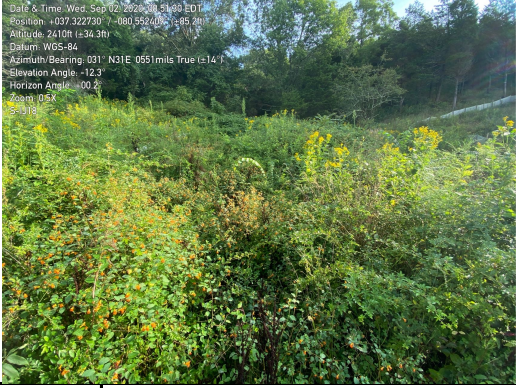
<p>Date &amp; Time: Wed, Sep 02, 2020, 07:46:00 EDT Position: +037.322730° / -080.552200° (-85.2m) Altitude: 2410ft (-634.3m) Datum: WGS-84 Azimuth/Bearing: 031° N31E 0551mils True (-14°) Elevation Angle: -12.3° Horizon Angle: -00.2° Zoom: 0.5X 11025+50</p>

<p>Date &amp; Time: Wed, Sep 02, 2020, 08:50:00 EDT Position: +037.374176° / -080.540000° (-83.2m) Altitude: 2521m (-824.9m) Datum: WGS-84 Azimuth/Bearing: 148° S148E 883mils True (-50°) Elevation Angle: -15.0° Horizon Angle: -00.1° Zoom: 1.0X 11034+00</p>			
<b>GPS Location</b>	1	<b>GPS Location</b>	2		
<b>Field Station#</b>	11025+50	<b>Field Station#</b>	11034+00		
<b>Pic 1 Desc.</b>	S-IJ18 and controls.	<b>Pic 2 Desc.</b>	Section of RoW showing conditions and controls.

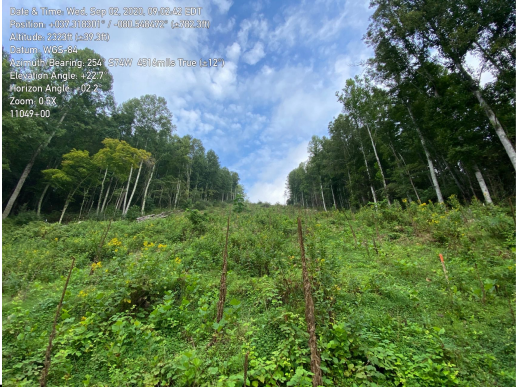
<p>Date &amp; Time: Wed, Sep 02, 2020, 09:04:00 EDT Position: +037.310000° / -080.549200° (-85.2m) Altitude: 2310ft (-693.0m) Datum: WGS-84 Azimuth/Bearing: 234° S234E 531mils True (-12°) Elevation Angle: -22° Horizon Angle: -02° Zoom: 0.8X 11049+00</p>

<b>GPS Location</b>	3	<b>GPS Location</b>	4		
<b>Field Station#</b>	11049+00	<b>Field Station#</b>	11050+10		
<b>Pic 3 Desc.</b>	Section of RoW showing conditions and controls.	<b>Pic 4 Desc.</b>	S-IJ16B/S-IJ17 and controls.

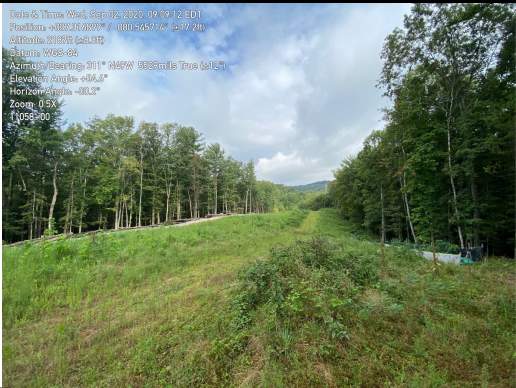
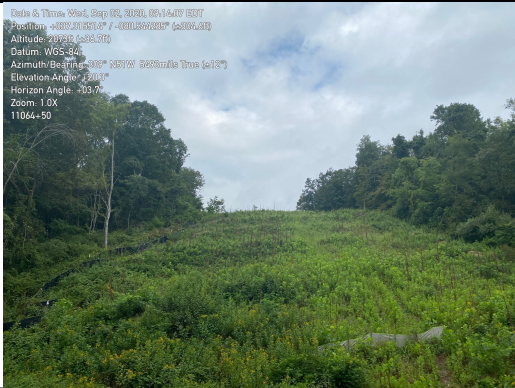
<p>Date &amp; Time: Wed, Sep 02, 2020, 09:44:00 EDT Position: +037.316510° / -080.546200° (-83.6m) Altitude: 2095ft (-638.5m) Datum: WGS-84 Azimuth/Bearing: -00° N00W 5023mils True (-13°) Elevation Angle: -10.0° Horizon Angle: -03.6° Zoom: 1.0X 11064+50</p>			
<b>GPS Location</b>	5	<b>GPS Location</b>	6		
<b>Field Station#</b>	11058+00	<b>Field Station#</b>	11064+50		
<b>Pic 5 Desc.</b>	Section of RoW showing conditions and controls.	<b>Pic 6 Desc.</b>	Section of RoW showing conditions and controls.

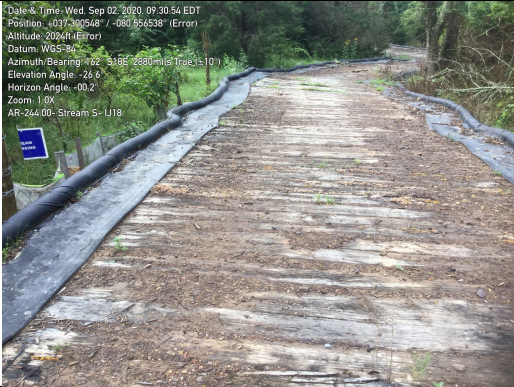
<p>Date &amp; Time: Wed, Sep 02, 2020, 09:30:54 EDT Position: +037.33250° / -080.556538° (Error) Altitude: 2024ft (+20m) Datum: WGS-84 Azimuth/Bearing: +62.5385° (338mils True) (+10°) Elevation Angle: -26.6° Horizon Angle: -00.2° Zoom: 1.0X Sta#10124-00- Stream S- IJ18</p>

<p>Date &amp; Time: Wed, Sep 02, 2020, 09:37:13 EDT Position: +037.332511° / -080.588362° (+0037.3325) Altitude: 2024ft (+20m) Datum: WGS-84 Azimuth/Bearing: 291° N49W 5173mils True (+10°) Elevation Angle: -08.2° Horizon Angle: -00.2° Zoom: 1.0X Sta#10121-00- Stream S- RR5</p>		<b>GPS Location</b>	See photo GPS
<b>Field Station#</b>	11023+88	<b>Field Station#</b>	11017+00	<b>GPS Location</b>	See photo GPS
<b>Pic 1 Desc.</b>	AR-244- Stream S-IJ18	<b>Pic 2 Desc.</b>	Stream S- RR5, buffers & ECD's

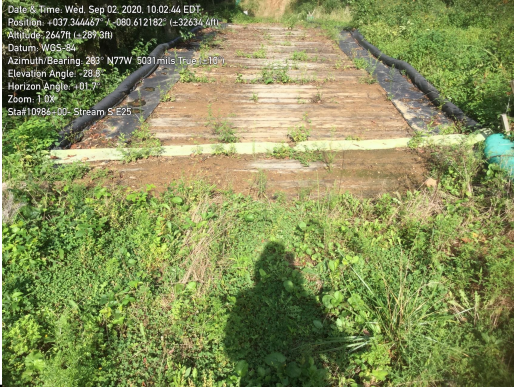
<p>Date &amp; Time: Wed, Sep 02, 2020, 10:02:44 EDT Position: +037.344667° / -080.612182° (+32634.6ft) Altitude: 2647ft (+2693ft) Datum: WGS-84 Azimuth/Bearing: 282° N77W 5331mils True (+10°) Elevation Angle: -28.6° Horizon Angle: -01.7° Zoom: 1.0X Sta#10986-00- Stream S-E25</p>

<b>Field Station#</b>	10986+00	<b>Field Station#</b>	10985+00	<b>GPS Location</b>	See photo GPS
<b>Pic 3 Desc.</b>	Stream S- E25- Bridge & ECD's.	<b>Pic 4 Desc.</b>	Stream S- E24- Buffers, bridge & ECD's

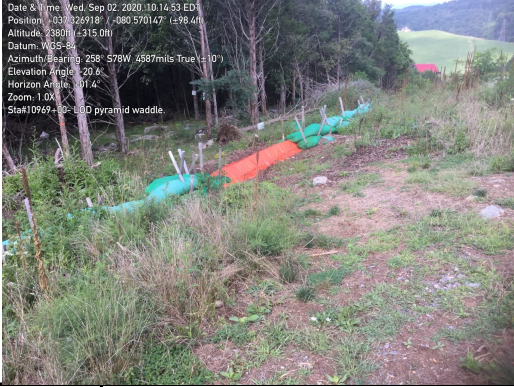
<p>Date &amp; Time: Wed, Sep 02, 2020, 10:14:53 EDT Position: +037.329118° / -080.570147° (+98.4ft) Altitude: 1980ft (+1915ft) Datum: WGS-84 Azimuth/Bearing: 258° S78W 4587mils True (+10°) Elevation Angle: -20.8° Horizon Angle: -01.4° Zoom: 1.0X Sta#10969-00- LOD pyramid waddle</p>

<b>Pic 5 Desc.</b>	LOD pyramid waddle	<b>Pic 6 Desc.</b>	Sensitive resource ECD's.

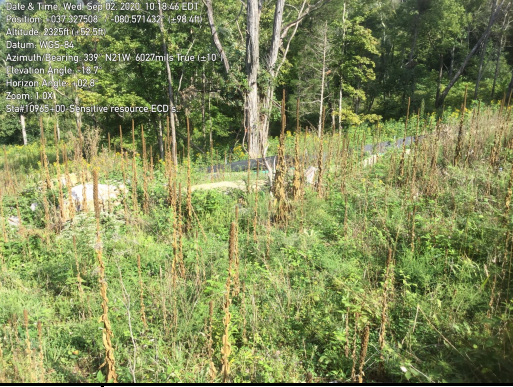
<p>Date &amp; Time: Wed, Sep 02, 2020, 10:19:46 EDT Position: +037.322254° / -080.571453° (+98.4ft) Altitude: 2325ft (+22.5ft) Datum: WGS-84 Azimuth/Bearing: 339° N21W 4027mils True (+10°) Elevation Angle: -18.7° Horizon Angle: -00.8° Zoom: 1.0X Sta#10965-00- Sensitive resource ECD</p>		<b>GPS Location</b>	See photo GPS
<b>Field Station#</b>	10969+00	<b>Field Station#</b>	10965+00	<b>GPS Location</b>	See photo GPS

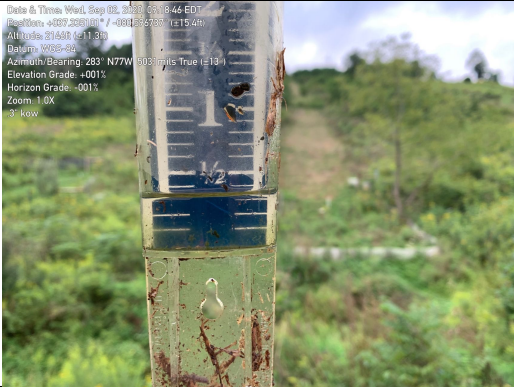
<p>Date &amp; Time: Wed, Sep 02, 2020, 07:18:44 EDT Position: +489.288361° / +680.367760° (+62.8°) Altitude: 2140ft (+611.5ft) Datum: WGS-84 Azimuth/Bearing: 283° N77W 593mils True (+13°) Elevation Grade: +001% Horizon Grade: -001% Zoom: 1.0x 3. kow</p>

<p>Date &amp; Time: Wed, Sep 02, 2020, 10:13:25 EDT Position: +487.787411° / +680.367760° (+62.8°) Altitude: 2080ft (+622.3ft) Datum: WGS-84 Azimuth/Bearing: 335° N25W 595mils True (+13°) Elevation Grade: +002% Horizon Grade: +003% Zoom: 1.0x 1" tabee</p>			
<b>GPS Location</b>	See picture above for GPS coordinates		<b>GPS Location</b>	See picture above for GPS coordinates	
<b>Field Station#</b>	+1		<b>Field Station#</b>	+1	
<b>Pic 1 Desc.</b>	.3" of rain recorded @ Kow Camp		<b>Pic 2 Desc.</b>	.1" of rain recorded @ Tabor

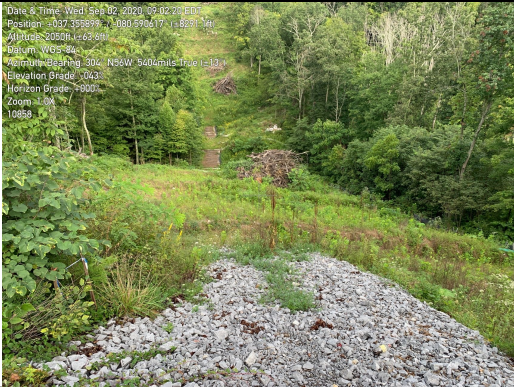
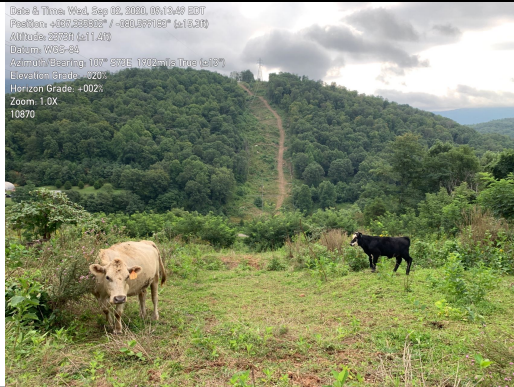
<b>GPS Location</b>	See picture above for GPS coordinates		<b>GPS Location</b>	See picture above for GPS coordinates	
<b>Field Station#</b>	10858+00		<b>Field Station#</b>	10870+00	
<b>Pic 3 Desc.</b>	ECD's and row conditions		<b>Pic 4 Desc.</b>	ECD's and row conditions

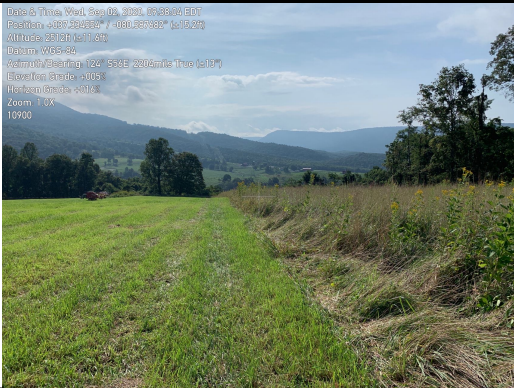
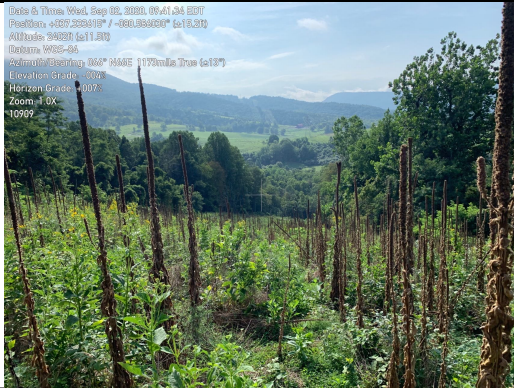
<b>Field Station#</b>	10900+00		<b>Field Station#</b>	10909+00	
<b>Pic 5 Desc.</b>	ECD's and row conditions		<b>Pic 6 Desc.</b>	ECD's and row conditions

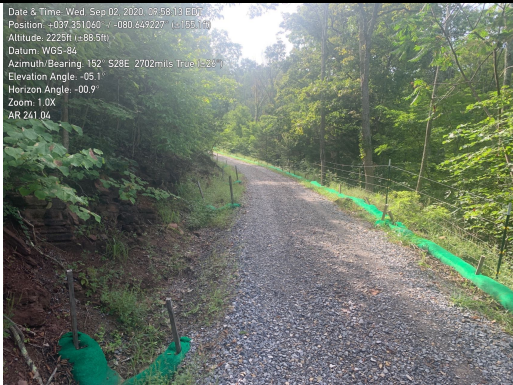
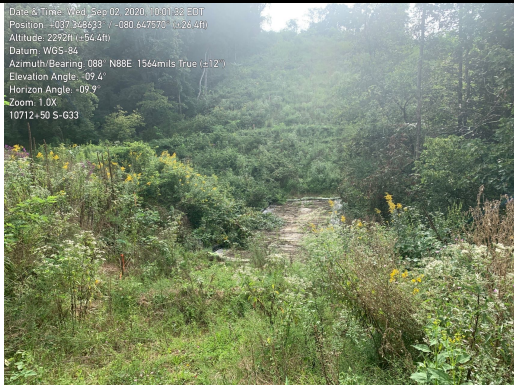
<p>Date &amp; Time: Wed Sep 02 2020 10:01:35 EDT Position: -037.245633, -080.647573, 11.284410 Altitude: 2292ft (+94.4ft) Datum: WGS-84 Azimuth/Bearing: 088° N88E 1544mils True (+12.1) Elevation Angle: -09.4 Horizon Angle: -00.9 Zoom: 1.0X 10712+50 S-G33</p>			
GPS Location	See photo for GPS location.		GPS Location	See photo for GPS location.	
Field Station#	10711+00		Field Station#	10712+50	
Pic 1 Desc.	CFS in place along AR 241.04.		Pic 2 Desc.	Sensitive resource buffer in place at stream S-G33.

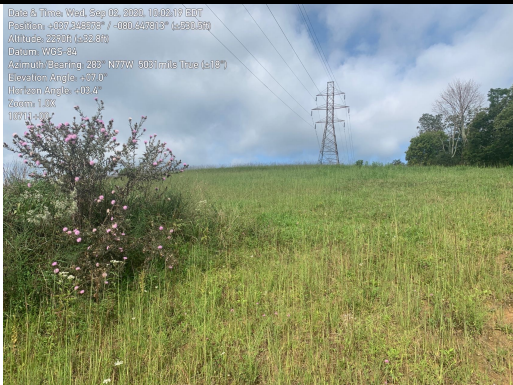
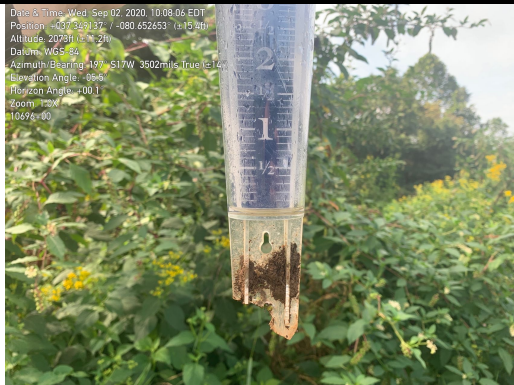
GPS Location	See photo for GPS location.		GPS Location	See photo for GPS location.	
Field Station#	10711+00		Field Station#	10696+00	
Pic 3 Desc.	ROW stabilized with natural vegetation growth.		Pic 4 Desc.	Rain gauge at Buffalo Anklets Road reads a trace amount.

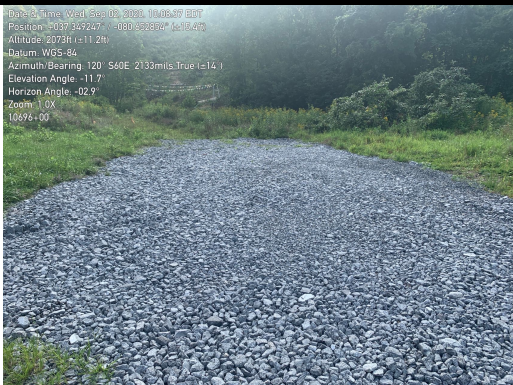
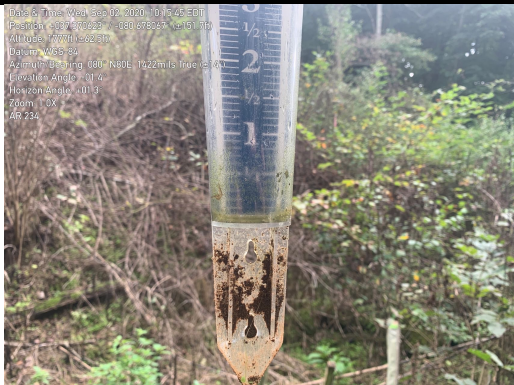
Pic 5 Desc.	RCE in place at Buffalo Anklets Road.		Pic 6 Desc.	Rain gauge at AR 234 reads a trace amount.

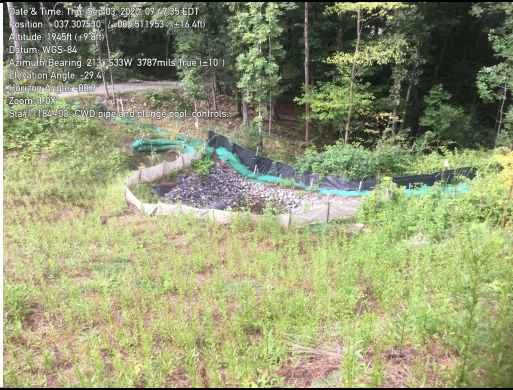
<p>Date &amp; Time: Thu, Sep 03, 2020 09:44:35 EDT  Position: +037.302510° / -080.511953° (+16.4ft)  Altitude: 1945ft (+26.2ft)  Datum: WGS-84  Azimuth/Bearing: 213° S33W 3787mils True (+10)  Elevation Angle: -29.4°  Horizon Angle: +00.9°  Zoom: 1.0X  Sta#11184+00- CWD pipe and plunge pool controls.</p>

<b>GPS Location</b>	See photo GPS	<b>GPS Location</b>	See photo GPS		
<b>Field Station#</b>	11190+00	<b>Field Station#</b>	11184+00		
<b>Pic 5 Desc.</b>	Sensitive resource area, row and drainage feature ECD's.	<b>Pic 6 Desc.</b>	CWD pipe and plunge pool.

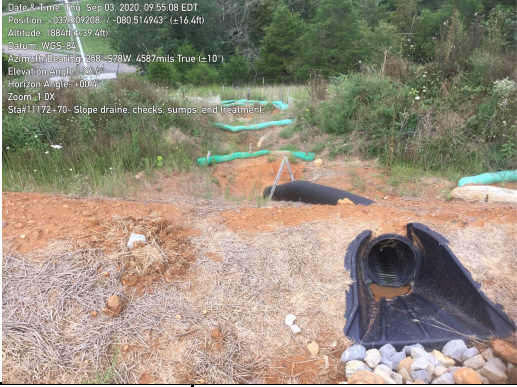
<b>GPS Location</b>	See photo GPS	<b>GPS Location</b>			
<b>Field Station#</b>	11172+70	<b>Field Station#</b>			
<b>Pic 7 Desc.</b>	Slope drain pipe, checks, sump pits, end treatment.	<b>Pic 8 Desc.</b>			
Insert image here		Insert image here			
<b>GPS Location</b>		<b>GPS Location</b>			
<b>Field Station#</b>		<b>Field Station#</b>			
<b>Pic 9 Desc.</b>		<b>Pic 10 Desc.</b>			
Insert image here		Insert image here			
<b>GPS Location</b>		<b>GPS Location</b>			
<b>Field Station#</b>		<b>Field Station#</b>			
<b>Pic 11 Desc.</b>		<b>Pic 12 Desc.</b>

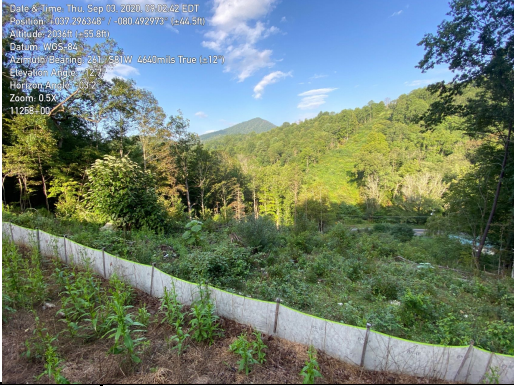
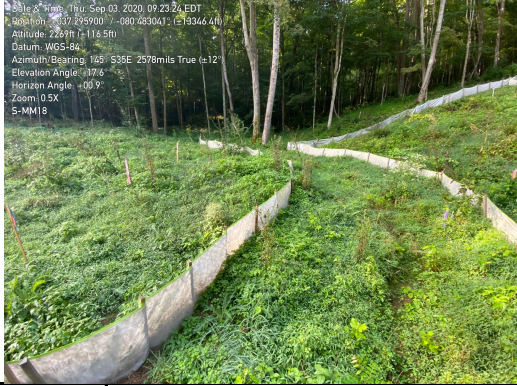
<p>Date &amp; Time: Thu, Sep 03, 2020, 09:23:24 EDT Position: +037.295900 / -080.483041 (+19.4ft) Altitude: 2219ft (+116.9ft) Datum: WGS-84 Azimuth/Bearing: 145 S38E 2578mils True (+12°) Elevation Angle: +37.6° Horizon Angle: +00.9° Zoom: 0.5X S-MM18</p>			
<b>GPS Location</b>	1	<b>GPS Location</b>	2		
<b>Field Station#</b>	11258+00	<b>Field Station#</b>	11292+80		
<b>Pic 1 Desc.</b>	Clearing stop/skip location.	<b>Pic 2 Desc.</b>	S-MM18 and controls.

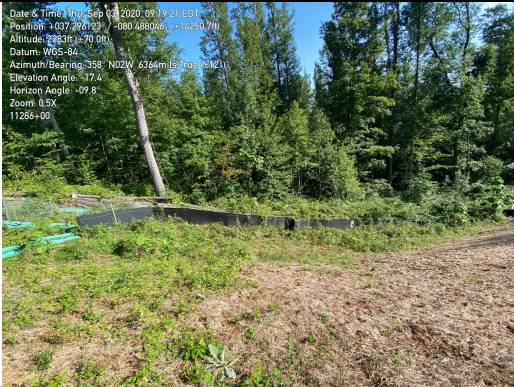
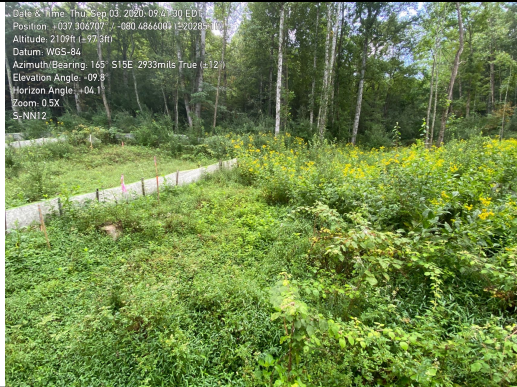
<b>GPS Location</b>	3	<b>GPS Location</b>	4		
<b>Field Station#</b>	11286+00	<b>Field Station#</b>	11327+85		
<b>Pic 3 Desc.</b>	Perimeter controls functional.	<b>Pic 4 Desc.</b>	S-NN12 and controls.

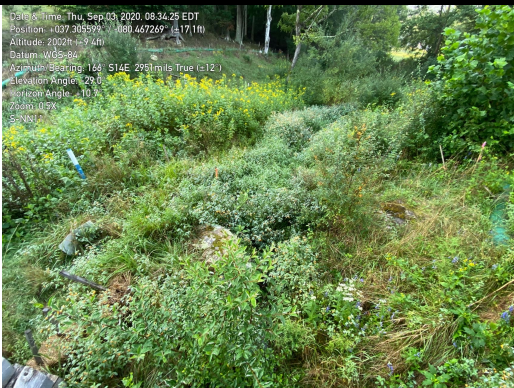
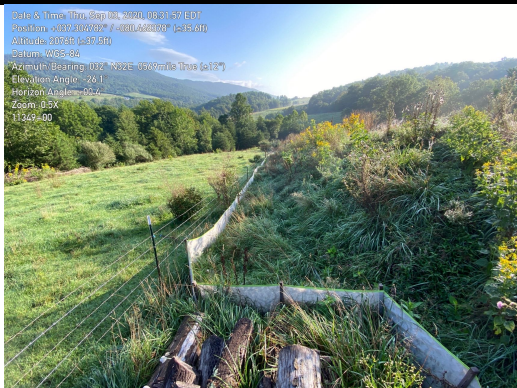
<p>Date &amp; Time: Thu, Sep 03, 2020, 08:31:57 EDT Position: +037.349727 / -080.468107 (+14.4ft) Altitude: 2020ft (+3.4ft) Datum: WGS-84 Azimuth/Bearing: 032 N02E 4629mils True (+15°) Elevation Angle: +26.1° Horizon Angle: +03.7° Zoom: 0.5X 11349+00</p>			
<b>GPS Location</b>	5	<b>GPS Location</b>	6		
<b>Field Station#</b>	11352+97	<b>Field Station#</b>	11349+00		
<b>Pic 5 Desc.</b>	S-NN11 and controls.	<b>Pic 6 Desc.</b>	Perimeter controls functional.

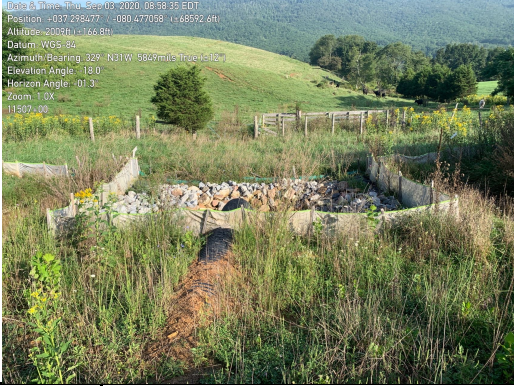
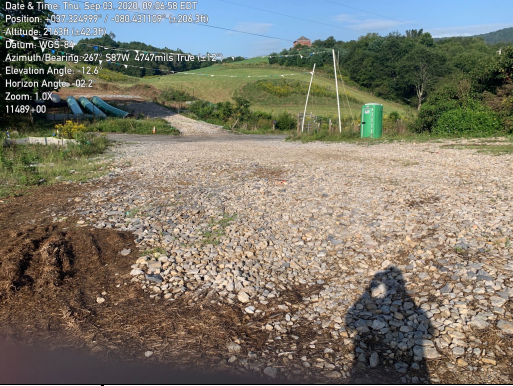
<b>GPS Location</b>	See photo for GPS location.		<b>GPS Location</b>	See photo for GPS location.	
<b>Field Station#</b>	11507+00		<b>Field Station#</b>	11489+00	
<b>Pic 1 Desc.</b>	Clean water diversion pipe and plunge pool in place.		<b>Pic 2 Desc.</b>	RCE in place at Stevers Gap Road.

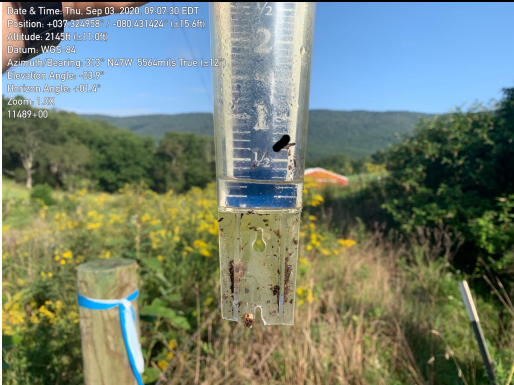
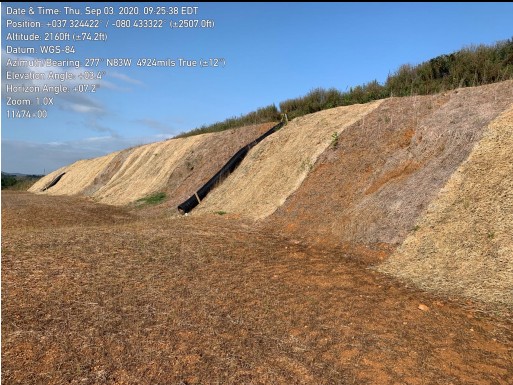
<b>GPS Location</b>	See photo for GPS location.		<b>GPS Location</b>	See photo for GPS location.	
<b>Field Station#</b>	11489+00		<b>Field Station#</b>	11474+00	
<b>Pic 3 Desc.</b>	Rain gauge at Stevers Gap Rad reads 0.3 inches.		<b>Pic 4 Desc.</b>	Two-tone stabilized with ECB.

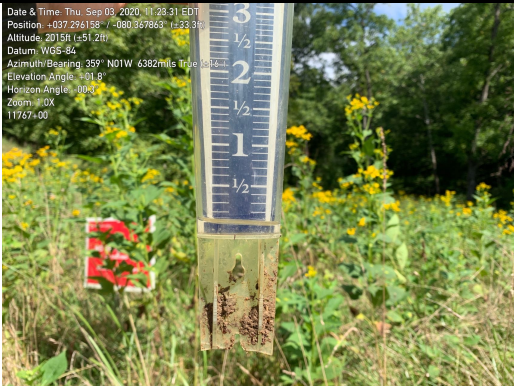
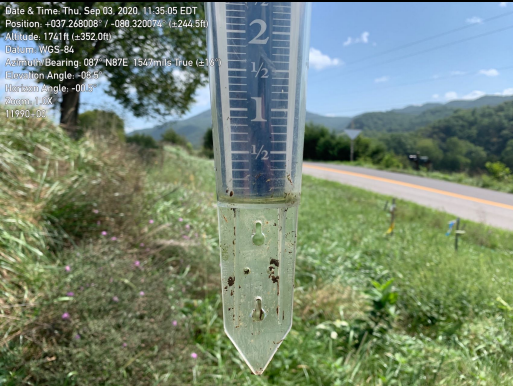
<b>GPS Location</b>	See photo for GPS location.		<b>GPS Location</b>	See photo for GPS location.	
<b>Field Station#</b>	11767+00		<b>Field Station#</b>	11990+00	
<b>Pic 5 Desc.</b>	Rain gauge at Mount Tabor Road reads 0.1 inches.		<b>Pic 6 Desc.</b>	Rain gauge at Catawba Road reads a trace amount.

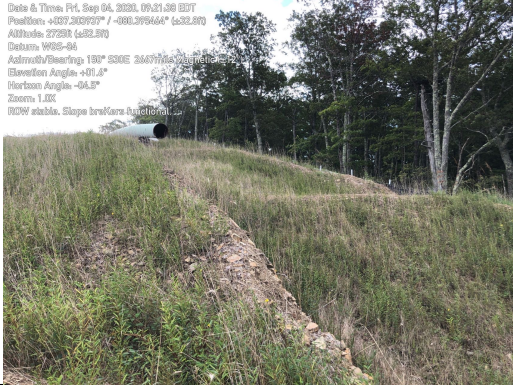
<p>Date &amp; Time: Fri, Sep 04, 2020, 09:26:07 EDT Position: +037.20468° / -080.396075° (±16.4m) Altitude: 2706ft (±39.4ft) Datum: WGS-84 Azimuth/Bearing: 249° S64W 442ft/mile Magnetic (±12°) Elevation Angle: -01° Horizon Angle: 00.0° Zoom: 1.0X Perimeter controls in place. 11663+00</p>

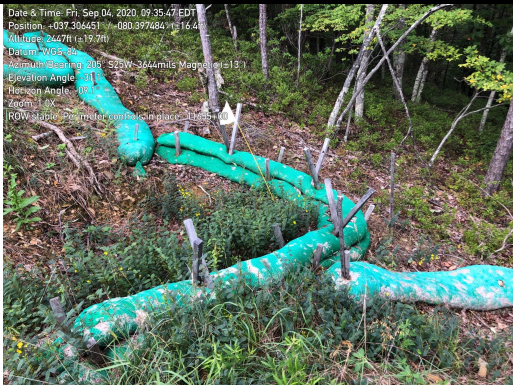
GPS Location		On photo		GPS Location	
Field Station#		11665+00		Field Station#	
Pic 1 Desc.		ROW stable. ECDs in place.		Pic 2 Desc.	
<p>Date &amp; Time: Fri, Sep 04, 2020, 09:35:47 EDT Position: +037.304651° / -080.397684° (±16.4m) Altitude: 2447ft (±19.7ft) Datum: WGS-84 Azimuth/Bearing: 328° S31W 344ft/mile Magnetic (±13°) Elevation Angle: -01° Horizon Angle: -02.7° Zoom: 1.0X ROW stable. Perimeter controls in place. 11665+00</p>

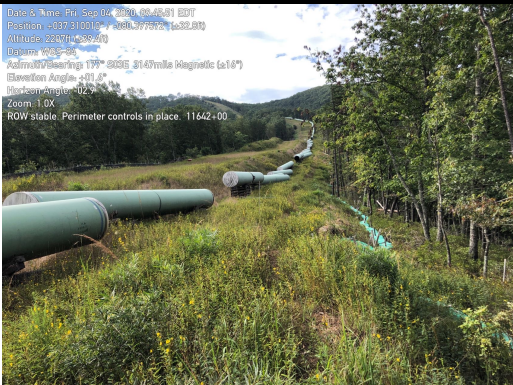
<p>Date &amp; Time: Fri, Sep 04, 2020, 09:40:01 EDT Position: +037.310016° / -080.397572° (±32.8ft) Altitude: 2371ft (±39.4ft) Datum: WGS-84 Azimuth/Bearing: 199° S03E 3147ft/mile Magnetic (±14°) Elevation Angle: +01.6° Horizon Angle: -02.7° Zoom: 1.0X ROW stable. Perimeter controls in place. 11642+00</p>

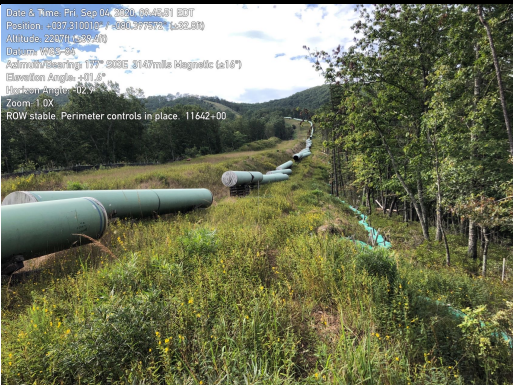
<p>Date &amp; Time: Fri, Sep 04, 2020, 09:48:01 EDT Position: +037.310016° / -080.397572° (±32.8ft) Altitude: 2371ft (±39.4ft) Datum: WGS-84 Azimuth/Bearing: 199° S03E 3147ft/mile Magnetic (±14°) Elevation Angle: +01.6° Horizon Angle: -02.7° Zoom: 1.0X ROW stable. Perimeter controls in place. 11642+00</p>

GPS Location		On photo		GPS Location	
Field Station#		11630+00		Field Station#	
Pic 5 Desc.		Perimeter controls are in place		Pic 6 Desc.

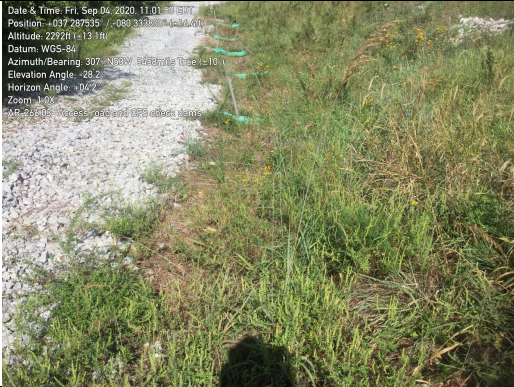
<p>Date &amp; Time: Fri, Sep 04, 2020, 11:01:30 EDT Position: 437.29735, -80.31331, 143.400 Altitude: 2277ft (+39.4ft) Datum: WGS-84 Azimuth/Bearing: 307° N 69° 04.83mils True (+10°) Elevation Angle: -28.2° Horizon Angle: -10.7° Zoom: 1.0x Sta#119001+00- Access road and controls.</p>

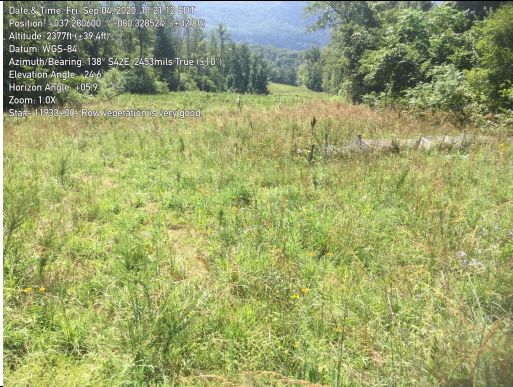
<p>Date &amp; Time: Fri, Sep 04, 2020, 11:21:19 EDT Position: 437.26260, -80.32632, 143.400 Altitude: 2277ft (+39.4ft) Datum: WGS-84 Azimuth/Bearing: 138° S 42E 2453mils True (+10°) Elevation Angle: -26.6° Horizon Angle: -10.7° Zoom: 1.0x Sta#11933+00- Row Vegetation is very good.</p>		<b>GPS Location</b>	See photo GPS
<b>Field Station#</b>	119001+00	<b>Field Station#</b>	11933+00	<b>GPS Location</b>	See photo GPS
<b>Pic 1 Desc.</b>	AR-266.03- Access road and controls.	<b>Pic 2 Desc.</b>	Row vegetation is very good.	<b>GPS Location</b>	See photo GPS

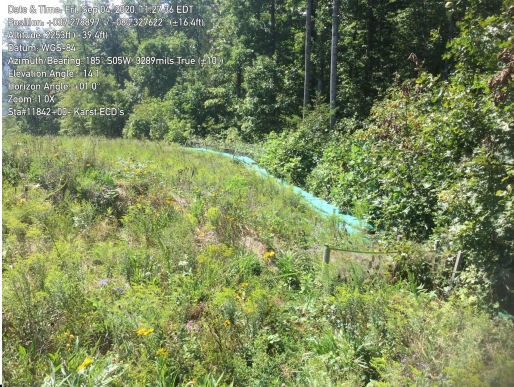
<p>Date &amp; Time: Fri, Sep 04, 2020, 11:24:01 EDT Position: 437.27263, -80.32762, 143.400 Altitude: 2066ft (+39.4ft) Datum: WGS-84 Azimuth/Bearing: 185° S 05W 389mils True (+10°) Elevation Angle: -12.4° Horizon Angle: -10.0° Zoom: 1.0x Sta#11942+00- Karst ECD's</p>

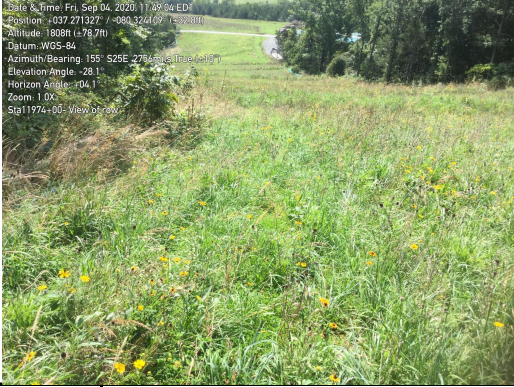
<p>Date &amp; Time: Fri, Sep 04, 2020, 11:39:04 EDT Position: 437.27122, -80.32269, 143.400 Altitude: 1809ft (+79.7ft) Datum: WGS-84 Azimuth/Bearing: 155° S 25E 2784mils True (+10°) Elevation Angle: -28.1° Horizon Angle: -10.4° Zoom: 1.0x Sta#11974+00- View of row, water bars and vegetation are in acceptable condition.</p>

<b>Field Station#</b>	11974+00	<b>Field Station#</b>	11986+00	<b>GPS Location</b>	See photo GPS
<b>Pic 5 Desc.</b>	View of the row, water bars and vegetation are in acceptable condition.	<b>Pic 6 Desc.</b>	Drainage feature ECD's	<b>GPS Location</b>	See photo GPS

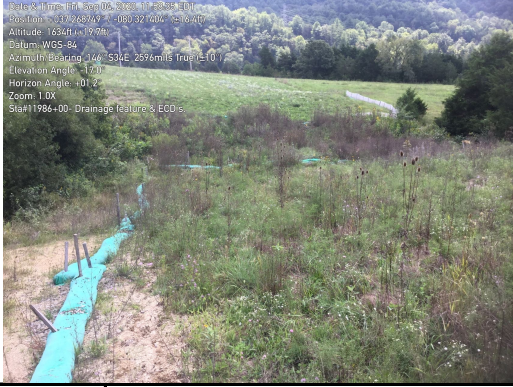
<p>Date &amp; Time: Fri, Sep 04, 2020, 11:39:45 EDT Position: 437.24849, -80.32700, 143.400 Altitude: 1634ft (+79.7ft) Datum: WGS-84 Azimuth/Bearing: 146° S 34E 2576mils True (+10°) Elevation Angle: -17.0° Horizon Angle: -10.7° Zoom: 1.0x Sta#11986+00- Drainage feature ECD's</p>		<b>GPS Location</b>	See photo GPS

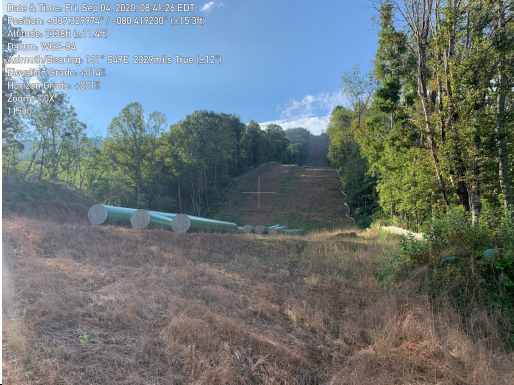
<p>Date &amp; Time: Fri, Sep 04, 2020 05:41:26 EDT Position: +039.321032 / -080.412989 / +15.31m Altitude: 2534ft (+11.4m) Datum: WGS-84 Azimuth/Bearing: 131° S30E 330mils True (+13°) Elevation Grade: +01% Horizon Grade: +01% Zoom: 1.0X 11530</p>

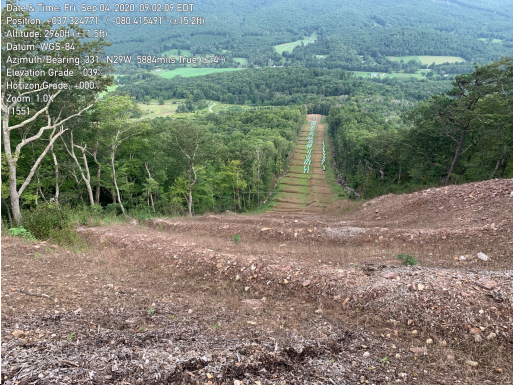
<p>Date &amp; Time: Fri, Sep 04, 2020 05:02:09 EDT Position: +037.325419 / -080.414290 / +15.41m Altitude: 2768ft (+7.1m) Datum: WGS-84 Azimuth/Bearing: 331° N29W 388mils True (+16°) Elevation Grade: +03% Horizon Grade: +00% Zoom: 1.0X 11551</p>			
<b>GPS Location</b>	See picture above for GPS coordinates		<b>GPS Location</b>	See picture above for GPS coordinates	
<b>Field Station#</b>	11530+00		<b>Field Station#</b>	11551+00	
<b>Pic 1 Desc.</b>	ECD's and row conditions		<b>Pic 2 Desc.</b>	ECD's and row conditions

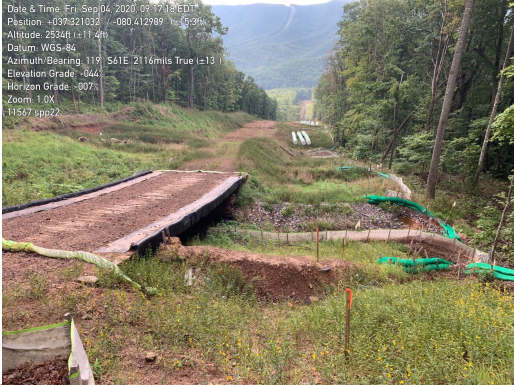
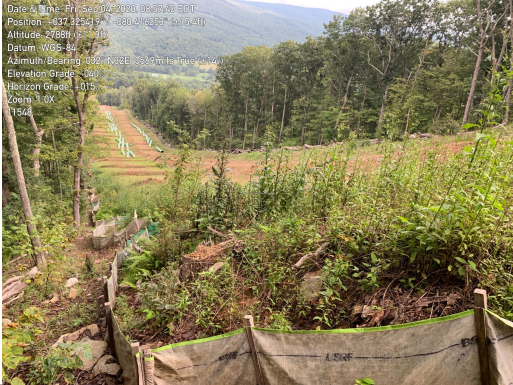
<b>GPS Location</b>	See picture above for GPS coordinates		<b>GPS Location</b>	See picture above for GPS coordinates	
<b>Field Station#</b>	11567+00		<b>Field Station#</b>	11548+00	
<b>Pic 3 Desc.</b>	ECD's and row conditions		<b>Pic 4 Desc.</b>	ECD's and row conditions

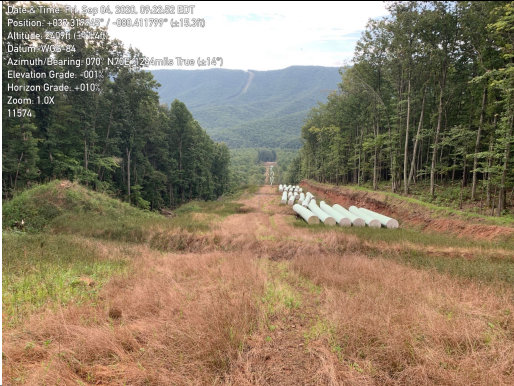
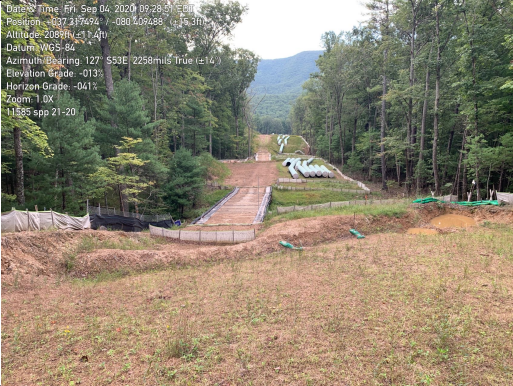
<b>Field Station#</b>	11574+00		<b>Field Station#</b>	11585+00	
<b>Pic 5 Desc.</b>	ECD's and row conditions		<b>Pic 6 Desc.</b>	ECD's and row conditions

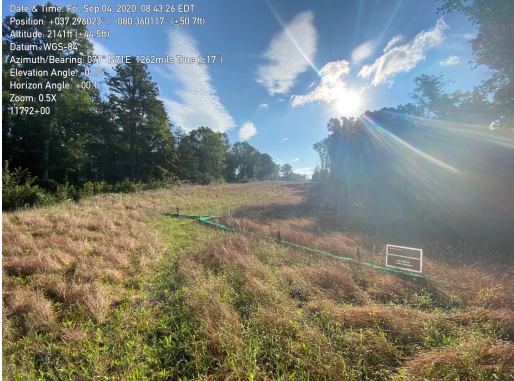
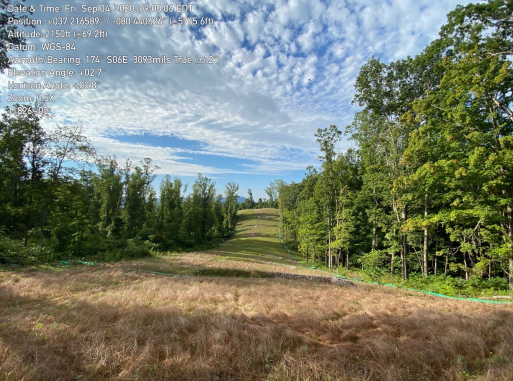
<b>GPS Location</b>	1	<b>GPS Location</b>	2		
<b>Field Station#</b>	11792+00	<b>Field Station#</b>	11826+00		
<b>Pic 1 Desc.</b>	Section of restored RoW showing conditions and controls.		<b>Pic 2 Desc.</b>	Section of restored RoW showing conditions and controls.

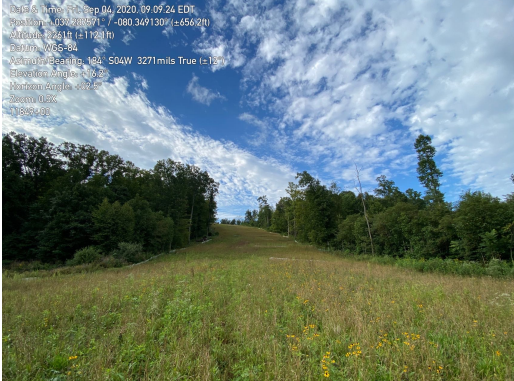
<b>GPS Location</b>	3	<b>GPS Location</b>	4		
<b>Field Station#</b>	11849+00	<b>Field Station#</b>	11863+65		
<b>Pic 3 Desc.</b>	Section of restored RoW showing conditions and controls.		<b>Pic 4 Desc.</b>	P-KL2 and controls.

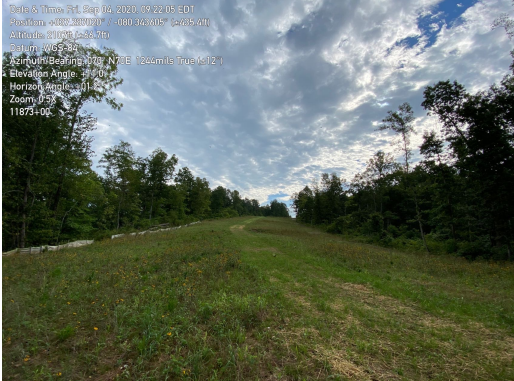
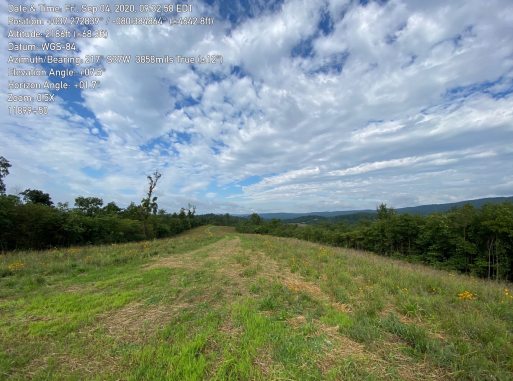
<b>GPS Location</b>	5	<b>GPS Location</b>	6		
<b>Field Station#</b>	11873+00	<b>Field Station#</b>	11899+50		
<b>Pic 5 Desc.</b>	Section of restored RoW showing conditions and controls.		<b>Pic 6 Desc.</b>	Section of restored RoW showing conditions and controls.

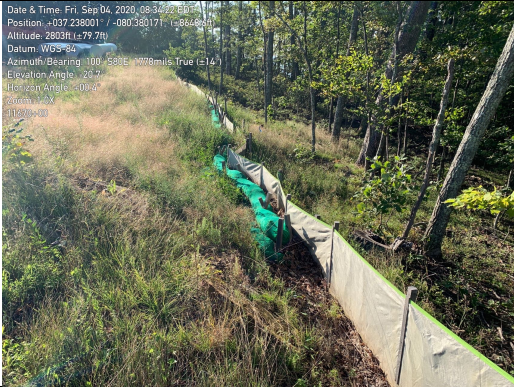
<b>GPS Location</b>	See photo for GPS location.		<b>GPS Location</b>	See photo for GPS location.	
<b>Field Station#</b>	11670+00		<b>Field Station#</b>	11672+00	
<b>Pic 1 Desc.</b>	Triple stack compost filter sock and priority one silt fence in place along LOD.		<b>Pic 2 Desc.</b>	ROW stabilized with seed and mulch.

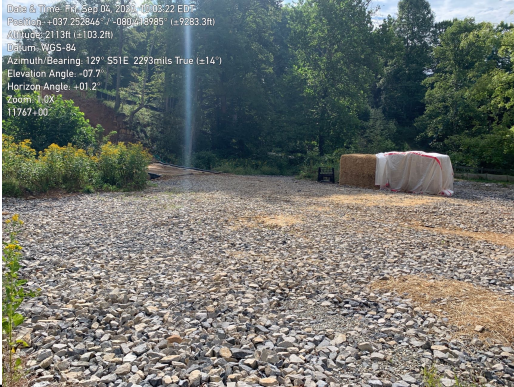
<b>GPS Location</b>	See photo for GPS location.		<b>GPS Location</b>	See photo for GPS location.	
<b>Field Station#</b>	11767+00		<b>Field Station#</b>	11687+40	
<b>Pic 3 Desc.</b>	RCE in place at Main Line Valve 26.		<b>Pic 4 Desc.</b>	Sensitive resource buffer in place at stream S-MN21.

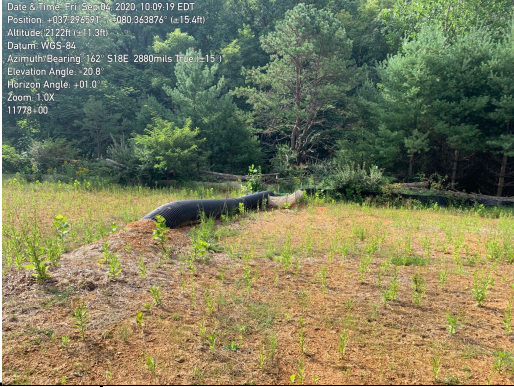
<b>GPS Location</b>	See photo for GPS location.		<b>GPS Location</b>	See photo for GPS location.	
<b>Field Station#</b>	11778+00		<b>Field Station#</b>	11776+00	
<b>Pic 5 Desc.</b>	Clean water diversion pipe and plunge pool in place.		<b>Pic 6 Desc.</b>	Reinforced super silt fence in place along LOD.
