Visual Site Inspection Report

Project Name	H-600 Pipeline Spread H	AFE	124300138	Spread	H-600 Pipeline Spread H
Contractor	Precision			Report #	11854
Inspector	John Brcic			Date/Time	6/15/2020 1:31 PM
Permit #	TBD	Inspection Type	VA SWPP	Station Begin	12433+75
State	VA	Inspection Area	Partial	Station End	12544+06
County	Montgomery	Ground	Wet	Temperature (°F)	60.00
Municipality	N/A	Weather	Light Rain	Rain Gauge (in)	1.00
				Rain Accumulation Time (days)	1.00

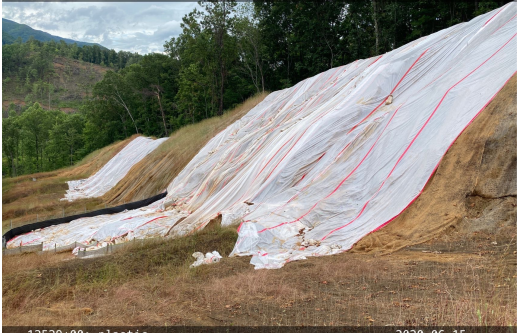
12529+00: plastic sheeting intact 2020-06-15 11:00:11-04:00		DIRECTION S (T) 37.21647°N 080.19755°W ACCURACY 19 m DATUM WGS84

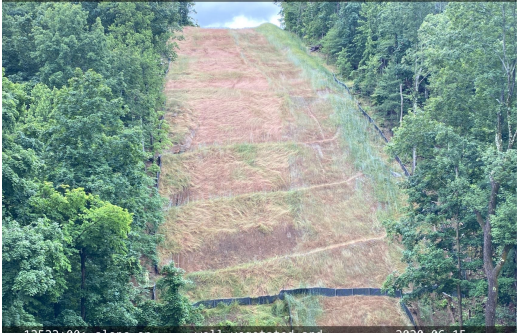
12522+00: slope on GAS side of S-EF19 well vegetated and stable 2020-06-15 11:42:52-04:00			
GPS Location	See photo		GPS Location	See photo	
Field Station#	12529+00		Field Station#	12522+00	
Pic 7 Desc.	Plastic sheeting on stockpiles approximately 1500 feet on CIS of Yellow Finch Road is intact and functioning properly.		Pic 8 Desc.	Slope on GAS of stream S-EF19 well vegetated and stable.	
DIRECTION N (T) 37.21569°N 080.19732°W ACCURACY 13 m DATUM WGS84

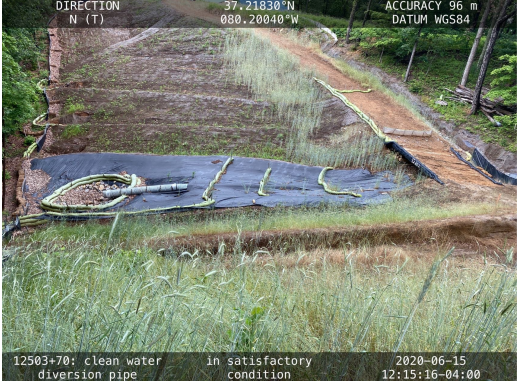
12503+70: clean water diversion pipe in satisfactory condition 2020-06-15 12:15:16-04:00			
GPS Location	See photo		GPS Location	See photo	
Field Station#	12517+00		Field Station#	12503+70	
Pic 11 Desc.	Slope on CIS of stream S-EF19 well vegetated and stable.		Pic 12 Desc.	Clean water diversion pipe in satisfactory condition between MLV-28 and stream S-EF19.

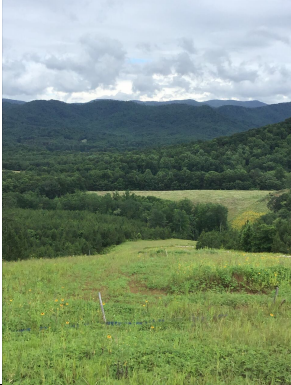
GPS Location	0000	GPS Location	00000		
Field Station#	13437+00	Field Station#	13496+76		
Pic 1 Desc.	Vegetation photo	Pic 2 Desc.	Monitored rock lined channel during rain events showing clear water exiting the LOD

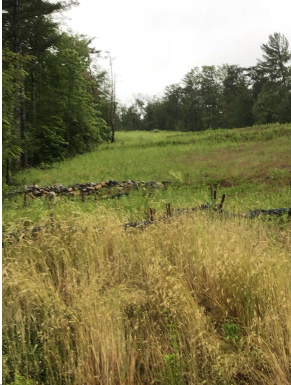
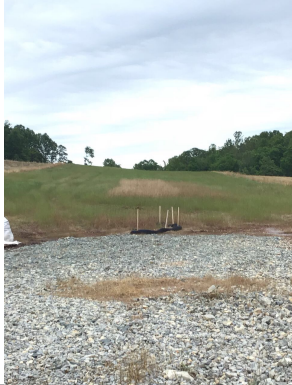
GPS Location	00000	GPS Location	00000		
Field Station#	13496+76	Field Station#	13644+82		
Pic 3 Desc.	Monitored vegetation throughout during rain events traveling road crossings	Pic 4 Desc.	Row photo showing vegetation		
Insert image here			Insert image here		
GPS Location		GPS Location			
Field Station#		Field Station#			
Pic 5 Desc.		Pic 6 Desc.

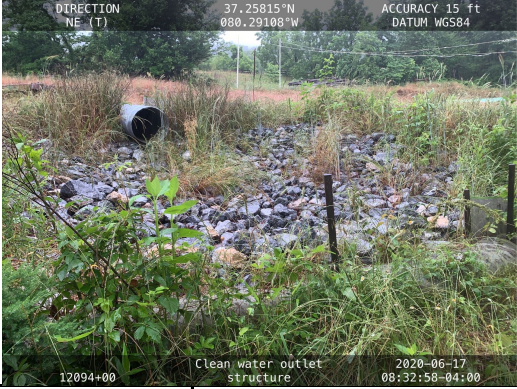
<p>DIRECTION NE (T) 37.25815°N 080.29108°W ACCURACY 15 ft DATUM WGS84</p> <p>12094+00 Clean water outlet structure 2020-06-17 08:32:50-04:00</p>

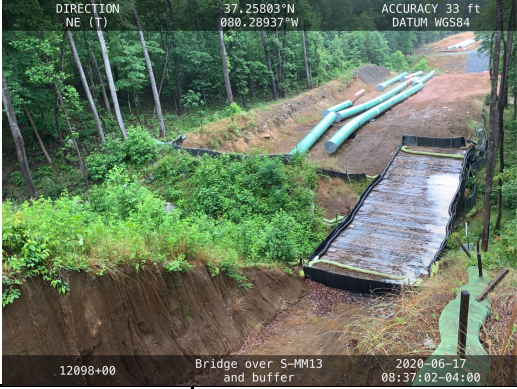
<p>DIRECTION NE (T) 37.25803°N 080.28937°W ACCURACY 33 ft DATUM WGS84</p> <p>12098+00 Bridge over S-MM13 and buffer 2020-06-17 08:37:02-04:00</p>			
GPS Location	See photo for gps location data.		GPS Location	See photo for gps location data.	
Field Station#	12094+00		Field Station#	12098+00	
Pic 7 Desc.	Photo shows the clean water outlet structure.		Pic 8 Desc.	Photo shows the bridge over stream S-MM13 and buffer ECDs.

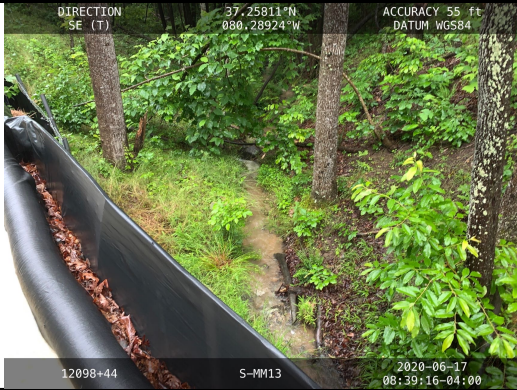
<p>DIRECTION SE (T) 37.25811°N 080.28924°W ACCURACY 55 ft DATUM WGS84</p> <p>12098+44 S-MM13 2020-06-17 08:39:16-04:00</p>

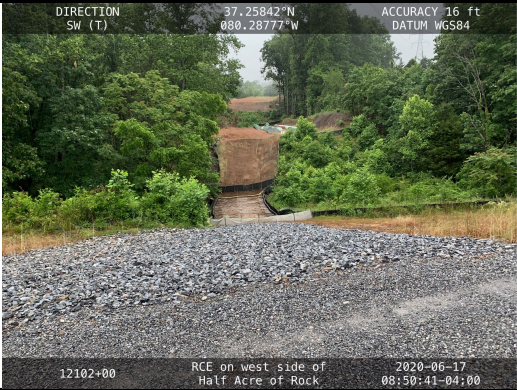
<p>DIRECTION SW (T) 37.25842°N 080.28777°W ACCURACY 16 ft DATUM WGS84</p> <p>12102+00 RCE on west side of Half Acre of Rock Road 2020-06-17 08:50:41-04:00</p>

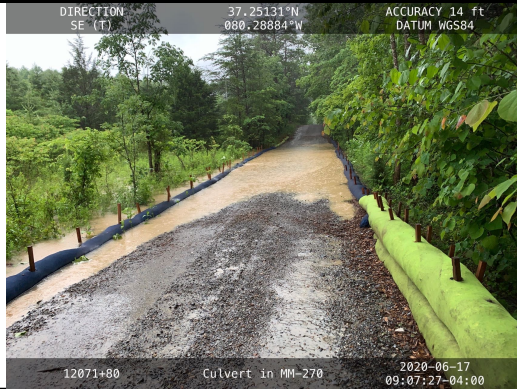
<p>DIRECTION SE (T) 37.25131°N 080.28884°W ACCURACY 14 ft DATUM WGS84</p> <p>12071+80 Culvert in MM-270 2020-06-17 09:07:27-04:00</p>

<p>DIRECTION S (T) 37.26873°N 080.31330°W ACCURACY 41 ft DATUM WGS84</p> <p>12013+97 Bridge over S-G36 2020-06-17 10:10:42-04:00</p>			
GPS Location	See photo for gps location data.		GPS Location	See photo for gps location data.	
Field Station#	12071+80		Field Station#	12013+97	
Pic 11 Desc.	Photo shows the standing water on MN-270 due to the restricted culvert.		Pic 12 Desc.	Photo shows the bridge over stream S-G36.

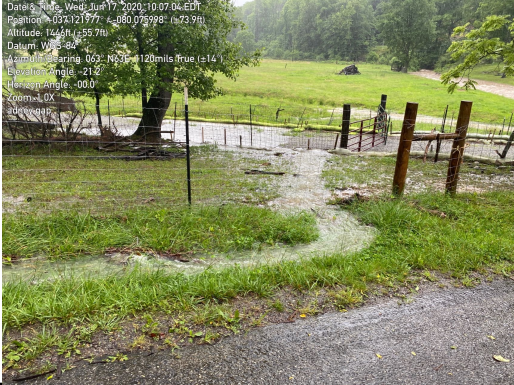
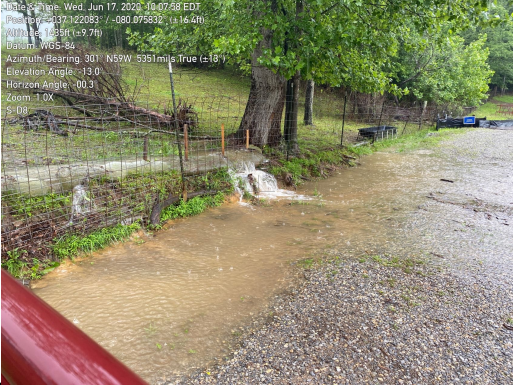
GPS Location	See photo for coordinates.		GPS Location	See photo for coordinates.	
Field Station#	13190+00		Field Station#	13190+00	
Pic 3 Desc.	MVP-AR-29, water from off ROW drainage ditch along Adney Gap flowing onto access road.		Pic 4 Desc.	MVP-AR-29, water from off ROW drainage ditch along Adney Gap flowing onto access road.

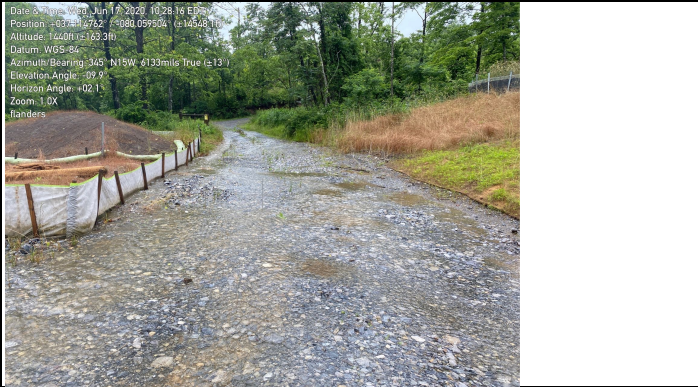
GPS Location	See photo for coordinates.		GPS Location	See photo for coordinates.	
Field Station#	13197+50		Field Station#	13262+50	
Pic 7 Desc.	S-D8, water at top of banks.		Pic 8 Desc.	MVP-FR-293.01, Flanders Road, water flowing onto ROW from off ROW stream and wetland complex, minor erosion in gravel.

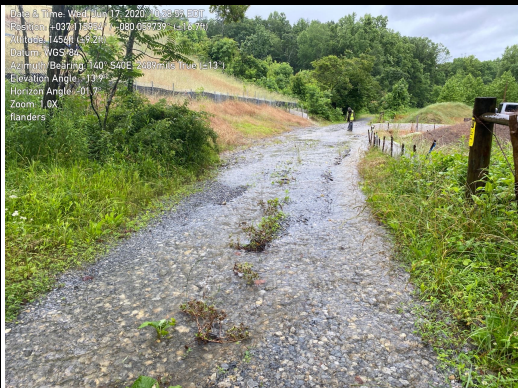
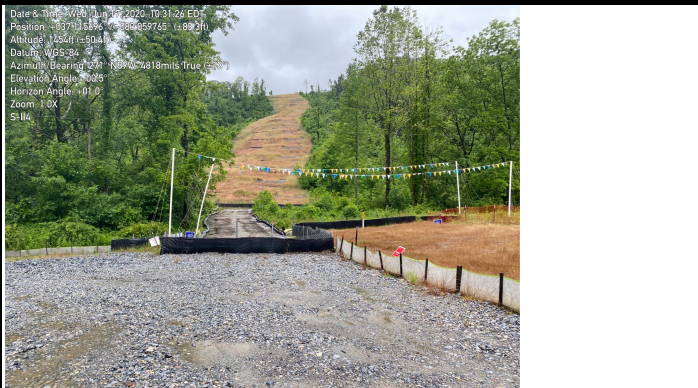
GPS Location	See photo for coordinates.		GPS Location	See photo for coordinates.	
Field Station#	13262+50		Field Station#	13262+00	
Pic 9 Desc.	MVP-FR-293.01, Flanders Road, water flowing onto ROW from off ROW stream and wetland complex, minor erosion in gravel.		Pic 10 Desc.	GAS S-II4, ECDs functioning acceptably, water sheet flowing from off ROW complex across ROW and ATWS-1055.

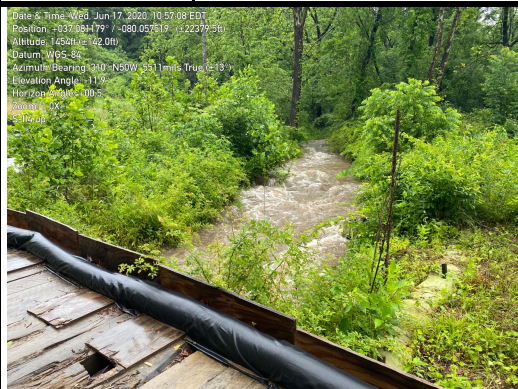
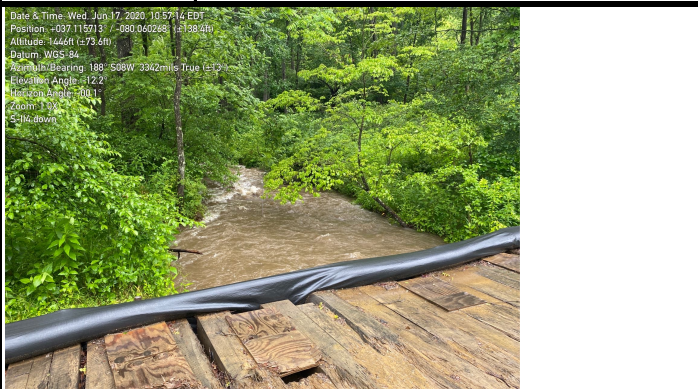
GPS Location	See photo for coordinates.		GPS Location	See photo for coordinates.	
Field Station#	13260+60		Field Station#	13260+60	
Pic 11 Desc.	S-II4, upstream, stream flowing swiftly, at bankfull width.		Pic 12 Desc.	S-II4, downstream, stream flowing swiftly, at bankfull width.

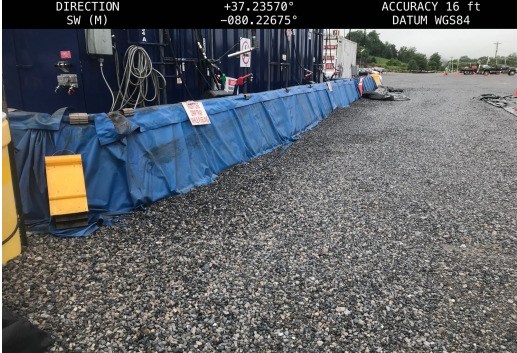
MVP-PY-006_061820 No fuel spills north of tanks 2020-06-18 07:16:37-04:00

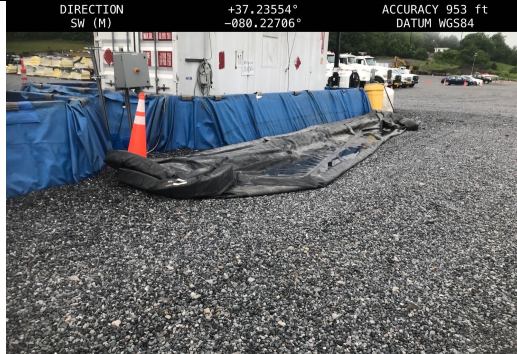
MVP-PY-006_061820 Secondary containment on site for tankers offloading fuel into off road fuel unit. Looking SW. 2020-06-18 07:17:15-04:00		DIRECTION N (M) +37.23563° -080.22690° ACCURACY 16 ft DATUM WGS84

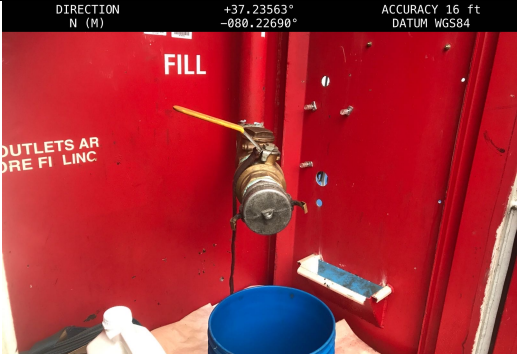
MVP-PY-006_061820 No leaky internal fittings 2020-06-18 07:18:49-04:00			
GPS Location	MVP-PY-006 See photo for gps data		GPS Location	MVP-PY-006 See photo for gps data	
Field Station#	+0		Field Station#	+0	
Pic 11 Desc.	Secondary containment on site for tankers offloading fuel into off road fuel unit. Looking SW.		Pic 12 Desc.	Off Road Fuel unit no leaky internal fittings. Looking N.

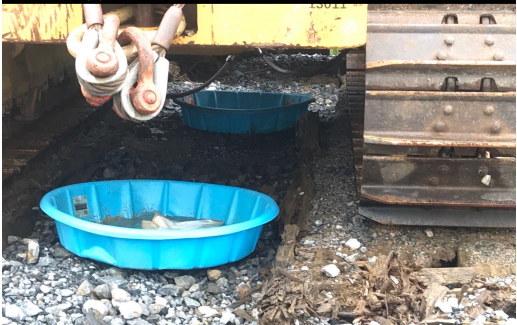
MVP-LY-049_061820		Containment under stored equipment		2020-06-18 08:29:37-04:00	
GPS Location		MVP-LY-049 See photo for gps data			
Field Station#		+0			
Pic 13 Desc.		Condition of containment under stored equipment. Looking SW.			
<div>DIRECTION S (M) +37.27298° -080.11826° ACCURACY 0.88 mi DATUM WGS84</div>

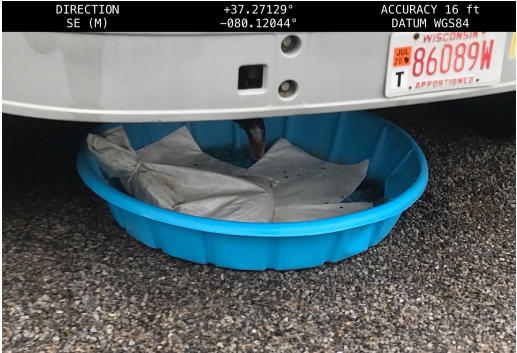
MVP-LY-049_061820		Containment under stored equipment		2020-06-18 08:32:06-04:00	
GPS Location		MVP-LY-049 See photo for gps data			
Field Station#		+0			
Pic 15 Desc.		Condition of containment under stored equipment. Looking S.			
<div>DIRECTION SE (M) +37.27128° -080.12045° ACCURACY 16 ft DATUM WGS84</div>

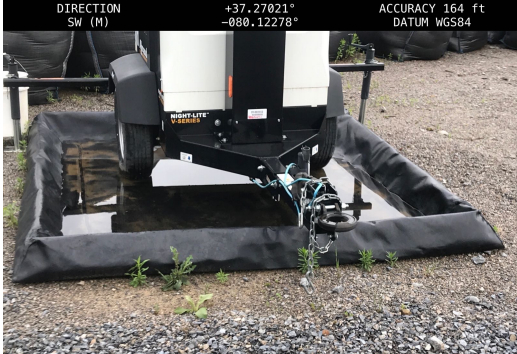
MVP-LY-049_061820		Containment under stored vehicle		2020-06-18 08:50:05-04:00	
GPS Location		MVP-LY-049 See photo for gps data			
Field Station#		+0			
Pic 17 Desc.		Condition of containment under stored vehicle. Looking SE.			
<div>DIRECTION S (M) +37.26972° -080.12416° ACCURACY 16 ft DATUM WGS84</div>

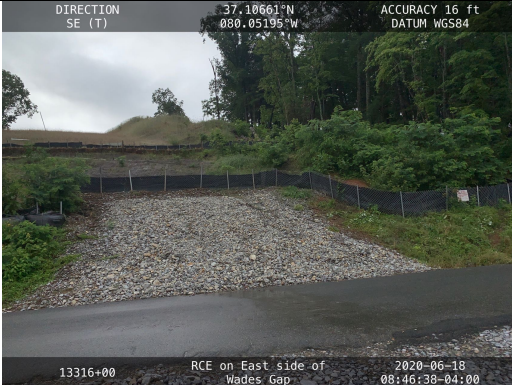
GPS Location	See photo for gps location data.		GPS Location	See photo for gps location data.	
Field Station#	13316+00		Field Station#	13319+00	
Pic 1 Desc.	Photo shows the RCE on the east side of Wades Gap Road.		Pic 2 Desc.	Photo shows the ROW condition from about 13319+00 to 13323+00 and the bridge over stream S-GH15.

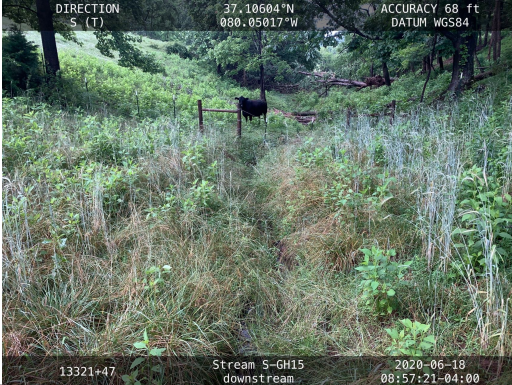
GPS Location	See photo for gps location data.		GPS Location	See photo for gps location data.	
Field Station#	13321+47		Field Station#	13324+00	
Pic 3 Desc.	Photo shows stream S-GH15 downstream from the ROW crossing.		Pic 4 Desc.	Photo shows the bridge over stream S-GH14 and buffer.

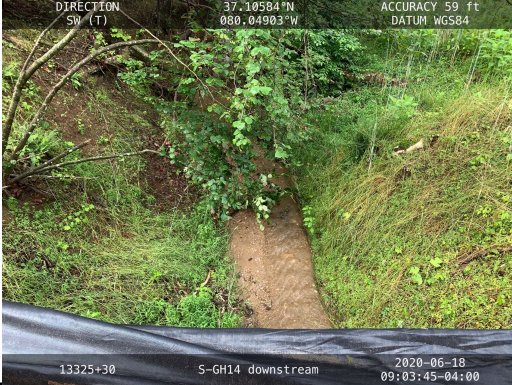
GPS Location	See photo for gps location data.		GPS Location	See photo for gps location data.	
Field Station#	13325+30		Field Station#	13325+20	
Pic 5 Desc.	Photo shows stream S-GH14 downstream from the ROW crossing.		Pic 6 Desc.	Photo shows the bridge over stream S-GH14.

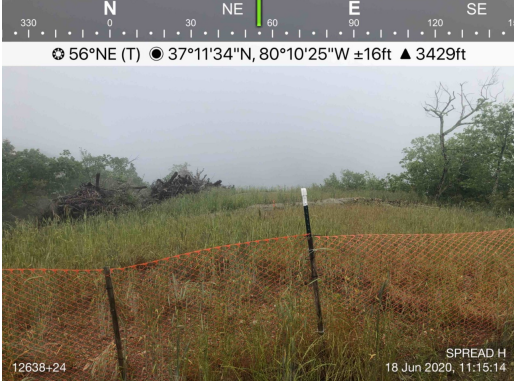
GPS Location	see photo		GPS Location	see photo	
Field Station#	12638+24		Field Station#	12640+00	
Pic 1 Desc.	Waerbars in place and functioning on this slope.		Pic 2 Desc.	Vegetation filling in and controls functioning on this slope.

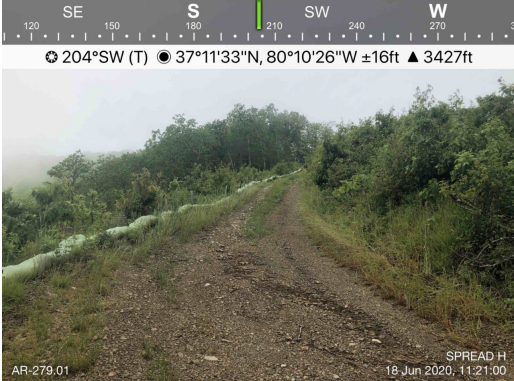
GPS Location	see photo		GPS Location	see photo	
Field Station#	279+01		Field Station#	12679+00	
Pic 3 Desc.	AR-279.01 in good condition with controls in place.		Pic 4 Desc.	CIS of Honeysuckle Rd. in good condition. Controls functioning and vegetation filling in.

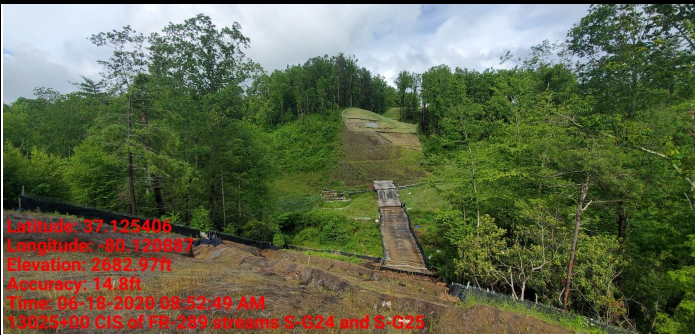
GPS Location	See pic for GPS location		GPS Location	See pic for GPS location	
Field Station#	13025+00		Field Station#	13040+00	
Pic 13 Desc.	Streams S-G24 and S-G25 on the CIS of access road FR-289 and the GAS of the BRP.		Pic 14 Desc.	GAS of access road FR-289.

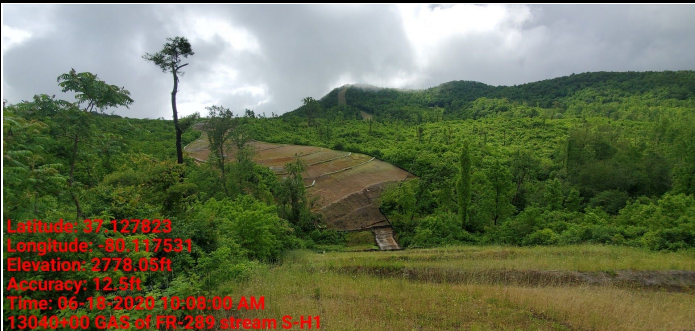
GPS Location	See pic for GPS location		GPS Location	See pic for GPS location	
Field Station#	13040+00		Field Station#	13062+00	
Pic 15 Desc.	Stream crossing S-H1 on the GAS of access road FR-289.		Pic 16 Desc.	Stream S-G26 and the CIS of FR-290.

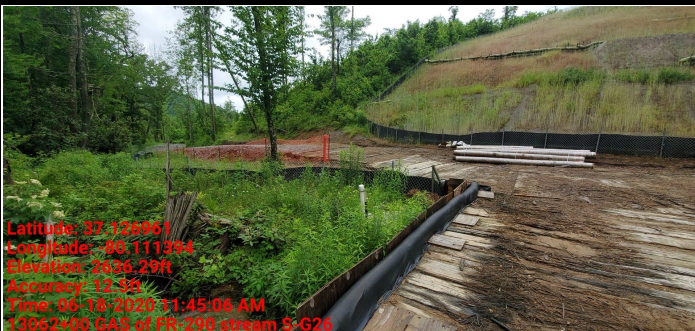
GPS Location	See pic for GPS location		GPS Location	See pic for GPS location	
Field Station#	13062+00		Field Station#	13063+00	
Pic 17 Desc.	Down stream of equipment bridge stream S-G26.		Pic 18 Desc.	Stream S-G27 on the down stream side of the equipment bridge.

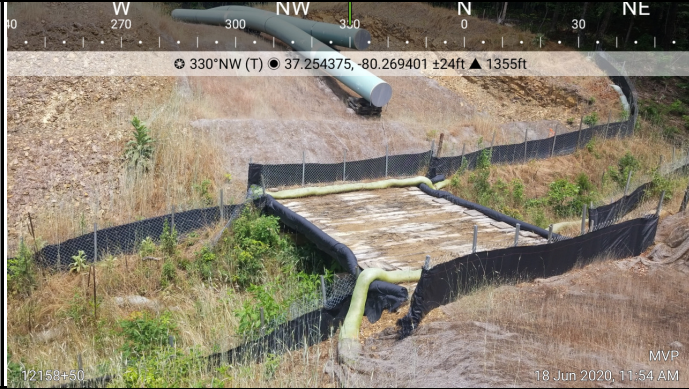
GPS Location	See Above		GPS Location	See Above	
Field Station#	12156+75		Field Station#	12158+50	
Pic 7 Desc.	Head-water area Stream S-C23, Looking NorthEast. ECDs are functional.		Pic 8 Desc.	Head-water area Stream S-C23, Looking NorthWest. ECDs are functional.

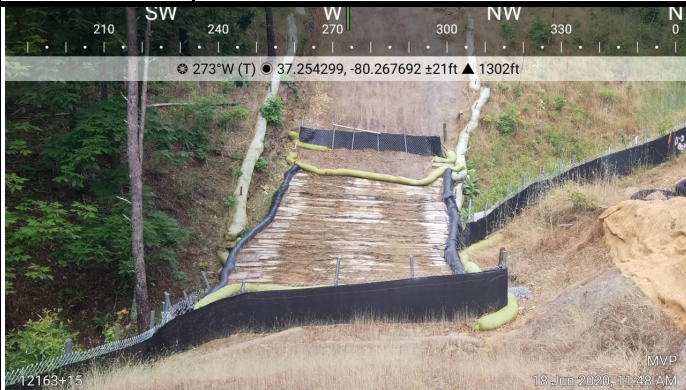
GPS Location	See Above		GPS Location	See Above	
Field Station#	12163+15		Field Station#	12163+50	
Pic 9 Desc.	Stream S-C25, Looking West. ECDs are functional.		Pic 10 Desc.	Temporary vegetation remains stable and ECDs are functional. Looking West.

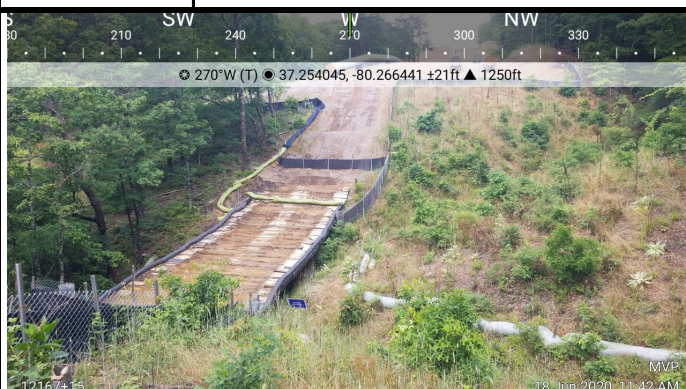
GPS Location	See Above		GPS Location	See Above	
Field Station#	12167+15		Field Station#	12169+00	
Pic 11 Desc.	Stream S-C24, Looking West. ECDs are functional.		Pic 12 Desc.	Temporary vegetation remains stable and ECDs are functional. Looking West.

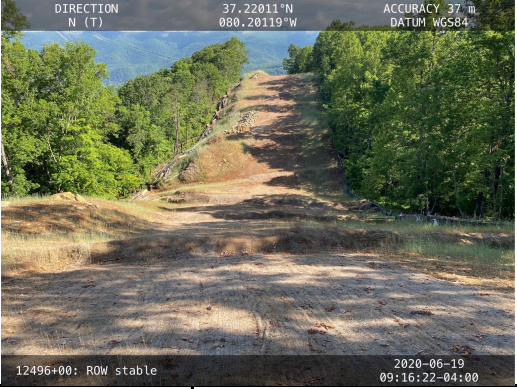
AFE	124300138	Date/Time	6/19/2020 11:19 AM	Report #	
Pictures					
  <p>DIRECTION SE (T) 37.21846°N 080.20045°W ACCURACY 11 m DATUM WGS84</p> <p>12505+00: slope on GAS if clean water diversion pipe remains stable 2020-06-19 09:03:45-04:00</p>

<p>DIRECTION N (T) 37.22011°N 080.20119°W ACCURACY 37 m DATUM WGS84</p> <p>12496+00: ROW stable 2020-06-19 09:16:22-04:00</p>			
GPS Location	See photo		GPS Location	See photo	
Field Station#	12505+00		Field Station#	12496+00	
Pic 13 Desc.	Slope on going away side of clean water diversion pipe sparsely vegetated, but remains stable with blanket covering.		Pic 14 Desc.	Row remains stable.	
  <p>DIRECTION NW (T) 37.22289°N 080.20179°W ACCURACY 11 m DATUM WGS84</p> <p>12485+00(2): overlooking MLV-28 2020-06-19 09:33:32-04:00</p>

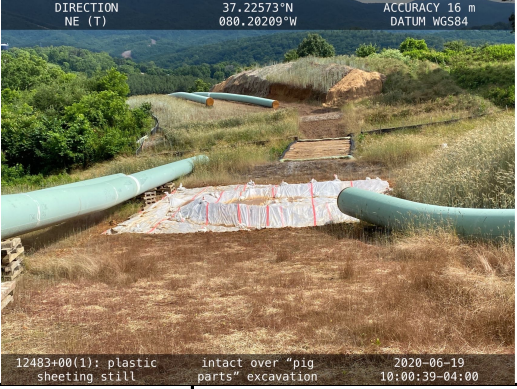
<p>DIRECTION NE (T) 37.22573°N 080.20209°W ACCURACY 16 m DATUM WGS84</p> <p>12483+00(1): plastic sheeting still intact over "pig parts" excavation 2020-06-19 10:00:39-04:00</p>

GPS Location	See photo		GPS Location	See photo	
Field Station#	12485+00		Field Station#	12483+00	
Pic 15 Desc.	Overlooking MLV-28, ROW stable		Pic 16 Desc.	Plastic sheeting covering the "pig parts" excavation site remains intact.	
  <p>DIRECTION NE (T) 37.22693°N 080.20242°W ACCURACY 15 m DATUM WGS84</p> <p>12477+00: ROW and stockpiles remain stable 2020-06-19 10:04:19-04:00</p>

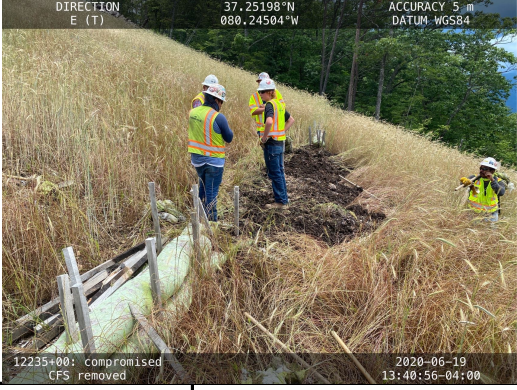
<p>DIRECTION E (T) 37.25198°N 080.24504°W ACCURACY 5 m DATUM WGS84</p> <p>12235+00: compromised CFS removed 2020-06-19 13:40:36-04:00</p>			
GPS Location	See photo		GPS Location	See photo	
Field Station#	12477+00		Field Station#	12235+00	
Pic 17 Desc.	ROW and stockpiles remain stable.		Pic 18 Desc.	Laborers remove badly disintegrating CFS in 4 locations in the permanent restoration atop Reese Mountain per MBP action items.
