# Visual Site Inspection Report

| <b>Project Name</b> | H-600 Pipeline Spread H | <b>AFE</b> | 124300138 | <b>Spread</b> | H-600 Pipeline Spread H |
| <b>Contractor</b> | Precision | | | <b>Report #</b> | 12081 |
| <b>Inspector</b> | Logan Box | | | <b>Date/Time</b> | 6/24/2020 4:18 PM |

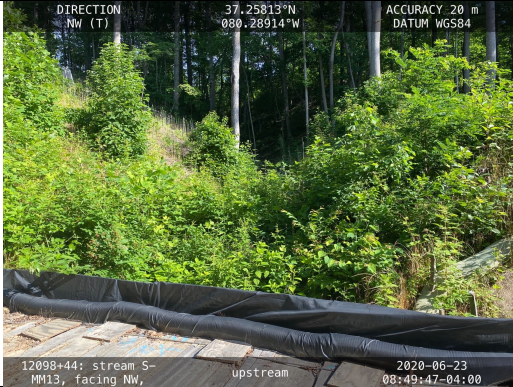
| <b>Field Station#</b> | 12101+51 | | <b>Field Station#</b> | 12098+44 | |

| <b>Pic 1 Desc.</b> | Stream S-MM11, facing east | | <b>Pic 2 Desc.</b> | Stream S-MM13, facing northwest, upstream | |

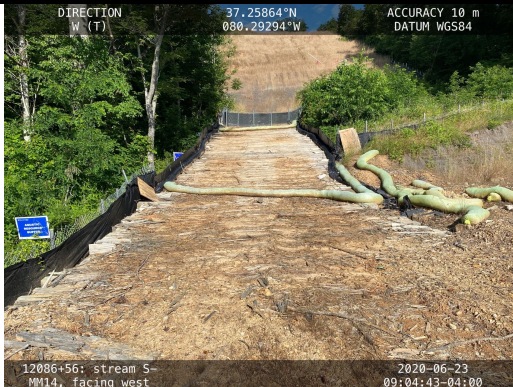
| <b>Field Station#</b> | 12193+00 | | <b>Field Station#</b> | 12086+56 | |

| <b>Pic 3 Desc.</b> | Clean water diversion pipe between AR 270 and 270.1, in satisfactory condition, inlet and outlet free of sediment. | | <b>Pic 4 Desc.</b> | Stream S-MM14, facing west | |

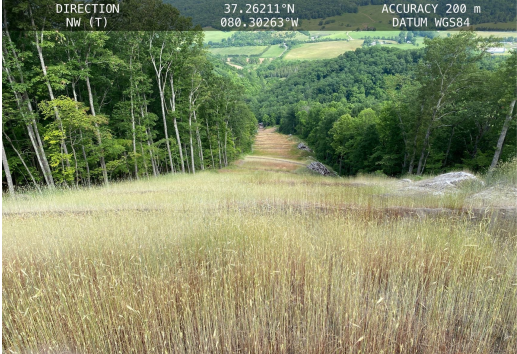
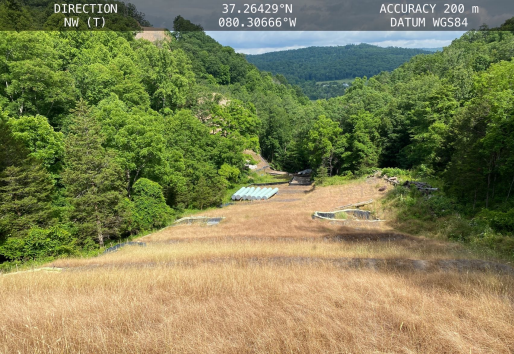
| <b>Field Station#</b> | 12053+00 | | <b>Field Station#</b> | 12040+00 | |

| <b>Pic 7 Desc.</b> | ROW stable | | <b>Pic 8 Desc.</b> | ROW stable | |

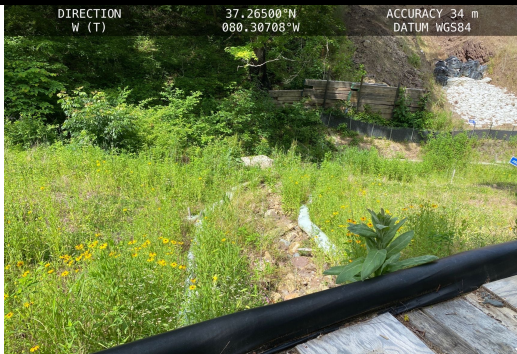
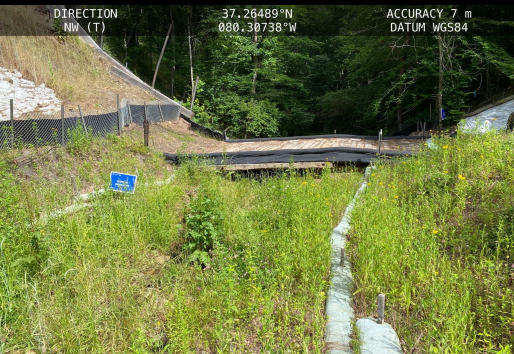
| <b>Field Station#</b> | 12035+75 | | <b>Field Station#</b> | 12035+11 | |

| <b>Pic 9 Desc.</b> | Stream S-PP23, facing west, downstream | | <b>Pic 10 Desc.</b> | Stream S-G40, facing northwest, downstream | |

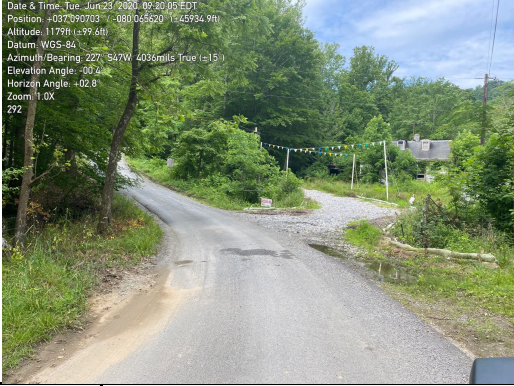
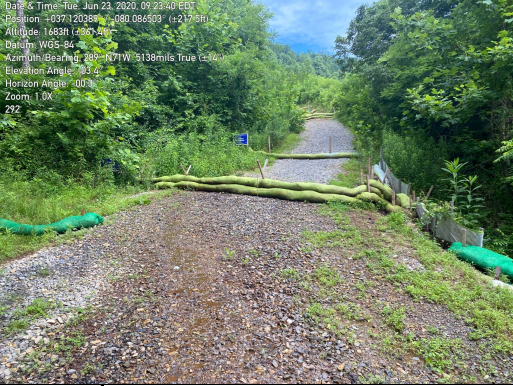
| <b>Field Station#</b> | 13141+00 | | <b>Field Station#</b> | 13141+00 | |

| <b>Pic 1 Desc.</b> | MVP-FR-292, Adney Gap, RCE in acceptable condition, ECDs functioning acceptably. | | <b>Pic 2 Desc.</b> | MVP-FR-292, ECDs functioning acceptably. | |

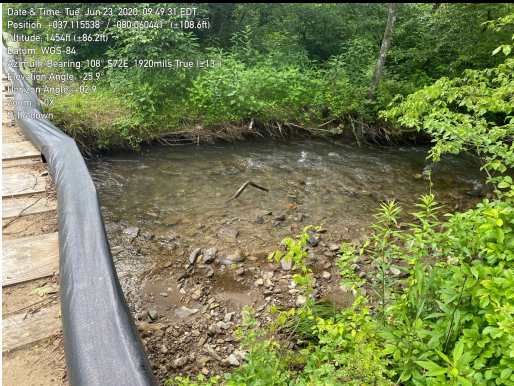
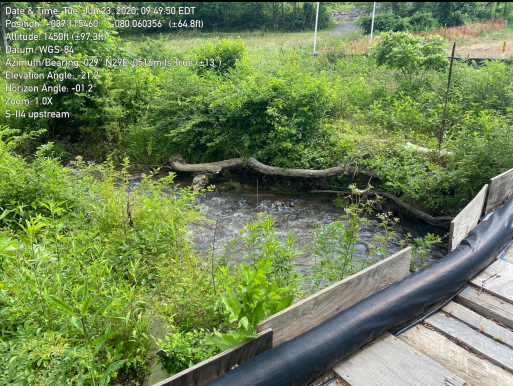
| <b>Field Station#</b> | 13260+60 | | <b>Field Station#</b> | 13260+60 | |

| <b>Pic 5 Desc.</b> | S-II4, downstream, no environmental issues noted. | | <b>Pic 6 Desc.</b> | S-II4, upstream, no environmental issues noted. | |

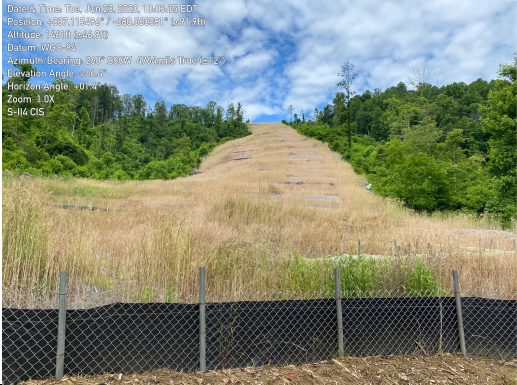
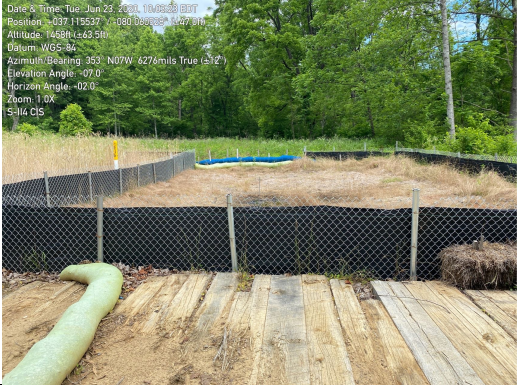
| <b>Field Station#</b> | 13260+00 | | <b>Field Station#</b> | 13260+00 | |

| <b>Pic 7 Desc.</b> | Good vegetative cover noted across LOD, waterbars and rock weirs stable. | | <b>Pic 8 Desc.</b> | CIS S-II4, ECDs functioning acceptably. | |

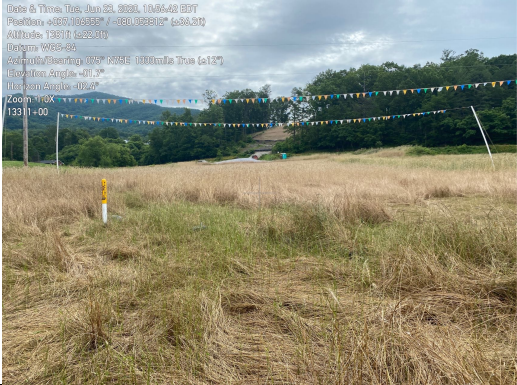
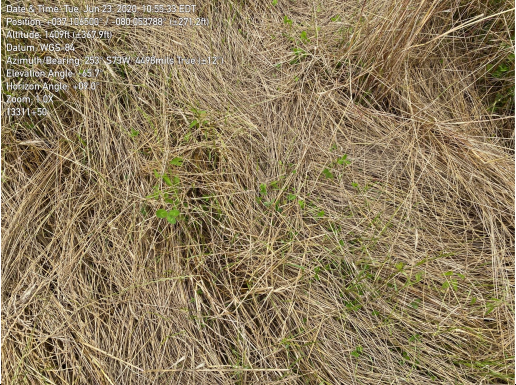
| <b>Field Station#</b> | 13311+00 | | <b>Field Station#</b> | 13310+50 | |

| <b>Pic 13 Desc.</b> | CIS Wades Gap, good vegetative cover noted across LOD, some vegetation matted down. | | <b>Pic 14 Desc.</b> | Clover noted in matted vegetation. | |

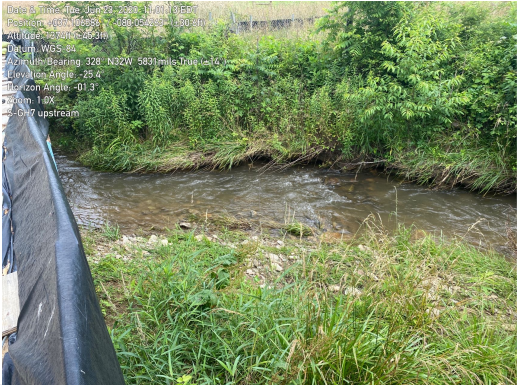
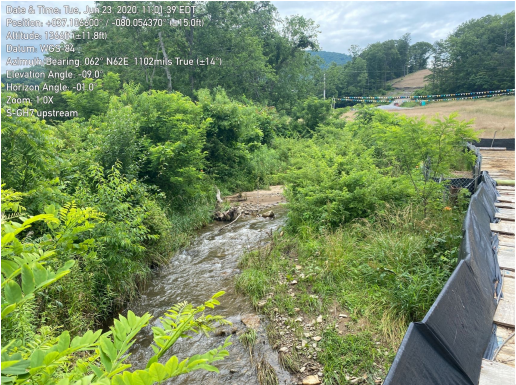
| <b>Field Station#</b> | 13309+09 | | <b>Field Station#</b> | 13309+09 | |

| <b>Pic 15 Desc.</b> | S-GH7, upstream, no changes noted to stream bed or banks at crossing. | | <b>Pic 16 Desc.</b> | S-GH7, upstream, native material deposition on right descending bank noted upstream of crossing. | |

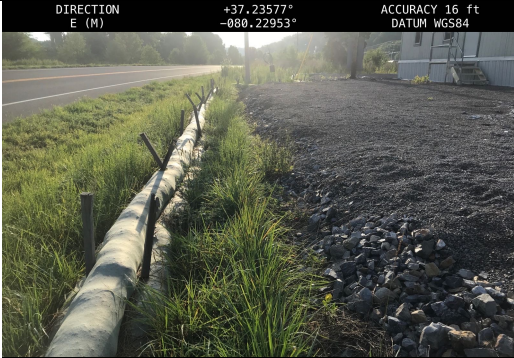
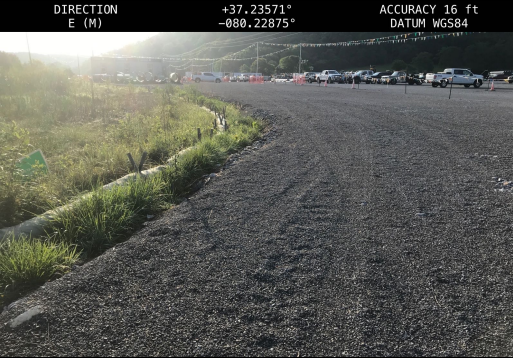
| <b>Pic 1 Desc.</b> | Condition of compost filter sock along north LOD. Looking E. | | <b>Pic 2 Desc.</b> | Condition of compost filter sock and buffer on the south side of feature. Looking E. | |

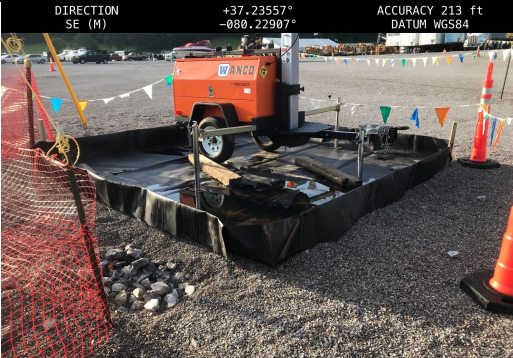
| <b>Pic 3 Desc.</b> | Condition of compost filter sock along the south LOD. Sock over grown with tall grass and weeds. Looking SW. | | <b>Pic 4 Desc.</b> | Condition of containment under light. Looking SE. | |

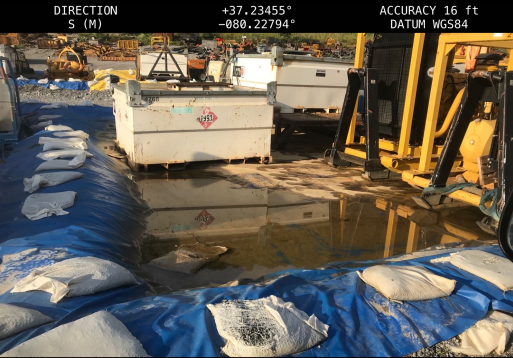
| <b>Pic 5 Desc.</b> | Condition of containment. Holding small amount of stormwater. Looking S. | | <b>Pic 6 Desc.</b> | Condition of containment. Holding small amount of stormwater. Looking S. | |

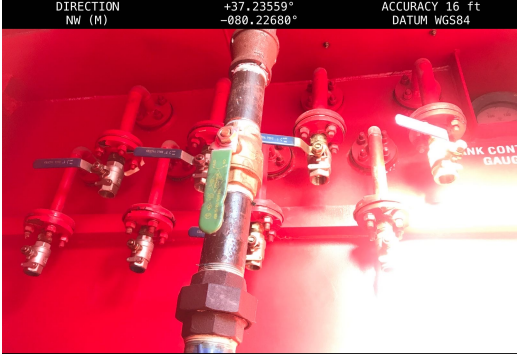
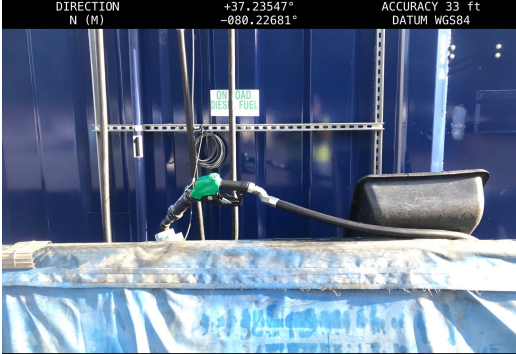
| MVP-PY-006_062420    No leaky internal fittings    2020-06-24 07:53:12-04:00 | | MVP-PY-006_062420    No leaky fittings or nozzles    2020-06-24 07:54:24-04:00 | | | |
| <b>Pic 17 Desc.</b> | Off Road Fuel unit no leaky internal fittings. Looking NW. | | <b>Pic 18 Desc.</b> | Blue Bulk Fuel tanks no leaky fittings or nozzles. Looking S. | |

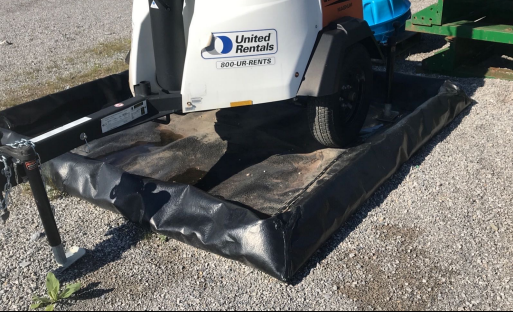
| <p>DIRECTION S (M) +37.27187° -080.12287° ACCURACY 98 ft DATUM WGS84</p> <p>MVP-LY-049_062420 Condition of rock entrance 2020-06-24 08:24:27-04:00</p> | | <p>DIRECTION SW (M) +37.27099° -080.12210° ACCURACY 16 ft DATUM WGS84</p> <p>MVP-LY-049_062420 Condition of containment 2020-06-24 09:02:58-04:00</p> | | | |
| <b>Pic 1 Desc.</b> | Condition of rock entrance on center drive. Looking S. | <b>Pic 2 Desc.</b> | Condition of containment under light plant. Looking SW. | | |

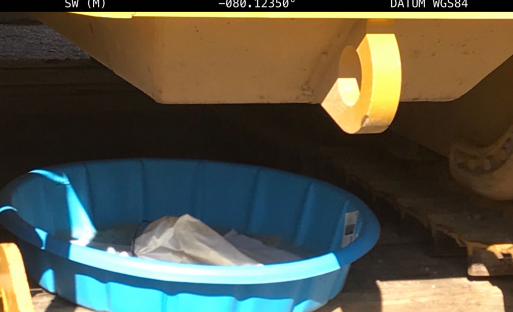
| <p>DIRECTION SW (M) +37.27018° -080.12236° ACCURACY 33 ft DATUM WGS84</p> <p>MVP-LY-049_062420 Containment under stored equipment 2020-06-24 09:22:21-04:00</p> | | <p>DIRECTION SW (M) +37.26956° -080.12350° ACCURACY 16 ft DATUM WGS84</p> <p>MVP-LY-049_062420 Containment under stored equipment 2020-06-24 09:24:19-04:00</p> | | | |

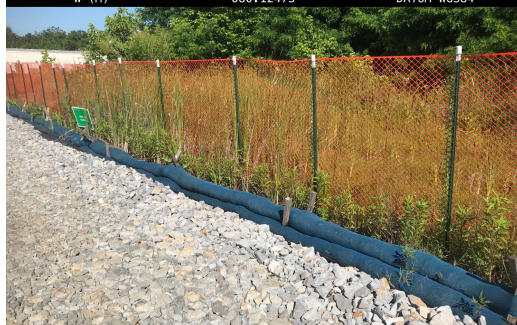
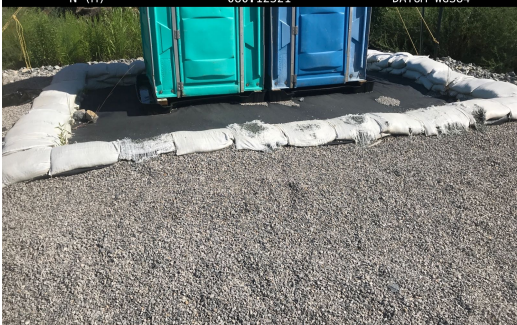
| MVP-LY-049_062420 Condition of CFS & safety fence at ... 2020-06-24 09:34:12-04:00 | | MVP-LY-049_062420 Condition of trays and containment 2020-06-24 09:35:33-04:00 | | | |

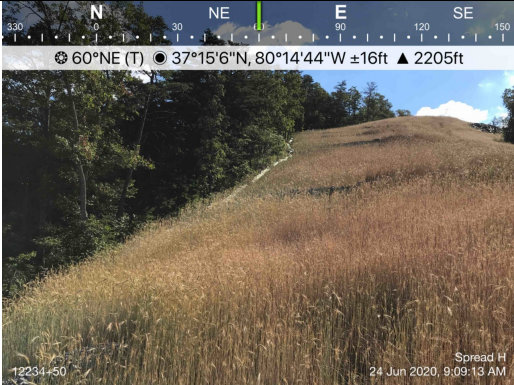
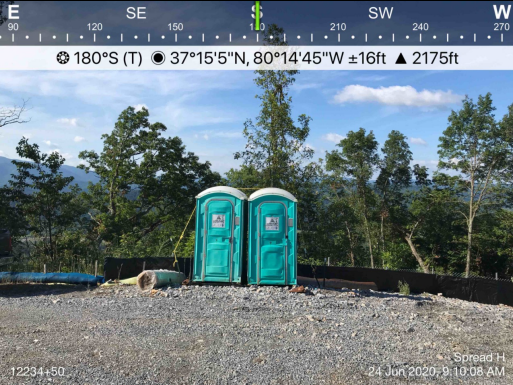
| <b>Field Station#</b> | 12234+50 | | <b>Field Station#</b> | 12234+50 | |

| <b>Pic 1 Desc.</b> | Start of inspection area, permanent waterbars in good condition. | | <b>Pic 2 Desc.</b> | Portajohns in secondary containment. | |

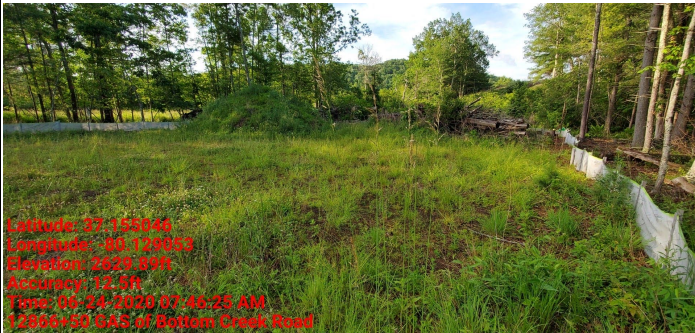
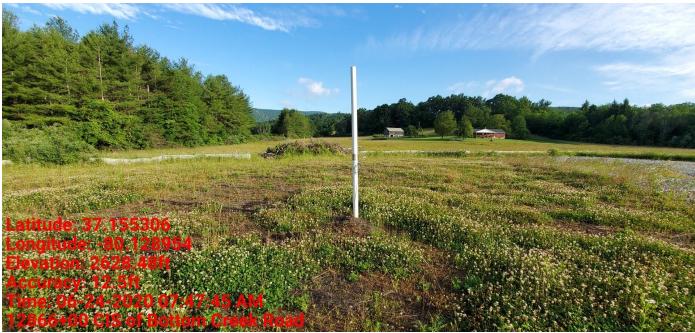
| Field Station# | 12866+50 | | Field Station# | 12866+00 | |

| Pic 1 Desc. | GAS of the Bottom Creek Road crossing. | | Pic 2 Desc. | CIS of the Bottom Creek Road crossing. | |

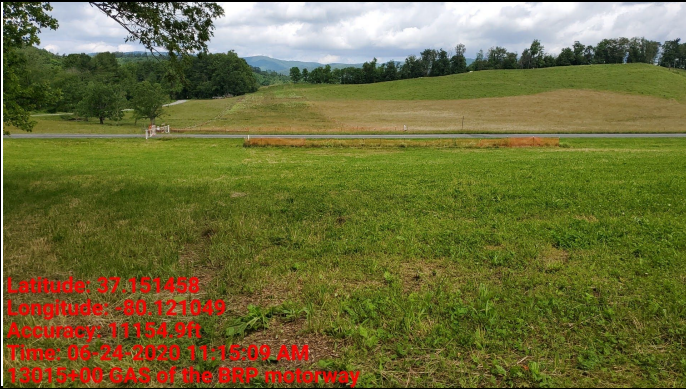
| <b>Pic 13 Desc.</b> | The BRP motorway from the GAS. | | <b>Pic 14 Desc.</b> | The GAS of the BRP, the non-ag portion. | |

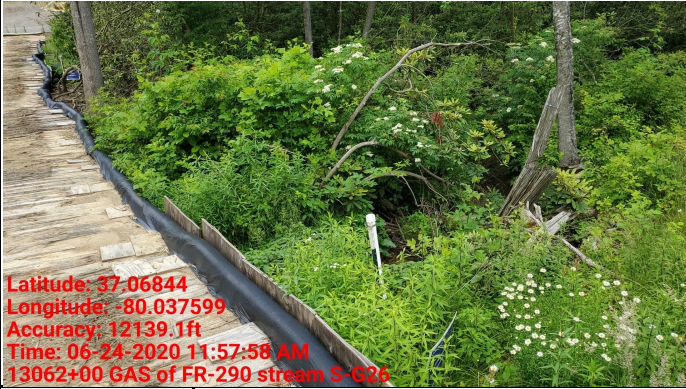
| <b>Pic 15 Desc.</b> | Downstream side of the equipment bridge. | | <b>Pic 16 Desc.</b> | Upstream side of the equipment bridge. | |

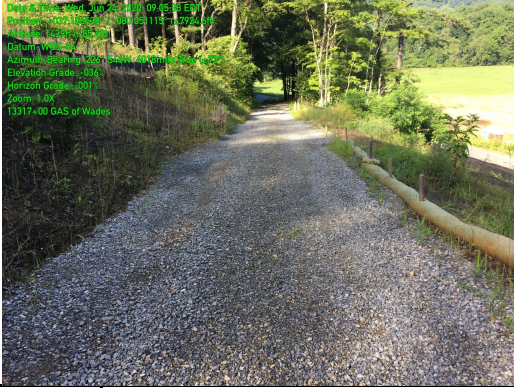
| <b>Pic 1 Desc.</b> | Private driveway, GAS Wades Gap Road. | | <b>Pic 2 Desc.</b> | ROW stabilized, perimeter ECDs in acceptable condition. | |

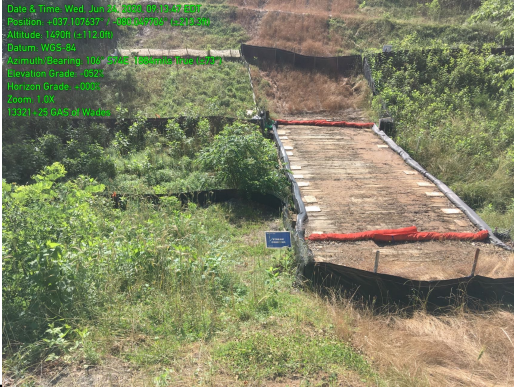
| <b>Pic 3 Desc.</b> | S-GH15, ECDs along stream in acceptable condition. | | <b>Pic 4 Desc.</b> | ROW stabilized with acceptable vegetive cover across LOD. | |

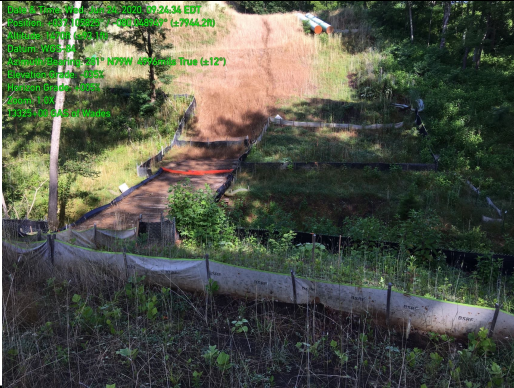
| <b>Pic 5 Desc.</b> | S-GH14, ECDs along stream in acceptable condition. | | <b>Pic 6 Desc.</b> | ROW stabilized with acceptable vegetive cover across LOD. | |

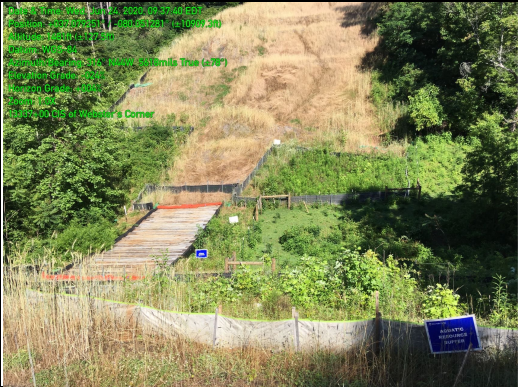
| Pic 7 Desc. | S-GH11, stream buffer well vegetated, ECDs functioning acceptably. | | Pic 8 Desc. | S-GH9, ECDs in acceptable condition along stream banks, moderate vegetation noted across LOD. | |

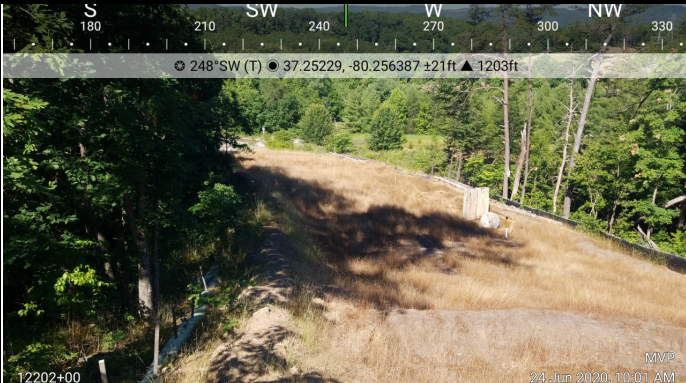
| Pic 13 Desc. | Temporary vegetation remains stable and ECDs are functional. Looking West. | | Pic 14 Desc. | Temporary vegetation remains stable and ECDs are functional. Looking West. | |

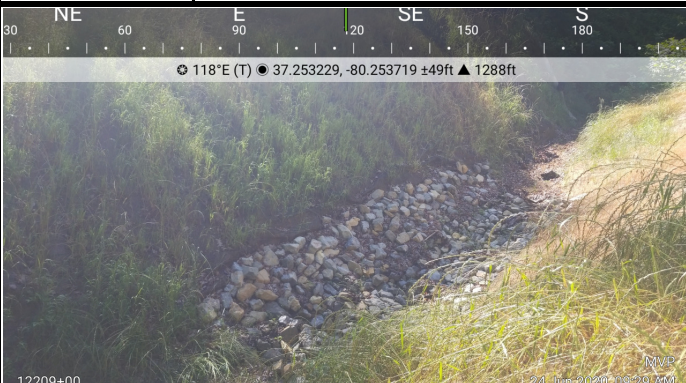
| Pic 15 Desc. | Temporary and permanent vegetation remain stable and ECDs are functional. Looking SouthEast. | | Pic 16 Desc. | Temporary and permanent vegetation remain stable and ECDs are functional. Looking West. | |

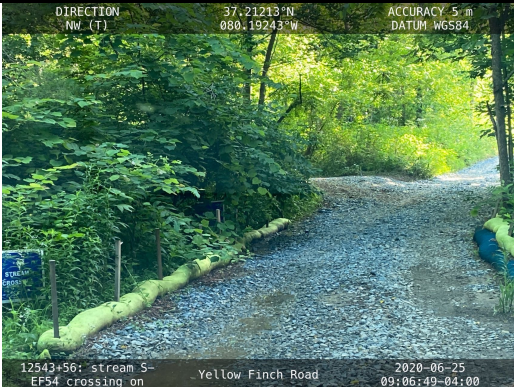
| <b>Pic 1 Desc.</b> | Stream S-EF54 on Yellow Finch Road, facing northwest | | <b>Pic 2 Desc.</b> | Yellow Finch Road road near the ROW crossing. | |

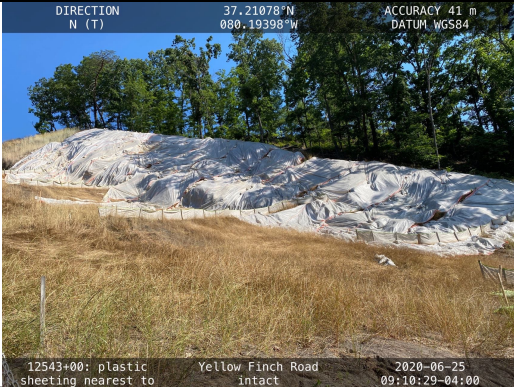
| <b>Pic 3 Desc.</b> | Plastic sheeting nearest to Yellow Finch Road remains intact. | | <b>Pic 4 Desc.</b> | Fill slope drains on GAS of landowner's crossing remain satisfactory condition and are functioning per design. | |

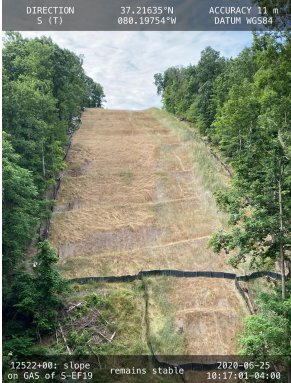
| <b>Pic 7 Desc.</b> | Slope on going away side of stream S-EF19 remains stable. | | <b>Pic 8 Desc.</b> | Stream S-EF19, facing west, downstream | |

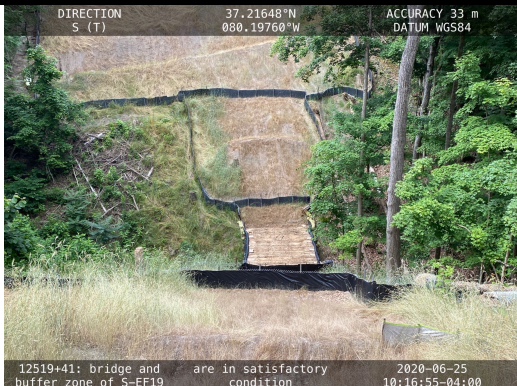
| <b>Pic 9 Desc.</b> | Bridge and buffer zone of stream S-EF19 are in satisfactory condition. | | <b>Pic 10 Desc.</b> | Slope on coming in side of stream S-EF19 remains stable. | |

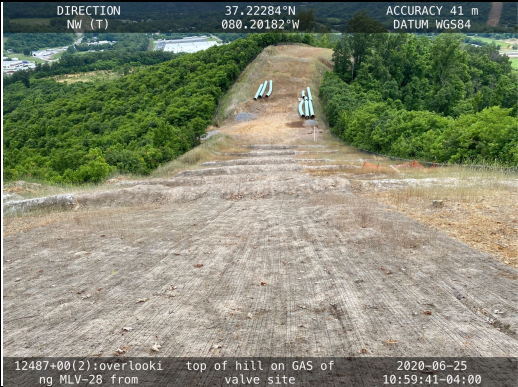
| <b>Pic 13 Desc.</b> | Slope on going away side of MLV-28 remains stable. | | <b>Pic 14 Desc.</b> | Water deflectors on MVP-AR-MLV-28 remain in good repair and functioning per design. | |
