Visual Site Inspection Report

Project Name	H-600 Pipeline Spread H	AFE	124300138	Spread	H-600 Pipeline Spread H
Contractor	Precision			Report #	12276
Inspector	Dawn McCullough			Date/Time	6/29/2020 1:24 PM
Permit #	TBD	Inspection Type	VA SWPP	Station Begin	13140+00
State	VA	Inspection Area	Partial	Station End	13315+70
County	Franklin	Ground	Dry	Temperature (°F)	88.00
Municipality	N/A	Weather	Sunny	Rain Gauge (in)	0.00
				Rain Accumulation Time (days)	1.00

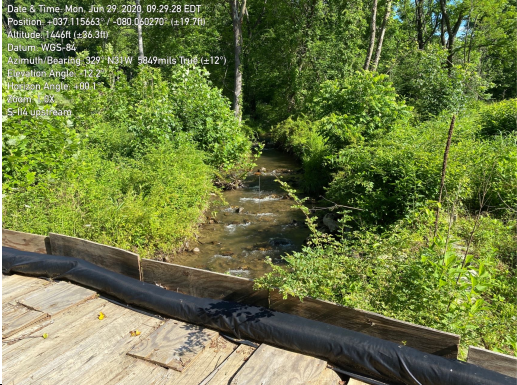
GPS Location		See photo for coordinates.		GPS Location	
Field Station#		13260+60		Field Station#	
Pic 7 Desc.		S-II4, upstream, no environmental issues noted at stream crossing.		Pic 8 Desc.	
<p>Date & Time: Mon, Jun 29, 2020, 10:00:27 EDT Position: +037.115805° / -080.059186° (+183.3m) Altitude: 1420ft (+51.2m) Datum: WGS-84 Azimuth/Bearing: 200° 888W 2765mils True (+124°) Elevation Angle: +05.3° Horizon Angle: +00.9° Zoom: 1.0X Handers</p>

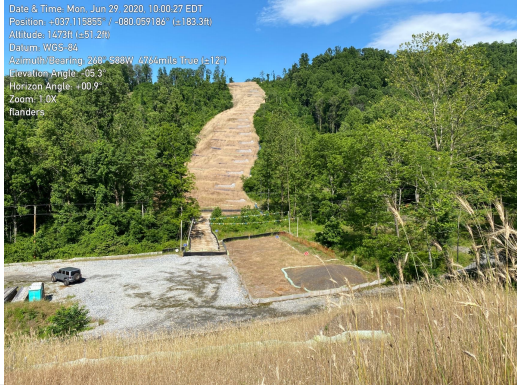
GPS Location		See photo for coordinates.		GPS Location	
Field Station#		13263+00		Field Station#	
Pic 9 Desc.		Stabilized ROW and ATWS at Flanders Road crossing.		Pic 10 Desc.	
<p>Date & Time: Mon, Jun 29, 2020, 10:31:05 EDT Position: +037.113283° / -080.063242° (+295.3m) Altitude: 1325ft (+6.3ft) Datum: WGS-84 Azimuth/Bearing: 100° 535E 1796mils True (+122°) Elevation Angle: +00.6° Horizon Angle: +00.8° Zoom: 1.0X 13286+00</p>

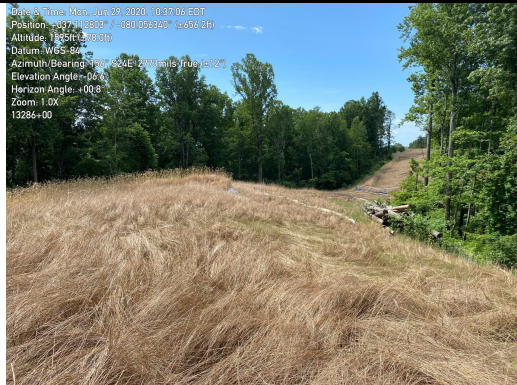
GPS Location		See photo for coordinates.		GPS Location	
Field Station#		13286+00		Field Station#	
Pic 11 Desc.		Good vegetative cover noted across LOD, permanent waterbars and waterbar extensions in acceptable condition.		Pic 12 Desc.

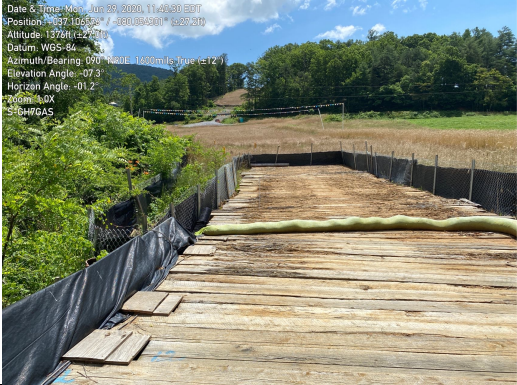
GPS Location	See photo for coordinates.		GPS Location	See photo for coordinates.	
Field Station#	13309+25		Field Station#	13309+09	
Pic 13 Desc.	GAS S-GH7, equipment bridge in acceptable condition, ECDs functioning acceptably.		Pic 14 Desc.	S-GH7, downstream, no environmental issues noted.	
<p>Date & Time: Mon, Jun 29, 2020, 11:39:51 EDT Position: +037.106614° / -080.054375° (+14.40) Altitude: 1374ft (+24.30) Datum: WGS-84 Azimuth/Bearing: 042. N62E 1102mils True (+12.1) Elevation Angle: -15.4 Horizon Angle: -01.3 Zoom: 1.0X S-GH7 upstream</p>

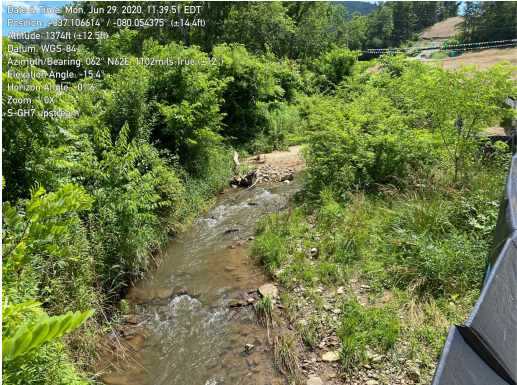
GPS Location	See photo for coordinates.		GPS Location	See photo for coordinates.	
Field Station#	13309+09		Field Station#	13311+00	
Pic 15 Desc.	S-GH7, upstream, no changes noted to stream.		Pic 16 Desc.	Moderate to good vegetative cover noted across LOD.	
<p>Date & Time: Mon, Jun 29, 2020, 11:30:37 EDT Position: +037.106579° / -080.052195° (+20.00) Altitude: 1414ft (+33.30) Datum: WGS-84 Azimuth/Bearing: 240. S60W 4338mils True (+12.1) Elevation Angle: +01.6 Horizon Angle: +00.9 Zoom: 1.0X wades gap CIS</p>

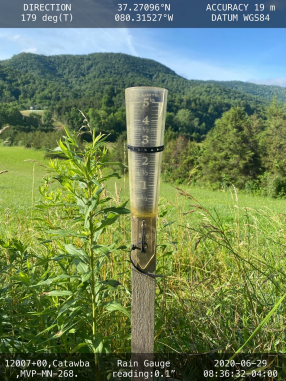
GPS Location	See photo GPS for location		GPS Location	See photo GPS for location	
Field Station#	12007+00		Field Station#	12005+00	
Pic 1 Desc.	Rain gauge reading: 0.1".		Pic 2 Desc.	Topsoil piles are well vegetated.

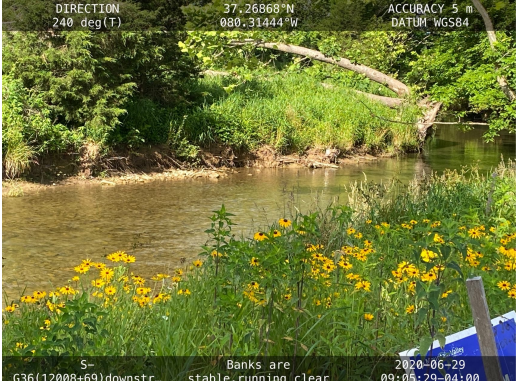
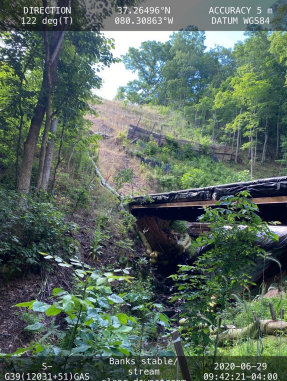
GPS Location	See photo GPS for location		GPS Location	See photo GPS for location	
Field Station#	12008+69		Field Station#	12031+51	
Pic 3 Desc.	S-G36 banks are stable and and stream is running.		Pic 4 Desc.	S-G39 banks and surrounding ECDs are stable and stream is running clear.

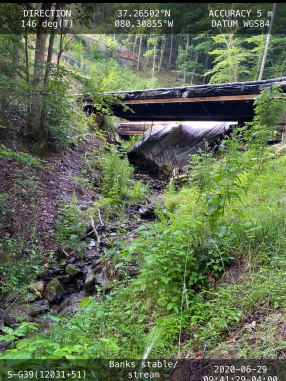
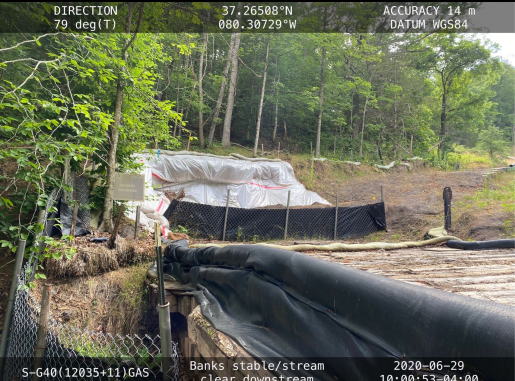
GPS Location	See photo GPS for location		GPS Location	See photo GPS for location	
Field Station#	12031+51		Field Station#	12035+11	
Pic 5 Desc.	S-G39 banks and surrounding ECDs are stable and stream is running clear.		Pic 6 Desc.	S-G40 banks and surrounding ECDs are stable and stream is running clear.

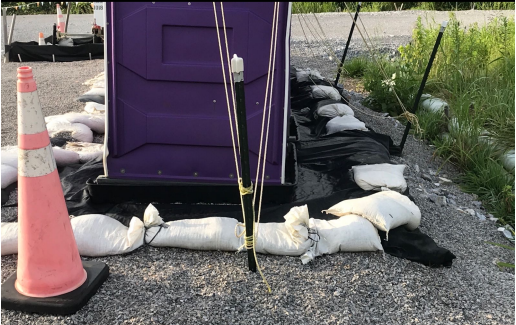
MVP-PY-006_063020 Condition of trays and containment 2020-06-30 07:37:21-04:00			
GPS Location	MVP-PY-006 See photo for gps data		GPS Location	MVP-PY-006 See photo for gps data	
Field Station#	+0		Field Station#	+0	
Pic 13 Desc.	Condition of compost filter sock, signage and buffer flagging for feature. Looking E.		Pic 14 Desc.	Condition of the trays and containment under toilets. Looking SE.	
DIRECTION NE (M) +37.23507° -080.23005° ACCURACY 16 ft DATUM WGS84   MVP-PY-006_063020 Condition of west rock entrance 2020-06-30 07:38:59-04:00		DIRECTION SE (M) +37.23520° -080.22951° ACCURACY 16 ft DATUM WGS84   MVP-PY-006_063020 Condition of CFS along south LOD 2020-06-30 07:39:57-04:00

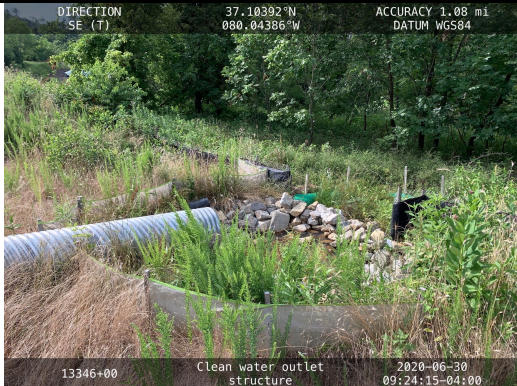
GPS Location	See photo for gps location data.		GPS Location	See photo for gps location data.	
Field Station#	13346+00		Field Station#	13348+00	
Pic 9 Desc.	Photo shows the clean water outlet structure.		Pic 10 Desc.	Photo shows the bridge over stream S-RR08 and buffer ECDs.

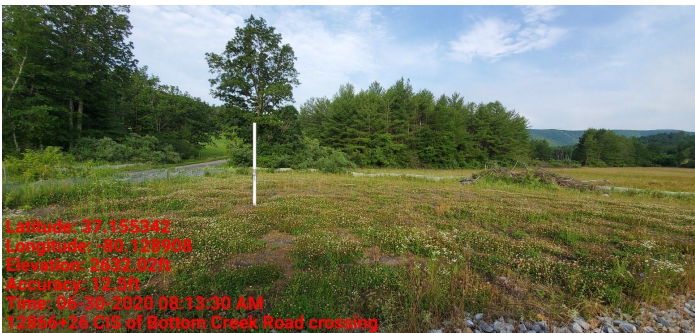
<p>Latitude: 37.155343 Longitude: -80.128958 Elevation: 2639.02ft Accuracy: 12.5ft Time: 06/30/2020 08:13:30 AM 12866+26 CIS of Bottom Creek Road crossing</p>		
GPS Location	See pic for GPS location		GPS Location	See pic for GPS location	
Field Station#	12866+26		Field Station#	12866+26	
Pic 1 Desc.	GAS of the Bottom Creek Road crossing		Pic 2 Desc.	CIS of the Bottom Creek Road crossing.

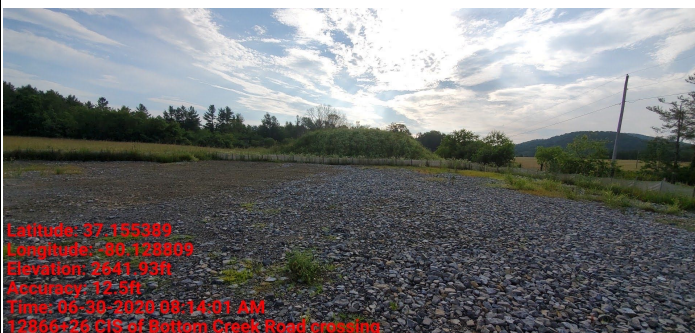
GPS Location	See pic for GPS location		GPS Location	See pic for GPS location	
Field Station#	12866+26		Field Station#	12957+30	
Pic 3 Desc.	CIS of the Bottom Creek Road crossing ATWS and topsoil pile.		Pic 4 Desc.	Access road RO-287 at streams S-Z16.

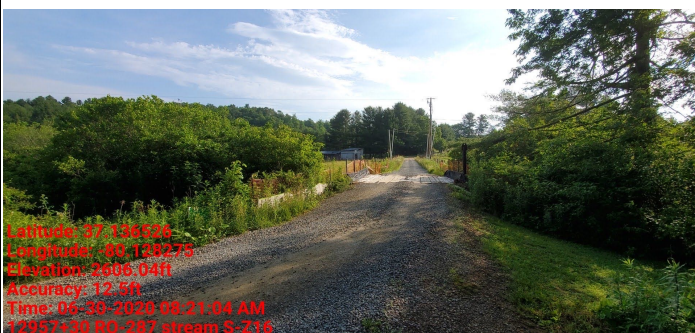
<p>Latitude: 37.135421 Longitude: -80.134171 Elevation: 2608.69ft Accuracy: 12.5ft Time: 06/30/2020 08:24:45 AM 12957+30 RO-287 stream S-Z17</p>		
GPS Location	See pic for GPS location		GPS Location	See pic for GPS location	
Field Station#	12957+30		Field Station#	12957+30	
Pic 5 Desc.	Access road RO-287 at streams S-Z16.		Pic 6 Desc.	Access road RO-287 at streams S-Z17.

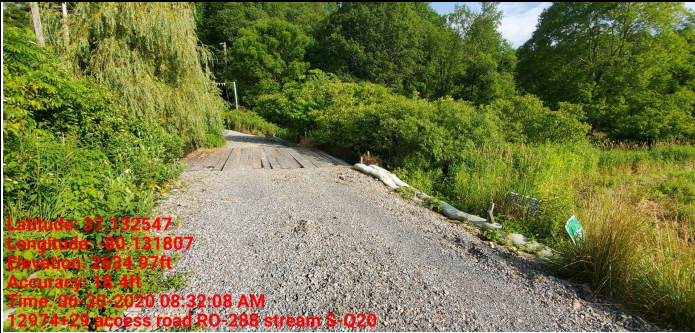
<p>Latitude: 37.129489 Longitude: -80.130308 Elevation: 2650.67ft Accuracy: 12.5ft Time: 06-30-2020 08:34:50 AM 12994+02 GAS of the US-221 Road crossing</p>		
GPS Location	See pic for GPS location		GPS Location	See pic for GPS location	
Field Station#	12974+29		Field Station#	12994+02	
Pic 7 Desc.	Access road RO-288 at streams S-Q20.		Pic 8 Desc.	GAS of the US-221 Road crossing.

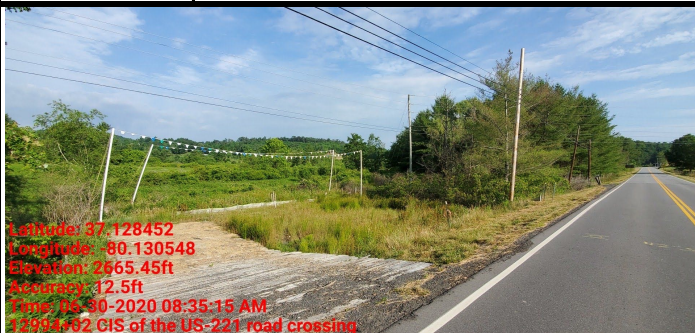
GPS Location	See pic for GPS location		GPS Location	See pic for GPS location	
Field Station#	12994+02		Field Station#	13012+62	
Pic 9 Desc.	CIS of the US-221 road crossing.		Pic 10 Desc.	GAS of the BRP motorway.

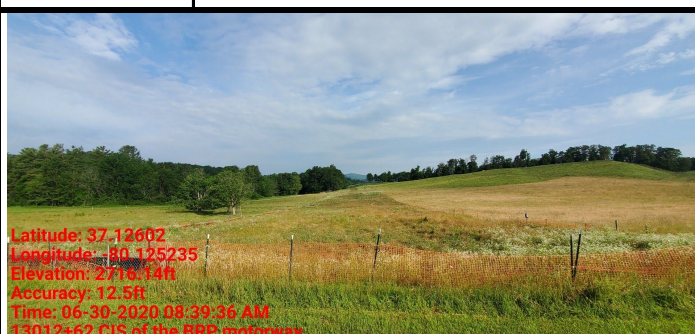
<p>Latitude: 37.12602 Longitude: -80.125235 Elevation: 2716.14ft Accuracy: 12.5ft Time: 06-30-2020 08:39:36 AM 13012+62 CIS of the BRP motorway</p>

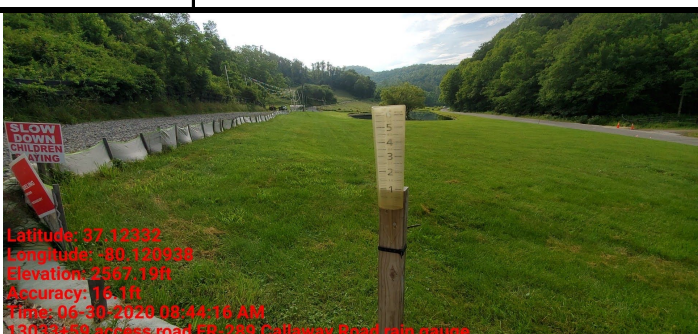
<p>Latitude: 37.12352 Longitude: -80.120038 Elevation: 2567.19ft Accuracy: 15.1ft Time: 06-30-2020 08:44:16 AM 13033+59 access road RR-269 Callaway Road rain gauge</p>		
GPS Location	See pic for GPS location		GPS Location	See pic for GPS location	
Field Station#	13012+62		Field Station#	13033+59	
Pic 11 Desc.	CIS of the BRP motorway.		Pic 12 Desc.	Callaway Road rain gauge. 0.0" total precipitation

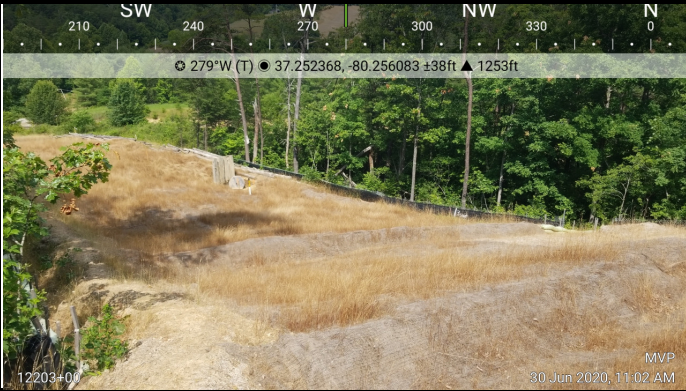
GPS Location	See Above		GPS Location	See Above	
Field Station#	12203+00		Field Station#	12210+00	
Pic 13 Desc.	Temporary vegetation remains stable and ECDs are functional. Looking West.		Pic 14 Desc.	Temporary vegetation remains stable and ECDs are functional. Looking SouthWest.

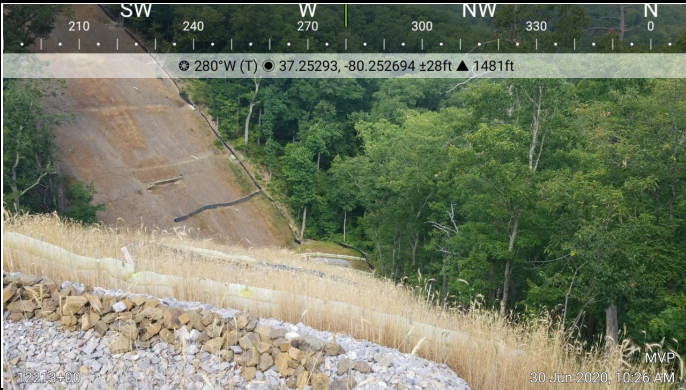
GPS Location	See Above		GPS Location	See Above	
Field Station#	12213+00		Field Station#	12213+00	
Pic 15 Desc.	Temporary and permanent vegetation remain stable and ECDs are functional. Looking West.		Pic 16 Desc.	Environmental crews over-seeded with upland permanent grass seed mix near station 12211+00 - 12214+50.

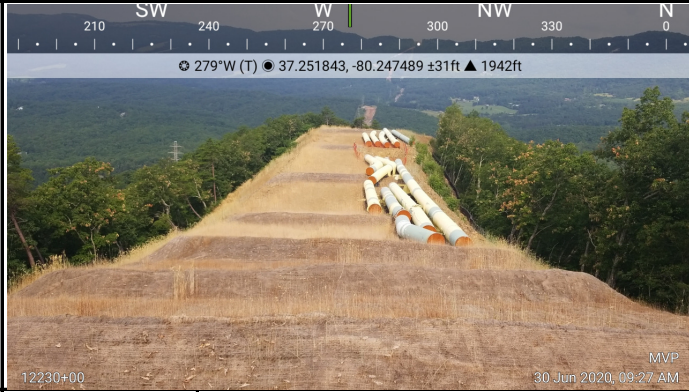
GPS Location	See Above		GPS Location	See Above	
Field Station#	12223+00		Field Station#	12230+00	
Pic 17 Desc.	Temporary vegetation remains stable and ECDs are functional. Looking NorthWest.		Pic 18 Desc.	Temporary vegetation remains stable and ECDs are functional. Looking West.

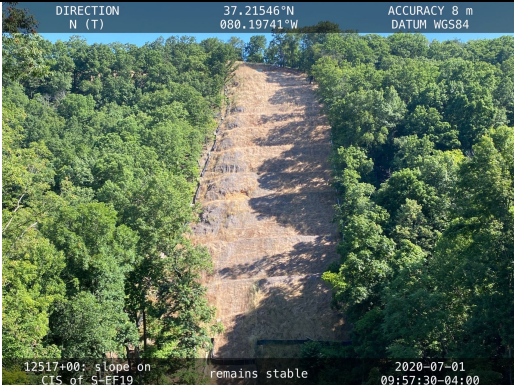
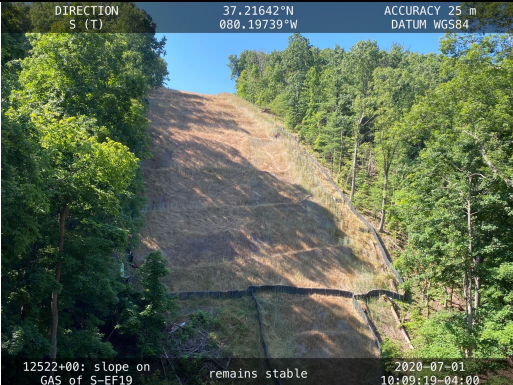
GPS Location	See photo		GPS Location	See photo	
Field Station#	12517+00		Field Station#	12522+00	
Pic 3 Desc.	Slope on coming in side of stream S-EF19, remains stable.		Pic 4 Desc.	Slope on going away side of stream S-EF19 remains stable.

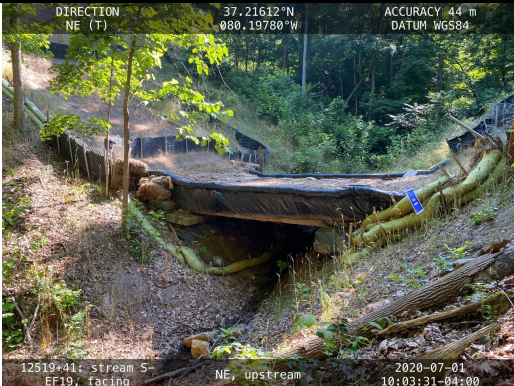
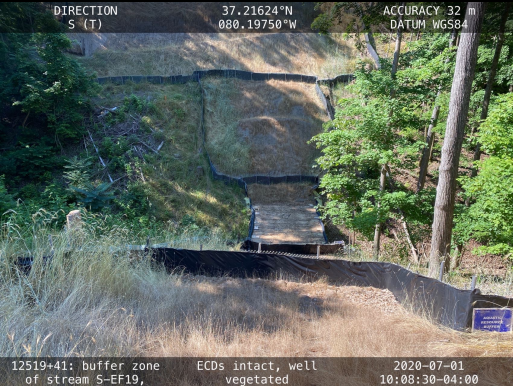
GPS Location	See photo		GPS Location	See photo	
Field Station#	12519+41		Field Station#	12519+41	
Pic 5 Desc.	Stream S-Ef19, facing northeast, upstream		Pic 6 Desc.	Buffer zone of stream S-EF19 stable, ECDs intact.

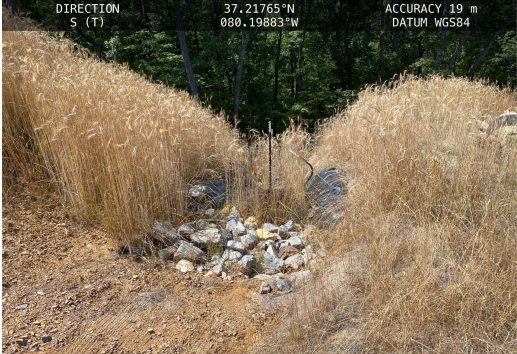
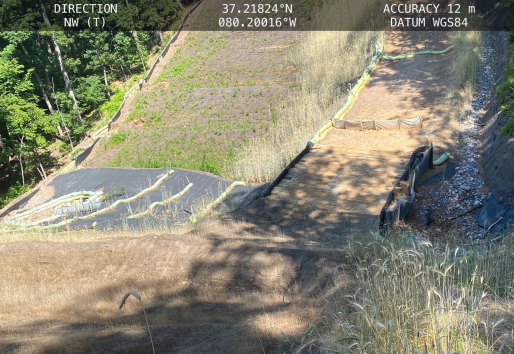
GPS Location	See photo		GPS Location	See photo	
Field Station#	12508+92		Field Station#	12503+70	
Pic 7 Desc.	Fill slope drain intact, inlet free of sediment.		Pic 8 Desc.	Clean water diversion pipe in satisfactory condition.

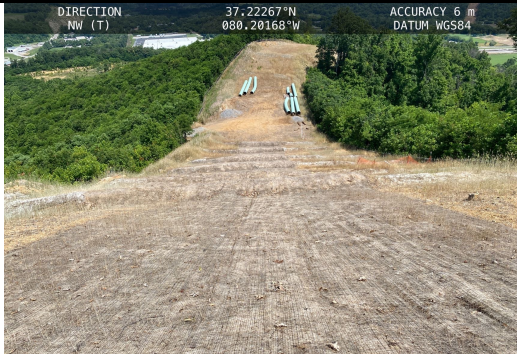
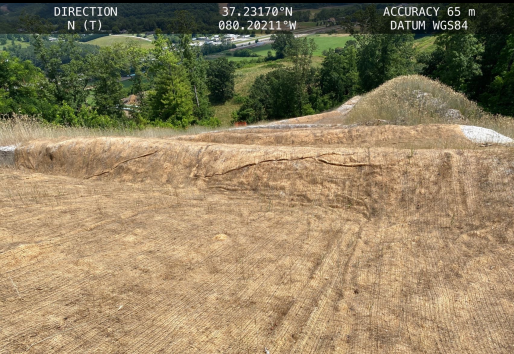
GPS Location	See photo		GPS Location	See photo	
Field Station#	12487+00		Field Station#	12487+00	
Pic 9 Desc.	Slope on going away side of MLV-28 remains stable.		Pic 10 Desc.	Recently stabilized slope between "pig parts" and MLV-28 is stable.

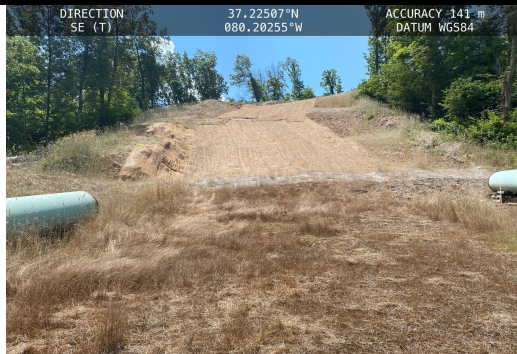
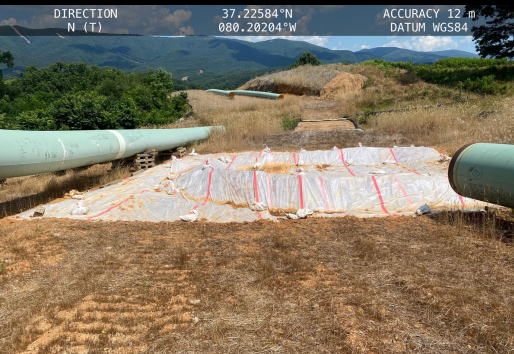
GPS Location	See photo		GPS Location	See photo	
Field Station#	12483+00		Field Station#	12483+00	
Pic 11 Desc.	Slope stable on going away side of site of "pig parts" excavation.		Pic 12 Desc.	Plastic sheeting over "pig parts" site remains secure and intact.

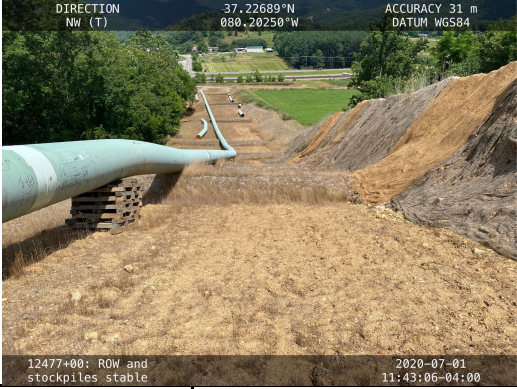
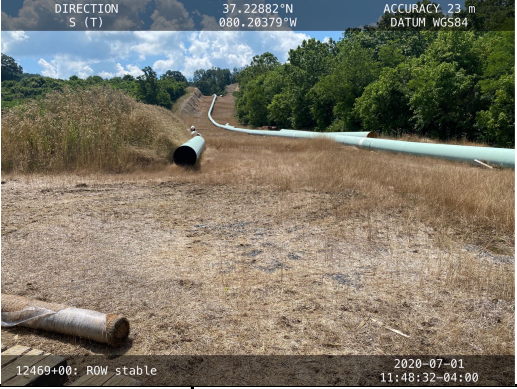
GPS Location	See photo		GPS Location	See photo	
Field Station#	12477+00		Field Station#	12469+00	
Pic 13 Desc.	ROW and stockpiles stable.		Pic 14 Desc.	ROW stable where it turns 90 degrees away from Highway 11.

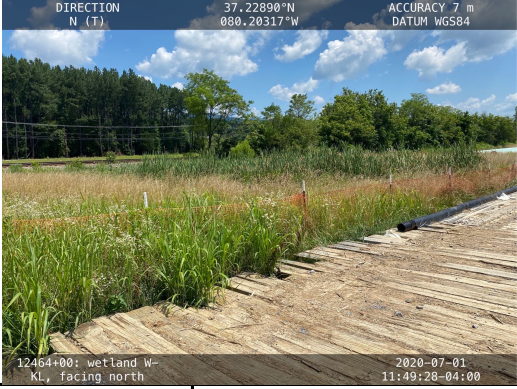
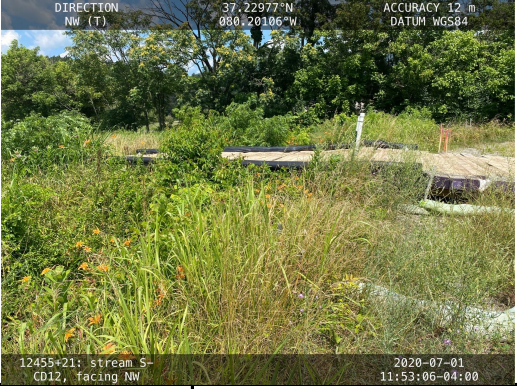
GPS Location	See photo		GPS Location	See photo	
Field Station#	12464+00		Field Station#	12455+21	
Pic 15 Desc.	Wetland W-KL58, facing north		Pic 16 Desc.	Stream S-CD12, facing northwest, upstream

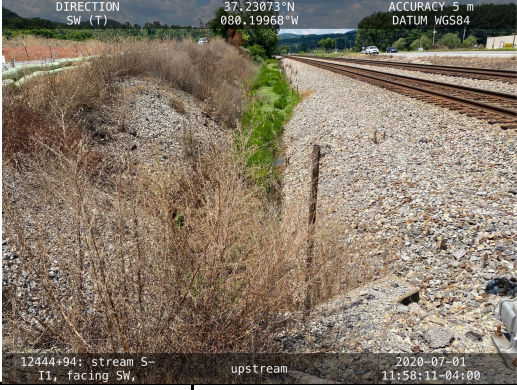
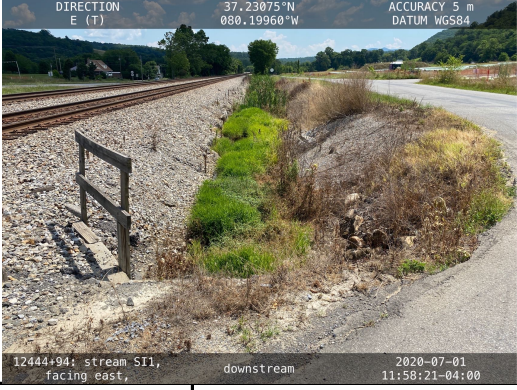
GPS Location	See photo		GPS Location	See photo	
Field Station#	12444+94		Field Station#	12444+94	
Pic 17 Desc.	Stream S-I1, facing southwest, upstream		Pic 18 Desc.	Stream S-I1, facing northeast, downstream

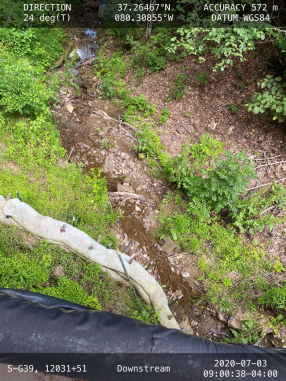
GPS Location	See photo GPS for location		GPS Location	See photo GPS for location	
Field Station#	12031+51		Field Station#	12031+51	
Pic 1 Desc.	Downstream water is low and clear.		Pic 2 Desc.	New signage installed with stream ID on it.

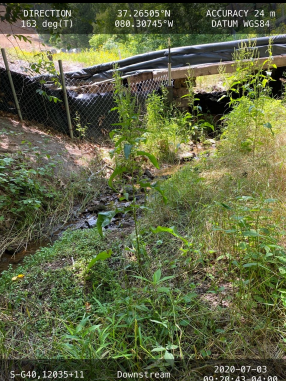
GPS Location	See photo GPS for location		GPS Location	See photo GPS for location	
Field Station#	12035+11		Field Station#	12035+11	
Pic 5 Desc.	Stream running low and clear. ECDs are in acceptable condition.		Pic 6 Desc.	ECDs and vegetation are acceptable.

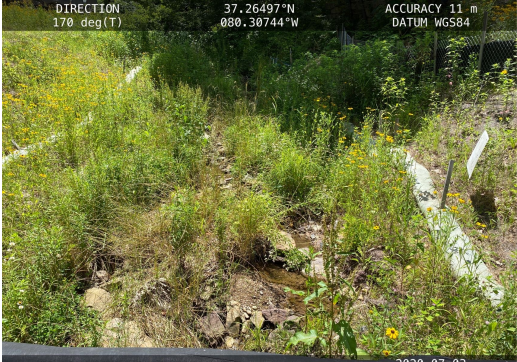
<p>DIRECTION 170 deg(T) 37.26497°N 080.30744°W ACCURACY 11 m DATUM WGS84</p> <p>S-G40,12035+11 Upstream 2020-07-03 09:22:10-04:00</p>

<p>DIRECTION 74 deg(T) 37.26501°N 080.30743°W ACCURACY 16 m DATUM WGS84</p> <p>S-G40,12035+11 CIS from bridge 2020-07-03 09:22:49-04:00</p>			
GPS Location	See photo GPS for location		GPS Location	See photo GPS for location	
Field Station#	12035+11		Field Station#	12035+11	
Pic 7 Desc.	Stream running low and clear. ECDs are in acceptable condition.		Pic 8 Desc.	ECDs are in acceptable condition.

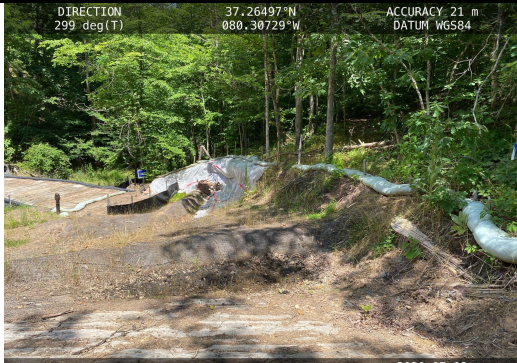
<p>DIRECTION 299 deg(T) 37.26497°N 080.30729°W ACCURACY 21 m DATUM WGS84</p> <p>S-PP23,12035+75 GAS from bridge 2020-07-03 09:25:25-04:00</p>

Field Station#	12035+75		Field Station#	12035+75	
Pic 9 Desc.	ECDs are acceptable.		Pic 10 Desc.	Stream bed is dry. ECDs and vegetation acceptable.

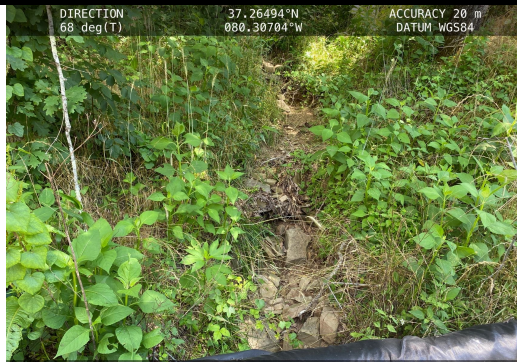
<p>DIRECTION 68 deg(T) 37.26494°N 080.30704°W ACCURACY 20 m DATUM WGS84</p> <p>S-PP23,12035+75 Upstream 2020-07-03 09:26:38-04:00</p>

<p>DIRECTION 202 deg(T) 37.26454°N 080.30664°W ACCURACY 5 m DATUM WGS84</p> <p>12037+75 West Plunge pools @ CWD 2020-07-03 09:31:26-04:00</p>			
GPS Location	See photo GPS for location		GPS Location	See photo GPS for location	
Field Station#	12035+75		Field Station#	12037+75	
Pic 11 Desc.	Stream bed is dry. ECDs and vegetation acceptable.		Pic 12 Desc.	Plunge pools and CWD are in acceptable condition.

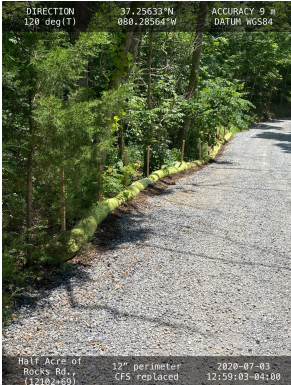
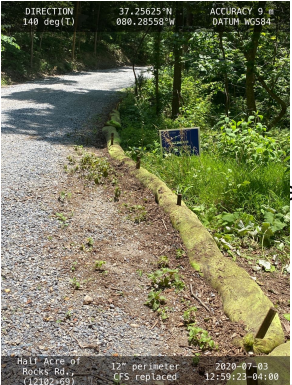
GPS Location	See photo GPS for location		GPS Location	See photo GPS for location	
Field Station#	12102+69		Field Station#	12102+69	
Pic 15 Desc.	Deteriorated 12" perimeter CFS replaced.		Pic 16 Desc.	Deteriorated 12" perimeter CFS replaced.

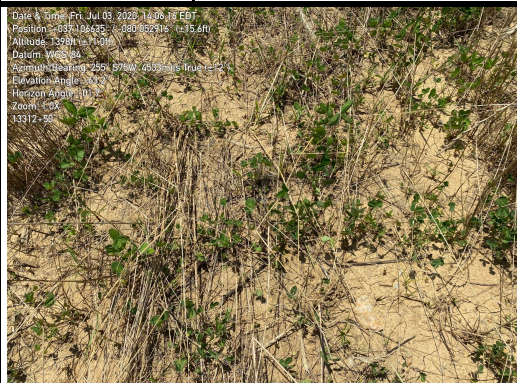
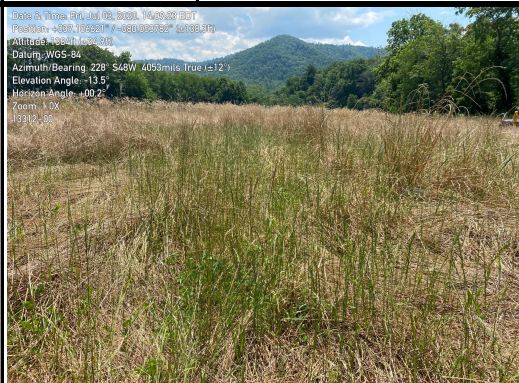
Pic 11 Desc.				Perennial vegetating establishing in permanently restored ROW.				Pic 12 Desc.				Vegetative cover in permanently restored area of ROW.

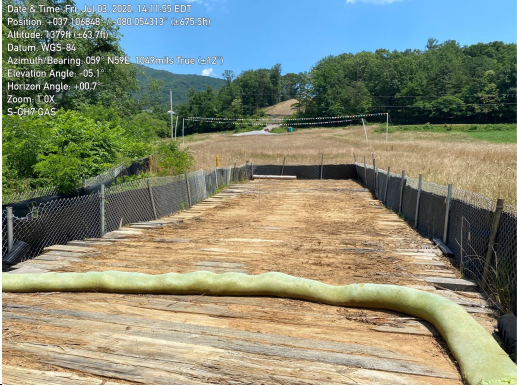
GPS Location	See photos for coordinates.	GPS Location	See photos for coordinates.
Field Station#	13309+25	Field Station#	13309+09
Pic 13 Desc.	GAS S-GH7, bridge and perimeter ECDs in acceptable condition.	Pic 14 Desc.	S-GH7, upstream, no changes noted to stream bed or banks.
<p>Date & Time: Fri Jul 03, 2020 14:13:09 EDT Position: -037.106556, -080.054229 (s1675.5H) Altitude: 1300ft (s151.4H) Datum: WGS 84 Azimuth/Bearing: 314° N44W 359mils True (s12.1) Elevation Angle: -42.5 Horizon Angle: -04.6 Zoom: 1.0X S-GH7 upstream</p>

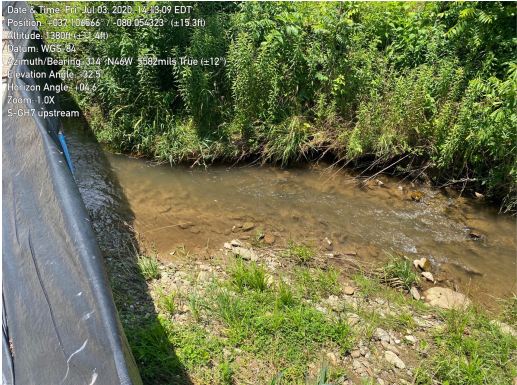
GPS Location	See photos for coordinates.	GPS Location	See photos for coordinates.
Field Station#	13309+09	Field Station#	13309+09
Pic 15 Desc.	S-GH7, upstream, no changes noted to stream bed or banks.	Pic 16 Desc.	S-GH7, downstream, no environmental issues noted.
<p>Date & Time: Fri Jul 03, 2020 14:15:40 EDT Position: -037.106557, -080.053387 (s1675.5H) Altitude: 1305ft (s11.1H) Datum: WGS 84 Azimuth/Bearing: 100° NS/W 591mils True (s12.1) Elevation Angle: -07.2 Horizon Angle: -02.2 Zoom: 1.0X 13308+00</p>
