Visual Site Inspection Report

| Project Name | H-600 Pipeline Spread H | AFE | 124300138 | Spread | H-600 Pipeline Spread H |
| Inspector | John Brcic | | | Date/Time | 7/13/2020 1:53 PM |
| Permit # | TBD | Inspection Type | VA SWPP | Station Begin | 12443+75 |

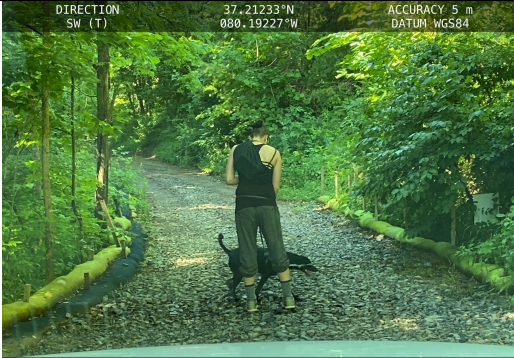
| Field Station# | 12543+56 | | Field Station# | 12543+56 | |

| Pic 1 Desc. | A protester and their dog delayed security as they brought me back to ROW for SWPPP inspection on Yellow Finch Road. | | Pic 2 Desc. | Stream S-EF54, facing northeast, on Yellow Finch Road | |

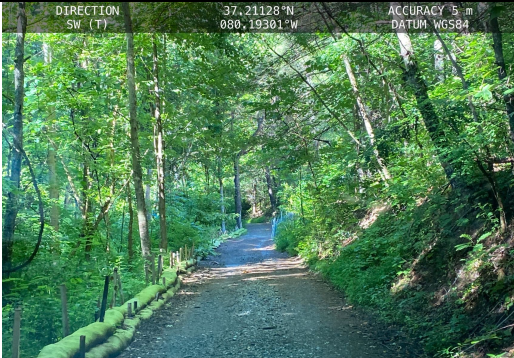
| Field Station# | 12543+56 | | Field Station# | 12543+00 | |

| Pic 3 Desc. | Yellow Finch Road near the MVP ROW. | | Pic 4 Desc. | Plastic sheeting nearest to Yellow Finch Road is intact and secure. | |

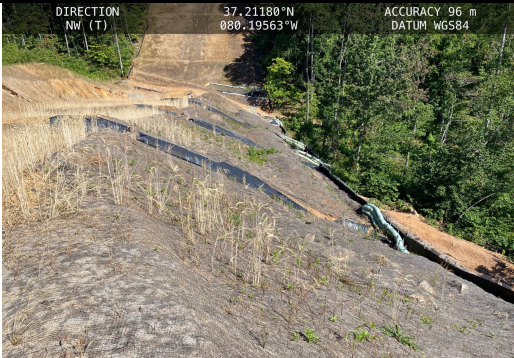
| Field Station# | 12536+00 | | Field Station# | 12522+00 | |

| <p>DIRECTION NW (T) 37.21180°N 080.19563°W ACCURACY 96 m DATUM WGS84</p> <p>12536+00: sparse slope, but blanket vegetation on fill still intact 2020-07-13 09:50:32-04:00</p> | | <p>DIRECTION S (T) 37.21663°N 080.19753°W ACCURACY 38 m DATUM WGS84</p> <p>12522+00: slope on GAS of S-EF19 remains stable 2020-07-13 10:47:42-04:00</p> | | | |

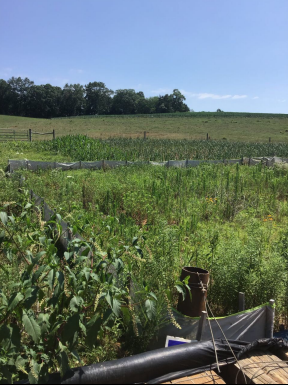
| Field Station# | 13666+27 | Field Station# | 13665+90 | | |

| Pic 1 Desc. | Inspected silt fence | Pic 2 Desc. | Row photo | | |

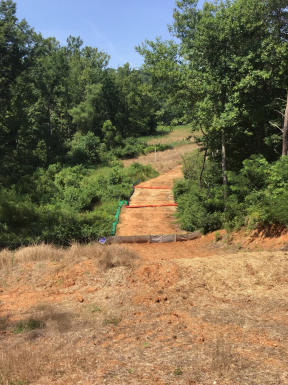
| Field Station# | 13659+09 | Field Station# | 13666+10 | | |

| Pic 3 Desc. | Row photo showing equipment bridge in place | Pic 4 Desc. | Observed erosion control blanket recently installed | | |

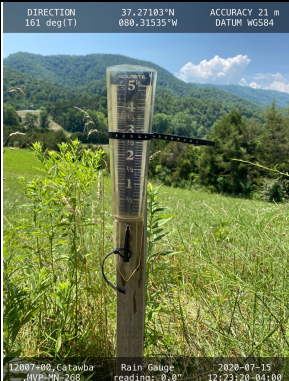
| Field Station# | 12007+00 | | Field Station# | 12013+97 | |

| Pic 13 Desc. | Rain gauge reading was zero. | | Pic 14 Desc. | Downstream on AR crossing G36 | |

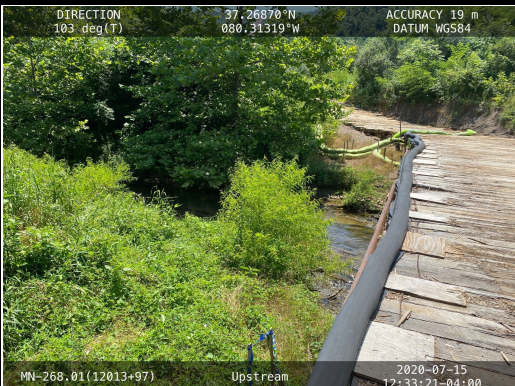
| Field Station# | 12013+97 | | Field Station# | 12015+84 | |

| Pic 15 Desc. | Upstream on AR crossing G36 | | Pic 16 Desc. | G38, upstream | |

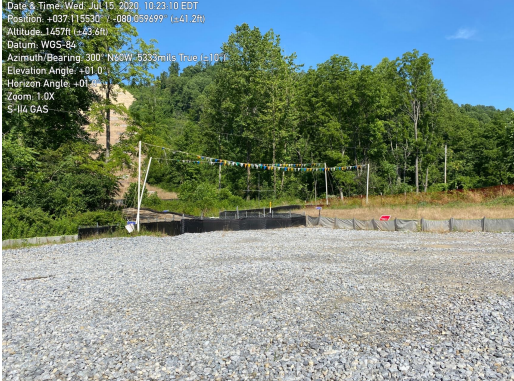
| Field Station# | 13261+50 | | Field Station# | 13261+00 | |

| Pic 1 Desc. | GAS S-II4, perimeter controls in acceptable condition. | | Pic 2 Desc. | S-II4, bridge in acceptable condition. | |

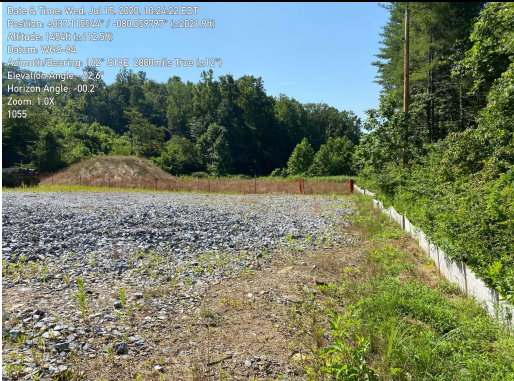
| Field Station# | 13261+00 | | Field Station# | 13261+00 | |

| Pic 3 Desc. | ATWS 1055, partially restored area well vegetated, soil piles stable. | | Pic 4 Desc. | GAS S-II4, perimeter controls in functioning acceptably. | |

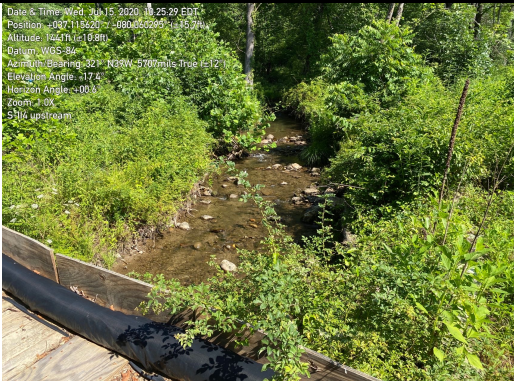
| Field Station# | 13260+60 | | Field Station# | 13260+60 | |

| Pic 5 Desc. | S-II4, upstream, no changes noted to stream bed or banks, banks well vegetated. | | Pic 6 Desc. | S-II4, upstream, no environmental issues noted. | |

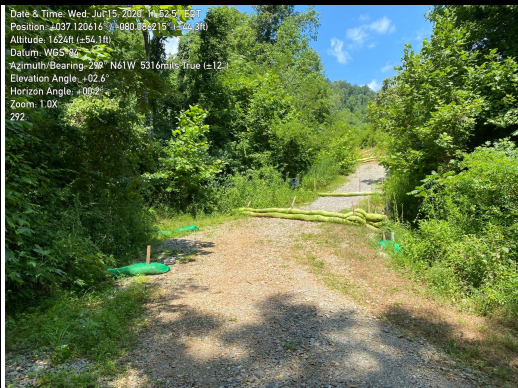
| AFE | 124300138 | Date/Time | 7/15/2020 7:21 PM | Report # | |
|--|--|---|---|--|--|
| Field Station# | 13142+00 | | Field Station# | 13190+00 | |

| AFE | 124300138 | Date/Time | 7/15/2020 7:21 PM | Report # | |
|--|--|---|---|--|--|
| Pic 9 Desc. | MVP-FR-292, ECDs in acceptable condition. | | Pic 10 Desc. | MVP-AR-29, RCE and perimeter controls in acceptable condition. | |

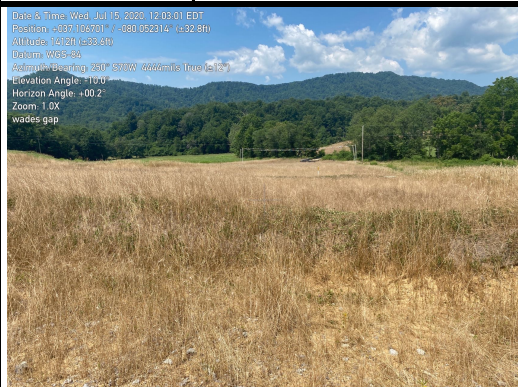
| AFE | 124300138 | Date/Time | 7/15/2020 7:21 PM | Report # | |
|--|--|---|---|--|--|
| Field Station# | 13312+50 | | Field Station# | 13312+50 | |

| AFE | 124300138 | Date/Time | 7/15/2020 7:21 PM | Report # | |
|--|--|---|---|--|--|
| Pic 11 Desc. | Good vegetative cover noted across LOD. | | Pic 12 Desc. | Waterbar, sump, and end treatment in acceptable condition. | |

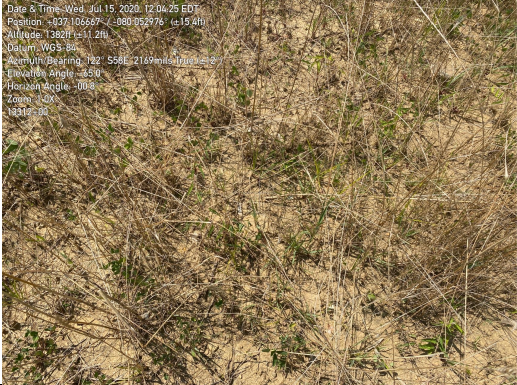
| Field Station# | 13312+00 | | Field Station# | 13310+00 | |

| Pic 13 Desc. | Vegetation noted on ROW. | | Pic 14 Desc. | Good vegetative cover noted across LOD. | |

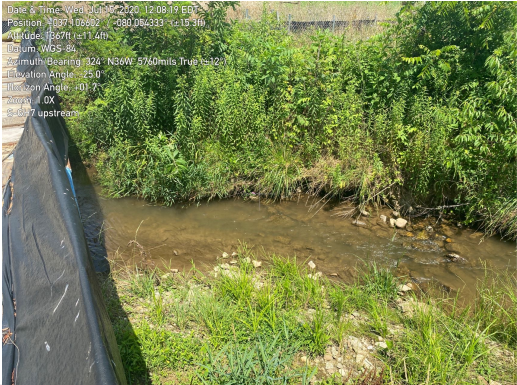
| Field Station# | 13309+09 | | Field Station# | 13309+25 | |

| Pic 15 Desc. | S-GH7, upstream, no changes noted to stream bed or banks. | | Pic 16 Desc. | GAS S-GH7, perimeter ECDs in acceptable condition. | |

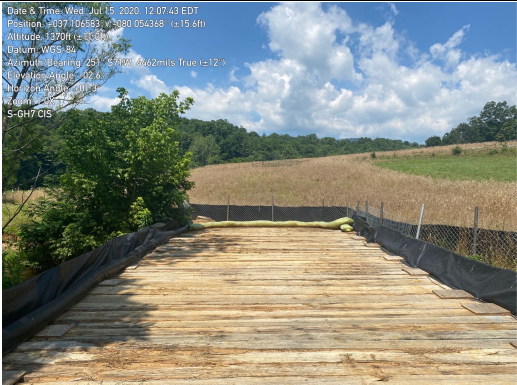
| Field Station# | 13309+09 | | Field Station# | 13309+09 | |

| Pic 17 Desc. | CIS S-GH7, ROW stable with good vegetative cover. | | Pic 18 Desc. | S-GH7, downstream, no environmental issues noted. | |

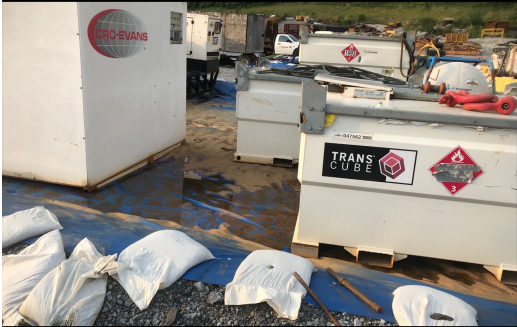
| MVP-PY-006_071620 Condition of containment 2020-07-16 07:24:37-04:00 | | | | MVP-PY-006_071620 Condition of containment 2020-07-16 07:24:41-04:00 | |
| Pic 7 Desc. | Condition of containment. Holding some stormwater. No sheen present. Looking SE. | | Pic 8 Desc. | Condition of containment. Holding some stormwater no sheen present. Looking S. | |

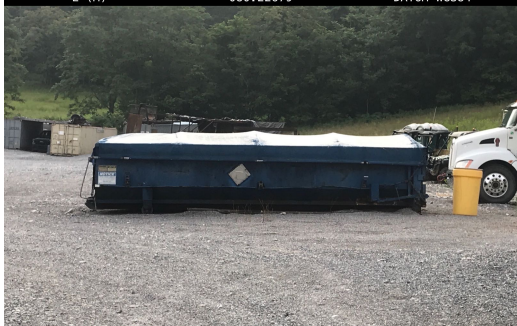
| MVP-PY-006_071620 No debris around hazardous waste ... 2020-07-16 07:25:40-04:00 | | | | MVP-PY-006_071620 No loose trash around dumpsters 2020-07-16 07:28:02-04:00 | |
| Pic 9 Desc. | No debris around hazardous waste dumpster. Looking E. | | Pic 10 Desc. | No loose trash around dumpsters. Looking SW. | |

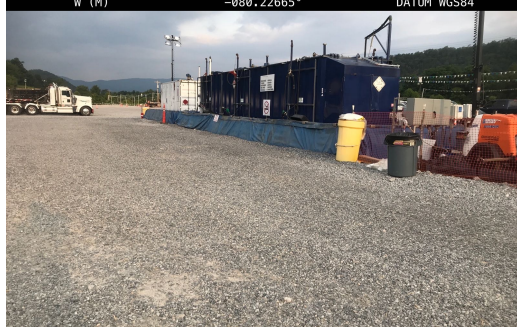
| MVP-PY-006_071620 No fuel spills south of tanks 2020-07-16 07:29:44-04:00 | | | | MVP-PY-006_071620 No leaky internal fittings 2020-07-16 07:30:35-04:00 | |

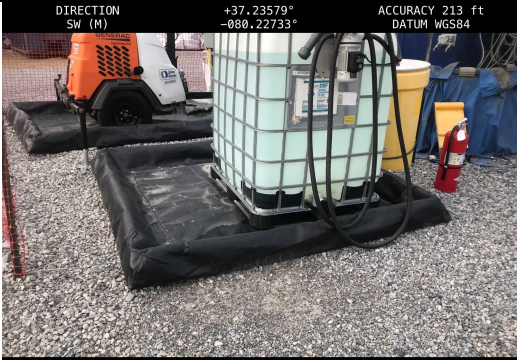
| Pic 13 Desc. | Condition of containment under DEF Tank. Free of stormwater. Looking SW. | | Pic 14 Desc. | Secondary containment on site for tankers offloading fuel into Blue Bulk fuel tanks. Looking NW. | |

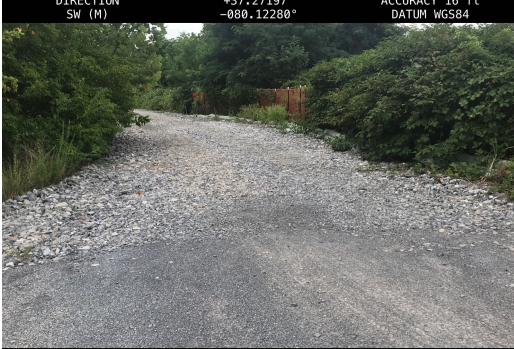
| Pic 1 Desc. | Condition of rock entrance on north drive. Looking SW. | | Pic 2 Desc. | Condition of compost filter sock and safety fence along feature W-CV21A. Looking W. | |

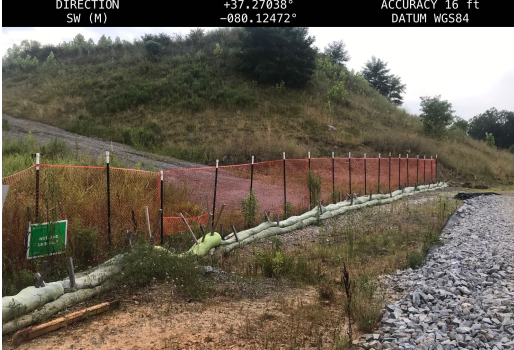
| Pic 3 Desc. | Landowner disturbance within 100' of feature. Area not stabilized and no impacts. Looking SW. | | Pic 4 Desc. | Landowner disturbance along compost filter sock and feature. Area not stabilized and no impacts. Looking SE | |

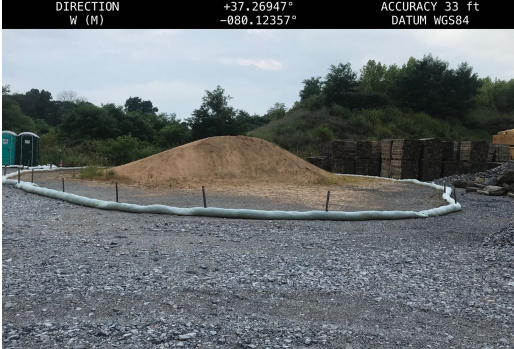
| Pic 5 Desc. | Condition of compost filter sock around sand pile. Looking W. | | Pic 6 Desc. | Condition of containment under stored equipment. Looking SW. | |

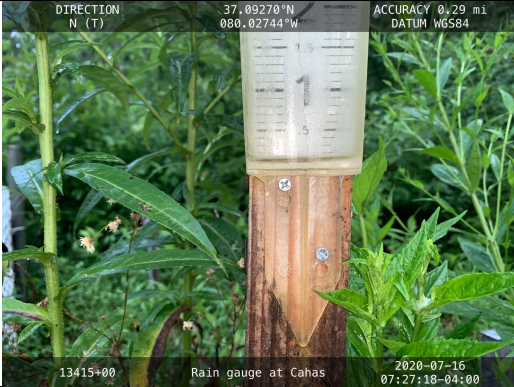
| Pic 1 Desc. | Photo shows the rain gauge at Cahas. 0.1 inches of rainfall. | | Pic 2 Desc. | Photo shows the ROW condition from about 13411+00 to 13414+00. | |

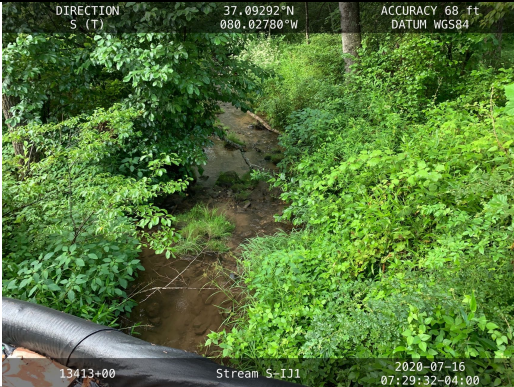
| Pic 3 Desc. | Photo shows stream S-IJ1 downstream from the ROW crossing. | | Pic 4 Desc. | Photo shows the bridge over stream S-IJ1. | |

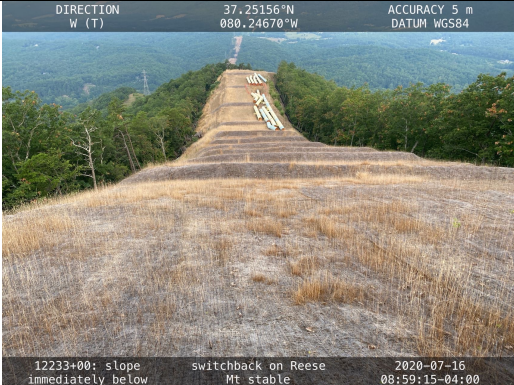
| Pic 1 Desc. | Slope immediately downhill from the switchback on Reese Mountain remains stable. | | Pic 2 Desc. | The steep slope on the coming in side of the ravine between Bradshaw Road and Reese Mountain remains stable. | |

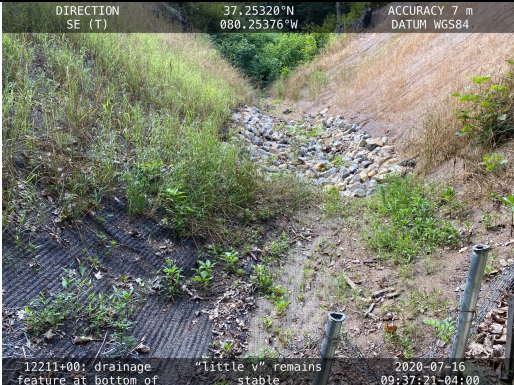
| Stations 12119+17 to 12234+50.....Activity since last SWPPP inspection. Badly degraded perimeter compost filter sock was removed from station 12211+00 to 12212+00 in response to an MBP action item, and with the approval from DEQ. | | | | | |

| Pic 3 Desc. | The drainage feature at the bottom of the ravine between Bradshaw Road and Reese Mountain free of any erosion. | | Pic 4 Desc. | Permanent restoration between Bradshaw Road and Reese Mountain remains stable, minimal permanent vegetation. | |

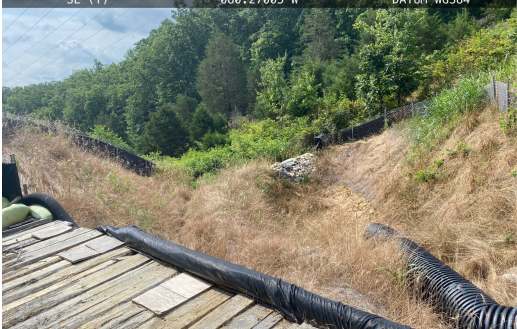
| Pic 13 Desc. | Clean water diversion channel and temporary sediment trap are in satisfactory condition and functioning per design. | | Pic 14 Desc. | Drainage feature between AR 272 and 273 remains stable. | |

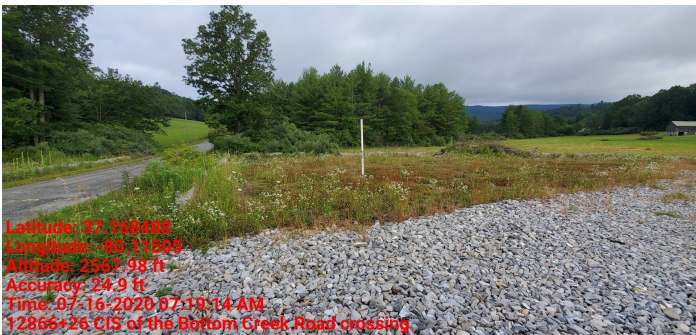
| Pic 1 Desc. | CIS of the Bottom Creek Road crossing. | | Pic 2 Desc. | GAS of the Bottom Creek Road crossing. | |

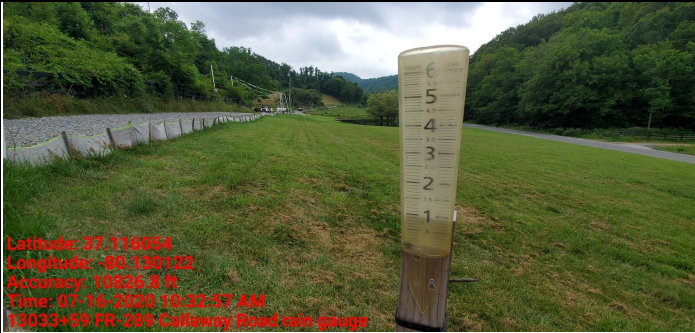
| Pic 13 Desc. | | | FR-289 Callaway Road rain gauge. 0.0" total precipitation. | | |

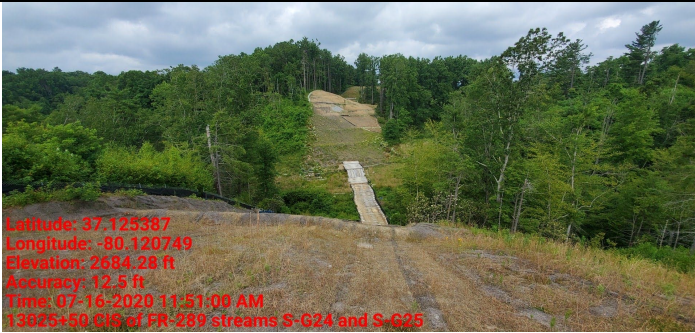
| Pic 14 Desc. | | | GAS of the BRP streams S-G24 and S-G25. | | |

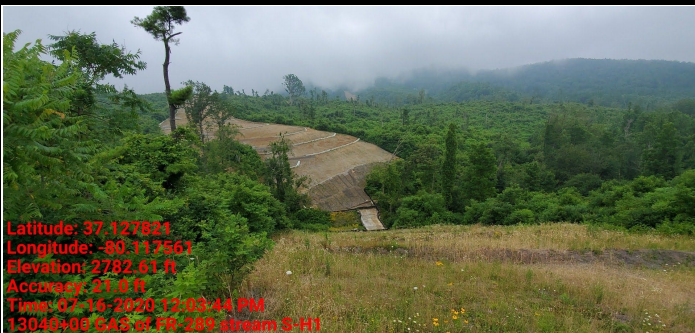
| Pic 15 Desc. | | | Stream S-H1 on the GAS of access FR-289. | | |

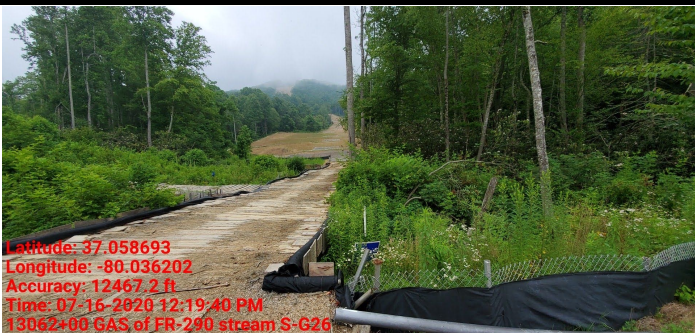
| Pic 16 Desc. | | | Stream S-G26 on the GAS of access FR-290. | | |

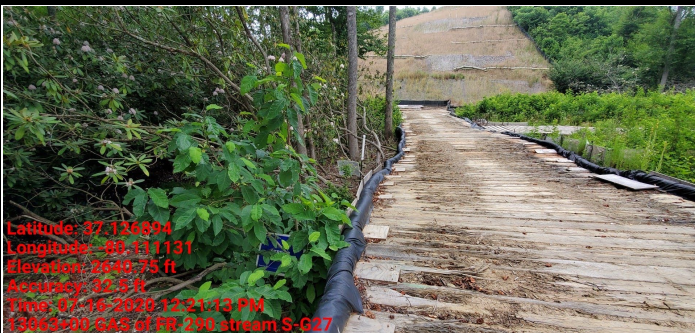
| Field Station# | | | 13063+00 | | |

| <p>Latitude: 37.126894 Longitude: -80.111131 Elevation: 2840.75 ft Accuracy: 22.5 ft Time: 07-16-2020 12:21:13 PM 13063+00 GAS of FR-290 stream S-G27</p> | | | <p>Latitude: 37.114598 Longitude: -80.097196 Elevation: 2129.92 ft Accuracy: 22.3 ft Time: 07-16-2020 12:40:18 PM 13115+97 access road FR-291 ATWS</p> | | |

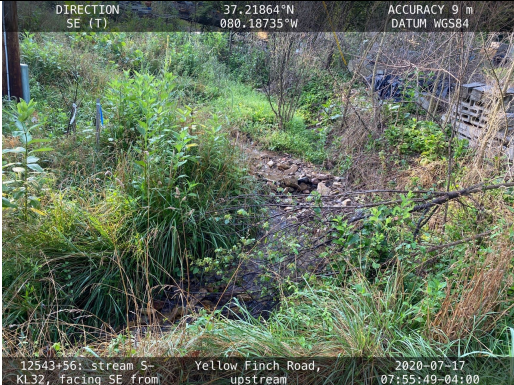
| Field Station# | 12543+56 | | Field Station# | 12543+56 | |

| Pic 1 Desc. | Stream S-KL32, facing southeast, upstream from Yellow Finch Road. | | Pic 2 Desc. | Stream S-EF54 on Yellow Finch Road, facing northeast | |

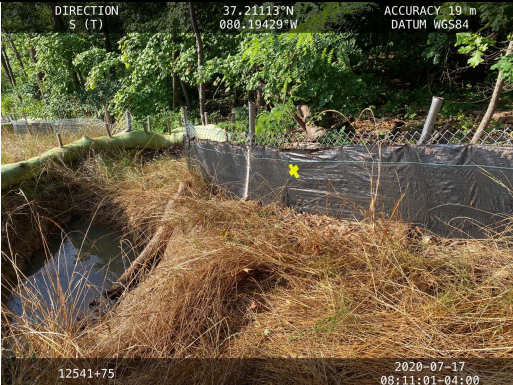
| Field Station# | 12543+56 | | Field Station# | 12541+75 | |

| Pic 3 Desc. | MVP ROW crossing at Yellow Finch Road. | | Pic 4 Desc. | A small hole was observed near the bottom off the SSF on the slope on CIS of Yellow Finch Road. | |

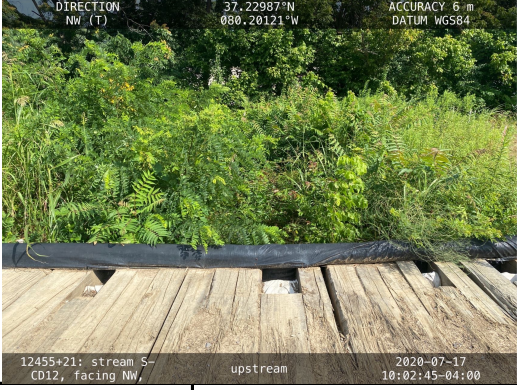
| Field Station# | 1245+00 | | Field Station# | 12444+94 | |

| <p>DIRECTION NW (T) 37.22987°N 080.20121°W ACCURACY 6 m DATUM WGS84</p> <p>12455+21: stream S-CD12, facing NW, upstream 2020-07-17 10:02:45-04:00</p> | | <p>DIRECTION SW (T) 37.23073°N 080.19966°W ACCURACY 7 m DATUM WGS84</p> <p>12444+94: stream S-I1, facing SW, downstream 2020-07-17 10:07:24-04:00</p> | | | |
