## Visual Site Inspection Report

| <b>Project Name</b> | H-600 Pipeline Spread H | <b>AFE</b> | 124300138 | <b>Spread</b> | H-600 Pipeline Spread H |
| <b>Contractor</b> | Precision | | | <b>Report #</b> | 12861 |
| <b>Inspector</b> | Logan Box | | | <b>Date/Time</b> | 7/22/2020 5:05 PM |

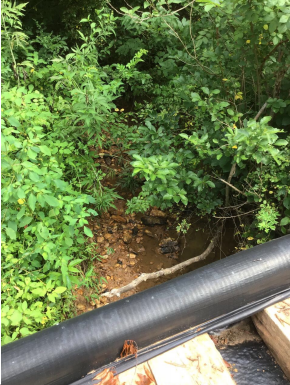
| <b>Pic 3 Desc.</b> | Stream crossing photo facing upstream | <b>Pic 4 Desc.</b> | Stream crossing photo facing downstream | | |

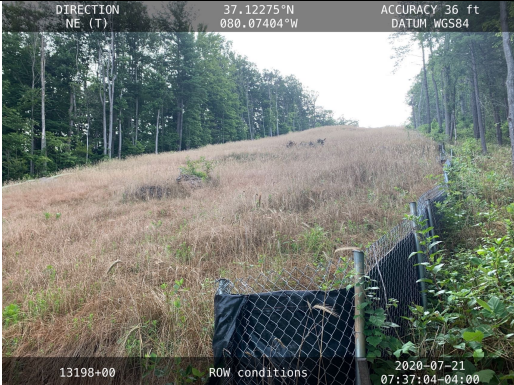
| <b>Field Station#</b> | 13198+00 | | <b>Field Station#</b> | 13204+00 | |

| <b>Pic 1 Desc.</b> | Photo shows the ROW condition from about 13198+00 to 13203+00. | | <b>Pic 2 Desc.</b> | Photo shows the ROW condition from about 13204+00 to 13210+00. | |

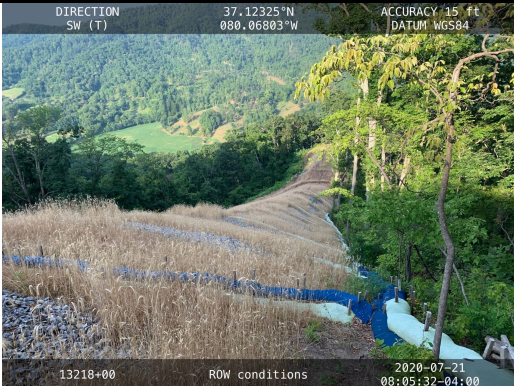
| <b>Field Station#</b> | 13218+00 | | <b>Field Station#</b> | 13223+00 | |

| <b>Pic 5 Desc.</b> | Photo shows the ROW condition from about 13211+00 to 13218+00. | | <b>Pic 6 Desc.</b> | Photo shows the ROW condition from about 13223+00 to 13230+00. | |

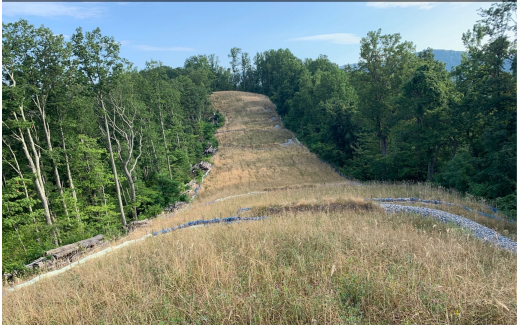
| <b>Field Station#</b> | 13231+00 | | <b>Field Station#</b> | 13252+00 | |

| <b>Pic 7 Desc.</b> | Photo shows the ROW condition from about 13224+00 to 13231+00. | | <b>Pic 8 Desc.</b> | Photo shows the perimeter ECDs from 13251+00 to 13252+00. | |

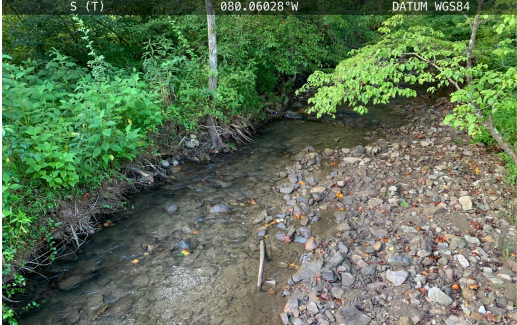
| <b>Field Station#</b> | 13259+00 | | <b>Field Station#</b> | 13260+00 | |

| <b>Pic 9 Desc.</b> | Photo shows the bridge over stream S-II4 and adjacent buffer ECDs. | | <b>Pic 10 Desc.</b> | Photo shows stream S-II4 downstream from the ROW crossing. | |

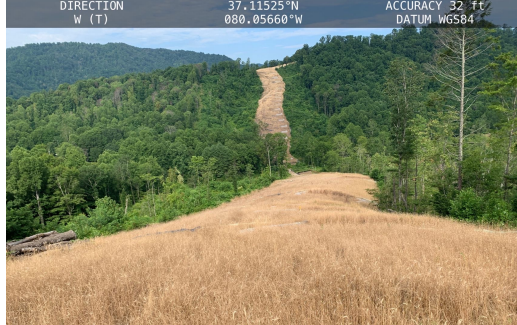
| <b>Field Station#</b> | 13272+00 | | <b>Field Station#</b> | 13283+00 | |

| <b>Pic 11 Desc.</b> | Photo shows the ROW condition from about 13268+00 to 13272+00. | | <b>Pic 12 Desc.</b> | Photo shows the ROW condition from about 13283+00 to 13288+00. | |

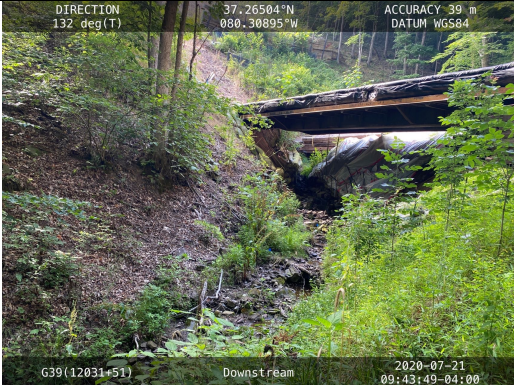
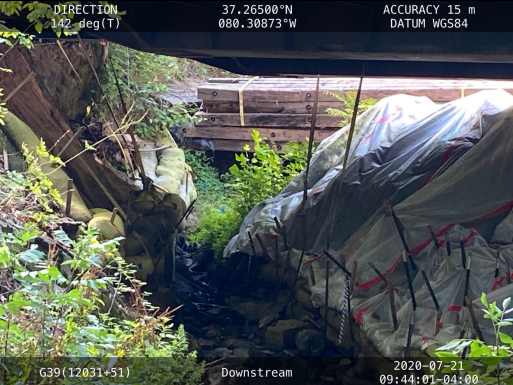
| <b>Field Station#</b> | 12031+51 | | <b>Field Station#</b> | 12031+51 | |

| <b>Pic 1 Desc.</b> | G39 downstream | | <b>Pic 2 Desc.</b> | G39 downstream | |

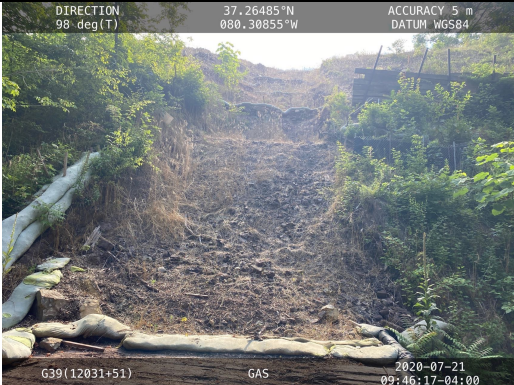
| <b>Field Station#</b> | 12031+51 | | <b>Field Station#</b> | 12031+51 | |

| <b>Pic 3 Desc.</b> | GAS G39 | | <b>Pic 4 Desc.</b> | CIS G39 | |

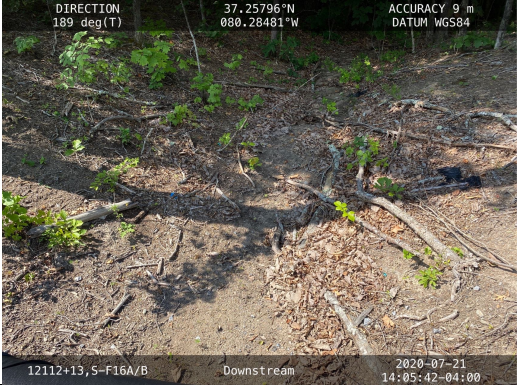
| <b>Field Station#</b> | 12112+13 | | <b>Field Station#</b> | 12108+41 | |

| <b>Pic 13 Desc.</b> | F16A/B downstream | | <b>Pic 14 Desc.</b> | F15 downstream | |

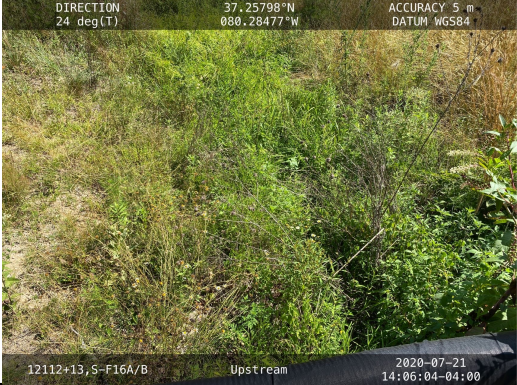
| <b>Field Station#</b> | 12112+13 | | <b>Field Station#</b> | 12101+57 | |

| <b>Pic 15 Desc.</b> | F16A/B upstream | | <b>Pic 16 Desc.</b> | MM11 downstream | |

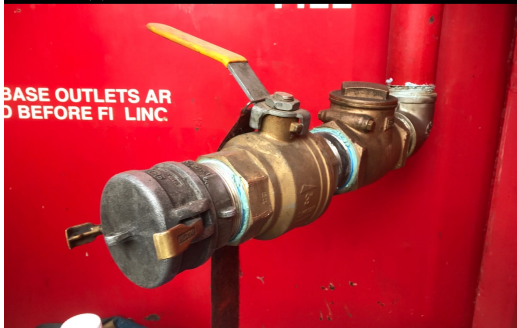
| <b>Field Station#</b> | +0 | | <b>Field Station#</b> | +0 | |

| <b>Pic 9 Desc.</b> | Off Road Fuel unit no leaky internal fittings. Looking W. | | <b>Pic 10 Desc.</b> | No loose trash around dumpsters. Looking SE. | |

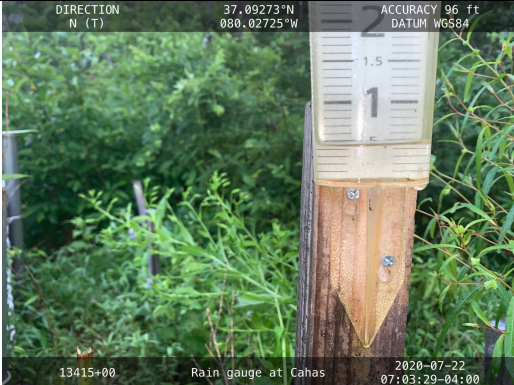
| <b>Field Station#</b> | 13415+00 | | <b>Field Station#</b> | 13338+00 | |

| <b>Pic 1 Desc.</b> | Photo shows the rain gauge at Cahas. 0.5 inches of rainfall within the last 24 hours. | | <b>Pic 2 Desc.</b> | Photo shows the perimeter ECDs from about 13337+50 to 13338+00. | |

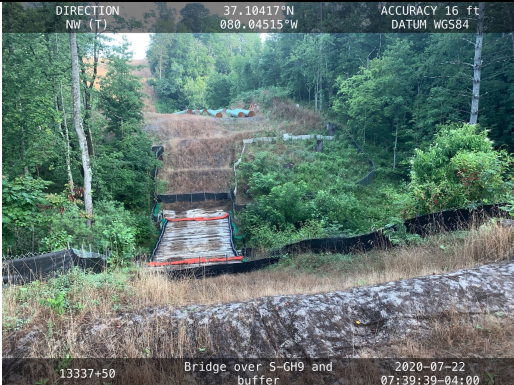
| <b>Field Station#</b> | 13337+50 | | <b>Field Station#</b> | 13337+13 | |

| <b>Pic 3 Desc.</b> | Photo shows the bridge over stream S-GH9 and adjacent buffer. | | <b>Pic 4 Desc.</b> | Photo shows stream S-GH9 downstream from the ROW crossing. | |

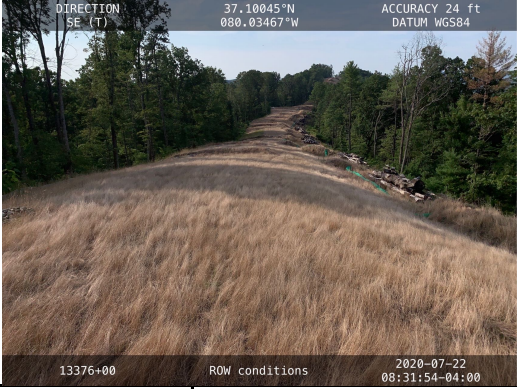
| <b>Field Station#</b> | 13376+00 | | <b>Field Station#</b> | 13369+00 | |

| <b>Pic 7 Desc.</b> | Photo shows the ROW condition from about 13376+00 to 13385+00. | | <b>Pic 8 Desc.</b> | Photo shows the ROW condition from about 13366+0 to 13369+00. | |

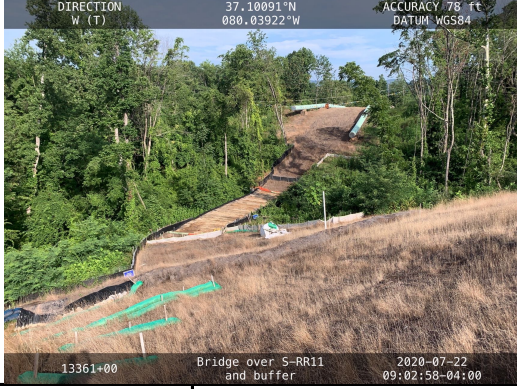
| <b>Field Station#</b> | 13361+00 | | <b>Field Station#</b> | 13358+64 | |

| <b>Pic 9 Desc.</b> | Photo shows the bridge over stream S-RR11 and adjacent buffer. | | <b>Pic 10 Desc.</b> | Photo shows stream S-RR11 downstream from the ROW crossing. | |

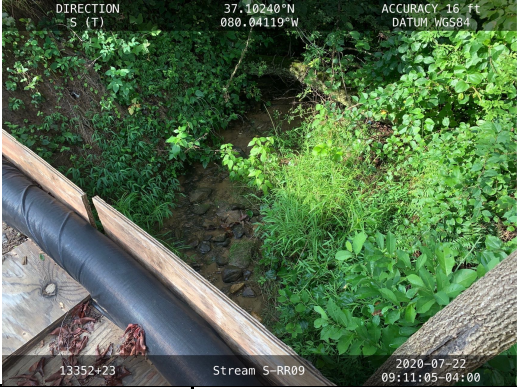
| <b>Field Station#</b> | 13352+23 | | <b>Field Station#</b> | 13352+30 | |

| <b>Pic 13 Desc.</b> | Photo shows stream S-RR09 downstream from the ROW crossing. | | <b>Pic 14 Desc.</b> | Photo shows the bridge over stream S-RR09. | |

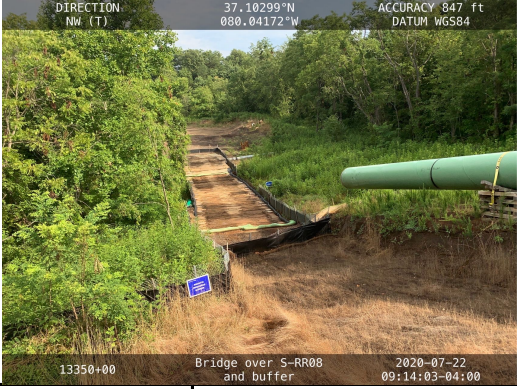
| <b>Field Station#</b> | 13350+00 | | <b>Field Station#</b> | 13348+50 | |

| <b>Pic 15 Desc.</b> | Photo shows the bridge over stream S-RR08 and adjacent buffer. | | <b>Pic 16 Desc.</b> | Photo shows the bridge over stream S-RR08. | |

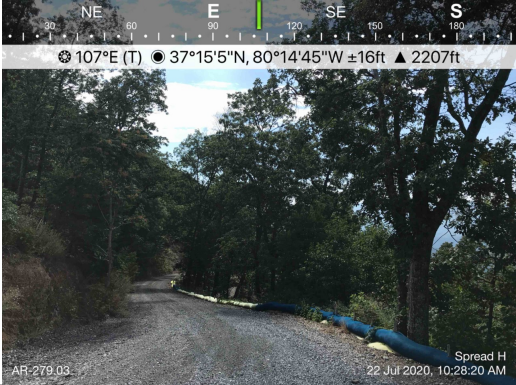
| <b>Pic 1 Desc.</b> | Start of inspection area, Perm. waterbars in good condition. | | <b>Pic 2 Desc.</b> | Portajohns in secondary containment. | |

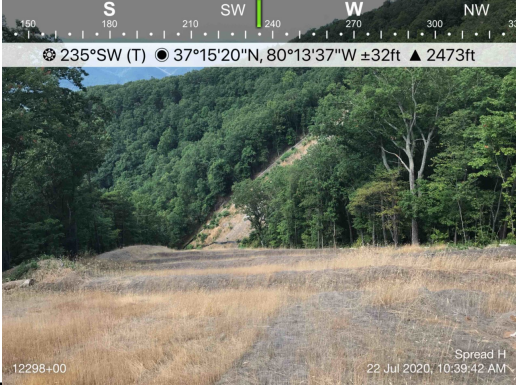
| <b>Pic 3 Desc.</b> | Controls in place and functioning on AR-279.03 | | <b>Pic 4 Desc.</b> | SSF controls in good condition, vegetative stabilization is mature and uniform. | |

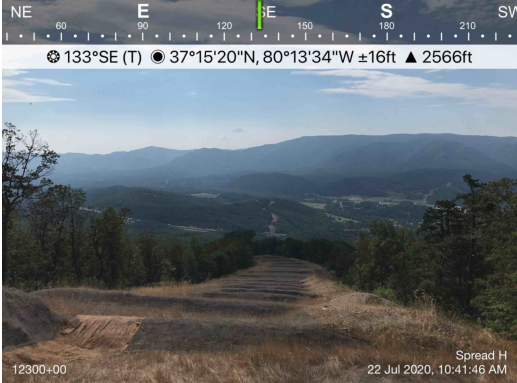
| <b>Pic 7 Desc.</b> | Waterbars are stabilized with erosion control blanketing and in good condition on Reese Mtn. | | <b>Pic 8 Desc.</b> | Bridge controls at this stream crossing in good condition. | |

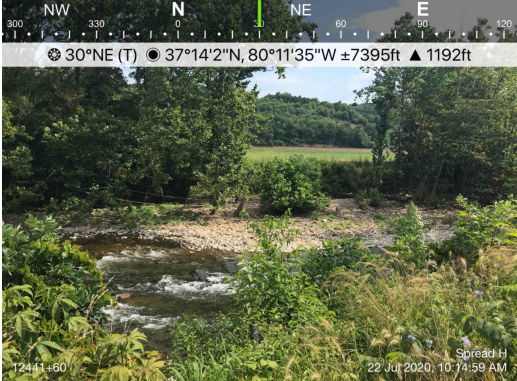
| <b>Pic 13 Desc.</b> | Roanoke River crossing area in good condition. | <b>Pic 14 Desc.</b> | Rock CE and Timbermatting controls in good condition near Rte. 11 Crossing. | | |

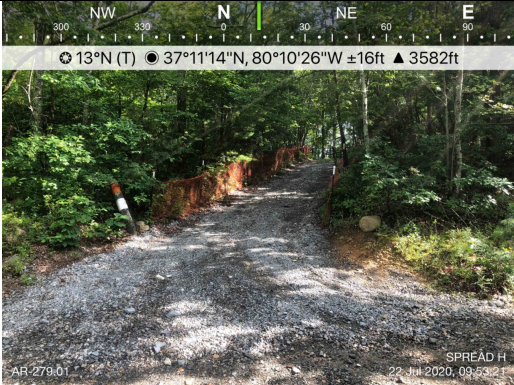
| <b>Pic 1 Desc.</b> | AR-279.01 remains in good condition with controls in place. | | <b>Pic 2 Desc.</b> | CFS along AR-279.01 remains in good condition and is functioning. | |

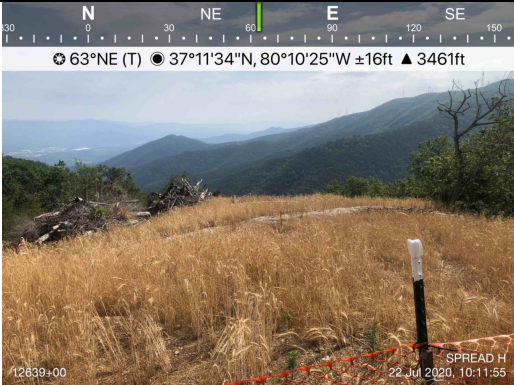
| <b>Pic 3 Desc.</b> | GAS slope of AR-279.01 in good condition. Vegetation has filled in and inhibiting erosion. | | <b>Pic 4 Desc.</b> | Waterbars on this slope are in good condition and functioning. | |

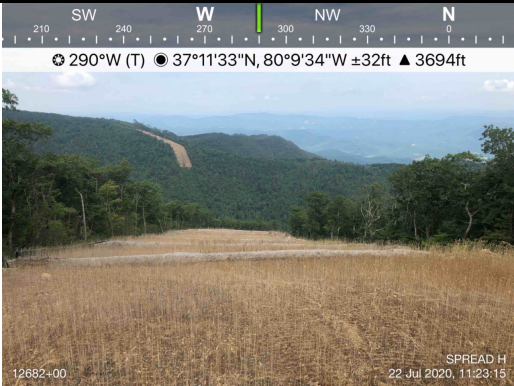
| <b>Pic 5 Desc.</b> | Vegetation continuing to fill in on the CIS of Honeysuckle Rd. ROW in good condition with controls in place. | | <b>Pic 6 Desc.</b> | Waterbars on this slope in good condition and functioning. | |

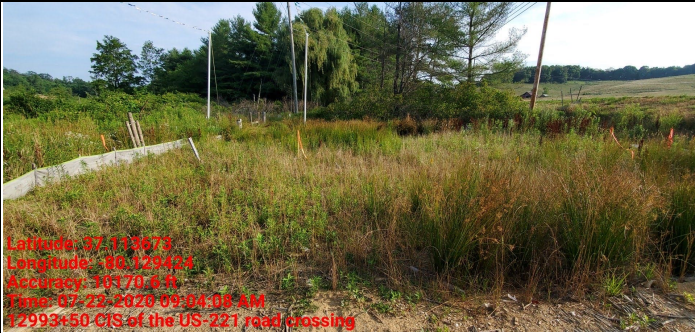
| Pic 13 Desc. | CIS of the US-221 road crossing. | | Pic 14 Desc. | CIS of the BRP motorway | |

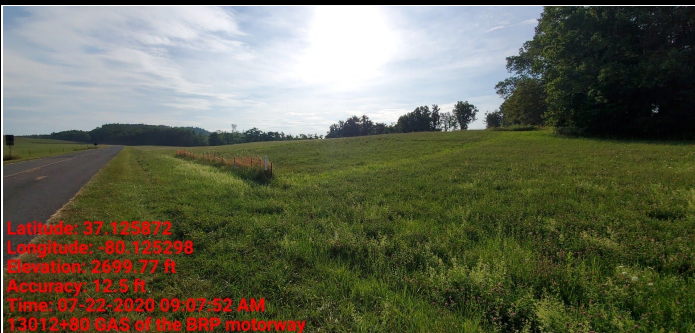
| Pic 15 Desc. | GAS of the BRP motorway. | | Pic 16 Desc. | FR-289 Callaway Road rain gauge. 0.0" total precipitation. | |

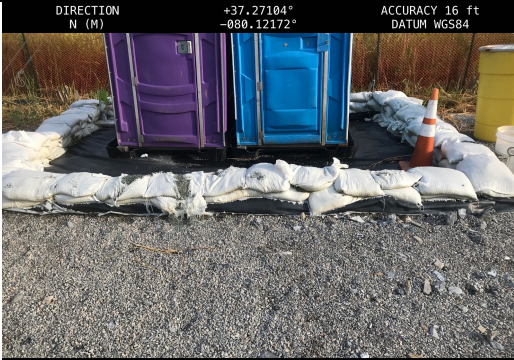
| <b>Pic 3 Desc.</b> | Condition of trays and containment under toilets. Looking N. | | <b>Pic 4 Desc.</b> | Condition of containments under stored vehicle. Looking NW. | |

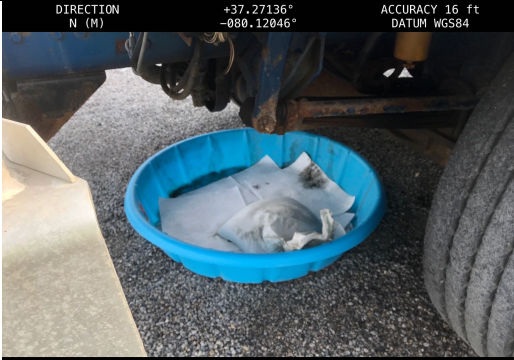
| <b>Pic 5 Desc.</b> | Condition of containment under stored vehicle. Looking N. | | <b>Pic 6 Desc.</b> | Condition of containment under stored vehicle. Looking SE. | |

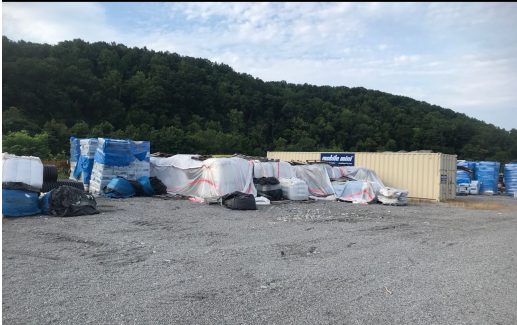
| MVP-LY-049_072220    Restoration supplies covered and protected    2020-07-22 08:37:47-04:00 | | MVP-LY-049_072220    Containment under stored equipment    2020-07-22 08:38:34-04:00 | | | |
| <b>Pic 7 Desc.</b> | Restoration supplies covered and protected from the elements. Looking SW. | | <b>Pic 8 Desc.</b> | Condition of containment under stored equipment. Looking SW. | |

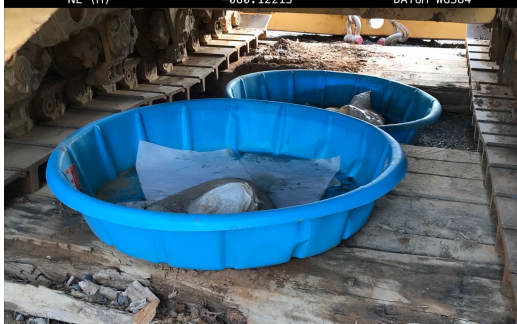
| MVP-LY-049_072220    Containments under stored equipment    2020-07-22 08:39:01-04:00 | | MVP-LY-049_072220    Containment under stored equipment    2020-07-22 08:39:19-04:00 | | | |
| <b>Pic 9 Desc.</b> | Condition of containments under stored equipment. Looking NE. | | <b>Pic 10 Desc.</b> | Condition of containment under stored equipment. Looking SW. | |

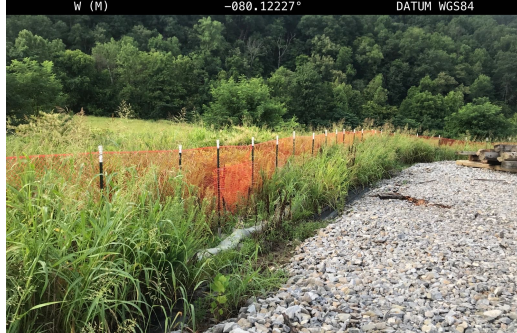
| MVP-LY-049_072220    Condition of CFS and safety fence along ...    2020-07-22 08:41:45-04:00 | | MVP-LY-049_072220    Condition of CFS around sand pile    2020-07-22 08:42:40-04:00 | | | |

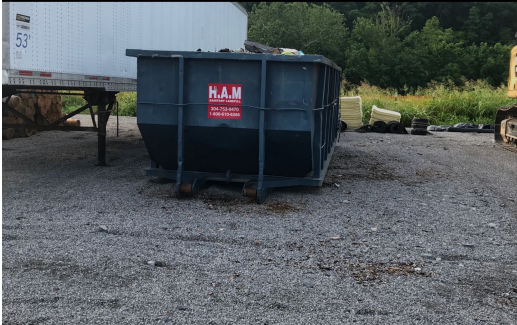
| MVP-LY-049_072220 No loose trash around south dumpster 2020-07-22 08:44:56-04:00 | | | | MVP-LY-049_072220 No debris around hazardous waste 2020-07-22 08:45:51-04:00 | |
| <b>Pic 13 Desc.</b> | No loose trash around south dumpster. Looking SE. | | <b>Pic 14 Desc.</b> | No debris or deposits around hazardous waste materials dumpsters. Looking W. | |

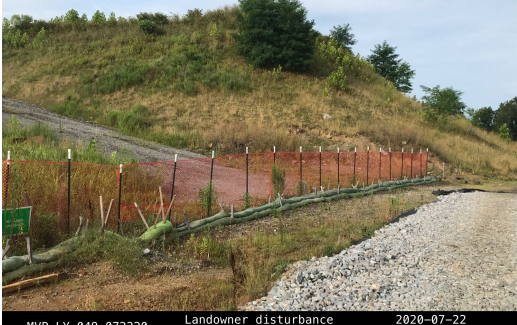
| MVP-LY-049_072220 Landowner disturbance within 100' of 2020-07-22 08:47:26-04:00 | | | | MVP-LY-049_072220 Condition of CFS & safety fence 2020-07-22 08:47:45-04:00 | |

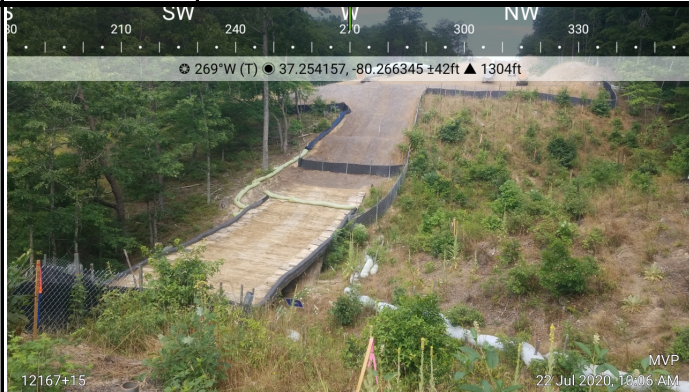
| Pic 9 Desc. | Stream S-C25, Looking West. ECDs are functional. | | Pic 10 Desc. | Stream S-C24, Looking West. ECDs are functional. | |
