Visual Site Inspection Report

Project Name	H-600 Pipeline Spread H	AFE	124300138	Spread	H-600 Pipeline Spread H
Contractor	Precision			Report #	13015
Inspector	Tammy Kruizenga			Date/Time	7/27/2020 4:35 PM
Permit #	TBD	Inspection Type	VA SWPP	Station Begin	12005+00
State	VA	Inspection Area	Partial	Station End	12119+17
County	Montgomery	Ground	Dry	Temperature (°F)	88.00
Municipality	N/A	Weather	Sunny	Rain Gauge (in)	0.40
				Rain Accumulation Time (days)	1.00

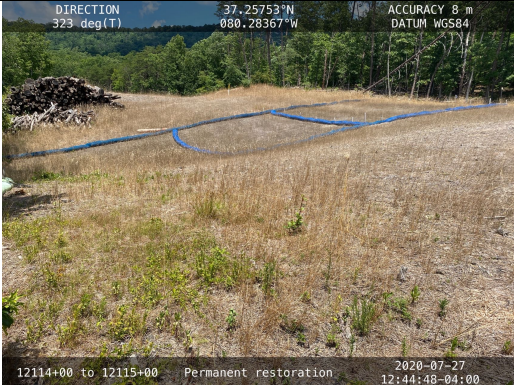
GPS Location	See photo GPS for location		GPS Location	See photo GPS for location	
Field Station#	12124+00		Field Station#	12101+57	
Pic 1 Desc.	Permanent restoration		Pic 2 Desc.	S-MM11, Downstream, Dry

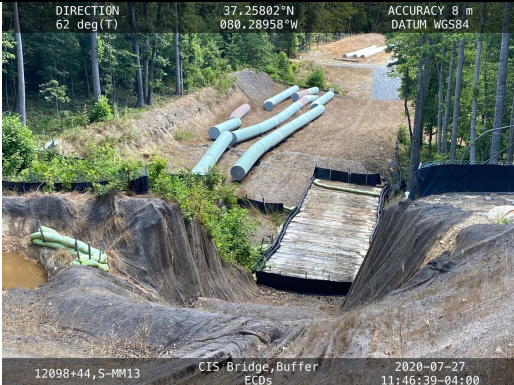
GPS Location	See photo GPS for location		GPS Location	See photo GPS for location	
Field Station#	12098+44		Field Station#	12086+56	
Pic 3 Desc.	CIS to GAS of S-MM11: bridge, buffer, ECDs are acceptable.		Pic 4 Desc.	S-MM14, Downstream, Dry

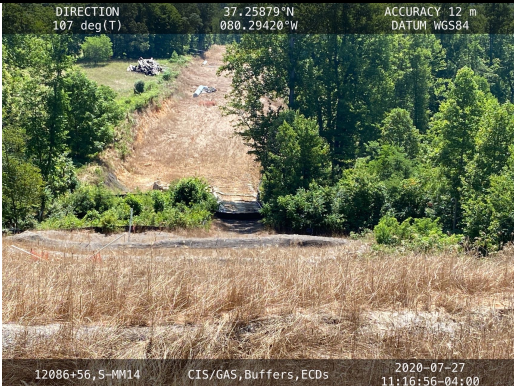
GPS Location	See photo GPS for location		GPS Location	See photo GPS for location	
Field Station#	12086+56		Field Station#	12076+95	
Pic 5 Desc.	CIS to GAS of S-MM14: bridge, buffer, ECDs are acceptable.		Pic 6 Desc.	S-MM15, Downstream, Dry

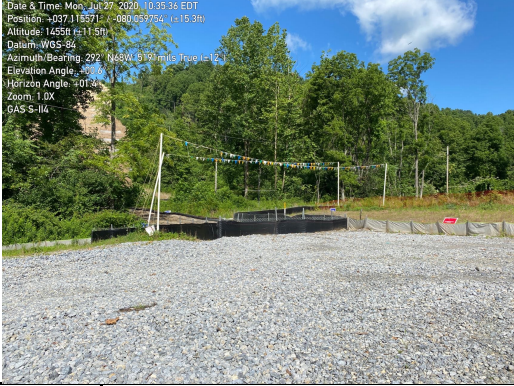
GPS Location	See photo for coordinates.		GPS Location	See photo for coordinates.	
Field Station#	13261+00		Field Station#	13260+60	
Pic 1 Desc.	ATWS-1055, GAS S-II4, RCE in acceptable condition, ECDs functioning acceptable, ROW stabilized.		Pic 2 Desc.	S-II4, upstream, no environmental issues noted.

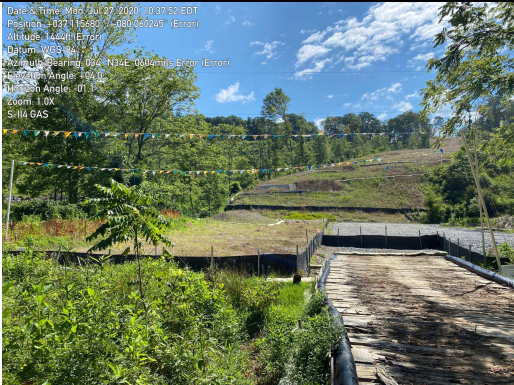
GPS Location	See photo for coordinates.		GPS Location	See photo for coordinates.	
Field Station#	13260+60		Field Station#	13260+60	
Pic 3 Desc.	GAS S-II4, buffer well vegetated, ROW stabilized, perimeter ECDs and bridge in acceptable condition.		Pic 4 Desc.	S-II4, downstream, no changes noted to stream bed or banks.

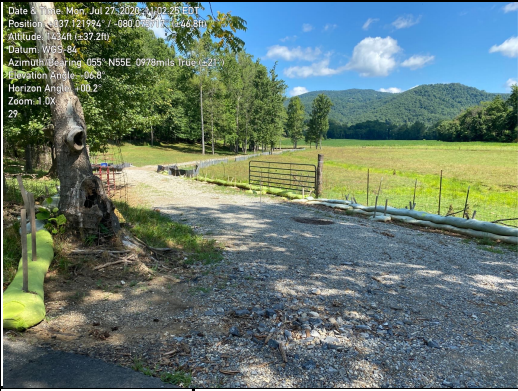
GPS Location	See photo for coordinates.		GPS Location	See photo for coordinates.	
Field Station#	13191+00		Field Station#	13191+00	
Pic 7 Desc.	MVP-AR-29, RCE and ECDs in acceptable condition, gate left open, no cattle noted.		Pic 8 Desc.	MVP-AR-29, SSF in acceptable condition, no cattle noted.	
<p><small>Date & Time: Mon Jul 27 2020 12:08:55 EDT Position: +037.122618 / -080.070519 (+292.5ft) Altitude: 1410ft (+32.2ft) Datum: WGS-84 Azimuth Bearing: 28° N79W 499mils True (+5°) Elevation Angle: -04.5° Horizon Angle: -01.0° Zoom: 1.0X restoring gap active logging</small></p>

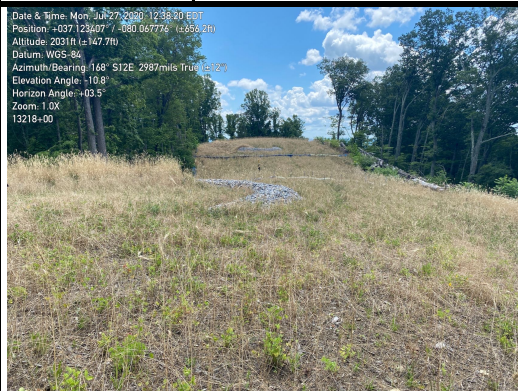
Field Station#	13219+00		Field Station#	13220+00	
Pic 11 Desc.	Good vegetative cover noted across LOD, with perennials establishing in area.		Pic 12 Desc.	Good vegetative cover noted across LOD, with perennials establishing in area.

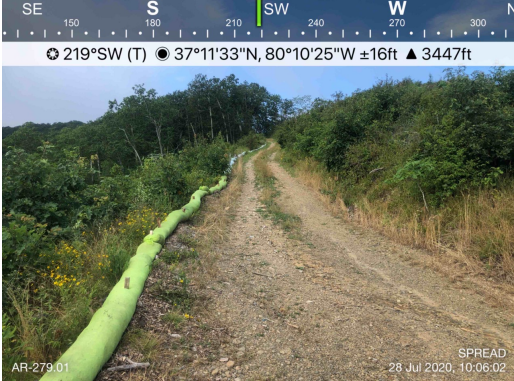
GPS Location	see photo	GPS Location	see photo		
Field Station#	279+01	Field Station#	12638+00		
Pic 1 Desc.	AR-279.01 remains in good condition with controls in place.	Pic 2 Desc.	GAS slope of AR-279.01 in good condition. Vegetation has filled in and inhibiting erosion.

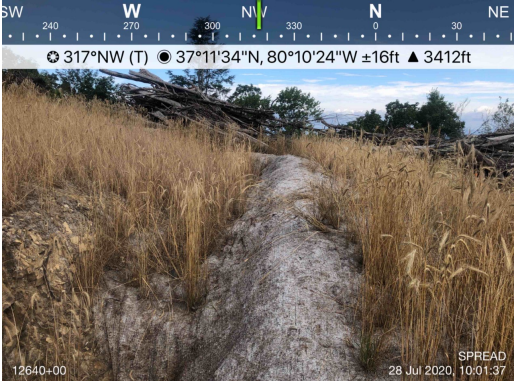
GPS Location	see photo	GPS Location	see photo		
Field Station#	12640+00	Field Station#	12686+00		
Pic 3 Desc.	Waterbars on this slope are in good condition and functioning.	Pic 4 Desc.	Vegetation continuing to fill in on the CIS of Honeysuckle Rd. ROW in good condition with controls in place.

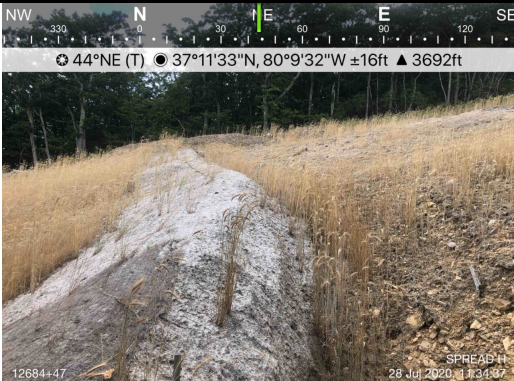
GPS Location	see photo	GPS Location	see photo		
Field Station#	12684+47	Field Station#	12690+29		
Pic 5 Desc.	Waterbars on this slope in good condition and functioning.	Pic 6 Desc.	Rain gauge at Honeysuckle Rd. showing 0.0" inches of rain.

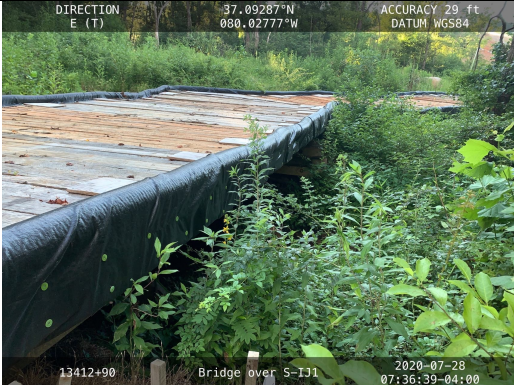
GPS Location	See photo for gps location data.		GPS Location	See photo for gps location data.	
Field Station#	13412+90		Field Station#	13413+00	
Pic 1 Desc.	Photo shows the bridge over stream S-IJ1.		Pic 2 Desc.	Photo shows stream S-IJ1 downstream from the ROW crossing.

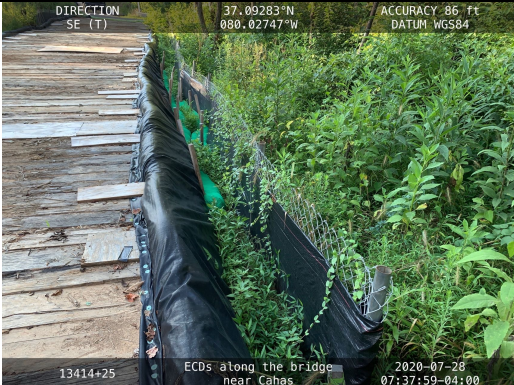
GPS Location	See photo for gps location data.		GPS Location	See photo for gps location data.	
Field Station#	13414+25		Field Station#	13415+30	
Pic 3 Desc.	Photo shows the ECDs along the bridge near Cahas.		Pic 4 Desc.	Photo shows the bridge on the west side of Cahas.

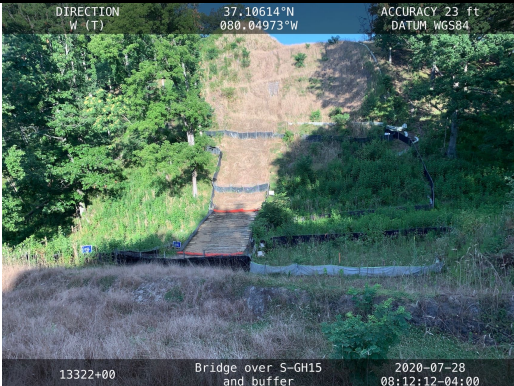
GPS Location	See photo for gps location data.		GPS Location	See photo for gps location data.	
Field Station#	13322+00		Field Station#	13325+20	
Pic 5 Desc.	Photo shows the bridge over stream S-GH15 and adjacent buffer ECDs.		Pic 6 Desc.	Photo shows the bridge over stream S-GH14.

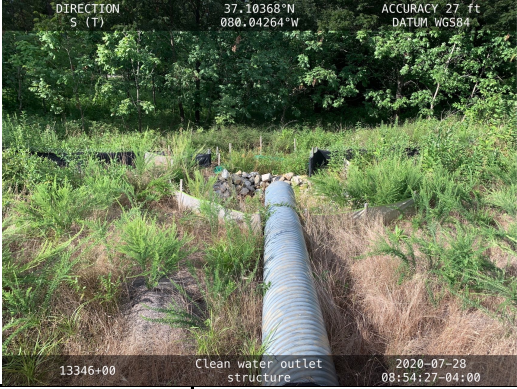
GPS Location	See photo for gps location data.		GPS Location	See photo for gps location data.	
Field Station#	13346+00		Field Station#	13348+00	
Pic 13 Desc.	Photo shows the clean water outlet structure		Pic 14 Desc.	Photo shows the ROW condition from about 13348+00 to 13350+00.

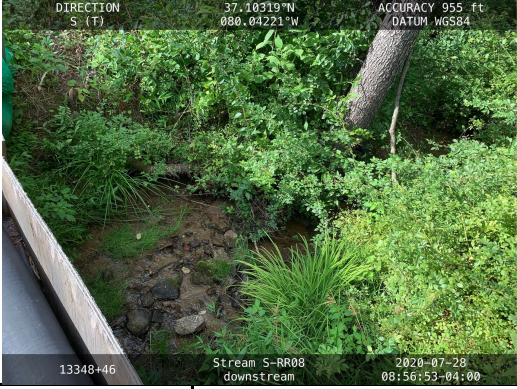
GPS Location	See photo for gps location data.		GPS Location	See photo for gps location data.	
Field Station#	13348+46		Field Station#	13352+00	
Pic 15 Desc.	Photo shows stream S-RR08 downstream from the ROW crossing.		Pic 16 Desc.	Photo shows the bridge over stream S-RR09.

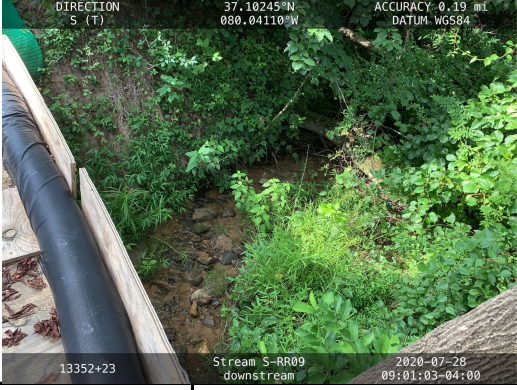
GPS Location	See photo for gps location data.		GPS Location	See photo for gps location data.	
Field Station#	13352+23		Field Station#	13353+00	
Pic 17 Desc.	Photo shows stream S-RR09 downstream from the ROW crossing.		Pic 18 Desc.	Photo shows the ROW condition from about 13353+00 to 13356+00.

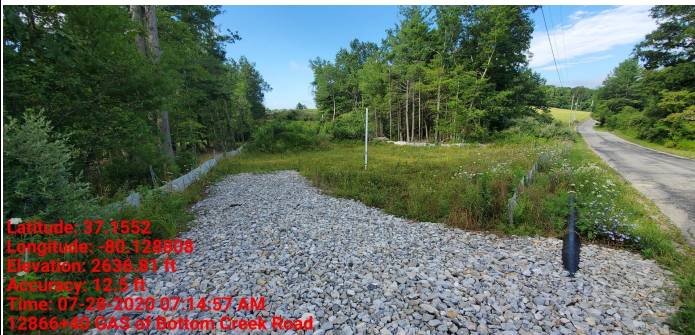
<p>Latitude: 37.1552 Longitude: -80.128608 Elevation: 2636.81 ft Accuracy: 12.5 ft Time: 07-28-2020 07:14:57 AM 12866+40 GAS of Bottom Creek Road</p>

<p>Latitude: 37.155275 Longitude: -80.128646 Elevation: 2637.9 ft Accuracy: 12.5 ft Time: 07-28-2020 07:14:34 AM 12866+00 CIS of Bottom Creek Road</p>		
GPS Location	See pic for GPS location		GPS Location	See pic for GPS location	
Field Station#	12866+40		Field Station#	12866+00	
Pic 1 Desc.	GAS of Bottom Creek Road crossing.		Pic 2 Desc.	CIS of the Bottom Creek Road crossing.

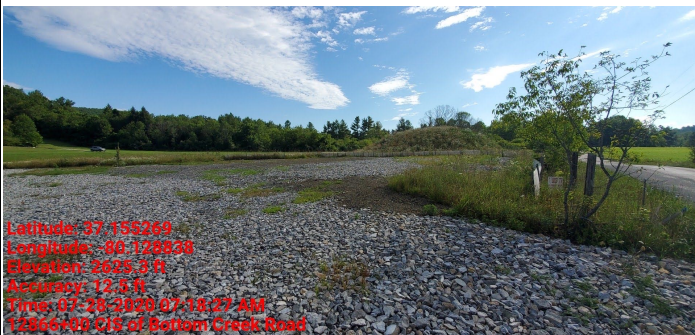
<p>Latitude: 37.155269 Longitude: -80.128628 Elevation: 2636.4 ft Accuracy: 12.5 ft Time: 07-28-2020 07:14:57 AM 12866+00 CIS of Bottom Creek Road</p>

GPS Location	See pic for GPS location		GPS Location	See pic for GPS location	
Field Station#	12866+00		Field Station#	12957+30	
Pic 3 Desc.	CIS of the Bottom Creek Road crossing ATWS and topsoil pile.		Pic 4 Desc.	Access road RO-287 at stream S-Z17.

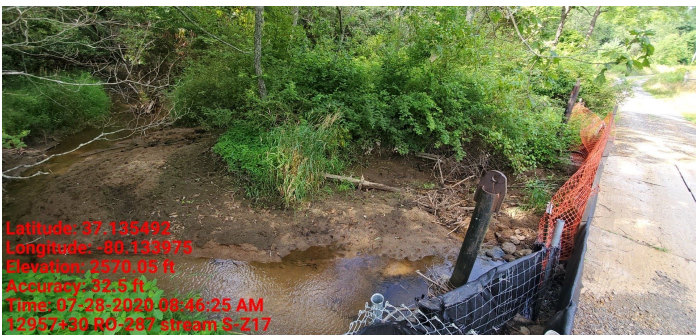
<p>Latitude: 37.135492 Longitude: -80.133479 Elevation: 2570.05 ft Accuracy: 52.5 ft Time: 07-28-2020 09:46:25 AM 12957+30 RO-287 stream S-Z17</p>

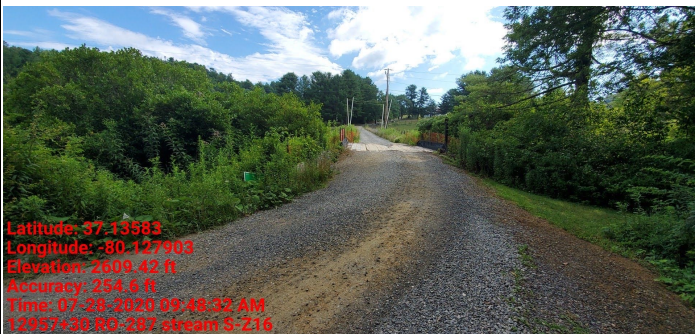
<p>Latitude: 37.13583 Longitude: -80.127903 Elevation: 2609.42 ft Accuracy: 254.8 ft Time: 07-28-2020 09:46:32 AM 12957+30 RO-287 stream S-Z16</p>

<p>Latitude: 37.132631 Longitude: -80.12233 Elevation: 2628.58 ft Accuracy: 45.7 ft Time: 07-28-2020 09:56:06 AM 12974+29 RO-288 stream S-Q20</p>		
GPS Location	See pic for GPS location		GPS Location	See pic for GPS location	
Field Station#	12957+30		Field Station#	12974+29	
Pic 5 Desc.	Access road RO-287 at stream S-Z16.		Pic 6 Desc.	Access road RO-288 at stream S-Q20.

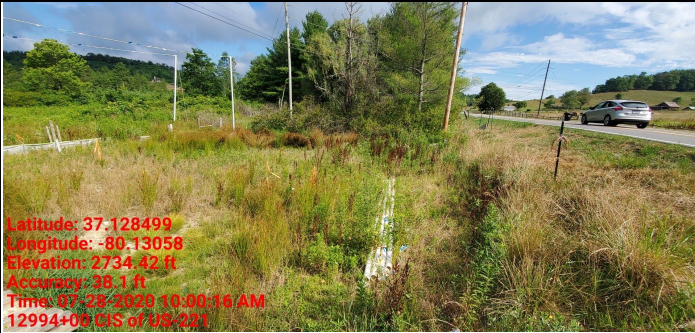
GPS Location	See pic for GPS location		GPS Location	See pic for GPS location	
Field Station#	12994+00		Field Station#	12994+20	
Pic 7 Desc.	CIS of the US-221 road crossing.		Pic 8 Desc.	GAS of the US-221 road crossing.

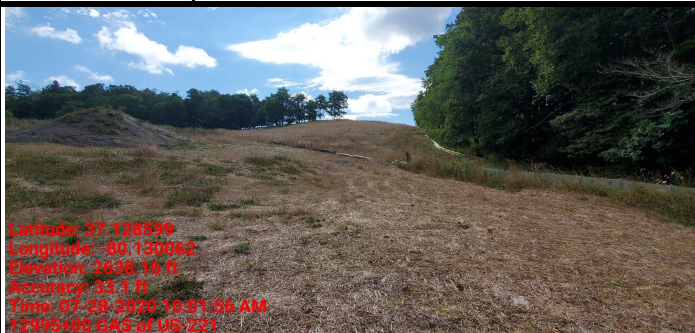
GPS Location	See pic for GPS location		GPS Location	See pic for GPS location	
Field Station#	12995+00		Field Station#	13012+62	
Pic 9 Desc.	GAS of the US-221 road crossing.		Pic 10 Desc.	CIS of the BRP motorway.

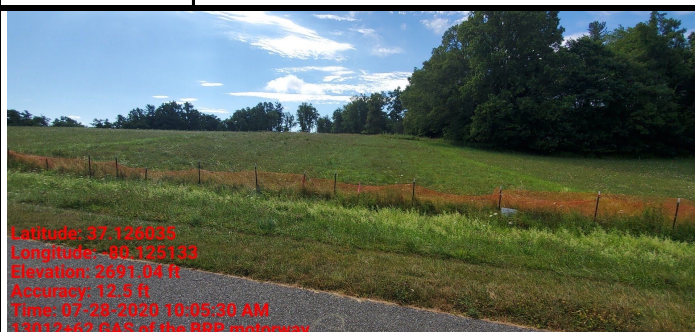
GPS Location	See pic for GPS location		GPS Location	See pic for GPS location	
Field Station#	13012+62		Field Station#	13033+59	
Pic 11 Desc.	GAS of the BRP motorway		Pic 12 Desc.	Callaway Road rain gauge. 0.0" total precipitation.

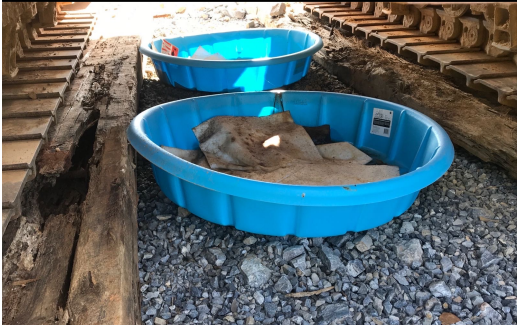
MVP-LY-049_072820		Containments under stored equipment		2020-07-28 08:42:32-04:00	
GPS Location	MVP-LY-049 See photo for gps data		GPS Location	MVP-LY-049 See photo for gps data	
Field Station#	+0		Field Station#	+0	
Pic 13 Desc.	Condition of containments under stored equipment. Looking SE.		Pic 14 Desc.	Condition of containment under stored equipment. Looking S.	
DIRECTION W (M) +37.27046° -080.12468° ACCURACY 164 ft DATUM WGS84

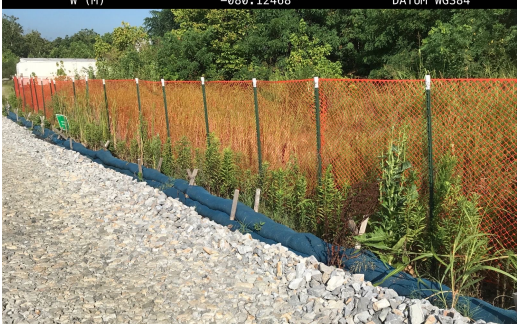
Pic 15 Desc.	Condition of compost filter sock and safety fence along feature W-CV21A. Looking W.		Pic 16 Desc.	Landowner disturbance along compost filter sock and feature W-CV21B. No impacts. Looking S.	
DIRECTION SW (M) +37.27034° -080.12474° ACCURACY 16 ft DATUM WGS84

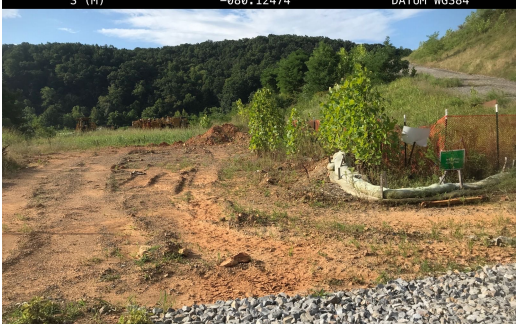
MVP-LY-049_072820		Condition of CFS & safety fence		2020-07-28 08:49:18-04:00	
GPS Location	MVP-LY-049 See photo for gps data		GPS Location	MVP-LY-049 See photo for gps data	
Field Station#	+0		Field Station#	+0

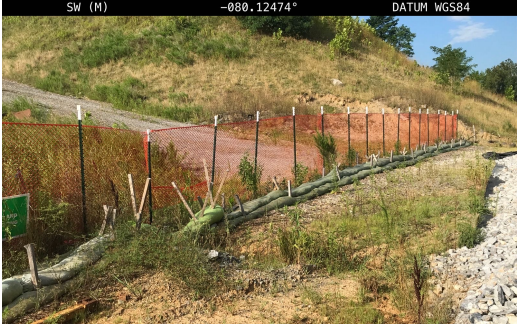
MVP-LY-049_072820		Landowner disturbance within 100' of ...		2020-07-28 08:49:50-04:00	
GPS Location	MVP-LY-049 See photo for gps data		GPS Location	MVP-LY-049 See photo for gps data	
Field Station#	+0		Field Station#	+0	
Pic 17 Desc.	Landowner disturbance within 100' of feature W-CV21B. No impacts. Looking SW.		Pic 18 Desc.	Condition of compost filter sock around sand pile. Looking W.

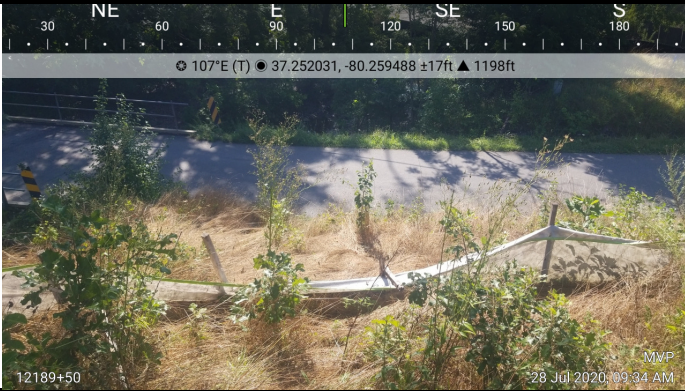
<p>12189+50</p> <p>28 Jul 2020, 09:34 AM</p>		
GPS Location	See Above		GPS Location	See Above	
Field Station#	12167+15		Field Station#	12189+50	
Pic 13 Desc.	Stream S-C24, Looking West. ECDs are functional.		Pic 14 Desc.	P1 Siltfence repair required. Item has been added to punchlist for Environmental Crew to complete.	
  <p>12193+00</p> <p>28 Jul 2020, 09:28 AM</p>

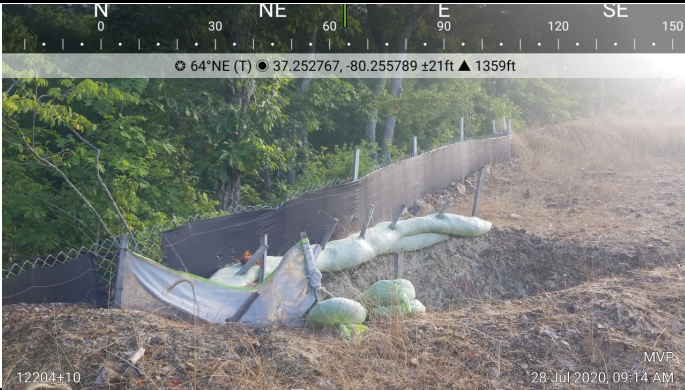
<p>12204+10</p> <p>28 Jul 2020, 09:14 AM</p>		
GPS Location	See Above		GPS Location	See Above	
Field Station#	12193+00		Field Station#	12204+10	
Pic 15 Desc.	Stream S-C21, Looking SouthWest. ECDs are functional.		Pic 16 Desc.	P1 Siltfence repair required. Item has been added to punchlist for Environmental Crew to complete.	
  <p>12211+00</p> <p>28 Jul 2020, 09:00 AM</p>			  <p>12214+00</p> <p>28 Jul 2020, 09:03 AM</p>

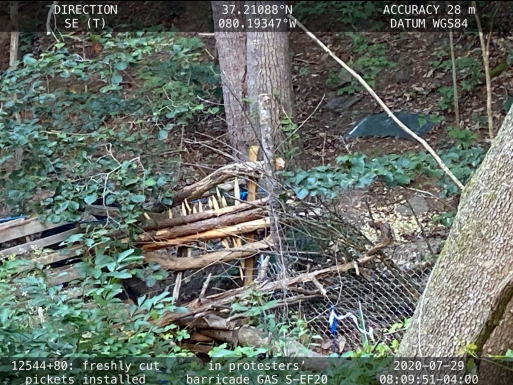
<p>DIRECTION SE (T) 37.21088°N 080.19347°W ACCURACY 28 m DATUM WGS84</p> <p>12544+80: freshly cut pickets installed in protesters' barricade GAS S-EF20 2020-07-29 08:09:51-04:00</p>			
GPS Location	See photo		GPS Location	See photo	
Field Station#	12543+56		Field Station#	12544+80	
Pic 1 Desc.	A small tree was cut within the LOD of access road MVP-MN-278.01 (Yellow Finch Rd) by a 3rd party across from turnaround.		Pic 2 Desc.	Freshly cut pickets were installed in the protester barricade which may explain the small trees cut near along Yellow Finch Road.

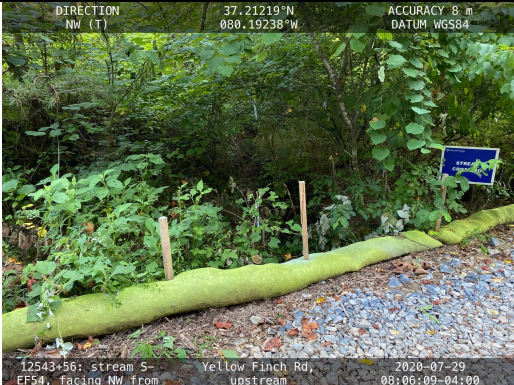
<p>DIRECTION NW (T) 37.21219°N 080.19238°W ACCURACY 8 m DATUM WGS84</p> <p>12543+56: stream S-EF54, facing NW from Yellow Finch Rd, upstream 2020-07-29 08:06:09-04:00</p>

GPS Location	See photo		GPS Location	See photo	
Field Station#	12543+56		Field Station#	12543+56	
Pic 3 Desc.	Stream S-EF54, facing northwest from Yellow Finch Road, upstream		Pic 4 Desc.	Stream S-EF54 where it crosses Yellow Finch Road.

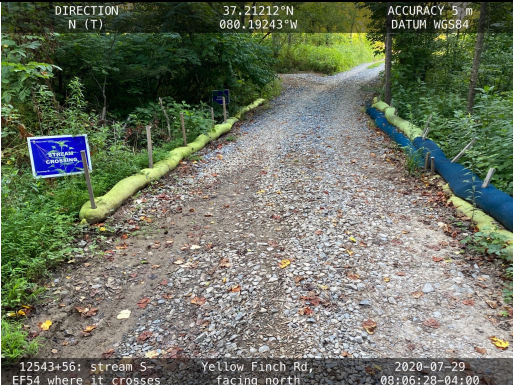
<p>DIRECTION N (T) 37.21212°N 080.19243°W ACCURACY 5 m DATUM WGS84</p> <p>12543+56: stream S-EF54 where it crosses Yellow Finch Rd, facing north 2020-07-29 08:06:28-04:00</p>

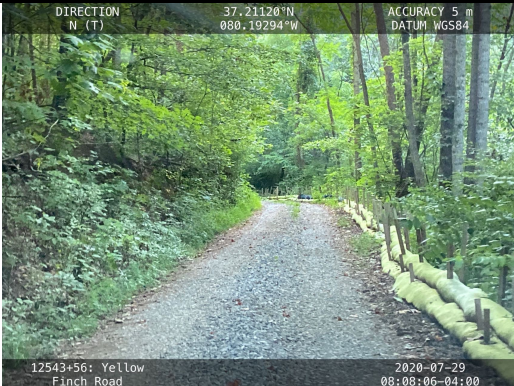
<p>DIRECTION N (T) 37.21120°N 080.19294°W ACCURACY 5 m DATUM WGS84</p> <p>12543+56: Yellow Finch Road 2020-07-29 08:08:06-04:00</p>

<p>DIRECTION N (T) 37.21086°N 080.19388°W ACCURACY 33 m DATUM WGS84</p> <p>12543+00: plastic sheeting intact and secure nearest to Yellow Finch Rd 2020-07-29 08:11:59-04:00</p>			
GPS Location	See photo		GPS Location	See photo	
Field Station#	12543+56		Field Station#	12543+00	
Pic 5 Desc.	Yellow Finch Road		Pic 6 Desc.	Plastic sheeting nearest to Yellow Finch Road remains intact and secure.

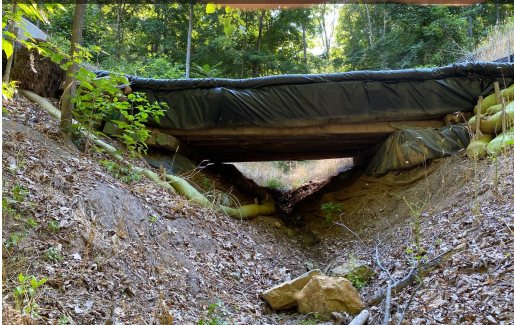
12517+00: slope on CIS of S-EF19 remains		stable		2020-07-29 09:07:37-04:00	
GPS Location	See photo				
Field Station#	12517+00				
Pic 7 Desc.	Slope on coming in side of stream S-EF19 remains stable.				
<div>DIRECTION S (T) 37.21632°N 080.19753°W ACCURACY 42 m DATUM WGS84</div>

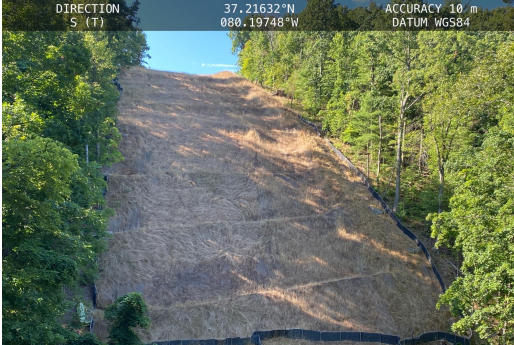
12519+21: buffer zone of S-EF19 remains		stable, ECDs intact		2020-07-29 09:19:35-04:00	
GPS Location	See photo				
Field Station#	12519+41				
Pic 9 Desc.	Buffer zone of stream S-EF19 remains stable, ECDs intact.				
<div>DIRECTION S (T) 37.21765°N 080.19890°W ACCURACY 8 m DATUM WGS84</div>

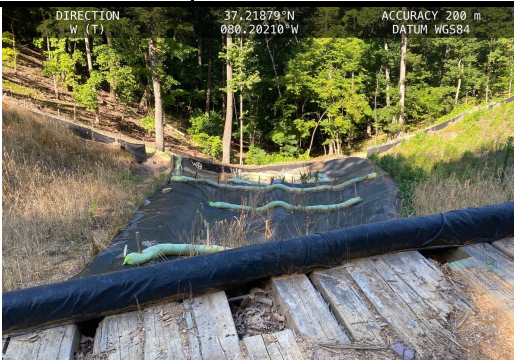
12508+92: slope drain inlet in good		condition, free of sediment		2020-07-29 09:38:58-04:00	
GPS Location	See photo				
Field Station#	12508+92				
Pic 11 Desc.	Slope drain inlet in good condition, free of sediment.				
<div>DIRECTION W (T) 37.21879°N 080.20210°W ACCURACY 200 m DATUM WGS84</div>

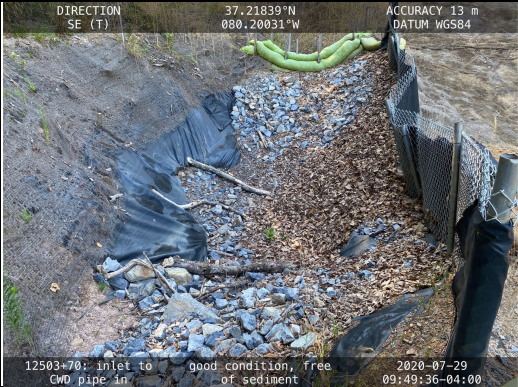
GPS Location	See photo		GPS Location	See photo	
Field Station#	12503+70		Field Station#	12505+00	
Pic 13 Desc.	Clean water diversion pipe inlet in satisfactory condition, free of sediment.		Pic 14 Desc.	Slope on going away side of the clean water diversion pipe remains stable.

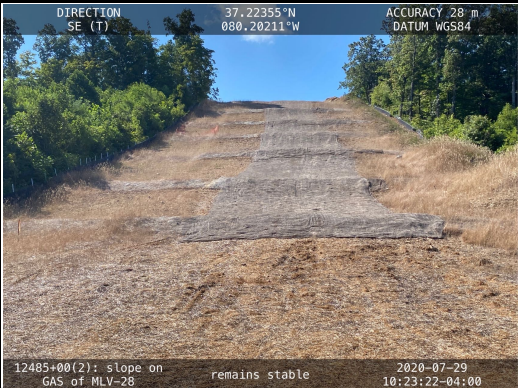
GPS Location	See photo		GPS Location	See photo	
Field Station#	12485+00		Field Station#	12483+30	
Pic 15 Desc.	Slope on going away side of MLV-28 remains stable.		Pic 16 Desc.	Water deflectors on access road MVP-MLV-MN-28 remain in good repair.

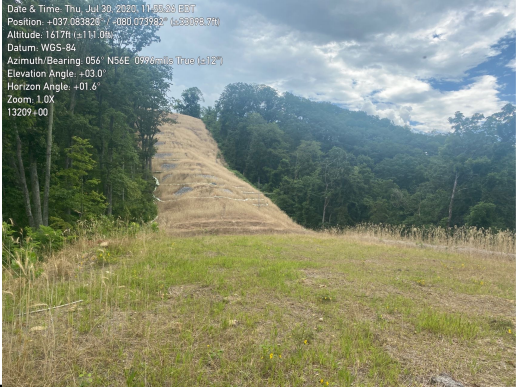
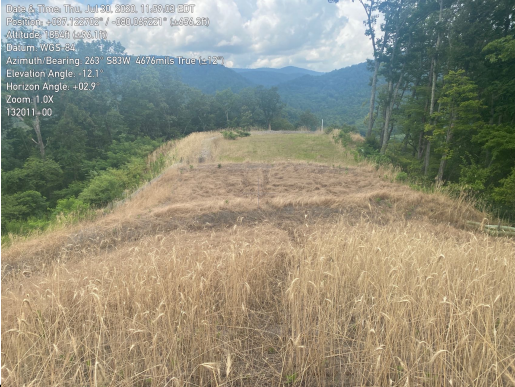
GPS Location	See photo for coordinates.		GPS Location	See photo for coordinates.	
Field Station#	13209+00		Field Station#	13211+00	
Pic 3 Desc.	Moderate to good vegetative cover in both stabilized and restored areas.		Pic 4 Desc.	Moderate to good vegetative cover in stabilized area.

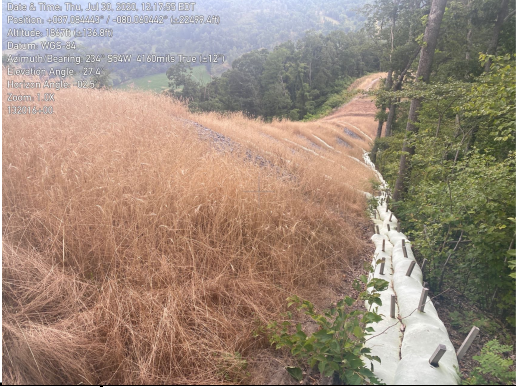
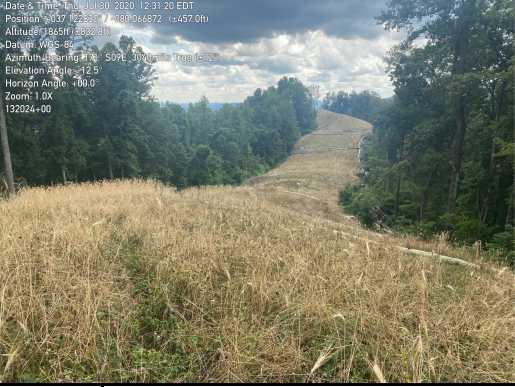
GPS Location	See photo for coordinates.		GPS Location	See photo for coordinates.	
Field Station#	13216+00		Field Station#	13224+00	
Pic 5 Desc.	Restored ROW stable with good vegetative cover, perimeter controls functioning acceptably.		Pic 6 Desc.	Restored ROW stable with good vegetative cover across LOD.

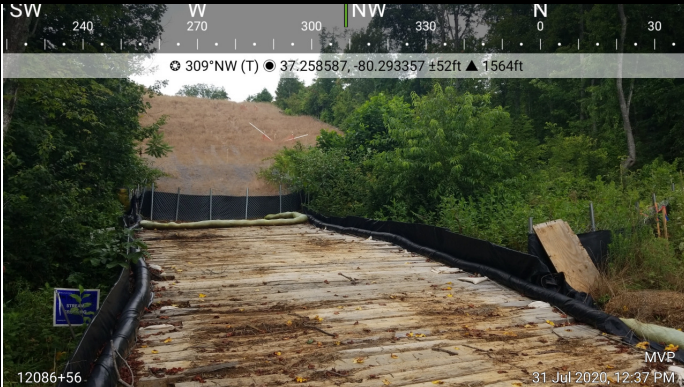
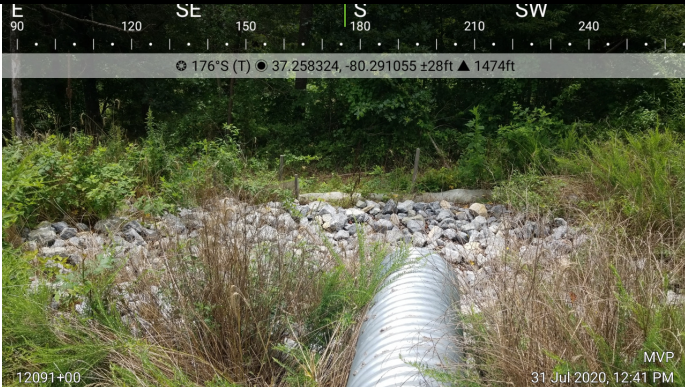
GPS Location	See Above		GPS Location	See Above	
Field Station#	12086+56		Field Station#	12091+00	
Pic 13 Desc.	Overview of Waterbody S-MM14. ECDs functional and in good condition.		Pic 14 Desc.	ROW Overview. Temporary Restoration. ECDs functional and in good condition.

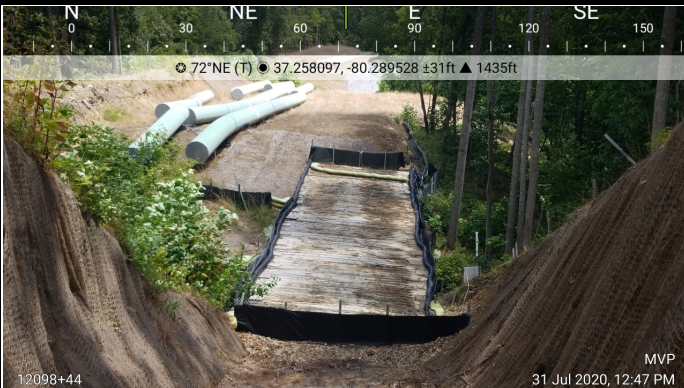
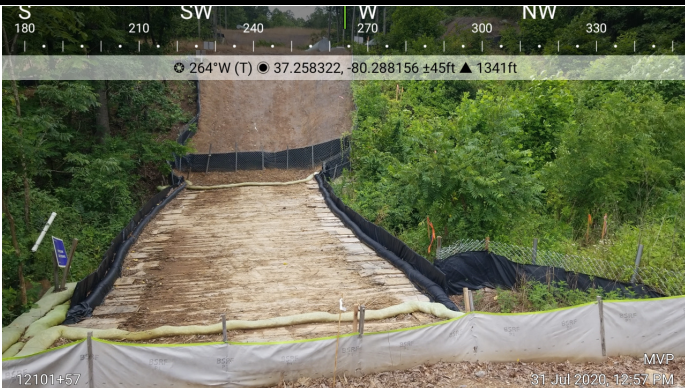
GPS Location	See Above		GPS Location	See Above	
Field Station#	12098+44		Field Station#	12101+57	
Pic 15 Desc.	Overview of Waterbody S-MM13. ECDs functional and in good condition.		Pic 16 Desc.	Overview of Waterbody S-MM11. ECDs functional and in good condition.

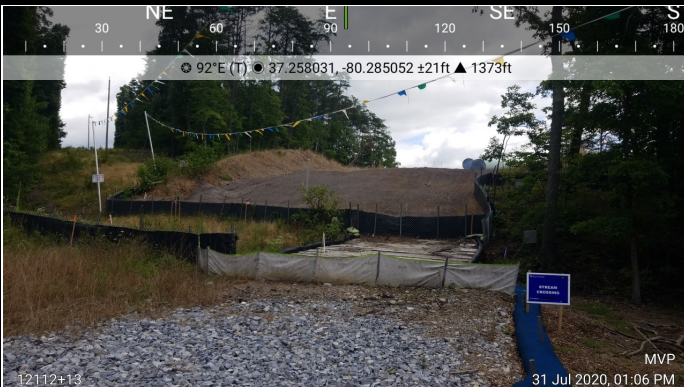
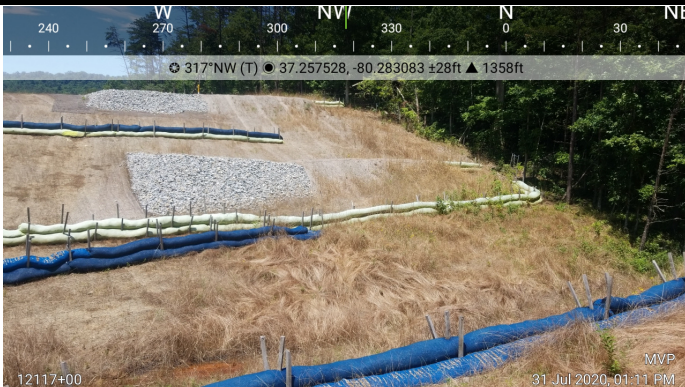
GPS Location	See Above		GPS Location	See Above	
Field Station#	12112+13		Field Station#	12117+00	
Pic 17 Desc.	Overview of Waterbody S-F16A/B. ECDs functional and in good condition.		Pic 18 Desc.	ROW Overview. Permanent Restoration. ECDs functional and in good condition.

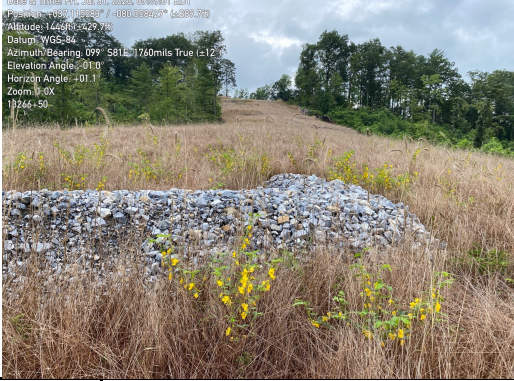
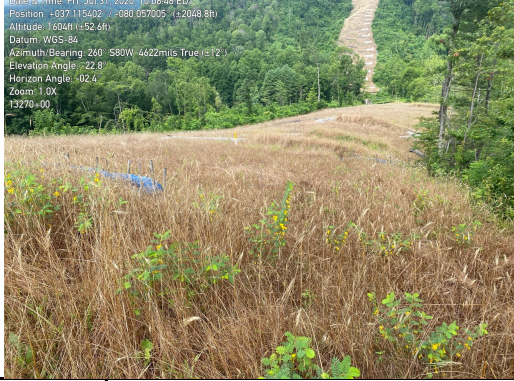
GPS Location	See photo for coordinates.		GPS Location	See photo for coordinates.	
Field Station#	13266+00		Field Station#	13270+00	
Pic 1 Desc.	Restored ROW stable, vegetation established across LOD.		Pic 2 Desc.	Restored ROW stable, vegetation established across LOD.	
<p>Date & Time: Fri Jul 31, 2020 10:07:10 EDT Position: +037°11'54.02" / -080°05'05.1" (+2048.8m) Altitude: 1659ft (+507.0m) Datum: WGS-84 Azimuth/Bearing: 198° 51'18" 3520mils True (+12.6°) Elevation Angle: -18.5° Horizon Angle: -01.1° Zoom: 1.0X 13270+00</p>

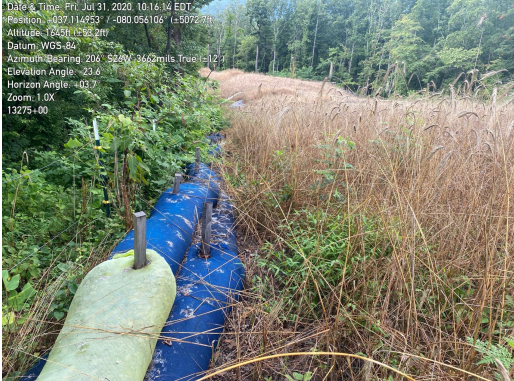
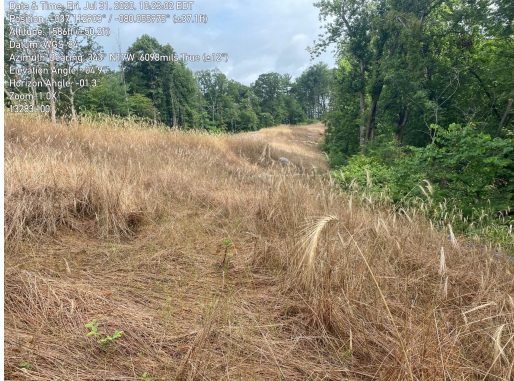
Pic 5 Desc.	Restored ROW stable, vegetation established across LOD.		Pic 6 Desc.	Restored ROW stable, vegetation established across LOD.

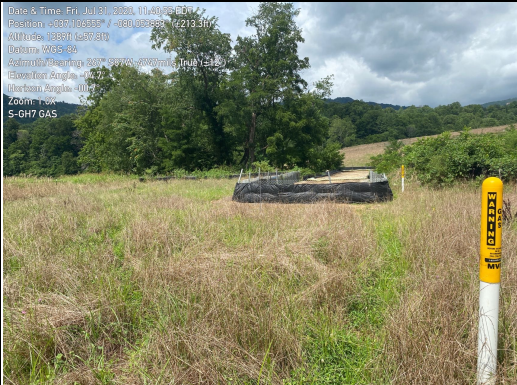
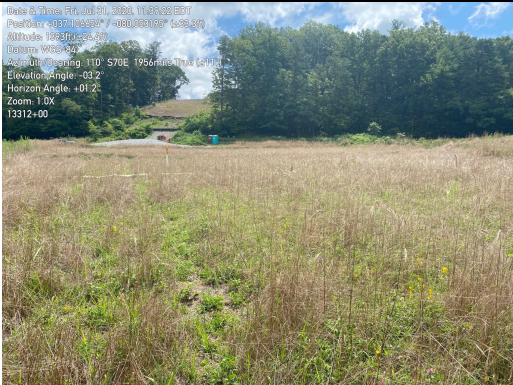
GPS Location	See photo for coordinates.		GPS Location	See photo for coordinates.	
Field Station#	13311+00		Field Station#	13312+00	
Pic 13 Desc.	GAS S-GH7, vegetative cover noted across LOD with permanent vegetation beginning to establish.		Pic 14 Desc.	Vegetative cover noted across LOD with permanent vegetation beginning to establish in restored area.

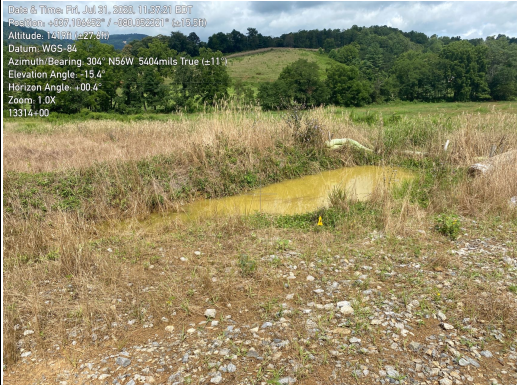
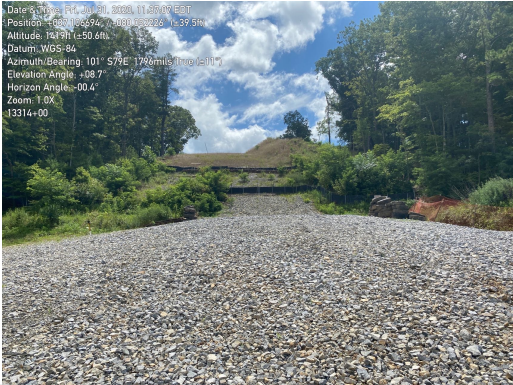
GPS Location	See photo for coordinates.		GPS Location	See photo for coordinates.	
Field Station#	13314+00		Field Station#	13314+00	
Pic 15 Desc.	Temporary waterbar, sump, and outlet in acceptable condition.		Pic 16 Desc.	CIS Wades Gap, RCE in good condition, perimeter controls also in acceptable condition.

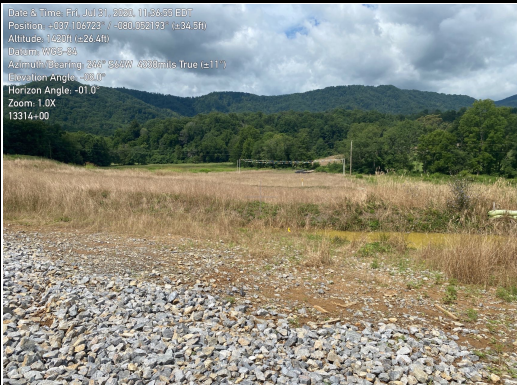
Insert image here	
GPS Location	See photo for coordinates.		GPS Location		
Field Station#	13314+00		Field Station#		
Pic 17 Desc.	CIS Wades Gap, temporarily stabilized area has good vegetative cover throughout.		Pic 18 Desc.
