Visual Site Inspection Report

Project Name	H-600 Pipeline Spread H	AFE	124300138	Spread	H-600 Pipeline Spread H
Contractor	Precision			Report #	12452
Inspector	Pat Davis			Date/Time	7/6/2020 4:00 PM
Permit #	TBD	Inspection Type	VA SWPP	Station Begin	+0
State	VA	Inspection Area	Partial	Station End	+0
County	Montgomery	Ground	Damp	Temperature (°F)	91.00
Municipality	N/A	Weather	Sunny	Rain Gauge (in)	0.10
				Rain Accumulation Time (days)	0.00

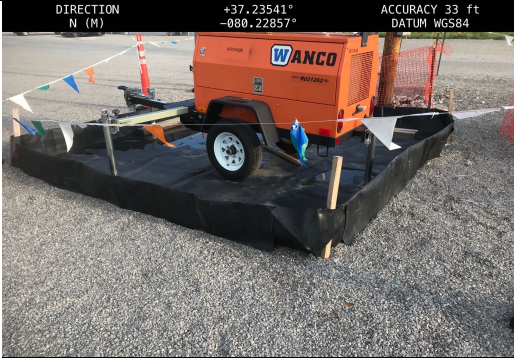
GPS Location	MVP-PY-006 See photo for gps data		GPS Location	MVP-PY-006 See photo for gps data	
Field Station#	+0		Field Station#	+0	
Pic 1 Desc.	Condition of containment under light plant. Looking N		Pic 2 Desc.	Condition of signage and buffer flagging for feature W-008. Looking N.

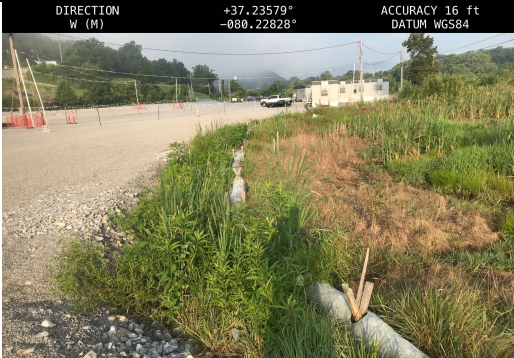
GPS Location	MVP-PY-006 See photo for gps data		GPS Location	MVP-PY-006 See photo for gps data	
Field Station#	+0		Field Station#	+0	
Pic 3 Desc.	Condition of compost filter sock along the south edge of feature W-008. Looking W.		Pic 4 Desc.	Condition of containment under stored equipment. Looking N.

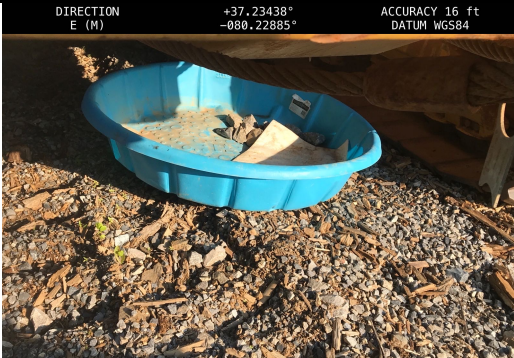
GPS Location	MVP-PY-006 See photo for gps data		GPS Location	MVP-PY-006 See photo for gps data	
Field Station#	+0		Field Station#	+0	
Pic 5 Desc.	Condition of containment under stored equipment. Looking W.		Pic 6 Desc.	Condition of containment under stored vehicle. Looking N.

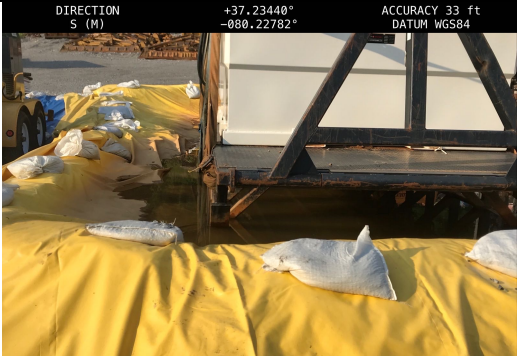
<p>DIRECTION S (M) +37.23440° -080.22782° ACCURACY 33 ft DATUM WGS84</p> <p>MVP-PY-006_070620 Condition of containment 2020-07-06 07:52:36-04:00</p>

<p>DIRECTION W (M) +37.23417° -080.22619° ACCURACY 33 ft DATUM WGS84</p> <p>MVP-PY-006_070620 No debris around hazardous waste 2020-07-06 07:54:50-04:00</p>			
GPS Location	MVP-PY-006 See photo for gps data		GPS Location	MVP-PY-006 See photo for gps data	
Field Station#	+0		Field Station#	+0	
Pic 7 Desc.	Condition of containment. Holding some stormwater. Looking S.		Pic 8 Desc.	No debris around hazardous waste dumpster. Looking W.

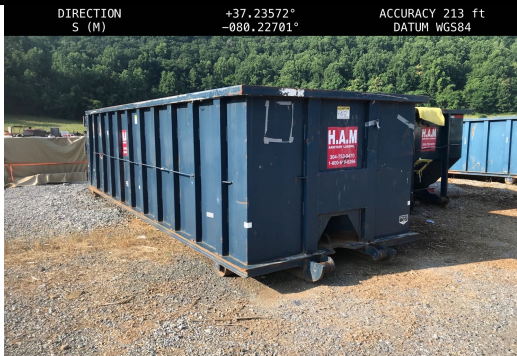
<p>DIRECTION S (M) +37.23572° -080.22781° ACCURACY 213 ft DATUM WGS84</p> <p>MVP-PY-006_070620 No loose trash around dumpsters 2020-07-06 08:42:11-04:00</p>

GPS Location	MVP-PY-006 See photo for gps data		GPS Location	MVP-PY-006 See photo for gps data	
Field Station#	+0		Field Station#	+0	
Pic 9 Desc.	No loose trash around dumpsters. Looking S.		Pic 10 Desc.	Condition of trays and containment under toilets. Looking N.

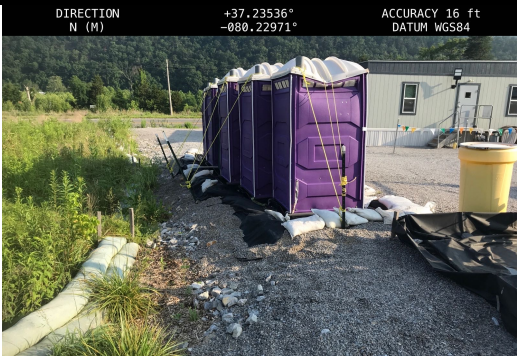
<p>DIRECTION N (M) +37.23536° -080.22971° ACCURACY 16 ft DATUM WGS84</p> <p>MVP-PY-006_070620 Condition of trays and containment 2020-07-06 08:14:17-04:00</p>

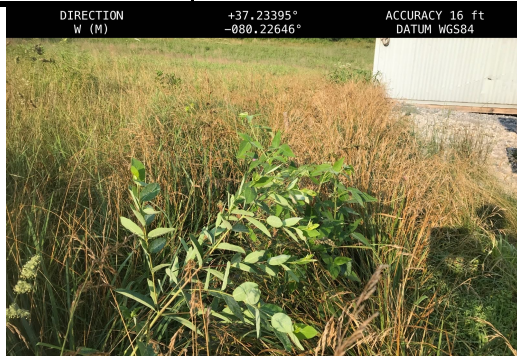
<p>DIRECTION W (M) +37.23395° -080.22646° ACCURACY 16 ft DATUM WGS84</p> <p>MVP-PY-006-070620 Condition of CFS south LOD 2020-07-06 07:55:41-04:00</p>

<p>DIRECTION NW (M) +37.23571° -080.22686° ACCURACY 541 ft DATUM WGS84</p> <p>MVP-PY-006-070620 No fuel spills south of tanks 2020-07-06 08:43:13-04:00</p>			
GPS Location	MVP-PY-006 See photo for gps data		GPS Location	MVP-PY-006 See photo for gps data	
Field Station#	+0		Field Station#	+0	
Pic 11 Desc.	Condition of compost filter sock along south LOD. Looking W.		Pic 12 Desc.	No fuel spills south of bulk fuel tanks. Looking NW.

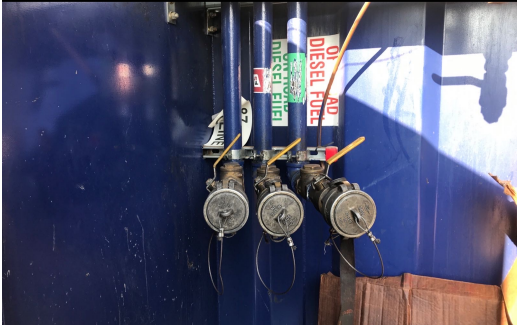
MVP-PY-006_070620 No leaky internal fittings 2020-07-06 08:43:47-04:00		DIRECTION S (M) +37.23584° -080.22712° ACCURACY 213 ft DATUM WGS84

MVP-PY-006_070620 Condition of containment 2020-07-06 08:44:34-04:00			
GPS Location	MVP-PY-006 See photo for gps data		GPS Location	MVP-PY-006 See photo for gps data	
Field Station#	+0		Field Station#	+0	
Pic 13 Desc.	Blue bulk fuel tanks no leaky internal fittings. Looking SW.		Pic 14 Desc.	Condition of containment under the DEF tank. Looking S.	
DIRECTION SW (M) +37.23563° -080.22680° ACCURACY 16 ft DATUM WGS84

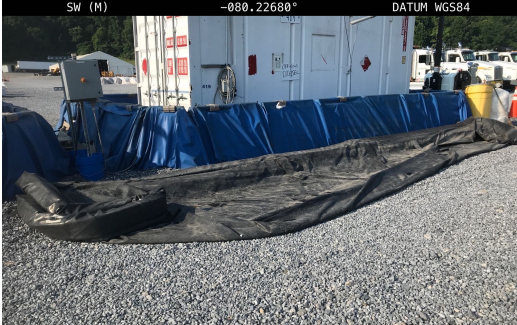
MVP-PY-006_070620 Containment on site for tankers ... 2020-07-06 08:45:22-04:00		DIRECTION NW (M) +37.23558° -080.22694° ACCURACY 16 ft DATUM WGS84

GPS Location	MVP-PY-006 See photo for gps data		GPS Location	MVP-PY-006 See photo for gps data	
Field Station#	+0		Field Station#	+0	
Pic 15 Desc.	Containment on site for tankers offloading fuel into the off road fuel unit. Looking SW.		Pic 16 Desc.	Off Road Fuel unit no leaky internal fittings. Looking NW.	
DIRECTION SW (M) +37.23558° -080.22694° ACCURACY 16 ft DATUM WGS84

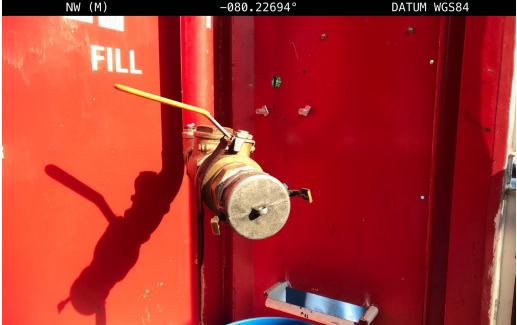
MVP-PY-006-070620 No leaky internal fittings 2020-07-06 08:47:24-04:00

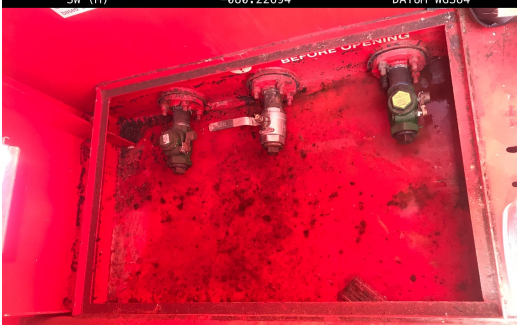
MVP-PY-006_070620 Internal drip tray empty 2020-07-06 08:47:32-04:00		DIRECTION N (M) +37.23559° -080.22692° ACCURACY 33 ft DATUM WGS84

MVP-PY-006_070620 No leaky fittings or nozzles 2020-07-06 08:48:39-04:00			
GPS Location	MVP-PY-006 See photo for gps data		GPS Location	MVP-PY-006 See photo for gps data	
Field Station#	+0		Field Station#	+0	
Pic 17 Desc.	Off Road Fuel unit the internal drip tray is empty. Looking SW.		Pic 18 Desc.	Blue Bulk Fuel tanks no leaky fittings or nozzles. Refueling pan on site. Looking N

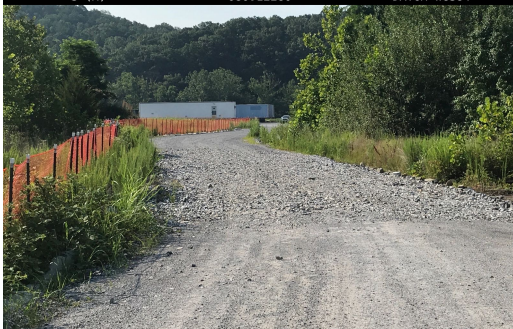
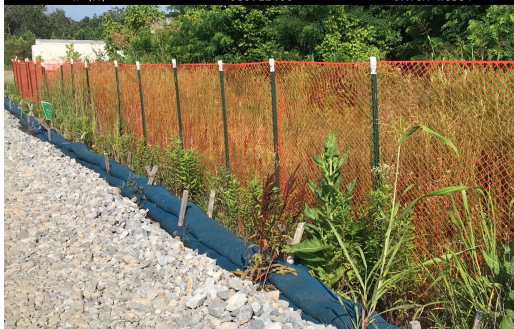
MVP-LY-049_070620		Condition of rock entrance		2020-07-06 09:17:23-04:00	
MVP-LY-049_070620		Condition of CFS & safety fence		2020-07-06 09:21:10-04:00	
GPS Location	MVP-LY-049 See photo for gps data			GPS Location	MVP-LY-049 See photo for gps data
Field Station#	+0			Field Station#	+0
Pic 1 Desc.	Condition of rock entrance on center drive. No sediment on stone. Looking S.			Pic 2 Desc.	Condition of compost filter sock and safety fence along edge of feature W-CV21A. Looking W.
	<div>DIRECTION SW (M)</div> <div>+37.27039° -080.12468°</div> <div>ACCURACY 16 ft DATUM WGS84</div>			<div>DIRECTION S (M)</div> <div>+37.27039° -080.12472°</div> <div>ACCURACY 16 ft DATUM WGS84</div>

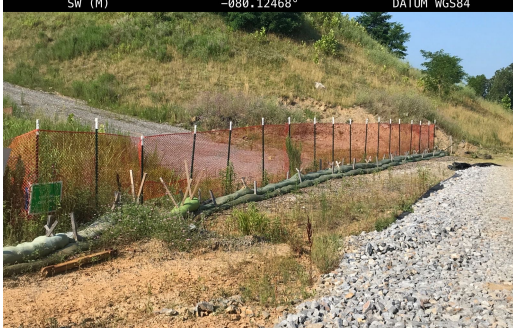
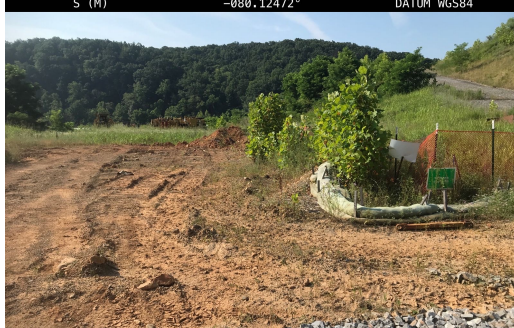
MVP-LY-049_070620		Landowner disturbance within 100' of ...		2020-07-06 09:21:25-04:00	
MVP-LY-049_070620		Landowner disturbance along CFS and feature		2020-07-06 09:21:38-04:00	
GPS Location	MVP-LY-049 See photo for gps data			GPS Location	MVP-LY-049 See photo for gps data
Field Station#	+0			Field Station#	+0
Pic 3 Desc.	Landowner disturbance within 100' of feature W-CV21B. No impacts. Looking SW.			Pic 4 Desc.	Landowner disturbance along compost filter sock and feature W-CV21B. No impacts. Looking S.
	<div>DIRECTION N (M)</div> <div>+37.27066° -080.12346°</div> <div>ACCURACY 16 ft DATUM WGS84</div>			<div>DIRECTION E (M)</div> <div>+37.26934° -080.12363°</div> <div>ACCURACY 16 ft DATUM WGS84</div>

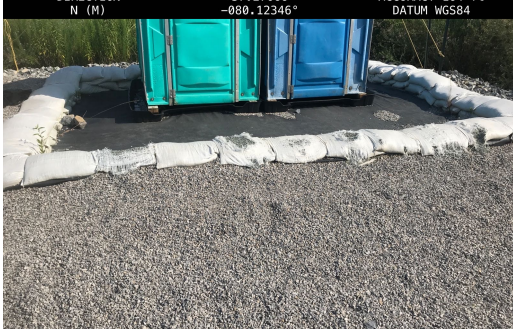
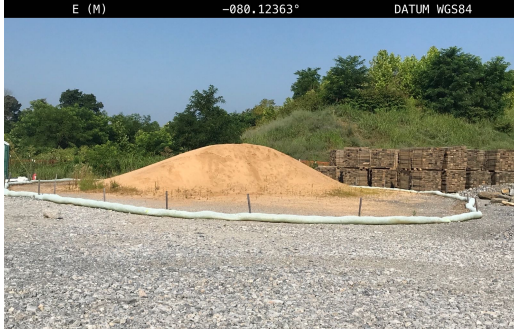
MVP-LY-049_070620		Condition of trays and containment		2020-07-06 09:23:15-04:00	
MVP-LY-049_070620		Condition of containment around ...		2020-07-06 09:25:36-04:00	
GPS Location	MVP-LY-049 See photo for gps data			GPS Location	MVP-LY-049 See photo for gps data

Field Station#	+0			Field Station#	+0
Pic 5 Desc.	Condition of trays and containment under toilets. Looking N.			Pic 6 Desc.	Condition of compost filter sock around sand pile. Looking E.

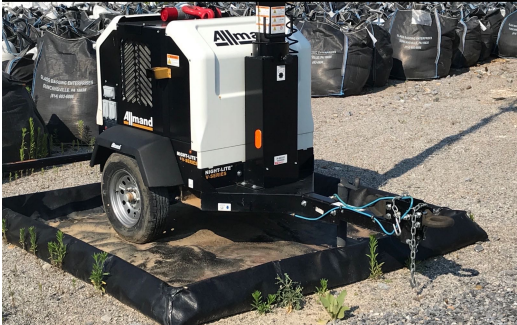
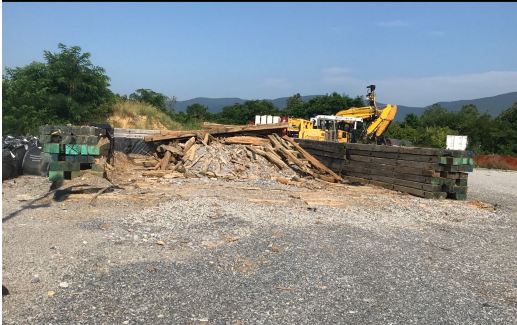
MVP-LY-049-070620		Containment under light plant 2020-07-06 09:26:59-04:00		MVP-LY-049_070620	
GPS Location	MVP-LY-049 See photo for gps data		GPS Location	MVP-LY-049 See photo for gps data	
Field Station#	+0		Field Station#	+0	
Pic 7 Desc.	Condition of containment under light plant. Looking SW.		Pic 8 Desc.	Condition of temporary trash transfer pit. All debris inside boundary of pit. Looking W.	
DIRECTION SE (M) +37.27059° -080.12246° ACCURACY 16 ft DATUM WGS84

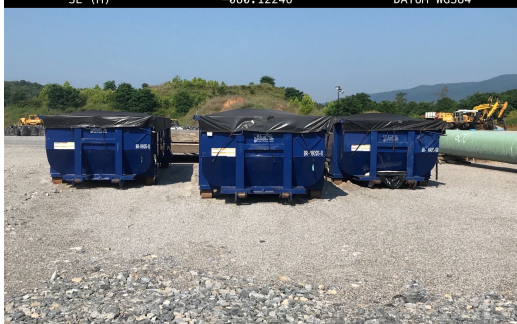
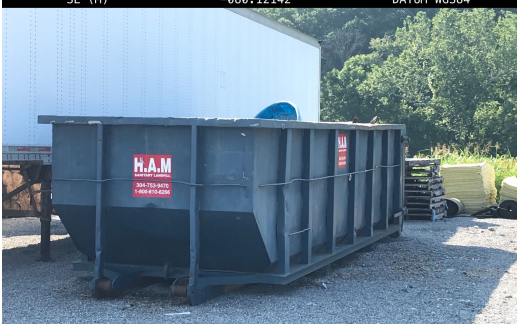
MVP-LY-049_070620		No debris around hazardous waste ... 2020-07-06 09:27:54-04:00		MVP-LY-049-070620	
GPS Location	MVP-LY-049 See photo for gps data		GPS Location	MVP-LY-049 See photo for gps data

Field Station#	+0		Field Station#	+0	
Pic 9 Desc.	No debris around hazardous waste dumpsters. Looking SE.		Pic 10 Desc.	No loose trash around south dumpster. Looking SE.	
DIRECTION S (M) +37.27020° -080.12168° ACCURACY 33 ft DATUM WGS84

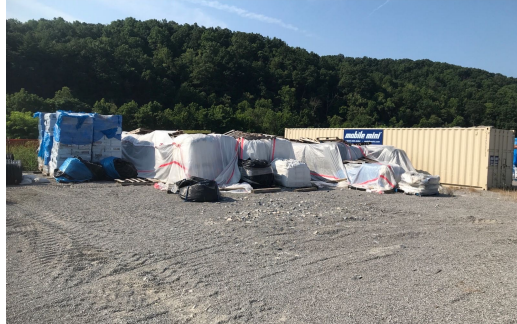
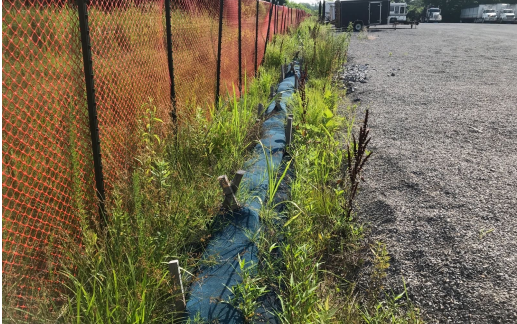
MVP-LY-049_070620		Restoration supplies covered and protected 2020-07-06 09:30:17-04:00		MVP-LY-049_070620	
GPS Location	MVP-LY-049 See photo for gps data		GPS Location	MVP-LY-049 See photo for gps data	
Field Station#	+0		Field Station#	+0	
Pic 11 Desc.	Restoration supplies covered and protected from the elements. Looking S.		Pic 12 Desc.	Condition of compost filter sock and safety fence along north LOD. Looking NE.

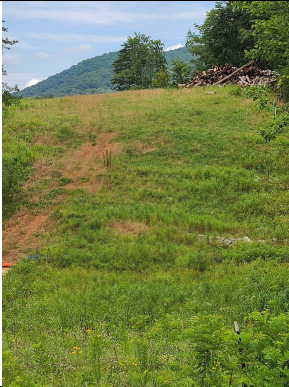
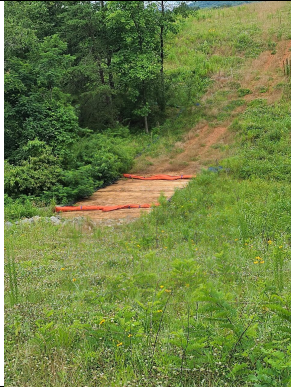
GPS Location	00000	GPS Location	00000		
Field Station#	13533+32	Field Station#	13533+32		
Pic 1 Desc.	Vegetation photo	Pic 2 Desc.	Checked equipment bridges over streams

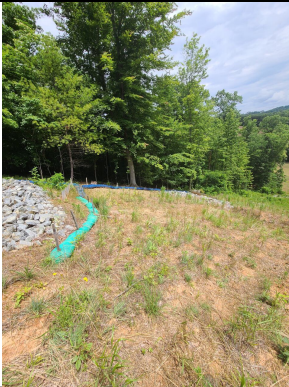
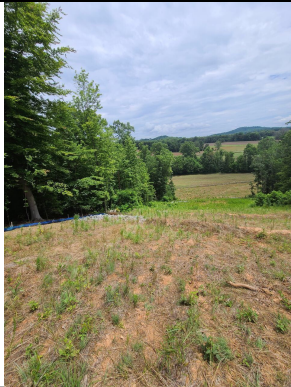
GPS Location	00000	GPS Location	00000		
Field Station#	13620+00	Field Station#	13620+00		
Pic 3 Desc.	Monitored ECDs throughout	Pic 4 Desc.	Row photo showing vegetation		
Insert image here			Insert image here		
GPS Location		GPS Location			
Field Station#		Field Station#			
Pic 5 Desc.		Pic 6 Desc.

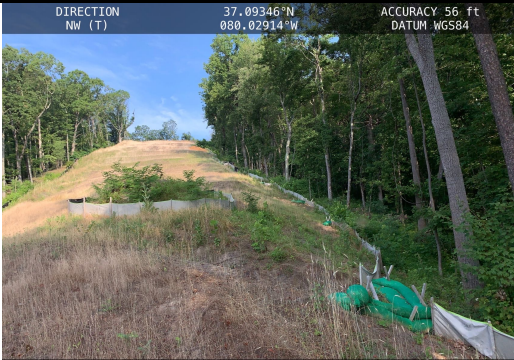
<p>DIRECTION NW (T) 37.09346°N 080.02914°W ACCURACY 56 ft DATUM WGS84</p> <p>13410+00 ROW and ECD conditions 2020-07-06 08:35:37-04:00</p>

<p>DIRECTION NW (T) 37.09508°N 080.03137°W ACCURACY 223 ft DATUM WGS84</p> <p>13398+00 ROW and ECD conditions 2020-07-06 08:45:43-04:00</p>			
GPS Location	See photo for gps location data.		GPS Location	See photo for gps location data.	
Field Station#	13410+00		Field Station#	13398+00	
Pic 5 Desc.	Photo shows the ROW and ECD conditions from about 13404+00 to 13410+00.		Pic 6 Desc.	Photo shows the ROW conditions from about 13385+00 to 13398+00.

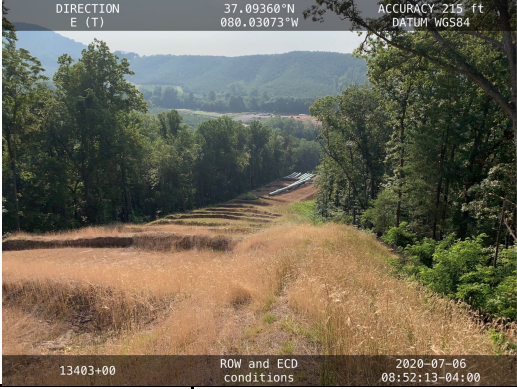
GPS Location	See photo for gps location data.		GPS Location	See photo for gps location data.	
Field Station#	13403+00		Field Station#	13319+00	
Pic 7 Desc.	Photo shows the ROW conditions from about 13403+00 to 13408+00		Pic 8 Desc.	Photo shows the ROW conditions from about 13319+00 to 13323+00.

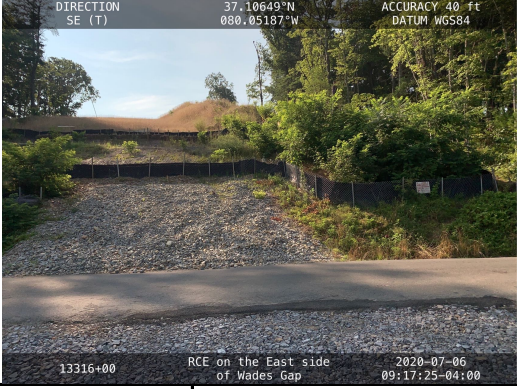
GPS Location	See photo for gps location data.		GPS Location	See photo for gps location data.	
Field Station#	13317+00		Field Station#	13316+00	
Pic 9 Desc.	Photo shows the landowner driveway crossing near Wades Gap Road.		Pic 10 Desc.	Photo shows the RCE on the east side of Wades Gap Road.

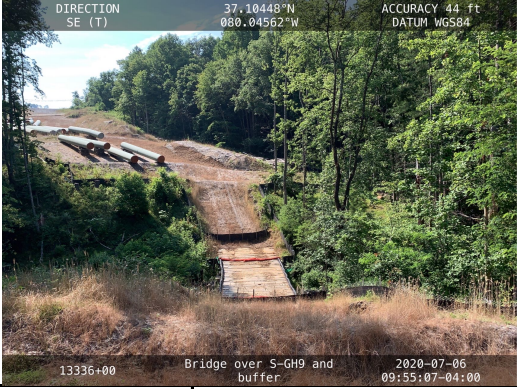
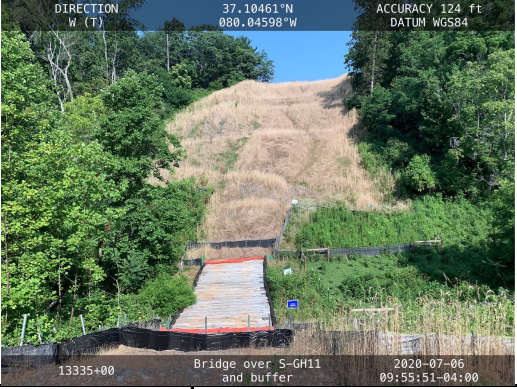
GPS Location	See photo for gps location data.		GPS Location	See photo for gps location data.	
Field Station#	13336+00		Field Station#	13335+00	
Pic 13 Desc.	Photo shows the bridge over stream S-GH9 and buffer ECDs.		Pic 14 Desc.	Photo shows the bridge over stream S-GH11 and buffer ECDs.

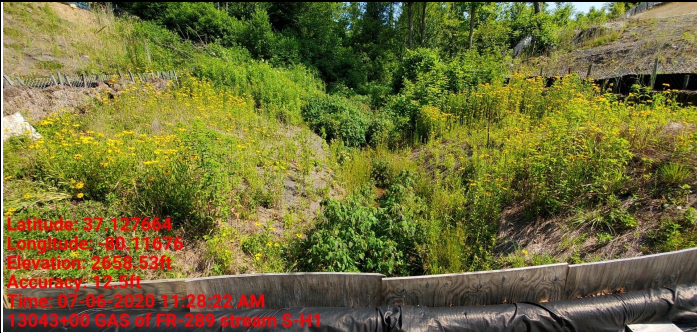
<p>Latitude: 37.127864 Longitude: -80.111818 Elevation: 2658.53ft Accuracy: 12.5ft Time: 07-06-2020 11:28:32 AM 13043+00 GAS of FR-289 stream S-H1</p>

<p>Latitude: 37.066057 Longitude: -80.0369 Accuracy: 11.64 ft Time: 07-06-2020 01:00:59 PM 13061+44 CIS of FR-290</p>		
GPS Location	See pic for GPS location		GPS Location	See pic for GPS location	
Field Station#	13043+00		Field Station#	13061+44	
Pic 13 Desc.	Stream crossing S-H1 on the GAS of FR-289.		Pic 14 Desc.	Slope on the CIS of FR-290.

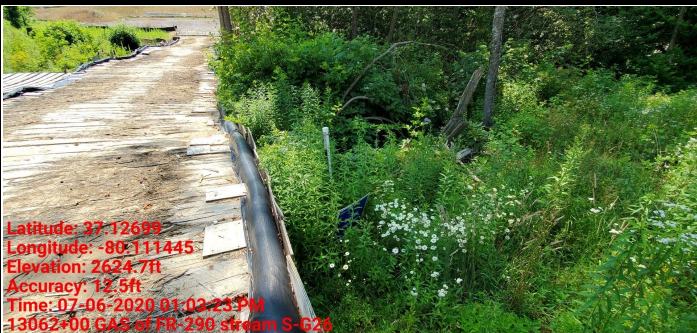
<p>Latitude: 37.12699 Longitude: -80.111445 Elevation: 2624.7ft Accuracy: 12.5ft Time: 07-06-2020 01:02:25 PM 13062+00 GAS of FR-290 stream S-G26</p>

Field Station#	13062+00		Field Station#	13063+00	
Pic 15 Desc.	Stream crossing S-G26 downstream side of equipment bridge.		Pic 16 Desc.	Stream crossing S-G27 downstream side of equipment bridge.

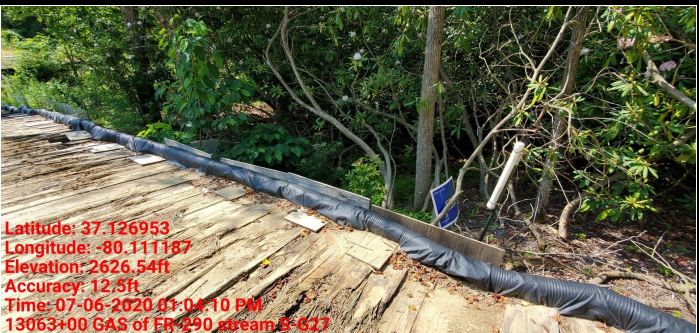
<p>Latitude: 37.126953 Longitude: -80.111187 Elevation: 2626.54ft Accuracy: 12.5ft Time: 07-06-2020 01:04:10 PM 13063+00 GAS of FR-290 stream S-G27</p>		
GPS Location	See pic for GPS location		GPS Location	See pic for GPS location

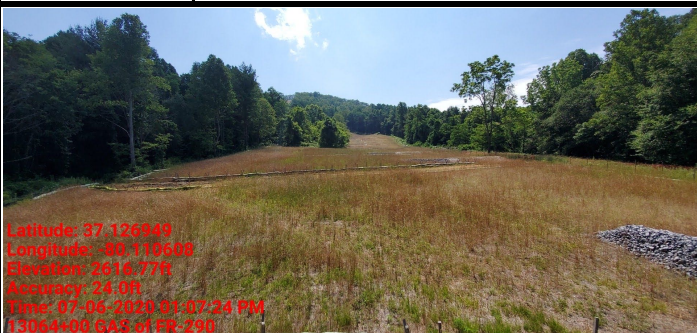
<p>Latitude: 37.126949 Longitude: -80.110689 Elevation: 2638.77ft Accuracy: 24.0ft Time: 07-06-2020 01:07:24 PM 13064+00 GAS of FR-290</p>

<p>Latitude: 37.126961 Longitude: -80.110554 Elevation: 2630.12ft Accuracy: 12.8ft Time: 07-06-2020 01:07:47 PM 13064+00 GAS of FR-290</p>		
GPS Location	See pic for GPS location		GPS Location	See pic for GPS location	
Field Station#	13064+00		Field Station#	13064+00	
Pic 17 Desc.	ROW on the GAS of FR-290		Pic 18 Desc.	ATWS on the GAS of FR-290.

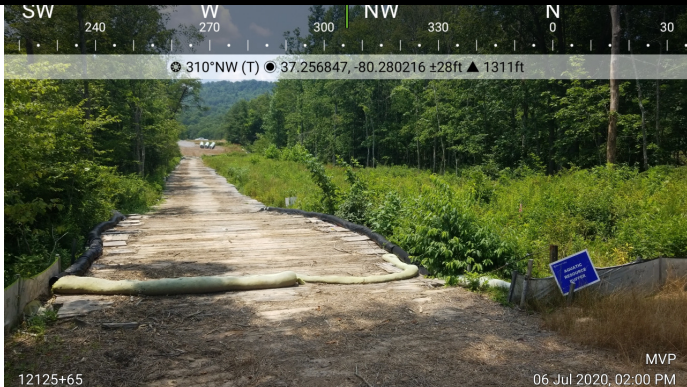
GPS Location	See Above		GPS Location	See Above	
Field Station#	12125+65		Field Station#	12133+00	
Pic 1 Desc.	Stream S-MM31, Looking NorthWest. ECDs are functional.		Pic 2 Desc.	Stream S-C29, Looking West. ECDs are functional.

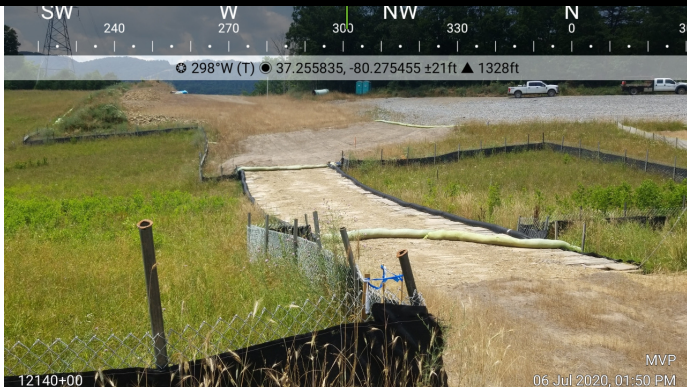
GPS Location	See Above		GPS Location	See Above	
Field Station#	12140+00		Field Station#	12144+50	
Pic 3 Desc.	Wetland W-C6, Looking West. ECDs are functional.		Pic 4 Desc.	Wetland W-C5, Looking West. ECDs are functional.

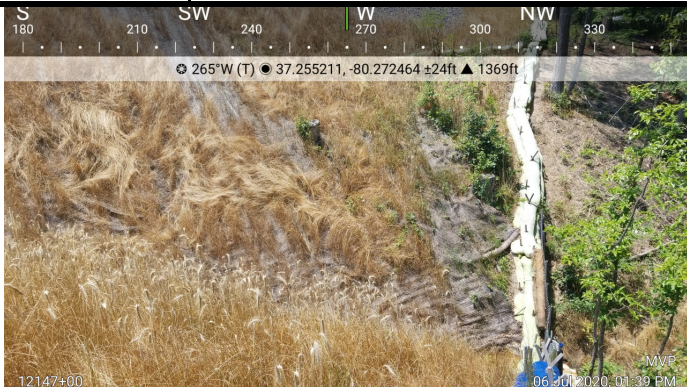
GPS Location	See Above		GPS Location	See Above	
Field Station#	12147+00		Field Station#	12156+75	
Pic 5 Desc.	Temporary and permanent vegetation remain stable and ECDs are functional. Looking West.		Pic 6 Desc.	Head-water area Stream S-C23, Looking SouthWest. ECDs are functional.

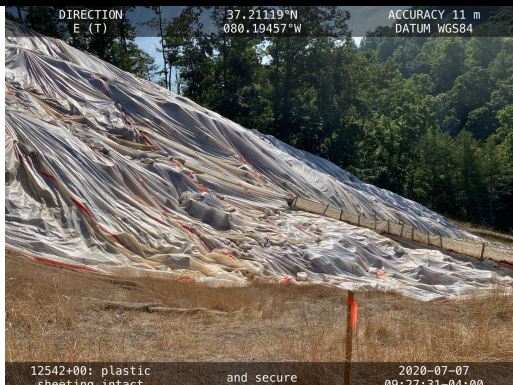
<p>DIRECTION E (T) 37.21119°N 080.19457°W ACCURACY 11 m DATUM WGS84</p> <p>12542+00: plastic sheeting intact and secure 2020-07-07 09:27:31-04:00</p>

GPS Location	See photo		GPS Location	See photo	
Field Station#	12543+00		Field Station#	12542+00	
Pic 3 Desc.	Yellow Finch Road crossing as viewed from hillside on coming in side of road.		Pic 4 Desc.	Plastic sheeting on stockpiles nearest to Yellow Finch Road remains intact and secure.

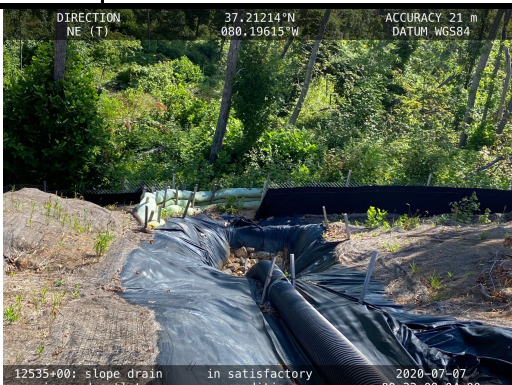
<p>DIRECTION NE (T) 37.21214°N 080.19615°W ACCURACY 21 m DATUM WGS84</p> <p>12535+00: slope drain pipe and outlet in satisfactory condition 2020-07-07 09:32:09-04:00</p>

<p>DIRECTION N (T) 37.21217°N 080.19627°W ACCURACY 9 m DATUM WGS84</p> <p>12534+00: CWD pipe outlet discolored, but free of sediment 2020-07-07 09:35:01-04:00</p>			
GPS Location	See photo		GPS Location	See photo	
Field Station#	12535+00		Field Station#	12534+00	
Pic 5 Desc.	Fill slope drain and outlet in satisfactory condition.		Pic 6 Desc.	CWD pipe plunge pool outlet is discolored, but free of any sediment.

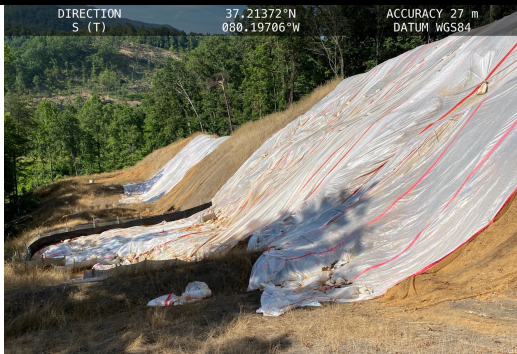
<p>DIRECTION S (T) 37.21372°N 080.19706°W ACCURACY 27 m DATUM WGS84</p> <p>12529+00: plastic sheeting intact and secure appr 1500' from Yellow Finch 2020-07-07 09:45:55-04:00</p>		  <p>DIRECTION S (T) 37.21633°N 080.19745°W ACCURACY 19 m DATUM WGS84</p> <p>12522+00: slope on GAS of S-EF19 remains stable 2020-07-07 10:03:08-04:00</p>

GPS Location	See photo		GPS Location	See photo	
Field Station#	12529+00		Field Station#	12522+00	
Pic 9 Desc.	Plastic sheeting approximately 1500 feet from Yellow Finch Road is intact and secure.		Pic 10 Desc.	Slope on going away side of stream S-EF19 remains stable.	
  <p>DIRECTION N (T) 37.21565°N 080.19778°W ACCURACY 200 m DATUM WGS84</p> <p>12523+00: SSF perimeter controls in satisfactory condition 2020-07-07 09:57:15-04:00</p>

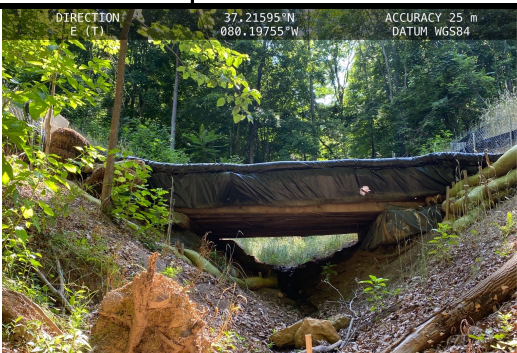
<p>DIRECTION E (T) 37.21595°N 080.19755°W ACCURACY 25 m DATUM WGS84</p> <p>12519+41: stream S-EF19, facing east, upstream 2020-07-07 10:00:43-04:00</p>			
GPS Location	See photo		GPS Location	See photo	
Field Station#	12523+00		Field Station#	12519+41	
Pic 11 Desc.	SSF perimeter controls are in satisfactory condition.		Pic 12 Desc.	Stream S-EF19, facing east, upstream

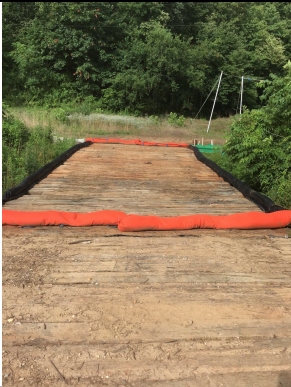
GPS Location	000000	GPS Location	0000000		
Field Station#	13643+66	Field Station#	13541+99		
Pic 3 Desc.	Monitored ECDs and equipment bridges	Pic 4 Desc.	Monitored ECDs and water bars on hill side above stream crossing.		
Insert image here			Insert image here		
GPS Location		GPS Location			
Field Station#		Field Station#			
Pic 5 Desc.		Pic 6 Desc.

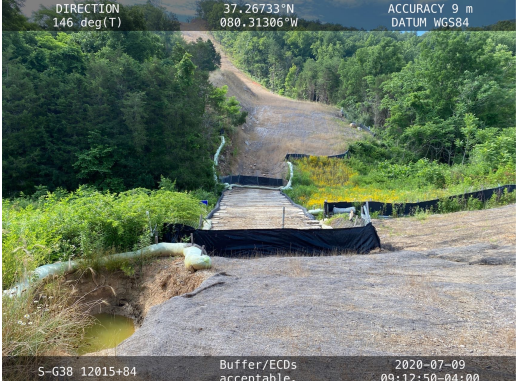
<p>DIRECTION 146 deg(T) 37.26733°N 080.31306°W ACCURACY 9 m DATUM WGS84 S-G38 12015+84 Buffer/ECDs acceptable. 2020-07-09 09:12:50-04:00</p>

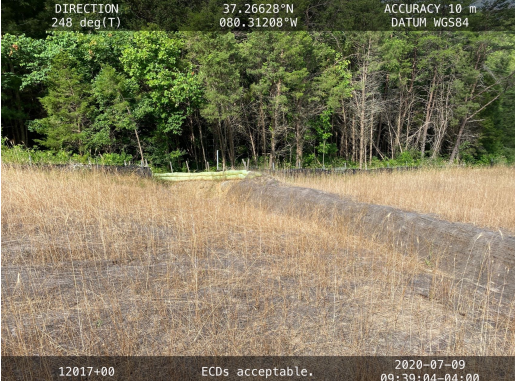
<p>DIRECTION 248 deg(T) 37.26628°N 080.31208°W ACCURACY 10 m DATUM WGS84 12017+00 ECDs acceptable. 2020-07-09 09:39:04-04:00</p>

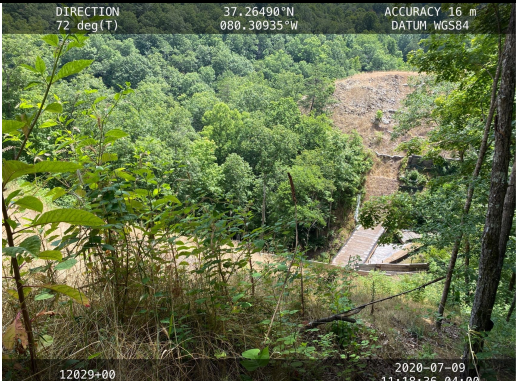
<p>DIRECTION 72 deg(T) 37.26490°N 080.30935°W ACCURACY 16 m DATUM WGS84 12029+00 2020-07-09 11:18:36-04:00</p>

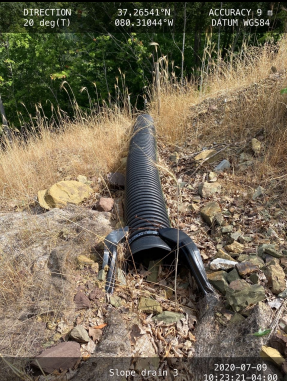
<p>DIRECTION 26 deg(T) 37.26541°N 080.31044°W ACCURACY 9 m DATUM WGS84 Slope drain 3 2020-07-09 10:23:21-04:00</p>	
GPS Location	See photo GPS for location		GPS Location	See photo GPS for location	
Field Station#	12029+00		Field Station#	12027+00	
Pic 5 Desc.	All stable.		Pic 6 Desc.	Drain intact.

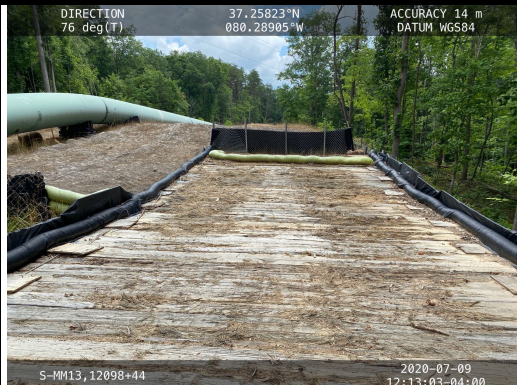
GPS Location	See photo GPS for location		GPS Location	See photo GPS for location	
Field Station#	12098+44		Field Station#	12086+56	
Pic 11 Desc.	ECDs are in acceptable condition at S-MM13.		Pic 12 Desc.	S-MM14 is low and surrounding ECDs are in acceptable condition.

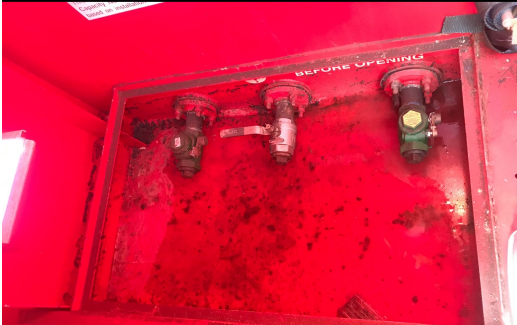
DIRECTION S (M) +37.23566° -080.22688° ACCURACY 33 ft DATUM WGS84  			
MVP-PY-006_071020 Internal drip tray empty 2020-07-10 07:47:50-04:00		MVP-PY-006_071020 No loose trash around dumpsters 2020-07-10 07:49:14-04:00			
GPS Location	MVP-PY-006 See photo for gps data		GPS Location	MVP-PY-006 See photo for gps data	
Field Station#	+0		Field Station#	+0	
Pic 7 Desc.	Off Road Fuel unit internal drip pan empty. Looking W.		Pic 8 Desc.	No loose trash around dumpsters. Looking S.	
DIRECTION W (M) +37.23428° -080.22646° ACCURACY 33 ft DATUM WGS84

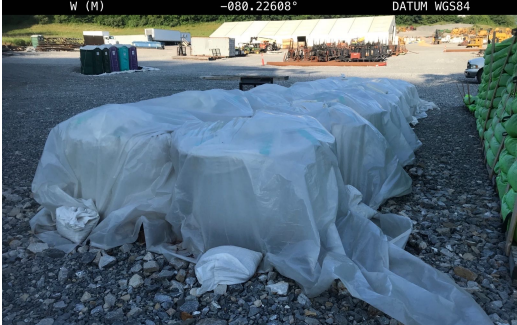
MVP-PY-006_071020 No debris around hazardous waste ... 2020-07-10 07:51:05-04:00		MVP-PY-006_071020 Restoration supplies covered and protected 2020-07-10 07:53:43-04:00

GPS Location	MVP-PY-006 See photo for gps data		GPS Location	MVP-PY-006 See photo for gps data	
Field Station#	+0		Field Station#	+0	
Pic 9 Desc.	No debris around hazardous waste dumpster. Looking W.		Pic 10 Desc.	Restoration supplies covered and protected from the elements. Looking W.	
DIRECTION S (M) +37.23471° -080.22580° ACCURACY 16 ft DATUM WGS84

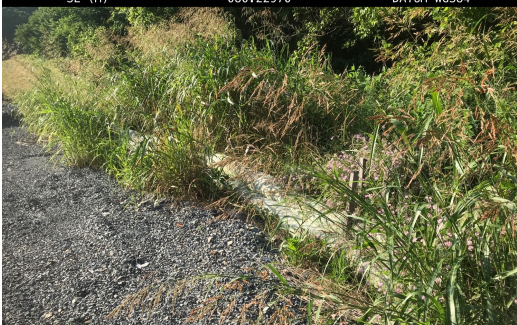
MVP-PY-006_071020 Condition of CFS along east LOD 2020-07-10 07:53:56-04:00		MVP-PY-006_071020 Condition of CFS along south LOD 2020-07-10 07:56:28-04:00			
GPS Location	MVP-PY-006 See photo for gps data		GPS Location	MVP-PY-006 See photo for gps data	
Field Station#	+0		Field Station#	+0	
Pic 11 Desc.	Condition of compost filter sock along east LOD boundary. Compost sock over grown with vegetation. Looking S.		Pic 12 Desc.	Condition of compost filter sock along south LOD boundary. Compost sock over grown with vegetation. Looking SE.

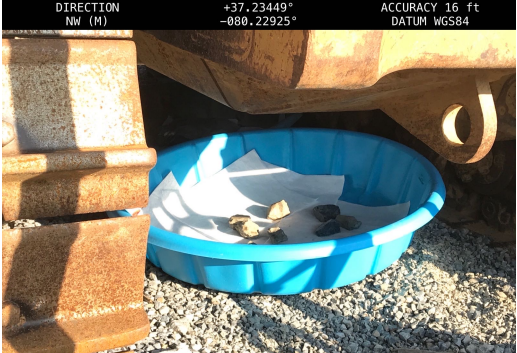
+37.23461° -080.22791° ACCURACY 16 ft DATUM WGS84 MVP-PY-006_071020 Condition of containment 2020-07-10 08:01:58-04:00		+37.23449° -080.22925° ACCURACY 16 ft DATUM WGS84 MVP-PY-006_071020 Containment under stored equipment 2020-07-10 07:58:00-04:00

GPS Location	MVP-PY-006 See photo for gps data		GPS Location	MVP-PY-006 See photo for gps data	
Field Station#	+0		Field Station#	+0	
Pic 15 Desc.	Condition of containment. Holding some stormwater. No sheen. Looking S.		Pic 16 Desc.	Condition of containment under stored equipment. Looking NW.	
DIRECTION N (M)  		DIRECTION S (M)

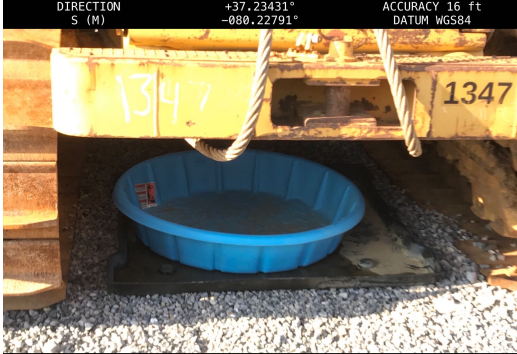
+37.23395° -080.22703° ACCURACY 541 ft DATUM WGS84 MVP-PY-006_071020 Containment under stored vehicle 2020-07-10 08:00:02-04:00		+37.23431° -080.22791° ACCURACY 16 ft DATUM WGS84 MVP-PY-006_071020 Containment under stored equipment 2020-07-10 08:00:57-04:00			
GPS Location	MVP-PY-006 See photo for gps data		GPS Location	MVP-PY-006 See photo for gps data	
Field Station#	+0		Field Station#	+0	
Pic 17 Desc.	Condition of containment under stored vehicle. Looking N.		Pic 18 Desc.	Condition of containment under stored equipment. Looking S.

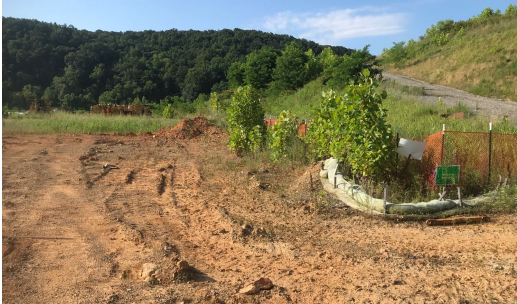
DIRECTION S (M) +37.27040° -080.12474° ACCURACY 16 ft DATUM WGS84	
MVP-LY-049_071020		Landowner disturbance along CFS and feature 2020-07-10 08:54:55-04:00		MVP-LY-049_071020	
GPS Location		MVP-LY-049 See photo for gps data		GPS Location	
Field Station#		+0		Field Station#	
Pic 12 Desc.		Landowner disturbance along compost filter sock and feature W-CV21B. No impacts. Looking S.

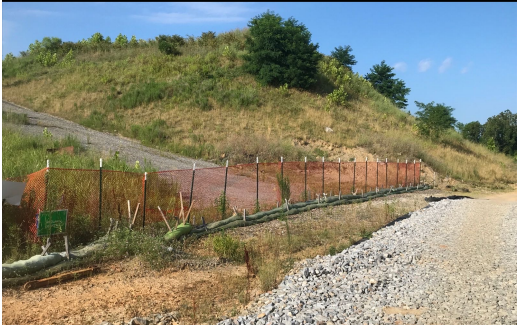
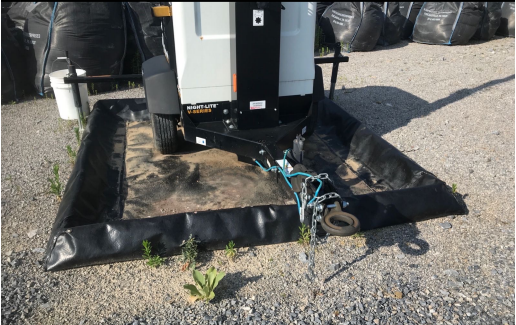
MVP-LY-049_071020 Landowner disturbance within 100' of ... 2020-07-10 08:55:12-04:00		MVP-LY-049_071020 Condition of containment 2020-07-10 08:59:31-04:00			
GPS Location	MVP-LY-049 See photo for gps data		GPS Location	MVP-LY-049 See photo for gps data	
Field Station#	+0		Field Station#	+0	
Pic 13 Desc.	Landowner disturbance within 100' of feature W-CV21B. No impacts. Looking SW.		Pic 14 Desc.	Condition of containment under light plant. Free of stormwater. Looking SW.	
DIRECTION W (M) +37.26939° -080.12372° ACCURACY 16 ft DATUM WGS84		DIRECTION SW (M) +37.27038° -080.12216° ACCURACY 16 ft DATUM WGS84

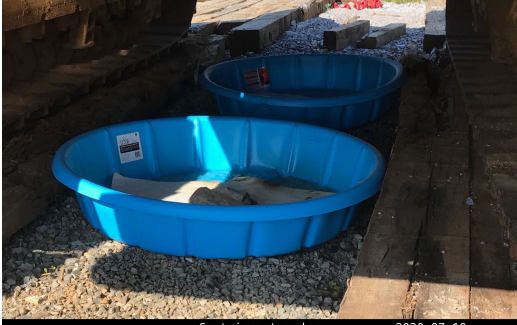
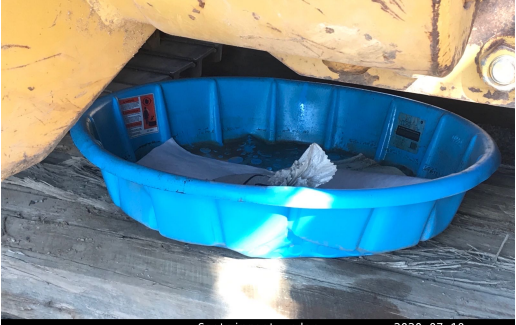
MVP-LY-049_071020 Containment under stored equipment 2020-07-10 09:27:02-04:00		MVP-LY-049_071020 Containment under stored equipment 2020-07-10 09:29:20-04:00

GPS Location	MVP-LY-049 See photo for gps data		GPS Location	MVP-LY-049 See photo for gps data	
Field Station#	+0		Field Station#	+0	
Pic 15 Desc.	Condition of containment under stored equipment. Looking W.		Pic 16 Desc.	Condition of containment under stored equipment. Looking SW.	
DIRECTION E (M) +37.27037° -080.12218° ACCURACY 16 ft DATUM WGS84		DIRECTION SE (M) +37.27022° -080.12194° ACCURACY 16 ft DATUM WGS84

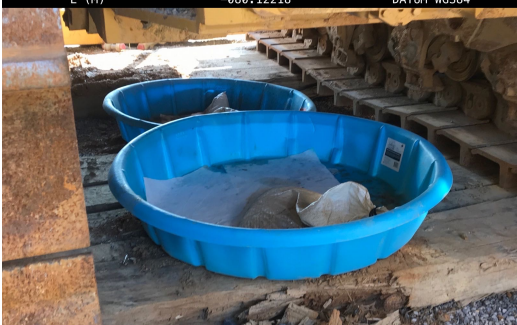
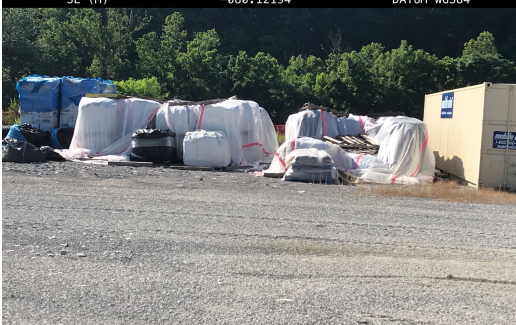
MVP-LY-049_071020 Containment under stored equipment 2020-07-10 09:29:52-04:00		MVP-LY-049_071020 Restoration supplies covered and protected 2020-07-10 09:30:33-04:00			
GPS Location	MVP-LY-049 See photo for gps data		GPS Location	MVP-LY-049 See photo for gps data	
Field Station#	+0		Field Station#	+0	
Pic 17 Desc.	Condition of containment under stored equipment. Looking E.		Pic 18 Desc.	Restoration supplies covered and protected from the elements. Looking SE.

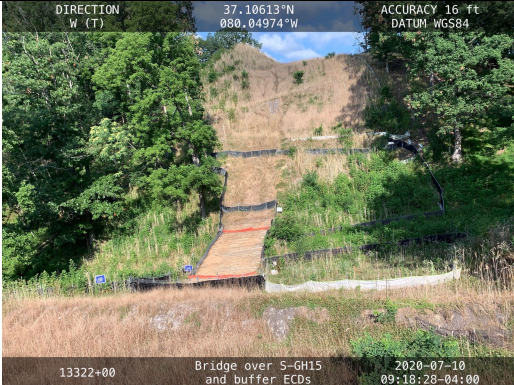
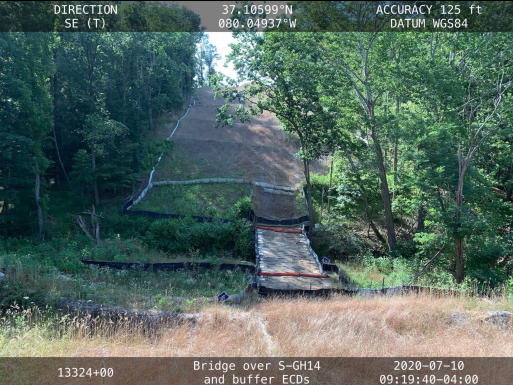
GPS Location	See photo for gps location data.		GPS Location	See photo for gps location data.	
Field Station#	13322+00		Field Station#	13324+00	
Pic 1 Desc.	Photo shows the bridge over stream S-GH15 and adjacent ROW conditions.		Pic 2 Desc.	Photo shows the bridge over stream S-GH14 and buffer ECDs.

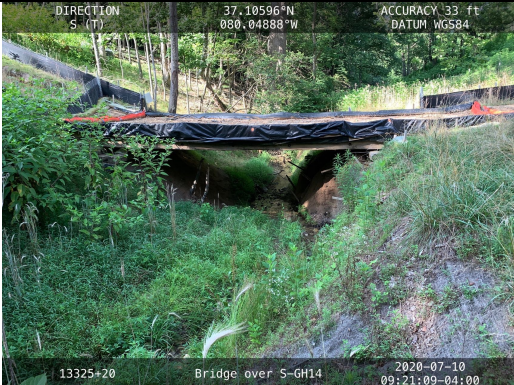
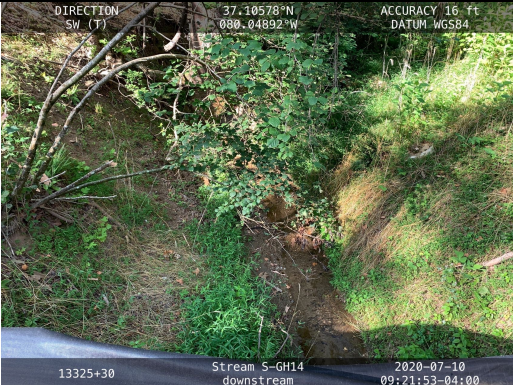
GPS Location	See photo for gps location data.		GPS Location	See photo for gps location data.	
Field Station#	13325+20		Field Station#	13325+30	
Pic 3 Desc.	Photo shows the bridge over stream S-GH14.		Pic 4 Desc.	Photo shows stream S-GH14 downstream from the ROW crossing.

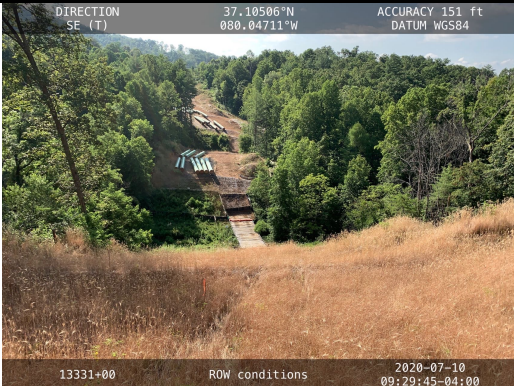
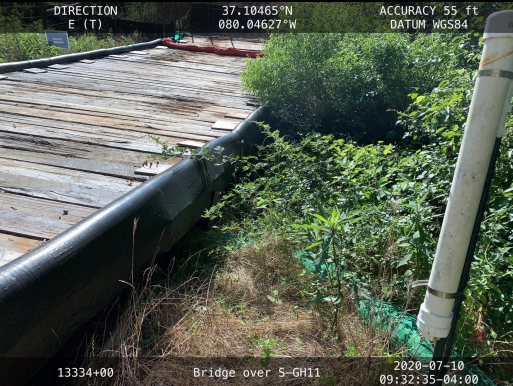
GPS Location	See photo for gps location data.		GPS Location	See photo for gps location data.	
Field Station#	13331+00		Field Station#	13334+00	
Pic 5 Desc.	Photo shows the ROW condition from about 13331+00 to 13336+00.		Pic 6 Desc.	Photo shows the bridge over stream S-GH11.

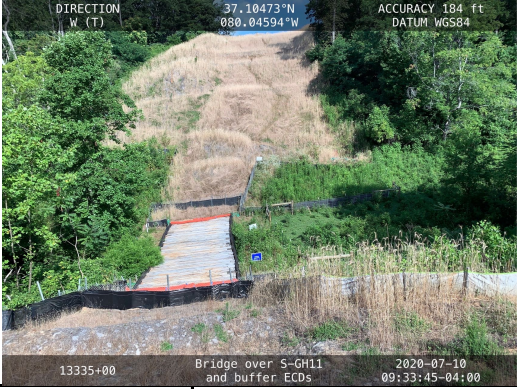
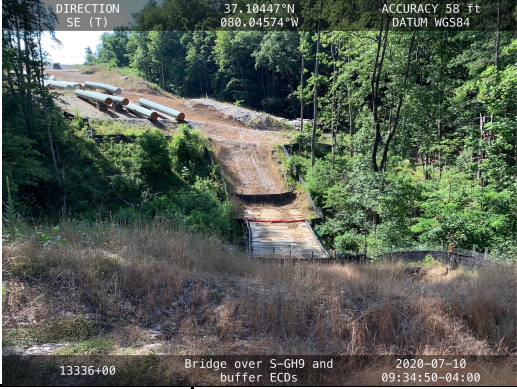
GPS Location	See photo for gps location data.		GPS Location	See photo for gps location data.	
Field Station#	13335+00		Field Station#	13336+00	
Pic 7 Desc.	Photo shows the bridge over stream S-GH11 and buffer ECDs.		Pic 8 Desc.	Photo shows the bridge over stream S-GH9 and buffer ECDs.

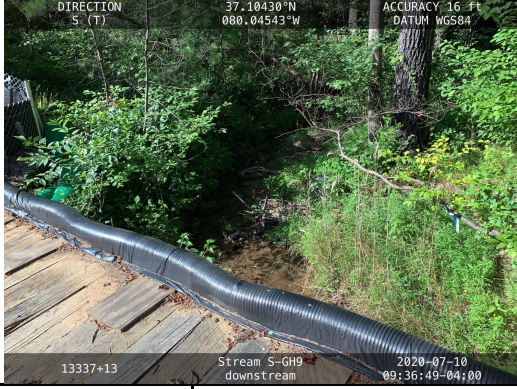
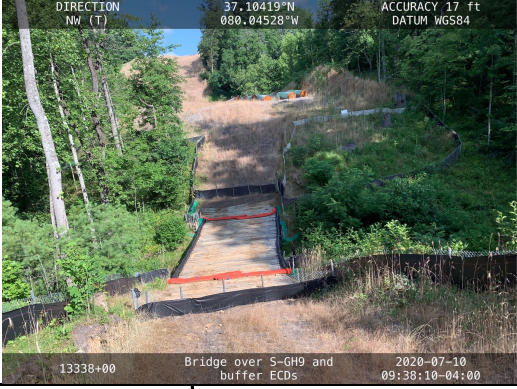
GPS Location	See photo for gps location data.		GPS Location	See photo for gps location data.	
Field Station#	13337+13		Field Station#	13338+00	
Pic 9 Desc.	Photo shows stream S-GH9 downstream from the ROW crossing.		Pic 10 Desc.	Photo shows the bridge over stream S-GH9 and buffer ECDs.

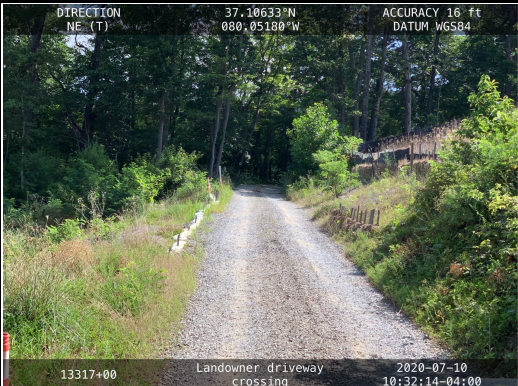
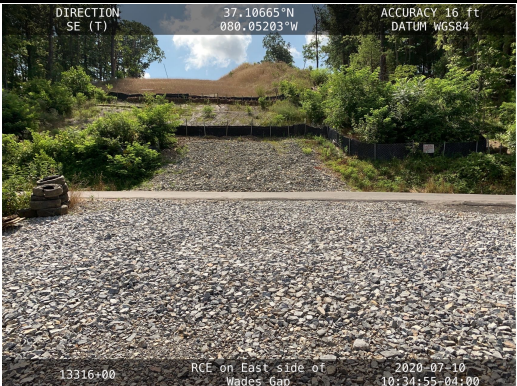
GPS Location	See photo for gps location data.		GPS Location	See photo for gps location data.	
Field Station#	13317+00		Field Station#	13316+00	
Pic 15 Desc.	Photo shows the landowner driveway near Wades Gap Road.		Pic 16 Desc.	Photo shows the RCE on the east side of Wades Gap Road.

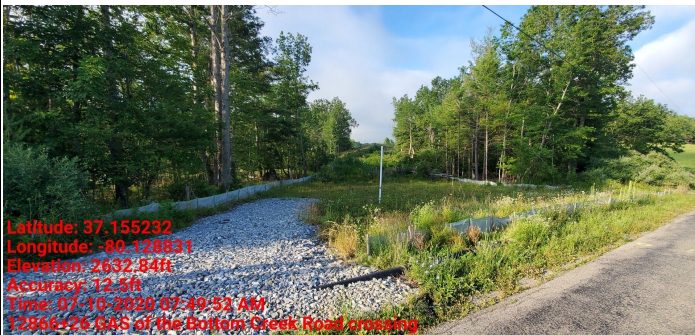
<p>Latitude: 37.155232 Longitude: -80.128831 Elevation: 2632.84ft Accuracy: 12.5ft Time: 07-10-2020 07:49:51 AM 12866+26 GAS of the Bottom Creek Road crossing</p>

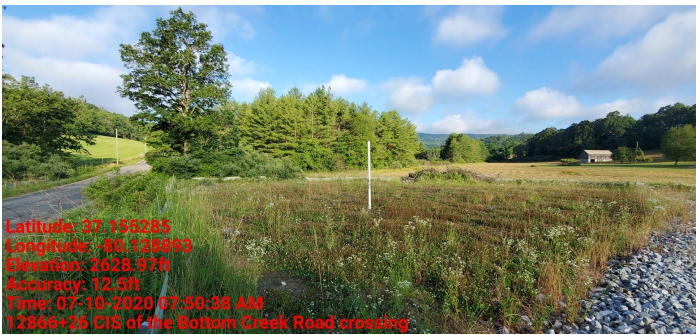
<p>Latitude: 37.150283 Longitude: -80.128803 Elevation: 2628.97ft Accuracy: 12.5ft Time: 07-10-2020 07:50:38 AM 12866+26 CIS of the Bottom Creek Road crossing</p>		
GPS Location	See pic for GPS location		GPS Location	See pic for GPS location	
Field Station#	12866+26		Field Station#	12866+26	
Pic 1 Desc.	GAS of the Bottom Creek Road crossing		Pic 2 Desc.	CIS of the Bottom Creek Road crossing

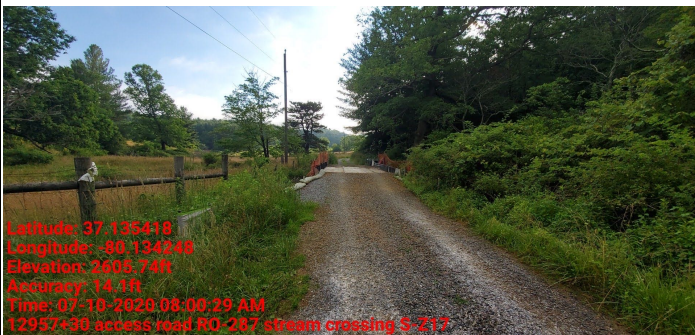
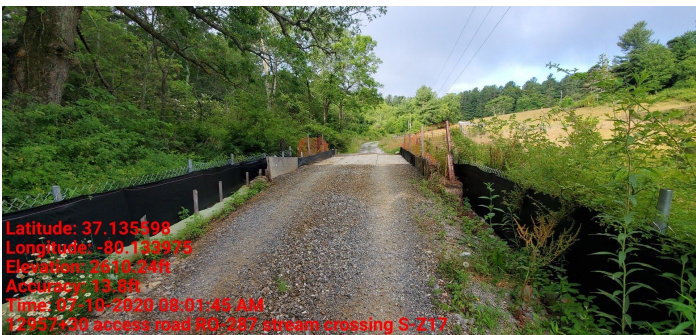
GPS Location	See pic for GPS location		GPS Location	See pic for GPS location	
Field Station#	12957+30		Field Station#	12957+30	
Pic 3 Desc.	Access road RO-287 at stream crossing S-Z17.		Pic 4 Desc.	Access road RO-287 at stream crossing S-Z17.

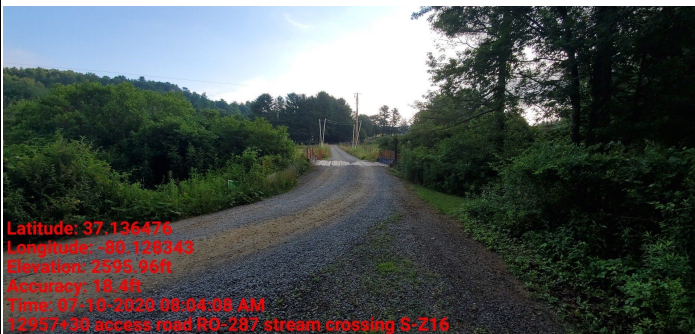
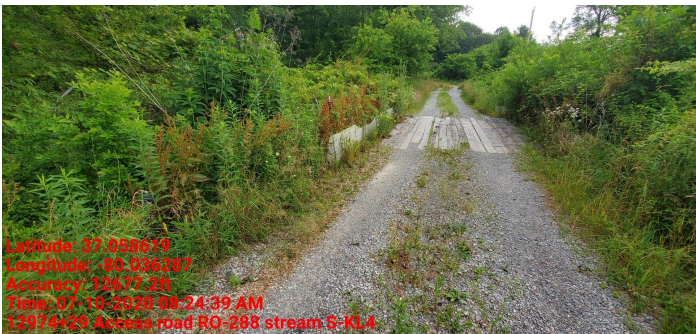
<p>Latitude: 37.088619 Longitude: -80.086207 Elevation: 1247.72ft Accuracy: 12.4ft Time: 07-10-2020 08:24:39 AM 12974+29 Access road RO-288 stream S-K14</p>		
GPS Location	See pic for GPS location		GPS Location	See pic for GPS location	
Field Station#	12957+30		Field Station#	12974+29	
Pic 5 Desc.	Access road RO-287 at stream crossing S-Z16.		Pic 6 Desc.	Access road RO-288 at stream crossing S-K14

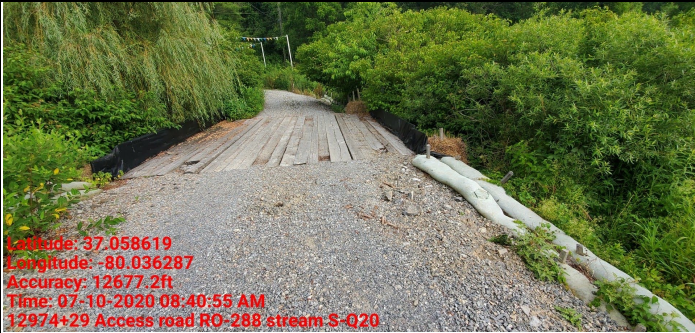
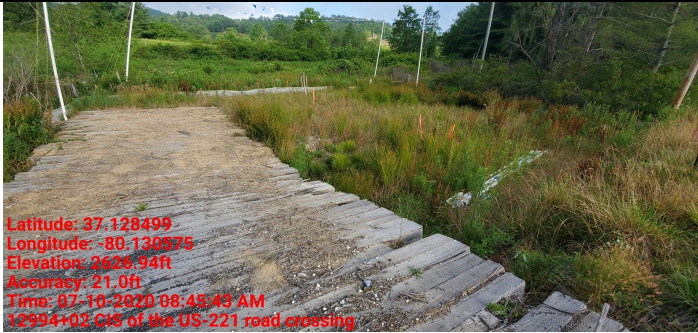
<p>Latitude: 37.128499 Longitude: -80.130575 Elevation: 2626.94ft Accuracy: 21.0ft Time: 07-10-2020 08:45:40 AM 12994+02 CIS of the US-221 road crossing</p>		
GPS Location	See pic for GPS location		GPS Location	See pic for GPS location	
Field Station#	12974+29		Field Station#	12994+02	
Pic 7 Desc.	Access road RO-288 at stream crossing S-Q20		Pic 8 Desc.	CIS of the US-221 road crossing.

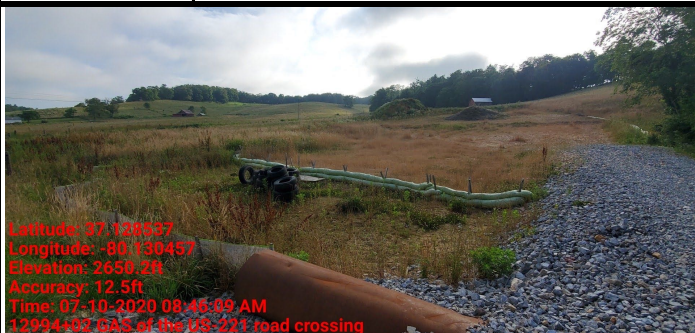
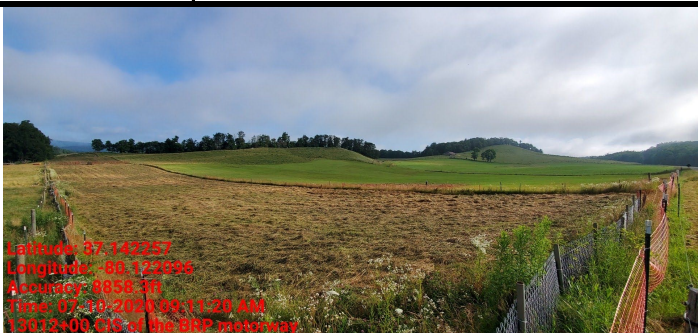
GPS Location	See pic for GPS location		GPS Location	See pic for GPS location	
Field Station#	12994+02		Field Station#	13012+00	
Pic 9 Desc.	GAS of the US-221 road crossing.		Pic 10 Desc.	CIS of the BRP motorway. Vegetation mowed down for hay by land tenant at request of the BRP.
