Visual Site Inspection Report

Project Name	H-600 Pipeline Spread H	AFE	124300138	Spread	H-600 Pipeline Spread H
Contractor	Precision			Report #	12452
Inspector	Pat Davis			Date/Time	7/6/2020 4:00 PM
Permit #	TBD	Inspection Type	VA SWPP	Station Begin	+0
State	VA	Inspection Area	Partial	Station End	+0
County	Montgomery	Ground	Damp	Temperature (°F)	91.00
Municipality	N/A	Weather	Sunny	Rain Gauge (in)	0.10
				Rain Accumulation Time (days)	0.00

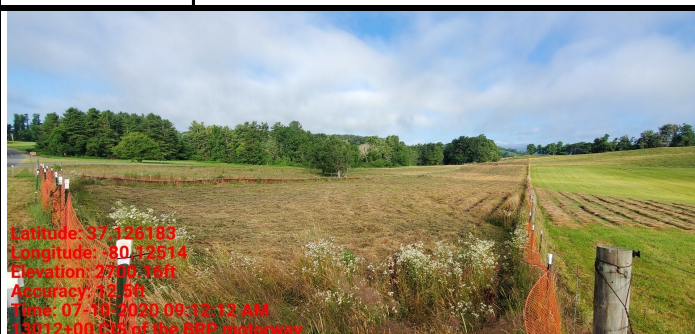
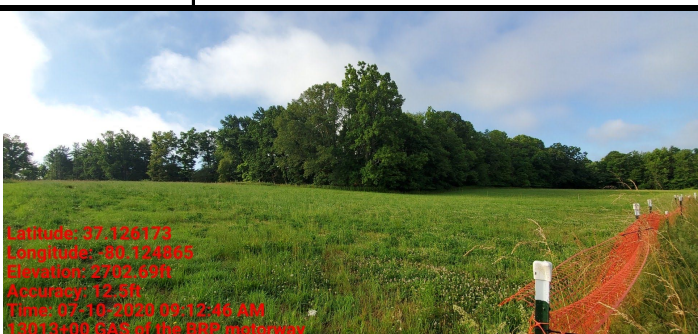
<p>Latitude: 37.126173 Longitude: -80.126055 Elevation: 2702.6ft Accuracy: 12.5ft Time: 07-10-2020 09:12:46 AM 13013+00 GAS of the BRP motorway</p>		
GPS Location	See pic for GPS location		GPS Location	See pic for GPS location	
Field Station#	13012+00		Field Station#	13013+00	
Pic 11 Desc.	CIS of the BRP motorway. Vegetation mowed down for hay by land tenant at request of the BRP.		Pic 12 Desc.	GAS of the BRP motorway.

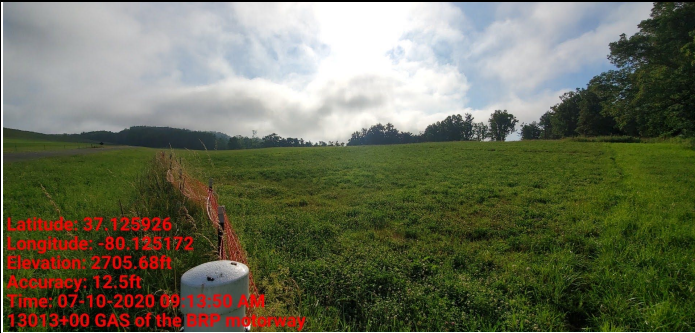
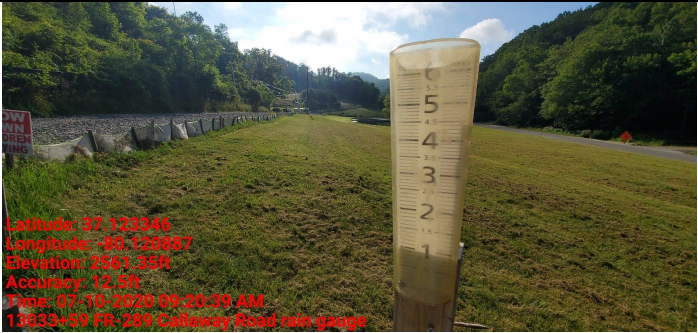
<p>Latitude: 37.123946 Longitude: -80.125937 Elevation: 2561.35ft Accuracy: 12.5ft Time: 07-10-2020 09:20:33 AM 13033+59 FR-289 Callaway Road rain gauge</p>		
GPS Location	See pic for GPS location		GPS Location	See pic for GPS location	
Field Station#	13013+00		Field Station#	13033+59	
Pic 13 Desc.	GAS of the BRP motorway.		Pic 14 Desc.	Callaway Road rain gauge 0.0" total precipitation.

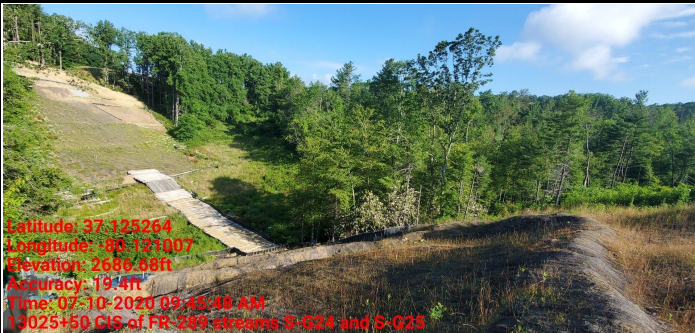
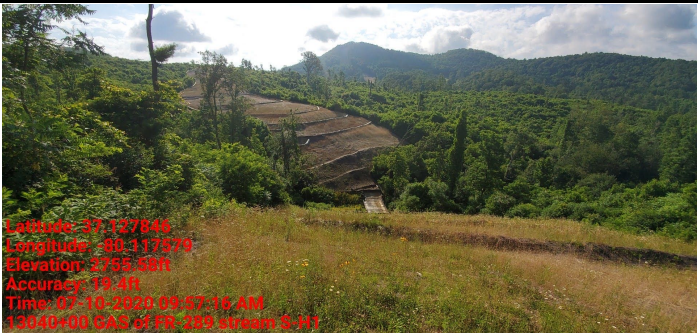
GPS Location	See pic for GPS location		GPS Location	See pic for GPS location	
Field Station#	13025+50		Field Station#	13040+00	
Pic 15 Desc.	Streams S-G24 and S-G25 on the CIS of access road FR-289.		Pic 16 Desc.	Stream S-H1 on the GAS of access road FR-289.

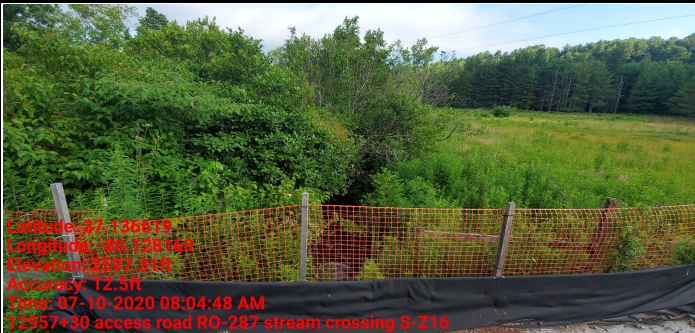
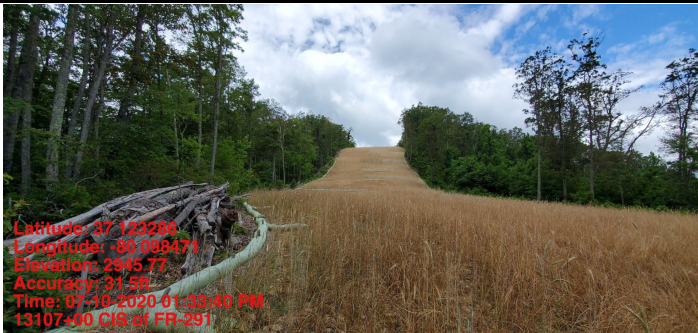
<p>Latitude: 37.122280 Longitude: -80.098471 Elevation: 2985.77 Accuracy: 31.5ft Time: 07-10-2020 01:25:40 PM 13107+00 CIS of FR-291</p>		
GPS Location	See pic for GPS location		GPS Location	See pic for GPS location	
Field Station#	12957+30		Field Station#	13107+00	
Pic 17 Desc.	Stream S-Z16 at access road RO-287.		Pic 18 Desc.	Restored ROW on CIS of FR-291.

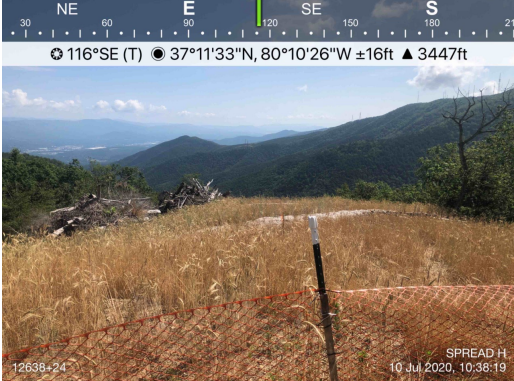
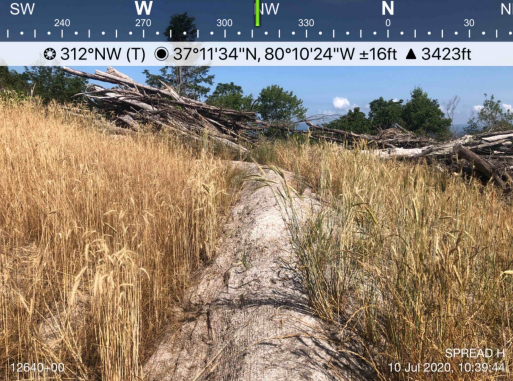
GPS Location	see photo		GPS Location	see photo	
Field Station#	12638+24		Field Station#	12640+00	
Pic 1 Desc.	GAS of AR-279.01 in good condition with vegetation filling in.		Pic 2 Desc.	Waterbars in good condition on this slope.

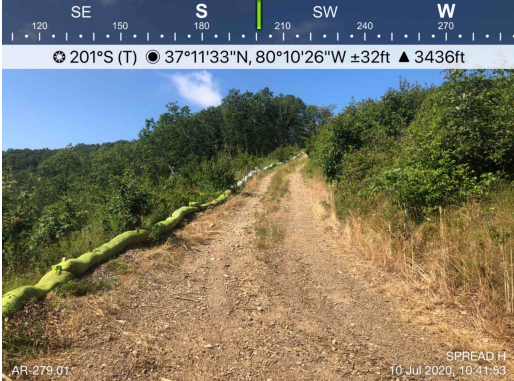
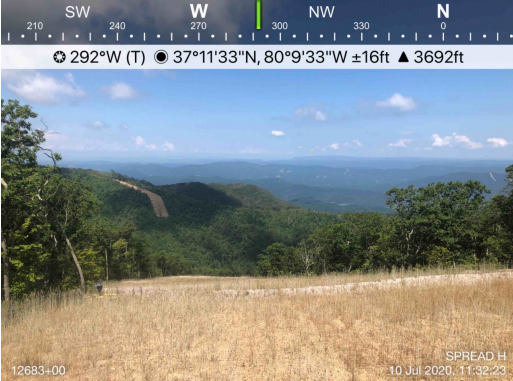
GPS Location	see photo		GPS Location	see photo	
Field Station#	279+01		Field Station#	12683+00	
Pic 3 Desc.	AR-279.01 in good condition with controls in place.		Pic 4 Desc.	Vegetation continuing to fill in on this section of ROW.

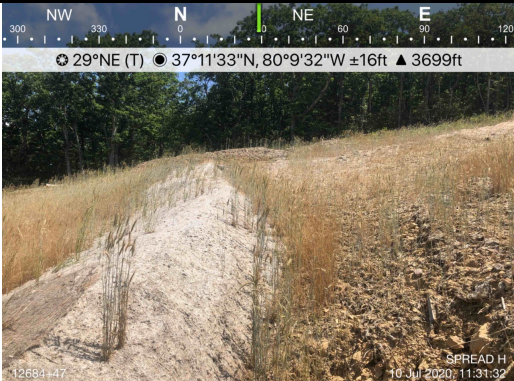
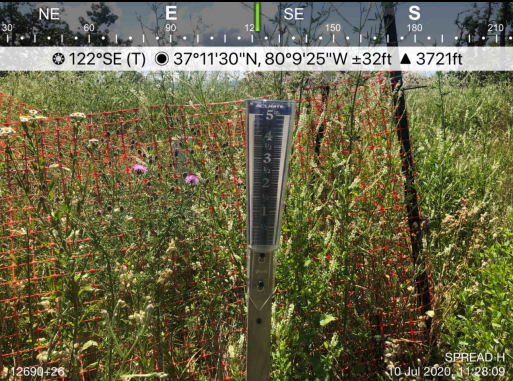
GPS Location	see photo		GPS Location	see photo	
Field Station#	12684+47		Field Station#	12690+29	
Pic 5 Desc.	Waterbars on the CIS of Honeysuckle in good condition and functioning.		Pic 6 Desc.	0" of precipitation
