# Visual Site Inspection Report

<b>Project Name</b>	H-600 Pipeline Spread H	<b>AFE</b>	124300138	<b>Spread</b>	H-600 Pipeline Spread H
<b>Contractor</b>	Precision			<b>Report #</b>	13474
<b>Inspector</b>	John Brcic			<b>Date/Time</b>	8/10/2020 11:45 AM
<b>Permit #</b>	TBD	<b>Inspection Type</b>	VA SWPP	<b>Station Begin</b>	12443+75
<b>State</b>	VA	<b>Inspection Area</b>	Partial	<b>Station End</b>	12544+06
<b>County</b>	Montgomery	<b>Ground</b>	Dry	<b>Temperature (°F)</b>	83.00
<b>Municipality</b>	N/A	<b>Weather</b>	Sunny	<b>Rain Gauge (in)</b>	0.00
				<b>Rain Accumulation Time (days)</b>	3.00

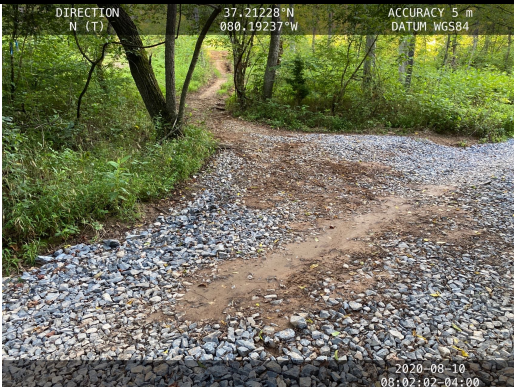
<b>GPS Location</b>	See photo		<b>GPS Location</b>	See photo	
<b>Field Station#</b>	12543+56		<b>Field Station#</b>	12543+56	
<b>Pic 3 Desc.</b>	Sediment deposits on Yellow Finch Road originating from landowner's driveway at turnaround.		<b>Pic 4 Desc.</b>	MVP ROW crossing on Yellow Finch Road as seen from slope on coming in side of the road.

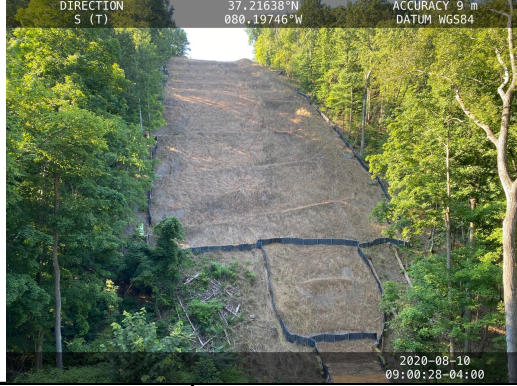
<b>GPS Location</b>	See photo		<b>GPS Location</b>	See photo	
<b>Field Station#</b>	12522+00		<b>Field Station#</b>	12508+92	
<b>Pic 11 Desc.</b>	Slope on going away side of stream S-EF19 remains stable.		<b>Pic 12 Desc.</b>	A small area at the top of the hill past the CWD pipe needs to be stabilized.

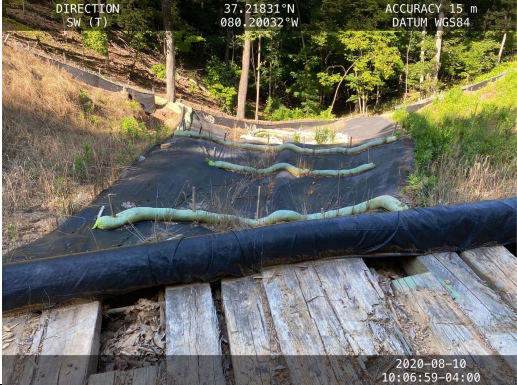
<b>GPS Location</b>	See photo		<b>GPS Location</b>	See photo	
<b>Field Station#</b>	12503+70		<b>Field Station#</b>	12506+00	
<b>Pic 13 Desc.</b>	Clean water diversion pipe continues to function per design.		<b>Pic 14 Desc.</b>	Slope on going away side of the clean water diversion pipe remains stable.

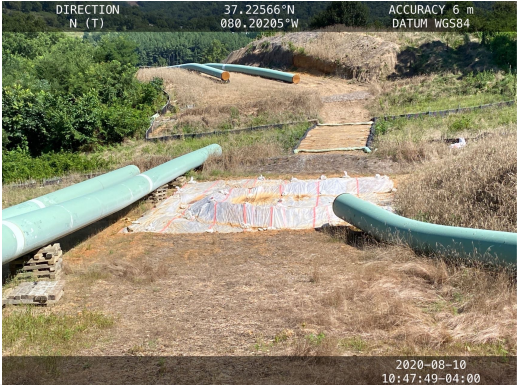
<b>GPS Location</b>	See photo		<b>GPS Location</b>	See photo	
<b>Field Station#</b>	12483+00		<b>Field Station#</b>	12460+75	
<b>Pic 15 Desc.</b>	Plastic sheeting on the "pig parts" excavation site remains intact and secure.		<b>Pic 16 Desc.</b>	Wetland W-KL58, facing west

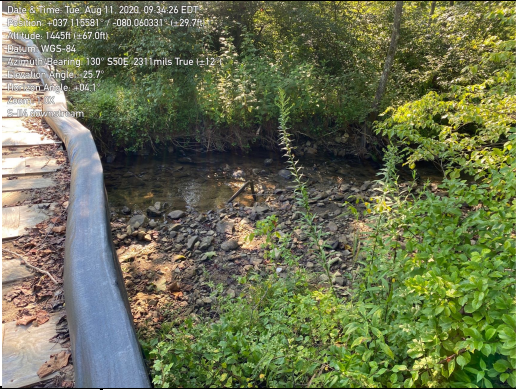
<p>Date &amp; Time: Tue Aug 11, 2020 09:36:28 EDT Position: +037.1153N, -080.060331 W (+29.7ft) Altitude: 1445ft (+67.0ft) Datum: WGS-84 Azimuth/Bearing: 130° S50E 231mils True (+12°) Elevation Angle: +25.7° Horizon Angle: +04.1° Zoom: 1.0X S-II4 GIS</p>

<p>Date &amp; Time: Tue Aug 11, 2020 09:36:48 EDT Position: +037.1153N, -080.060331 W (+29.7ft) Altitude: 1438ft (+66.9ft) Datum: WGS-84 Azimuth/Bearing: 316° N46W 582mils True (+12°) Elevation Angle: +25.7° Horizon Angle: +00.7° Zoom: 1.0X S-II4 GIS</p>			
<b>GPS Location</b>	See photo for coordinates.		<b>GPS Location</b>	See photo for coordinates.	
<b>Field Station#</b>	13260+60		<b>Field Station#</b>	13260+60	
<b>Pic 1 Desc.</b>	S-II4, downstream, no changes noted to stream bed or banks, water level low, water flowing clear.		<b>Pic 2 Desc.</b>	S-II4, upstream, no changes noted to stream bed or banks, banks well vegetated.

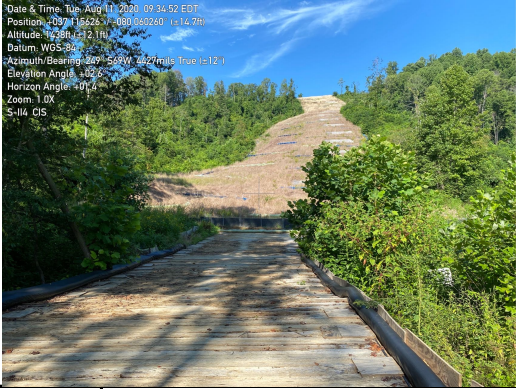
<p>Date &amp; Time: Tue Aug 11, 2020 09:51:01 EDT Position: +037.1157N, -080.061976 W (+9.0ft) Altitude: 1280ft (+60.4ft) Datum: WGS-84 Azimuth/Bearing: 122° S58E 210mils True (+13°) Elevation Angle: +20.8° Horizon Angle: +03.0° Zoom: 1.0X S-II4 GIS</p>			
<b>GPS Location</b>	See photo for coordinates.		<b>GPS Location</b>	See photo for coordinates.	
<b>Field Station#</b>	13260+60		<b>Field Station#</b>	13254+00	
<b>Pic 3 Desc.</b>	CIS S-II4, bridge clean, perimeter ECDs in acceptable condition.		<b>Pic 4 Desc.</b>	Permanent waterbars stable, live vegetation sporadic.

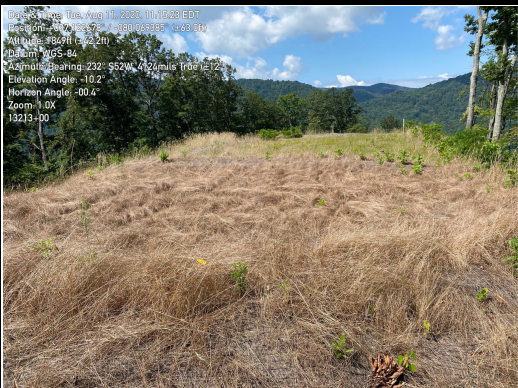
<b>GPS Location</b>	See photo for coordinates.		<b>GPS Location</b>	See photo for coordinates.	
<b>Field Station#</b>	13213+00		<b>Field Station#</b>	13211+00	
<b>Pic 15 Desc.</b>	Temporarily stabilized area, waterbars and sumps acceptable.		<b>Pic 16 Desc.</b>	Temporary vegetative cover sparse to moderate.	
<p><small>Date &amp; Time: Tue, Aug 11, 2020 13:07:15 EDT Position: +037.122261 / +080.076669 (+455.5ft) Altitude: 1405ft (+512.7ft) Datum: WGS-84 Azimuth Bearing: 388° N15W 613ymins True (+12°) Elevation Angle: -38.0° Horizon Angle: -00.4° Zoom: 1.0X 29 S-D19</small></p>

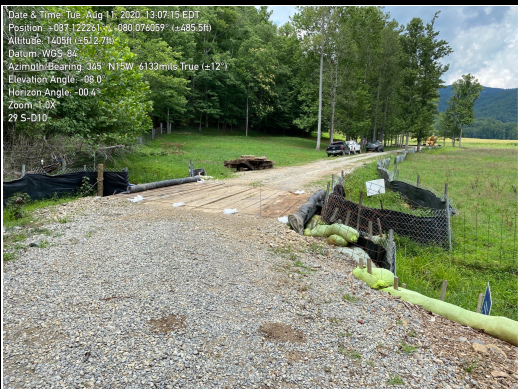
<b>Field Station#</b>	13190+00		<b>Field Station#</b>	13142+00	
<b>Pic 17 Desc.</b>	MVP-AR-29, punch list item 278 compelled, bridge repair.		<b>Pic 18 Desc.</b>	ECDs functioning acceptably along MVP-FR-292 and on not disturbed logging road on ROW.

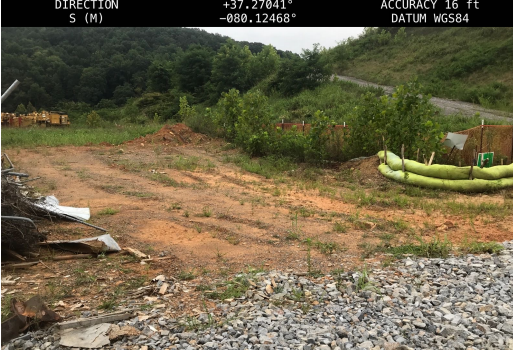
<b>GPS Location</b>	MVP-LY-049 See photo for gps data		<b>GPS Location</b>	MVP-LY-049 See photo for gps data	
<b>Field Station#</b>	+0		<b>Field Station#</b>	+0	
<b>Pic 3 Desc.</b>	Landowner disturbance within 100' of feature W-CV21B. Area not stabilized. No impacts. Looking SW.		<b>Pic 4 Desc.</b>	Landowner disturbance along compost filter sock and feature W-CV21B. Area not stabilized. Looking S.

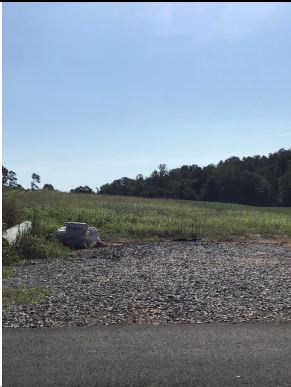
<b>GPS Location</b>	0000	<b>GPS Location</b>	00000		
<b>Field Station#</b>	13644+90	<b>Field Station#</b>	13562+62		
<b>Pic 3 Desc.</b>	Vegetation photo at Leaning oak		<b>Pic 4 Desc.</b>	Photo showing vegetation coverage going away side of Bethlehem rd	
Insert image here			Insert image here		
<b>GPS Location</b>		<b>GPS Location</b>			
<b>Field Station#</b>		<b>Field Station#</b>			
<b>Pic 5 Desc.</b>		<b>Pic 6 Desc.</b>

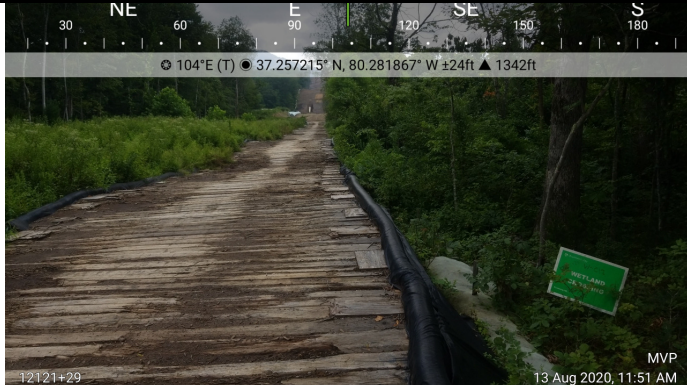
<b>GPS Location</b>	See Above	<b>GPS Location</b>	See Above		
<b>Field Station#</b>	12103+00	<b>Field Station#</b>	12121+29		
<b>Pic 1 Desc.</b>	Rain Gauge at Half Acre of Rocks Road reads 0.4".	<b>Pic 2 Desc.</b>	Overview of Wetland W-C12. ECDs functional and in good condition.

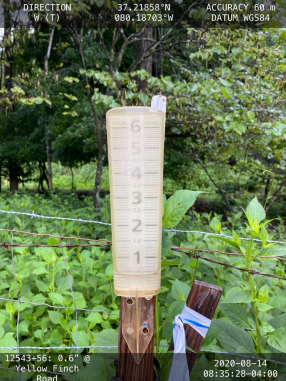
<b>GPS Location</b>	See photo		<b>GPS Location</b>	See photo	
<b>Field Station#</b>	12543+56		<b>Field Station#</b>	12543+56	
<b>Pic 1 Desc.</b>	There was 0.6" of rain in the gauge at Yellow Finch Road this morning.		<b>Pic 2 Desc.</b>	Stream S-EF20b, facing north from Yellow Finch Road, upstream

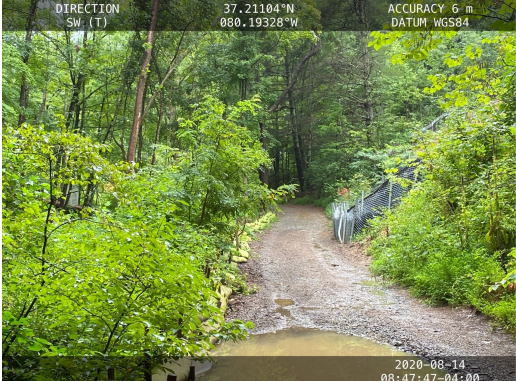
<b>GPS Location</b>	See photo		<b>GPS Location</b>	See photo	
<b>Field Station#</b>	12543+56		<b>Field Station#</b>	12543+00	
<b>Pic 3 Desc.</b>	Yellow Finch Road, MVP-MN-278.01, at the MVP ROW crossing.		<b>Pic 4 Desc.</b>	Plastic sheeting nearest to Yellow Finch Road remains intact and stable.

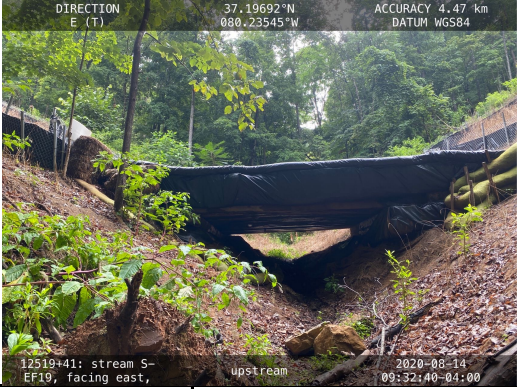
<p>DIRECTION E (T) 37.19692°N 080.23545°W ACCURACY 4.47 m DATUM WGS84</p> <p>12519+41: stream S-EF19, facing east, upstream 2020-08-14 09:32:40-04:00</p>

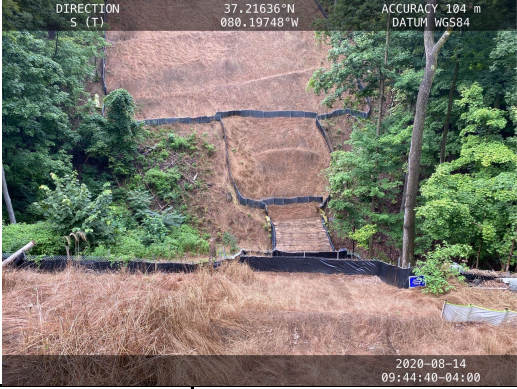
<p>DIRECTION S (T) 37.21636°N 080.19748°W ACCURACY 104 m DATUM WGS84</p> <p>2020-08-14 09:44:40-04:00</p>			
<b>GPS Location</b>	See photo		<b>GPS Location</b>	See photo	
<b>Field Station#</b>	12519+41		<b>Field Station#</b>	12519+41	
<b>Pic 7 Desc.</b>	Stream S-EF19, facing east, upstream		<b>Pic 8 Desc.</b>	Buffer zone of stream S-EF19 remains stable, ECDs intact and functioning properly.

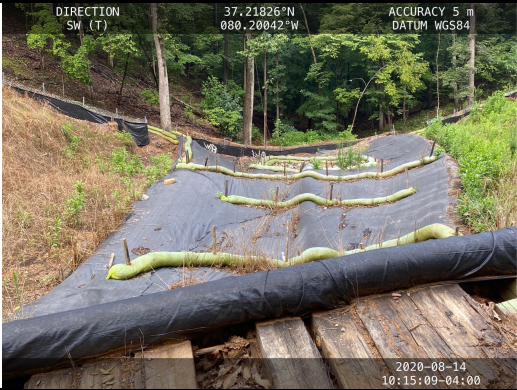
<b>GPS Location</b>	See photo		<b>GPS Location</b>	See photo	
<b>Field Station#</b>	12507+87		<b>Field Station#</b>	12503+70	
<b>Pic 9 Desc.</b>	Slope drain in good repair.		<b>Pic 10 Desc.</b>	Clean water diversion pipe in satisfactory condition.

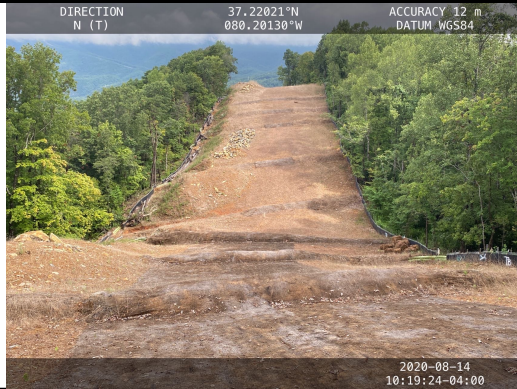
<p>DIRECTION N (T) 37.22021°N 080.20130°W ACCURACY 12 m DATUM WGS84</p> <p>2020-08-14 10:19:24-04:00</p>		  <p>DIRECTION N (T) 37.22267°N 080.20171°W ACCURACY 10 m DATUM WGS84</p> <p>2020-08-14 10:26:19-04:00</p>			
<b>GPS Location</b>	See photo		<b>GPS Location</b>	See photo	
<b>Field Station#</b>	12496+00		<b>Field Station#</b>	12487+00	
<b>Pic 11 Desc.</b>	ROW stable		<b>Pic 12 Desc.</b>	Slope on going away side of ML -28 remains stable.

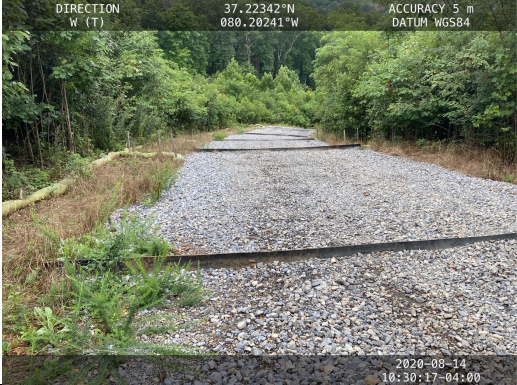
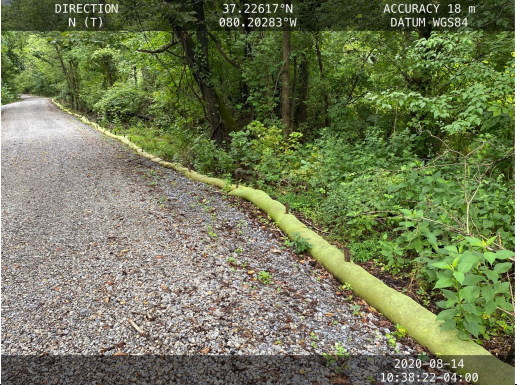
<small>37.22617°N 080.20283°W ACCURACY 18 m DATUM WGS84</small> <small>2020-08-14 10:38:22-04:00</small>			
<b>GPS Location</b>	See photo		<b>GPS Location</b>	See photo	
<b>Field Station#</b>	12483+30		<b>Field Station#</b>	12483+30	
<b>Pic 13 Desc.</b>	Water deflectors on access road MVP-MLV-AR-28 continue to function per design.		<b>Pic 14 Desc.</b>	CFS perimeter controls along access road MVP-MLV-AR-28 are in good repair.	
<small>DIRECTION SE (T)</small>

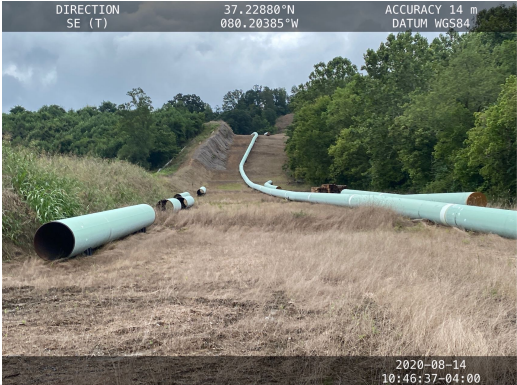
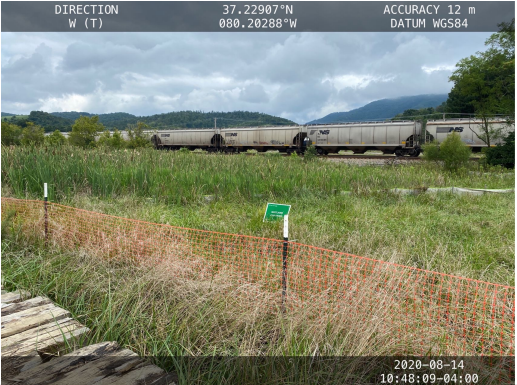
<b>GPS Location</b>	See photo		<b>GPS Location</b>	See photo	
<b>Field Station#</b>	12469+00		<b>Field Station#</b>	12460+75	
<b>Pic 15 Desc.</b>	ROW stable		<b>Pic 16 Desc.</b>	Wetland W-KL58, facing west	
<small>DIRECTION SE (T)</small>

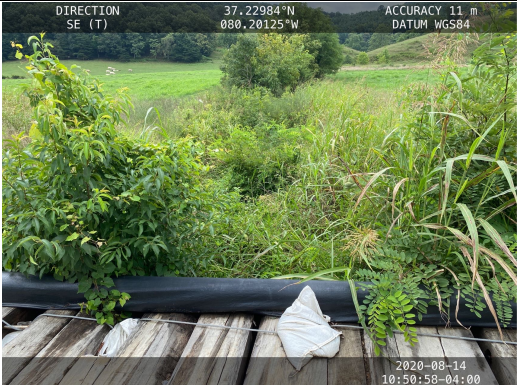
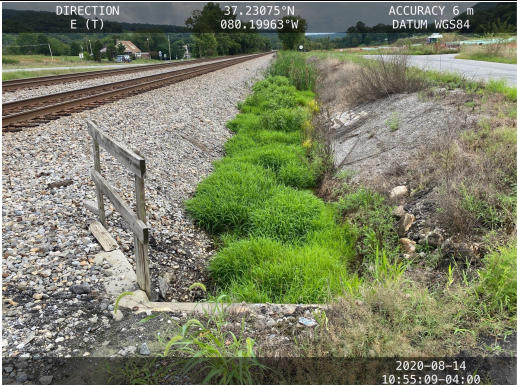
<small>37.23075°N 080.19963°W ACCURACY 6 m DATUM WGS84</small> <small>2020-08-14 10:55:09-04:00</small>			
<b>GPS Location</b>	See photo		<b>GPS Location</b>	See photo	
<b>Field Station#</b>	12455+21		<b>Field Station#</b>	12444+94	
<b>Pic 17 Desc.</b>	Stream S-CD12, facing southeast, upstream		<b>Pic 18 Desc.</b>	Stream S-I1, facing east, downstream
