# Visual Site Inspection Report

<b>Project Name</b>	H-600 Pipeline Spread H	<b>AFE</b>	124300138	<b>Spread</b>	H-600 Pipeline Spread H
<b>Contractor</b>	Precision			<b>Report #</b>	13683
<b>Inspector</b>	Dawn McCullough			<b>Date/Time</b>	8/17/2020 5:05 PM
<b>Permit #</b>	TBD	<b>Inspection Type</b>	VA SWPP	<b>Station Begin</b>	13140+00
<b>State</b>	VA	<b>Inspection Area</b>	Partial	<b>Station End</b>	13262+50
<b>County</b>	Franklin	<b>Ground</b>	Damp	<b>Temperature (°F)</b>	84.00
<b>Municipality</b>	N/A	<b>Weather</b>	Sunny	<b>Rain Gauge (in)</b>	0.10
				<b>Rain Accumulation Time (days)</b>	1.00

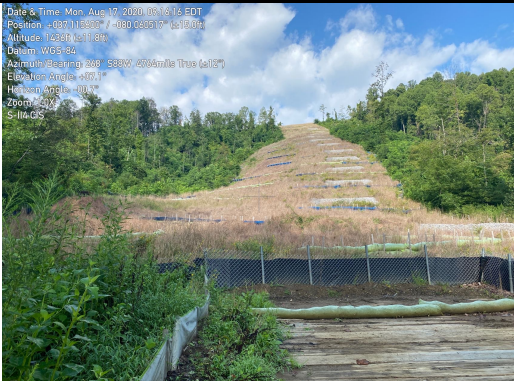
<b>Pic 5 Desc.</b>	CIS S-II4, ROW stable with good vegetative cover across LOD.		<b>Pic 6 Desc.</b>	Permanent waterbars and rock weirs stable.

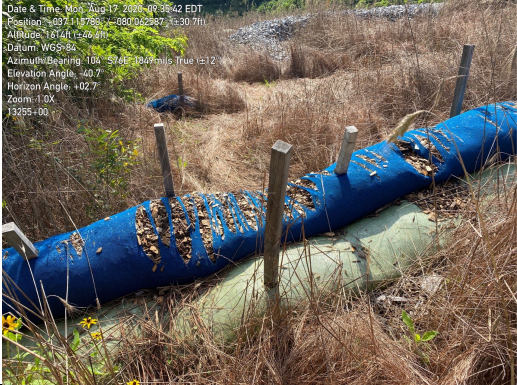
<p>Date &amp; Time: Mon, Aug 17, 2020 09:25:42 EDT Position: +037.115785° / -080.062247° (-12:30 7H) Altitude: 1614ft (+46.8M) Datum: WGS-84 Azimuth/Bearing: 106° S46E 124Wmils True (+12°) Elevation Angle: +02.7° Horizon Angle: +02.7° Zoom: 1.0X 13255+00</p>

<p>Date &amp; Time: Mon, Aug 17, 2020 09:28:38 EDT Position: +037.115714° / -080.063121° (-12:29 5H) Altitude: 1626ft (+49.2M) Datum: WGS-84 Azimuth/Bearing: 225° S45W 400mils True (+12°) Elevation Angle: +01.1° Horizon Angle: +02.3° Zoom: 1.0X 13252+00</p>			
<b>GPS Location</b>	See photo for coordinates.		<b>GPS Location</b>	See photo for coordinates.	
<b>Field Station#</b>	13255+00		<b>Field Station#</b>	13252+00	
<b>Pic 7 Desc.</b>	Previously reported deterioration of CFS, evidence of wildlife, deterioration likely being accelerated.		<b>Pic 8 Desc.</b>	Good vegetative cover across LOD.

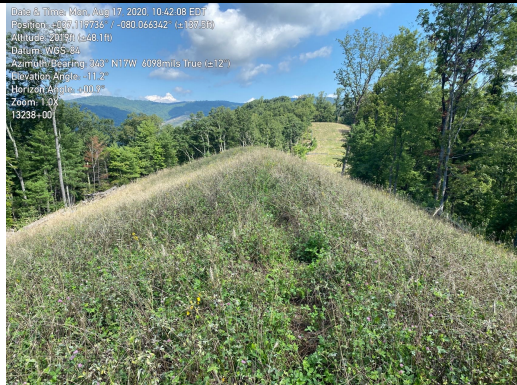
<p>Date &amp; Time: Mon, Aug 17, 2020 10:42:08 EDT Position: +037.116736° / -080.063342° (-12:05 2H) Altitude: 2015ft (+61.1M) Datum: WGS-84 Azimuth/Bearing: 102° N17W 809mils True (+12°) Elevation Angle: +01.2° Horizon Angle: +00.3° Zoom: 1.0X 13238+00</p>

<b>GPS Location</b>	See photo for coordinates.		<b>GPS Location</b>	See photo for coordinates.	
<b>Field Station#</b>	13238+00		<b>Field Station#</b>	13236+00	
<b>Pic 11 Desc.</b>	Good vegetative cover noted across LOD, heavy cover of clover.		<b>Pic 12 Desc.</b>	Restored ROW stable.

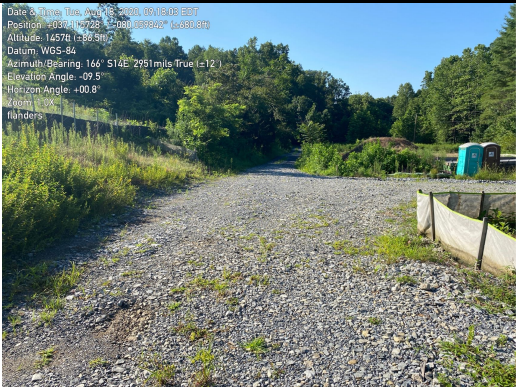
GPS Location	See photo for coordinates.		GPS Location	See photo for coordinates.	
Field Station#	13265+00		Field Station#	13265+00	
Pic 3 Desc.	Permanently restored ROW stable with acceptable vegetative cover.		Pic 4 Desc.	Permanently restored ROW stable with acceptable vegetative cover.	
<p>Date &amp; Time Tue Aug 18, 2020 3:32:28 EDT Position: +031.11575° / +080.05555° (+24.2m) Altitude: 1329ft (+41.2m) Datum: WGS-84 Azimuth/Bearing: 014° N14E 0284mils True (±12°) Elevation Angle: -10.3° Horizon Angle: +00.2° Zoom: 1.0X 13268+00</p>

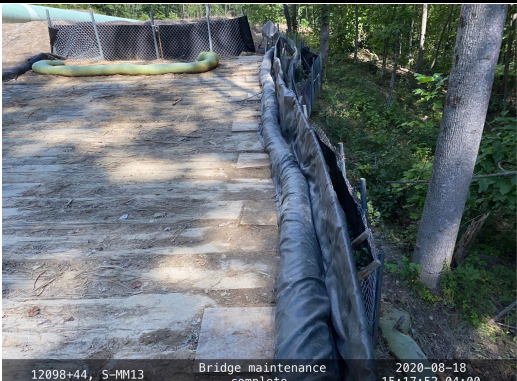
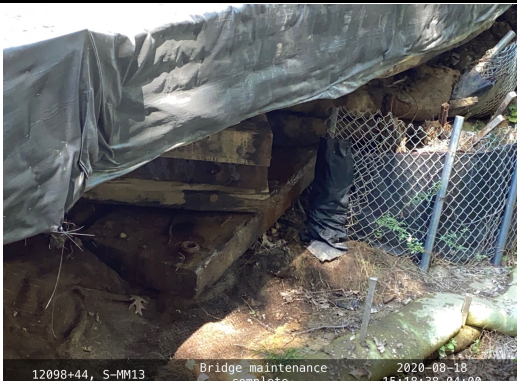
<b>GPS Location</b>	See photo GPS for location		<b>GPS Location</b>	See photo GPS for location	
<b>Field Station#</b>	12098+44		<b>Field Station#</b>	12098+44	
<b>Pic 17 Desc.</b>	Bridge maintenance completed.		<b>Pic 18 Desc.</b>	Bridge maintenance completed.

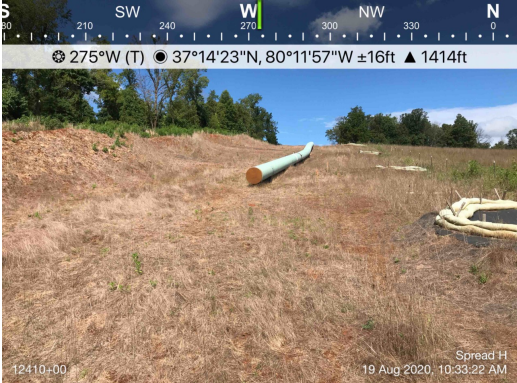
<b>GPS Location</b>	See photo		<b>GPS Location</b>	See photo	
<b>Field Station#</b>	12300+00		<b>Field Station#</b>	12410+00	
<b>Pic 7 Desc.</b>	Waterbars and end treatment controls on this slope in good condition.		<b>Pic 8 Desc.</b>	Vegetative stabilization is mature and uniform on this slope.

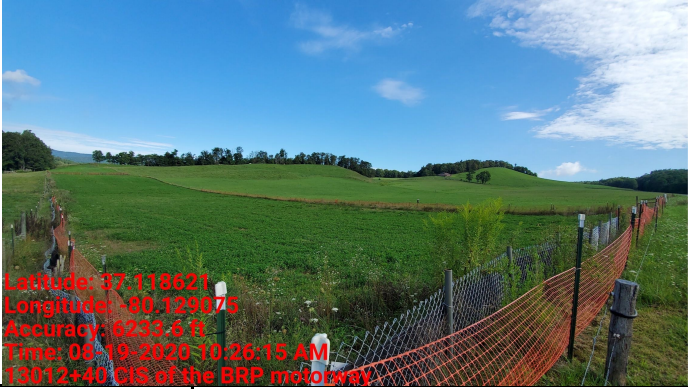
<p>Latitude: 37.118621 Longitude: -80.129075 Accuracy: 6233.6 ft Time: 08-19-2020 10:26:15 AM 13012+40 CIS of the BRP motorway</p>

<p>Latitude: 37.118621 Longitude: -80.129075 Accuracy: 6233.6 ft Time: 08-19-2020 10:27:10 AM 13012+80 GAS of the BRP motorway</p>			
<b>GPS Location</b>	See pic for GPS location		<b>GPS Location</b>	See pic for GPS location	
<b>Field Station#</b>	13012+40		<b>Field Station#</b>	13012+80	
<b>Pic 13 Desc.</b>	CIS of the BRP motorway		<b>Pic 14 Desc.</b>	GAS of the BRP motorway.

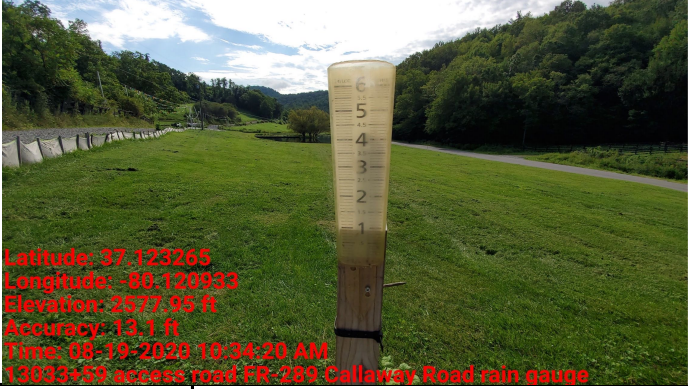
<p>Latitude: 37.123265 Longitude: -80.128933 Elevation: 2577.95 ft Accuracy: 13.1 ft Time: 08-19-2020 10:34:20 AM 13033+59 access road FR-289 Callaway Road rain gauge</p>

<b>GPS Location</b>	See pic for GPS location		<b>GPS Location</b>	See pic for GPS location	
<b>Field Station#</b>	13033+59		<b>Field Station#</b>	13025+50	
<b>Pic 15 Desc.</b>	Callaway Road rain gauge. 0.0" total precipitation.		<b>Pic 16 Desc.</b>	Streams S-G24 and S-G25 on GAS of the BRP and CIS of FR-289.

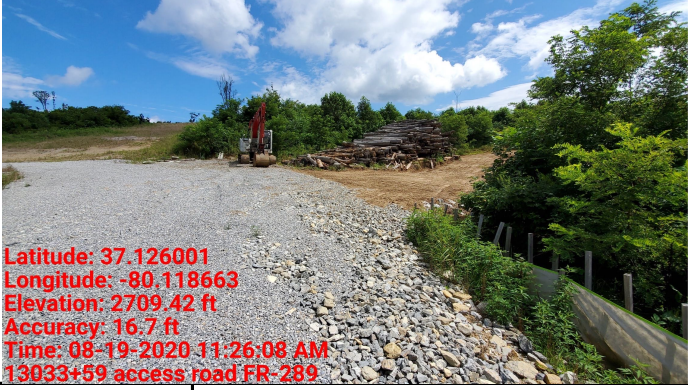
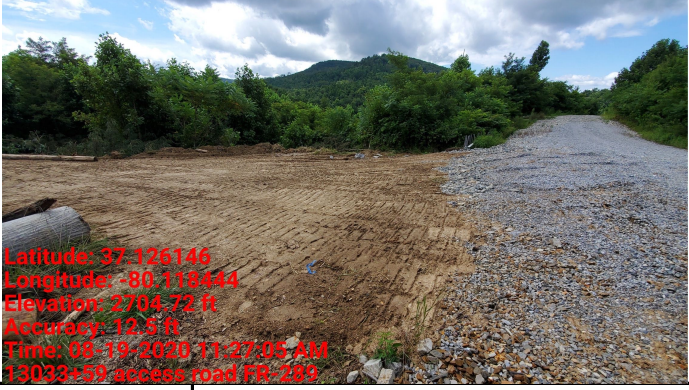
<p>Latitude: 37.126146 Longitude: -80.118444 Elevation: 2704.72 ft Accuracy: 12.5 ft Time: 08-19-2020 11:27:05 AM 13033+59 access road FR-289</p>			
<b>GPS Location</b>	See pic for GPS location		<b>GPS Location</b>	See pic for GPS location	
<b>Field Station#</b>	13033+59		<b>Field Station#</b>	13033+59	
<b>Pic 17 Desc.</b>	Access road FR-289 at the ROW. Landowner removed P1 silt fence to construct access for his property.		<b>Pic 18 Desc.</b>	Access road FR-289 at the ROW. Landowner removed P1 silt fence to construct access for his property.

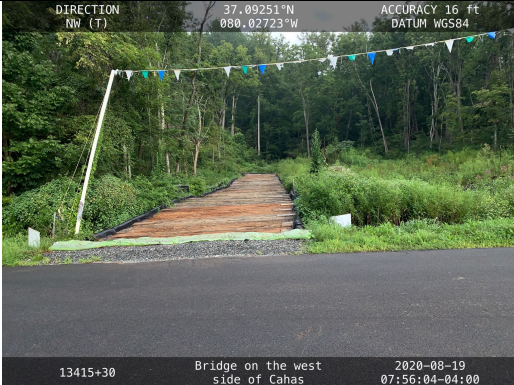
<p>DIRECTION NW (T) 37.09251°N 080.02723°W ACCURACY 16 ft DATUM WGS84</p> <p>13415+30 Bridge on the west side of Cahas 2020-08-19 07:56:04-04:00</p>

<p>DIRECTION NW (T) 37.09289°N 080.02768°W ACCURACY 15 ft DATUM WGS84</p> <p>13414+00 Bridge over S-IJ1 and stream buffer 2020-08-19 07:58:20-04:00</p>			
<b>GPS Location</b>	See photo for gps location data.		<b>GPS Location</b>	See photo for gps location data.	
<b>Field Station#</b>	13415+00		<b>Field Station#</b>	13414+00	
<b>Pic 1 Desc.</b>	Photo shows the bridge on the west side of Cahas.		<b>Pic 2 Desc.</b>	Photo shows the bridge over stream S-IJ1 and stream buffer.

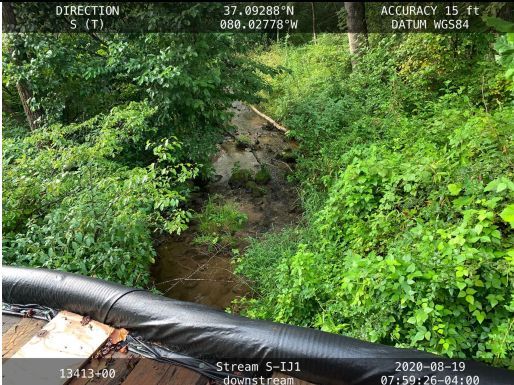
<p>DIRECTION S (T) 37.09288°N 080.02778°W ACCURACY 15 ft DATUM WGS84</p> <p>13413+00 Stream S-IJ1 downstream 2020-08-19 07:59:26-04:00</p>

<b>GPS Location</b>	See photo for gps location data.		<b>GPS Location</b>	See photo for gps location data.	
<b>Field Station#</b>	13413+00		<b>Field Station#</b>	13341+00	
<b>Pic 3 Desc.</b>	Photo shows stream S-IJ1 downstream from the ROW crossing.		<b>Pic 4 Desc.</b>	Photo shows the ROW condition from about 13338+00 to 13341+00.

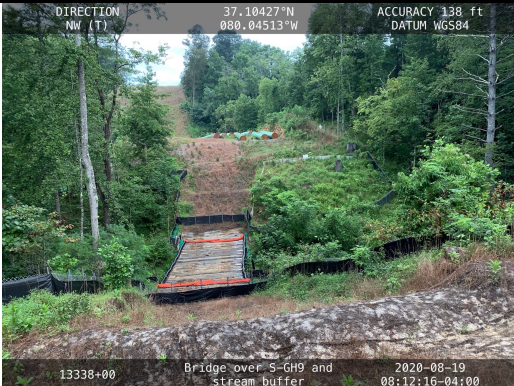
<p>DIRECTION NW (T) 37.10427°N 080.04513°W ACCURACY 138 ft DATUM WGS84</p> <p>13338+00 Bridge over S-GH9 and stream buffer 2020-08-19 08:12:16-04:00</p>

<p>DIRECTION N (T) 37.10419°N 080.04514°W ACCURACY 0.45 m DATUM WGS84</p> <p>13337+00 Bridge over S-GH9 2020-08-19 08:13:45-04:00</p>			
<b>GPS Location</b>	See photo for gps location data.		<b>GPS Location</b>	See photo for gps location data.	
<b>Field Station#</b>	13338+00		<b>Field Station#</b>	13337+00	
<b>Pic 5 Desc.</b>	Photo shows the bridge over stream S-GH9 and stream buffer.		<b>Pic 6 Desc.</b>	Photo shows the bridge over stream S-GH9.

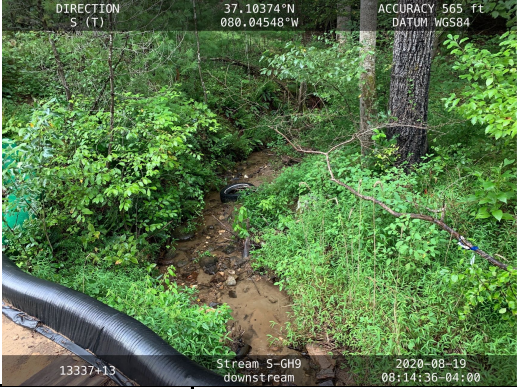
<b>GPS Location</b>	See photo for gps location data.		<b>GPS Location</b>	See photo for gps location data.	
<b>Field Station#</b>	13337+13		<b>Field Station#</b>	13336+00	
<b>Pic 7 Desc.</b>	Photo shows stream S-GH9 downstream from the ROW crossing.		<b>Pic 8 Desc.</b>	Photo shows the bridge over stream S-GH9 and stream buffer.

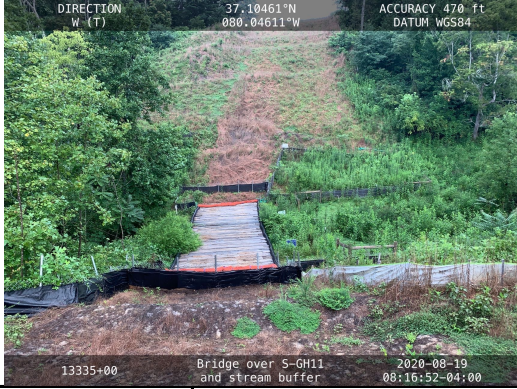
<b>GPS Location</b>	See photo for gps location data.		<b>GPS Location</b>	See photo for gps location data.	
<b>Field Station#</b>	13335+00		<b>Field Station#</b>	13326+00	
<b>Pic 9 Desc.</b>	Photo shows the bridge over stream S-GH11 and stream buffer.		<b>Pic 10 Desc.</b>	Photo shows the bridge over stream S-GH14 and stream buffer.

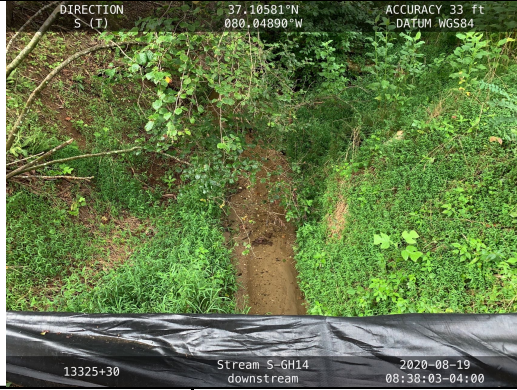
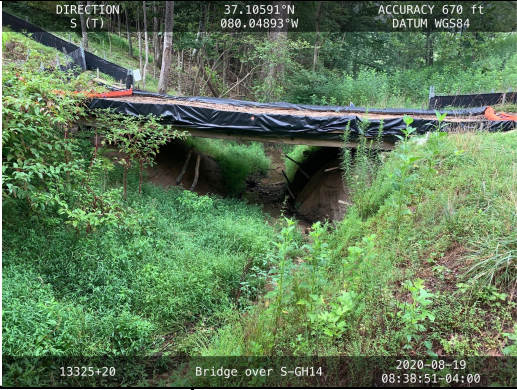
<b>GPS Location</b>	See photo for gps location data.		<b>GPS Location</b>	See photo for gps location data.	
<b>Field Station#</b>	13325+30		<b>Field Station#</b>	13325+20

<b>Pic 11 Desc.</b>	Photo shows stream S-GH14 downstream from the ROW crossing.		<b>Pic 12 Desc.</b>	Photo shows the bridge over stream S-GH14.

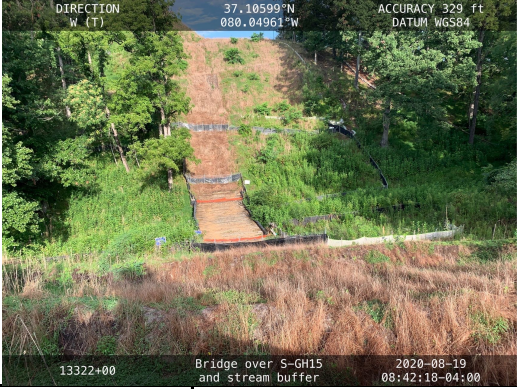
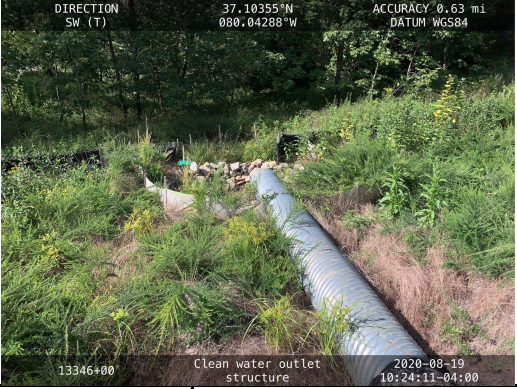
<b>GPS Location</b>	See photo for gps location data.		<b>GPS Location</b>	See photo for gps location data.	
<b>Field Station#</b>	13322+00		<b>Field Station#</b>	13346+00	
<b>Pic 13 Desc.</b>	Photo shows the bridge over stream S-GH15 and stream buffer.		<b>Pic 14 Desc.</b>	Photo shows the clean water outlet structure.

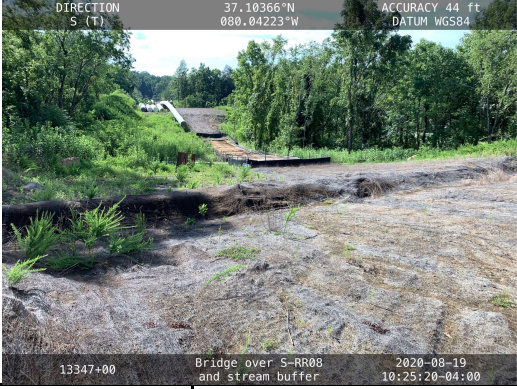
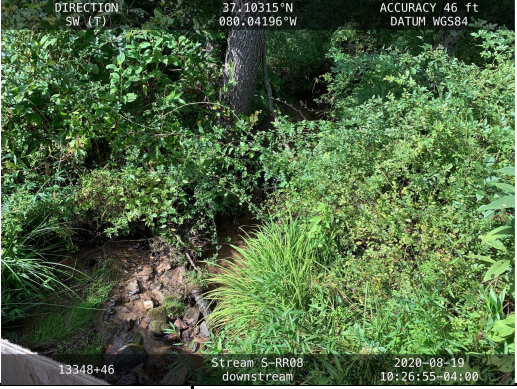
<b>GPS Location</b>	See photo for gps location data.		<b>GPS Location</b>	See photo for gps location data.	
<b>Field Station#</b>	13347+00		<b>Field Station#</b>	13348+46	
<b>Pic 15 Desc.</b>	Photo shows the bridge over stream S-RR08 and stream buffer.		<b>Pic 16 Desc.</b>	Photo shows stream S-RR08 downstream from the ROW crossing.

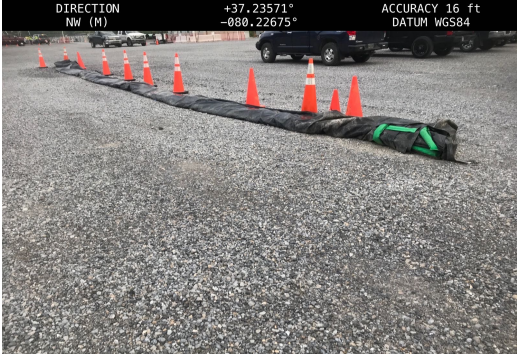
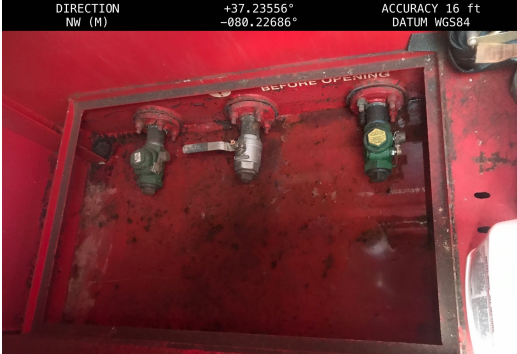
MVP-PY-006_081920 Secondary containment on site for tankers ... 2020-08-19 07:17:13-04:00		MVP-PY-006_081920 Internal drip tray empty 2020-08-19 07:18:26-04:00			
<b>GPS Location</b>	MVP-PY-006 See photo for gps		<b>GPS Location</b>	MVP-PY-006 See photo for gps	
<b>Field Station#</b>	+0		<b>Field Station#</b>	+0	
<b>Pic 7 Desc.</b>	Secondary containment on site for tankers offloading fuel into the Blue Bulk fuel tanks. Looking NW.		<b>Pic 8 Desc.</b>	Off Road Fuel unit internal drip pan empty. Looking NW.	
DIRECTION N (M) +37.23557° -080.22690° ACCURACY 16 ft DATUM WGS84

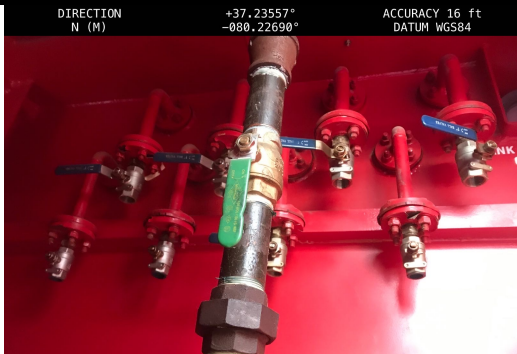
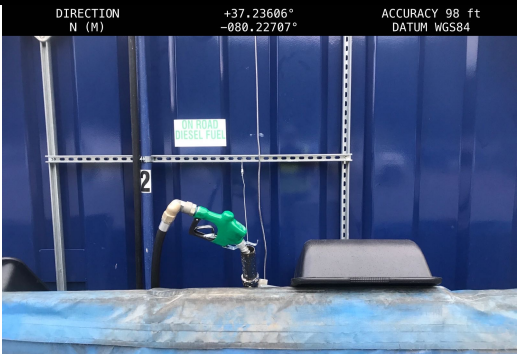
MVP-PY-006_081920 No leaky internal fittings 2020-08-19 07:18:31-04:00		MVP-PY-006_081920 No leaky fittings or nozzles 2020-08-19 07:19:28-04:00

<b>GPS Location</b>	MVP-PY-006 See photo for gps		<b>GPS Location</b>	MVP-PY-006 See photo for gps	
<b>Field Station#</b>	+0		<b>Field Station#</b>	+0	
<b>Pic 9 Desc.</b>	Off Road Fuel unit no leaky internal fittings. Looking NW.		<b>Pic 10 Desc.</b>	Blue Bulk Fuel tanks no leaky fittings or nozzles. Looking N.	
DIRECTION SE (M) +37.23560° -080.22669° ACCURACY 33 ft DATUM WGS84  		DIRECTION SE (M) +37.23405° -080.22670° ACCURACY 16 ft DATUM WGS84

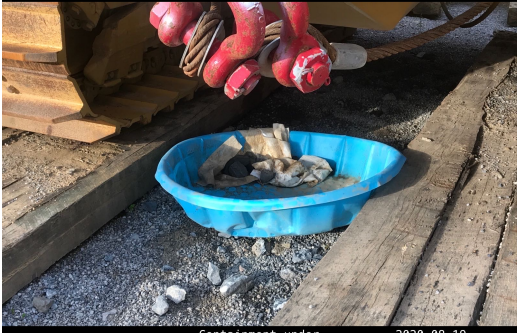
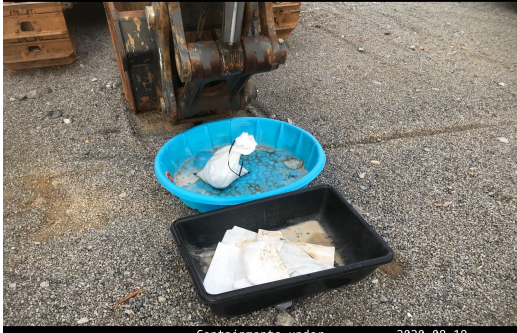
<small>MVP-LY-049_081920</small> <small>Containment under stored equipment</small> <small>2020-08-19 08:03:23-04:00</small>		<small>MVP-LY-049_081920</small> <small>Containments under stored equipment</small> <small>2020-08-19 08:08:37-04:00</small>			
<b>GPS Location</b>	MVP-LY-049 See photo for gps data		<b>GPS Location</b>	MVP-LY-049 See photo for gps data	
<b>Field Station#</b>	+0		<b>Field Station#</b>	+0	
<b>Pic 7 Desc.</b>	Condition of containment under stored equipment. Looking SW.		<b>Pic 8 Desc.</b>	Condition of containments under stored equipment. Looking W.	
<b>DIRECTION</b> SW (M)

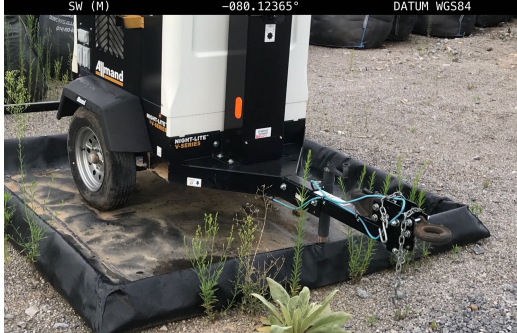
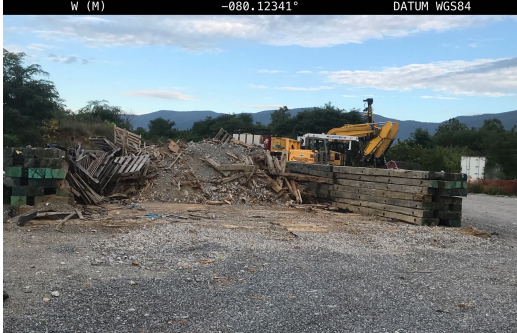
<small>MVP-LY-049_081920</small> <small>Containment under light plant</small> <small>2020-08-19 08:09:30-04:00</small>		<small>MVP-LY-049_081920</small> <small>Condition of temporary trash _</small> <small>2020-08-19 08:09:45-04:00</small>

<b>GPS Location</b>	MVP-LY-049 See photo for gps data		<b>GPS Location</b>	MVP-LY-049 See photo for gps data	
<b>Field Station#</b>	+0		<b>Field Station#</b>	+0	
<b>Pic 9 Desc.</b>	Condition of containment under light plant. Looking NW.		<b>Pic 10 Desc.</b>	Condition of temporary trash transfer pit. Looking W.	
<b>DIRECTION</b> SE (M)

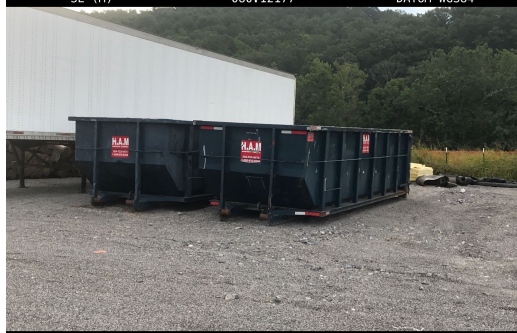
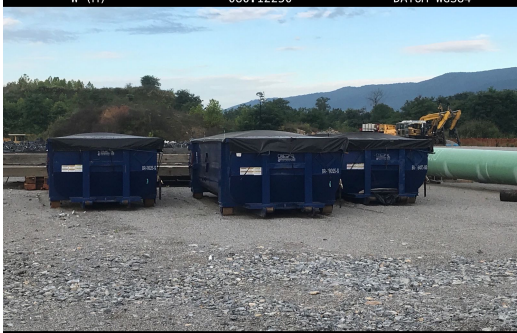
<small>MVP-LY-049_081920</small> <small>No loose trash around south dumpsters</small> <small>2020-08-19 08:10:43-04:00</small>		<small>MVP-LY-049_081920</small> <small>No deposits around hazardous waste _</small> <small>2020-08-19 08:11:20-04:00</small>			
<b>GPS Location</b>	MVP-LY-049 See photo for gps data		<b>GPS Location</b>	MVP-LY-049 See photo for gps data	
<b>Field Station#</b>	+0		<b>Field Station#</b>	+0	
<b>Pic 11 Desc.</b>	No loose trash around south dumpsters. Looking SE.		<b>Pic 12 Desc.</b>	No deposits around hazardous waste dumpsters. Looking W.

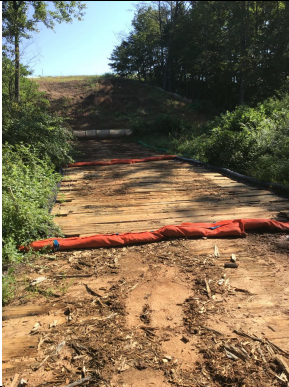
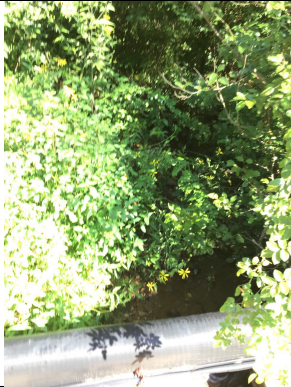
<b>GPS Location</b>	00000	<b>GPS Location</b>	0000		
<b>Field Station#</b>	13659+03	<b>Field Station#</b>	13659+03		
<b>Pic 1 Desc.</b>	Observed equipment bridges and ECDs throughout my travels		<b>Pic 2 Desc.</b>	Stream crossing photo facing downstream

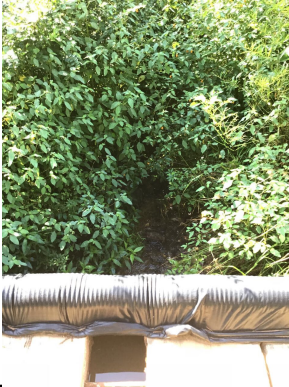
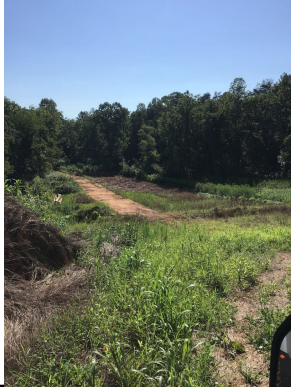
<b>GPS Location</b>	00000	<b>GPS Location</b>	0000		
<b>Field Station#</b>	13659+03	<b>Field Station#</b>	13655+56		
<b>Pic 3 Desc.</b>	Stream observation photo facing upstream		<b>Pic 4 Desc.</b>	Row photo showing vegetation and equipment mats in place	
Insert image here			Insert image here		
<b>GPS Location</b>		<b>GPS Location</b>			
<b>Field Station#</b>		<b>Field Station#</b>			
<b>Pic 5 Desc.</b>			<b>Pic 6 Desc.</b>

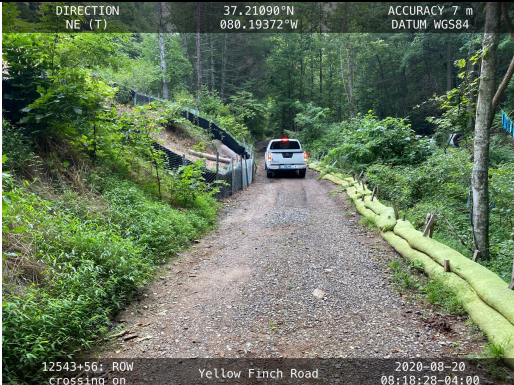
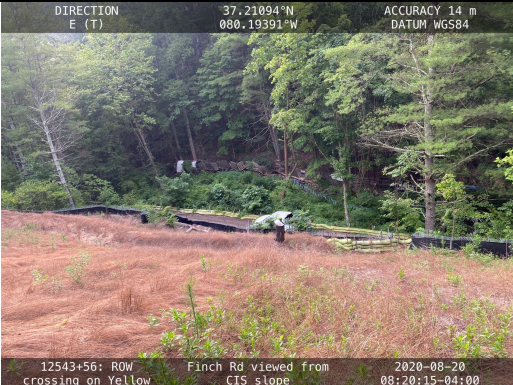
<b>GPS Location</b>	See photo		<b>GPS Location</b>	See photo	
<b>Field Station#</b>	12543+56		<b>Field Station#</b>	12543+56	
<b>Pic 3 Desc.</b>	MVP ROW crossing on Yellow Finch Road.		<b>Pic 4 Desc.</b>	MVP ROW crossing on Yellow Finch Road, viewed from slope on coming in side of road.

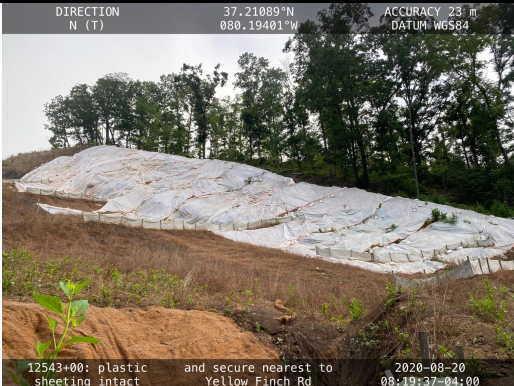
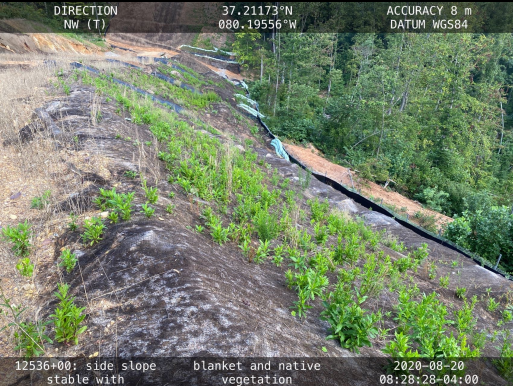
<b>GPS Location</b>	See photo		<b>GPS Location</b>	See photo	
<b>Field Station#</b>	12543+00		<b>Field Station#</b>	12536+00	
<b>Pic 5 Desc.</b>	Plastic sheeting nearest to Yellow Finch Road remains intact and secure.		<b>Pic 6 Desc.</b>	Fill slope stable with blanket and native vegetative cover.

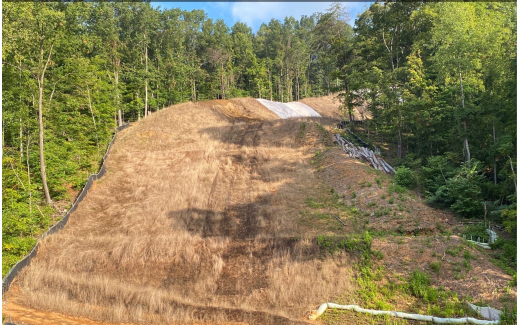
<div>12533+00: slope on CIS of landowner</div> <div>crossing remains stable</div> <div>2020-08-20 08:36:11-04:00</div> </div>		<div> <div>DIRECTION SW (T)</div> <div>37.21374°N 080.19714°W</div> <div>ACCURACY 17 m DATUM WGS84</div>

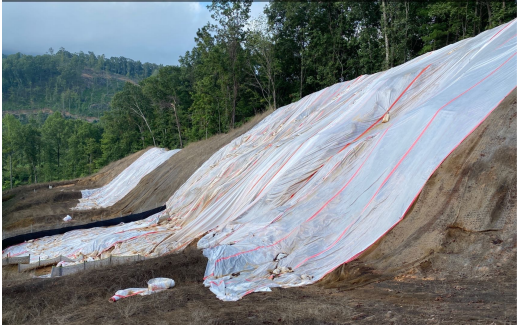
<div>12529+00: plastic sheeting appr 1500'</div> <div>from Yellow Finch Rd intact and secure</div> <div>2020-08-20 08:50:31-04:00</div> </div>			
<b>GPS Location</b>	See photo		<b>GPS Location</b>	See photo	
<b>Field Station#</b>	12533+00		<b>Field Station#</b>	12529+00	
<b>Pic 7 Desc.</b>	Slope on coming in side of landowner's crossing remains stable.		<b>Pic 8 Desc.</b>	Plastic sheeting approximately 1500' from Yellow Finch Road remains intact and secure.

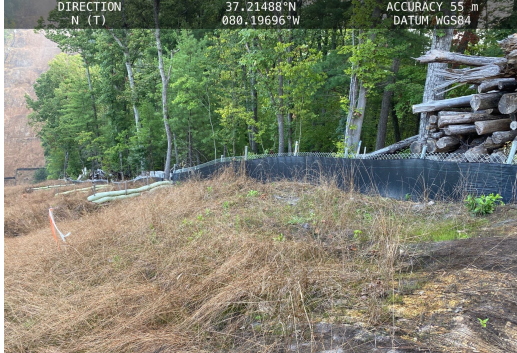
<div>12523+00: perimeter controls on slopes</div> <div>leading down to S- EF19 in good repair</div> <div>2020-08-20 08:54:00-04:00</div> </div>		<div> <div>DIRECTION N (T)</div> <div>37.21548°N 080.19730°W</div> <div>ACCURACY 13 m DATUM WGS84</div>

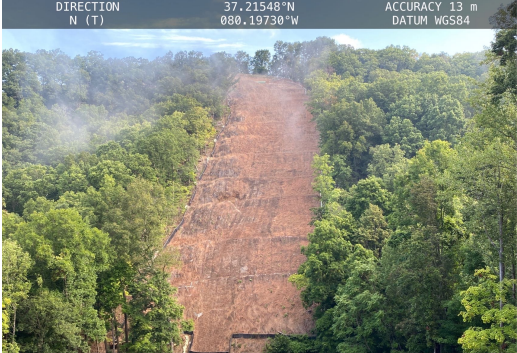
<div>12517+00: slope on CIS of S-EF19</div> <div>remains stable</div> <div>2020-08-20 08:59:50-04:00</div> </div>			
<b>GPS Location</b>	See photo		<b>GPS Location</b>	See photo	
<b>Field Station#</b>	12523+00		<b>Field Station#</b>	12517+00	
<b>Pic 9 Desc.</b>	Perimeter controls on slope on both sides of stream S-EF19 in good repair.		<b>Pic 10 Desc.</b>	Slope on coming in side of stream S-EF19 remain stable.	
<div> <div>DIRECTION E (T)</div> <div>37.21600°N 080.19745°W</div> <div>ACCURACY 57 m DATUM WGS84</div>

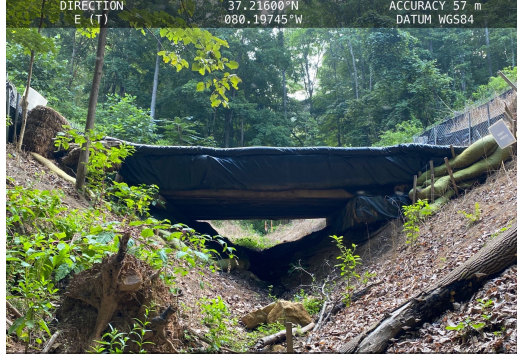
<div>12519+41: stream S- EF19, facing east,</div> <div>upstream</div> <div>2020-08-20 09:07:08-04:00</div> </div>		<div> <div>DIRECTION S (T)</div> <div>37.21646°N 080.19752°W</div> <div>ACCURACY 23 m DATUM WGS84</div>

<b>GPS Location</b>	See photo		<b>GPS Location</b>	See photo	
<b>Field Station#</b>	12519+41		<b>Field Station#</b>	12522+00	
<b>Pic 11 Desc.</b>	Stream S-EF19, facing east, upstream		<b>Pic 12 Desc.</b>	Slope on going away side of stream S-EF19 remains stable.

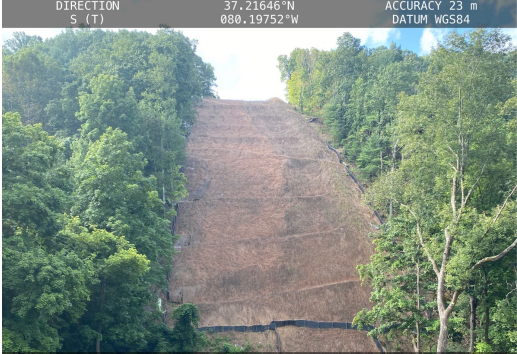
<div>12522+00: slope on GAS of S-EF19</div> <div>remains stable</div> <div>2020-08-20 09:10:17-04:00</div> </div>

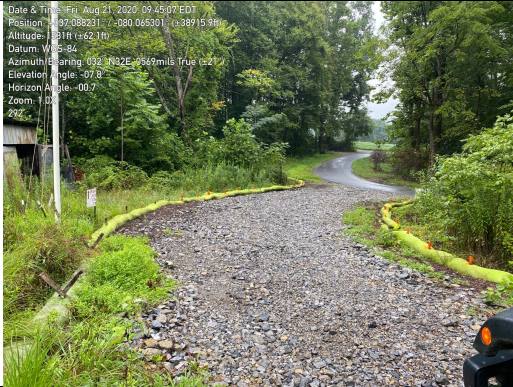
<b>GPS Location</b>	See photo for coordinates.		<b>GPS Location</b>	See photo for coordinates.	
<b>Field Station#</b>	13142+00		<b>Field Station#</b>	13148+00	
<b>Pic 1 Desc.</b>	MVP-FR-292, ECDs in acceptable condition on access road and old logging road on ROW.		<b>Pic 2 Desc.</b>	MVP-FR-292, ECDs in acceptable condition along access road.

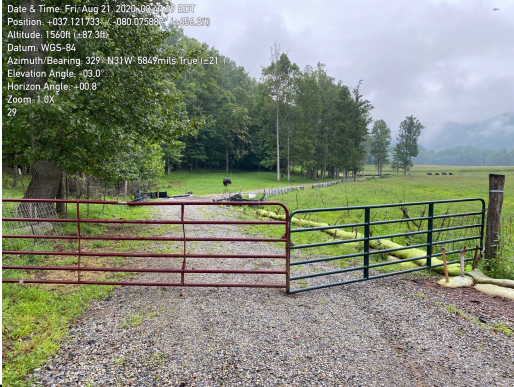
<b>GPS Location</b>	See photo for coordinates.		<b>GPS Location</b>	See photo for coordinates.	
<b>Field Station#</b>	13190+00		<b>Field Station#</b>	13190+00	
<b>Pic 3 Desc.</b>	MVP-AR-29, access road and ECDs in acceptable condition, gate closed, cattle noted in field.		<b>Pic 4 Desc.</b>	MVP-AR-29, Adney Gap, RCE in acceptable condition.

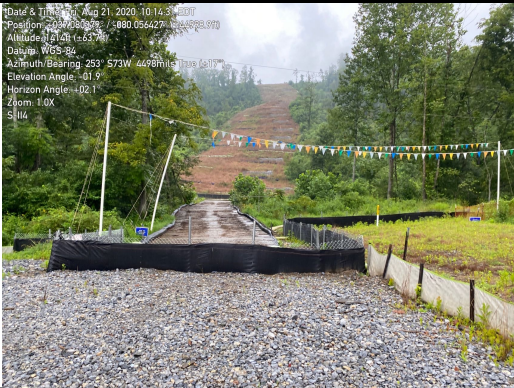
<b>Field Station#</b>	13262+00		<b>Field Station#</b>	13262+00	
<b>Pic 5 Desc.</b>	S-II4, ECDs along stream and ROW in acceptable condition.		<b>Pic 6 Desc.</b>	ATWS-1055, restored area stable with good vegetative cover.

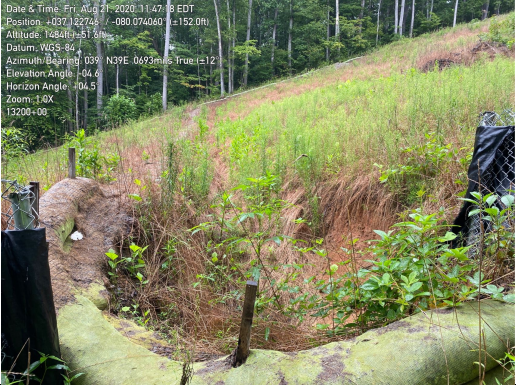
<p>Date &amp; Time: Fri, Aug 21, 2020 11:42:19 EDT Position: +037.122726 / -080.074040 (+152.0ft) Altitude: 1484ft (+51.5ft) Datum: WGS-84 Azimuth/Bearing: 03° N3°E 069/mils True (+12°) Elevation Angle: +04° Horizon Angle: +04.5° Zoom: 1.0X 13200+00</p>			
<b>GPS Location</b>	See photo for coordinates.		<b>GPS Location</b>	See photo for coordinates.	
<b>Field Station#</b>	13197+50		<b>Field Station#</b>	13200+00	
<b>Pic 13 Desc.</b>	S-D8, no disturbance in area.		<b>Pic 14 Desc.</b>	Waterbar, sump and outlet protection in acceptable condition, ROW stable.

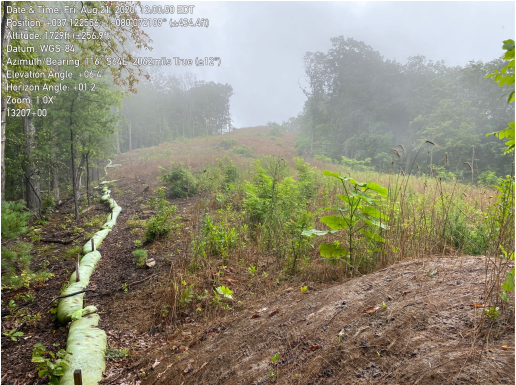
<p>Date &amp; Time: Fri, Aug 21, 2020 12:00:00 EDT Position: +037.122536 / -080.073187 (+33.4ft) Altitude: 1725ft (+52.6ft) Datum: WGS-84 Azimuth/Bearing: 116° S34°W 400/mils True (+13°) Elevation Angle: +04° Horizon Angle: +01.2° Zoom: 1.0X 13207+00</p>			
<b>GPS Location</b>	See photo for coordinates.		<b>GPS Location</b>	See photo for coordinates.	
<b>Field Station#</b>	13201+00		<b>Field Station#</b>	13207+00	
<b>Pic 15 Desc.</b>	Waterbar, sump and outlet protection in acceptable condition, ROW stable.		<b>Pic 16 Desc.</b>	CFS perimeter control functioning acceptably.

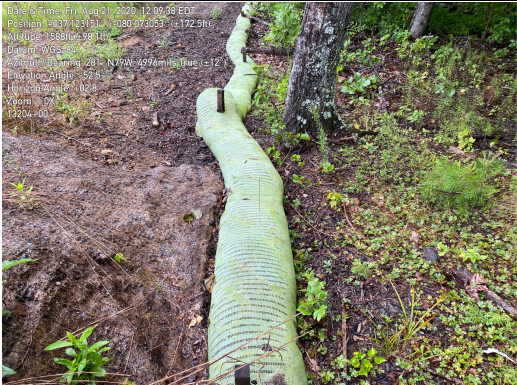
<b>GPS Location</b>	See photo for coordinates.		<b>GPS Location</b>	See photo for coordinates.	
<b>Field Station#</b>	13204+00		<b>Field Station#</b>	13197+50	
<b>Pic 17 Desc.</b>	Minor degradation noted on CFS.		<b>Pic 18 Desc.</b>	Dillons Mill, clean of rock and sediment.
