Visual Site Inspection Report

Project Name	H-600 Pipeline Spread H	AFE	124300138	Spread	H-600 Pipeline Spread H
Contractor	Precision			Report #	13882
Inspector	Dawn McCullough			Date/Time	8/24/2020 2:00 PM
Permit #	TBD	Inspection Type	VA SWPP	Station Begin	13262+50
State	VA	Inspection Area	Partial	Station End	13315+70
County	Franklin	Ground	Damp	Temperature (°F)	86.00
Municipality	N/A	Weather	Sunny	Rain Gauge (in)	0.60
				Rain Accumulation Time (days)	1.00

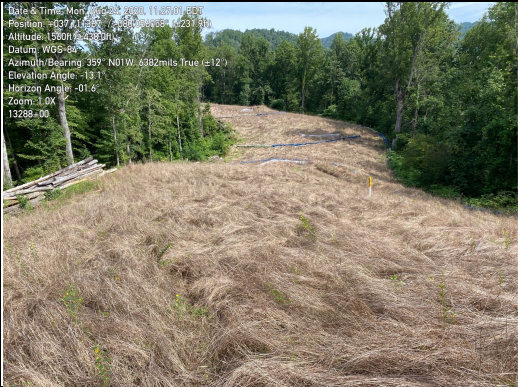
GPS Location	See photo for coordinates.		GPS Location	See photo for coordinates.	
Field Station#	13288+00		Field Station#	13296+00	
Pic 7 Desc.	ROW stable, vegetation noted across LOD.		Pic 8 Desc.	ROW stable, vegetation noted across LOD.	
<p><small>Date & Time: Mon, Aug 24, 2020, 11:37:48 EDT Position: +437.138423° / -680.03151° (±12.3m) Altitude: 1522m (±11.4m) Datum: WGS-84 Azimuth/Bearing: 179° S01E 3182mils True (±12°) Elevation Angle: -19.6° Horizon Angle: -00.7° Zoom: 1.0X 13301+00</small></p>

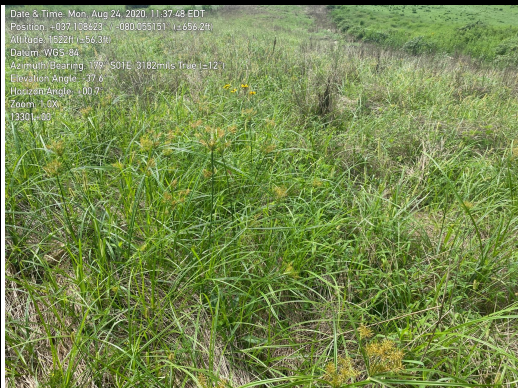
GPS Location	See photo for coordinates.		GPS Location	See photo for coordinates.	
Field Station#	13301+00		Field Station#	13301+00	
Pic 9 Desc.	Permanent vegetation establishing in agricultural field.		Pic 10 Desc.	ROW stable, with good vegetative cover noted across LOD.	
<p><small>Date & Time: Mon, Aug 24, 2020, 11:45:39 EDT Position: +437.104959° / -680.033199° (±12.3m) Altitude: 1418ft (±11.4m) Datum: WGS-84 Azimuth/Bearing: 221° S44W 3982mils True (±12°) Elevation Angle: -08.2° Horizon Angle: +05.1° Zoom: 1.0X 13306+00</small></p>

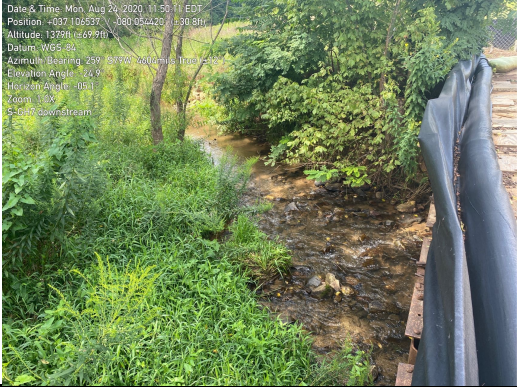
GPS Location		See photo for coordinates.		GPS Location	
Field Station#		13309+09		Field Station#	
Pic 13 Desc.		S-GH7, downstream, no environmental issues noted, water level slightly up compared to last inspection.		Pic 14 Desc.	
<p><small>Date & Time: Mon, Aug 24, 2020, 11:55:09 EDT Position: +037.106537° / -080.05420° (+30.8h) Altitude: 1393ft (+699ft) Datum: WGS-84 Azimuth/Bearing: 088° N88E 0450mils True (+12°) Elevation Angle: -00.0° Horizon Angle: -00.7° Zoom: 1.0X S-GH7 GAS</small></p>

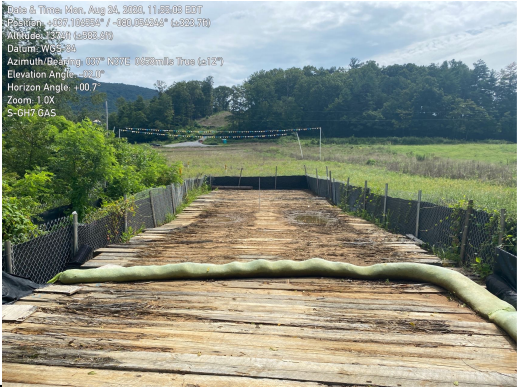
GPS Location		See photo for coordinates.		GPS Location	
Field Station#		13309+25		Field Station#	
Pic 15 Desc.		GAS S-GH7, bridge and perimeter ECDs in acceptable condition.		Pic 16 Desc.	
<p><small>Date & Time: Mon, Aug 24, 2020, 11:55:04 EDT Position: +037.106537° / -080.05420° (+30.8h) Altitude: 1393ft (+699ft) Datum: WGS-84 Azimuth/Bearing: 281° S81W 4640mils True (+12°) Elevation Angle: -11.2° Horizon Angle: -02.3° Zoom: 1.0X 13312+00</small></p>

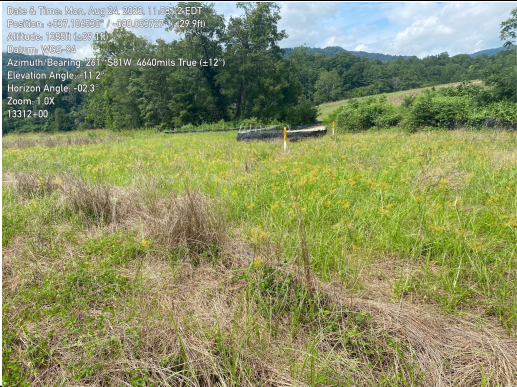
GPS Location		See photo for coordinates.		GPS Location	
Field Station#		13312+00		Field Station#	
Pic 17 Desc.		ROW stable, good vegetative cover noted across LOD, permanent establishing.		Pic 18 Desc.

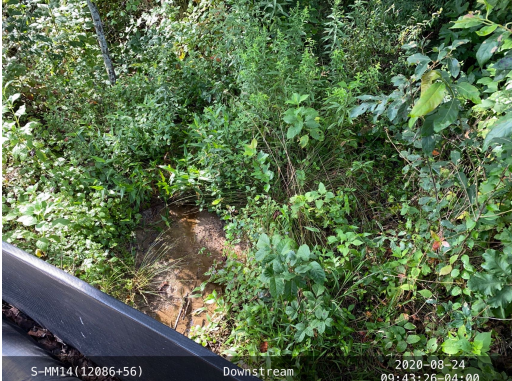
S-MM14(12086+56) Downstream 2020-08-24 09:43:26-04:00		S-MM13(12098+44) ECDs acceptable 2020-08-24 09:49:48-04:00			
GPS Location	See photo GPS for location		GPS Location	See photo GPS for location	
Field Station#	12086+56		Field Station#	12098+44	
Pic 3 Desc.	Downstream water flow		Pic 4 Desc.	ECDs are acceptable

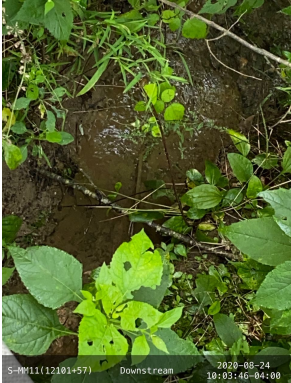
GPS Location	See photo GPS for location		GPS Location	See photo GPS for location	
Field Station#	12101+57		Field Station#	12108+41	
Pic 7 Desc.	Downstream water flow		Pic 8 Desc.	ECDs are acceptable

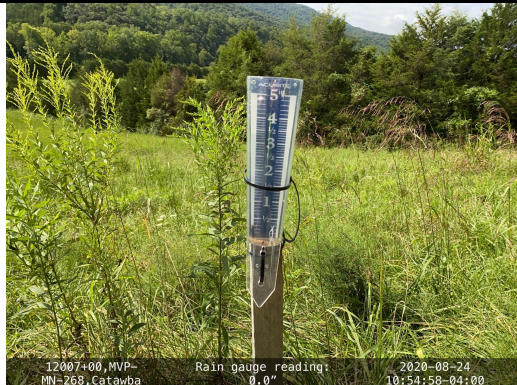
GPS Location	See photo GPS for location		GPS Location	See photo GPS for location	
Field Station#	12007+00		Field Station#	12013+97	
Pic 11 Desc.	Rain gauge reading: 0.00"		Pic 12 Desc.	ECDs surrounding bridge are acceptable.

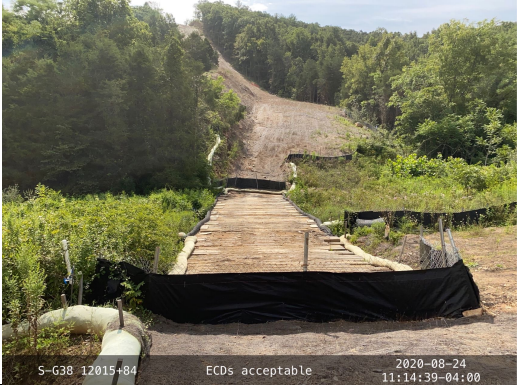
<p>S-G38 12015+84 ECDs acceptable 2020-08-24 11:14:39-04:00</p>

<p>S-G36 12008+69 ECDs/Banks acceptable 2020-08-24 11:17:18-04:00</p>			
GPS Location	See photo GPS for location		GPS Location	See photo GPS for location	
Field Station#	12015+84		Field Station#	12008+69	
Pic 13 Desc.	ECDs are acceptable		Pic 14 Desc.	ECDs/banks are acceptable.

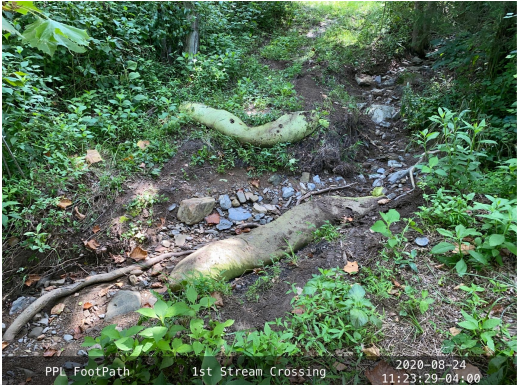
<p>PPL FootPath 1st Stream Crossing 2020-08-24 11:23:29-04:00</p>

<p>PPL FootPath 1st Stream Crossing 2020-08-24 11:23:59-04:00</p>			
GPS Location	See photo GPS for location		GPS Location	See photo GPS for location	
Field Station#	00000+00		Field Station#	00000+00	
Pic 15 Desc.	Damaged CFS and stakes at 1st stream crossing on PPL Footpath		Pic 16 Desc.	Damaged CFS and stakes at 1st stream crossing on PPL Footpath

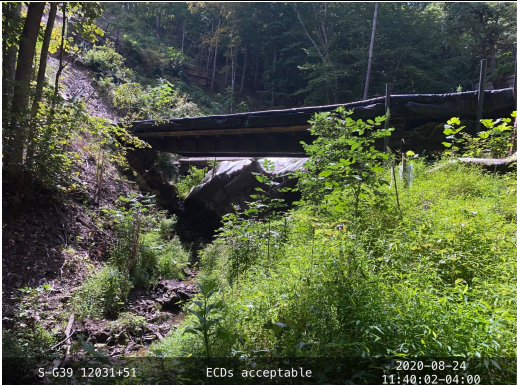
<p>S-G39 12031+51 ECDs acceptable 2020-08-24 11:40:02-04:00</p>

GPS Location	See photo GPS for location		GPS Location	See photo GPS for location	
Field Station#	12031+51		Field Station#	12035+11	
Pic 17 Desc.	ECDs acceptable		Pic 18 Desc.	ECDs acceptable

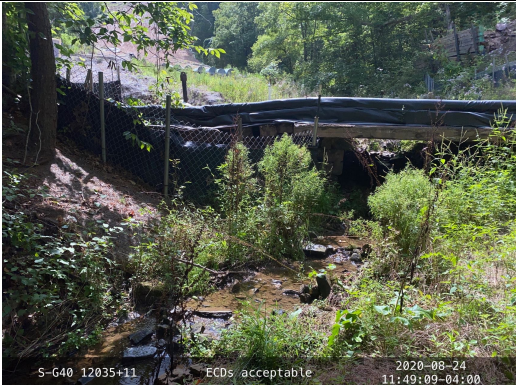
<p>S-G40 12035+11 ECDs acceptable 2020-08-24 11:49:09-04:00</p>

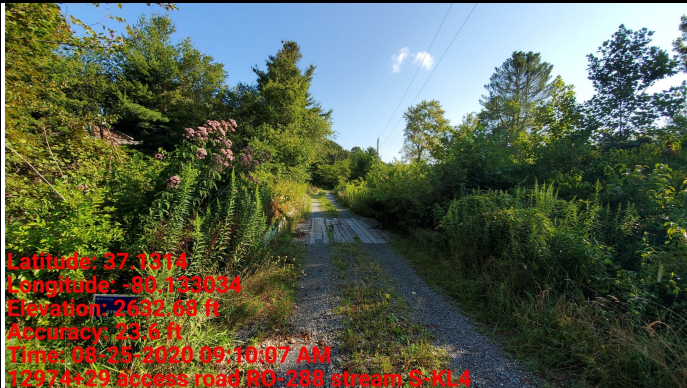
Latitude: 37.1314 Longitude: -80.133034 Elevation: 2632.49 ft Accuracy: 13.6 ft Time: 08-25-2020 09:10:07 AM 12974+29 access road RO-288 stream S-KL4			Latitude: 37.132646 Longitude: -80.132023 Elevation: 2627.3 ft Accuracy: 12.5 ft Time: 08-25-2020 09:12:36 AM 12974+29 access road RO-288 stream S-Q20

GPS Location	See pic for GPS location		GPS Location	See pic for GPS location	
Field Station#	12974+29		Field Station#	12974+29	
Pic 9 Desc.	Access road RO-288 at stream S-KL4.		Pic 10 Desc.	Access road RO-288 at stream S-Q20.

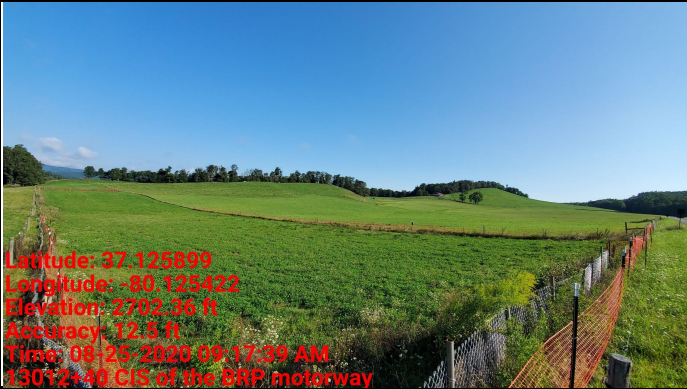
<p>Latitude: 37.125899 Longitude: -80.125422 Elevation: 2702.36 ft Accuracy: 12.5 ft Time: 08-25-2020 09:17:09 AM 13012+40 CIS of the BRP motorway</p>

<p>Latitude: 37.125926 Longitude: -80.125175 Elevation: 2697.05 ft Accuracy: 12.5 ft Time: 08-25-2020 09:18:21 AM 13012+60 GAS of the BRP motorway</p>		
GPS Location	See pic for GPS location		GPS Location	See pic for GPS location	
Field Station#	13012+40		Field Station#	13012+60	
Pic 13 Desc.	CIS of the BRP motorway.		Pic 14 Desc.	GAS of the BRP motorway.

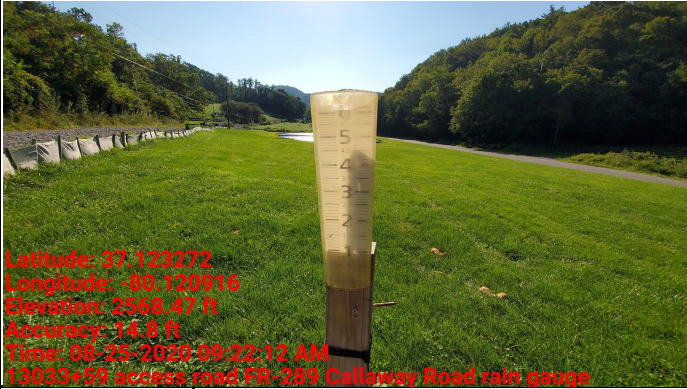
<p>Latitude: 37.123272 Longitude: -80.120916 Elevation: 2568.47 ft Accuracy: 14.8 ft Time: 08-25-2020 09:22:12 AM 13033+59 access road FR-289 Callaway Road rain gauge</p>

GPS Location	See pic for GPS location		GPS Location	See pic for GPS location	
Field Station#	13033+59		Field Station#	13025+50	
Pic 15 Desc.	Callaway Road rain gauge. 0.0" total precipitation.		Pic 16 Desc.	CIS of access road FR-289 streams S-G24 and S-G25.

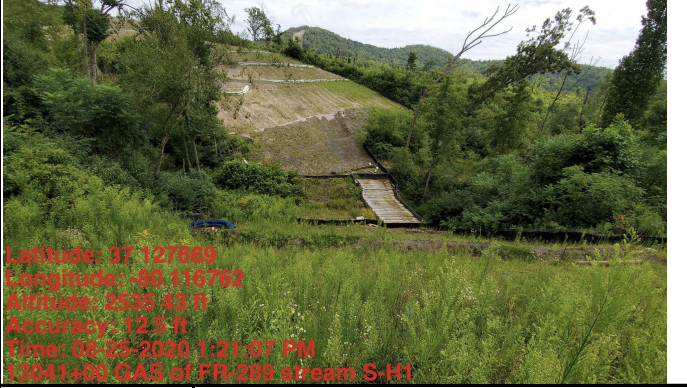
<p>Latitude: 37.127609 Longitude: -80.116762 Altitude: 2535.43 ft Accuracy: 12.5 ft Time: 08-25-2020 1:21:07 PM 13041+00 GAS of FR-289 stream S-H1</p>

<p>Latitude: 37.127175 Longitude: -80.111539 Altitude: 2628.97 ft Accuracy: 12.5 ft Time: 08-25-2020 1:47:01 PM 13061+00 CIS of FR-290 streams S-G26 and S-G27</p>		
GPS Location	See pic for GPS location		GPS Location	See pic for GPS location	
Field Station#	13041+00		Field Station#	13061+00	
Pic 17 Desc.	GAS of access road FR-289 stream S-H1.		Pic 18 Desc.	CIS of access road FR-290 streams S-G26 and S-G27.

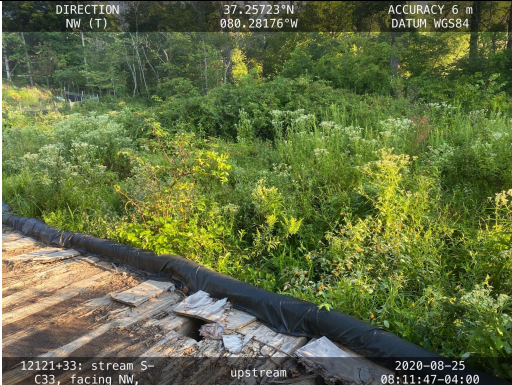
GPS Location	See photo		GPS Location	See photo	
Field Station#	12121+33		Field Station#	12121+83	
Pic 1 Desc.	Stream S-C33, facing northwest, upstream		Pic 2 Desc.	Stream S-C36, facing northwest, upstream

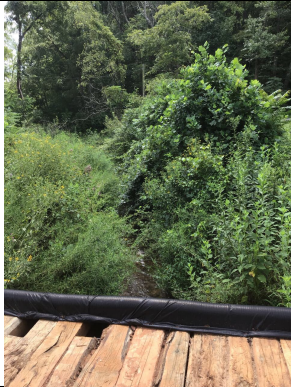
GPS Location	00000	GPS Location	00000		
Field Station#	13631+27	Field Station#	13643+63		
Pic 1 Desc.	P1 damaged from land owner, added to the punch list	Pic 2 Desc.	Stream crossing photo facing downstream

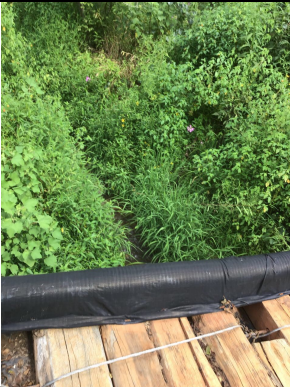
GPS Location	00000	GPS Location	00000		
Field Station#	13643+63	Field Station#	13643+63		
Pic 3 Desc.	Stream crossing photo facing upstream	Pic 4 Desc.	Photo showing ECDs and equipment bridge in place and functioning		
Insert image here		Insert image here			
GPS Location		GPS Location			
Field Station#		Field Station#			
Pic 5 Desc.		Pic 6 Desc.

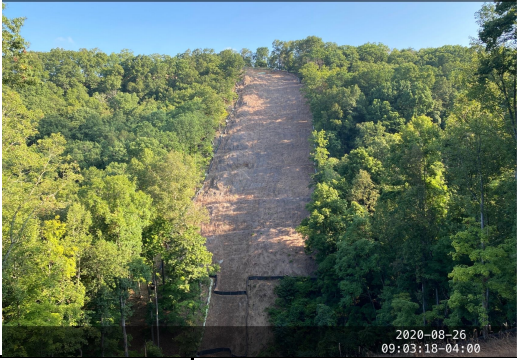
2020-08-26 09:03:18-04:00			
GPS Location	See photo		GPS Location	See photo	
Field Station#	12529+00		Field Station#	12517+00	
Pic 7 Desc.	Plastic sheeting approximately 1500 feet from Yellow Finch Road remains intact and secure.		Pic 8 Desc.	Slope on coming in side of stream S-EF19 remains stable.	
DIRECTION E (T) 37.21609°N 080.19737°W ACCURACY 60 m DATUM WGS84

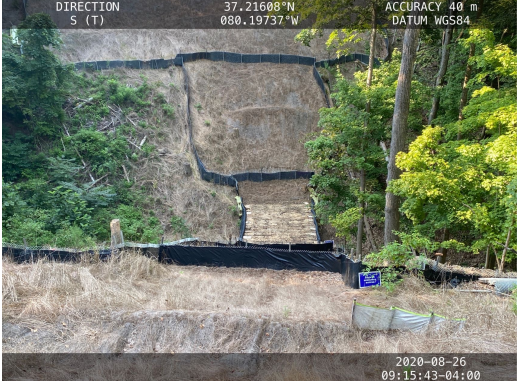
2020-08-26 09:15:43-04:00			
GPS Location	See photo		GPS Location	See photo	
Field Station#	12519+41		Field Station#	12519+41	
Pic 9 Desc.	Stream S-EF19, facing east, upstream		Pic 10 Desc.	The buffer zone of stream S-EF19 remains intact and stable, ECDs are still in satisfactory condition.

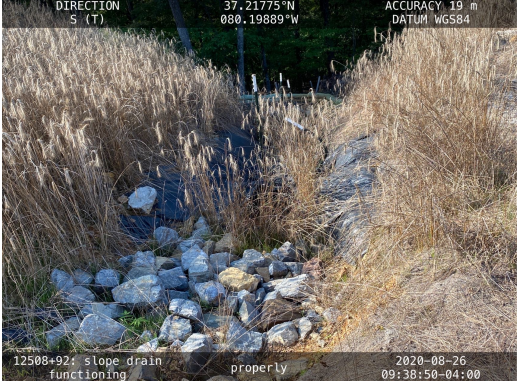
12508+92: slope drain functioning properly 2020-08-26 09:38:50-04:00			
GPS Location	See photo		GPS Location	See photo	
Field Station#	12523+00		Field Station#	12508+92	
Pic 11 Desc.	The slope on the going away side of stream S-EF19 remains stable.		Pic 12 Desc.	This slope drain is in good repair and functioning properly.

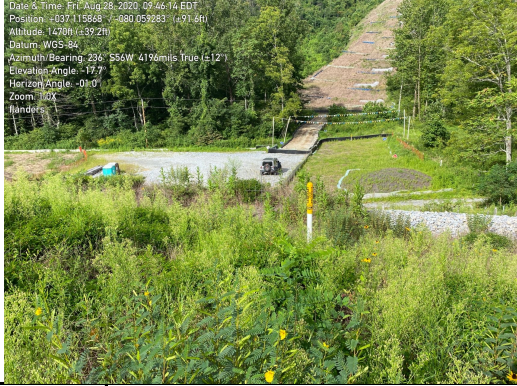
<p>Date & Time: Fri, Aug 28, 2020 09:46:14 EDT Position: +3371115468 / +080 053283 (+197.6m) Altitude: 1420m (+139.2m) Datum: WGS-84 Azimuth Bearing: 236° 55'56" 4196mils True (+127°) Elevation Angle: -17.7° Horizon Angle: -08.0° Zoom: 1.0X Flanders</p>			
GPS Location	See photo for coordinates.		GPS Location	See photo for coordinates.	
Field Station#	13262+50		Field Station#	13264+00	
Pic 1 Desc.	MVP-FR-293.01, Flanders Road, access road in acceptable condition.		Pic 2 Desc.	GAS of MVP-FR-293.02 well vegetated.

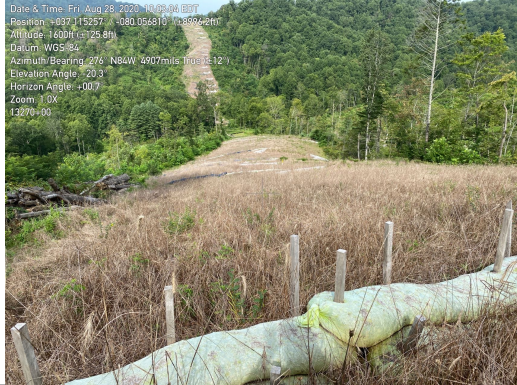
GPS Location	See photo for coordinates.		GPS Location	See photo for coordinates.	
Field Station#	13264+00		Field Station#	13270+00	
Pic 3 Desc.	Vegetative cover noted across ROW, both temporary and permanent vegetation noted.		Pic 4 Desc.	Vegetative cover noted in restored area across LOD, ROW stable.

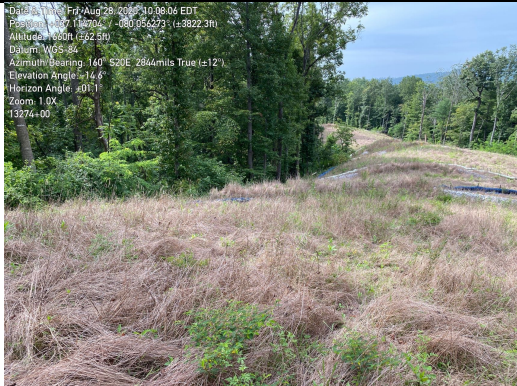
Field Station#	13274+00		Field Station#	13274+00	
Pic 5 Desc.	Restored ROW stable, vegetative cover noted across LOD.		Pic 6 Desc.	Restored ROW stable, vegetative cover noted across LOD.

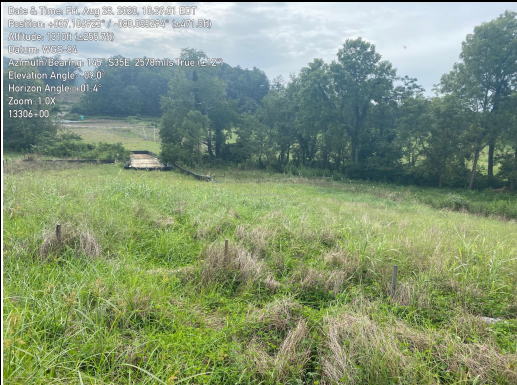
GPS Location		See photo for coordinates.		GPS Location		See photo for coordinates.	
Field Station#		13306+00		Field Station#		13309+09	
Pic 13 Desc.		CIS S-GH7, ROW well vegetated with both temporary and permanent vegetation.		Pic 14 Desc.		S-GH7, downstream, no changes noted to stream bed or banks, water clear.	
<p>Date & Time: Fri, Aug 28, 2020, 1:42:25 EDT Position: +037.106548° / -080.083227° (NAD83) Altitude: 1379ft (±1.1m) Datum: WGS-84 Azimuth/Bearing: 316° N26W 341mils True (±1°) Elevation Angle: +26.8 Horizon Angle: +05.7 Zoom: 1.0X S-GH7 downstream</p>

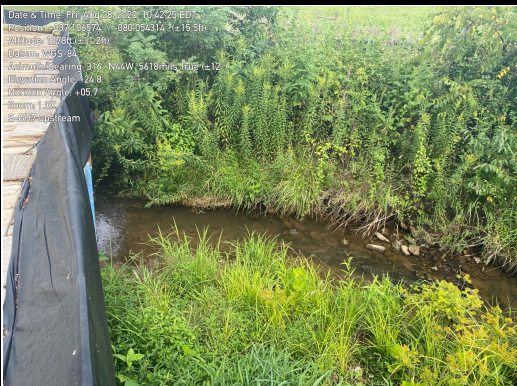
GPS Location		See photo for coordinates.		GPS Location		See photo for coordinates.	
Field Station#		13309+09		Field Station#		13309+20	
Pic 15 Desc.		S-GH7, upstream, no changes noted to stream bed or banks.		Pic 16 Desc.		GAS S-GH7, bridge over stream in acceptable condition, perimeter controls in acceptable condition.	
<p>Date & Time: Fri, Aug 28, 2020, 1:43:17 EDT Position: +037.106548° / -080.083227° (NAD83) Altitude: 1339ft (±1.1m) Datum: WGS-84 Azimuth/Bearing: 103° S77E 1831mils True (±1°) Elevation Angle: +04.7 Horizon Angle: +01.9 Zoom: 1.0X S-GH7 GAS</p>

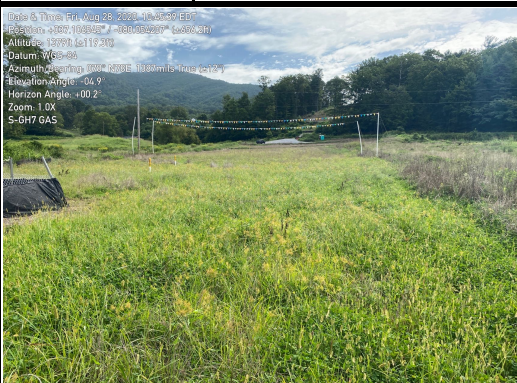
Field Station#		13310+50		Field Station#		13313+00	
Pic 17 Desc.		GAS S-GH7 looking towards Wades Gap Road crossing, good vegetative cover noted across LOD.		Pic 18 Desc.		Moderate vegetative cover noted in stabilized section of ROW.

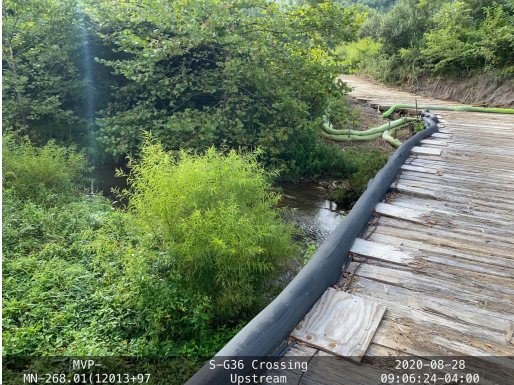
GPS Location	See photo GPS for location		GPS Location	See photo GPS for location	
Field Station#	12013+97		Field Station#	12015+84	
Pic 3 Desc.	MVP-MN-268.01 Bridge crossing S-G36.		Pic 4 Desc.	ECDs surrounding S-G38 are acceptable.

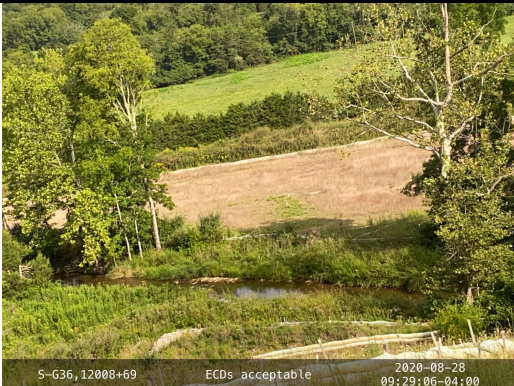
GPS Location	See photo GPS for location		GPS Location	See photo GPS for location	
Field Station#	12008+69		Field Station#	12031+51	
Pic 5 Desc.	ECDs are acceptable surrounding the banks of S-G36 pipe crossing.		Pic 6 Desc.	S-G39 Under Bridge

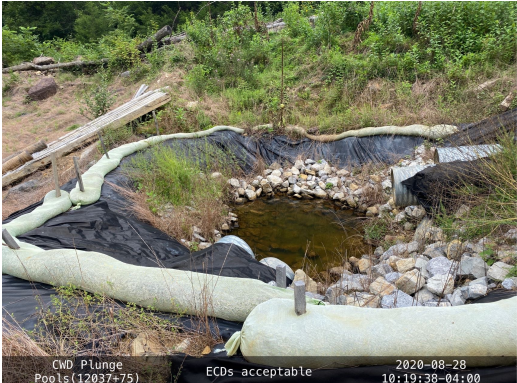
GPS Location	See photo GPS for location	GPS Location	See photo GPS for location		
Field Station#	12037+75	Field Station#	12039+00		
Pic 15 Desc.	Plunge pool is in acceptable condition.	Pic 16 Desc.	Sump ECDs are acceptable.

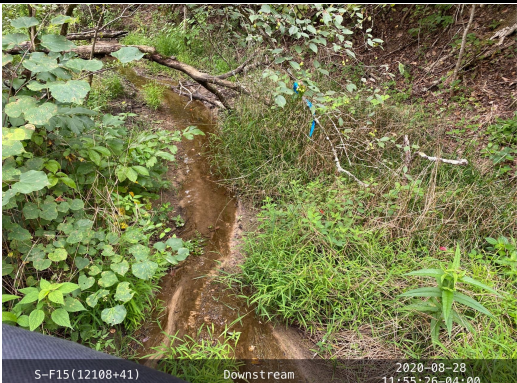
GPS Location	See photo GPS for location	GPS Location	See photo GPS for location		
Field Station#	12108+41	Field Station#	12112+13		
Pic 17 Desc.	S-F15 Downstream	Pic 18 Desc.	S-F16A/B Downstream
