Visual Site Inspection Report

| Project Name | H-600 Pipeline Spread I | AFE | 124300139 | Spread | H-600 Pipeline Spread I |
| Contractor | Precision | | | Report # | 12418 |

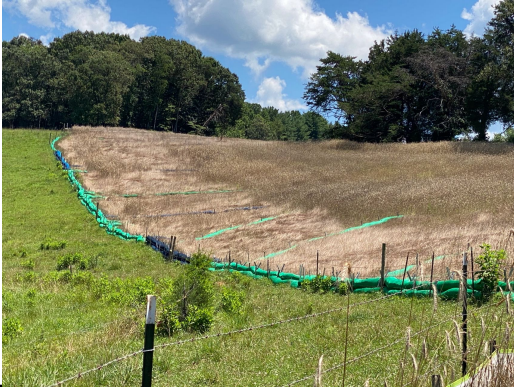
| Field Station# | 14105+26 | Field Station# | 14115+00 | | |

| Pic 1 Desc. | Approximately 14105+26. Overview of stream crossing, equipment bridge and ECDs at stream S-KL41. | | Pic 2 Desc. | Approximately 14115+00. Overview of ROW. ROW temporarily stabilized and has temporary and permanent vegetation growing. | |

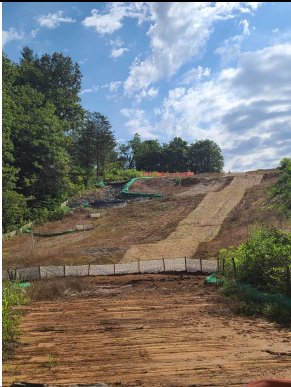
| Pic 1 Desc. | Monitored equipment bridge and ECDs | Pic 2 Desc. | Stream crossing photo facing downstream | | |

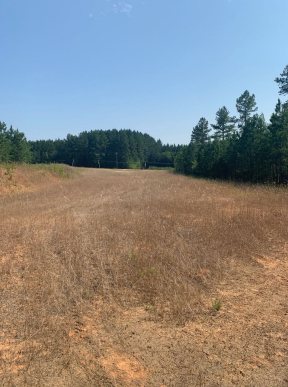
| Pic 1 Desc. | Observing RCE. | Pic 2 Desc. | Observing temporary vegetation. | | |

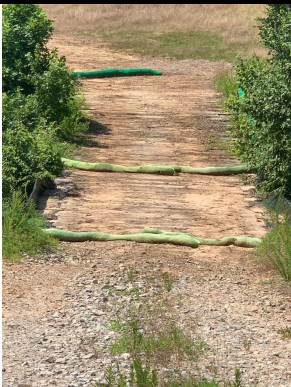
| Pic 1 Desc. | Observing temporary vegetation. | Pic 2 Desc. | Observing access road and temporary vegetation. | | |

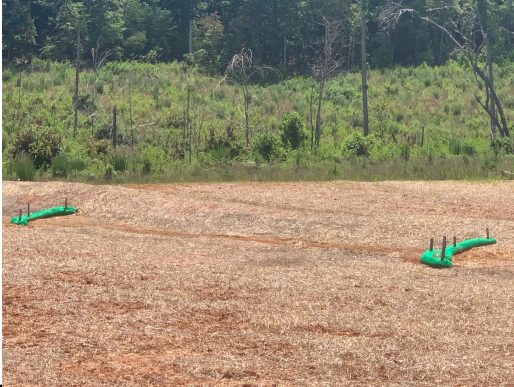
| Pic 1 Desc. | Observing equipment crossing and ECD's performing as they should. | | Pic 2 Desc. | Observing ECD's performing as they should. | |

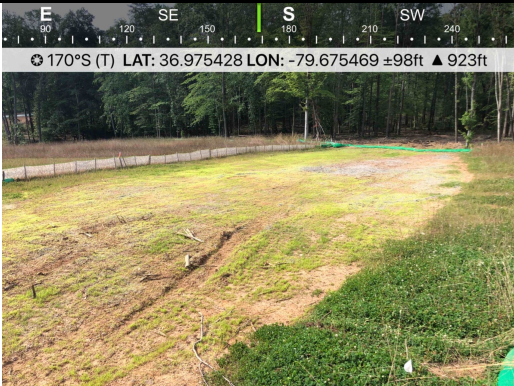
| Pic 3 Desc. | Equipment bridge clean at stream S-GH16 | | Pic 4 Desc. | Permanent stabilization on the CIS of Ramsey Memorial Road | |

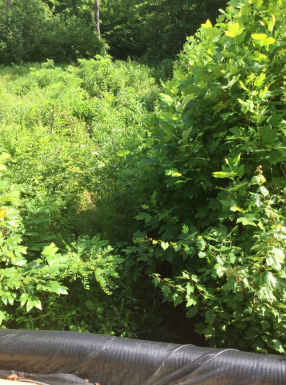
| Pic 1 Desc. | Permanent vegetation coming in along ROW in final cleanup area. | | Pic 2 Desc. | Permanent breaker rock end treatment and perimeter CFS in place and functional. | |

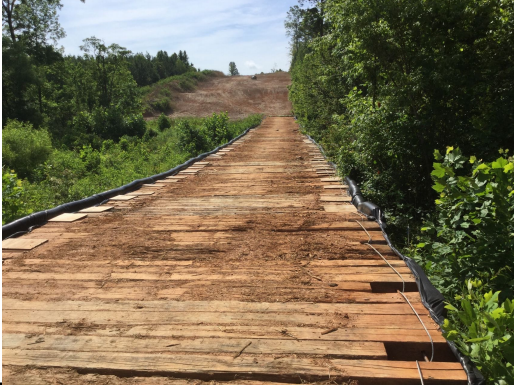
| Pic 3 Desc. | Equipment bridge and surrounding ECD's in place and functional at streams S-CC13/14 | | Pic 4 Desc. | Downstream view of S-CC14. No issues observed. | |

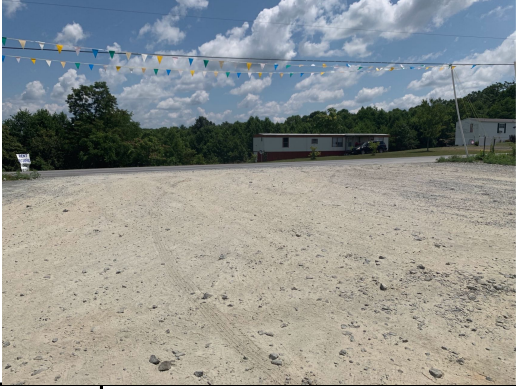
| Pic 3 Desc. | Secondary containment structure for fuel cell in compliance. | Pic 4 Desc. | Secondary containment structure on north end of gravel yard liner has been replaced. (Issue from previous inspection addressed by contractor) | | |

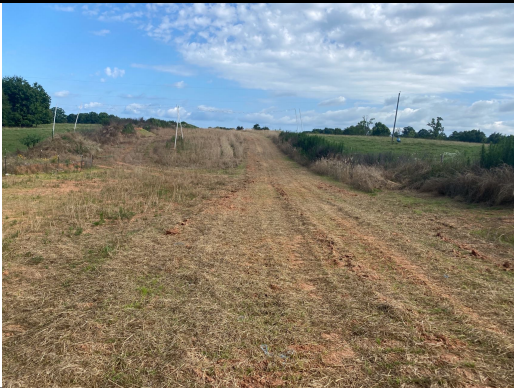
| Pic 3 Desc. | Approximately 14000+00. Overview of adjacent pond overflow flowing onto ROW. Minimal flow across ROW at time of inspection. | | Pic 4 Desc. | Approximately 13998+15. Overview of stream crossing, equipment bridge and ECDs at stream S-KL36. | |

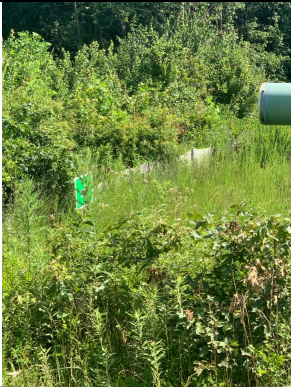
| Pic 1 Desc. | Observing temporary vegetation. | Pic 2 Desc. | Observing RCE. | | |

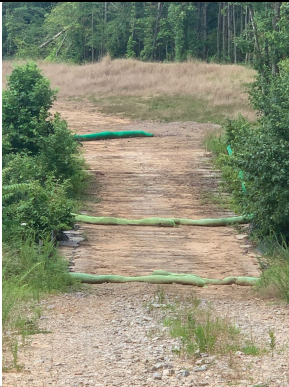
| Pic 1 Desc. | Observing temporary vegetation. | | Pic 2 Desc. | Observing temporary vegetation and signage. | |

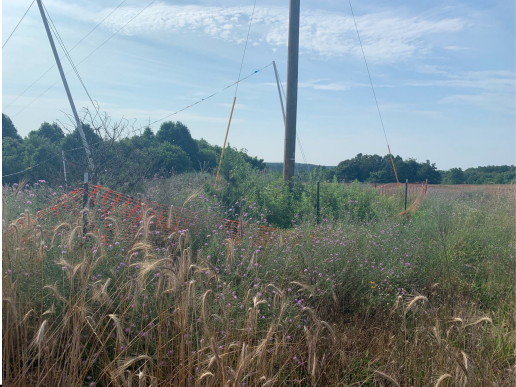
| Pic 1 Desc. | Observing sump and end treatment performing as they should. | Pic 2 Desc. | Observing p1 that requires maintenance. | | |

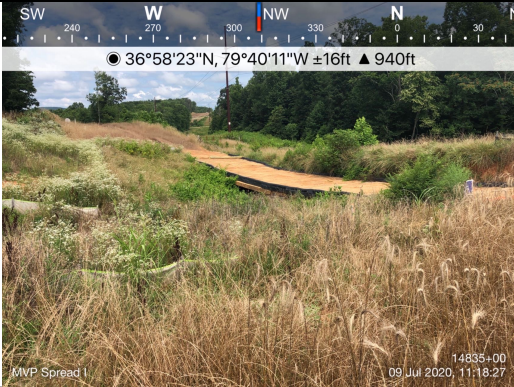
| Pic 1 Desc. | Waterbar end treatment in acceptable condition | | Pic 2 Desc. | Clean water diversion plunge pool in acceptable condition | |

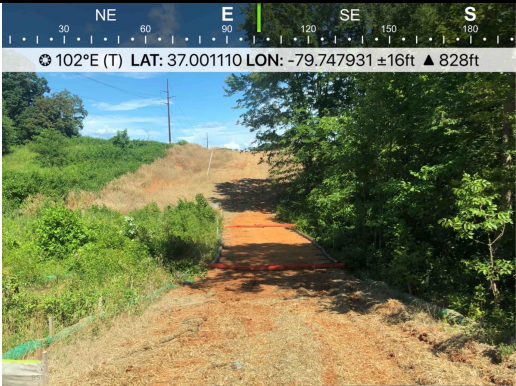
| Pic 3 Desc. | Equipment bridge clean and maintained at stream S-H38 | Pic 4 Desc. | Sump pit cleaned out on the CIS of Simmons Creek Road | | |

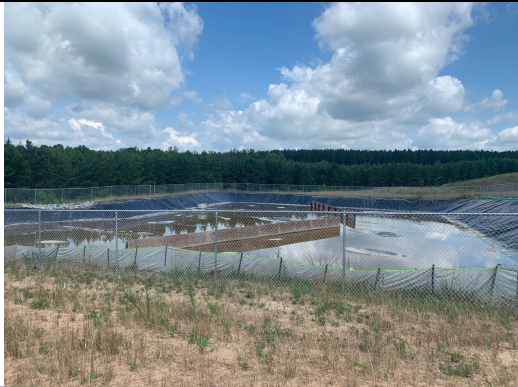
| Pic 1 Desc. | Observing ECD's performing as they should. | Pic 2 Desc. | Observing ECD's performing as they should. | | |
