Visual Site Inspection Report

Project Name H-600 Pipeline Spread I		AFE 124300139	Spread H-600 Pipeline Spread I
Contractor Precision		Report # 13753	
Inspector Justin Burch		Date/Time 8/19/2020 9:17 AM	
Permit # TBD	Inspection Type VA SWPP	Station Begin 14694+75	
State VA	Inspection Area Full	Station End 15142+66	
County Franklin/Pittsylvania	Ground Wet	Temperature (°F) 83.00	
Municipality Chatham	Weather Sunny	Rain Gauge (in) 2.00	
			Rain Accumulation Time (days) 6.00

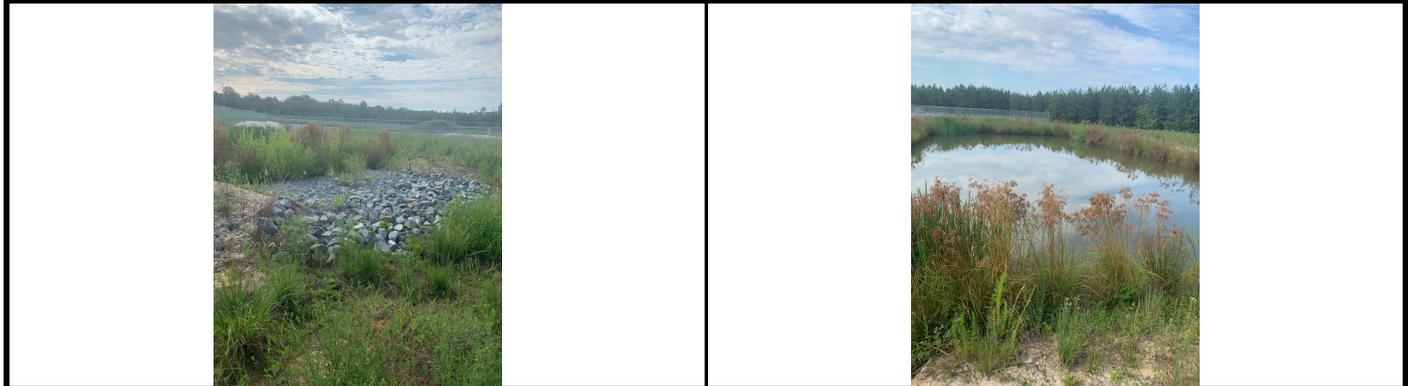
Pic 1 Desc.	Observing rock drain	Pic 2 Desc.	Observing emergency overflow at the storm water pond.
--------------------	----------------------	--------------------	---
