Visual Site Inspection Report

Project Name	H-600 Pipeline Spread G	AFE	124300137	Spread	H-600 Pipeline Spread G
Contractor	Precision			Report #	17728
Inspector	Len Kruizenga			Date/Time	12/7/2020 8:26 AM
Permit #	TBD	Inspection Type	VA SWPP	Station Begin	12005+00
State	VA	Inspection Area	Full	Station End	12005+00
County	Giles	Ground	Wet	Temperature (°F)	33.00
Municipality	N/A	Weather	Cloudy	Rain Gauge (in)	0.00
				Rain Accumulation Time (days)	1.00

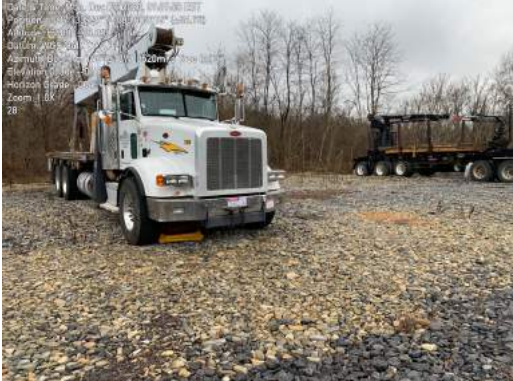
GPS Location	See picture above for GPS coordinates		GPS Location	See picture above for GPS coordinates	
Field Station#	12005+00		Field Station#	12005+00	
Pic 3 Desc.	ECD's and row conditions		Pic 4 Desc.	ECD's and row conditions

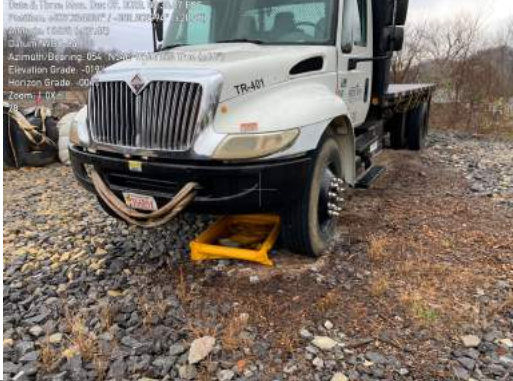
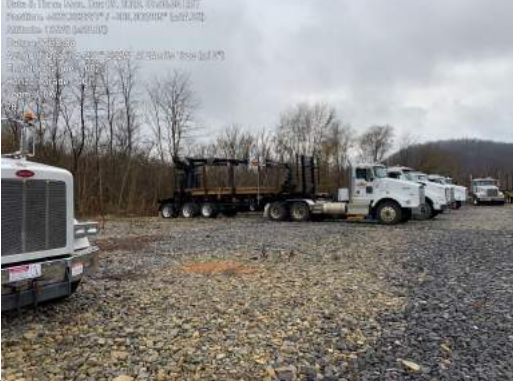
GPS Location	See picture above for GPS coordinates		GPS Location	See picture above for GPS coordinates	
Field Station#	12005+00		Field Station#	12005+00	
Pic 5 Desc.	ECD's and row conditions		Pic 6 Desc.	ECD's and row conditions

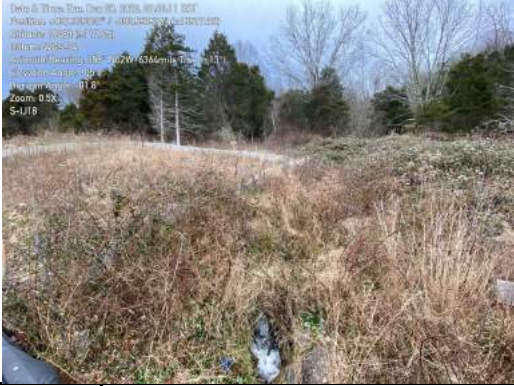
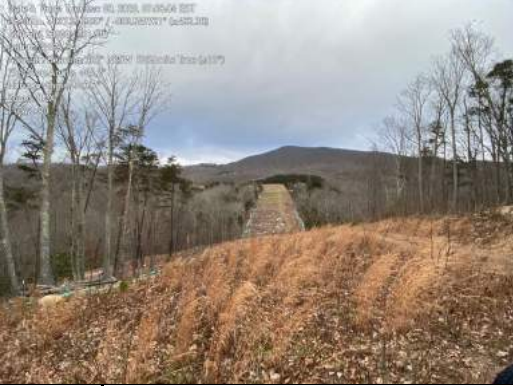
<p> Date & Time: Tue Dec 8, 2020 8:29:11 EST Position: 43°02'00"N 74°48'00"W (43.033333, -74.800000) Altitude: 1050 ft (320 m) Azimuth: 295.0° Azimuth Bearing: 10.5° (10.5° clockwise from 0°) Azimuth Angle: 0.18° Zoom: 0.5X S-IJ18 </p>			
GPS Location	1	GPS Location	2		
Field Station#	11025+50	Field Station#	11042+00		
Pic 1 Desc.	S-IJ18 and controls.	Pic 2 Desc.	Section of RoW showing conditions and controls.

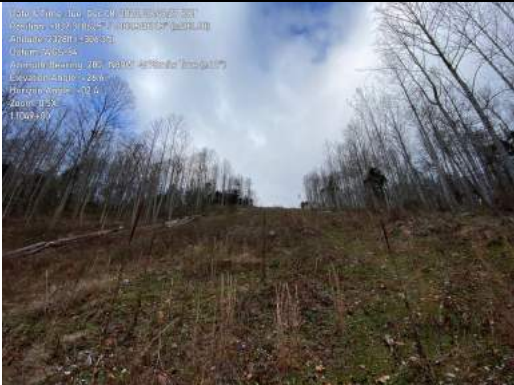
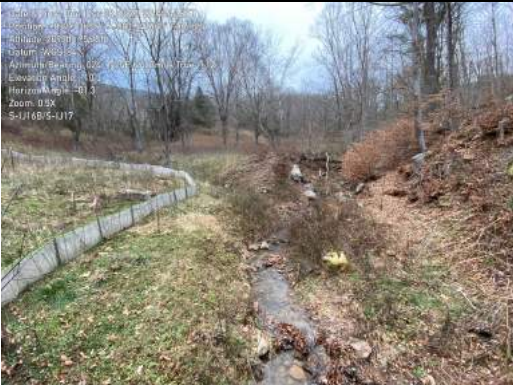
GPS Location	3	GPS Location	4		
Field Station#	11049+00	Field Station#	11050+10		
Pic 3 Desc.	Section of RoW showing conditions and controls.	Pic 4 Desc.	S-IJ16B/S-IJ17 and controls.

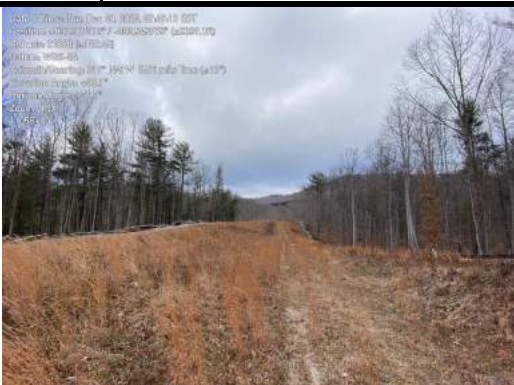
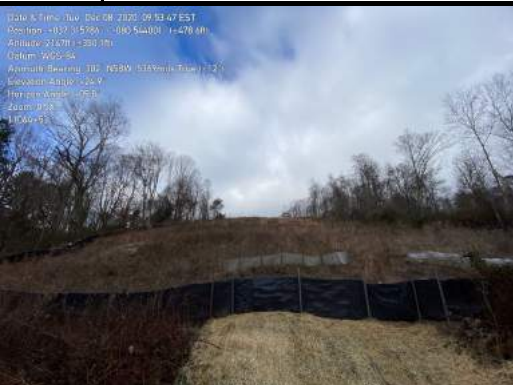
<p> Date & Time: Tue Dec 8, 2020 8:29:11 EST Position: 43°02'00"N 74°48'00"W (43.033333, -74.800000) Altitude: 1050 ft (320 m) Azimuth: 295.0° Azimuth Bearing: 10.5° (10.5° clockwise from 0°) Azimuth Angle: 0.18° Zoom: 0.5X S-IJ18 </p>			
GPS Location	5	GPS Location	6		
Field Station#	11058+00	Field Station#	11064+53		
Pic 5 Desc.	Section of RoW showing conditions and controls.	Pic 6 Desc.	Section of RoW showing conditions and controls.

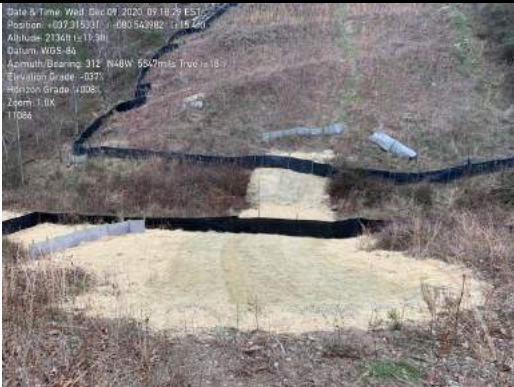
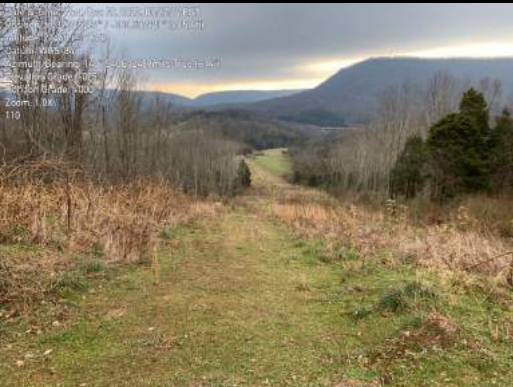
GPS Location	See picture above for GPS coordinates		GPS Location	See picture above for GPS coordinates	
Field Station#	11068+00		Field Station#	11073+00	
Pic 1 Desc.	ECD's and row conditions		Pic 2 Desc.	ECD's and row conditions

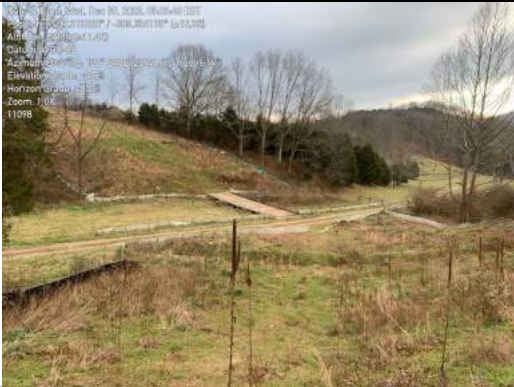
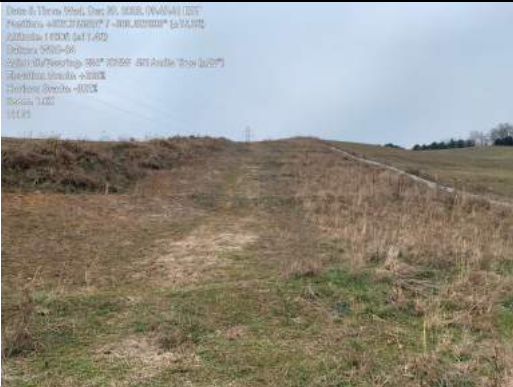
GPS Location	See picture above for GPS coordinates		GPS Location	See picture above for GPS coordinates	
Field Station#	11098+00		Field Station#	11101+00	
Pic 3 Desc.	ECD's and row conditions		Pic 4 Desc.	ECD's and row conditions

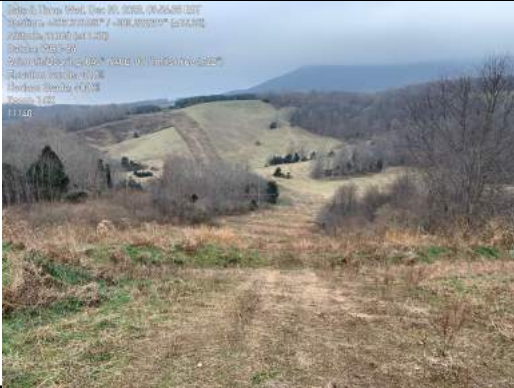
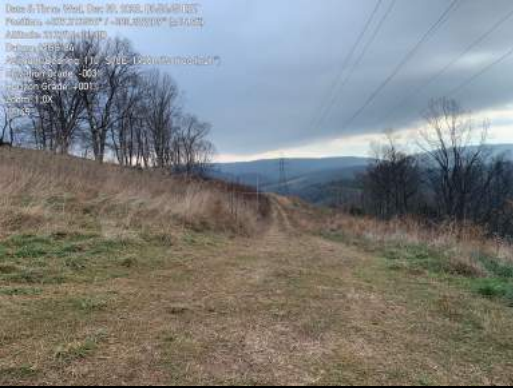
GPS Location	See picture above for GPS coordinates		GPS Location	See picture above for GPS coordinates	
Field Station#	11140+00		Field Station#	11145+00	
Pic 5 Desc.	ECD's and row conditions		Pic 6 Desc.	ECD's and row conditions

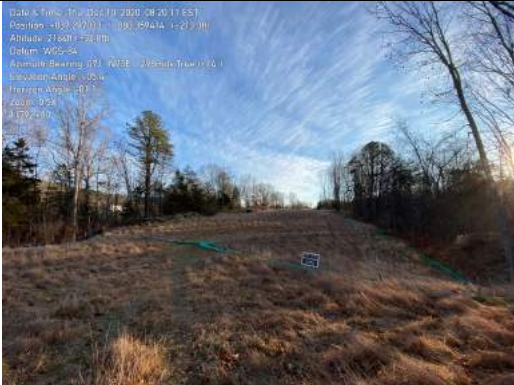
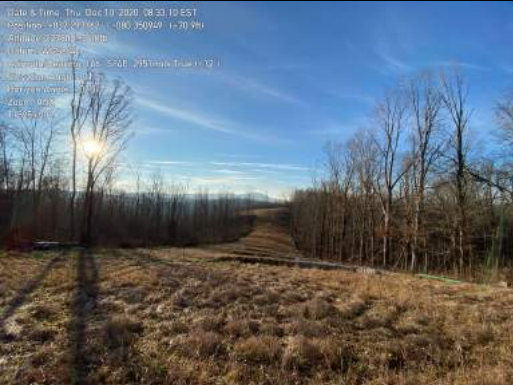
GPS Location	1	GPS Location	2		
Field Station#	11792+00	Field Station#	11825+00		
Pic 1 Desc.	Section of restored RoW showing conditions and controls.		Pic 2 Desc.	Section of restored RoW showing conditions and controls.

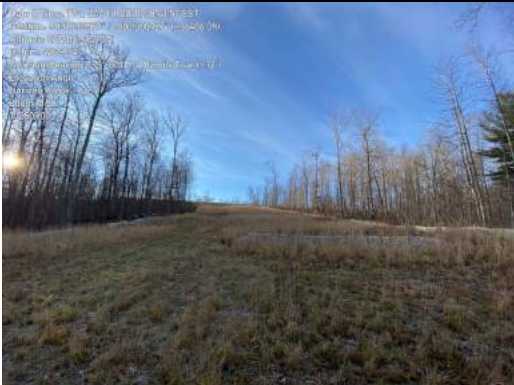
GPS Location	3	GPS Location	4		
Field Station#	11850+00	Field Station#	11863+65		
Pic 3 Desc.	Section of restored RoW showing conditions and controls.		Pic 4 Desc.	P-KL2 and controls.

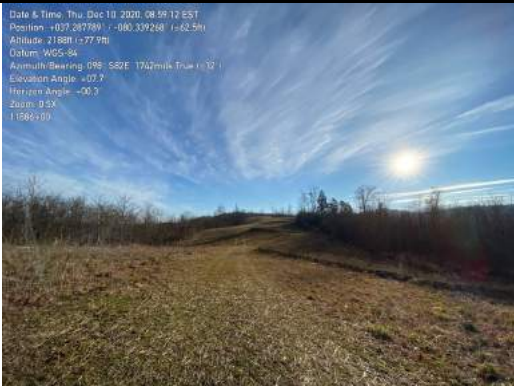
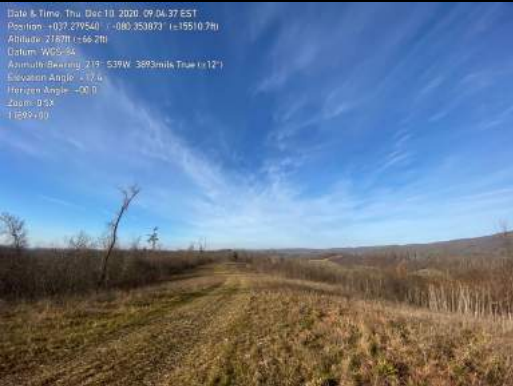
GPS Location	5	GPS Location	6		
Field Station#	11886+00	Field Station#	11899+00		
Pic 5 Desc.	Section of restored RoW showing conditions and controls.		Pic 6 Desc.	Section of restored RoW showing conditions and controls.
