Visual Site Inspection Report

Project Name	H-600 Pipeline Spread H	AFE	124300138	Spread	H-600 Pipeline Spread H
Contractor	Precision	Report #	16021		
Inspector	Pat Davis	Date/Time	10/26/2020 5:00 PM		
Permit #	TBD	Inspection Type	VA SWPP	Station Begin	+0
State	VA	Inspection Area	Partial	Station End	+0
County	Montgomery	Ground	Damp	Temperature (°F)	71.00
Municipality	N/A	Weather	Sunny	Rain Gauge (in)	0.20
				Rain Accumulation Time (days)	0.00

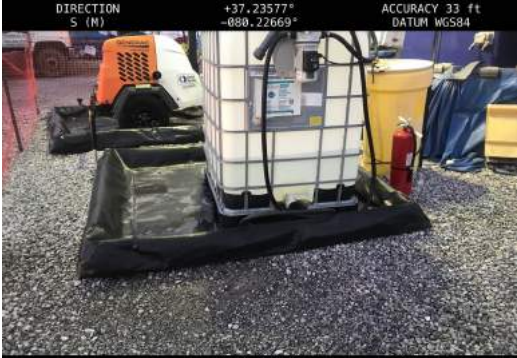
GPS Location	MVP-PL-006 See photo for gps data	GPS Location	MVP-PL-006 See photo for gps data		
Field Station#	+0	Field Station#	+0		
Pic 7 Desc.	Condition of containment under DEF tank. Looking S.	Pic 8 Desc.	Secondary containment on site for tankers offloading fuel into Blue Bulk fuel tanks. Looking NW.

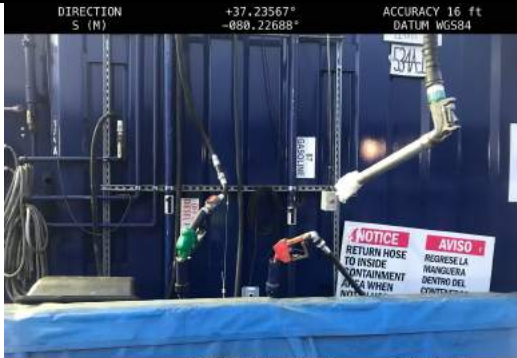
GPS Location	MVP-PL-006 See photo for gps data	GPS Location	MVP-PL-006 See photo for gps data		
Field Station#	+0	Field Station#	+0		
Pic 9 Desc.	Blue Bulk Fuel tanks no leaky fittings or nozzles. Looking S.	Pic 10 Desc.	Off Road Fuel unit containment holding stormwater. Looking W.

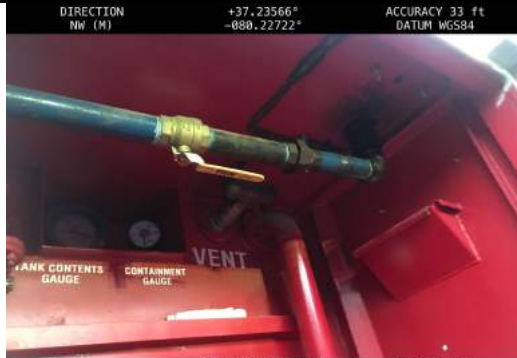
GPS Location	MVP-PL-006 See photo for gps data	GPS Location	MVP-PL-006 See photo for gps data		
Field Station#	+0	Field Station#	+0		
Pic 11 Desc.	Off Road Fuel unit located a leaky elbow fitting. Advised contractor. Looking W.	Pic 12 Desc.	Off Road Fuel unit leak dripping on absorbing pads. Looking W.

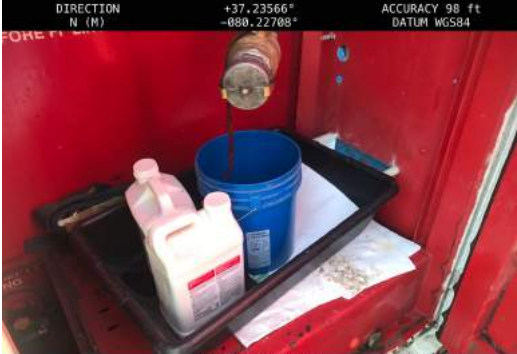
<p>DIRECTION N (M) +37.23566° -080.22708° ACCURACY 98 ft DATUM WGS84</p> <p>MVP-PY-006_102620 Drip pan and more pads added 2020-10-26 13:24:07-04:00</p>

<p>DIRECTION SE (M) +37.23559° -080.22681° ACCURACY 33 ft DATUM WGS84</p> <p>MVP-PY-006_102620 No loose trash around dumpsters 2020-10-26 07:41:27-04:00</p>			
GPS Location	MVP-PL-006 See photo for gps data		GPS Location	MVP-PL-006 See photo for gps data	
Field Station#	+0		Field Station#	+0	
Pic 13 Desc.	Off Road Fuel unit drip pan and more pads placed to catch drips. Looking NW.		Pic 14 Desc.	No loose trash around dumpsters. Looking SE.

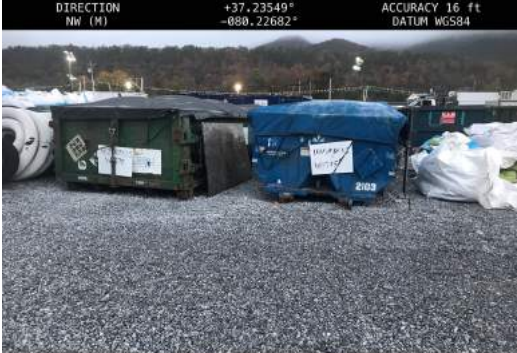
<p>DIRECTION NW (M) +37.23549° -080.22682° ACCURACY 16 ft DATUM WGS84</p> <p>MVP-PY-006_102620 No deposits around hazardous waste ... 2020-10-26 07:42:21-04:00</p>

GPS Location	MVP-PL-006 See photo for gps data		GPS Location	MVP-PL-006 See photo for gps data	
Field Station#	+0		Field Station#	+0	
Pic 15 Desc.	No deposits around hazardous waste dumpsters. Looking NW.		Pic 16 Desc.	Condition of containment under stored equipment. Looking S.

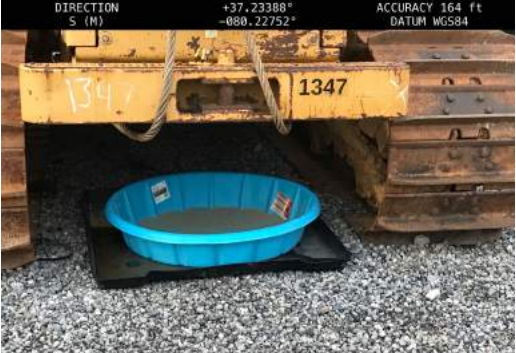
<p>DIRECTION S (M) +37.23388° -080.22752° ACCURACY 164 ft DATUM WGS84</p> <p>MVP-PY-006_102620 Containment under stored equipment 2020-10-26 07:47:14-04:00</p>

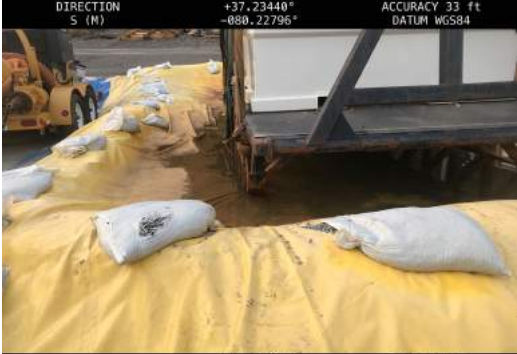
<p>DIRECTION S (M) +37.23440° -080.22796° ACCURACY 33 ft DATUM WGS84</p> <p>MVP-PY-006_102620 Condition of containment 2020-10-26 08:09:29-04:00</p>

<p>DIRECTION SW (M) +37.23460° -080.22792° ACCURACY 33 ft DATUM WGS84</p> <p>MVP-PL-006_102620 Condition of containment 2020-10-26 08:09:50-04:00</p>			
GPS Location	MVP-PL-006 See photo for gps data		GPS Location	MVP-PL-006 See photo for gps data	
Field Station#	+0		Field Station#	+0	
Pic 17 Desc.	Condition of containment, holding stormwater. No sheen present. Looking S.		Pic 18 Desc.	Condition of containment, holding stormwater. No sheen present. Looking SE.

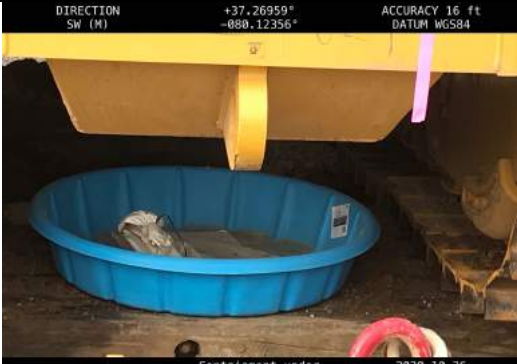
GPS Location	MVP-LY-049 See photo for gps data	GPS Location	MVP-LY-049 See photo for gps data		
Field Station#	+0	Field Station#	+0		
Pic 13 Desc.	Condition of containment under stored equipment. Looking SW.	Pic 14 Desc.	Condition of containments under stored equipment. Looking E.

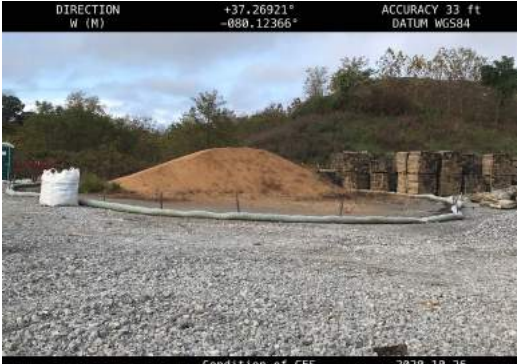
GPS Location	MVP-LY-049 See photo for gps data	GPS Location	MVP-LY-049 See photo for gps data		
Field Station#	+0	Field Station#	+0		
Pic 15 Desc.	Condition of compost filter sock around sand pile. Looking W.	Pic 16 Desc.	Condition of containment under stored vehicle. Looking NE.

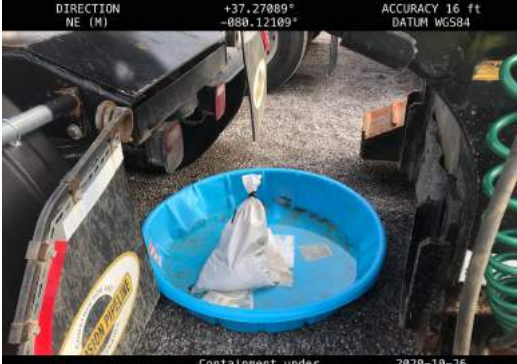
GPS Location	MVP-LY-049 See photo for gps data	GPS Location	MVP-LY-049 See photo for gps data		
Field Station#	+0	Field Station#	+0		
Pic 17 Desc.	Condition of containment under stored vehicle. Looking NE.	Pic 18 Desc.	Condition of containment under stored vehicle. Looking SW.

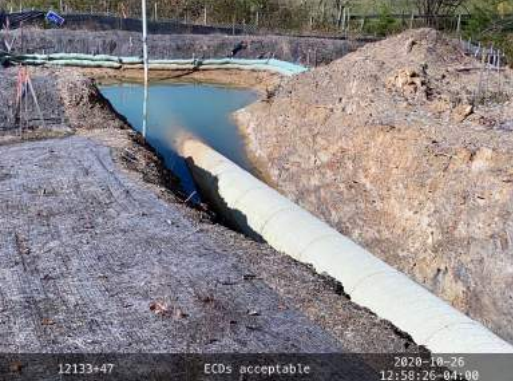
GPS Location	See photo GPS for location		GPS Location	See photo GPS for location	
Field Station#	12132+73		Field Station#	12133+47	
Pic 1 Desc.	All surrounding ECDs at S-C29 are in acceptable condition.		Pic 2 Desc.	All ECDs are functioning and in acceptable condition.

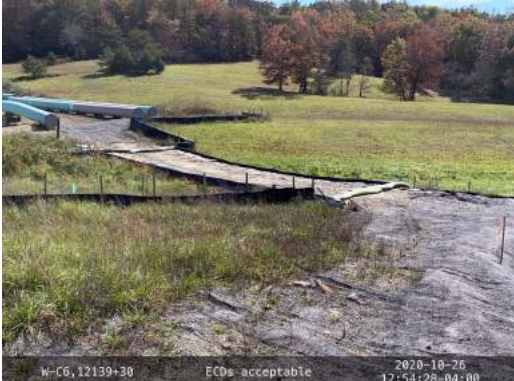
GPS Location	See photo GPS for location		GPS Location	See photo GPS for location	
Field Station#	12139+30		Field Station#	12144+47	
Pic 3 Desc.	All ECDs surrounding W-C6 are in acceptable condition.		Pic 4 Desc.	All ECDs surrounding W-C5 are in acceptable condition.

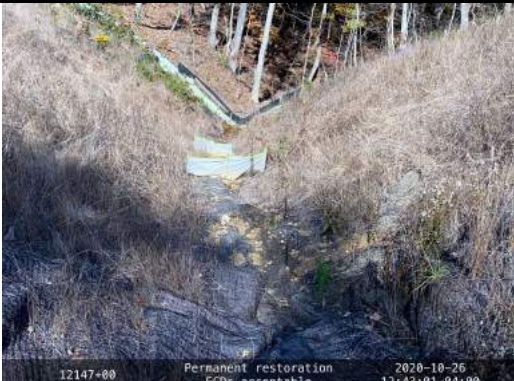
GPS Location	See photo GPS for location		GPS Location	See photo GPS for location	
Field Station#	12147+00		Field Station#	12166+47	
Pic 5 Desc.	ECDs are functioning acceptably.		Pic 6 Desc.	All surrounding ECDs at S-C24 are intact and functioning properly.

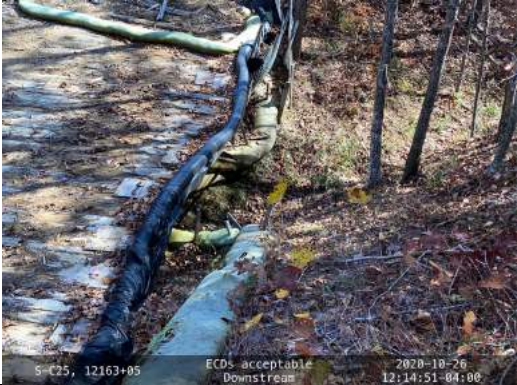
<p>S-C25, 12163+05 ECDs acceptable Downstream 2020-10-26 12:14:51-04:00</p>

<p>S-C25, 12163+05 ECDs acceptable 2020-10-26 12:12:30-04:00</p>			
GPS Location	See photo GPS for location		GPS Location	See photo GPS for location	
Field Station#	12163+05		Field Station#	12163+05	
Pic 7 Desc.	All ECDs surrounding S-C25 are in acceptable condition.		Pic 8 Desc.	All ECDs surrounding S-C25 are in acceptable condition.

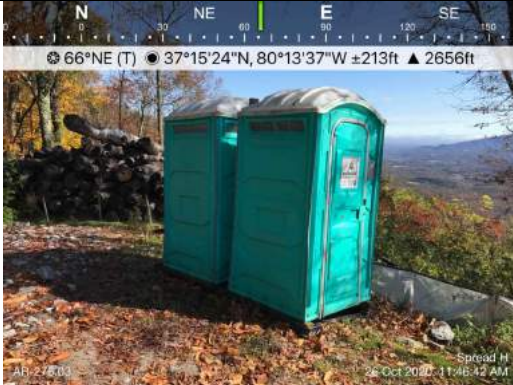
GPS Location	See photo	GPS Location	See photo		
Field Station#	12233+50	Field Station#	276+03		
Pic 1 Desc.	Start of inspection area, Perm. Waterbars in good condition.	Pic 2 Desc.	Portajohns within secondary containment.

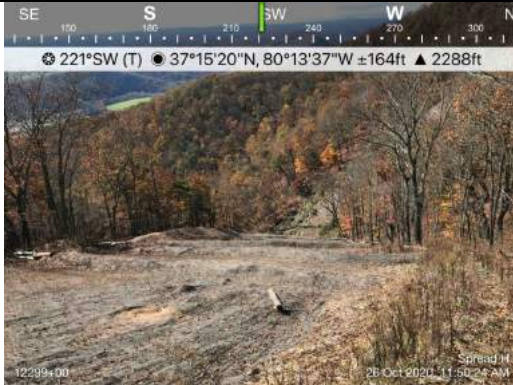
GPS Location	See photo	GPS Location	See photo		
Field Station#	12284+84	Field Station#	12299+00		
Pic 3 Desc.	SSF and CFS controls in good condition.	Pic 4 Desc.	Waterbars are stabilized with ECB and in good condition in the Reese Mtn "V"

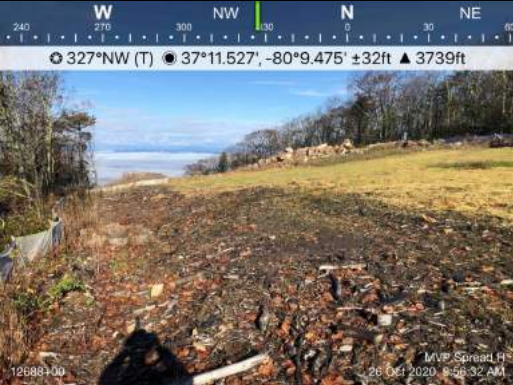
GPS Location	See Picture Watermark		GPS Location	See Picture Watermark	
Field Station#	12688+00		Field Station#	12688+00	
Pic 1 Desc.	Previously stabilized area on CIS Honeysuckle Road. Seed germination was observed.		Pic 2 Desc.	Stabilized area on CIS Honeysuckle Road. Seed germination was consist within straw area.

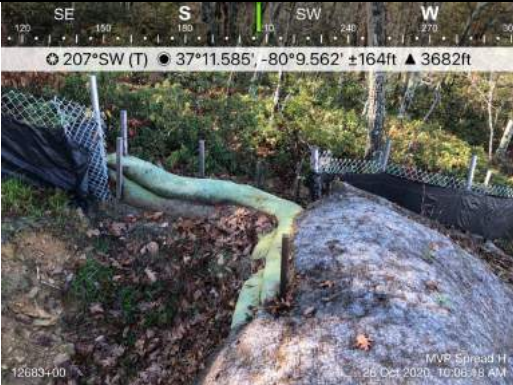
GPS Location	See Picture Watermark		GPS Location	See Picture Watermark	
Field Station#	12679+00		Field Station#	12683+00	
Pic 3 Desc.	Waterbars stabilized with erosion control matting, and vegetation is well established on the ROW between waterbars.		Pic 4 Desc.	Waterbar sump pit and end treatment in good condition.

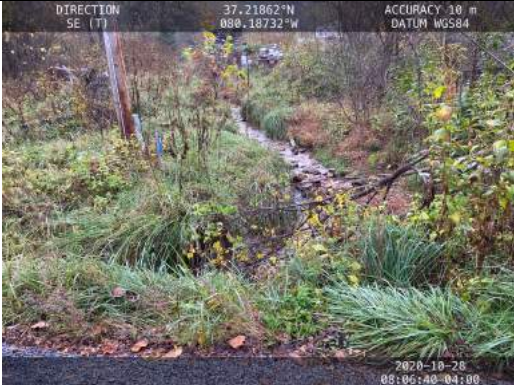
GPS Location	See photo		GPS Location	See photo	
Field Station#	12544+06		Field Station#	12544+06	
Pic 1 Desc.	Stream S-KL32, facing southeast from Yellow Finch Road, upstream		Pic 2 Desc.	Stream S-EF20b, facing south Yellow Finch Road, upstream

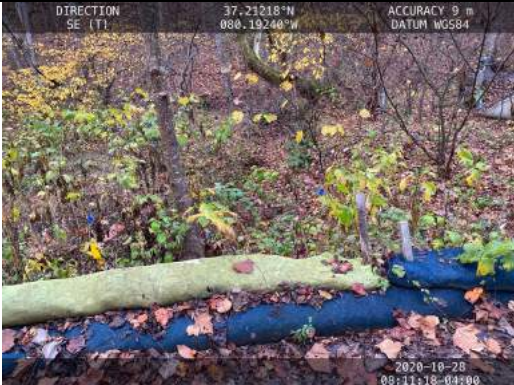
GPS Location	See photo		GPS Location	See photo	
Field Station#	12544+06		Field Station#	12544+06	
Pic 3 Desc.	Stream S-EF54, facing southeast from Yellow Finch Road, upstream		Pic 4 Desc.	Stairs have been cut into the road bank on Yellow Finch Road, next to stream S-EF54, by the inhabitant of this temporary shelter.

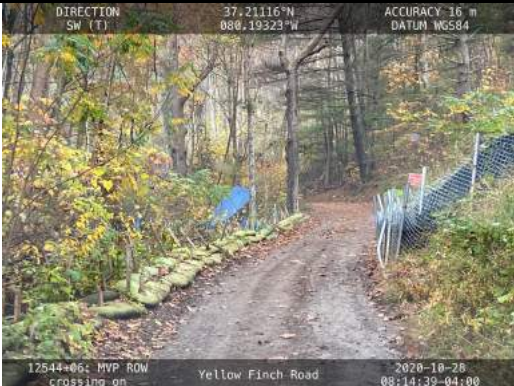
GPS Location	See photo		GPS Location	See photo	
Field Station#	12544+06		Field Station#	12543+00	
Pic 5 Desc.	MVP ROW crossing on Yellow Finch Road.		Pic 6 Desc.	Plastic sheeting on stockpiles nearest to Yellow Finch Road remains intact and secure.

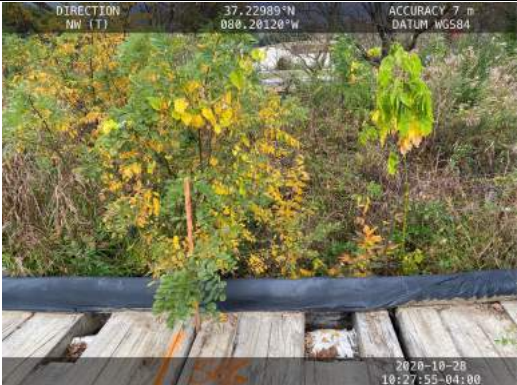
GPS Location	See photo		GPS Location	See photo	
Field Station#	12455+21		Field Station#	12444+94	
Pic 17 Desc.	Stream S-CD12, facing northwest, downstream		Pic 18 Desc.	Stream S-I1, facing southwest, upstream

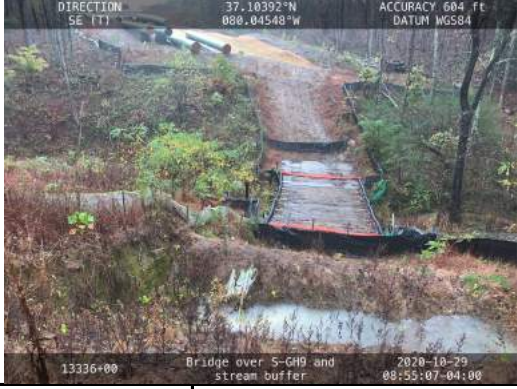
GPS Location	See photo for gps location data.		GPS Location	See photo for gps location data.	
Field Station#	13336+00		Field Station#	13335+00	
Pic 9 Desc.	Photo shows the bridge over stream S-GH9 and adjacent stream buffer.		Pic 10 Desc.	Photo shows the bridge over stream S-GH11 and adjacent stream buffer.

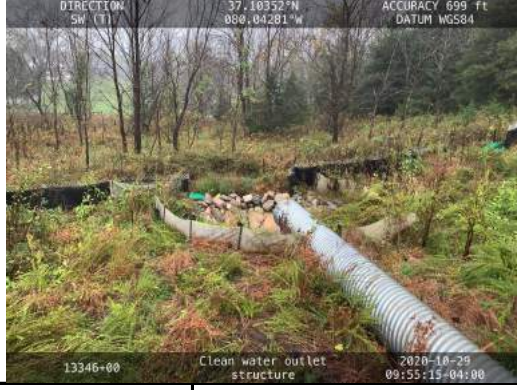
GPS Location	See photo for gps location data.		GPS Location	See photo for gps location data.	
Field Station#	13346+00		Field Station#	13348+46	
Pic 11 Desc.	Photo shows the clean water outlet structure.		Pic 12 Desc.	Photo shows stream S-RR08 downstream from the bridge.

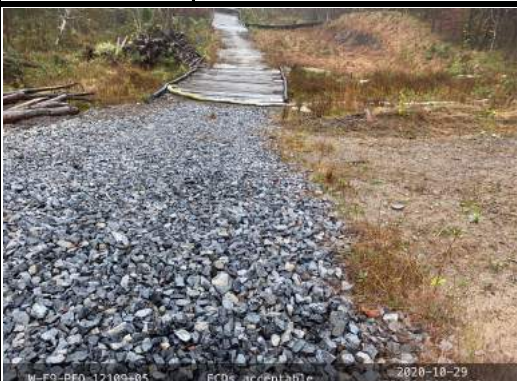
GPS Location	See photo GPS for location		GPS Location	See photo GPS for location	
Field Station#	12098+44		Field Station#	12108+41	
Pic 15 Desc.	ECDs on CIS of S-MM13 are in acceptable condition.		Pic 16 Desc.	ECDs surrounding S-F15 are in acceptable condition.

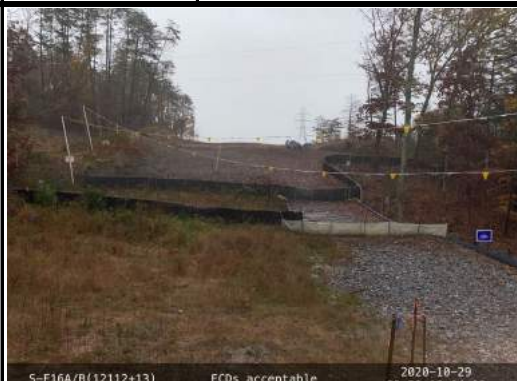
GPS Location	See photo GPS for location		GPS Location	See photo GPS for location	
Field Station#	12109+05		Field Station#	12112+13	
Pic 17 Desc.	RCE on CIS of MVP-MN-271(12109+62) is in acceptable condition. ECDs at W-F9-PFO(wetland) are intact.		Pic 18 Desc.	ECDs surrounding S-F16A/B are in acceptable condition.

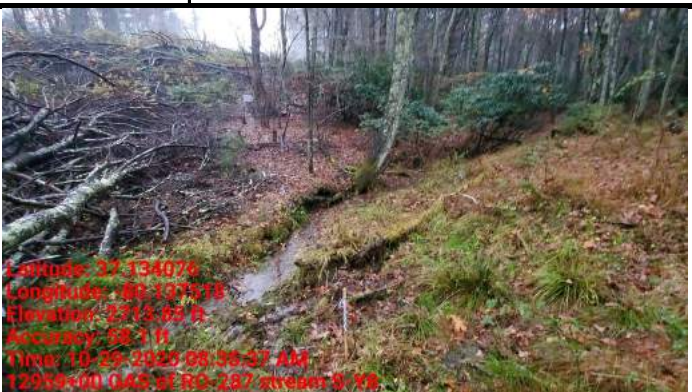
<p>Latitude: 37.134511 Longitude: -80.127647 Elevation: 2775.74 ft Accuracy: 43.8 ft Time: 10-29-2020 08:33:25 AM 12958+00 GAS of RO-287 stream S-Y7</p>

<p>Latitude: 37.134076 Longitude: -80.127318 Elevation: 2713.65 ft Accuracy: 58.1 ft Time: 10-29-2020 08:39:37 AM 12958+00 GAS of RO-287 stream S-Y8</p>			
GPS Location	See pic for GPS location		GPS Location	See pic for GPS location	
Field Station#	12958+00		Field Station#	1295+90	
Pic 5 Desc.	Stream S-Y7 on the GAS of RO-287.		Pic 6 Desc.	Stream S-Y8 on the GAS of RO-287.

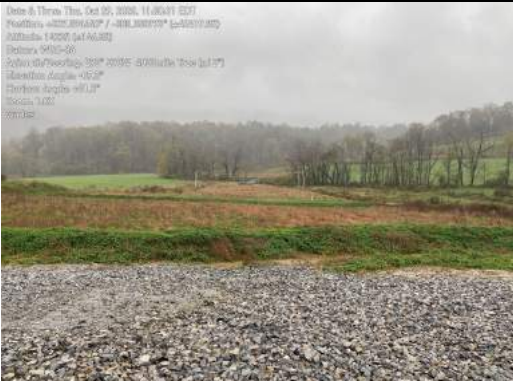
GPS Location	See photo for coordinates.		GPS Location	See photo for coordinates.	
Field Station#	13262+50		Field Station#	13262+50	
Pic 1 Desc.	MVP-FR-293.01, Flanders Road in acceptable condition.		Pic 2 Desc.	MVP-FR-293.01, Flanders Road in acceptable condition.

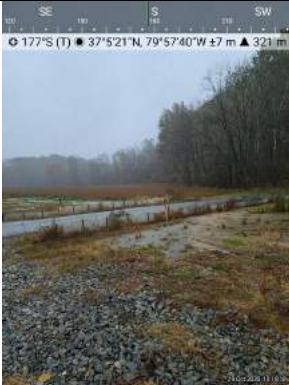
GPS Location	00000	GPS Location	00000		
Field Station#	13644+73	Field Station#	13644+90		
Pic 1 Desc.	Saturated row photo taken while traveling road crossings during rain events , over 2" of rain fall at time of inspection		Pic 2 Desc.	P1 requires maintenance, damaged from storm water during heavy rain events, documented and sent in to be added to the punch list, over 2 inches of rainfall at the time

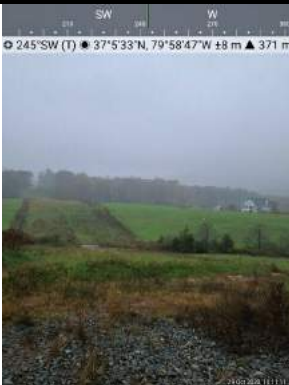
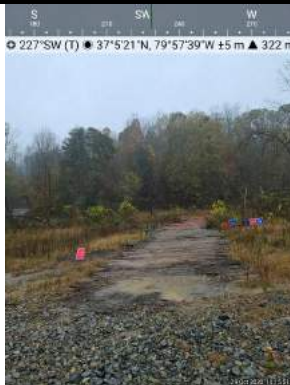
GPS Location	00000	GPS Location	00000		
Field Station#	13575+30	Field Station#	13643+67		
Pic 3 Desc.	Saturated row photo during rain events.		Pic 4 Desc.	Row photo showing saturated conditions during rain events.

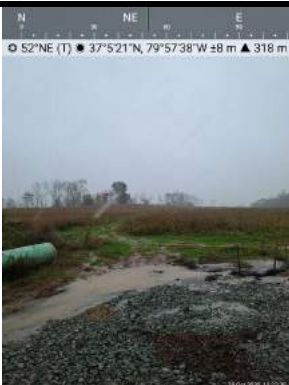
GPS Location	00000	GPS Location	00000		
Field Station#	13645+00	Field Station#	13541+73		
Pic 5 Desc.	Saturated row photo during heavy rain events while checking row conditions.		Pic 6 Desc.	Row photo taken during heavy rain events, traveled road crossings checking row conditions

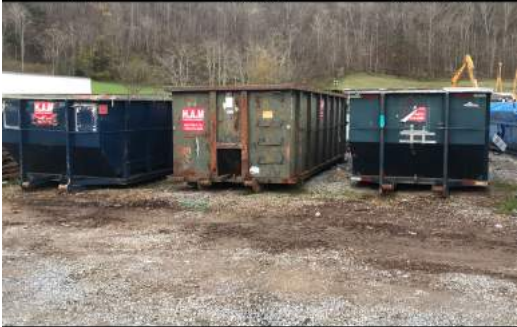
DIRECTION SE (M) +37.23552° -080.22687° ACCURACY 16 ft DATUM WGS84	
MVP-PY-006_103020		No loose trash around dumpsters		MVP-PY-006_103020	
2020-10-30 09:09:20-04:00				2020-10-30 09:09:44-04:00	
GPS Location	MVP-PY-006 See photo for gps data		GPS Location	MVP-PY-006 See photo for gps data	
Field Station#	+0		Field Station#	+0	
Pic 13 Desc.	No loose trash around dumpsters. Looking SE.		Pic 14 Desc.	No deposits around hazardous waste dumpsters. Looking SE.	
DIRECTION W (M) +37.23441° -080.22744° ACCURACY 33 ft DATUM WGS84

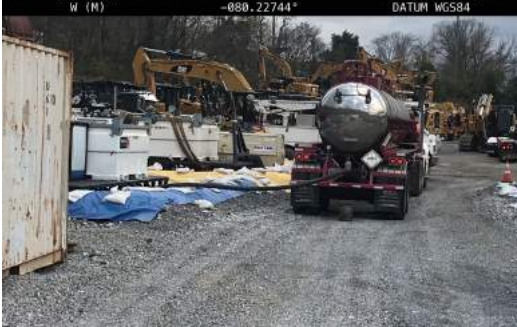
DIRECTION W (M) +37.23463° -080.22770° ACCURACY 33 ft DATUM WGS84	
MVP-PY-006_103020		3rd party pumping out containment		MVP-PY-006_103020	
2020-10-30 09:16:41-04:00				2020-10-30 09:19:37-04:00	
GPS Location	MVP-PY-006 See photo for gps data		GPS Location	MVP-PY-006 See photo for gps data

Field Station#	+0		Field Station#	+0	
Pic 15 Desc.	3rd Party removing stormwater from poly containment. Looking W.		Pic 16 Desc.	3rd Party removing stormwater from poly containment. Looking W.	
DIRECTION N (M) +37.23456° -080.22811° ACCURACY 16 ft DATUM WGS84

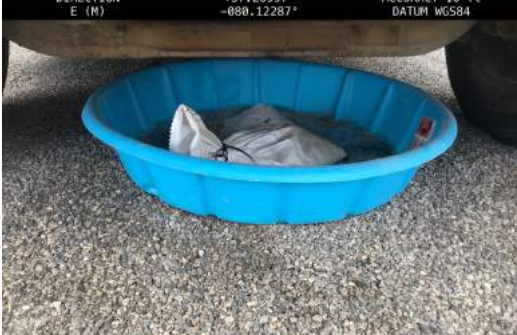
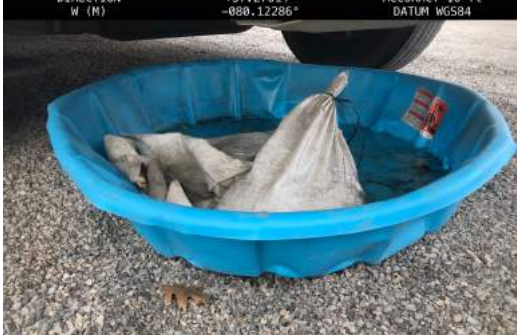
MVP-LY-049_103020 Containment under stored vehicle 2020-10-30 10:15:20-04:00		MVP-LY-049_103020 Containment under stored vehicle 2020-10-30 10:17:22-04:00

GPS Location	MVP-LY-049 See photo for gps data		GPS Location	MVP-LY-049 See photo for gps data	
Field Station#	+0		Field Station#	+0	
Pic 17 Desc.	Condition of containment under stored vehicle. Looking E.		Pic 18 Desc.	Condition of containment under stored vehicle. Looking W.

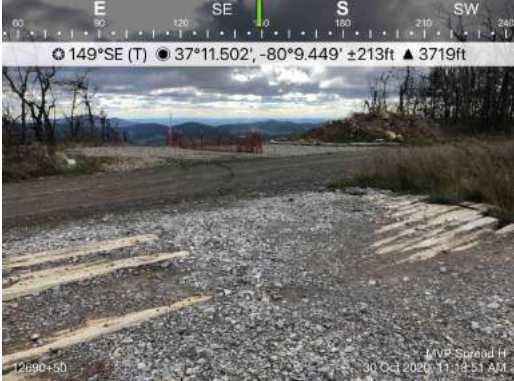
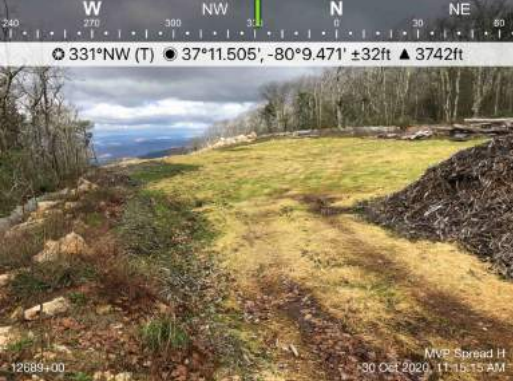
GPS Location	See Picture Watermark		GPS Location	See Picture Watermark	
Field Station#	12690+50		Field Station#	12689+00	
Pic 1 Desc.	Rock construction entrances at Honeysuckle Road. No maintenance necessary.		Pic 2 Desc.	Recently stabilized area on CIS Honeysuckle Road continues to germinate.

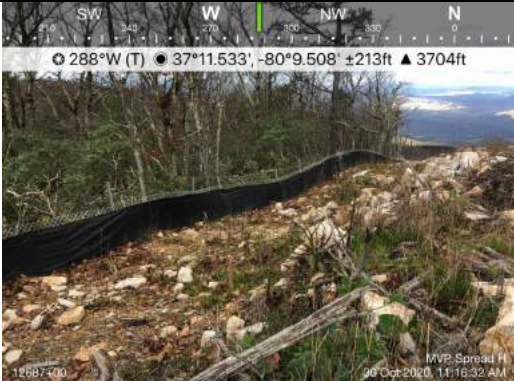
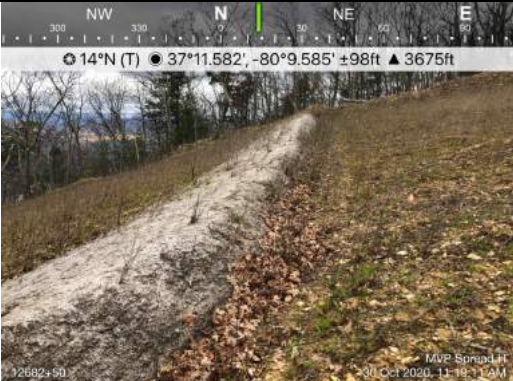
GPS Location	See Picture Watermark		GPS Location	See Picture Watermark	
Field Station#	12687+00		Field Station#	12682+50	
Pic 3 Desc.	Perimeter super silt fence is installed and in good condition.		Pic 4 Desc.	Waterbars in good condition and stabilized with erosion control matting.

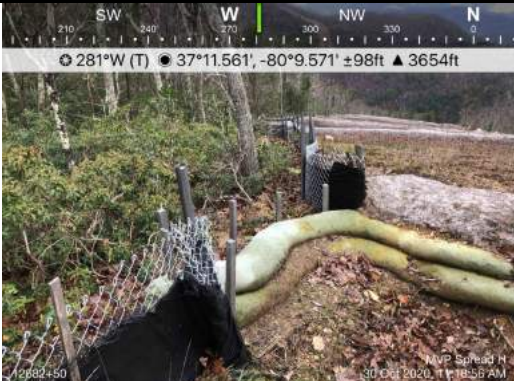
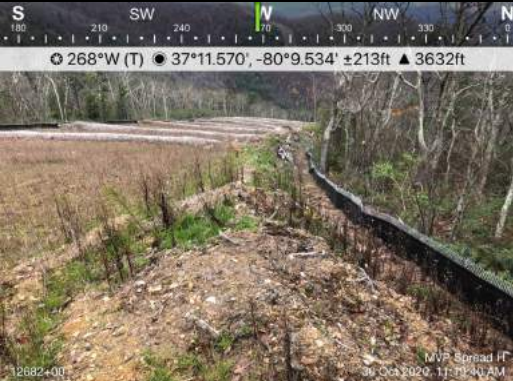
GPS Location	See Picture Watermark		GPS Location	See Picture Watermark	
Field Station#	12682+50		Field Station#	12682+00	
Pic 5 Desc.	Waterbar end treatment in good condition and no maintenance is needed.		Pic 6 Desc.	Diversion berm and perimeter controls are in good condition.

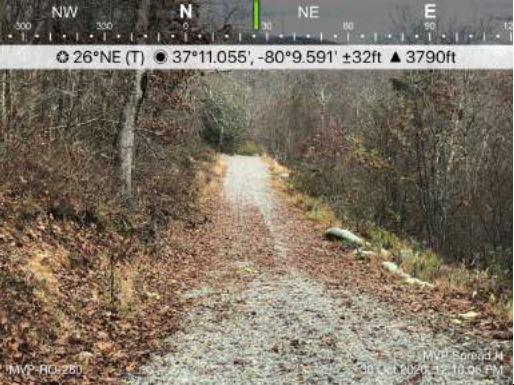
GPS Location	See Picture Watermark		GPS Location	See Picture Watermark	
Field Station#	12701+00		Field Station#	12701+00	
Pic 13 Desc.	ATWS-1224 is in good condition. No material currently stored here.		Pic 14 Desc.	MVP-RO-280 is in good condition with no maintenance necessary.
