Visual Site Inspection Report

Project Name	H-600 Pipeline Spread H	AFE	124300138	Spread	H-600 Pipeline Spread H
Contractor	Precision			Report #	16595
Inspector	Logan Box			Date/Time	11/9/2020 4:25 PM
Permit #	TBD	Inspection Type	VA SWPP	Station Begin	13415+51
State	VA	Inspection Area	Partial	Station End	13525+99
County	Franklin	Ground	Damp	Temperature (°F)	70.00
Municipality	N/A	Weather	Cloudy	Rain Gauge (in)	0.00
				Rain Accumulation Time (days)	0.00

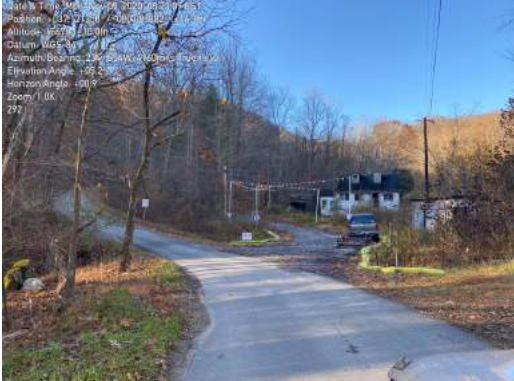
GPS Location	See photo for coordinates.		GPS Location	See photo for coordinates.	
Field Station#	131480+00		Field Station#	13190+00	
Pic 1 Desc.	MVP-FR-292, RCE in acceptable condition.		Pic 2 Desc.	MVP-AR-29, RCE in acceptable condition.

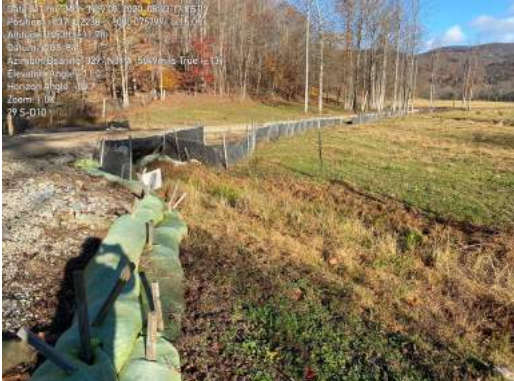
GPS Location	See photo for coordinates.		GPS Location	See photo for coordinates.	
Field Station#	13190+00		Field Station#	13190+00	
Pic 3 Desc.	S-D10, downstream, ECDs along access road functioning properly.		Pic 4 Desc.	S-D10, outlet of culvert, no turbidity noted.

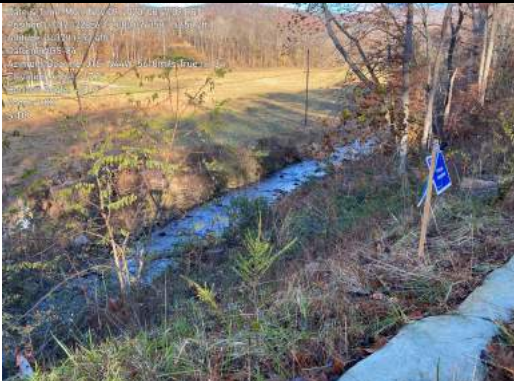
GPS Location	See photo for coordinates.		GPS Location	See photo for coordinates.	
Field Station#	13197+50		Field Station#	13197+75	
Pic 5 Desc.	S-D8, no ground disturbance at stream crossing.		Pic 6 Desc.	GAS Dillons Mill road, ROW stable with perimeter ECDs functioning acceptably.

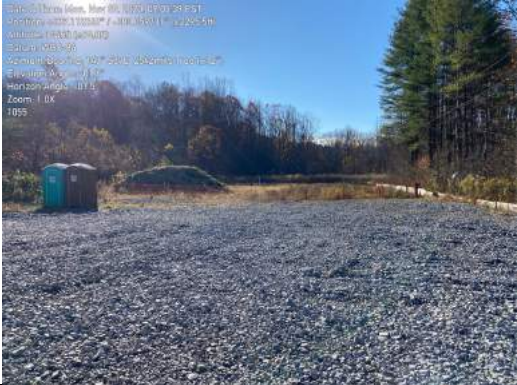
GPS Location	See photo for coordinates.		GPS Location	See photo for coordinates.	
Field Station#	13262+00		Field Station#	13262+00	
Pic 7 Desc.	ATWS-1055, workspace partially restored, stable with good vegetative cover.		Pic 8 Desc.	MVP-FR-293.01, Flanders Road, road crossing in acceptable condition.

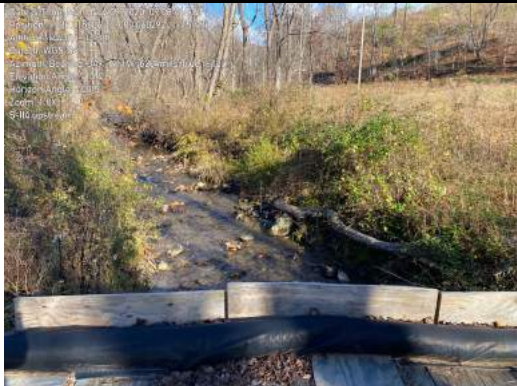
GPS Location	See photo for coordinates.		GPS Location	See photo for coordinates.	
Field Station#	13260+60		Field Station#	13260+60	
Pic 9 Desc.	S-II4, upstream, stream banks stable, no changes noted to stream bed, no turbidity noted.		Pic 10 Desc.	S-II4, downstream, no changes noted to bed or banks, no ROW impacts noted.

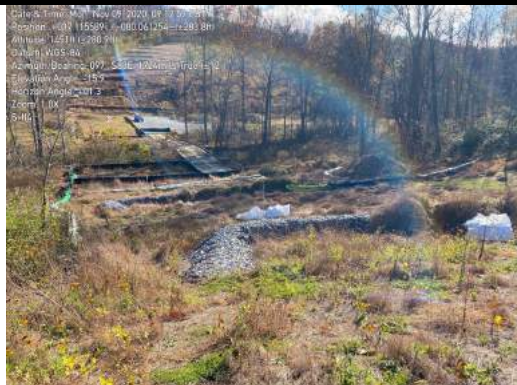
GPS Location	See photo for coordinates.		GPS Location	See photo for coordinates.	
Field Station#	13257+00		Field Station#	13260+60	
Pic 11 Desc.	ROW stable with acceptable vegetative cover.		Pic 12 Desc.	CIS S-II4, ECDs functioning acceptable along stream crossing.

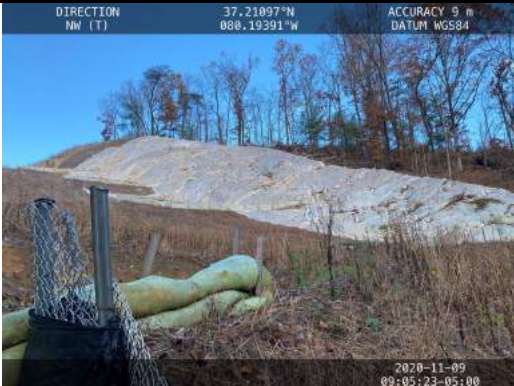
GPS Location	See photo		GPS Location	See photo	
Field Station#	12543+00		Field Station#	12529+00	
Pic 5 Desc.	Plastic sheeting on stockpiles nearest to Yellow Finch Road remains intact and secure.		Pic 6 Desc.	Plastic sheeting approximately 1500 feet from Yellow Finch Road is intact and secure.

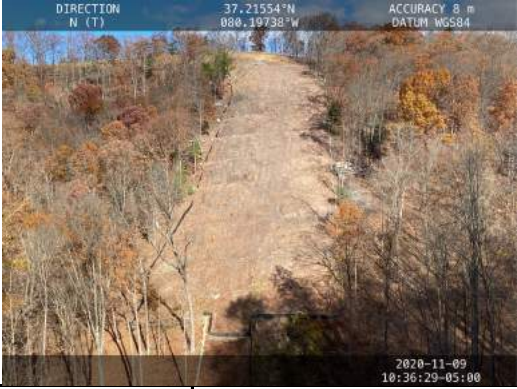
GPS Location	See photo		GPS Location	See photo	
Field Station#	12517+00		Field Station#	12519+41	
Pic 7 Desc.	Slope on the coming in side of stream S-EF19 remains stable.		Pic 8 Desc.	Stream S-EF19, facing east, upstream

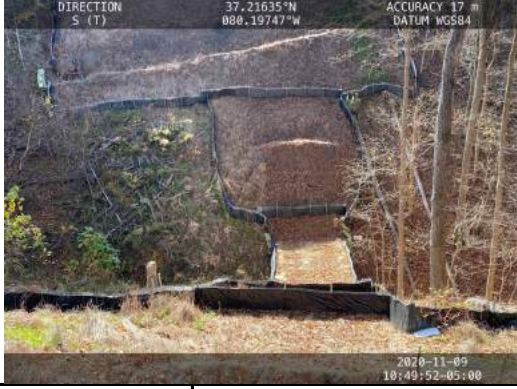
GPS Location	See photo		GPS Location	See photo	
Field Station#	12519+41		Field Station#	12523+00	
Pic 9 Desc.	Buffer zone of stream S-EF19 is still stable, ECDs remain intact and effective.		Pic 10 Desc.	Slope on going away side of stream S-EF19 remains well stabilized.

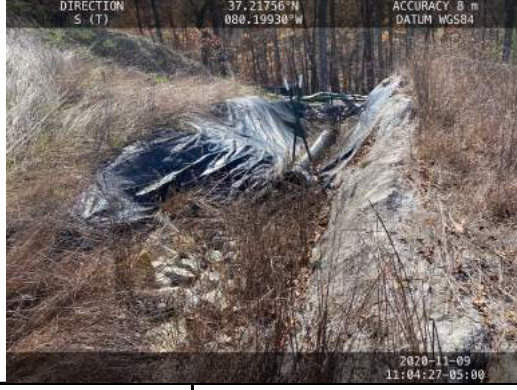
GPS Location	See photo		GPS Location	See photo	
Field Station#	12508+92		Field Station#	12503+70	
Pic 11 Desc.	Slope drain is in good repair and functioning properly.		Pic 12 Desc.	This clean water diversion pipe inlet is in satisfactory condition, free of sediment.

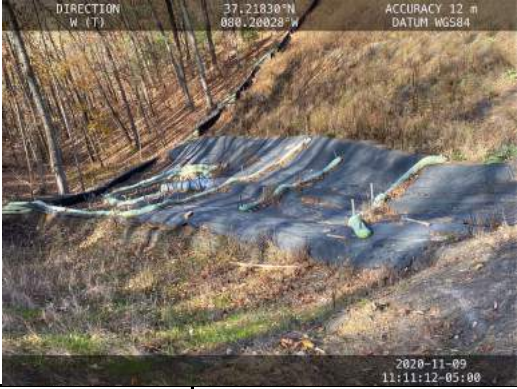
GPS Location	See photo		GPS Location	See photo	
Field Station#	12503+70		Field Station#	12506+00	
Pic 13 Desc.	The clean water diversion pipe is in good repair.		Pic 14 Desc.	The steep slope on the going away side of the clean water diversion pipe is stable.

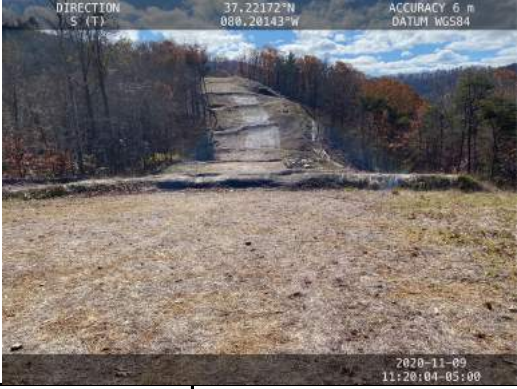
GPS Location	See photo		GPS Location	See photo	
Field Station#	12494+00		Field Station#	12486+00	
Pic 15 Desc.	ROW stable		Pic 16 Desc.	Slope on going away side of MLV-28 is stable.

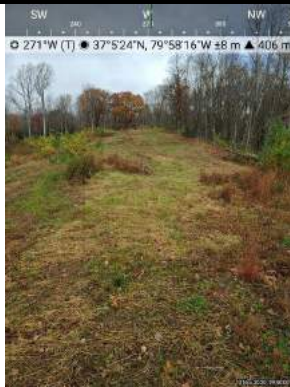
GPS Location	00000	GPS Location	0000		
Field Station#	13610+00	Field Station#	13590+99		
Pic 3 Desc.	Vegetation photo during routine inspection.		Pic 4 Desc.	During the EI's routine inspection today the EI noticed vegetation growing where a water bar was recently repaired .

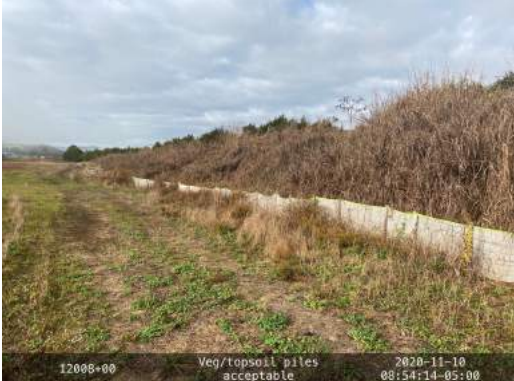
GPS Location	See photo GPS for location		GPS Location	See photo GPS for location	
Field Station#	12008+00		Field Station#	12008+69	
Pic 1 Desc.	Vegetation and P1 around topsoil piles is in acceptable condition.		Pic 2 Desc.	S-G36 banks are stable and well vegetated.

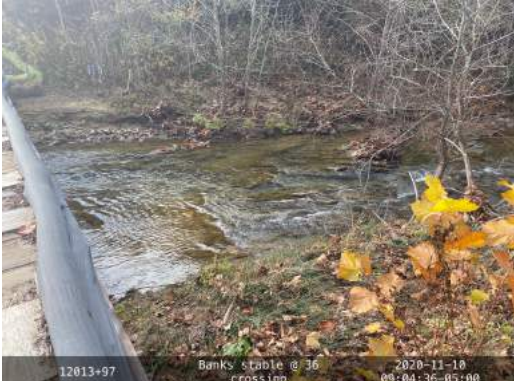
GPS Location	See photo GPS for location		GPS Location	See photo GPS for location	
Field Station#	12013+97		Field Station#	12015+84	
Pic 3 Desc.	Banks are stable and ECDs are in acceptable condition at bridge crossing over S-G36.		Pic 4 Desc.	S-G38 stream banks and buffers are stable and ECDs are in acceptable condition.

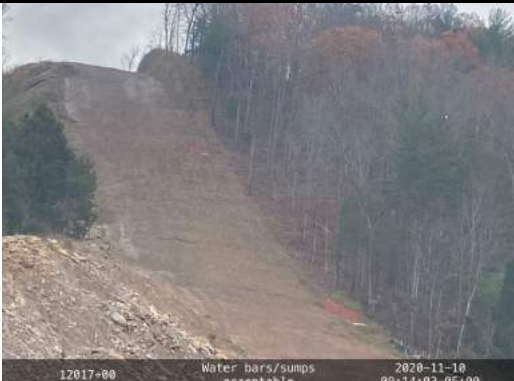
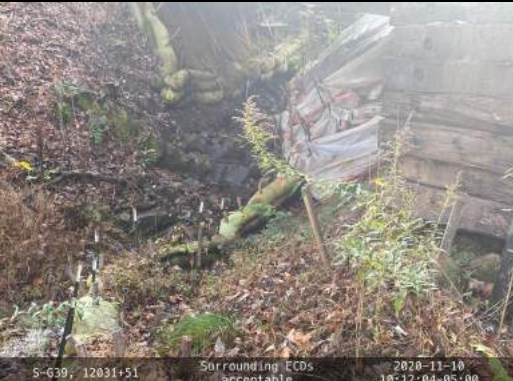
GPS Location	See photo GPS for location		GPS Location	See photo GPS for location	
Field Station#	12017+00		Field Station#	12031+51	
Pic 5 Desc.	Water bars,sumps, and perimeter controls are in acceptable condition in this area.		Pic 6 Desc.	ECDs are in acceptable condition under the bridge and surrounding S-G39.

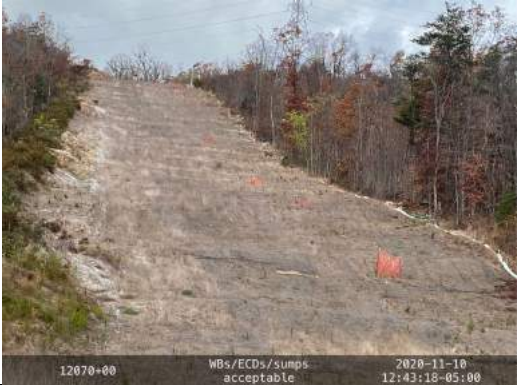
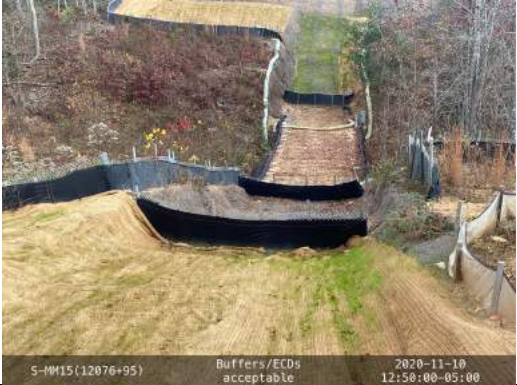
GPS Location	See photo GPS for location		GPS Location	See photo GPS for location	
Field Station#	12070+00		Field Station#	12076+95	
Pic 13 Desc.	Water bars, sumps, and perimeter controls are in acceptable condition in this area.		Pic 14 Desc.	ECDs, stream banks, and buffers are all in acceptable condition surrounding S-MM15.

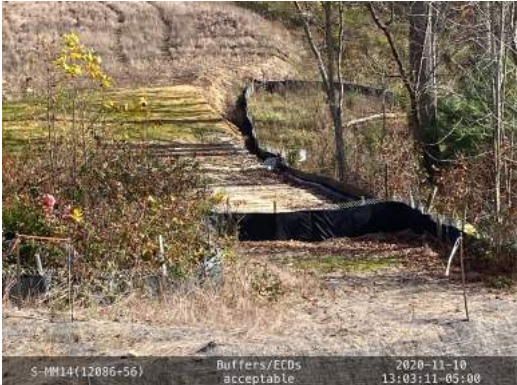
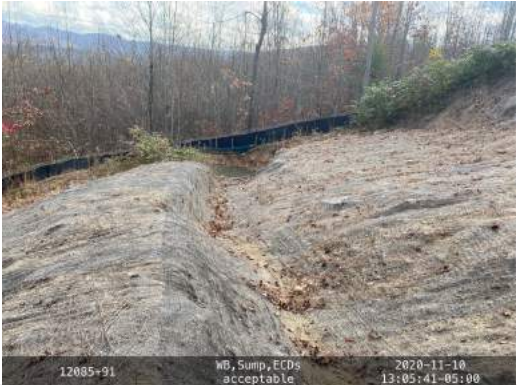
GPS Location	See photo GPS for location		GPS Location	See photo GPS for location	
Field Station#	12086+56		Field Station#	185+91	
Pic 15 Desc.	ECDs, stream banks, and buffers are all in acceptable condition surrounding S-MM14.		Pic 16 Desc.	Water bar, sump, and ECDs are in acceptable and functional condition.

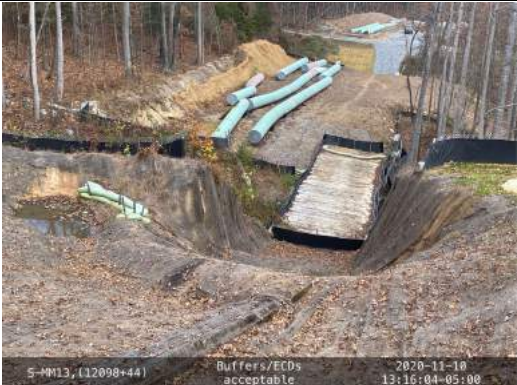
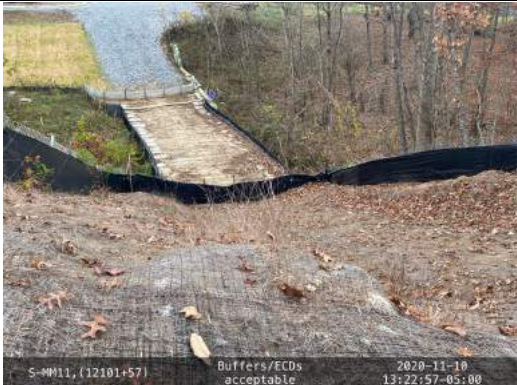
GPS Location	See photo GPS for location		GPS Location	See photo GPS for location	
Field Station#	12098+44		Field Station#	12101+57	
Pic 17 Desc.	ECDs, stream banks, and buffers are all in acceptable condition surrounding S-MM13.		Pic 18 Desc.	ECDs, stream banks, and buffers are all in acceptable condition surrounding S-MM11.

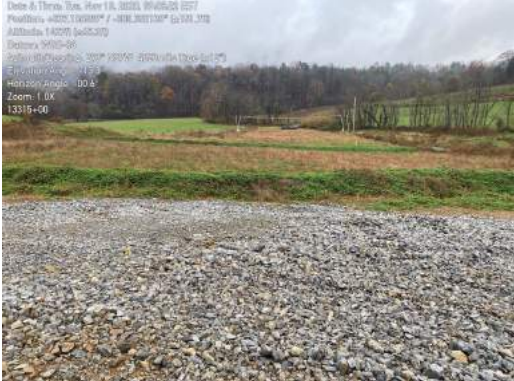
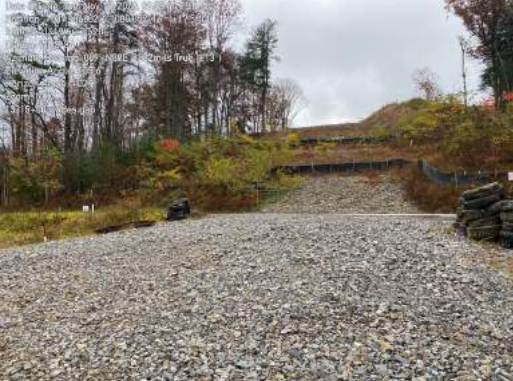
GPS Location	See photos for coordinates.		GPS Location	See photos for coordinates.	
Field Station#	13315+00		Field Station#	13315+00	
Pic 1 Desc.	ROW stable with acceptable vegetative cover across LOD.		Pic 2 Desc.	Wades Gap road crossing, RCE in a veot al condition.

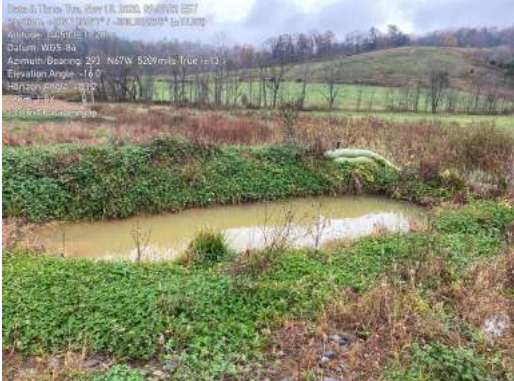
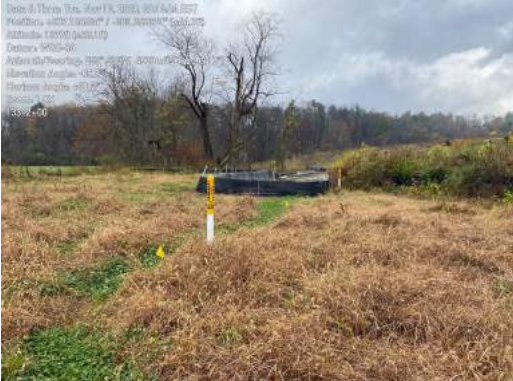
GPS Location	See photos for coordinates.		GPS Location	See photos for coordinates.	
Field Station#	13315+00		Field Station#	13312+00	
Pic 3 Desc.	Waterbar, sump and outlet functioning acceptably, no off ROW sediment noted.		Pic 4 Desc.	ROW stable with acceptable vegetative cover across LOD.

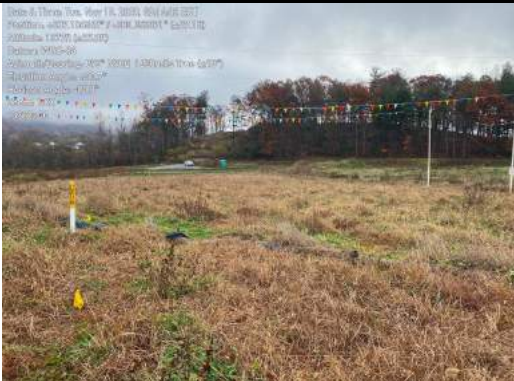
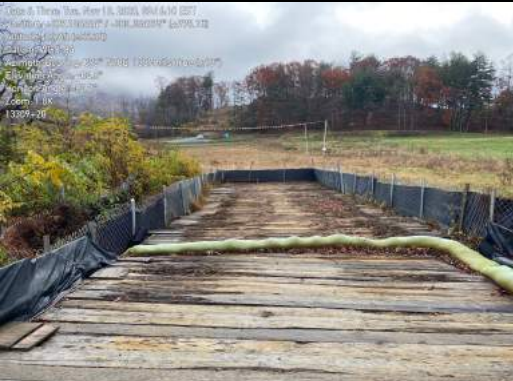
GPS Location	See photos for coordinates.		GPS Location	See photos for coordinates.	
Field Station#	13312+00		Field Station#	13309+20	
Pic 5 Desc.	ROW stable with acceptable vegetative cover across LOD.		Pic 6 Desc.	GAS of S-GH7, ECDs and bridge in acceptable condition.

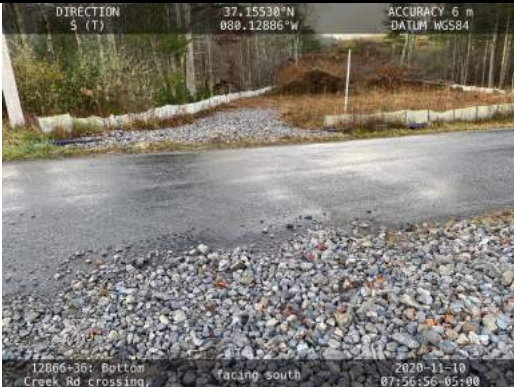
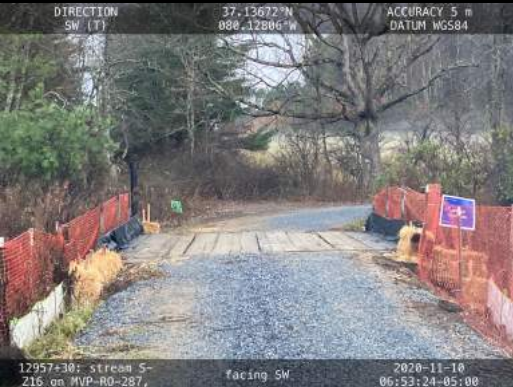
GPS Location	See photo		GPS Location	See photo	
Field Station#	12866+36		Field Station#	12957+30	
Pic 1 Desc.	Bottom Creek Road crossing, facing south		Pic 2 Desc.	Stream S-Z16 on access road MVP-RO-287, facing southwest

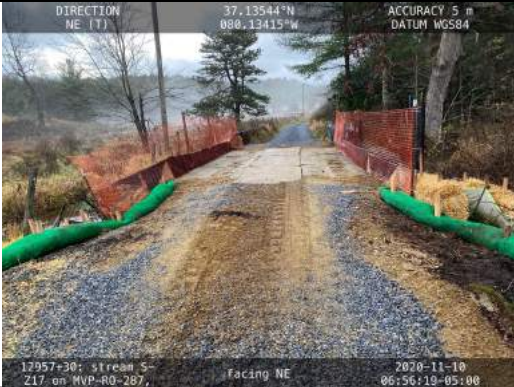
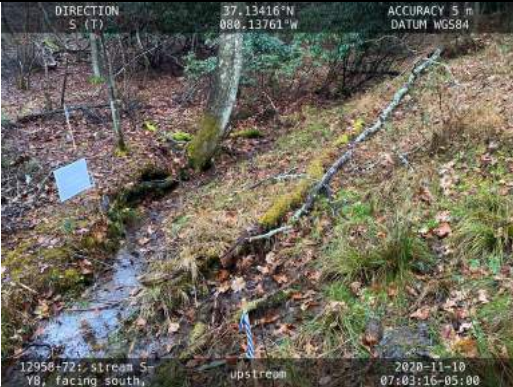
GPS Location	See photo		GPS Location	See photo	
Field Station#	12957+30		Field Station#	12958+72	
Pic 3 Desc.	Stream S-Z17 on access road MVP-RO-287, facing northeast		Pic 4 Desc.	Stream S-Y8, facing south, upstream

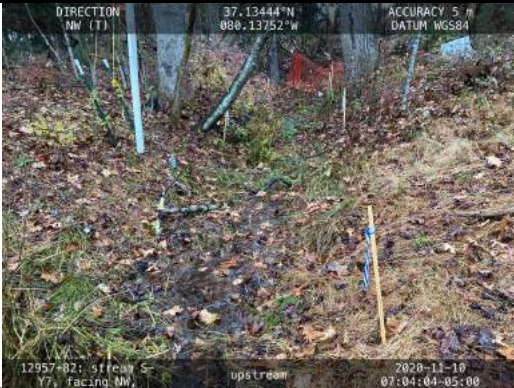
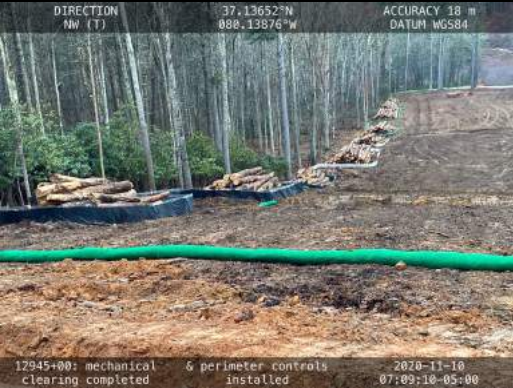
GPS Location	See photo		GPS Location	See photo	
Field Station#	12957+82		Field Station#	12945+00	
Pic 5 Desc.	Stream S-Y7, facing northwest, upstream		Pic 6 Desc.	Mechanical clearing has been completed between the buffer of stream S-IJ34 and MVP-RO-287, and perimeter ECDs installed

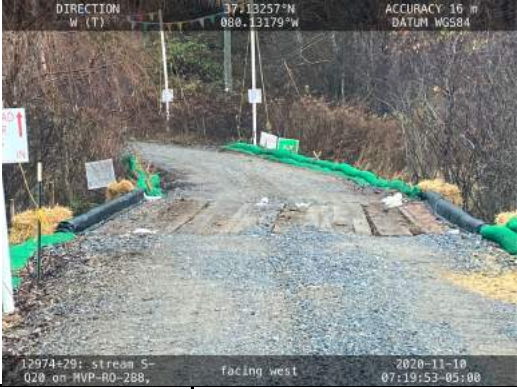
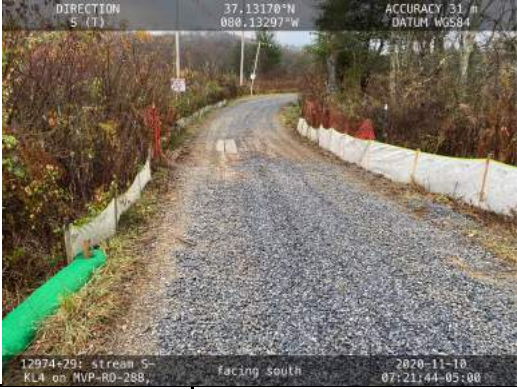
GPS Location	See photo		GPS Location	See photo	
Field Station#	12974+29		Field Station#	12974+29	
Pic 7 Desc.	Stream S-Q20 on access road MVP-RO-288, facing west		Pic 8 Desc.	Stream S-KL4 on access road MVP-RO-288, facing south

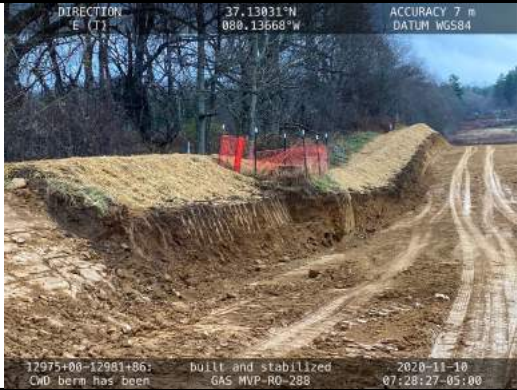
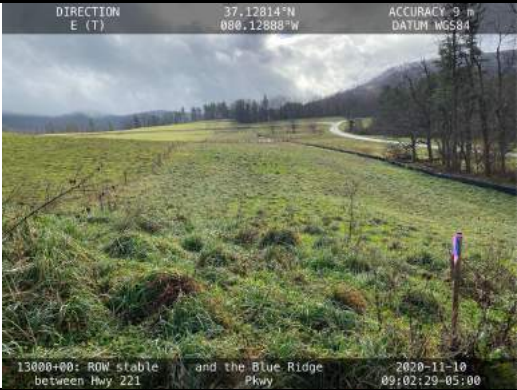
GPS Location	See photo		GPS Location	See photo	
Field Station#	12975+00		Field Station#	13000+00	
Pic 9 Desc.	Clean water diversion berm has been constructed and stabilized from ATWS-1309 to the end of disturbed ground at sta. 12981+86.		Pic 10 Desc.	ROW stable between Hwy 221 and the Blue Ridge Parkway.

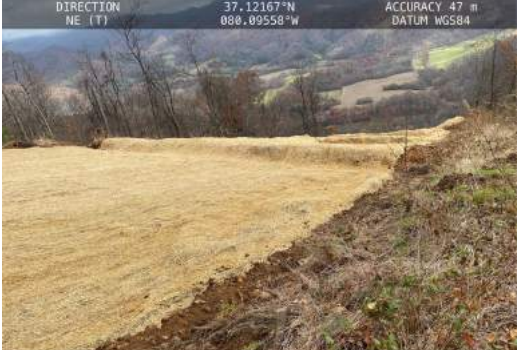
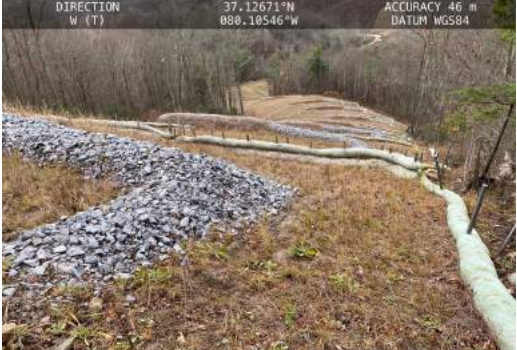
13116+00: ROW was re-stabilized after clearing finished @ GAS MVP-FR-291 2020-11-10 11:15:22-05:00		13080+00: ROW stable on steep slope between MVP-FR-290 & 291 2020-11-10 12:05:57-05:00			
GPS Location	See photo		GPS Location	See photo	
Field Station#	13116+00		Field Station#	13080+00	
Pic 13 Desc.	ROW was re-stabilized after mechanical clearing was finished for now on the going away side of access road MVP-FR-291.		Pic 14 Desc.	ROW stable on the long, steep hill between access roads MVP-FR-290 and 291.	
DIRECTION SW (T) 37.12696°N ACCURACY 20 m 088.11189°W DATUM WGS84

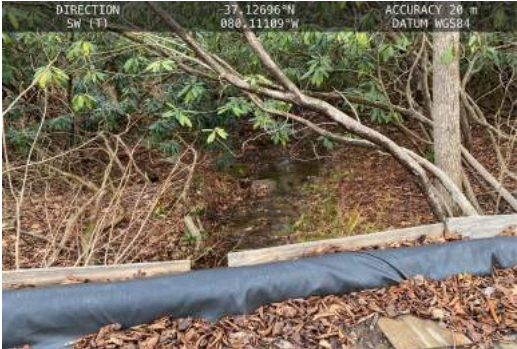
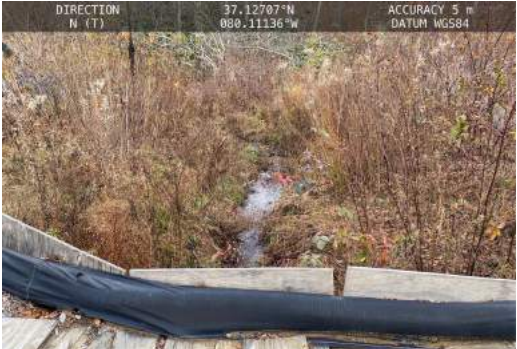
13062+96: stream S-G27 facing SW, downstream 2020-11-10 12:26:11-05:00		13061+89: stream S-G26, facing north, upstream 2020-11-10 12:26:54-05:00

GPS Location	See photo		GPS Location	See photo	
Field Station#	13062+96		Field Station#	13061+89	
Pic 15 Desc.	Stream S-G27, facing southwest, downstream		Pic 16 Desc.	Stream S-G26, facing north, upstream	
DIRECTION S (T) 37.12775°N ACCURACY 23 m 088.11672°W DATUM WGS84

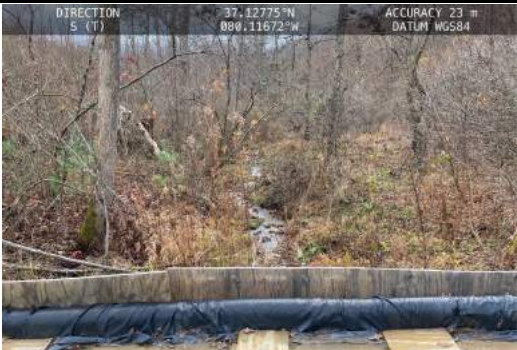
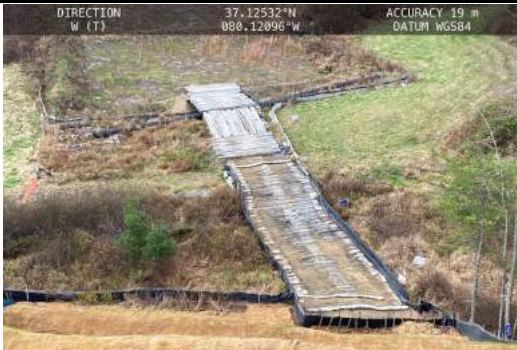
13042+58: stream S-H1, facing south, downstream 2020-11-10 12:46:58-05:00		13024+07: streams S-G24 and S-G25, facing west 2020-11-10 13:10:24-05:00			
GPS Location	See photo		GPS Location	See photo	
Field Station#	13042+58		Field Station#	13024+07	
Pic 17 Desc.	Stream S-H1, facing south, downstream		Pic 18 Desc.	Streams S-G24 and S-G25, facing west

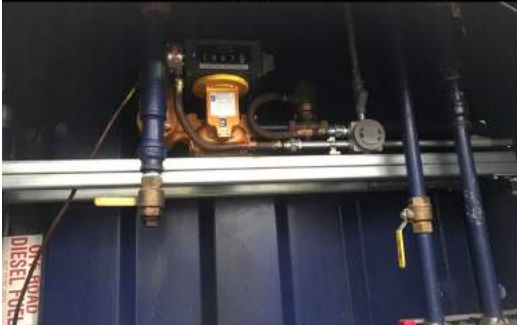
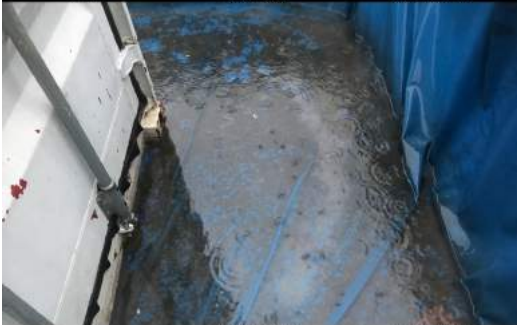
MVP-PY-006_111120 No leaky internal fittings 2020-11-11 07:22:10-05:00		DIRECTION NE (M) +37.23552° -080.22694° ACCURACY 16 ft DATUM WGS84

MVP-PY-006_111120 Condition of containment 2020-11-11 07:25:20-05:00			
GPS Location	MVP-PY-006 See photo for gps data		GPS Location	MVP-PY-006 See photo for gps data	
Field Station#	+0		Field Station#	+0	
Pic 7 Desc.	Blue Bulk Fuel tanks no leaky internal fittings. Looking W.		Pic 8 Desc.	Off Road Fuel unit containment. Holding stormwater. Looking W.	
DIRECTION W (M) +37.23558° -080.22699° ACCURACY 16 ft DATUM WGS84

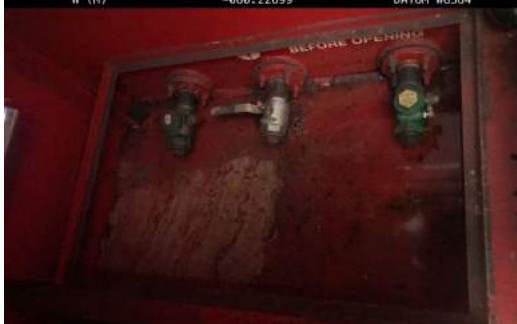
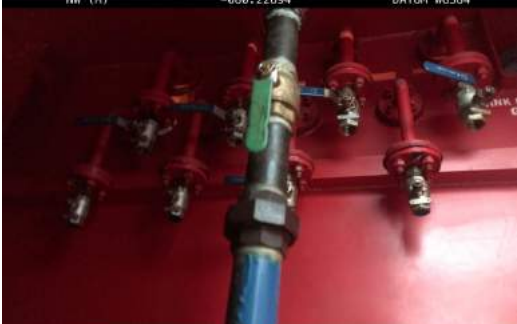
MVP-PY-006_111120 Condition of internal drip pan 2020-11-11 07:24:45-05:00		DIRECTION NW (M) +37.23555° -080.22694° ACCURACY 33 ft DATUM WGS84

MVP-PY-006_111120 No leaky internal fittings 2020-11-11 07:24:56-05:00

GPS Location	MVP-PY-006 See photo for gps data		GPS Location	MVP-PY-006 See photo for gps data	
Field Station#	+0		Field Station#	+0	
Pic 9 Desc.	Off Road Fuel unit internal drip pan pan holding some fluid. Looking W.		Pic 10 Desc.	Off Road Fuel unit no leaky internal fittings. Looking W.	
DIRECTION SE (M) +37.23544° -080.22677° ACCURACY 16 ft DATUM WGS84

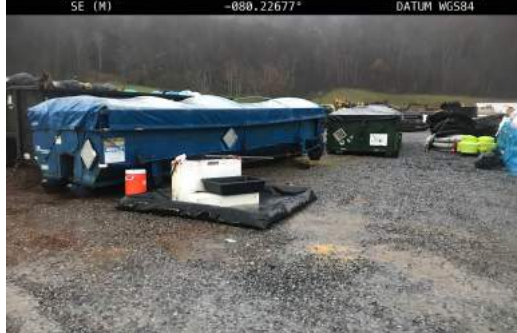
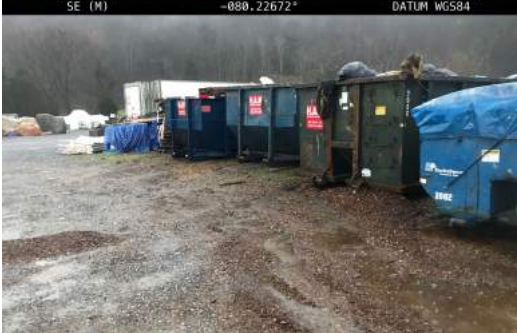
MVP-PY-006_111120 No deposits around hazardous waste ... 2020-11-11 07:26:15-05:00		DIRECTION SE (M) +37.23550° -080.22672° ACCURACY 16 ft DATUM WGS84

MVP-PY-006_111120 No loose trash around dumpsters 2020-11-11 07:26:23-05:00			
GPS Location	MVP-PY-006 See photo for gps data		GPS Location	MVP-PY-006 See photo for gps data	
Field Station#	+0		Field Station#	+0	
Pic 11 Desc.	No deposits around hazardous waste dumpsters. Looking SE.		Pic 12 Desc.	No loose trash around dumpsters. Looking SE.

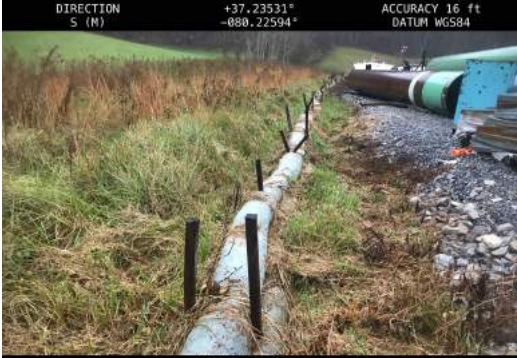
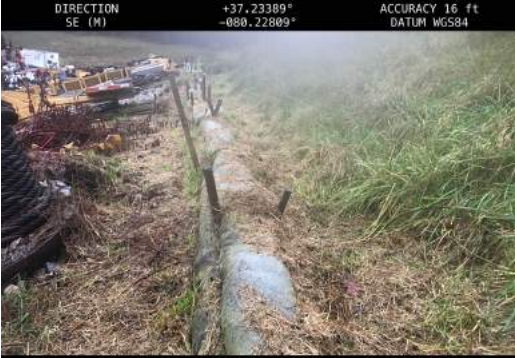
MVP-PY-006_111120 Condition of CF5 along LOD 2020-11-11 07:29:42-05:00		MVP-PY-006_111120 Condition of CF5 along LOD 2020-11-11 07:37:18-05:00			
GPS Location	MVP-PY-006 See photo for gps data		GPS Location	MVP-PY-006 See photo for gps data	
Field Station#	+0		Field Station#	+0	
Pic 13 Desc.	Condition of compost filter sock along east LOD. Looking S.		Pic 14 Desc.	Condition of compost filter sock along south LOD. Looking SE.

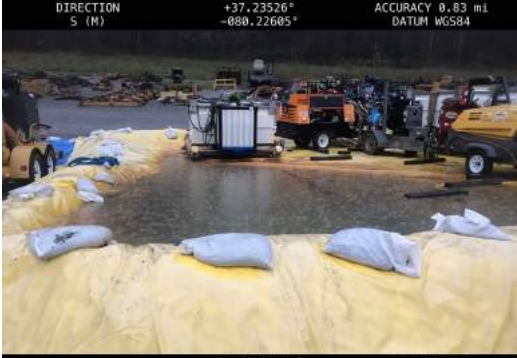
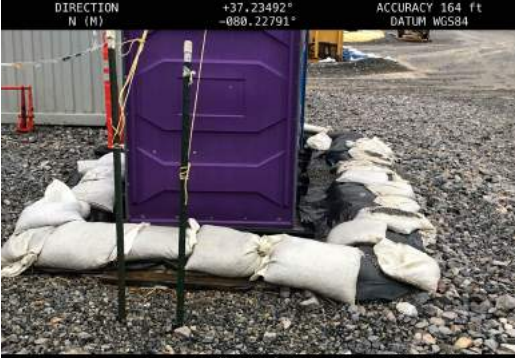
MVP-PY-006_111120 Condition of containment 2020-11-11 07:31:32-05:00		MVP-PY-006_111120 Condition of trays and containment 2020-11-11 07:44:32-05:00			
GPS Location	MVP-PY-006 See photo for gps data		GPS Location	MVP-PY-006 See photo for gps data	
Field Station#	+0		Field Station#	+0	
Pic 15 Desc.	Condition of containment. Holding storm water. No sheen noted. looking S.		Pic 16 Desc.	Condition of trays and containment under toilets. Looking N.

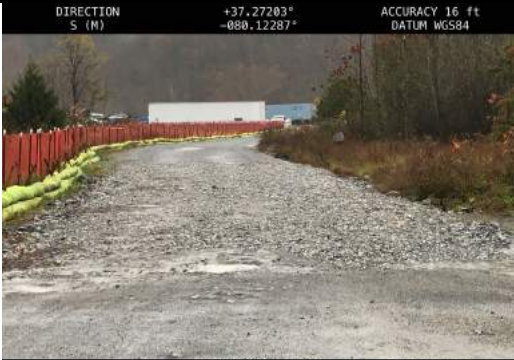
GPS Location	MVP-LY-049 See photo for gps data	GPS Location	MVP-LY-049 See photo for gps data		
Field Station#	+0	Field Station#	+0		
Pic 1 Desc.	Condition of rock entrance on center drive. No sediment on stone surface. Looking S.	Pic 2 Desc.	Condition of containment under light plant. Holding stormwater, no sheen noted. Looking S.

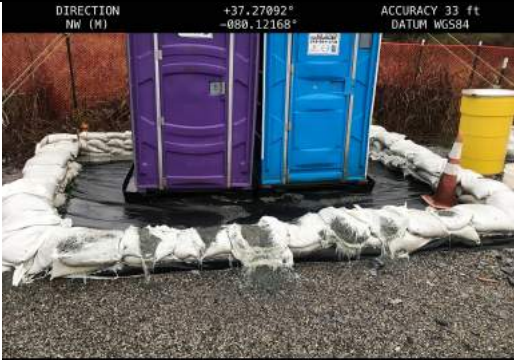
GPS Location	MVP-LY-049 See photo for gps data	GPS Location	MVP-LY-049 See photo for gps data		
Field Station#	+0	Field Station#	+0		
Pic 3 Desc.	Condition of trays and containment under toilets. Looking NW.	Pic 4 Desc.	Condition of compost filter sock and safety fence along feature W-CV21A. Looking W.

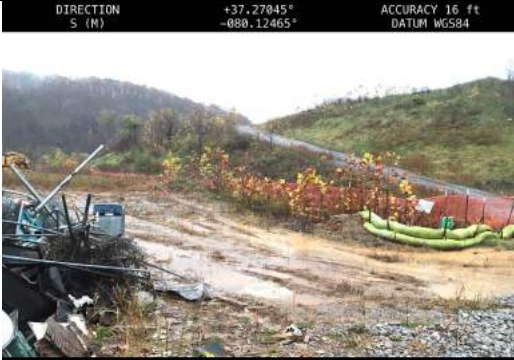
GPS Location	MVP-LY-049 See photo for gps data	GPS Location	MVP-LY-049 See photo for gps data		
Field Station#	+0	Field Station#	+0		
Pic 5 Desc.	Landowner soil disturbance along compost and feature W-CV21B. Area not stabilized. No impacts. Looking S.	Pic 6 Desc.	Landowner soil disturbance within 66' of feature W-CV21B. Area not stabilized. No impacts. Looking SW.

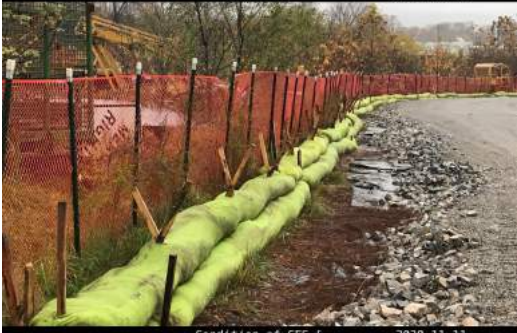
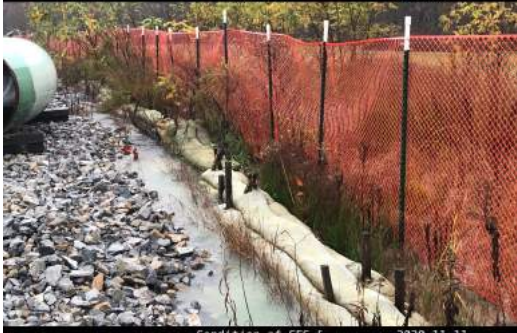
MVP-LY-049_111120 Condition of CFS & safety fence 2020-11-11 08:07:47-05:00		MVP-LY-049_111120 Condition of CFS & safety fence 2020-11-11 08:13:45-05:00			
GPS Location	MVP-LY-049 See photo for gps data		GPS Location	MVP-LY-049 See photo for gps data	
Field Station#	+0		Field Station#	+0	
Pic 7 Desc.	Condition of compost filter sock and safety fence along north LOD. Looking NE.		Pic 8 Desc.	Condition of compost filter sock and safety fence along south LOD. Looking SE.	
DIRECTION W (M) +37.26905° -080.12347° ACCURACY 16 ft DATUM WGS84

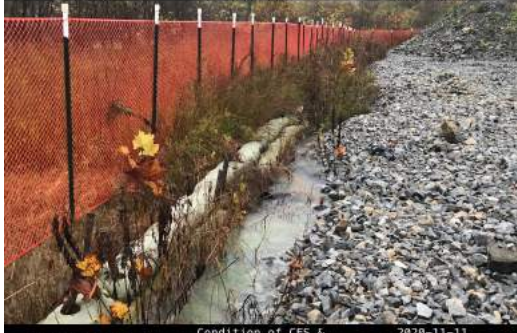
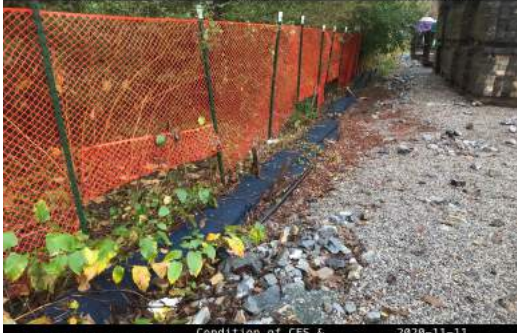
GPS Location	MVP-LY-049 See photo for gps data		GPS Location	MVP-LY-049 See photo for gps data	
Field Station#	+0		Field Station#	+0	
Pic 9 Desc.	Condition of compost filter sock and safety fence along south LOD. Looking W.		Pic 10 Desc.	Condition of compost filter sock and safety fence along east LOD. Looking SE.	
DIRECTION N (M) +37.27125° -080.12372° ACCURACY 16 ft DATUM WGS84

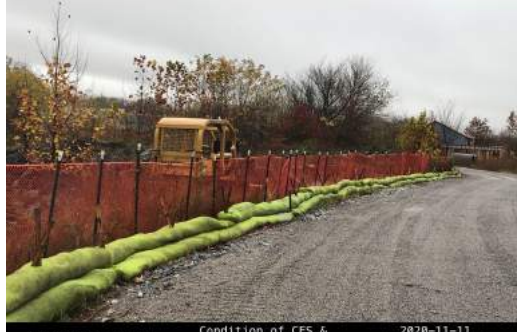
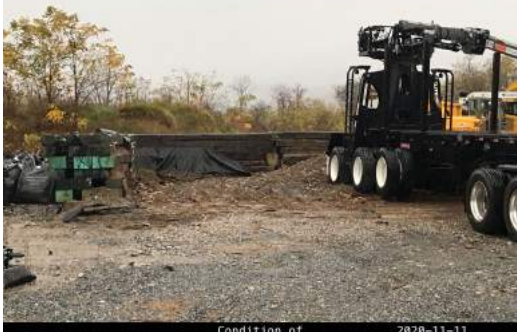
MVP-LY-049_111120 Condition of CFS & safety fence 2020-11-11 09:11:53-05:00		MVP-LY-049_111120 Condition of temporary trash 2020-11-11 08:08:34-05:00			
GPS Location	MVP-LY-049 See photo for gps data		GPS Location	MVP-LY-049 See photo for gps data	
Field Station#	+0		Field Station#	+0	
Pic 11 Desc.	Condition of compost filter sock and safety fence along north LOD. Looking NE.		Pic 12 Desc.	Condition of temporary trash transfer pit. most debris has been removed to landfill. Looking W.

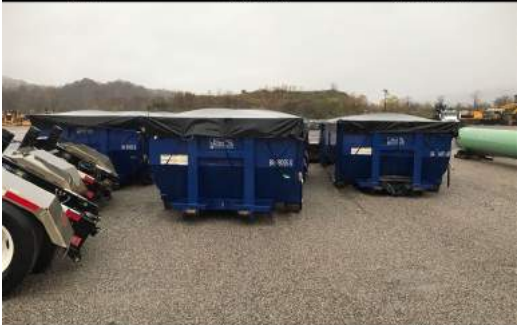
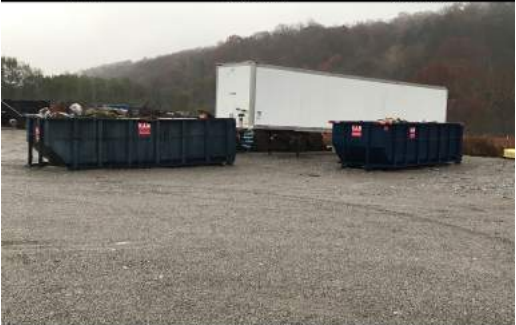
MVP-LY-049_111120 No deposits around hazardous waste ... 2020-11-11 08:09:30-05:00		MVP-LY-049_111120 No loose trash around south dumpsters 2020-11-11 08:10:34-05:00			
GPS Location	MVP-LY-049 See photo for gps data		GPS Location	MVP-LY-049 See photo for gps data	
Field Station#	+0		Field Station#	+0	
Pic 13 Desc.	No deposits around hazardous waste dumpsters. Looking SW.		Pic 14 Desc.	No loose trash around south dumpsters. Looking SE.	
DIRECTION W (M) +37.26926° -080.12359° ACCURACY 16 ft DATUM WGS84		DIRECTION S (M) +37.26946° -080.12439° ACCURACY 33 ft DATUM WGS84

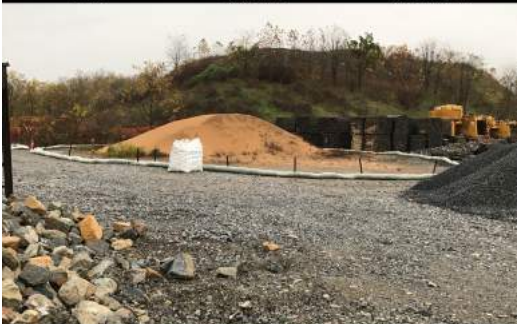
GPS Location	MVP-LY-049 See photo for gps data		GPS Location	MVP-LY-049 See photo for gps data	
Field Station#	+0		Field Station#	+0	
Pic 15 Desc.	Condition of compost filter sock around sand pile. Looking W.		Pic 16 Desc.	Condition of containment under stored equipment. Looking SE.	
DIRECTION SE (M) +37.27025° -080.12166° ACCURACY 33 ft DATUM WGS84		DIRECTION SE (M) +37.27003° -080.12178° ACCURACY 16 ft DATUM WGS84

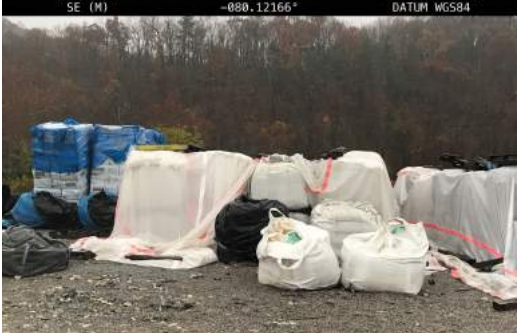
MVP-LY-049_111120 Restoration supplies needed covered 2020-11-11 08:19:53-05:00		MVP-LY-049_111120 Restoration supplies recovered 2020-11-11 12:29:52-05:00			
GPS Location	MVP-LY-049 See photo for gps data		GPS Location	MVP-LY-049 See photo for gps data	
Field Station#	+0		Field Station#	+0	
Pic 17 Desc.	Restoration supplies need to be recovered. Advised contractor. Looking SE.		Pic 18 Desc.	Restoration supplies recovered by contractor. Looking SE.

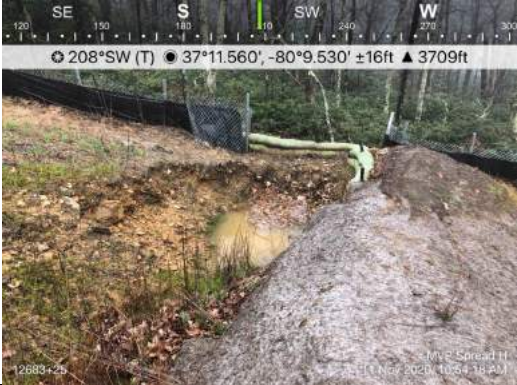
GPS Location	See Picture Watermark		GPS Location	See Picture Watermark	
Field Station#	12683+25		Field Station#	12638+24	
Pic 7 Desc.	Sump pit and waterbar end treatment in good condition and no maintenance is needed.		Pic 8 Desc.	MVP-RO-279.01 is in good condition and no maintenance to controls is needed.

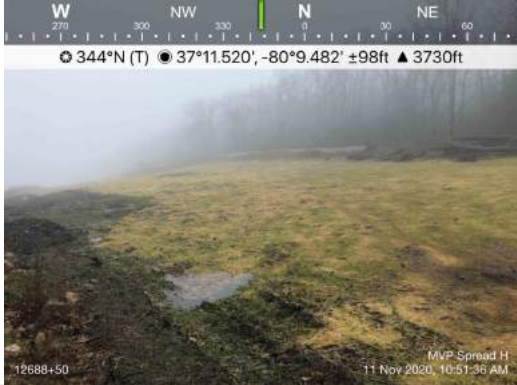
GPS Location	See Picture Watermark		GPS Location	See Picture Watermark	
Field Station#	12686+50		Field Station#	12639+00	
Pic 9 Desc.	Stabilization and seed germination continues to establish on CIS Honeysuckle Road.		Pic 10 Desc.	ROW remains well vegetated and no signs of accelerated erosion were observed.

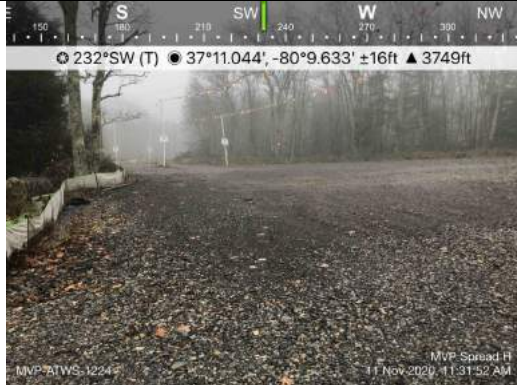
GPS Location	See Picture Watermark		GPS Location	See Picture Watermark	
Field Station#	12701+00		Field Station#	12701+00	
Pic 11 Desc.	MVP-ATWS-1224 is in good condition, and no material or equipment is stored here.		Pic 12 Desc.	MVP-ATWS-1225 is in good condition, and no material or equipment is stored here.

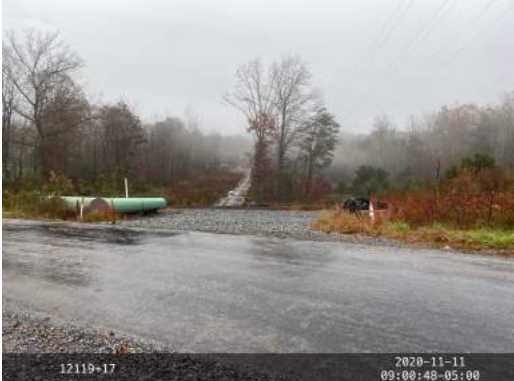
GPS Location	See photo GPS for location		GPS Location	See photo GPS for location	
Field Station#	12119+17		Field Station#	12120+00	
Pic 1 Desc.	RCE on GAS of Flatwoods Rd. is in acceptable condition with ECDs functioning.		Pic 2 Desc.	ECDs at W-C12, S-C33, S-C36, and W-C11 are all acceptable.

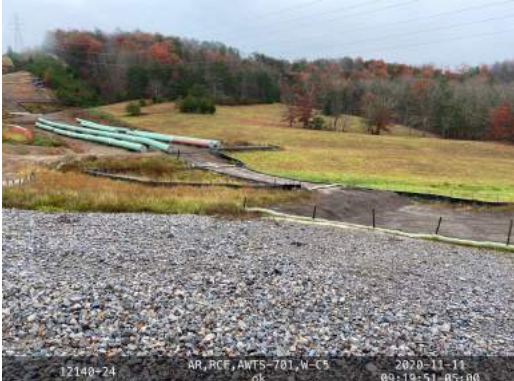
GPS Location	See photo GPS for location		GPS Location	See photo GPS for location	
Field Station#	12140+24		Field Station#	12146+00	
Pic 3 Desc.	MVP-MN-272, RCE, ATWS-701, and W-C5 are all in acceptable condition with ECDs functioning properly.		Pic 4 Desc.	This area is in acceptable condition with ECDs functioning properly.

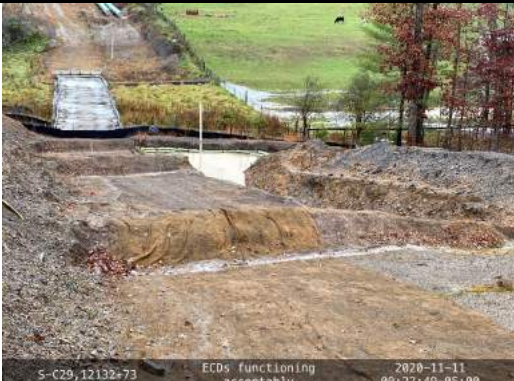
GPS Location	See photo GPS for location		GPS Location	See photo GPS for location	
Field Station#	12132+73		Field Station#	12133+12	
Pic 5 Desc.	S-C29 has stable banks and buffers. Surrounding ECDs are functioning acceptably.		Pic 6 Desc.	All ECDs in the area surrounding S-C29 are acceptable condition and functioning appropriately. No sediment leaving ROW.

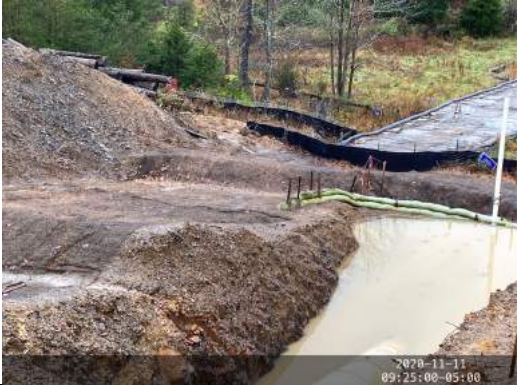
GPS Location	See photo GPS for location		GPS Location	See photo GPS for location	
Field Station#	12133+75		Field Station#	12153+28	
Pic 7 Desc.	All ECDs in the area surrounding S-C29 are acceptable condition and functioning appropriately. No sediment leaving ROW.		Pic 8 Desc.	CIS of MVP-MN-273 shows permanent restoration in acceptable condition. ECDs are acceptable and no sediment is leaving ROW.

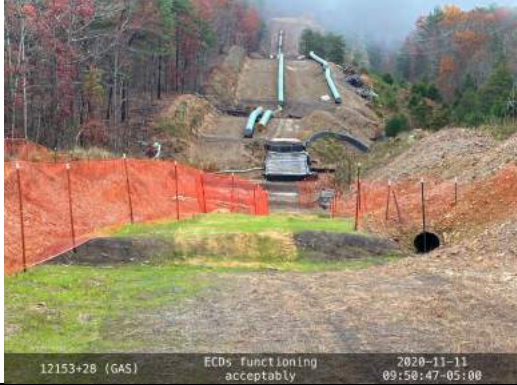
GPS Location	See photo GPS for location		GPS Location	See photo GPS for location	
Field Station#	12153+28		Field Station#	12190+75	
Pic 9 Desc.	Vegetation and ECDs are acceptable GAS of MVP-MN-273.		Pic 10 Desc.	Bradshaw Rd. and MVP-MN-274 intersection are in acceptable condition.

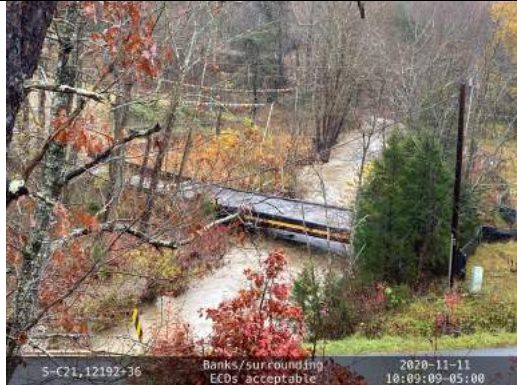
Pic 11 Desc.	Banks, buffers, and ECDs surrounding S-C21 are all in acceptable condition.		Pic 12 Desc.	ECDs are acceptable and functioning.

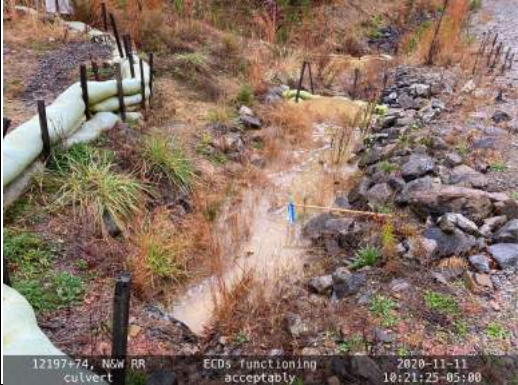
GPS Location	See photo GPS for location		GPS Location	See photo GPS for location	
Field Station#	12197+74		Field Station#	12199+90	
Pic 13 Desc.	ECDs are functioning properly at MVP-MN-275 culvert crossing GAS of N & W RR.		Pic 14 Desc.	Vegetation, water bars, and perimeter fencing are in acceptable condition.

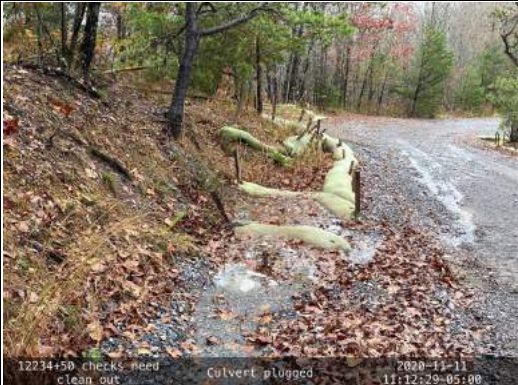
GPS Location	See photo GPS for location		GPS Location	See photo GPS for location	
Field Station#	12234+50		Field Station#	12234+50	
Pic 15 Desc.	This rilling and gully on MVP-MN-276.03 has been submitted to the punch list for maintenance.		Pic 16 Desc.	This undermined and over-topped sump on MVP-MN-276.03 has been put on the punch list for maintenance.

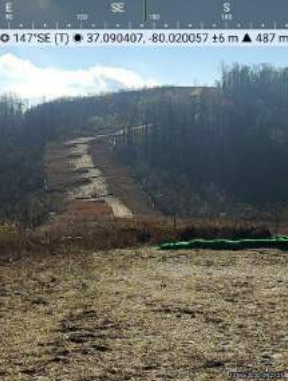
GPS Location	00000	GPS Location	00000		
Field Station#	13440+00	Field Station#	13437+75		
Pic 1 Desc.	Row photo taken by the EI during SWPPP inspection today showing ECDs in place and stabilization practices in place.		Pic 2 Desc.	The EI observed location of land owner activities where fire wood has been cut on row, the EI will continue to monitor for any issues.

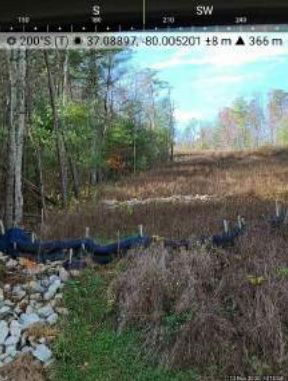
GPS Location	00000	GPS Location	00000		
Field Station#	13496+76	Field Station#	13437+75		
Pic 3 Desc.	EI monitored ECDs and rock outlet at Cahas #2 after recent flash floods , no environmental issues observed at time of inspection.		Pic 4 Desc.	EI noticed gravel washed from MVP-FR-293.02 into bar ditch along side Cahas Mountain road during flash flood events, documented and added to the punch

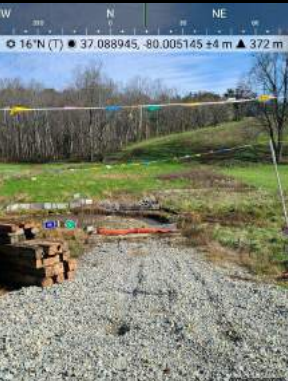
Field Station#	13497+78	Field Station#	13415+64		
Pic 5 Desc.	The EI monitored ECDs at stream crossing S-IJ10 where equipment mats were removed as maintenance repairs could not be completed at the time of removal. No		Pic 6 Desc.	The EI observed ECDs in place on hill side leading down to Cahas #1 , no environmental issues observed at the time of inspection.

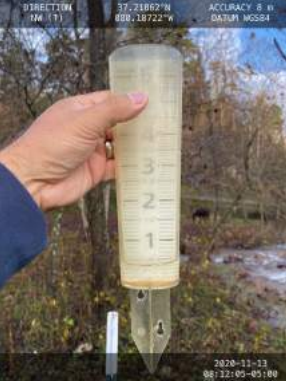
GPS Location	See photo		GPS Location	See photo	
Field Station#	12544+06		Field Station#	12544+06	
Pic 1 Desc.	0.5 inches of precipitation accumulated in the rain gauge at Yellow Finch Road from over the past 24 hours.		Pic 2 Desc.	Stream S-KL32, facing east, upstream from Yellow Finch Road

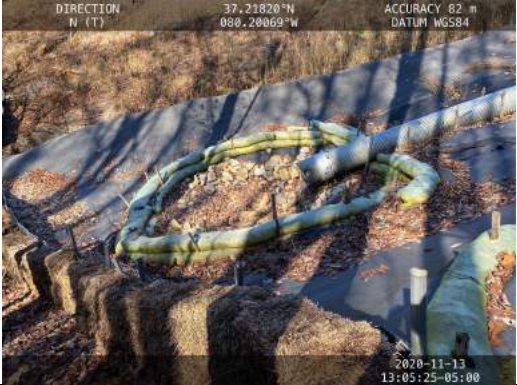
GPS Location	See photo		GPS Location	See photo	
Field Station#	12508+00		Field Station#	12503+70	
Pic 13 Desc.	Slope drain and it's outlet in satisfactory condition.		Pic 14 Desc.	Clean water diversion pipe outlet in good repair.

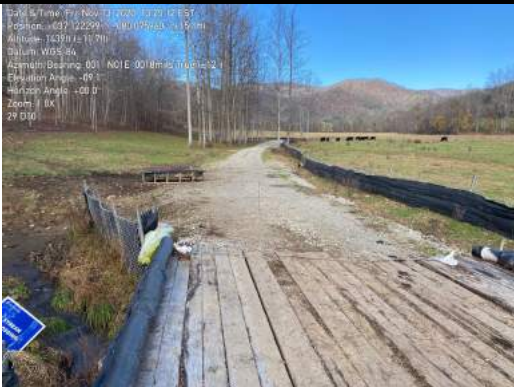
GPS Location	See photo for coordinates.		GPS Location	See photo for coordinates.	
Field Station#	13190+00		Field Station#	13190+00	
Pic 3 Desc.	MVP-AR-29, cattle noted in field, ECDs functioning acceptably.		Pic 4 Desc.	MVP-AR-29, S-D10, downstream, no impacted noted on stream banks or in stream channel.

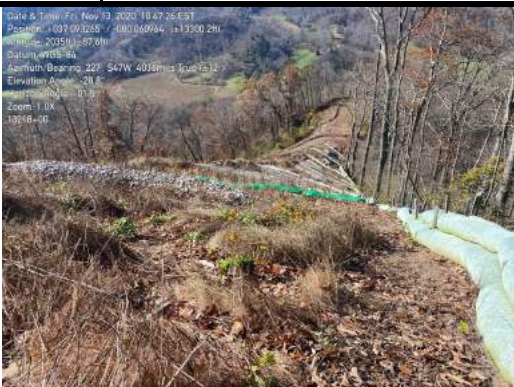
GPS Location	See photo for coordinates.		GPS Location	See photo for coordinates.	
Field Station#	13218+00		Field Station#	13218+00	
Pic 5 Desc.	ROW stable with acceptable vegetative cover across LOD.		Pic 6 Desc.	ROW stable with acceptable vegetative cover across LOD.

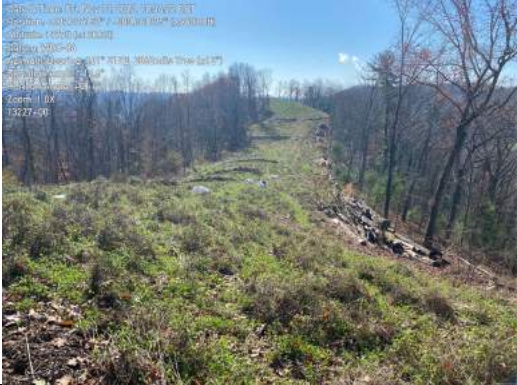
GPS Location	See photo for coordinates.		GPS Location	See photo for coordinates.	
Field Station#	13227+00		Field Station#	13243+00	
Pic 7 Desc.	ROW stable with acceptable vegetative cover across LOD.		Pic 8 Desc.	ROW stable with acceptable vegetative cover across LOD.

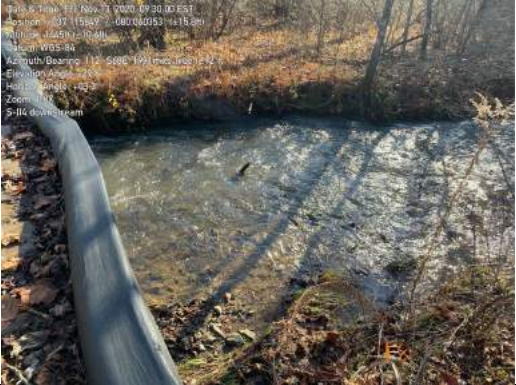
GPS Location	See photo for coordinates.		GPS Location	See photo for coordinates.	
Field Station#	13260+85		Field Station#	13260+60	
Pic 13 Desc.	Bridge across S-II4 in acceptable condition.		Pic 14 Desc.	S-II4, downstream, water slightly turbid, no stream impacts observed.
