Visual Site Inspection Report

Project Name	H-600 Pipeline Spread H	AFE	124300138	Spread	H-600 Pipeline Spread H
Contractor	Precision			Report #	16595
Inspector	Logan Box			Date/Time	11/9/2020 4:25 PM
Permit #	TBD	Inspection Type	VA SWPP	Station Begin	13415+51
State	VA	Inspection Area	Partial	Station End	13525+99
County	Franklin	Ground	Damp	Temperature (°F)	70.00
Municipality	N/A	Weather	Cloudy	Rain Gauge (in)	0.00
				Rain Accumulation Time (days)	0.00

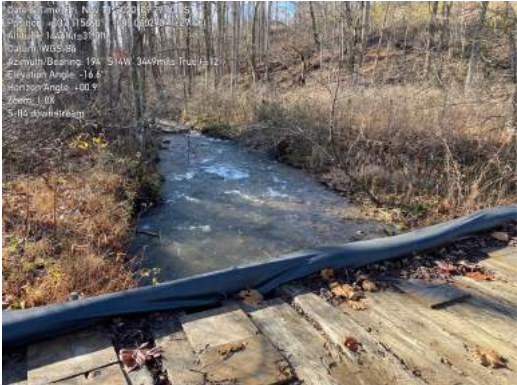
GPS Location	See photo for coordinates.		GPS Location	See photo for coordinates.	
Field Station#	13260+60		Field Station#	13260+60	
Pic 15 Desc.	S-II4, downstream, water slightly turbid, no stream impacts observed.		Pic 16 Desc.	No sediment noted in drainage channel in stream buffer.

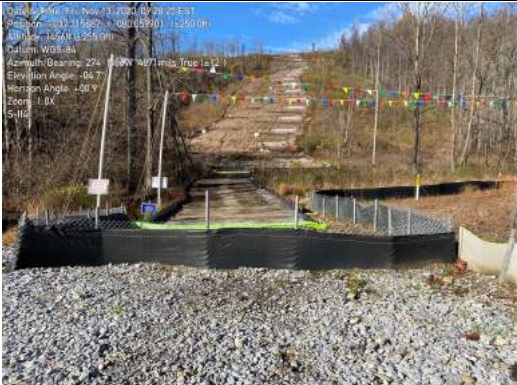
GPS Location	See photo for coordinates.		GPS Location	See photo for coordinates.	
Field Station#	13261+50		Field Station#	13262+50	
Pic 17 Desc.	S-II4, ECDs functioning acceptably.		Pic 18 Desc.	MVP-FR-293.01, Flanders Road, water flowing from off ROW drainage down road crossing on into ATWS-1055 as sheet flow.
