## Visual Site Inspection Report

<b>Project Name</b>	H-600 Pipeline Spread H	<b>AFE</b>	124300138	<b>Spread</b>	H-600 Pipeline Spread H
<b>Contractor</b>	Precision			<b>Report #</b>	14777
<b>Inspector</b>	Tammy Kruizenga			<b>Date/Time</b>	9/21/2020 12:56 PM
<b>Permit #</b>	TBD	<b>Inspection Type</b>	VA SWPP	<b>Station Begin</b>	12005+00
<b>State</b>	VA	<b>Inspection Area</b>	Partial	<b>Station End</b>	12119+17
<b>County</b>	Montgomery	<b>Ground</b>	Dry	<b>Temperature (°F)</b>	60.00
<b>Municipality</b>	N/A	<b>Weather</b>	Sunny	<b>Rain Gauge (in)</b>	0.00
				<b>Rain Accumulation Time (days)</b>	1.00

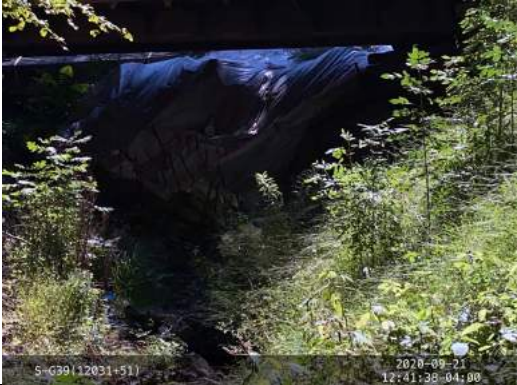
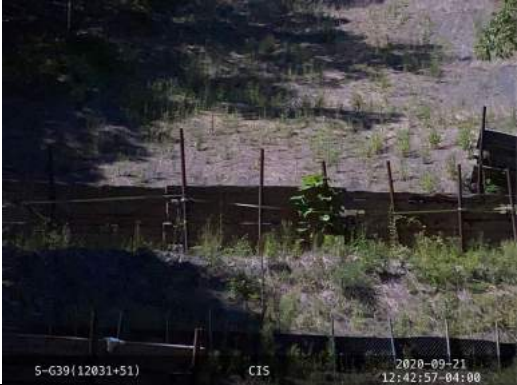
<b>GPS Location</b>	See photo GPS for location		<b>GPS Location</b>	See photo GPS for location	
<b>Field Station#</b>	12031+51		<b>Field Station#</b>	12031+51	
<b>Pic 7 Desc.</b>	All surrounding ECDs are acceptable.		<b>Pic 8 Desc.</b>	All surrounding ECDs are acceptable.

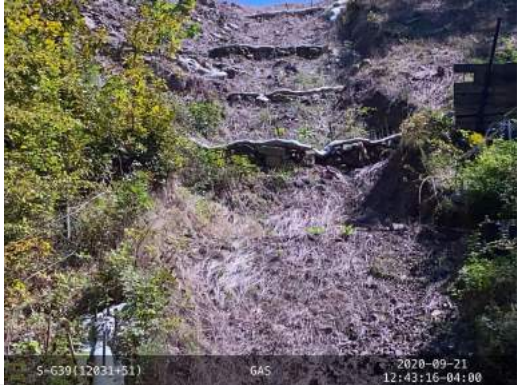
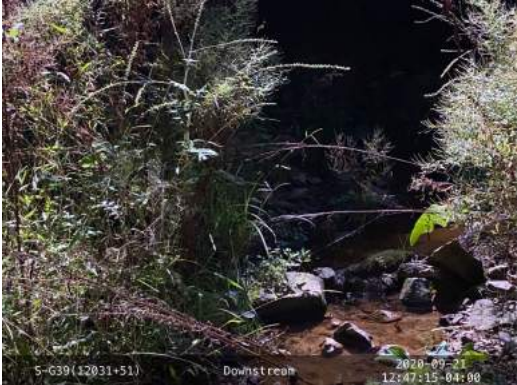
<b>GPS Location</b>	See photo GPS for location		<b>GPS Location</b>	See photo GPS for location	
<b>Field Station#</b>	12031+51		<b>Field Station#</b>	12031+51	
<b>Pic 9 Desc.</b>	All surrounding ECDs are acceptable.		<b>Pic 10 Desc.</b>	All surrounding ECDs are acceptable.

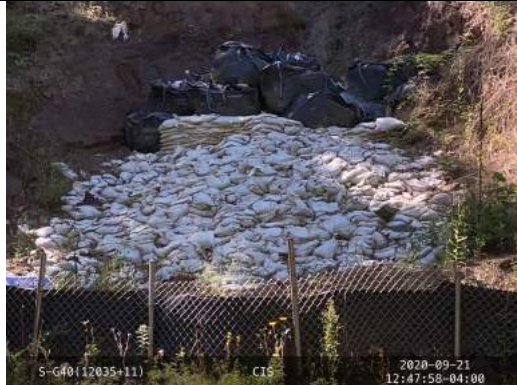
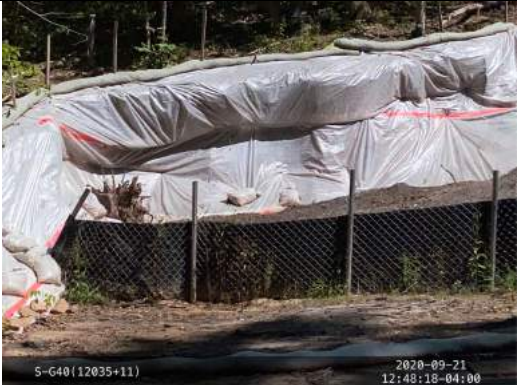
<b>GPS Location</b>	See photo GPS for location		<b>GPS Location</b>	See photo GPS for location	
<b>Field Station#</b>	12035+11		<b>Field Station#</b>	12035+11	
<b>Pic 11 Desc.</b>	All surrounding ECDs are acceptable.		<b>Pic 12 Desc.</b>	All surrounding ECDs are acceptable.

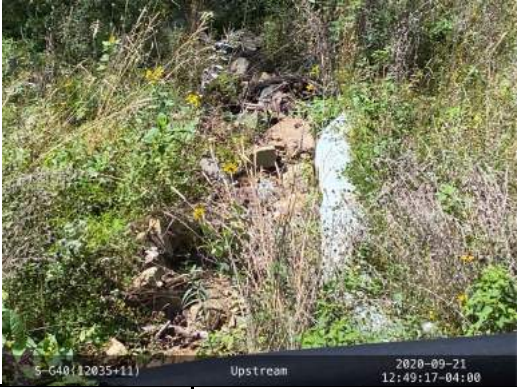
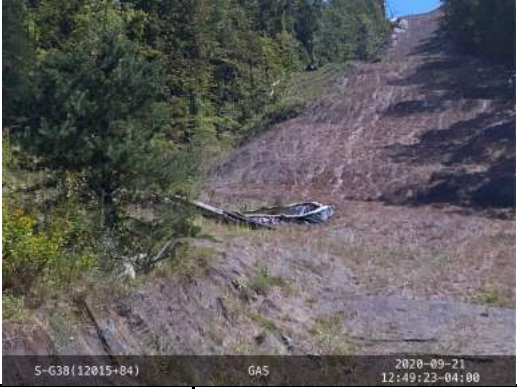
<b>GPS Location</b>	See photo GPS for location		<b>GPS Location</b>	See photo GPS for location	
<b>Field Station#</b>	12035+11		<b>Field Station#</b>	12015+84	
<b>Pic 13 Desc.</b>	All surrounding ECDs are acceptable.		<b>Pic 14 Desc.</b>	All surrounding ECDs are acceptable.

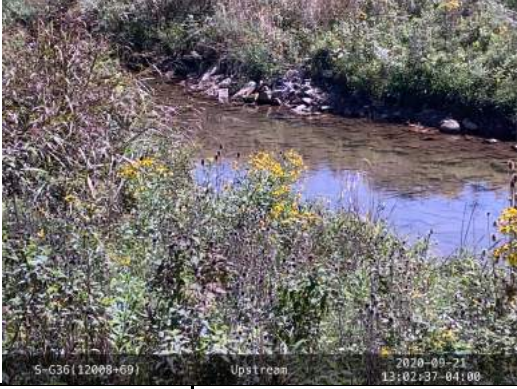
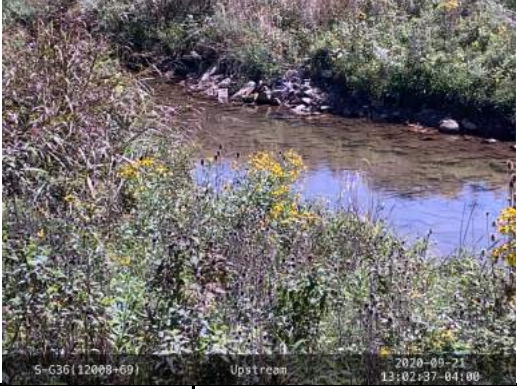
<b>GPS Location</b>	See photo GPS for location		<b>GPS Location</b>	See photo GPS for location	
<b>Field Station#</b>	12008+69		<b>Field Station#</b>	12008+69	
<b>Pic 15 Desc.</b>	All surrounding ECDs are acceptable.		<b>Pic 16 Desc.</b>	All surrounding ECDs are acceptable.

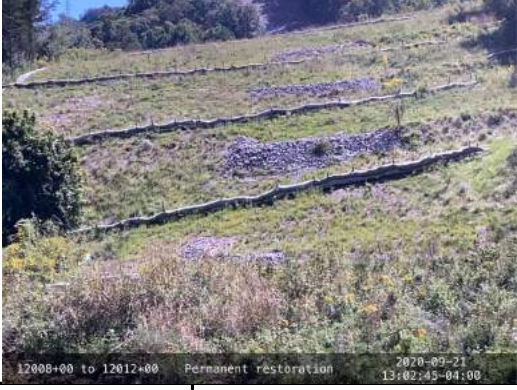
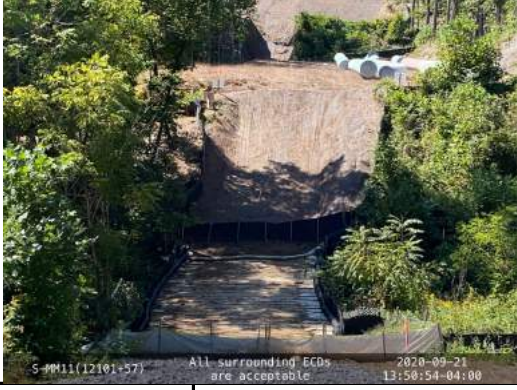
<b>GPS Location</b>	See photo GPS for location		<b>GPS Location</b>	See photo GPS for location	
<b>Field Station#</b>	12010+00		<b>Field Station#</b>	12101+57	
<b>Pic 17 Desc.</b>	All surrounding ECDs are acceptable.		<b>Pic 18 Desc.</b>	All surrounding ECDs are acceptable.

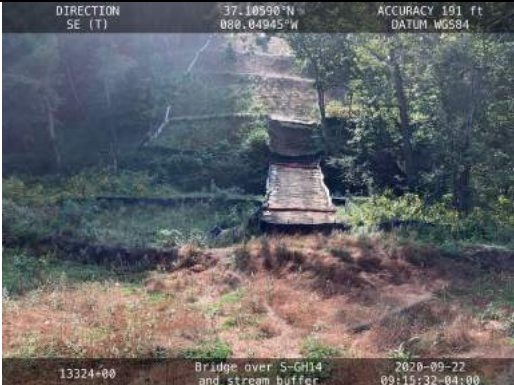
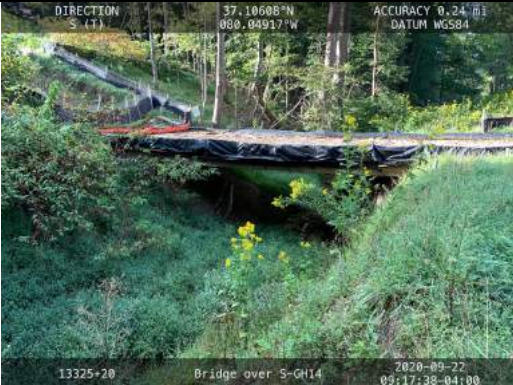
<b>GPS Location</b>	See photo for gps location data.		<b>GPS Location</b>	See photo for gps location data.	
<b>Field Station#</b>	13324+00		<b>Field Station#</b>	13325+20	
<b>Pic 3 Desc.</b>	Photo shows the bridge over stream S-GH14 and adjacent stream buffer.		<b>Pic 4 Desc.</b>	Photo shows the bridge over stream S-GH14.

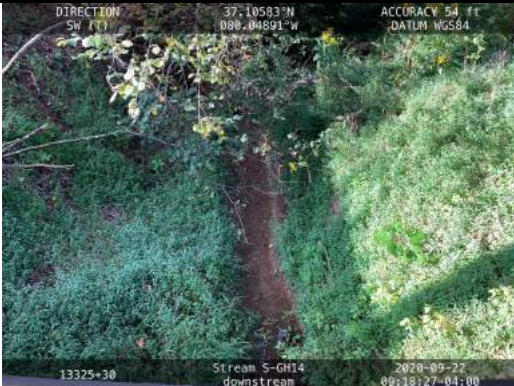
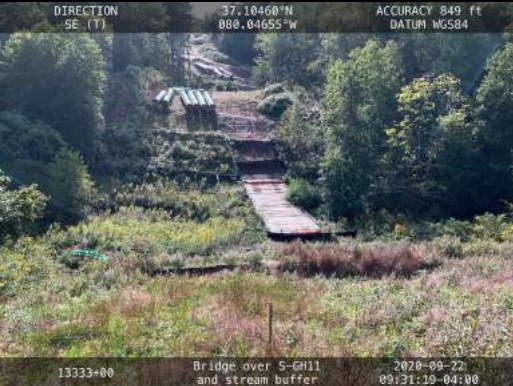
<b>Pic 5 Desc.</b>	Photo shows stream S-GH14 downstream from the bridge.		<b>Pic 6 Desc.</b>	Photo shows the bridge over stream S-GH11 and adjacent stream buffer.

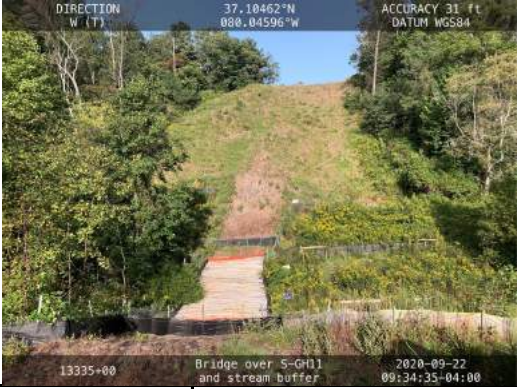
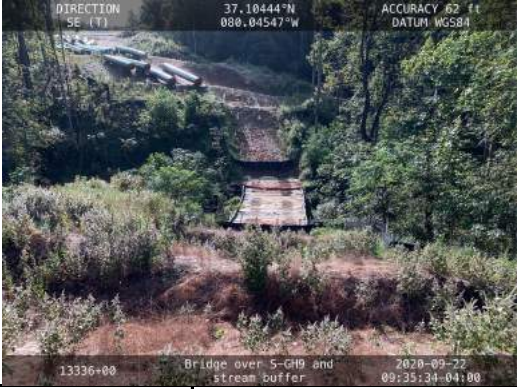
<b>GPS Location</b>	See photo for gps location data.		<b>GPS Location</b>	See photo for gps location data.	
<b>Field Station#</b>	13335+00		<b>Field Station#</b>	13336+00	
<b>Pic 7 Desc.</b>	Photo shows the bridge over stream S-GH11 and adjacent stream buffer.		<b>Pic 8 Desc.</b>	Photo shows the bridge over stream S-GH9 and adjacent stream buffer.

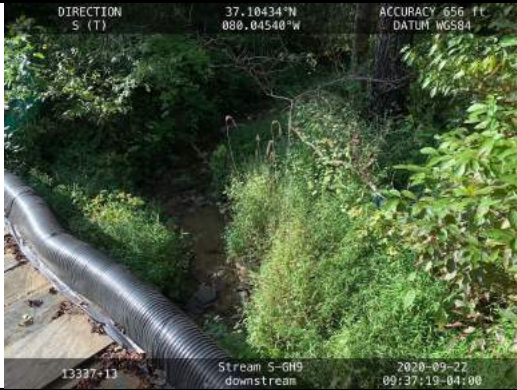
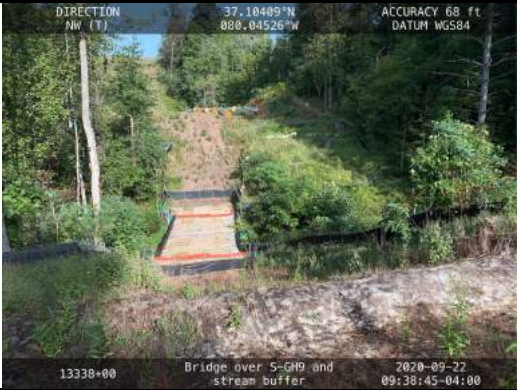
<b>GPS Location</b>	See photo for gps location data.		<b>GPS Location</b>	See photo for gps location data.	
<b>Field Station#</b>	13337+13		<b>Field Station#</b>	13338+00	
<b>Pic 9 Desc.</b>	Photo shows stream S-GH9 downstream from the bridge.		<b>Pic 10 Desc.</b>	Photo shows the bridge over stream S-GH9 and adjacent stream buffer.

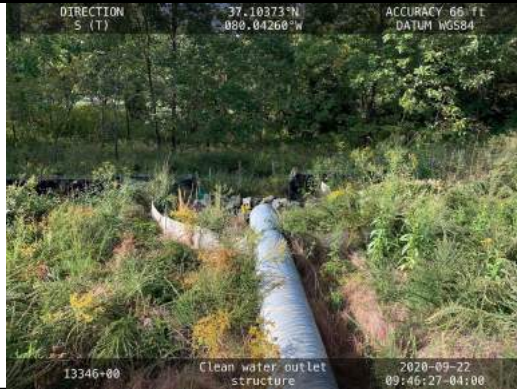
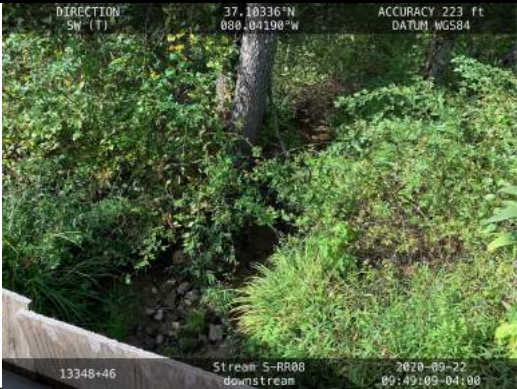
<b>Field Station#</b>	13346+00		<b>Field Station#</b>	13348+46	
<b>Pic 11 Desc.</b>	Photo shows the clean water outlet structure.		<b>Pic 12 Desc.</b>	Photo shows stream S-RR08 downstream from the bridge.

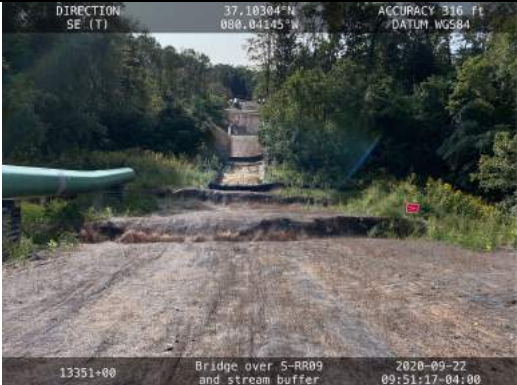
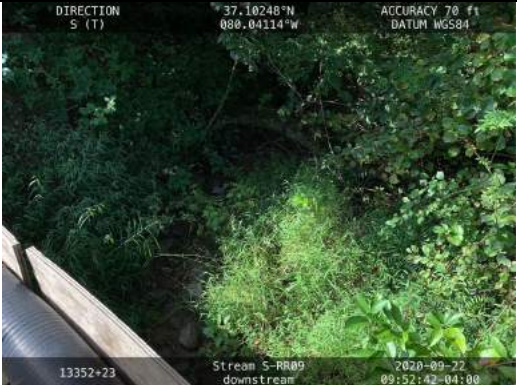
<b>GPS Location</b>	See photo for gps location data.		<b>GPS Location</b>	See photo for gps location data.	
<b>Field Station#</b>	13351+00		<b>Field Station#</b>	13352+23	
<b>Pic 13 Desc.</b>	Photo shows the bridge over stream S-RR09 and adjacent stream buffer.		<b>Pic 14 Desc.</b>	Photo shows stream S-RR09 downstream from the bridge.

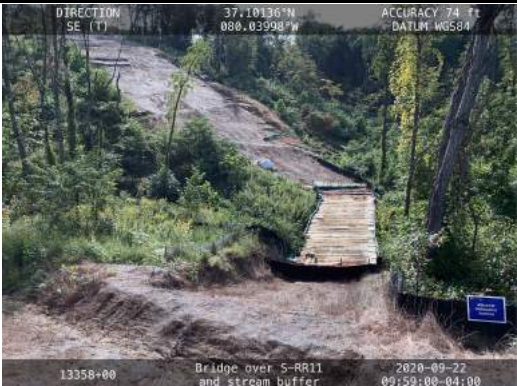
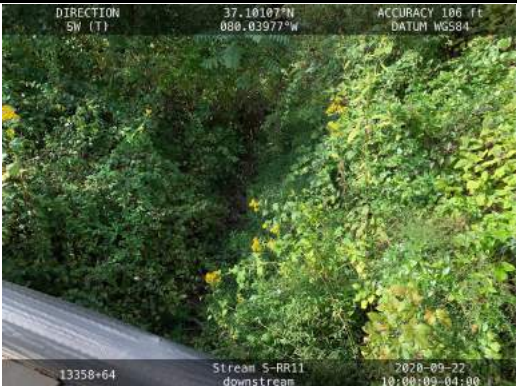
<b>GPS Location</b>	See photo for gps location data.		<b>GPS Location</b>	See photo for gps location data.	
<b>Field Station#</b>	13358+00		<b>Field Station#</b>	13358+64	
<b>Pic 15 Desc.</b>	Photo shows the bridge over stream S-RR11 and adjacent stream buffer.		<b>Pic 16 Desc.</b>	Photo shows stream S-RR11 downstream from the bridge.

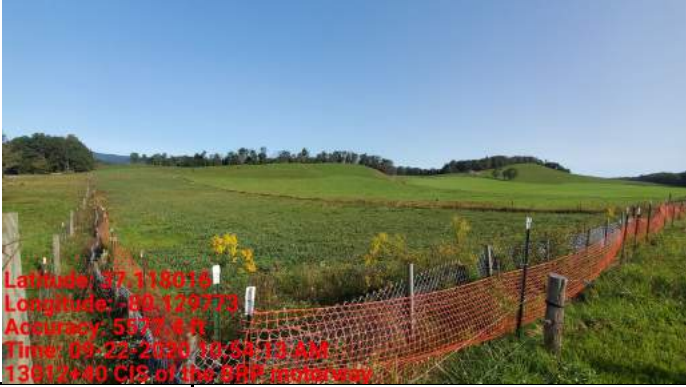
<p>Latitude: 37.118018 Longitude: -88.129773 Accuracy: 5975.8 ft Time: 09-22-2020 10:54:13 AM 13012+40 CIS of the BRP motorway</p>

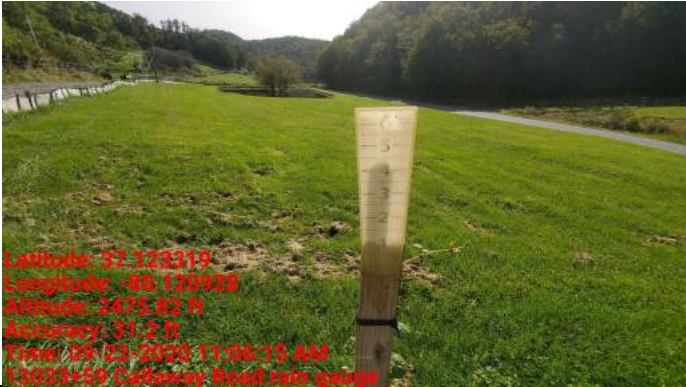
<p>Latitude: 37.123219 Longitude: -88.120928 Altitude: 2475.82 ft Accuracy: 31.2 ft Time: 09-22-2020 11:04:19 AM 13033+59 Callaway Road rain gauge</p>

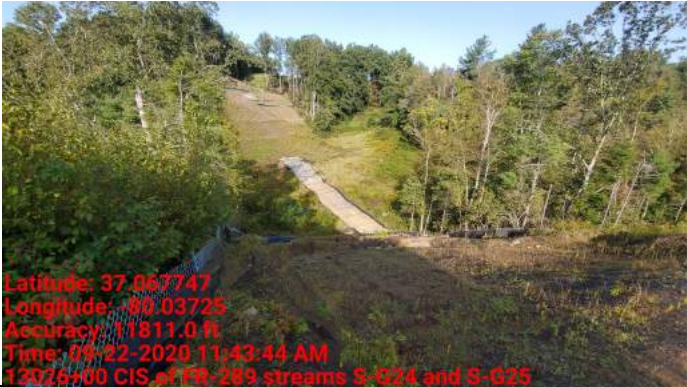
<p>Latitude: 37.067747 Longitude: -88.03725 Accuracy: 11811.0 ft Time: 09-22-2020 11:43:44 AM 13026+00 CIS of FR-289 streams S-G24 and S-G25</p>

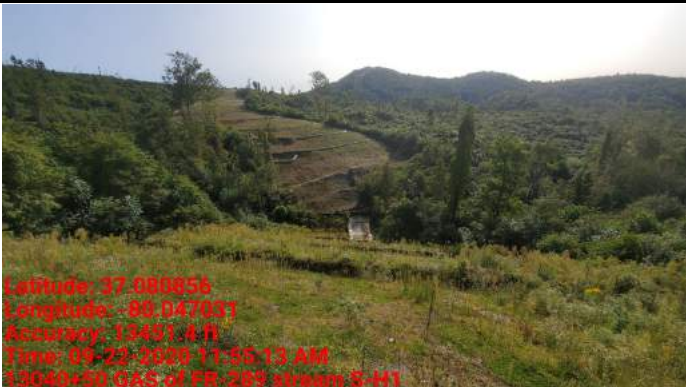
<p>Latitude: 37.088858 Longitude: -88.047831 Accuracy: 13421.4 ft Time: 09-22-2020 11:55:13 AM 13040+50 GAS of FR-289 stream S-H1</p>

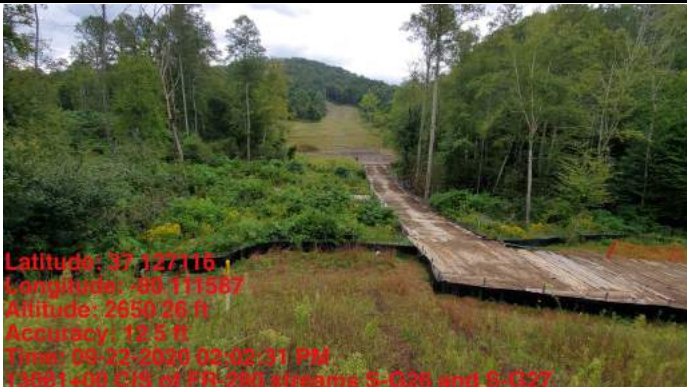
<p>Latitude: 37.127116 Longitude: -88.111587 Altitude: 2650.26 ft Accuracy: 12.5 ft Time: 09-22-2020 02:02:31 PM 13061+00 CIS of FR-289 streams S-G26 and S-G27</p>			
<b>GPS Location</b>	See pic for GPS location		<b>GPS Location</b>	See pic for GPS location	
<b>Field Station#</b>	13040+50		<b>Field Station#</b>	13061+00	
<b>Pic 17 Desc.</b>	Stream S-H1 on the GAS of access road FR-289.		<b>Pic 18 Desc.</b>	Streams S-G26 and S-G27 on the GAS of access road FR-290.

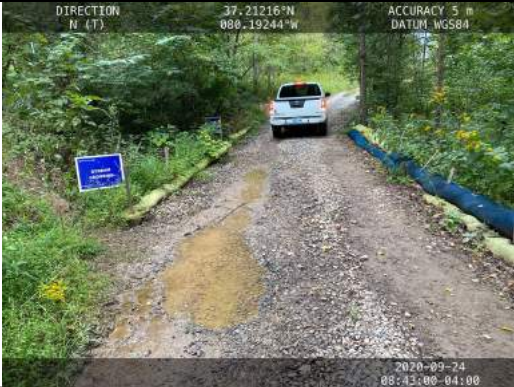
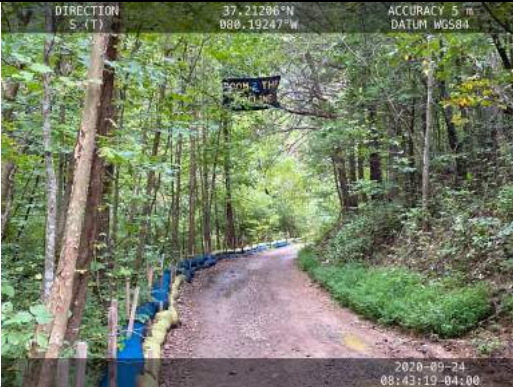
<b>GPS Location</b>	See photo		<b>GPS Location</b>	See photo	
<b>Field Station#</b>	12543+56		<b>Field Station#</b>	12543+56	
<b>Pic 3 Desc.</b>	Stream S-EF54 at Yellow Finch Road, facing north		<b>Pic 4 Desc.</b>	Yellow Finch Road near the ROW crossing

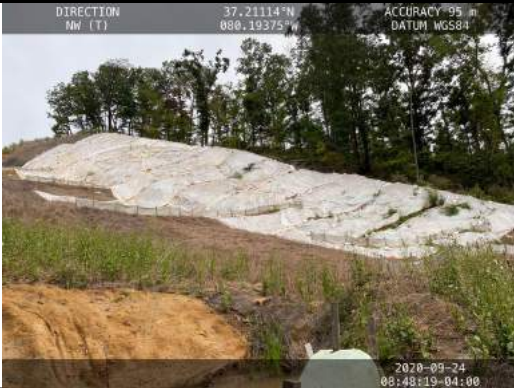
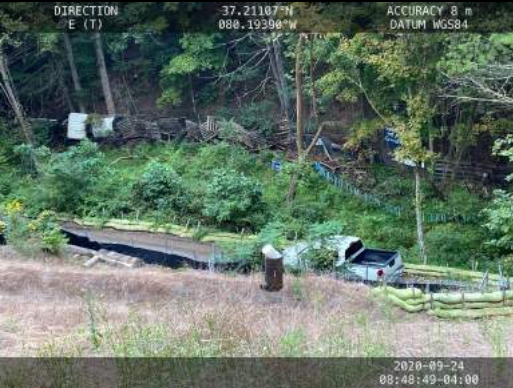
<b>GPS Location</b>	See photo		<b>GPS Location</b>	See photo	
<b>Field Station#</b>	12543+00		<b>Field Station#</b>	12543+56	
<b>Pic 5 Desc.</b>	The plastic sheeting on the stockpile nearest to Yellow Finch Road remains intact and secure.		<b>Pic 6 Desc.</b>	Yellow Finch Road crossing as viewed from the slope on the coming in side of the road.

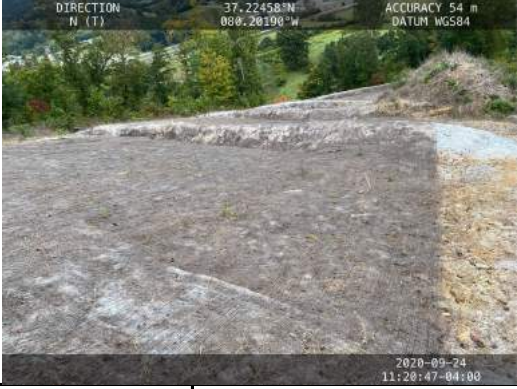
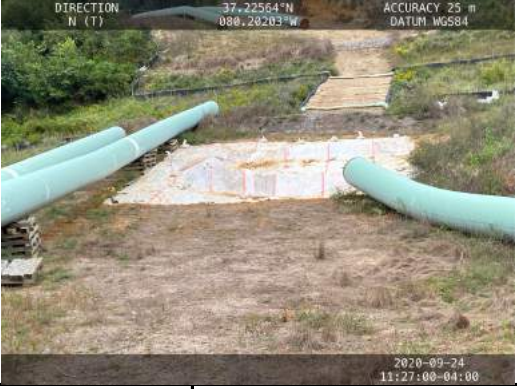
<b>GPS Location</b>	See photo		<b>GPS Location</b>	See photo	
<b>Field Station#</b>	12486+00		<b>Field Station#</b>	12482+00	
<b>Pic 15 Desc.</b>	ROW stable		<b>Pic 16 Desc.</b>	Plastic sheeting remains intact and secure where it cover the "pig parts" excavation site.

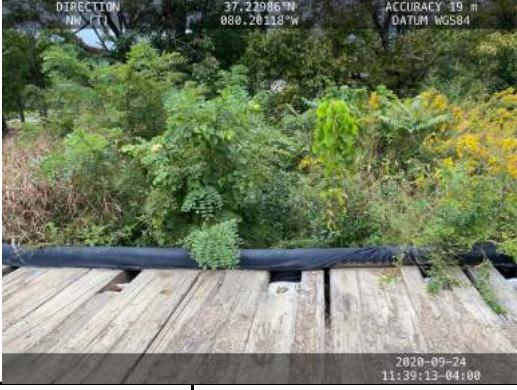
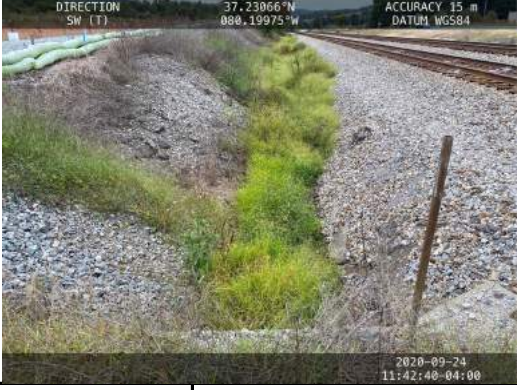
<b>GPS Location</b>	See photo		<b>GPS Location</b>	See photo	
<b>Field Station#</b>	12455+21		<b>Field Station#</b>	12444+94	
<b>Pic 17 Desc.</b>	Stream S-CD12, facing northwest, downstream		<b>Pic 18 Desc.</b>	Stream S-I1, facing southwest, upstream

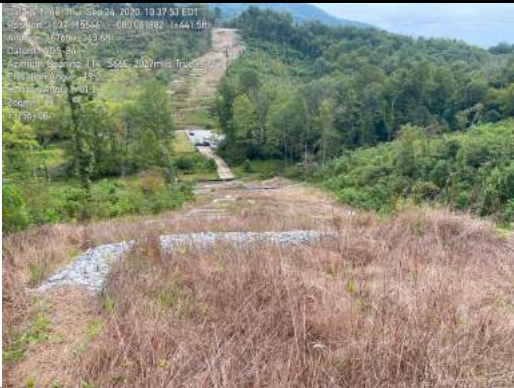
<b>GPS Location</b>	See photo for coordinates.		<b>GPS Location</b>	See photo for coordinates.	
<b>Field Station#</b>	13260+60		<b>Field Station#</b>	13260+50	
<b>Pic 3 Desc.</b>	S-II4, upstream, no changes noted to steam bed or banks.		<b>Pic 4 Desc.</b>	CIS S-II4, ROW stable with vegetation across LOD.

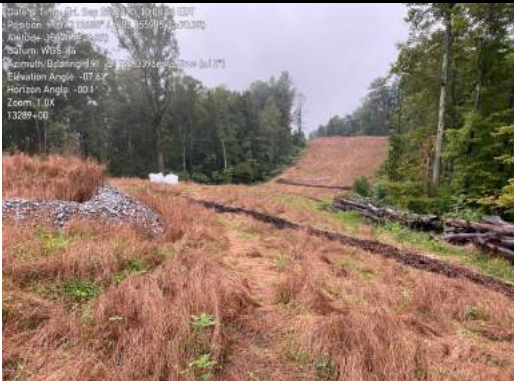
<b>GPS Location</b>	See photo for coordinates.		<b>GPS Location</b>	See photo for coordinates.	
<b>Field Station#</b>	13271+00		<b>Field Station#</b>	13276+00	
<b>Pic 3 Desc.</b>	ROW stable with acceptable vegetation across LOD.		<b>Pic 4 Desc.</b>	ROW stable with acceptable vegetation across LOD.
